**Flood Control Project Maintenance
Levee Inspections**
LMA District Cover Sheet
Spring 2016 Levee Inspection Results

Reclamation District No. 2095 Paradise Cut

Spring 2016 Levee Inspection Results

Waterway	Bank	Unit Miles
Unit No. 01 Paradise Cut	Left	1.45

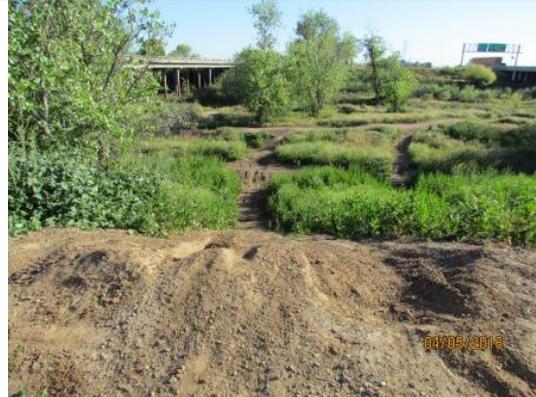
Photo 1 of 1 : SP_2016_RD2095_322_3_20160412_00025.jpg

LM Start	0.07	Rating **	M	Issue No.	3
LM End	0.07	Issue Type +	Ma	Location *	WS
Category	Earthen Levee		GPS Latitude/Longitude		
			Start	End	
Item	Slope Stability		37.770544 °	37.770544 °	
			-121.326193 °	-121.326193 °	
DWR ID	DWR_RD2095_01_s_2016_3				
Comment Code					
S3 : Repair the levee slope damaged by vehicle traffic and prevent access where possible.					
Inspector Comment

View of the vehicle tracks on the waterside levee slope.

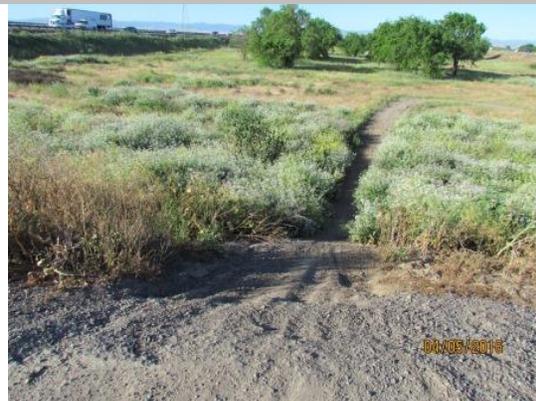
Photo 1 of 1 : SP_2016_RD2095_322_12_20160412_00026.jpg

LM Start	0.09	Rating **	M	Issue No.	12
LM End	0.09	Issue Type +	Ma	Location *	LS
Category	Earthen Levee		GPS Latitude/Longitude		
			Start	End	
Item	Slope Stability		37.770429 °	37.770429 °	
			-121.325986 °	-121.325986 °	
DWR ID	DWR_RD2095_01_s_2016_12				
Comment Code					
S3 : Repair the levee slope damaged by vehicle traffic and prevent access where possible.					
Inspector Comment

View of the vehicle tracks on the landside levee slope.

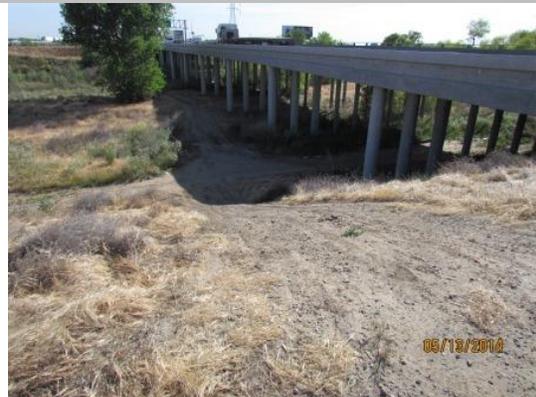
Photo 1 of 1 : SP_2016_RD2095_322_134_20160229_00010.jpg

LM Start	0.11	Rating **	M	Issue No.	134
LM End	0.11	Issue Type +	Ma	Location *	WS
Category	Earthen Levee		GPS Latitude/Longitude		
			Start	End	
Item	Slope Stability		37.770212 °	37.770212 °	
			-121.325675 °	-121.325675 °	
DWR ID	DWR_RD2095_01_s_2014_134				
Comment Code					
S3 : Repair the levee slope damaged by vehicle traffic and prevent access where possible.					
Inspector Comment

View of the vehicle access on the waterside levee slope.

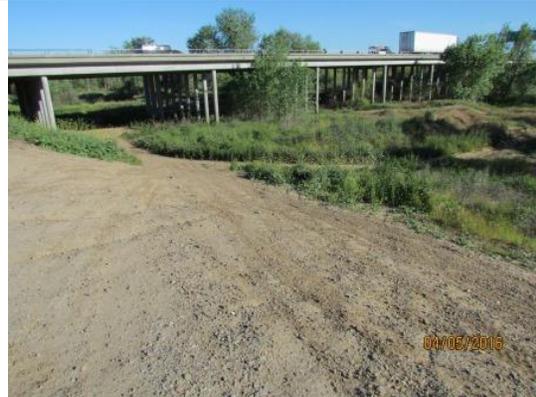
Photo 1 of 1 : SP_2016_RD2095_322_10_20160412_00027.jpg

LM Start	0.15	Rating **	M	Issue No.	10
LM End	0.15	Issue Type +	Ma	Location *	WS
Category	Earthen Levee		GPS Latitude/Longitude		
			Start	End	
Item	Slope Stability		37.769997°	37.769997°	
			-121.325055°	-121.325055°	
DWR ID	DWR_RD2095_01_f_2015_10				
Comment Code					
S3 : Repair the levee slope damaged by vehicle traffic and prevent access where possible.					
Inspector Comment

View of the vehicle tracks on the waterside levee slope.

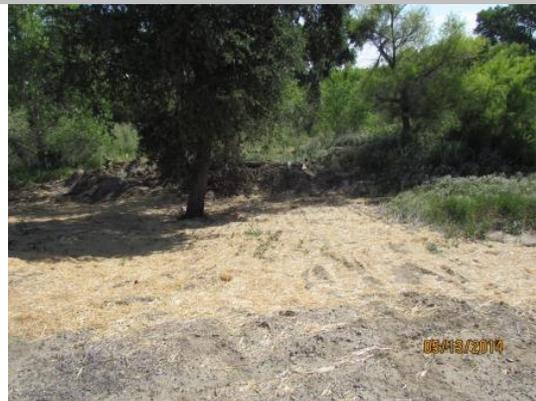
Photo 1 of 1 : SP_2016_RD2095_322_13_20160229_00009.jpg

LM Start	0.42	Rating **	A/W	Issue No.	13
LM End	0.42	Issue Type +	Ma	Location *	WS
Category	Earthen Levee		GPS Latitude/Longitude		
			Start	End	
Item	Slope Stability		37.766917°	37.766917°	
			-121.322267°	-121.322267°	
DWR ID	DWR_RD2095_01_s_2013_13				
Comment Code					
S3 : Repair the levee slope damaged by vehicle traffic and prevent access where possible.					
Inspector Comment					
LMA is actively controlling the slope instability.

View of the repaired waterside levee slope.

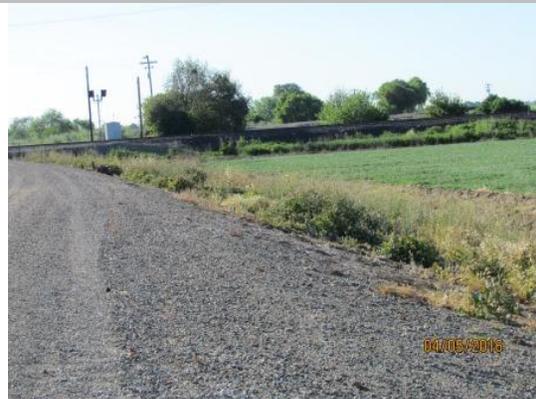
Photo 1 of 1 : SP_2016_RD2095_322_5_20160412_00028.jpg

LM Start	0.62	Rating **	M	Issue No.	5
LM End	0.69	Issue Type +	Ma	Location *	LS
Category	Earthen Levee		GPS Latitude/Longitude		
			Start	End	
Item	Vegetation		37.764481°	37.763897°	
			-121.320249°	-121.319164°	
DWR ID	DWR_RD2095_01_s_2016_5				
Comment Code					
V1 : Control annual grass and weeds on the levee slopes and easements.					
Inspector Comment

View of the vegetation on the landside levee slope.

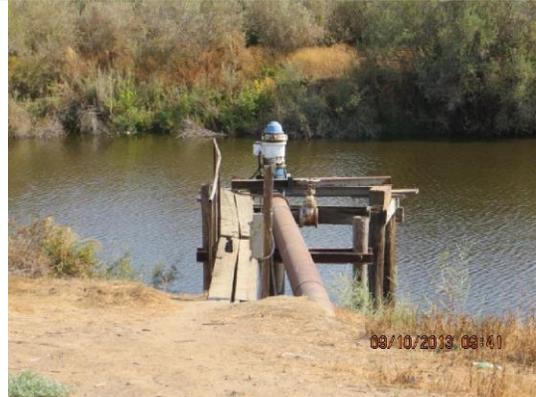
Photo 1 of 2 : UCIP_SP_2016_19787_33688.jpg

Comment Code					
Inspector Comment					
FS_ID:19787 DS_ID:21635 EP_NO: N/A Repair Type: Non-Urgent Crossing Status: Found UCIP Comments: Wooden walkway to pier possible safety hazard as wood planks are rotten. Positive closure device missing from distribution box on LS toe. FIELD_STRUCT_DESC: 16-inch steel irrigation pipe through the levee 8.0 feet below the crown. Pump on pile structure in the channel. 5'X5' concrete distribution box at the toe of the landward slope. Originally included in the 1964 O&M manual. Permit 18886 (2014) requested to authorize the pump station, pipe and distribution box as part of the construction of a new pipe using the same platform and distribution box. FS Date: 9/10/2013

Pump on pier on WS toe.

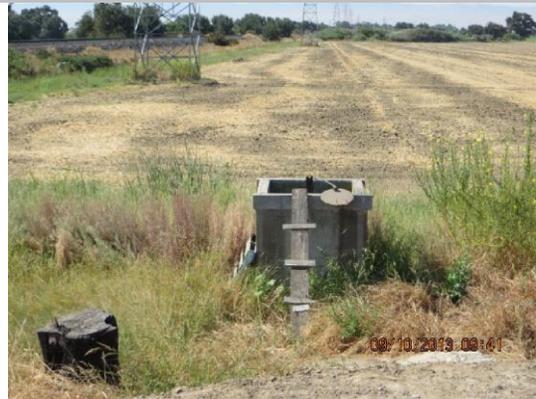
Photo 2 of 2 : UCIP_SP_2016_19787_33687.jpg

Concrete distribution box on LS toe.

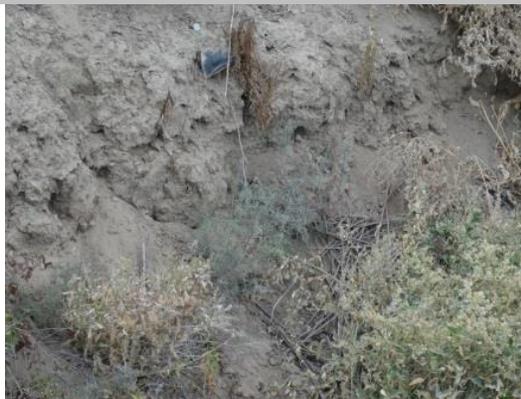
Photo 2 of 2 : SP_2016_RD2095_322_1_20160229_00002.jpg

LM Start	0.72	Rating **	M	Issue No.	1 (cont)
LM End	0.73	Issue Type +	Ma	Location *	WS
Category	Supplemental			GPS Latitude/Longitude	
				Start	End
Item	DWR Erosion Survey			37.763630 °	37.763630 °
				-121.319000 °	-121.319000 °
DWR ID	DWR_RD2095_01_s_2016_1

Comment Code					
Inspector Comment					
<p>08/04/2015: No significant change observed. 08/26/2014: No significant change observed. 08/28/2013: No significant change observed. 07/18/2012: No significant change observed. 09/02/2011: No significant change observed. 09/22/2010: No significant change observed. There is now considerable vegetation at the water line and along the lower berm slope. However, the erosion on the lower berm slope is still present and has not been corrected. 08/06/2010: Recommended for local maintenance issue, per CLRO. 07/29/2009: No major change since last visit; noticeable vegetation growth; erosion is on berm, but if left untreated, it will eventually erode into levee prism; site is recommended for annual assessment and monitoring of the site, per CLRO CES 2008 Report; Site # is the same as RM6.80,LM0.73; previously rated "U". 07/22/2008: Downstream of WPRR near siphon pipe & pump; sandy levee; visited by Jeff Van Gilder and LRO in 2008 for repair assessment; scouring downstream of RR crossing, possibly caused by eddy effects. 03/13/2007: Site visited on 03/13/2007. [2015 Site ID:RD2095U01RM6.74]</p>

Close view of the erosion.

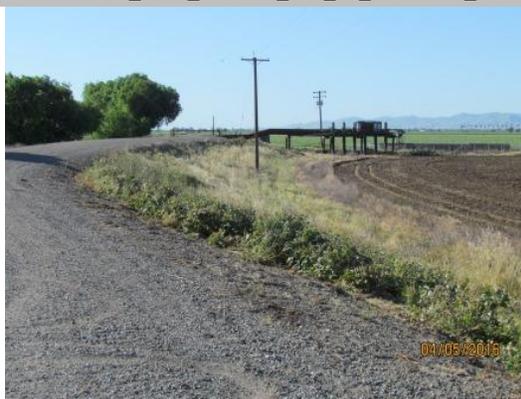
Photo 1 of 1 : SP_2016_RD2095_322_15_20160412_00029.jpg

LM Start	0.75	Rating **	M	Issue No.	15
LM End	0.85	Issue Type +	Ma	Location *	LS
Category	Earthen Levee			GPS Latitude/Longitude	
				Start	End
Item	Vegetation			37.763143 °	37.761794 °
				-121.318652 °	-121.317969 °
DWR ID	DWR_RD2095_01_s_2016_15				
Comment Code					
V1 : Control annual grass and weeds on the levee slopes and easements.					
Inspector Comment

View of the vegetation on the landside levee slope.

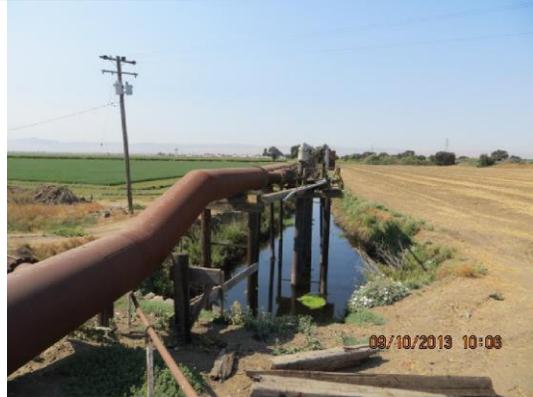
Photo 1 of 2 : UCIP_SP_2016_34387_62273.jpg

LM Start	0.87	Rating **	M	Issue No.	139
LM End	0.87	Issue Type +	En	Location *	LS
Category	Supplemental			GPS Latitude/Longitude	
				Start	End
Item	DWR UCIP Field Study			37.761554 °	37.761554 °
				-121.317847 °	-121.317847 °
DWR ID					
Comment Code					
Inspector Comment					
FS_ID:34387 DS_ID:21629 EP_NO: 6259 Repair Type: Non-Urgent Crossing Status: Found UCIP Comments: What appears to be the concrete headwall on the LS toe is tilting and failing. There is a possibility that the concrete is rubble used to fill in around levee toe. Good candidate for video inspection. FIELD_STRUCT_DESC: 30-inch corrugated metal pipe through levee 21.0 feet below crown. Slide gate in riser on the waterward slope. Concrete headwalls and aprons on both ends. Flap gate on the waterward end. Two corrugated metal cutoff walls (Permit No. 6259, 1969). FS Date: 9/10/2013

Pipe inlet located below 40-inch pipe at LS toe canal.

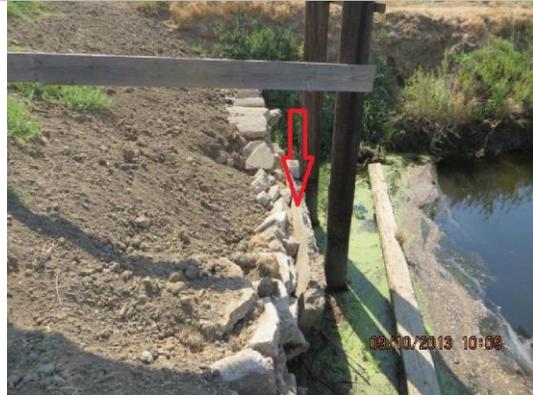
Photo 2 of 2 : UCIP_SP_2016_34387_62272.jpg

Concrete headwall on LS toe is tilting heavily towards canal.

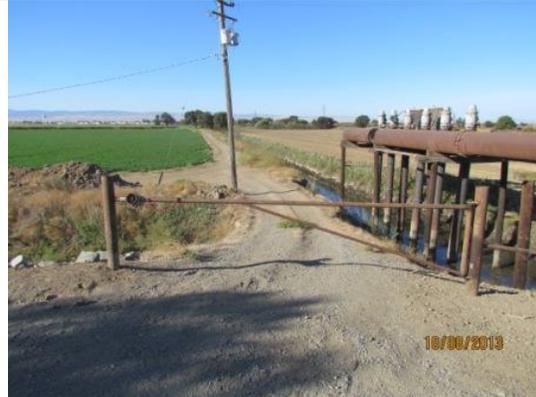
Photo 1 of 1 : SP_2016_RD2095_322_4_20160229_00004.jpg

View of the new gate at landside levee hinge.

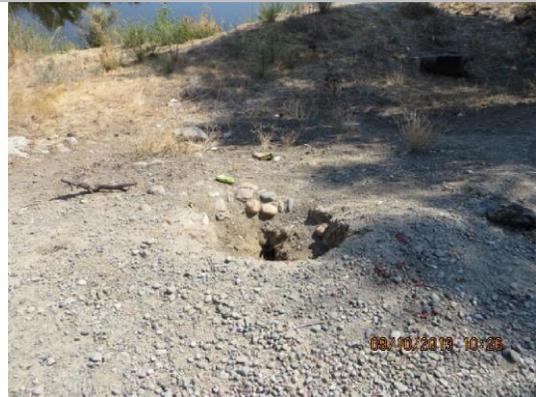
Photo 1 of 2 : UCIP_SP_2016_19815_33719.jpg

LM Start	0.91	Rating **	M	Issue No.	138
LM End	0.91	Issue Type +	En	Location *	LS
Category	Supplemental		GPS Latitude/Longitude		
			Start	End	
Item	DWR UCIP Field Study		37.761079 °	37.761079 °	
			-121.317567 °	-121.317567 °	
DWR ID					
Comment Code					
Inspector Comment					
FS_ID:19815 DS_ID:21630 EP_NO: N/A Repair Type: Non-Urgent Crossing Status: Indicator Found UCIP Comments: Pipe abandoned and should be verified as having been done so properly. FIELD_STRUCT_DESC: 12-inch steel stormdrain pipe through the levee 1.5 feet below the crown. Pump on pile structure in drain ditch on landward side. Siphon breaker in steel standpipe on the waterward slope. Originally included in the 1964 O&M manual. FS Date: 9/10/2013

Hole on LS shoulder where standpipe may have been located.

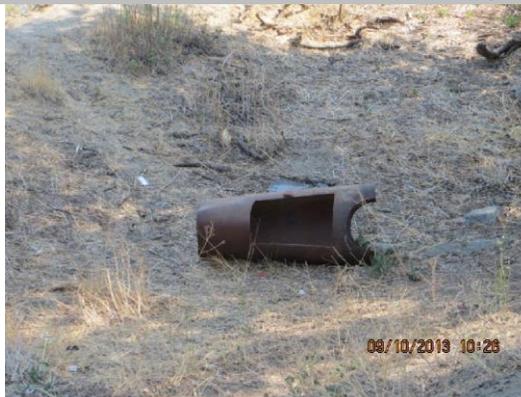
Photo 2 of 2 : UCIP_SP_2016_19815_33718.jpg

LM Start	0.91	Rating **	M	Issue No.	138 (cont)
LM End	0.91	Issue Type +	En	Location *	LS
Category	Supplemental			GPS Latitude/Longitude	
				Start	End
Item	DWR UCIP Field Study			37.761079 °	37.761079 °
				-121.317567 °	-121.317567 °
DWR ID					
Comment Code					
Inspector Comment					
FS_ID:19815 DS_ID:21630 EP_NO: N/A Repair Type: Non-Urgent Crossing Status: Indicator Found UCIP Comments: Pipe abandoned and should be verified as having been done so properly. FIELD_STRUCT_DESC: 12-inch steel stormdrain pipe through the levee 1.5 feet below the crown. Pump on pile structure in drain ditch on landward side. Siphon breaker in steel standpipe on the waterward slope. Originally included in the 1964 O&M manual. FS Date: 9/10/2013

Standpipe discarded on WS berm.

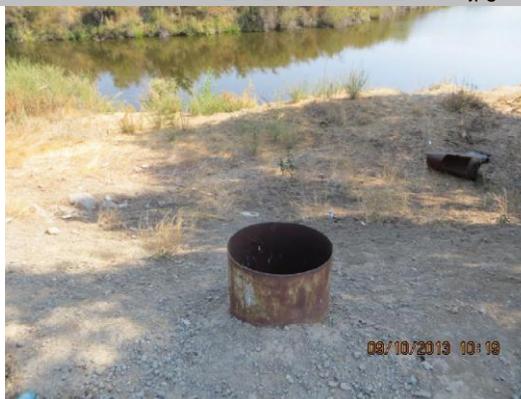
Photo 1 of 2 : UCIP_SP_2016_19813_33715.jpg

LM Start	0.91	Rating **	M	Issue No.	137
LM End	0.91	Issue Type +	En	Location *	LS
Category	Supplemental			GPS Latitude/Longitude	
				Start	End
Item	DWR UCIP Field Study			37.761046 °	37.761046 °
				-121.317540 °	-121.317540 °
DWR ID					
Comment Code					
Inspector Comment					
FS_ID:19813 DS_ID:21631 EP_NO: 6537 Repair Type: Non-Urgent Crossing Status: Found UCIP Comments: Corroded holes on pipe at outlet WS toe, good indication of internal pipe condition. Good candidate for video inspection. FIELD_STRUCT_DESC: 14-inch steel stormdrain discharge pipe through the levee 2.5 feet below the crown. Pump on pile structure in drain ditch on landward side. Siphon breaker in 24-inch CMP riser on the waterward shoulder and flap gate on the waterward end (Permit No. 6537, 1969). FS Date: 9/10/2013

Siphon Breaker/vent in 24-inch steel riser on WS shoulder.

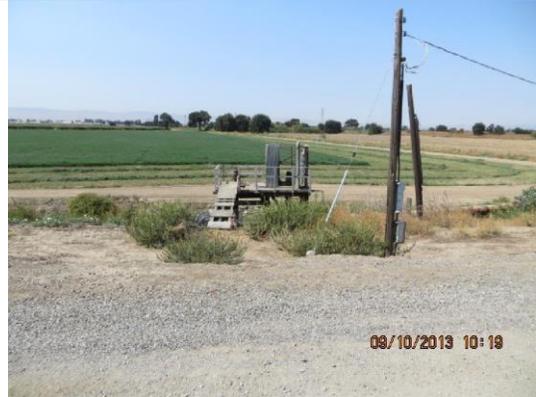
Photo 2 of 2 : UCIP_SP_2016_19813_33714.jpg

LM Start	0.91	Rating **	M	Issue No.	137 (cont)
LM End	0.91	Issue Type +	En	Location *	LS
Category	Supplemental			GPS Latitude/Longitude	
				Start	End
Item	DWR UCIP Field Study			37.761046 °	37.761046 °
				-121.317540 °	-121.317540 °
DWR ID					
Comment Code					
Inspector Comment					
FS_ID:19813 DS_ID:21631 EP_NO: 6537 Repair Type: Non-Urgent Crossing Status: Found UCIP Comments: Corroded holes on pipe at outlet WS toe, good indication of internal pipe condition. Good candidate for video inspection. FIELD_STRUCT_DESC: 14-inch steel stormdrain discharge pipe through the levee 2.5 feet below the crown. Pump on pile structure in drain ditch on landward side. Siphon breaker in 24-inch CMP riser on the waterward shoulder and flap gate on the waterward end (Permit No. 6537, 1969). FS Date: 9/10/2013

Pump on wooden pier at LS toe.

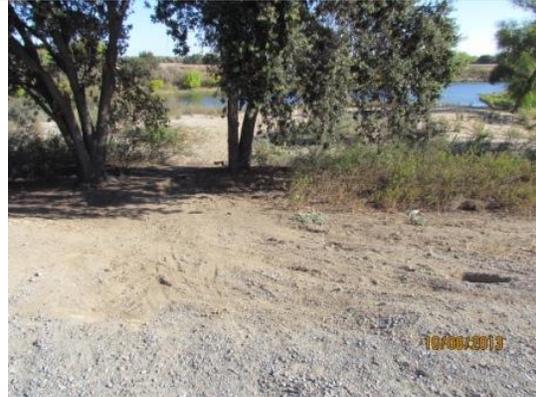
Photo 1 of 1 : SP_2016_RD2095_323_9_20160229_00008.jpg

LM Start	0.03	Rating **	A/W	Issue No.	9
LM End	0.03	Issue Type +	Ma	Location *	WS
Category	Earthen Levee		GPS Latitude/Longitude		
			Start	End	
Item	Slope Stability		37.758986 °	37.758986 °	
			-121.307854 °	-121.307854 °	
DWR ID	DWR_RD2095_02_s_2013_9				
Comment Code					
S3 : Repair the levee slope damaged by vehicle traffic and prevent access where possible.					
Inspector Comment

View of the vehicle tire ruts on waterside levee slope.

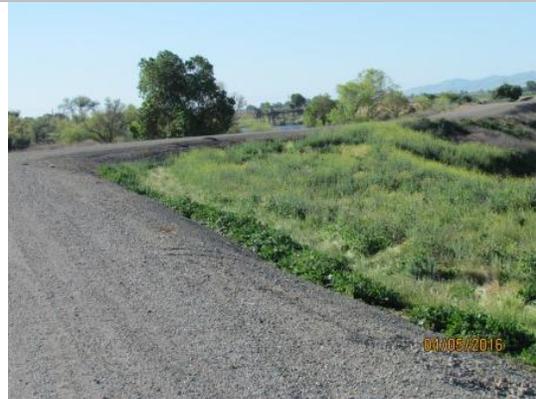
Photo 1 of 1 : SP_2016_RD2095_323_16_20160412_00021.jpg

LM Start	0.20	Rating **	M	Issue No.	16
LM End	0.34	Issue Type +	Ma	Location *	LS
Category	Earthen Levee		GPS Latitude/Longitude		
			Start	End	
Item	Vegetation		37.757042 °	37.755242 °	
			-121.306133 °	-121.305653 °	
DWR ID	DWR_RD2095_02_f_2015_16				
Comment Code					
V1 : Control annual grass and weeds on the levee slopes and easements.					
Inspector Comment

View of the tall vegetation on the landside levee slope.

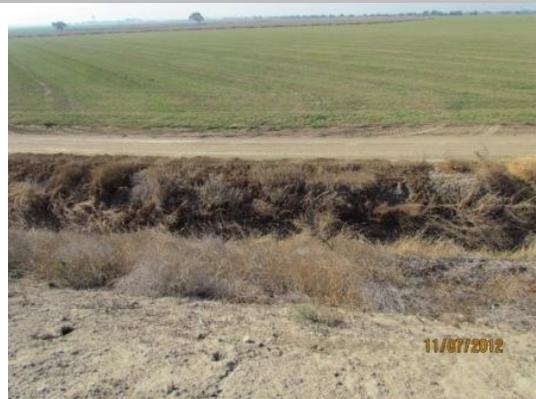
Photo 1 of 1 : SP_2016_RD2095_323_5_20160229_00006.jpg

LM Start	0.36	Rating **	M	Issue No.	5
LM End	0.82	Issue Type +	En	Location *	LS
Category	Earthen Levee		GPS Latitude/Longitude		
			Start	End	
Item	Encroachments		37.754952 °	37.749645 °	
			-121.305880 °	-121.301977 °	
DWR ID	DWR_RD2095_02_f_2012_5				
Comment Code					
DT : Ditch					
Inspector Comment

View of a ditch along the landside toe.

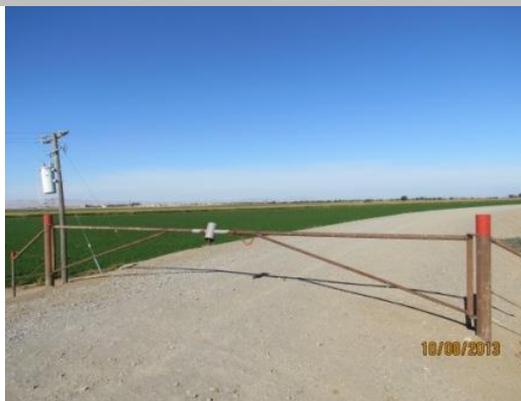
Photo 1 of 1 : SP_2016_RD2095_323_14_20160229_00009.jpg

View of new gate across levee crown.

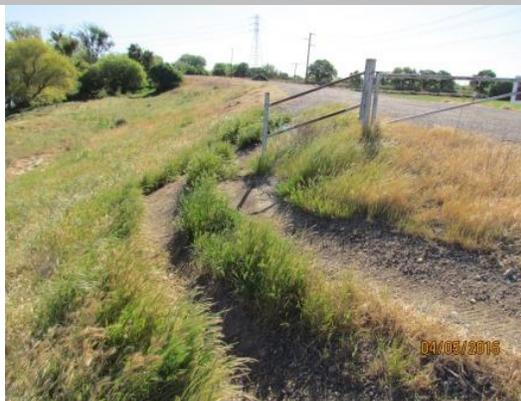
Photo 1 of 1 : SP_2016_RD2095_323_11_20160412_00022.jpg

LM Start	0.82	Rating **	M	Issue No.	11
LM End	0.82	Issue Type +	Ma	Location *	WS
Category	Earthen Levee		GPS Latitude/Longitude		
			Start	End	
Item	Slope Stability		37.749644 °	37.749644 °	
			-121.301960 °	-121.301960 °	
DWR ID	DWR_RD2095_02_s_2016_11				
Comment Code					
S3 : Repair the levee slope damaged by vehicle traffic and prevent access where possible.					
Inspector Comment

View of the vehicle tracks on the waterside levee slope.

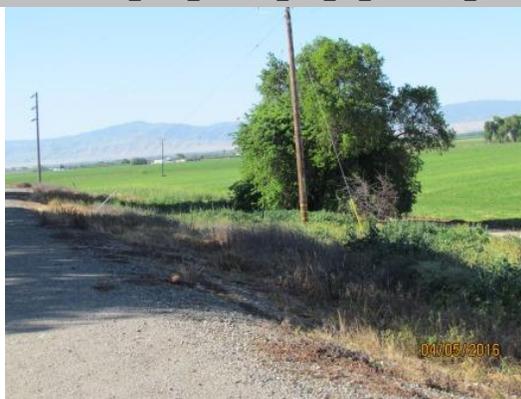
Photo 1 of 1 : SP_2016_RD2095_323_13_20160412_00023.jpg

View of the tall vegetation on the landside levee slope.

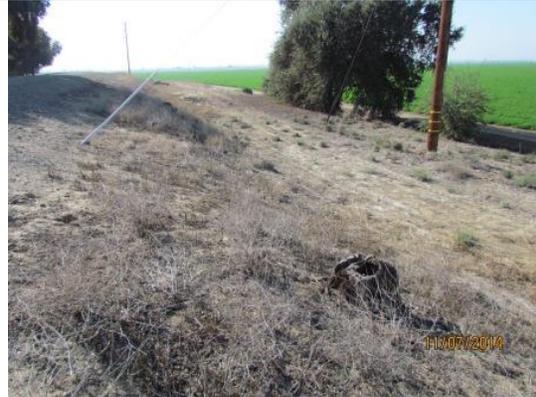
Photo 1 of 1 : SP_2016_RD2095_323_3_20160229_00005.jpg

View of the tree stumps on the landside levee slope..

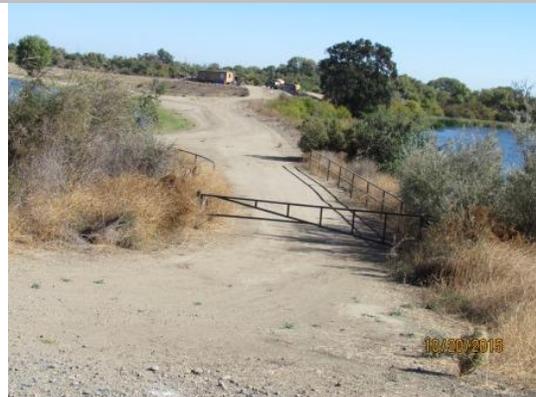
Photo 1 of 1 : SP_2016_RD2095_323_17_20160229_00011.jpg

View of the gate and fence in the floodway at the waterside levee toe.

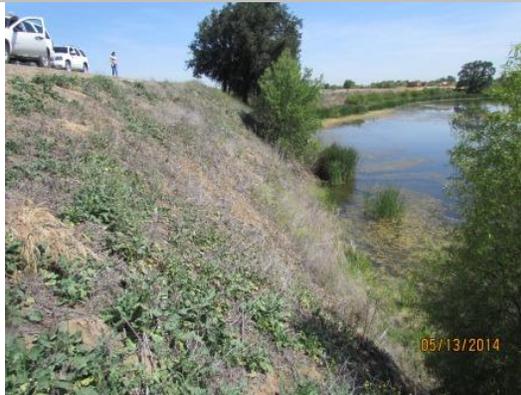
Photo 1 of 1 : SP_2016_RD2095_323_195_20160229_00013.jpg

View of the erosion on the waterside levee slope possibly eroding into the levee prism.

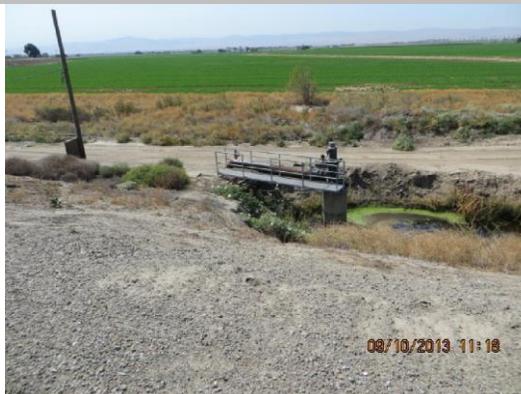
Photo 1 of 1 : UCIP_SP_2016_19863_33760.jpg

LM Start	1.48	Rating **	M	Issue No.	942
LM End	1.48	Issue Type +	En	Location *	WS
Category	Supplemental			GPS Latitude/Longitude	
				Start	End
Item	DWR UCIP Field Study			37.743142 °	37.743142 °
				-121.297692 °	-121.297692 °
DWR ID					
Comment Code					
Inspector Comment					
FS_ID:19863 DS_ID:21642 EP_NO: 4658 Repair Type: Non-Urgent Crossing Status: Found UCIP Comments: Pipe appears abandoned in place and re-routed to LM 1.652. Need to verify pipe was properly abandoned. Permit FIELD_STRUCT_DESC: *Abandoned* 14-inch pipe through levee 3.5-feet below crown. Pump on structure over drain ditch on the landward side. Flap gate on the waterward end (Permit No. 4658). Originally included in the 1968 O&M manual. FS Date: 9/10/2013

Pump visible on LS toe, but pipe has been re-routed to southwest.

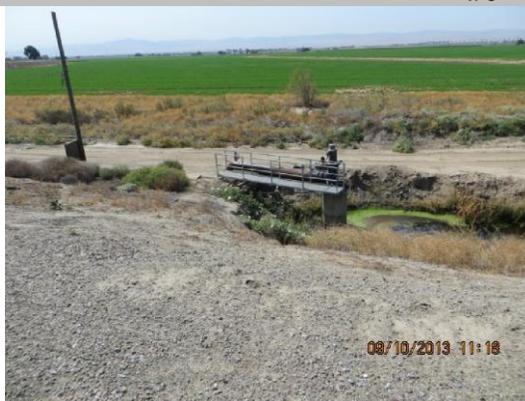
Photo 1 of 2 : UCIP_SP_2016_19866_33767.jpg

LM Start	1.63	Rating **	M	Issue No.	943
LM End	1.63	Issue Type +	En	Location *	WS
Category	Supplemental		GPS Latitude/Longitude		
			Start	End	
Item	DWR UCIP Field Study		37.741345 °	37.741345 °	
			-121.296189 °	-121.296189 °	
DWR ID					
Comment Code					
Inspector Comment					
FS_ID:19866 DS_ID:21654 EP_NO: 6298A Repair Type: Non-Urgent Crossing Status: Found UCIP Comments: No permit identified for this crossing. FIELD_STRUCT_DESC: 16-inch steel stormdrain pipe through the levee 2-feet below the crown. Siphon breaker in PVC riser on WS shoulder. Pump on pier in ditch on LS toe 750-feet to Northwest from crossing. FS Date: 9/10/2013

Pump located at levee toe 750-feet north west of pipe crossing.

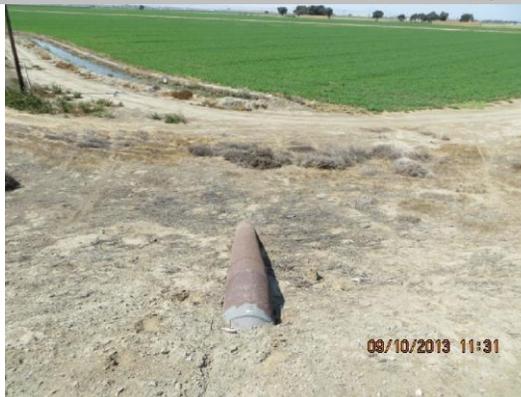
Photo 2 of 2 : UCIP_SP_2016_19866_33766.jpg

LM Start	1.63	Rating **	M	Issue No.	943 (cont)
LM End	1.63	Issue Type +	En	Location *	WS
Category	Supplemental			GPS Latitude/Longitude	
				Start	End
Item	DWR UCIP Field Study			37.741345 °	37.741345 °
				-121.296189 °	-121.296189 °
DWR ID					
Comment Code					
Inspector Comment					
FS_ID:19866 DS_ID:21654 EP_NO: 6298A Repair Type: Non-Urgent Crossing Status: Found UCIP Comments: No permit identified for this crossing. FIELD_STRUCT_DESC: 16-inch steel stormdrain pipe through the levee 2-feet below the crown. Siphon breaker in PVC riser on WS shoulder. Pump on pier in ditch on LS toe 750-feet to Northwest from crossing. FS Date: 9/10/2013

16-inch steel pipe on LS slope.

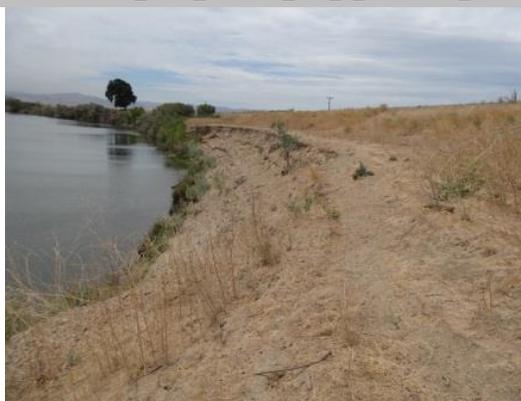
Photo 1 of 3 : SP_2016_RD2095_323_1_20160229_00001.jpg

LM Start	1.74	Rating **	M	Issue No.	1
LM End	1.77	Issue Type +	Ma	Location *	WS
Category	Supplemental			GPS Latitude/Longitude	
				Start	End
Item	DWR Erosion Survey			37.740196 °	37.740196 °
				-121.297662 °	-121.297662 °
DWR ID	DWR_RD2095_02_s_2016_1

Comment Code					
Inspector Comment					
08/04/2015: No significant change observed. 7/02/2014: No significant change observed. 08/28/2013: No significant change observed. 09/13/2012: The site has been visited by land survey. The vegetation on the site shows the erosion has not developed significantly from the last survey. The site was not visited by boat survey due to the limitation of navigable waterway. 08/23/2011: No significant change observed. 9/22/2010: No significant change observed. There is moderate vegetation growth on the berm. Despite the erosion occurring on the berm, corrective action should be taken before the issue becomes severe. 9/29/2009: Site is immediately downstream of a section of existing rip rap; there is a 20-foot berm remaining; berm will continue to erode unless erosion is mitigated; Site# is the same as RM62.6, LM1.87; recommended for annual assessment, per CES Evaluation 2008 Report 2006: Visited 10/20/06 [2015 Site ID:RD2095U02RM60.62]

Close view of the site.

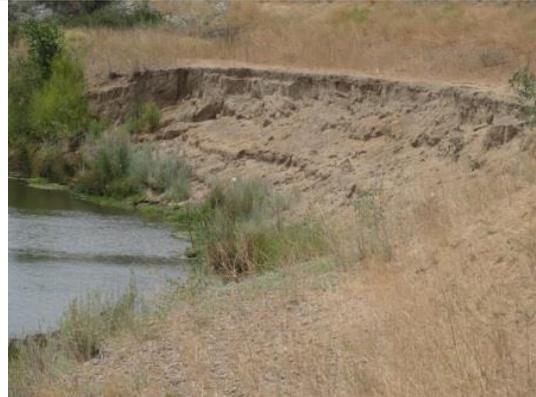
Photo 2 of 3 : SP_2016_RD2095_323_1_20160229_00002.jpg

08/04/2015: No significant change observed.
 7/02/2014: No significant change observed.
 08/28/2013: No significant change observed.
 09/13/2012: The site has been visited by land survey. The vegetation on the site shows the erosion has not developed significantly from the last survey.
 The site was not visited by boat survey due to the limitation of navigable waterway.
 08/23/2011: No significant change observed.
 9/22/2010: No significant change observed. There is moderate vegetation growth on the berm. Despite the erosion occurring on the berm, corrective action should be taken before the issue becomes severe.
 9/29/2009: Site is immediately downstream of a section of existing rip rap; there is a 20-foot berm remaining; berm will continue to erode unless erosion is mitigated; Site# is the same as RM62.6, LM1.87; recommended for annual assessment, per CES Evaluation 2008 Report 2006: Visited 10/20/06 [2015 Site ID:RD2095U02RM60.62]

View of the erosion.

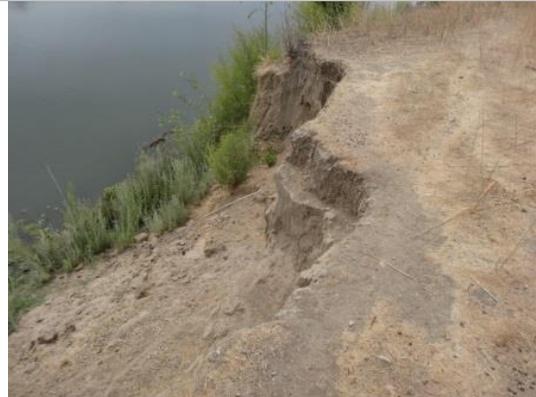
Photo 3 of 3 : SP_2016_RD2095_323_1_20160229_00003.jpg

Close view of the site.

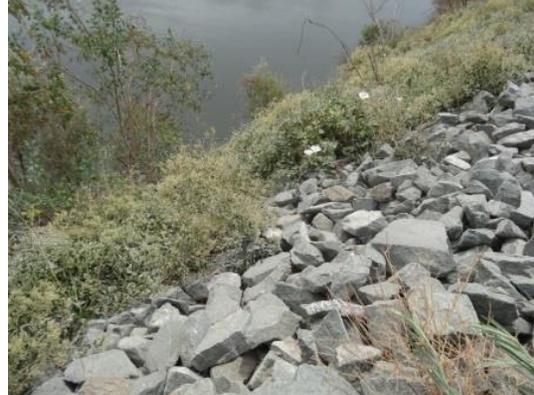
Photo 1 of 1 : SP_2016_RD2095_323_2_20160229_00004.jpg

Comment Code					
Inspector Comment					
<p>08/04/2015: No significant change observed. 7/02/2014: No significant change observed. 08/28/2013: No significant change observed. Dense vegetation blocks the visual inspection at the site. 09/13/2012: The site has been visited by land survey. The erosion is not visible from the levee slope because of dense vegetation at the site. Levee slope is protected by placed rocks. The site was not visited by boat survey due to the limitation of navigable waterway. 08/23/2011: Dense vegetation makes it difficult to view the possible erosion. No new development was observed on site. 09/23/2010: At the time of the inspection, the erosion site was difficult to view from the levee. The erosion is located on the bank toe, below the existing rip rap. There were no signs of repair on site, nor has the site been reported to be repaired by the district. Images taken from last year indicate that existing rip rap at the bank toe has sloughed exposing the underlying soils. Weakening of the toe could lead to future bank instability. 08/05/2010: Recommended for annual assessment and monitoring during flood events, per CLRO. 09/29/2009: No major change observed since last visit; sloughing of the rip rap above toe; erosion begins immediately downstream of existing rip rap revetment; roughly 15-foot berm remains; however, it will continue to erode and eventually intrude into the levee profile if left untreated. 10/20/2006: Just upstream of where berm starts to widen. [2015 Site ID:RD2095U02RM60.69]</p>

The erosion is not visible from the levee top. The levee slope is protected by riprap rocks.

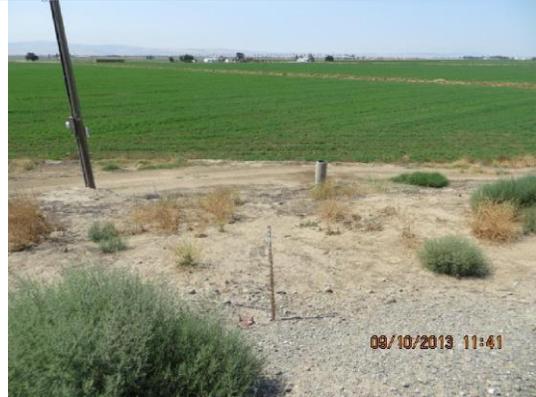
Photo 1 of 2 : UCIP_SP_2016_19867_33771.jpg

LM Start	2.08	Rating **	M	Issue No.	944
LM End	2.08	Issue Type +	En	Location *	WS
Category	Supplemental			GPS Latitude/Longitude	
				Start	End
Item	DWR UCIP Field Study			37.735416 °	37.735416 °
				-121.297860 °	-121.297860 °
DWR ID					
Comment Code					
Inspector Comment					
FS_ID:19867 DS_ID:21643 EP_NO: N/A Repair Type: Non-Urgent Crossing Status: Found UCIP Comments: Siphon breaker on LS shoulder does not appear to be functional. FIELD_STRUCT_DESC: 16-inch steel irrigation pipe through the levee 2.0-feet below the crown. Slant pump on steel platform on WS slope. Siphon breaker on the landward shoulder marked by T-post. Service pole and meter on the landward toe. Possible concrete standpipe on LS toe. Originally included in the 1968 O&M manual. FS Date: 9/10/2013

Siphon breaker on LS shoulder next to T-post with Power pole and concrete standpipe on LS toe.

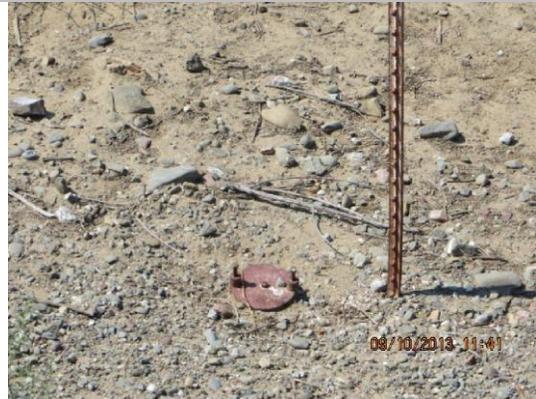
Photo 2 of 2 : UCIP_SP_2016_19867_33770.jpg

Siphon breaker on LS shoulder next to T-post.
