**Flood Control Project Maintenance
Levee Inspections**

Fall 2015 Levee Maintenance Deficiency Summary Report

San Joaquin River Basin

Reclamation District No. 2101 Blewett

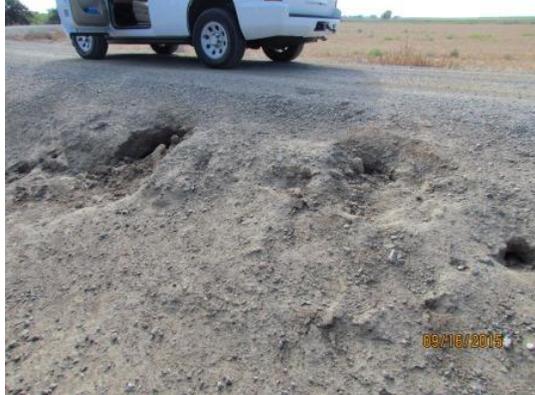
Photo 1 of 1 : FA_2015_RD2101_326_12_20150921_00026.jpg

LM Start	0.04	Rating **	U	Issue No.	12
LM End	0.04	Issue Type +	Ma	Location *	WS
Category	Earthen Levee			GPS Latitude/Longitude	
				Start	End
Item	Animal Control			37.657648 °	37.657648 °
				-121.253812 °	-121.253812 °
DWR ID	DWR_RD2101_01_s_2012_12				
Action/Comments					
No rodents visible, but rodent burrows visible; need to backfill and compact or grout burrows.

View of the rodent holes on the waterside levee slope, facing upstream.

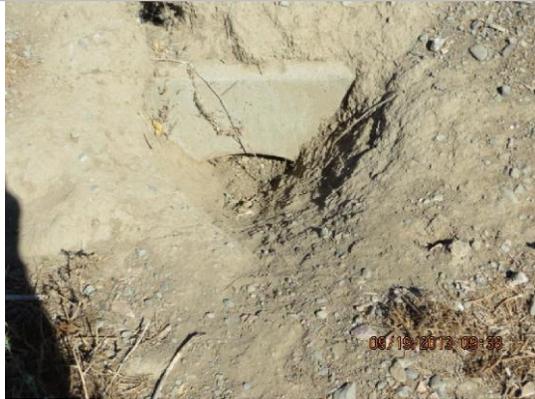
Photo 1 of 3 : UCIP_FA_2015_0599.jpg

LM Start	0.05	Rating **	U	Issue No.	945
LM End	0.05	Issue Type +	En	Location *	WS
Category	Supplemental			GPS Latitude/Longitude	
				Start	End
Item	DWR UCIP Field Study			37.657801 °	37.657801 °
				-121.253745 °	-121.253745 °
DWR ID					
Action/Comments					
Inspector Comments: FS_ID:26403 DS_ID:20699 EP_NO: N/A FS_HLM: 0.052 Repair Type: Urgent Crossing Status: Found UCIP Comments: Slide gate missing from WS toe. Pipe has heavy sediment buildup. FIELD_STRUCT_DESC: 18-inch corrugated metal pipe through levee 3-feet below crown. Concrete headwall on both ends. Slide gate at headwall on the waterward end. Originally included in the 1968 O&M manual. FS Date: 09/17/2013

Pipe and headwall visible on LS toe.

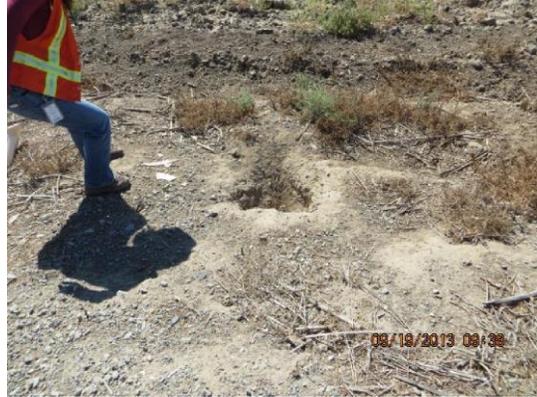
Photo 2 of 3 : UCIP_FA_2015_0600.jpg

LM Start	0.05	Rating **	U	Issue No.	945 (cont)
LM End	0.05	Issue Type +	En	Location *	WS
Category	Supplemental			GPS Latitude/Longitude	
				Start	End
Item	DWR UCIP Field Study			37.657801 °	37.657801 °
				-121.253745 °	-121.253745 °
DWR ID					
Action/Comments					
Inspector Comments: FS_ID:26403 DS_ID:20699 EP_NO: N/A FS_HLM: 0.052 Repair Type: Urgent Crossing Status: Found UCIP Comments: Slide gate missing from WS toe. Pipe has heavy sediment buildup. FIELD_STRUCT_DESC: 18-inch corrugated metal pipe through levee 3-feet below crown. Concrete headwall on both ends. Slide gate at headwall on the waterward end. Originally included in the 1968 O&M manual. FS Date: 09/17/2013

Pipe and headwall visible on LS toe.

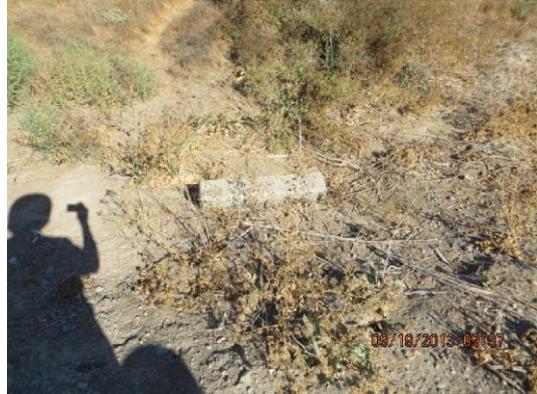
Photo 3 of 3 : UCIP_FA_2015_0601.jpg

Headwall on WS toe.

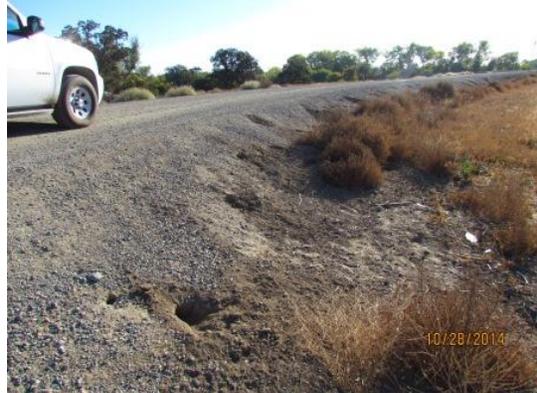
Photo 1 of 1 : FA_2015_RD2101_326_16_20150910_00008.jpg

LM Start	0.08	Rating **	M	Issue No.	16
LM End	0.08	Issue Type +	Ma	Location *	LS
Category	Earthen Levee		GPS Latitude/Longitude		
			Start	End	
Item	Animal Control		37.657811 °	37.657811 °	
			-121.253269 °	-121.253269 °	
DWR ID	DWR_RD2101_01_s_2013_16				
Action/Comments					
No rodents visible, but rodent burrows visible; need to backfill and compact or grout burrows. Inspector Comments: Continue rodent extermination and backfilling the rodent burrows.

View of rodent burrows on the landside levee slope.

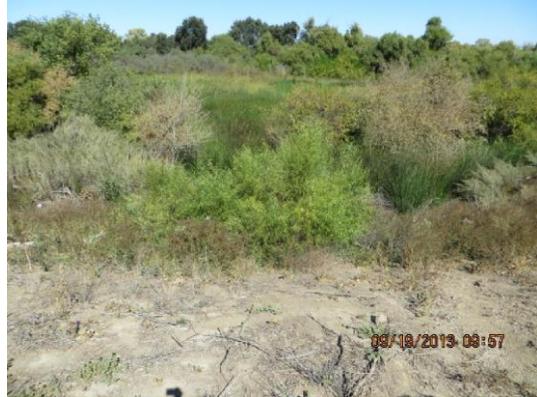
Photo 1 of 3 : UCIP_FA_2015_1873.jpg

LM Start	0.31	Rating **	M	Issue No.	946
LM End	0.31	Issue Type +	En	Location *	LS
Category	Supplemental		GPS Latitude/Longitude		
			Start	End	
Item	DWR UCIP Field Study		37.658142 °	37.658142 °	
			-121.250047 °	-121.250047 °	
DWR ID					
Action/Comments					
Inspector Comments: FS_ID:20785 DS_ID:20701 EP_NO: N/A FS_HLM: 0.315 Repair Type: Non-Urgent Crossing Status: Found UCIP Comments: Inlet blocked by soil from beaver activity. Outlet covered in soil. FIELD_STRUCT_DESC: 24-inch corrugated metal pipe through levee 21.0 feet below crown. Headwall and slide gate on the landward end. Concrete "U" headwall and flap gate on the waterward end. Originally included in the 1968 O&M manual. FS Date: 09/19/2013

Outlet covered in soil but likely at willow tree on WS slope.

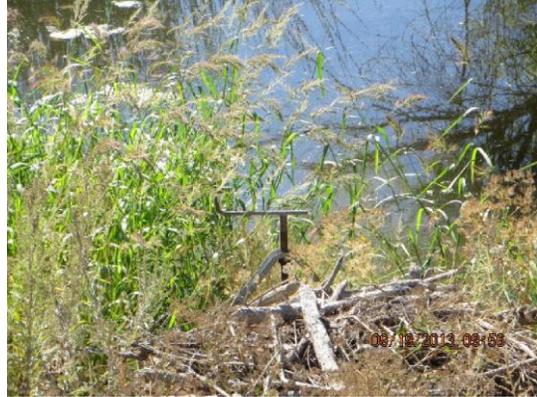
Photo 2 of 3 : UCIP_FA_2015_1874.jpg

LM Start	0.31	Rating **	M	Issue No.	946 (cont)
LM End	0.31	Issue Type +	En	Location *	LS
Category	Supplemental			GPS Latitude/Longitude	
				Start	End
Item	DWR UCIP Field Study			37.658142 °	37.658142 °
				-121.250047 °	-121.250047 °
DWR ID					
Action/Comments					
Inspector Comments: FS_ID:20785 DS_ID:20701 EP_NO: N/A FS_HLM: 0.315 Repair Type: Non-Urgent Crossing Status: Found UCIP Comments: Inlet blocked by soil from beaver activity. Outlet covered in soil. FIELD_STRUCT_DESC: 24-inch corrugated metal pipe through levee 21.0 feet below crown. Headwall and slide gate on the landward end. Concrete "U" headwall and flap gate on the waterward end. Originally included in the 1968 O&M manual. FS Date: 09/19/2013

Slide gate at concrete headwall on LS toe.

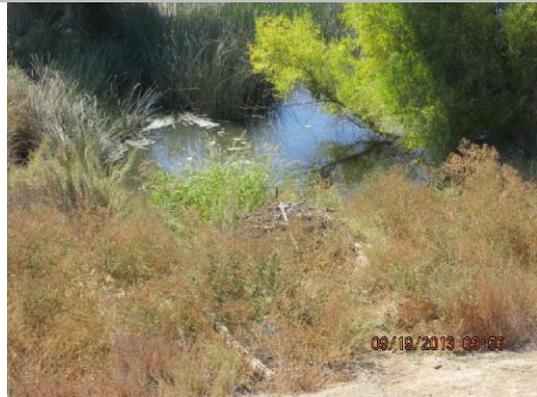
Photo 3 of 3 : UCIP_FA_2015_1875.jpg

Slide gate at concrete headwall on LS toe.

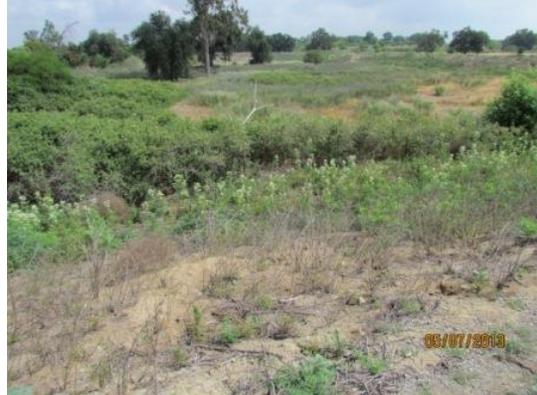
Photo 1 of 1 : FA_2015_RD2101_326_26_20150910_00010.jpg

View of the rodent burrows on the waterside levee slope.

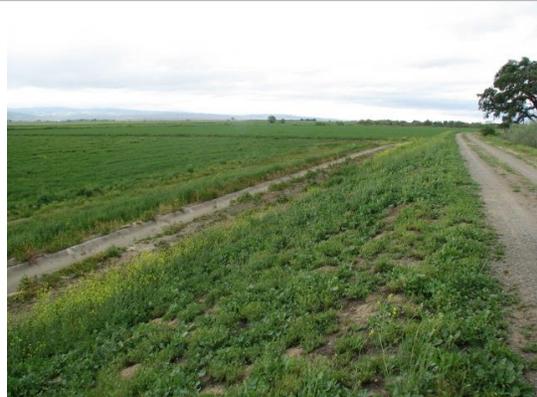
Photo 1 of 1 : FA_2015_RD2101_326_944_20150910_00017.jpg

LM Start	0.73	Rating **	M	Issue No.	944
LM End	1.76	Issue Type +	En	Location *	LS
Category	Earthen Levee		GPS Latitude/Longitude		
			Start	End	
Item	Encroachments		37.659827 °	37.651049 °	
			-121.243675 °	-121.231475 °	
DWR ID	DWR_RD2101_01_s_2012_944				
Action/Comments					
Ditch

Concrete ditch near landside toe.

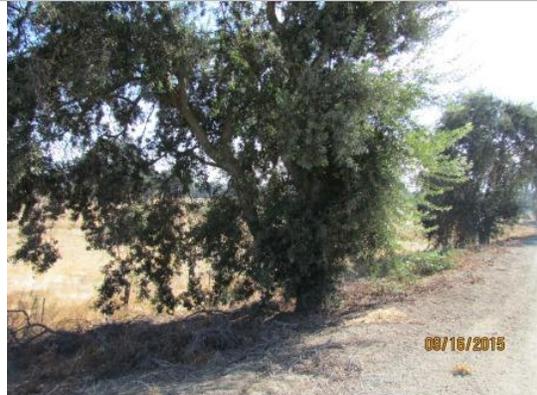
Photo 1 of 1 : FA_2015_RD2101_326_11_20150921_00027.jpg

LM Start	0.75	Rating **	M	Issue No.	11
LM End	0.75	Issue Type +	Ma	Location *	WS
Category	Earthen Levee		GPS Latitude/Longitude		
			Start	End	
Item	Trim / Thin Trees		37.659705 °	37.659705 °	
			-121.243306 °	-121.243306 °	
DWR ID	DWR_RD2101_01_f_2012_11				
Action/Comments					
Trim trees to at least five feet above ground level. Inspector Comments: Trim tree to allow access and visibility.

View of tree branches obstructing waterside slope.

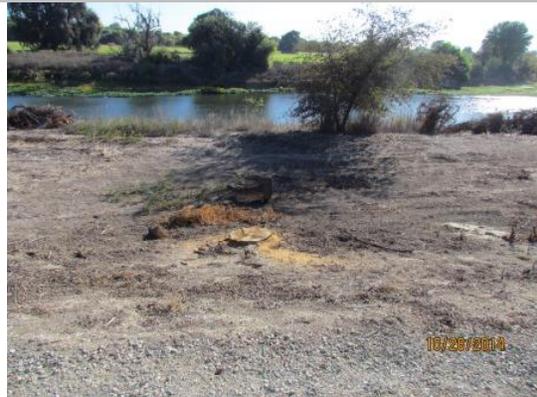
Photo 1 of 1 : FA_2015_RD2101_326_33_20150910_00016.jpg

View of the tree stump at the waterside levee toe.

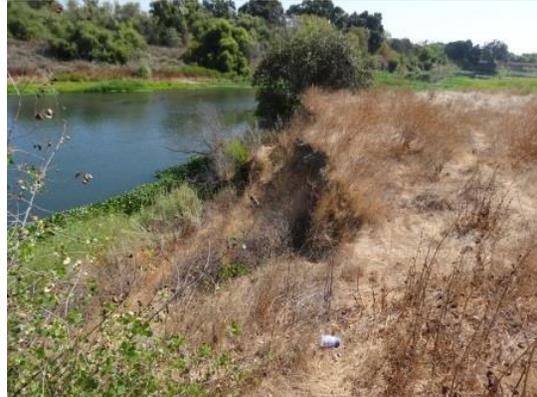
Photo 2 of 3 : SJR2015_RD2101U01RM73.92_3.jpg

Inspector Comments: 08/19/2015: No significant change observed.
 07/17/2014: No significant change observed.
 09/20/2013: Site has been visited. There are signs of further erosion development along the levee slope and toe.
 07/18/2012: The erosion has further developed toward levee crown. Vegetation has been removed.
 08/18/2011: The erosion progressed significantly during the past flood season. The levee toe along the erosion site was washed away, and the erosion has cut the levee structure up to the point about 1/3 of the levee slope. The scarp height is approximately 17 feet. Very dense vegetation and trees are visible.
 10/19/2010: No significant change observed on site. Remaining levee berm topsoil is of silty sand mixture. The erosion is near the downstream transition. An eddy has formed, and has scoured away a 100-foot section of the bank, possibly encroaching into the levee prism. Vegetation on site includes willows, oak, and cotton wood located from the bench to the toe. On the landside are rows of corn crop.

08/05/2010: Recommended for Repair, per CLRO.
 2009: Site recommended as annual assessment and monitoring if critical erosion site, per CLRO CES Evaluation 2008 Report; an eddy has formed, eroding bank and intruding into the levee prism; Site # is the same as RM76.3, LM1.89; previously rated "U".
 08/30/2007: Recommended for short list of immediate repair sites; silty sand levee material. [2015 Site ID:RD2101U01RM73.92]

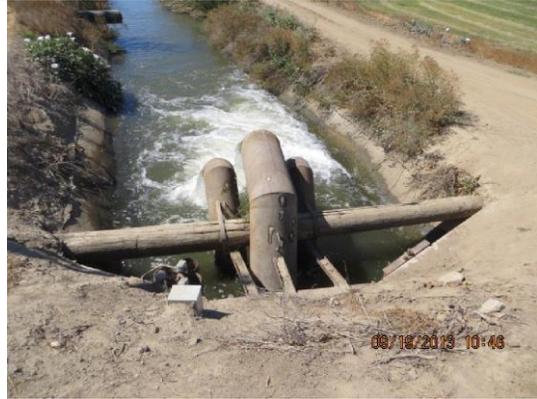
Photo 1 of 3 : UCIP_FA_2015_1778.jpg

Action/Comments
 Inspector Comments: FS_ID:20865
 DS_ID:20711
 EP_NO: N/A
 FS_HLM: 2.743
 Repair Type: Non-Urgent
 Crossing Status: Found
 UCIP Comments: Pipe leaking at pipe/concrete connection on WS slope.
 FIELD_STRUCT_DESC: 2 of 3: 20-inch steel pipe through levee 10.0-feet below crown encased in concrete. Pump on steel pier on WS. Gate valve in 16'X7' concrete vault on WS shoulder. Pipes discharge into concrete canal on LS toe. Originally included in the 1968 O&M manual.
 FS Date: 09/19/2013

20-inch steel pipe discharges into concrete channel on LS.

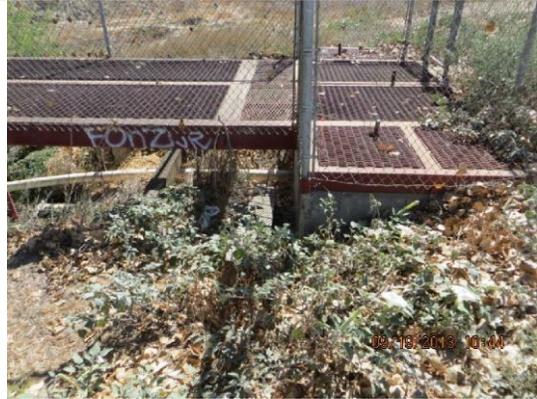
Photo 2 of 3 : UCIP_FA_2015_1779.jpg

Gate valve in concrete vault on WS shoulder.

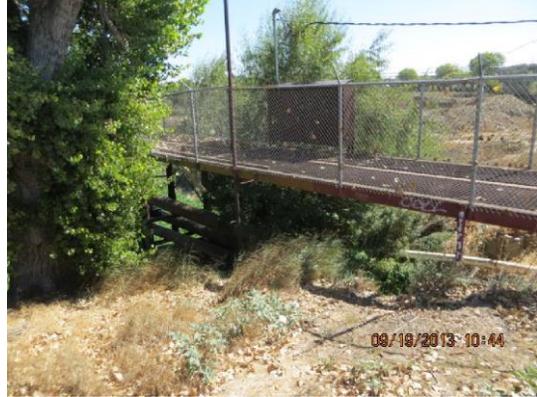
Photo 3 of 3 : UCIP_FA_2015_1780.jpg

LM Start	2.71	Rating **	M	Issue No.	947 (cont)
LM End	2.71	Issue Type +	En	Location *	LS
Category	Supplemental			GPS Latitude/Longitude	
				Start	End
Item	DWR UCIP Field Study			37.641976 °	37.641976 °
				-121.229745 °	-121.229745 °
DWR ID					
Action/Comments					
Inspector Comments: FS_ID:20865 DS_ID:20711 EP_NO: N/A FS_HLM: 2.743 Repair Type: Non-Urgent Crossing Status: Found

Pump on metal pier on WS.

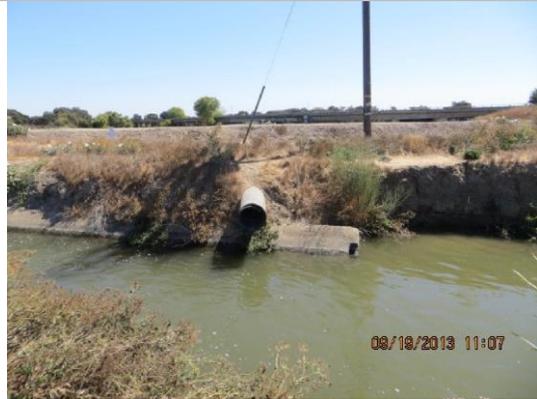
Photo 1 of 2 : UCIP_FA_2015_1888.jpg

LM Start	2.72	Rating **	M	Issue No.	948
LM End	2.72	Issue Type +	En	Location *	LS
Category	Supplemental			GPS Latitude/Longitude	
				Start	End
Item	DWR UCIP Field Study			37.641798 °	37.641798 °
				-121.229714 °	-121.229714 °
DWR ID					
Action/Comments					
Inspector Comments: FS_ID:22915 DS_ID:24679 EP_NO: N/A FS_HLM: 2.756 Repair Type: Non-Urgent Crossing Status: Found UCIP Comments: No permit identified for this crossing. FIELD_STRUCT_DESC: 18-inch PVC irrigation pipe through the levee 3.5-feet below the crown. No pump or other appurtances visible. FS Date: 09/19/2013

18-inch PVC pipe visible at outlet to irrigation canal on LS slope.

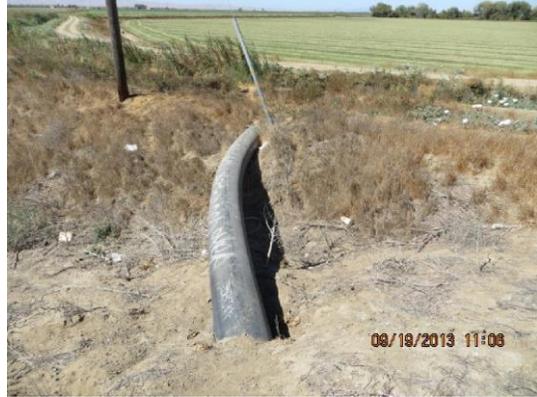
Photo 2 of 2 : UCIP_FA_2015_1889.jpg

LM Start	2.72	Rating **	M	Issue No.	948 (cont)	
LM End	2.72	Issue Type +	En	Location *	LS	
Category	Supplemental			GPS Latitude/Longitude		
			Start	End		
Item	DWR UCIP Field Study			37.641798 °	37.641798 °	
				-121.229714 °	-121.229714 °	
DWR ID						
Action/Comments						
Inspector Comments: FS_ID:22915 DS_ID:24679 EP_NO: N/A FS_HLM: 2.756 Repair Type: Non-Urgent Crossing Status: Found UCIP Comments: No permit identified for this crossing. FIELD_STRUCT_DESC: 18-inch PVC irrigation pipe through the levee 3.5-feet below the crown. No pump or other appurtenances visible. FS Date: 09/19/2013

18-inch PVC pipe visible at LS slope.

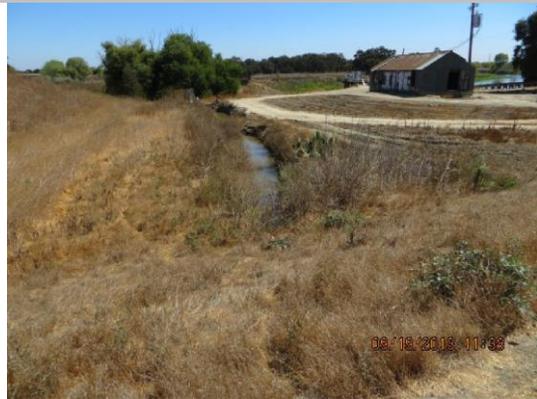
Photo 1 of 3 : UCIP_FA_2015_1590.jpg

LM Start	2.82	Rating **	U	Issue No.	949	
LM End	2.82	Issue Type +	En	Location *	LS	
Category	Supplemental			GPS Latitude/Longitude		
			Start	End		
Item	DWR UCIP Field Study			37.640566 °	37.640566 °	
				-121.230216 °	-121.230216 °	
DWR ID						
Action/Comments						
Inspector Comments: FS_ID:20872 DS_ID:20705 EP_NO: N/A FS_HLM: 2.858 Repair Type: Urgent Crossing Status: Found UCIP Comments: Flap gate missing from WS headwall. FIELD_STRUCT_DESC: 24-inch corrugated metal drain pipe through levee 11.0 feet below crown. Concrete "U" headwall on both ends. Flap gate on waterward end. Originally included in the 1968 O&M manual. FS Date: 09/19/2013

Concrete headwall visible on WS toe at canal.

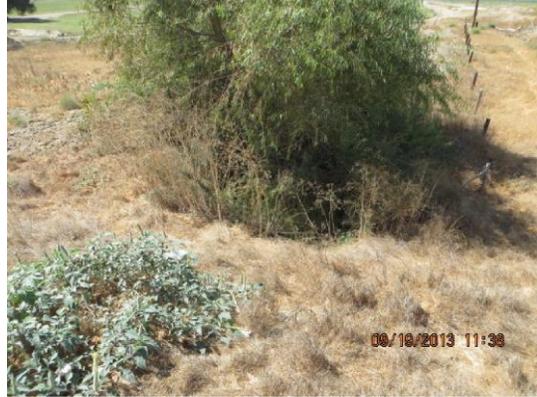
Photo 2 of 3 : UCIP_FA_2015_1591.jpg

LM Start	2.82	Rating **	U	Issue No.	949 (cont)
LM End	2.82	Issue Type +	En	Location *	LS
Category	Supplemental			GPS Latitude/Longitude	
				Start	End
Item	DWR UCIP Field Study			37.640566 °	37.640566 °
				-121.230216 °	-121.230216 °
DWR ID					
Action/Comments					
Inspector Comments: FS_ID:20872 DS_ID:20705 EP_NO: N/A FS_HLM: 2.858 Repair Type: Urgent Crossing Status: Found UCIP Comments: Flap gate missing from WS headwall. FIELD_STRUCT_DESC: 24-inch corrugated metal drain pipe through levee 11.0 feet below crown. Concrete "U" headwall on both ends. Flap gate on waterward end. Originally included in the 1968 O&M manual. FS Date: 09/19/2013

Concrete headwall visible at LS toe in ditch.

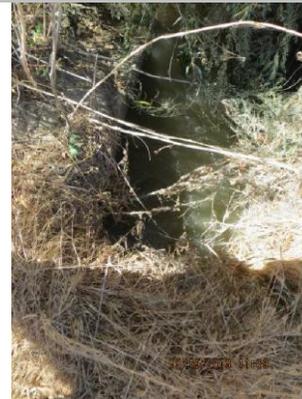
Photo 3 of 3 : UCIP_FA_2015_1783.jpg

Concrete headwall at LS toe.

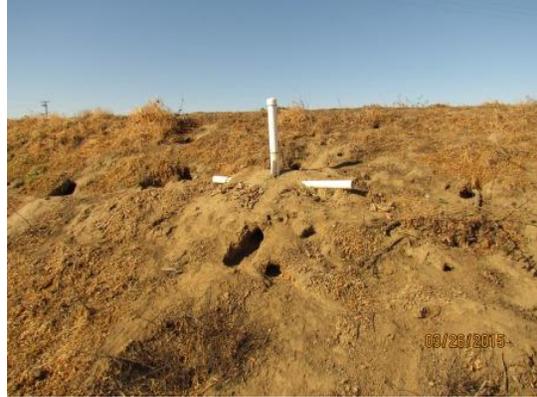
Photo 1 of 1 : FA_2015_RD2101_326_27_20150910_00011.jpg

LM Start	2.83	Rating **	U	Issue No.	27
LM End	2.83	Issue Type +	Ma	Location *	WS
Category	Earthen Levee			GPS Latitude/Longitude	
				Start	End
Item	Animal Control			37.640425 °	37.640425 °
				-121.230139 °	-121.230139 °
DWR ID	DWR_RD2101_01_s_2012_27				
Action/Comments					
No rodents visible, but rodent burrows visible; need to backfill and compact or grout burrows. Inspector Comments: Burrows on both sides of levee. Backfill the burrows to restore the levee to original condition.

View of multiple rodent holes on the levee slope.

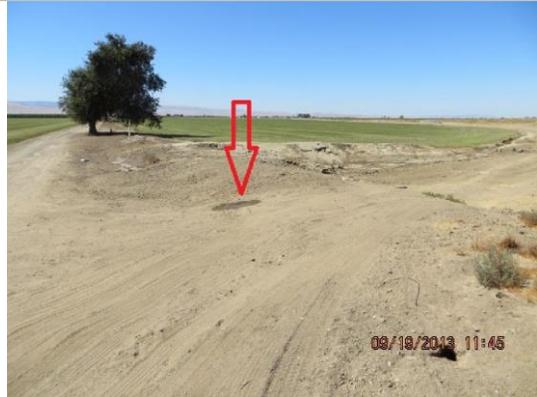
Photo 1 of 3 : UCIP_FA_2015_1595.jpg

LM Start	2.85	Rating **	M	Issue No.	950
LM End	2.85	Issue Type +	En	Location *	WS
Category	Supplemental			GPS Latitude/Longitude	
				Start	End
Item	DWR UCIP Field Study			37.640185 °	37.640185 °
				-121.230067 °	-121.230067 °
DWR ID					
Action/Comments					
Inspector Comments: FS_ID:20874 DS_ID:20712 EP_NO: N/A FS_HLM: 2.886 Repair Type: Non-Urgent Crossing Status: Found UCIP Comments: Leak off LS toe may indicate internal failure. Good candidate for video inspection. FIELD_STRUCT_DESC: 2 of 2: 30-inch concrete pipe through levee 11.0 feet below crown. Pump on metal pier on waterside berm. 12-inch steel riser next to 6'X10.5' concrete box with Screw gate inside on waterward side. Abandoned Pump house on waterward side. Originally included in the 1968 O&M manual. FS Date: 09/19/2013

Leak in pipe off LS toe.

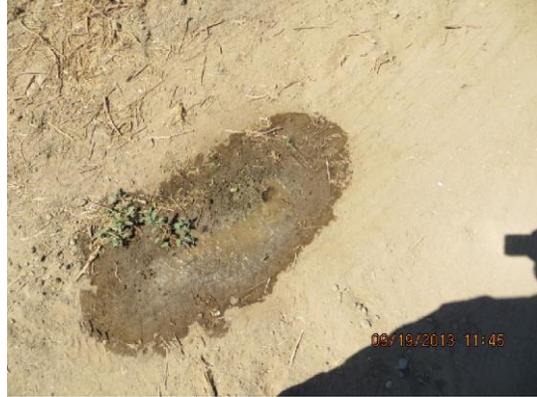
Photo 2 of 3 : UCIP_FA_2015_1596.jpg

LM Start	2.85	Rating **	M	Issue No.	950 (cont)
LM End	2.85	Issue Type +	En	Location *	WS
Category	Supplemental			GPS Latitude/Longitude	
				Start	End
Item	DWR UCIP Field Study			37.640185 °	37.640185 °
				-121.230067 °	-121.230067 °
DWR ID					
Action/Comments					
Inspector Comments: FS_ID:20874 DS_ID:20712 EP_NO: N/A FS_HLM: 2.886 Repair Type: Non-Urgent Crossing Status: Found UCIP Comments: Leak off LS toe may indicate internal failure. Good candidate for video inspection. FIELD_STRUCT_DESC: 2 of 2: 30-inch concrete pipe through levee 11.0 feet below crown. Pump on metal pier on waterside berm. 12-inch steel riser next to 6'X10.5' concrete box with Screw gate inside on waterward side. Abandoned Pump house on waterward side. Originally included in the 1968 O&M manual. FS Date: 09/19/2013

Leak in pipe off LS toe.

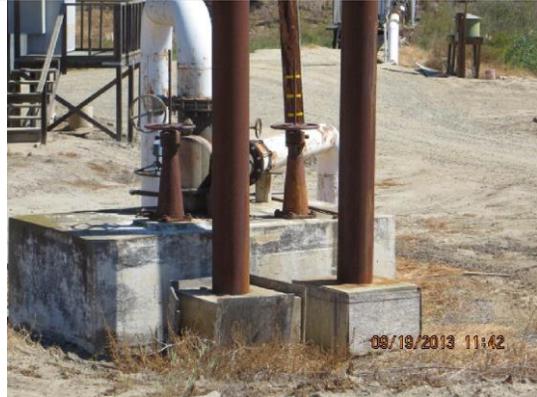
Photo 3 of 3 : UCIP_FA_2015_1597.jpg

Gatevalve in concrete vault with standpipe off WS toe.

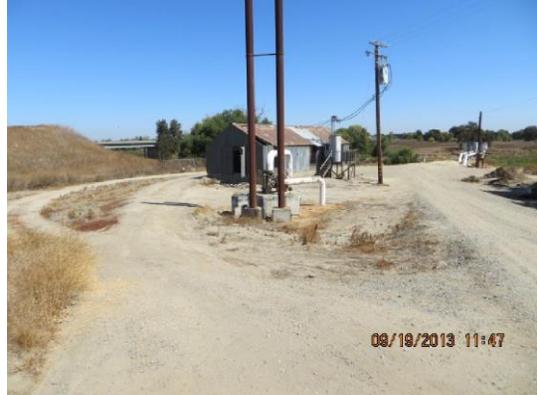
Photo 1 of 3 : UCIP_FA_2015_1592.jpg

LM Start	2.85	Rating **	M	Issue No.	951
LM End	2.85	Issue Type +	En	Location *	WS
Category	Supplemental			GPS Latitude/Longitude	
				Start	End
Item	DWR UCIP Field Study			37.640185 °	37.640185 °
				-121.230067 °	-121.230067 °
DWR ID					
Action/Comments					
Inspector Comments: FS_ID:20873 DS_ID:20706 EP_NO: N/A FS_HLM: 2.886 Repair Type: Non-Urgent Crossing Status: Found

12-inch steel riser at concrete box with gatevalve on WS berm.

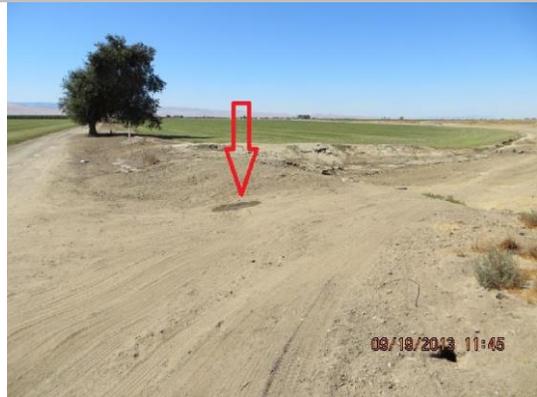
Photo 2 of 3 : UCIP_FA_2015_1593.jpg

Leak in pipe off LS toe.

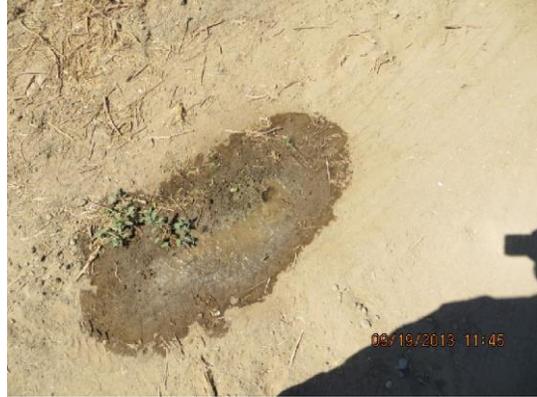
Photo 3 of 3 : UCIP_FA_2015_1594.jpg

LM Start	2.85	Rating **	M	Issue No.	951 (cont)
LM End	2.85	Issue Type +	En	Location *	WS
Category	Supplemental			GPS Latitude/Longitude	
				Start	End
Item	DWR UCIP Field Study			37.640185 °	37.640185 °
				-121.230067 °	-121.230067 °
DWR ID					
Action/Comments					
Inspector Comments: FS_ID:20873 DS_ID:20706 EP_NO: N/A FS_HLM: 2.886 Repair Type: Non-Urgent Crossing Status: Found

Leak in pipe off LS toe.

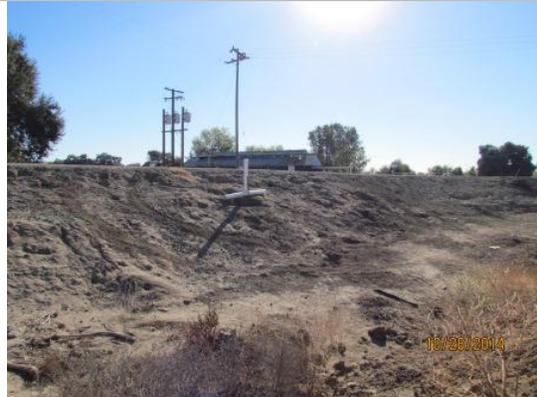
Photo 1 of 1 : FA_2015_RD2101_326_28_20150910_00012.jpg

LM Start	2.85	Rating **	A/W	Issue No.	28
LM End	2.85	Issue Type +	Ma	Location *	LS
Category	Earthen Levee			GPS Latitude/Longitude	
				Start	End
Item	Animal Control			37.640134 °	37.640134 °
				-121.230019 °	-121.230019 °
DWR ID	DWR_RD2101_01_s_2012_28				
Action/Comments					
No rodents visible, but rodent burrows visible; need to backfill and compact or grout burrows. Inspector Comments: Rodent holes were backfilled. Continue to monitor the area and exterminate the rodents.

View of numerous rodent holes with bait stations present.

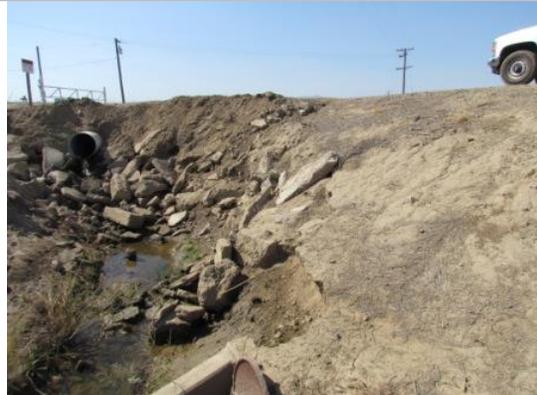
Photo 1 of 2 : FA_2015_RD2101_326_29_20150910_00013.jpg

LM Start	2.87	Rating **	M	Issue No.	29
LM End	2.87	Issue Type +	Ma	Location *	WS
Category	Earthen Levee			GPS Latitude/Longitude	
				Start	End
Item	Erosion / Bank Caving			37.639852 °	37.639852 °
				-121.229980 °	-121.229980 °
DWR ID	DWR_RD2101_01_s_2012_29				
Action/Comments					
Note and monitor erosion site.

View of repaired site, but it appears that erosion is still occurring.
09/25/2012

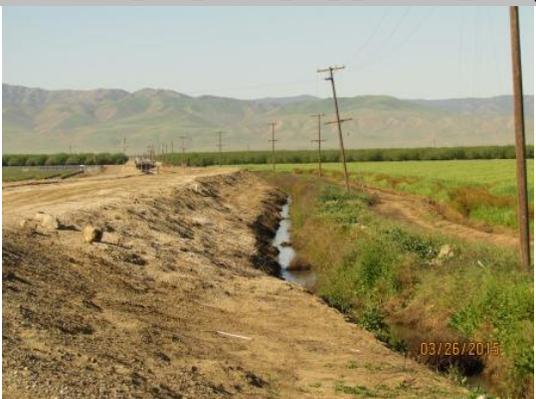
Photo 1 of 1 : FA_2015_RD2101_326_8_20150910_00004.jpg

LM Start	2.88	Rating **	M	Issue No.	8
LM End	3.15	Issue Type +	En	Location *	LS
Category	Earthen Levee			GPS Latitude/Longitude	
				Start	End
Item	Encroachments			37.639780 °	37.637167 °
				-121.230008 °	-121.233715 °
DWR ID	DWR_RD2101_01_f_2013_8				
Action/Comments					
Ditch

View of the ditch at the landside levee toe.

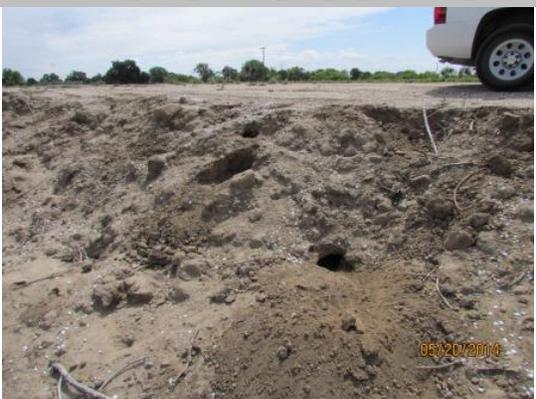
Photo 1 of 1 : FA_2015_RD2101_326_17_20150910_00009.jpg

LM Start	2.98	Rating **	M	Issue No.	17
LM End	2.98	Issue Type +	Ma	Location *	LS
Category	Earthen Levee			GPS Latitude/Longitude	
				Start	End
Item	Animal Control			37.638760 °	37.638760 °
				-121.231341 °	-121.231341 °
DWR ID	DWR_RD2101_01_s_2012_17				
Action/Comments					
Exterminate rodents and backfill and compact or grout burrows. Inspector Comments: Active burrows with rodents present.

Numerous burrows present, some already caving in, others are active.

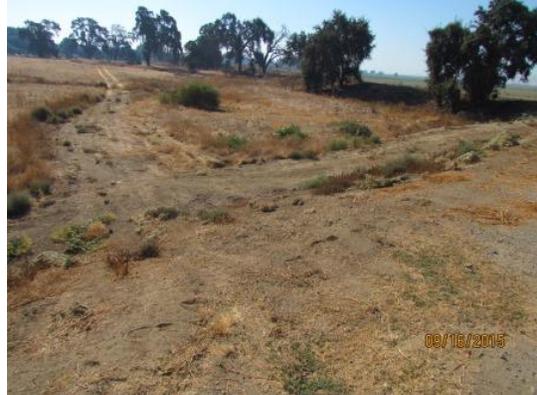
Photo 1 of 1 : FA_2015_RD2101_327_1_20150921_00002.jpg

LM Start	0.03	Rating **	A/W	Issue No.	1
LM End	0.03	Issue Type +	Ma	Location *	WS
Category	Earthen Levee			GPS Latitude/Longitude	
				Start	End
Item	Slope Stability			37.660251 °	37.660251 °
				-121.243372 °	-121.243372 °
DWR ID	DWR_RD2101_02_f_2015_1				
Action/Comments					
Repair the levee slope damaged by vehicle traffic and prevent access where possible. Inspector Comments: Monitor the slope for potential further erosion. Repair as needed.

View of the vehicle tracks on the levee slope.
