**Flood Control Project Maintenance
Levee Inspections**
LMA District Cover Sheet
Spring 2016 Levee Inspection Results

Reclamation District No. 2103 Wheatland Vicinity

Waterway	Bank	Unit Miles
Unit No. 01 South Dry Creek	Left	4.64

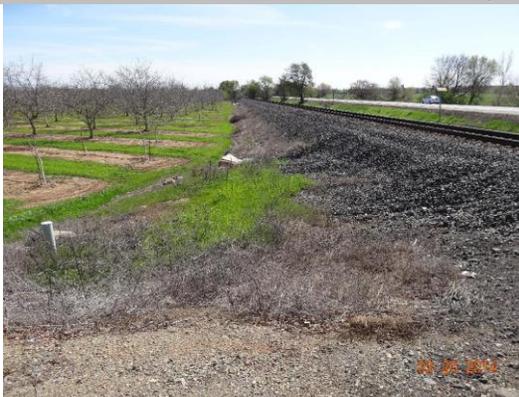
Photo 1 of 1 : UCIP_SP_2016_43823_73340.jpg

LM Start	0.55	Rating **	M	Issue No.	37
LM End	0.55	Issue Type +	En	Location *	LS
Category	Supplemental			GPS Latitude/Longitude	
				Start	End
Item	DWR UCIP Field Study			39.022654 °	39.022654 °
				-121.444665 °	-121.444665 °
DWR ID					
Comment Code					
Inspector Comment					
FS_ID:43823 DS_ID:19467 EP_NO: 16041 Repair Type: Non-Urgent Crossing Status: Indicator Found UCIP Comments: Needs markers at levee crossing. FIELD_STRUCT_DESC: 2-inch steel communication conduit encasing telephone cable through the levee, 2-feet below the crown. Extends to junction box 10-feet from landward toe, parallel to railroad tracks. (Permit No. 16041-1993). FS Date: 3/18/2015

Junction box visible on LS toe (at lower left of photo).

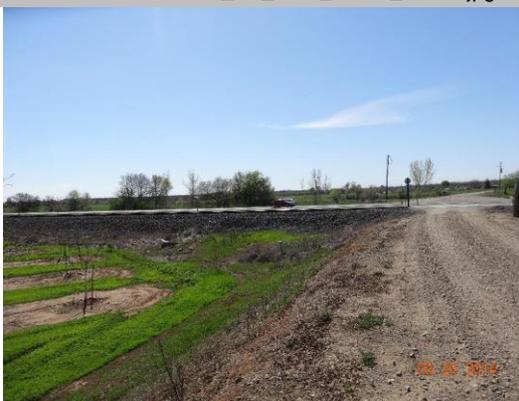
Photo 1 of 2 : UCIP_SP_2016_39987_71885.jpg

LM Start	0.56	Rating **	M	Issue No.	35
LM End	0.56	Issue Type +	En	Location *	LS
Category	Supplemental			GPS Latitude/Longitude	
				Start	End
Item	DWR UCIP Field Study			39.022665 °	39.022665 °
				-121.444688 °	-121.444688 °
DWR ID					
Comment Code					
Inspector Comment					
FS_ID:39987 DS_ID:24879 EP_NO: N/A Repair Type: Non-Urgent Crossing Status: Indicator Found UCIP Comments: Need to contact owner to obtain depth of line through levee. Also need permit authorizing conduit through levee. FIELD_STRUCT_DESC: Conduit line through levee. Markers visible on both sides. FS Date: 3/4/2014

View of landward side.

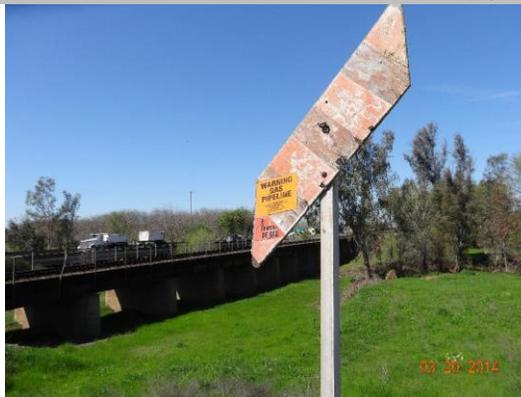
Photo 2 of 2 : UCIP_SP_2016_38323_69859.jpg

LM Start	0.56	Rating **	M	Issue No.	28 (cont)
LM End	0.56	Issue Type +	En	Location *	LS
Category	Supplemental			GPS Latitude/Longitude	
				Start	End
Item	DWR UCIP Field Study			39.022733 °	39.022733 °
				-121.444626 °	-121.444626 °
DWR ID					
Comment Code					
Inspector Comment					
FS_ID:38323 DS_ID:19469 EP_NO: 2098 Repair Type: Non-Urgent Crossing Status: Indicator Found UCIP Comments: Need to contact owner to determine status of crossing. Need date of last inspection and confirmation that crossing is still in operable condition. FIELD_STRUCT_DESC: 16-inch steel gas line through the levee, 3.0 feet below the crown. Marker on waterward slope. (Permit No. 2098-1955). This entry matches the Drainage or Irrigation Structure referenced in O&M manual (HLM 0.56). FS Date: 3/20/2014

Marker visible waterward side.

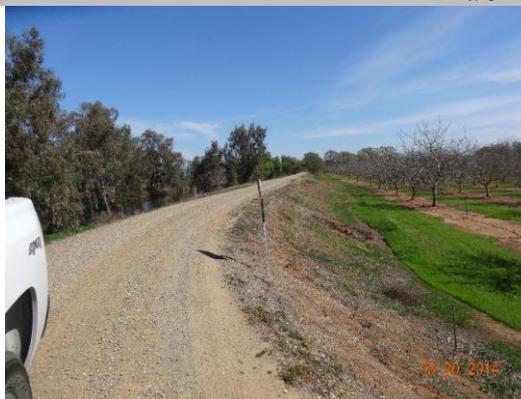
Photo 1 of 2 : UCIP_SP_2016_38324_69864.jpg

LM Start	0.62	Rating **	M	Issue No.	29
LM End	0.62	Issue Type +	En	Location *	LS
Category	Supplemental			GPS Latitude/Longitude	
				Start	End
Item	DWR UCIP Field Study			39.023513 °	39.023513 °
				-121.444168 °	-121.444168 °
DWR ID

Comment Code					
Inspector Comment					
FS_ID:38324 DS_ID:19470 EP_NO: 789 Repair Type: Non-Urgent Crossing Status: Indicator Found UCIP Comments: Need to contact owner to determine status of crossing. Need date of last inspection and confirmation that crossing is still in operable condition. FIELD_STRUCT_DESC: 16-inch steel gas line through levee, 3.0 feet below the crown. Concrete inspection chamber (24x18-inch with 4-inch walls) on the waterward shoulder, covered with dirt. Gas line marker on landward slope. Extends underneath Dry Creek channel, covered with concrete slab approx. 18-inches wide. (Permit No. 789-1939). This entry matches the Drainage or Irrigation Structure referenced in O&M manual (HLM 0.63). FS Date: 3/20/2014

View of levee crown looking upstream.

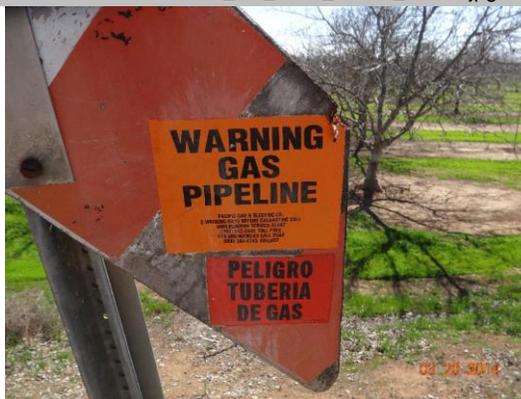
Photo 2 of 2 : UCIP_SP_2016_38324_69863.jpg

Comment Code					
Inspector Comment					
FS_ID:38324 DS_ID:19470 EP_NO: 789 Repair Type: Non-Urgent Crossing Status: Indicator Found UCIP Comments: Need to contact owner to determine status of crossing. Need date of last inspection and confirmation that crossing is still in operable condition. FIELD_STRUCT_DESC: 16-inch steel gas line through levee, 3.0 feet below the crown. Concrete inspection chamber (24x18-inch with 4-inch walls) on the waterward shoulder, covered with dirt. Gas line marker on landward slope. Extends underneath Dry Creek channel, covered with concrete slab approx. 18-inches wide. (Permit No. 789-1939). This entry matches the Drainage or Irrigation Structure referenced in O&M manual (HLM 0.63). FS Date: 3/20/2014

Contact information for gas pipeline.

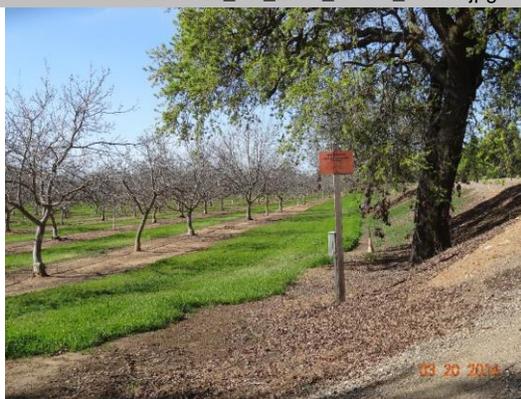
Photo 1 of 2 : UCIP_SP_2016_39988_71890.jpg

LM Start	0.81	Rating **	M	Issue No.	36
LM End	0.81	Issue Type +	En	Location *	LS
Category	Supplemental			GPS Latitude/Longitude	
	Start		End		
Item	DWR UCIP Field Study			39.024725 °	39.024725 °
				-121.440978 °	-121.440978 °
DWR ID					
Comment Code					
Inspector Comment					
FS_ID:39988 DS_ID:24880 EP_NO: N/A Repair Type: Non-Urgent Crossing Status: Indicator Found UCIP Comments: No marker found on waterward side--need to confirm with owner if crossing goes through levee. If so, need depth of crossing through levee. Also need to obtain permit number used to authorize crossing. FIELD_STRUCT_DESC: Conduit line through levee. Marker visible on landward side. FS Date: 3/4/2014

Underground cable line marker visible on landward side toe.

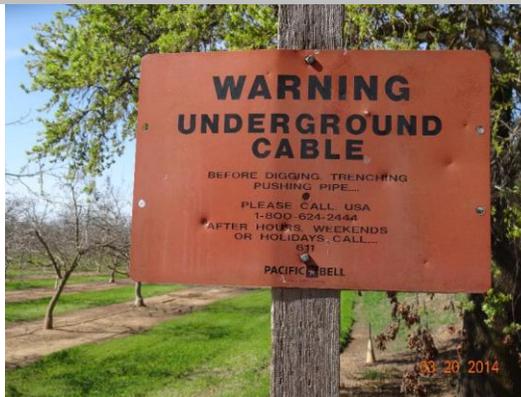
Photo 2 of 2 : UCIP_SP_2016_39988_71889.jpg

LM Start	0.81	Rating **	M	Issue No.	36 (cont)
LM End	0.81	Issue Type +	En	Location *	LS
Category	Supplemental			GPS Latitude/Longitude	
				Start	End
Item	DWR UCIP Field Study			39.024725 °	39.024725 °
				-121.440978 °	-121.440978 °
DWR ID					
Comment Code					
Inspector Comment					
FS_ID:39988 DS_ID:24880 EP_NO: N/A Repair Type: Non-Urgent Crossing Status: Indicator Found UCIP Comments: No marker found on waterward side--need to confirm with owner if crossing goes through levee. If so, need depth of crossing through levee. Also need to obtain permit number used to authorize crossing. FIELD_STRUCT_DESC: Conduit line through levee. Marker visible on landward side. FS Date: 3/4/2014

Marker is for underground cable line owned by Pacific Bell.

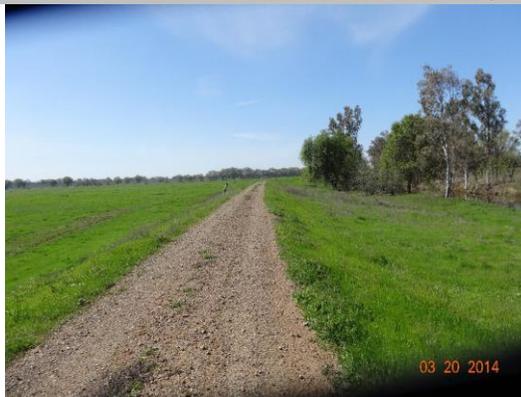
Photo 1 of 2 : UCIP_SP_2016_41183_69917.jpg

Comment Code					
Inspector Comment					
FS_ID:41183 DS_ID:19473 EP_NO: 1886 Repair Type: Non-Urgent Crossing Status: Indicator Found UCIP Comments: Need to coordinate with owner. Severely corroded section of steel pipe present on waterward side--no other evidence present at this location. Owner will need to coordinate with CVFPB and DWR-Inspector to determine proper action to abandon crossing. FIELD_STRUCT_DESC: Abandoned 12-inch steel irrigation pipe through the levee, 3.1 feet below the crown. Siphon breaker on the waterward slope. Concrete standpipe at the landward toe. Vertical pump on waterward side. Open on waterward end. Permit includes gravel dam through channel of Dry Creek. (Permit No. 1886-1959). This entry matches the Drainage or Irrigation Structure referenced in O&M manual (HLM 1.86). Crossing is angled 45 degrees. FS Date: 3/20/2014

Overview of levee crown.

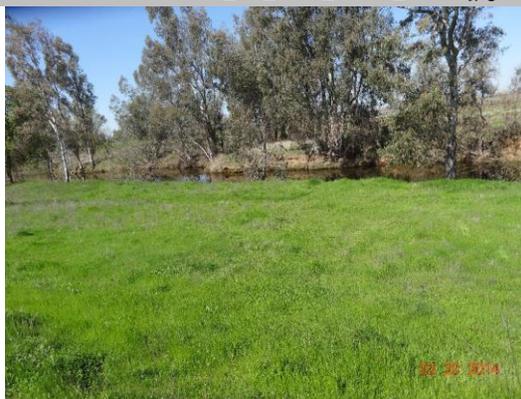
Photo 2 of 2 : UCIP_SP_2016_41183_69916.jpg

LM Start	1.80	Rating **	M	Issue No.	31 (cont)
LM End	1.80	Issue Type +	En	Location *	LS

View of waterward side.

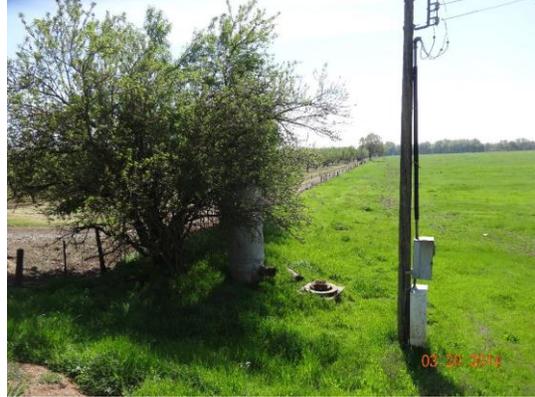
Photo 1 of 2 : UCIP_SP_2016_38327_69881.jpg

LM Start	1.86	Rating **	M	Issue No.	30
LM End	1.86	Issue Type +	En	Location *	LS
Category	Supplemental			GPS Latitude/Longitude	
				Start	End
Item	DWR UCIP Field Study			39.029694 °	39.029694 °
				-121.423946 °	-121.423946 °
DWR ID					
Comment Code					
Inspector Comment					
FS_ID:38327 DS_ID:19512 EP_NO: N/A Repair Type: Non-Urgent Crossing Status: Indicator Found UCIP Comments: Unable to determine if there is a crossing through pipe. Will need to coordinate with owner to determine additional information about appurtenances found on landward side. FIELD_STRUCT_DESC: Irrigation pump, service pole, and 36-inch concrete standpipe, 5 feet from the landward toe. No pump was found during field visit 3/20/14. FS Date: 3/20/2014

View of landward side.

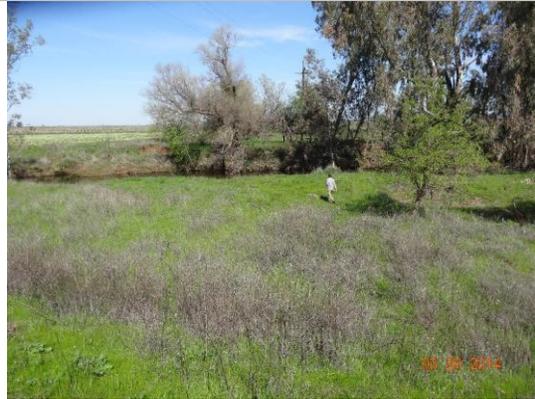
Photo 2 of 2 : UCIP_SP_2016_38327_69880.jpg

LM Start	1.86	Rating **	M	Issue No.	30 (cont)
LM End	1.86	Issue Type +	En	Location *	LS

View of waterward side.

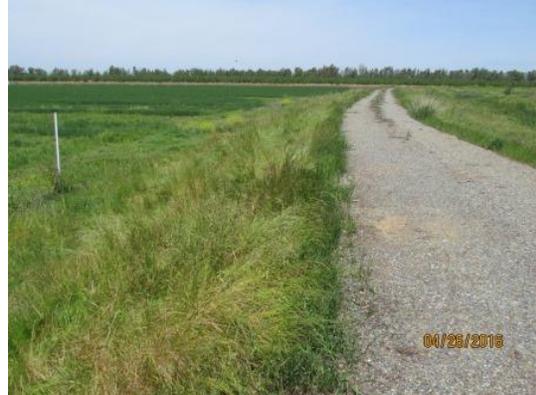
Photo 1 of 1 : SP_2016_RD2103_10_21_20160427_00038.jpg

View of vegetation on the landside slope looking upstream.

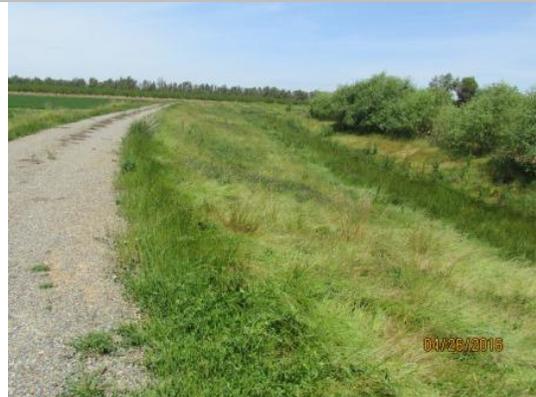
Photo 1 of 1 : SP_2016_RD2103_10_24_20160427_00039.jpg

LM Start	3.33	Rating **	M	Issue No.	24
LM End	3.53	Issue Type +	Ma	Location *	WS
Category	Earthen Levee		GPS Latitude/Longitude		
			Start	End	
Item	Vegetation		39.032923 °	39.030269 °	
			-121.400838 °	-121.401014 °	
DWR ID	DWR_RD2103_01_s_2016_24				
Comment Code					
V1 : Control annual grass and weeds on the levee slopes and easements.					
Inspector Comment

View of typical vegetation on waterside looking upstream.

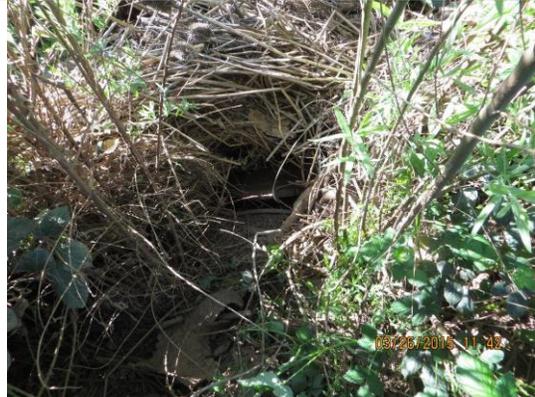
Photo 1 of 2 : UCIP_SP_2016_43954_73429.jpg

LM Start	3.59	Rating **	U	Issue No.	38
LM End	3.59	Issue Type +	En	Location *	WS
Category	Supplemental		GPS Latitude/Longitude		
			Start	End	
Item	DWR UCIP Field Study		39.033074 °	39.033074 °	
			-121.400434 °	-121.400434 °	
DWR ID					
Comment Code					
Inspector Comment					
FS_ID:43954 DS_ID:19478 EP_NO: N/A Repair Type: Urgent Crossing Status: Found UCIP Comments: Flapgate open and won't close due to vegetation and soil blocking its operation. FIELD_STRUCT_DESC: 24-inch CM drainpipe through the levee, 12.0 feet below the crown. Flap gate at the waterward end. FS Date: 3/26/2015

Flapgate at WS berm blocked by soil and vegetation bu8ildup.

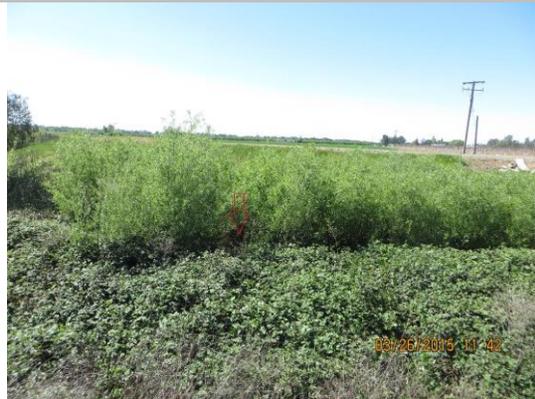
Photo 2 of 2 : UCIP_SP_2016_43954_73428.jpg

LM Start	3.59	Rating **	U	Issue No.	38 (cont)
LM End	3.59	Issue Type +	En	Location *	WS

Location of pipe and Flapgate on WS berm.

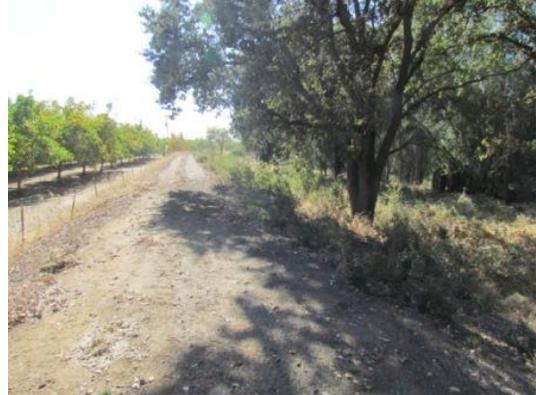
Photo 1 of 1 : SP_2016_RD2103_10_8_20160307_00003.jpg

This photo was taken from the crown of the levee facing west looking at the vegetation on the waterward slope of the levee.

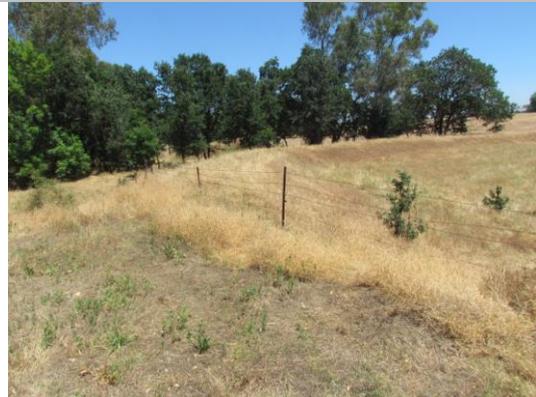
Photo 1 of 1 : SP_2016_RD2103_10_20_20160307_00005.jpg

LM Start	4.52	Rating **	M	Issue No.	20
LM End	4.52	Issue Type +	En	Location *	CR
Category	Earthen Levee		GPS Latitude/Longitude		
			Start	End	
Item	Encroachments		39.042220 °	39.042220 °	
			-121.393577 °	-121.393577 °	
DWR ID	DWR_RD2103_01_s_2015_20				
Comment Code					
FE : Fence					
Inspector Comment

View of the fence blocking access to the crown of the levee. View is from the crown facing upstream.

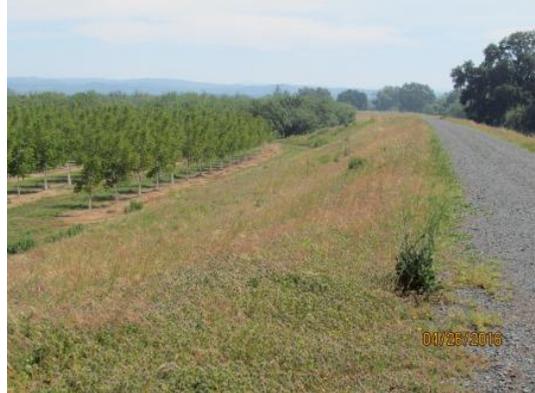
Photo 1 of 1 : SP_2016_RD2103_11_16_20160427_00031.jpg

View of typical vegetation on the landside slope looking downstream.

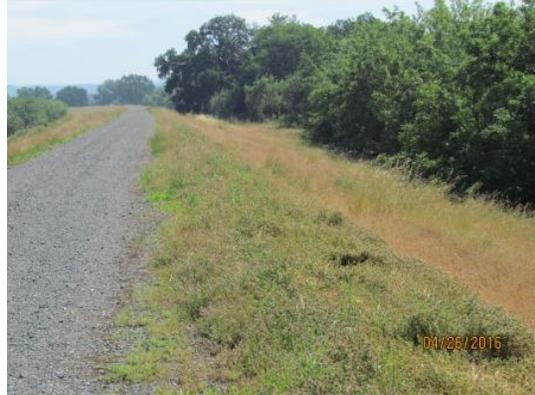
Photo 1 of 1 : SP_2016_RD2103_11_17_20160427_00032.jpg

LM Start	0.02	Rating **	M	Issue No.	17
LM End	4.73	Issue Type +	Ma	Location *	WS
Category	Earthen Levee		GPS Latitude/Longitude		
			Start	End	
Item	Vegetation		38.993534 °	39.030268 °	
			-121.436964 °	-121.368667 °	
DWR ID	DWR_RD2103_02_s_2016_17				
Comment Code					
V1 : Control annual grass and weeds on the levee slopes and easements.					
Inspector Comment

View of typical vegetation on the waterside looking downstream.

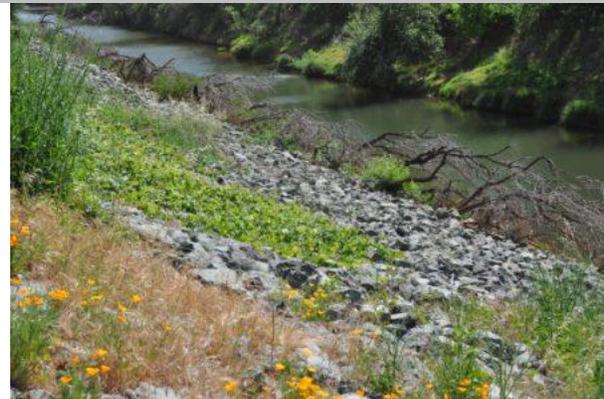
Photo 1 of 2 : SP_2016_RD2103_11_4_20160307_00001.jpg

LM Start	0.29	Rating **	A/W	Issue No.	4
LM End	0.50	Issue Type +	Ma	Location *	WS
Category	Earthen Levee		GPS Latitude/Longitude		
			Start	End	
Item	Riprap Revetments		38.994660 °	38.995537 °	
			-121.432170 °	-121.428535 °	
DWR ID	DWR_RD2103_02_s_2012_4				
Comment Code					
Inspector Comment					
The District has a concern with dead trees placed in the rip rap that may not stay in place during a high water event.

View of revetment with dead trees, Spring 2013.

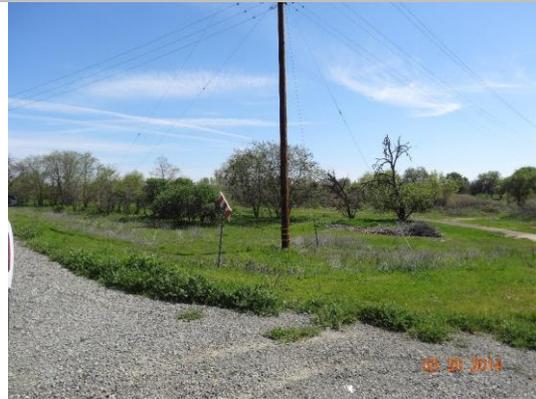
Photo 1 of 2 : UCIP_SP_2016_39993_69912.jpg

Comment Code					
Inspector Comment					
FS_ID:39993 DS_ID:19486 EP_NO: 5714 Repair Type: Non-Urgent Crossing Status: Indicator Found UCIP Comments: Need to contact owner to confirm crossing and determine status. FIELD_STRUCT_DESC: 12-inch steel sewer pipes through the levee, 3.1 feet below the crown. Siphon breaker in 24-inch CM pipe riser on the landward shoulder. Standard CM cutoff wall around pipe at centerline of levee. Extends from wastewater treatment plant on landward side to waste water lagoon on waterward side. Permit includes construction of lagoon with surrounding short levee, extending from/to project levee. (Permit No. 5714-1968). FS Date: 3/20/2014

View of waterward side.

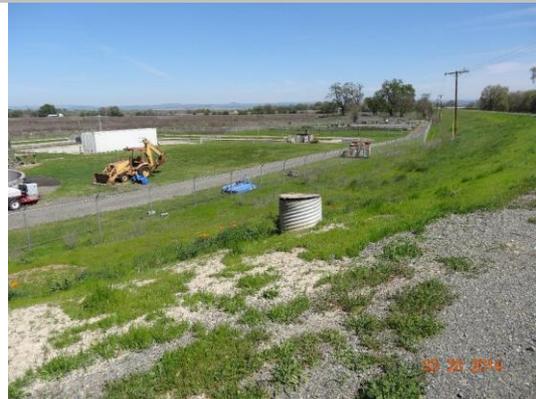
Photo 2 of 2 : UCIP_SP_2016_39993_69911.jpg

LM Start	1.26	Rating **	M	Issue No.	30 (cont)
LM End	1.26	Issue Type +	En	Location *	WS

CMP riser located on landward side.

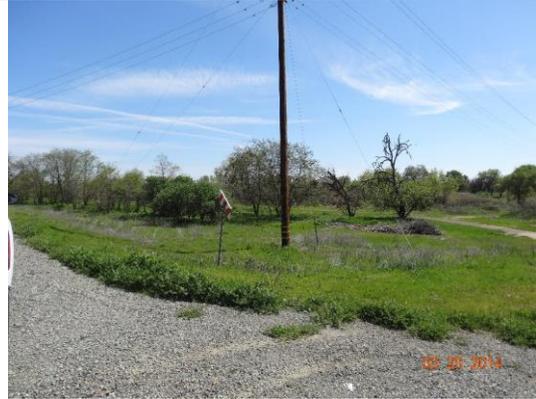
Photo 1 of 2 : UCIP_SP_2016_39994_69905.jpg

LM Start	1.29	Rating **	M	Issue No.	31
LM End	1.29	Issue Type +	En	Location *	WS
Category	Supplemental			GPS Latitude/Longitude	
				Start	End
Item	DWR UCIP Field Study			38.998322 °	38.998322 °
				-121.414688 °	-121.414688 °
DWR ID					
Comment Code					
Inspector Comment					
FS_ID:39994 DS_ID:19509 EP_NO: N/A Repair Type: Non-Urgent Crossing Status: Indicator Found UCIP Comments: Need to contact owner to determine details of the crossing through levee. FIELD_STRUCT_DESC: Wheatland Sewage Disposal Plant on waterward side, treatment plant on landward side. Service pole on waterward slope. FS Date: 3/20/2014

View of waterward side.

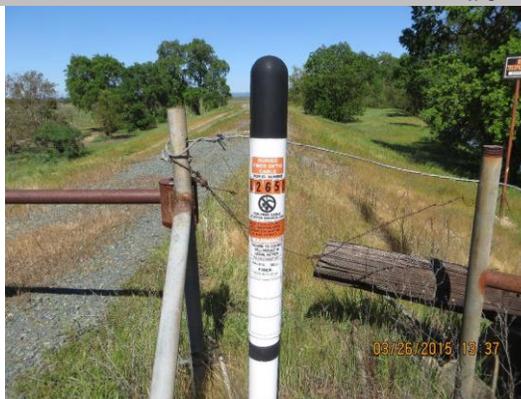
Photo 1 of 2 : UCIP_SP_2016_44089_73568.jpg

LM Start	1.76	Rating **	M	Issue No.	33
LM End	1.76	Issue Type +	En	Location *	WS
Category	Supplemental			GPS Latitude/Longitude	
				Start	End
Item	DWR UCIP Field Study			39.000557 °	39.000557 °
				-121.406581 °	-121.406581 °
DWR ID					
Comment Code					
Inspector Comment					
FS_ID:44089 DS_ID:25090 EP_NO: N/A Repair Type: Non-Urgent Crossing Status: Found UCIP Comments: No permit identified for this crossing. FIELD_STRUCT_DESC: Fiberoptic line through the levee at unknown depth. Marker visible on WS shoulder. 6-inch steel pipe visible on upstream side of railroad trestle. FS Date: 3/26/2015

Fiberoptic line marker on crown of levee

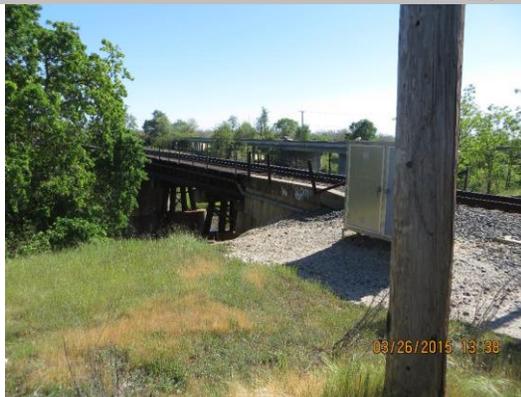
Photo 2 of 2 : UCIP_SP_2016_44089_73567.jpg

LM Start	1.76	Rating **	M	Issue No.	33 (cont)
LM End	1.76	Issue Type +	En	Location *	WS
Category	Supplemental			GPS Latitude/Longitude	
				Start	End
Item	DWR UCIP Field Study			39.000557 °	39.000557 °
				-121.406581 °	-121.406581 °
DWR ID					
Comment Code					
Inspector Comment					
FS_ID:44089 DS_ID:25090 EP_NO: N/A Repair Type: Non-Urgent Crossing Status: Found UCIP Comments: No permit identified for this crossing. FIELD_STRUCT_DESC: Fiberoptic line through the levee at unknown depth. Marker visible on WS shoulder. 6-inch steel pipe visible on upstream side of railroad trestle. FS Date: 3/26/2015

6-inch steel conduit visible on upstream side of railroad bridge.

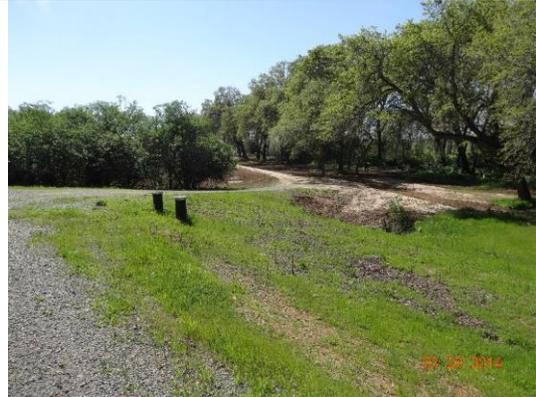
Photo 1 of 2 : UCIP_SP_2016_40045_71908.jpg

LM Start	2.60	Rating **	M	Issue No.	25
LM End	2.60	Issue Type +	En	Location *	LS
Category	Supplemental			GPS Latitude/Longitude	
				Start	End
Item	DWR UCIP Field Study			39.009394 °	39.009394 °
				-121.397300 °	-121.397300 °
DWR ID					
Comment Code					
Inspector Comment					
FS_ID:40045 DS_ID:19488 EP_NO: N/A Repair Type: Non-Urgent Crossing Status: Found UCIP Comments: Pipe has been plugged--visible on landward side. Need to contact owner to obtain additional information about abandoned crossing. FIELD_STRUCT_DESC: 1 of 2: 30-inch diameter CM irrigation pipe through levee, 13.8 feet below crown. Slide gates in 42-diameter riser on waterward slope. Concrete "U" headwall at both levee toes. Grouted spillway on landward side. (USACE-1962). This entry matches the Drainage or Irrigation Structure referenced in O&M manual (HLM 2.67). FS Date: 3/20/2014

View of waterward shoulder.

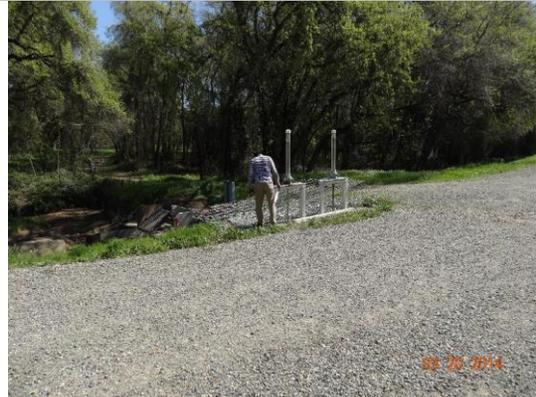
Photo 2 of 2 : UCIP_SP_2016_40045_71907.jpg

LM Start	2.60	Rating **	M	Issue No.	25 (cont)
LM End	2.60	Issue Type +	En	Location *	LS

Slide gates visible located on landward side.

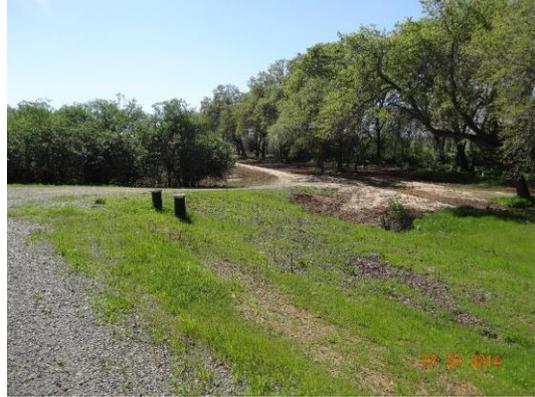
Photo 1 of 2 : UCIP_SP_2016_40046_71915.jpg

LM Start	2.60	Rating **	M	Issue No.	26
LM End	2.60	Issue Type +	En	Location *	LS
Category	Supplemental			GPS Latitude/Longitude	
				Start	End
Item	DWR UCIP Field Study			39.009408 °	39.009408 °
				-121.397296 °	-121.397296 °
DWR ID					
Comment Code					
Inspector Comment					
FS_ID:40046 DS_ID:19504 EP_NO: N/A Repair Type: Non-Urgent Crossing Status: Found UCIP Comments: Need to contact owner to determine status--crossing appears to be modified. Need to contact owner to obtain additional information about modified crossing. FIELD_STRUCT_DESC: 2 of 2: 30-inch diameter CM irrigation pipe through levee, 13.8 feet below crown. Slide gates in 42-diameter riser on waterward slope. Concrete "U" headwall at both levee toes. Grouted spillway on landward side. (USACE-1962). This entry matches the Drainage or Irrigation Structure referenced in O&M manual (HLM 2.67). FS Date: 3/20/2014

View of waterward side.

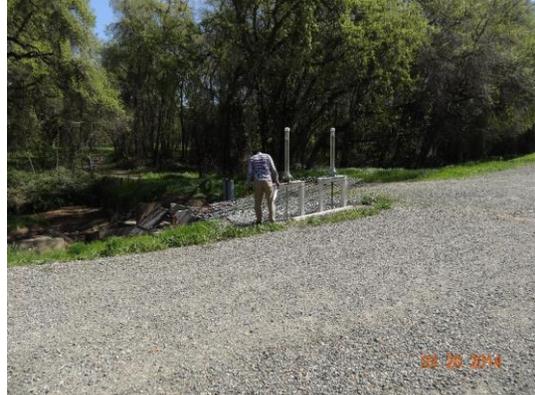
Photo 2 of 2 : UCIP_SP_2016_40046_71914.jpg

LM Start	2.60	Rating **	M	Issue No.	26 (cont)
LM End	2.60	Issue Type +	En	Location *	LS

View of landward side.

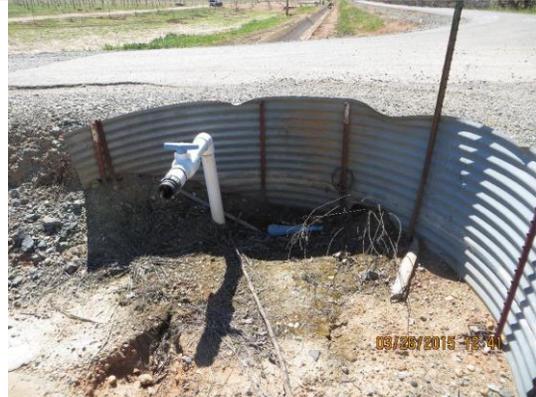
Photo 1 of 2 : UCIP_SP_2016_43957_73435.jpg

LM Start	3.94	Rating **	M	Issue No.	34
LM End	3.94	Issue Type +	En	Location *	LS
Category	Supplemental			GPS Latitude/Longitude	
				Start	End
Item	DWR UCIP Field Study			39.022486 °	39.022486 °
				-121.379343 °	-121.379343 °
DWR ID					
Comment Code					
Inspector Comment					
FS_ID:43957 DS_ID:19500 EP_NO: N/A Repair Type: Non-Urgent Crossing Status: Indicator Found UCIP Comments: Further evaluation necessary to determine alignment of crossing should be conducted. FIELD_STRUCT_DESC: 4-inch PVC water line through levee, 6-feet below the levee crown. Ball valve and Service connection point on LS shoulder. Pipe appears to run parallel to east, on LS slope just off crown but may cross at this location as well. An O+M entry matches the size and location for this crossing (O&M manual 1962, (HLM 4.05). FS Date: 3/26/2015

Service connection and ball valve visible on LS shoulder.

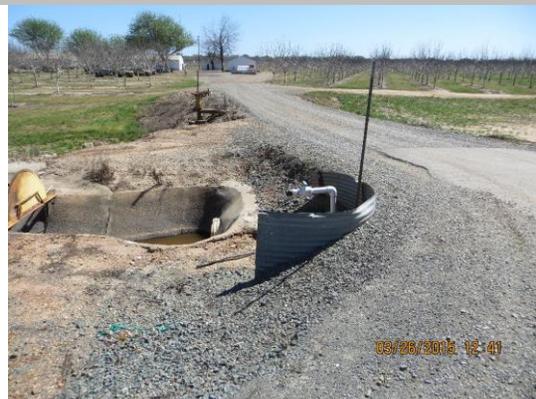
Photo 2 of 2 : UCIP_SP_2016_43957_73434.jpg

LM Start	3.94	Rating **	M	Issue No.	34 (cont)
LM End	3.94	Issue Type +	En	Location *	LS

Service connection and ball valve visible on LS shoulder.

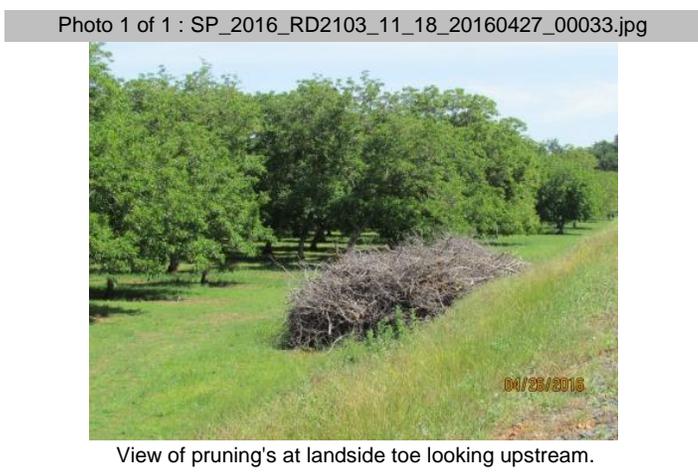
LM Start	4.53	Rating **	M	Issue No.	18
LM End	4.53	Issue Type +	En	Location *	LS
Category	Earthen Levee			GPS Latitude/Longitude	
				Start	End
Item	Encroachments			39.028565 °	39.028565 °
				-121.371704 °	-121.371704 °
DWR ID	DWR_RD2103_02_s_2016_18				
Comment Code					
PR : Prunings					
Inspector Comment

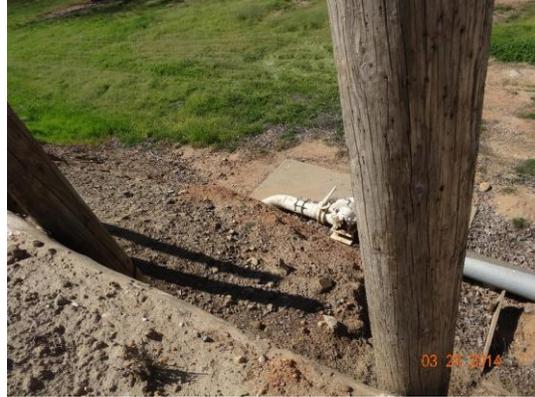
Photo 1 of 2 : UCIP_SP_2016_40049_71928.jpg

Comment Code					
Inspector Comment					
FS_ID:40049 DS_ID:19493 EP_NO: N/A Repair Type: Non-Urgent Crossing Status: Found UCIP Comments: Crossing has been modified---need to contact owner to obtain permit used for modification. FIELD_STRUCT_DESC: 24-inch corrugated metal irrigation pipe through levee, 10.6 feet below the crown. Slide gate in concrete square riser (not 36-inch CM riser as mentioned in desk study) on the waterward slope. Concrete "U" headwall and trash rack at waterward toe. 5x5-foot concrete distribution box and headwall at landward toe. (USACE-1962). This entry matches the Drainage or Irrigation Structure referenced in O&M manual (HLM 4.87). FS Date: 3/20/2014

Pipe visible on waterward side.

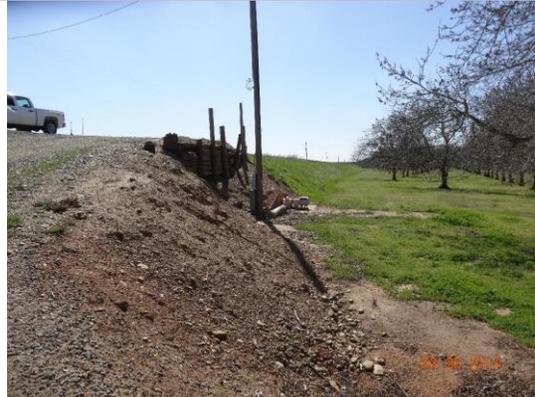
Photo 2 of 2 : UCIP_SP_2016_40049_71926.jpg

LM Start	4.74	Rating **	M	Issue No.	28 (cont)
LM End	4.74	Issue Type +	En	Location *	LS

Overview of waterward side.
