**Flood Control Project Maintenance
Levee Inspections**
LMA District Cover Sheet
Spring 2016 Levee Inspection Results

Sacramento Maintenance Yard Putah Creek

Spring 2016 Levee Inspection Results

Levee Inspection Report By Mile - Spring 2016

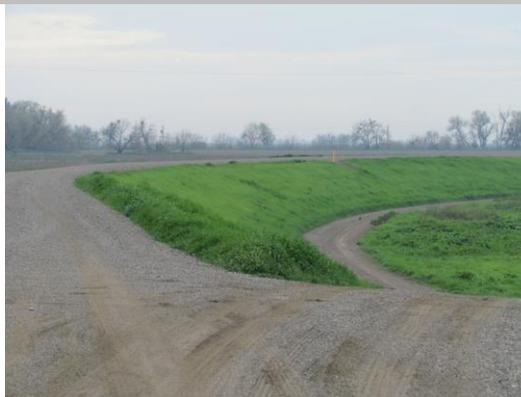
Photo 1 of 1 : SP_2016_ST0007_282_22_20160314_00024.jpg

LM Start	0.00	Rating **	A	Issue No.	22
LM End	0.27	Issue Type +	Ma	Location *	LS
Category	Earthen Levee			GPS Latitude/Longitude	
				Start	End
Item	Vegetation			38.523618 °	38.520310 °
				-121.631445 °	-121.633297 °
DWR ID	DWR_ST0007_01_s_2016_22				
Comment Code					
V1 : Control annual grass and weeds on the levee slopes and easements.					
Inspector Comment					
The grasses along this levee section aren't causing a problem.

Looking downstream from the levee mile 0.00 landward levee slope. There are grasses present on the levee section.

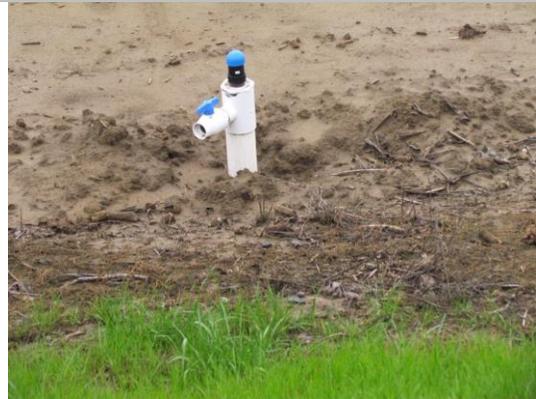
Photo 1 of 1 : SP_2016_ST0007_282_21_20160314_00025.jpg

LM Start	0.90	Rating **	U	Issue No.	21
LM End	0.90	Issue Type +	En	Location *	LS
Category	Earthen Levee		GPS Latitude/Longitude		
			Start	End	
Item	Encroachments		38.518722 °	38.518722 °	
			-121.644615 °	-121.644615 °	
DWR ID	DWR_ST0007_01_s_2016_21				
Comment Code					
PI : Pipe					
Inspector Comment					
Unauthorized pipe within the easement of the landside levee toe.

Unauthorized pipe within the easement along the landside toe.

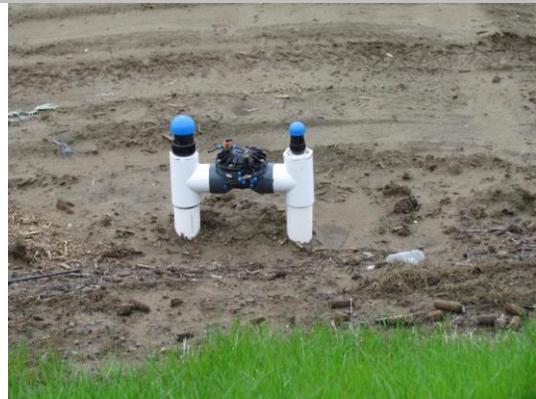
Photo 1 of 1 : SP_2016_ST0007_282_20_20160314_00026.jpg

LM Start	1.03	Rating **	U	Issue No.	20
LM End	1.03	Issue Type +	En	Location *	LS
Category	Earthen Levee		GPS Latitude/Longitude		
			Start	End	
Item	Encroachments		38.517865 °	38.517865 °	
			-121.646902 °	-121.646902 °	
DWR ID	DWR_ST0007_01_s_2016_20				
Comment Code					
PI : Pipe					
Inspector Comment					
Unauthorized pipe placed in easement landside toe.

Unauthorized pipe within the ease of the landside levee toe.

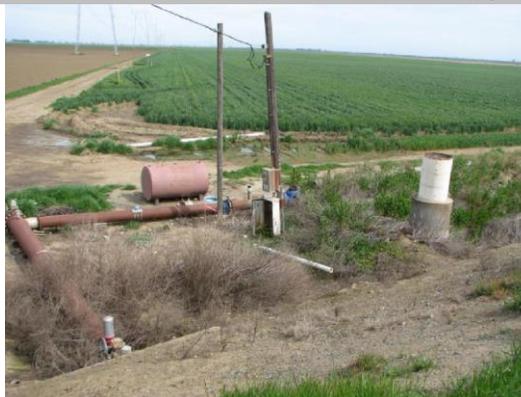
Photo 2 of 2 : UCIP_SP_2016_48122_60483.jpg

Comment Code					
Inspector Comment					
<p>FS_ID:48122 DS_ID:489 EP_NO: 10262 Repair Type: Non-Urgent Crossing Status: Found UCIP Comments: Pump is disconnected from pipe and could cause backflow at highwater event. Can't see size of pipe sleeved through 24-inch pipe. FIELD_STRUCT_DESC: 24-inch steel pipe through levee 12.5 feet below crown with concrete headwalls at both ends. A 18-inch pipe (field verified not 16-inch) is sleeved through the 24-inch pipe with annular space sealed at both ends. This structure was retained under an automatic board order (ABO) issued as Permit No. 10262. (Permit No. 10262 - Wells Fargo Bank, Trustee for S.H.) PVC Sleeved December of 2007 (unknown source). [Additional Reference(s): DWR Levee Log, March 2007. USACE Sacramento O&M Manual 119, December 1952] FS Date: 4/10/2014 2:48:00 PM</p>

pipe and pump/appurtenances on LS

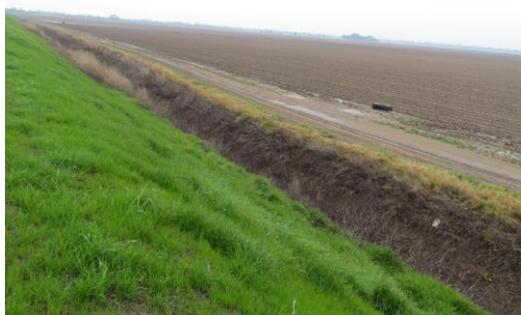
Photo 1 of 1 : SP_2016_ST0007_282_10_20160314_00027.jpg

LM Start	1.48	Rating **	U	Issue No.	10
LM End	2.67	Issue Type +	En	Location *	LS
Category	Earthen Levee			GPS Latitude/Longitude	
				Start	End
Item	Encroachments			38.515322 °	38.517376 °
				-121.654387 °	-121.676054 °
DWR ID	DWR_ST0007_01_s_2012_10				
Comment Code					
DT : Ditch					
Inspector Comment					
<p>This agriculture ditch is owned by Dos Rios Farms. Ending at levee mile 2.67 landside.</p>

Agriculture ditch within 10-foot landside levee toe.

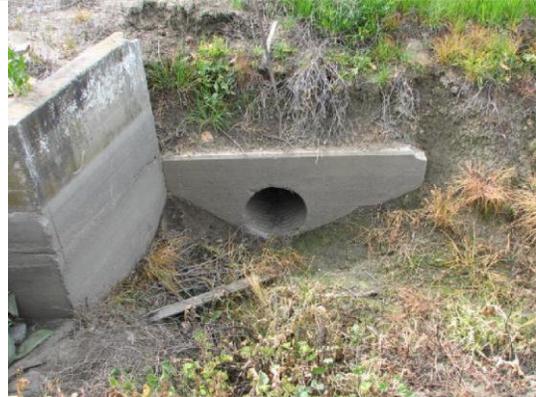
Photo 1 of 2 : UCIP_SP_2016_43033_60465.jpg

LM Start	2.13	Rating **	M	Issue No.	49
LM End	2.13	Issue Type +	En	Location *	WS
Category	Supplemental			GPS Latitude/Longitude	
				Start	End
Item	DWR UCIP Field Study			38.515739 °	38.515739 °
				-121.666432 °	-121.666432 °
DWR ID					
Comment Code					
Inspector Comment					
FS_ID:43033 DS_ID:491 EP_NO: 10262 Repair Type: Non-Urgent Crossing Status: Found UCIP Comments: Pipe has significant rust and exfoliation of metal showing at ends. Reccomend video inspection. FIELD_STRUCT_DESC: 24-inch pipe through levee 15.5 feet below crown. Slide gate on waterward end and concrete headwall on landward end. (ABO No. 10262 - Cowell) FS Date: 4/10/2014 2:45:00 PM

LS headwall

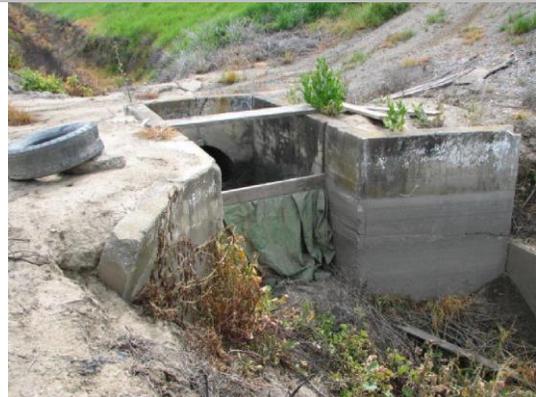
Photo 2 of 2 : UCIP_SP_2016_43033_60467.jpg

LM Start	2.13	Rating **	M	Issue No.	49 (cont)
LM End	2.13	Issue Type +	En	Location *	WS

LS distribution box

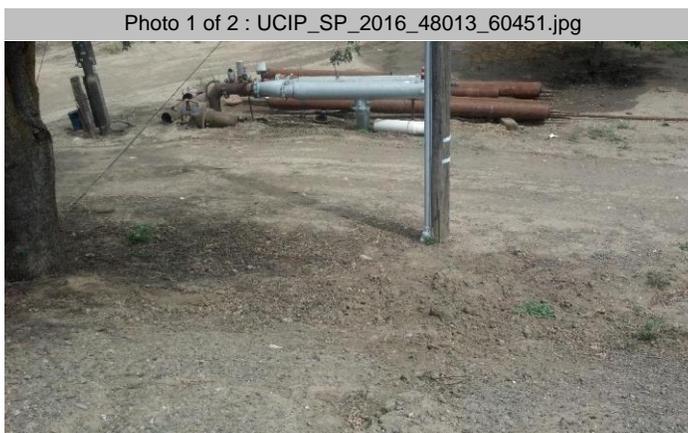
LM Start	3.22	Rating **	M	Issue No.	52
LM End	3.22	Issue Type +	En	Location *	WS
Category	Supplemental		GPS Latitude/Longitude		
			Start	End	
Item	DWR UCIP Field Study		38.519731 °	38.519731 °	
			-121.685681 °	-121.685681 °	
DWR ID					
Comment Code					
Inspector Comment					
FS_ID:48013 DS_ID:16849 EP_NO: N/A Repair Type: Non-Urgent Crossing Status: Found UCIP Comments: Old pipe and concrete hauled to county dump. Evidence of the 14-inch pipe is no longer present at site. See new picture. FIELD_STRUCT_DESC: 10-inch steel irrigation pipe through the levee 12-feet below crown. Pipe terminates at standpipe on waterside (WS) approximately 500 feet south of levee. Mobile pumping plant located in floodway at edge of stream 740 feet south of levee. FS Date: 4/10/2014 2:42:00 PM

Filter Plant on LS toe

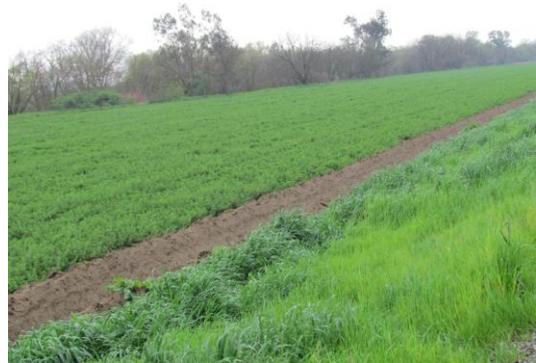
Photo 1 of 1 : SP_2016_ST0007_282_42_20160314_00029.jpg

LM Start	5.07	Rating **	U	Issue No.	42
LM End	5.28	Issue Type +	En	Location *	WS
Category	Earthen Levee		GPS Latitude/Longitude		
			Start	End	
Item	Encroachments		38.518017 °	38.518023 °	
			-121.718558 °	-121.722493 °	
DWR ID	DWR_ST0007_01_s_2016_42				
Comment Code					
DT : Ditch					
Inspector Comment					
Remove the agriculture ditch away from the easement waterside.

Agriculture ditch along the waterside within the 10-foot easement.

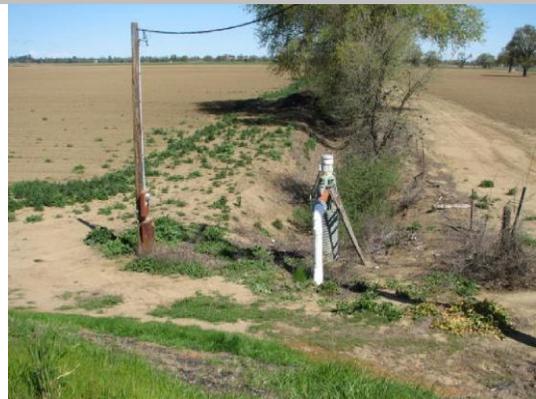
Photo 1 of 2 : UCIP_SP_2016_33367_60406.jpg

LM Start	5.56	Rating **	M	Issue No.	44
LM End	5.56	Issue Type +	En	Location *	WS
Category	Supplemental		GPS Latitude/Longitude		
			Start	End	
Item	DWR UCIP Field Study		38.518250 °	38.518250 °	
			-121.727685 °	-121.727685 °	
DWR ID					
Comment Code					
Inspector Comment					
FS_ID:33367 DS_ID:590 EP_NO: 14140 Repair Type: Non-Urgent Crossing Status: Found UCIP Comments: Air vent broken off on water side shoulder. Also, no flap gate or other positive closure device on either side of levee. No requirement in permit for applicant to install positive closure device, but it may be necessary if maintenance or upgrade is performed on pipe. FIELD_STRUCT_DESC: 6" PVC pipe though levee 16' FBC. 24" stand pipe with pump on land side. Pipe outfalls at creek with rip-rap. FS Date: 4/10/2014 2:35:30 PM

LS pump and pipe

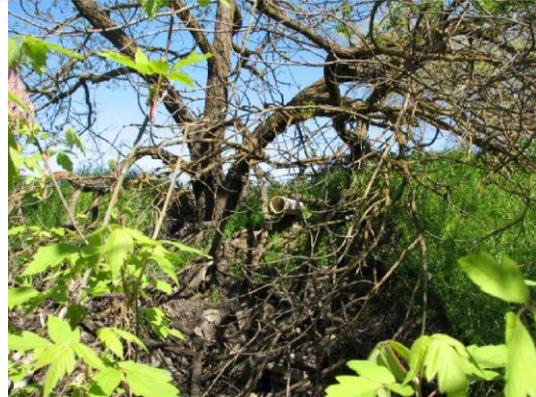
Photo 2 of 2 : UCIP_SP_2016_33367_60408.jpg

LM Start	5.56	Rating **	M	Issue No.	44 (cont)
LM End	5.56	Issue Type +	En	Location *	WS
Category	Supplemental			GPS Latitude/Longitude	
				Start	End
Item	DWR UCIP Field Study			38.518250 °	38.518250 °
				-121.727685 °	-121.727685 °
DWR ID					
Comment Code					
Inspector Comment					
FS_ID:33367 DS_ID:590 EP_NO: 14140 Repair Type: Non-Urgent Crossing Status: Found UCIP Comments: Air vent broken off on water side shoulder. Also, no flap gate or other positive closure device on either side of levee. No requirement in permit for applicant to install positive closure device, but it may be necessary if maintenance or upgrade is performed on pipe. FIELD_STRUCT_DESC: 6" PVC pipe though levee 16' FBC. 24" stand pipe with pump on land side. Pipe outfalls at creek with rip-rap. FS Date: 4/10/2014 2:35:30 PM

WS outfall at creek bank

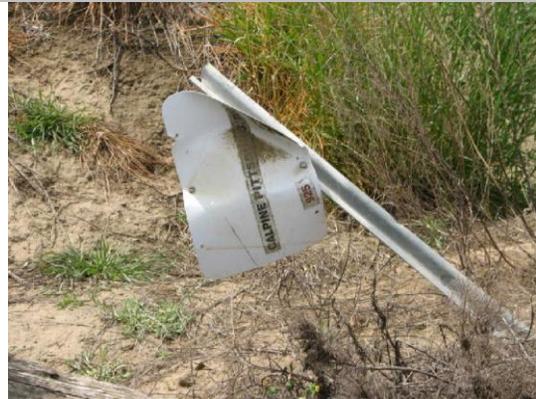
Photo 1 of 2 : UCIP_SP_2016_33347_60366.jpg

LM Start	6.48	Rating **	M	Issue No.	43
LM End	6.48	Issue Type +	En	Location *	WS
Category	Supplemental			GPS Latitude/Longitude	
				Start	End
Item	DWR UCIP Field Study			38.518120 °	38.518120 °
				-121.744570 °	-121.744570 °
DWR ID					
Comment Code					
Inspector Comment					
FS_ID:33347 DS_ID:506 EP_NO: 10820 Repair Type: Non-Urgent Crossing Status: Indicator Found UCIP Comments: Sign on LS bent over and broken. New signs need to be installed locating pipe that indicate a gas line crossing. The broken or missing signs do not indicate gasoline, only owner info. Owner is Calpine NRG Scott Vickers 707-249-9211. Supervisor will call phone number and ask for new signs to be installed. FIELD_STRUCT_DESC: 4-inch gas pipeline through the levee 2 feet below the crown. (App. No. 10820 - Dow Chemical) FS Date: 4/10/2014 2:28:50 PM

LS sign post with damaged sign.

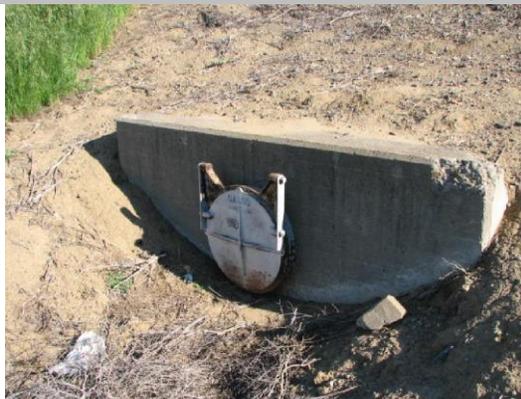
Photo 1 of 2 : UCIP_SP_2016_41353_60345.jpg

LM Start	7.35	Rating **	M	Issue No.	48
LM End	7.35	Issue Type +	En	Location *	WS
Category	Supplemental			GPS Latitude/Longitude	
				Start	End
Item	DWR UCIP Field Study			38.518510 °	38.518510 °
				-121.760474 °	-121.760474 °
DWR ID					
Comment Code					
Inspector Comment					
FS_ID:41353 DS_ID:516 EP_NO: 10260 Repair Type: Non-Urgent Crossing Status: Found UCIP Comments: Pipe is partially obstructed with sedimentation. Owner of pipe may have to clean sediment FIELD_STRUCT_DESC: 24-inch drainpipe through the levee 12.0 feet below the crown. Flap gate on waterward end. (ABO No. 10260 S.P. Trans. Co.) FS Date: 4/10/2014 2:25:00 PM

WS Flap Gate and headwall.

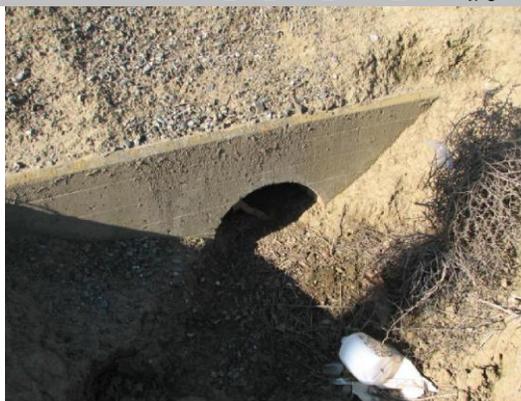
Photo 2 of 2 : UCIP_SP_2016_41353_60344.jpg

LM Start	7.35	Rating **	M	Issue No.	48 (cont)
LM End	7.35	Issue Type +	En	Location *	WS

LS headwall showing pipe partially blocked with soil.

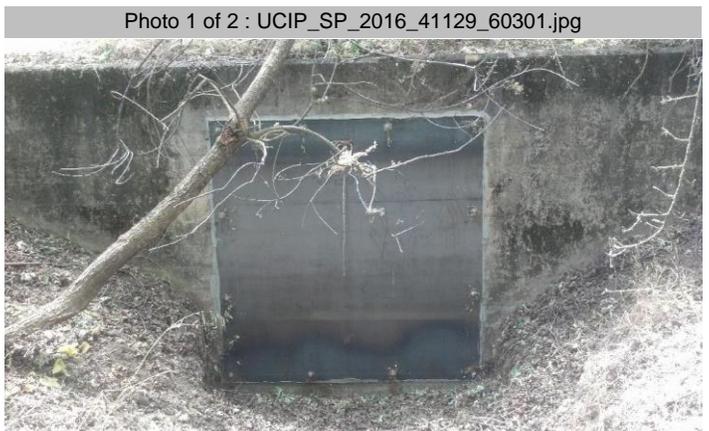
LM Start	8.69	Rating **	M	Issue No.	50
LM End	8.69	Issue Type +	En	Location *	WS
Category	Supplemental		GPS Latitude/Longitude		
			Start	End	
Item	DWR UCIP Field Study		38.523999 °	38.523999 °	
			-121.783037 °	-121.783037 °	
DWR ID					
Comment Code					
Inspector Comment					
FS_ID:41129 DS_ID:523 EP_NO: 10247 Repair Type: Non-Urgent Crossing Status: Found UCIP Comments: *ABANDONED* FIELD_STRUCT_DESC: *ABANDONED* 48-inch drain pipe through the levee 15.0 feet below the crown. Steel plate installed over inlet off LS toe (pipe not grouted). Flap gate on waterward end. Headwall on both ends. (ABO No.10247 U.C.D.) FS Date: 4/10/2014 2:21:00 PM

Steel plate installed over pipe off LS toe.

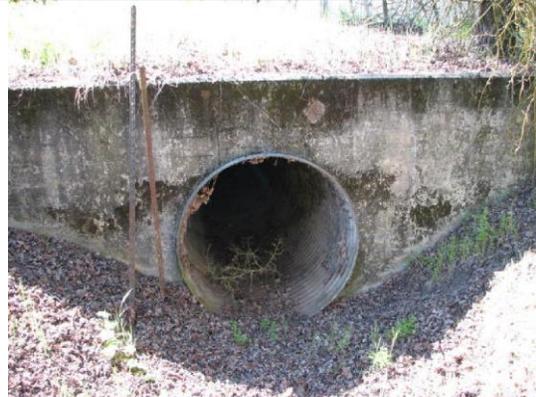
Photo 2 of 2 : UCIP_SP_2016_41129_60299.jpg

LM Start	8.69	Rating **	M	Issue No.	50 (cont)
LM End	8.69	Issue Type +	En	Location *	WS
Category	Supplemental			GPS Latitude/Longitude	
				Start	End
Item	DWR UCIP Field Study			38.523999 °	38.523999 °
				-121.783037 °	-121.783037 °
DWR ID					
Comment Code					
Inspector Comment					
FS_ID:41129 DS_ID:523 EP_NO: 10247 Repair Type: Non-Urgent Crossing Status: Found UCIP Comments: *ABANDONED* FIELD_STRUCT_DESC: *ABANDONED* 48-inch drain pipe through the levee 15.0 feet below the crown. Steel plate installed over inlet off LS toe (pipe not grouted). Flap gate on waterward end. Headwall on both ends. (ABO No.10247 U.C.D.) FS Date: 4/10/2014 2:21:00 PM

LS headwall and pipe before steel plate was installed over pipe to abandon it.

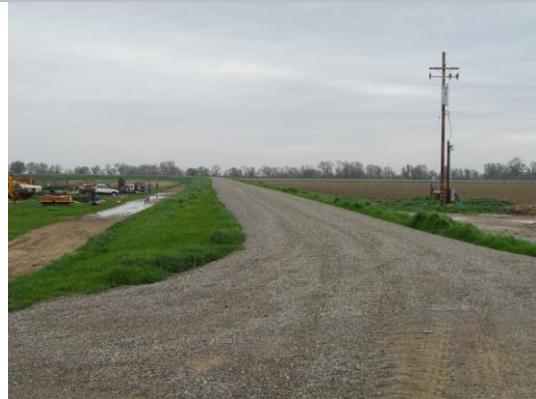
Photo 1 of 1 : SP_2016_ST0007_283_17_20160517_00023.jpg

Putah Creek Unit 2 levee mile 0.01 -2.10 looking downstream.

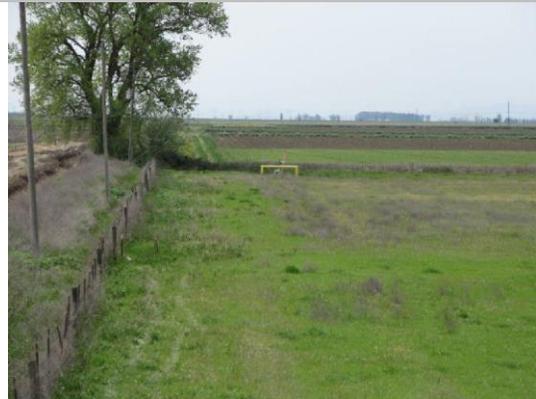
Photo 1 of 2 : UCIP_SP_2016_33400_60474.jpg

LM Start	1.60	Rating **	M	Issue No.	46
LM End	1.60	Issue Type +	En	Location *	LS
Category	Supplemental			GPS Latitude/Longitude	
				Start	End
Item	DWR UCIP Field Study			38.514250 °	38.514250 °
				-121.685980 °	-121.685980 °
DWR ID					
Comment Code					
Inspector Comment					
FS_ID:33400 DS_ID:16623 EP_NO: 9139 Repair Type: Non-Urgent Crossing Status: Indicator Found UCIP Comments: There are no appropriate gas markers present on levee to indicate pipe location. Markers need to be installed. No danger to the levee FIELD_STRUCT_DESC: 8-inch gas line through the levee 3.0 feet below crown under channel and through Unit No. 1 levee. (Permit No. 9139 - DOW) FS Date: 4/10/2014 2:45:48 PM

Gas vent 800-feet to south

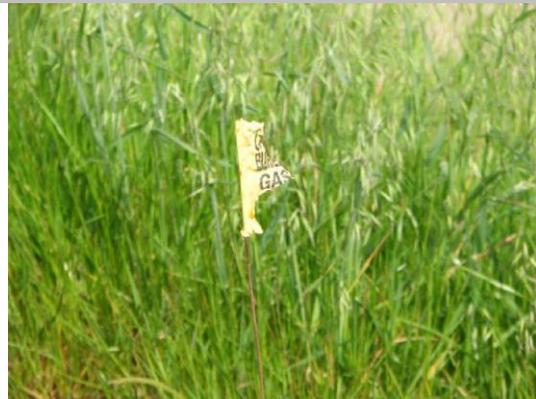
Photo 2 of 2 : UCIP_SP_2016_33400_60472.jpg

LM Start	1.60	Rating **	M	Issue No.	46 (cont)
LM End	1.60	Issue Type +	En	Location *	LS

small flag on WS shoulder

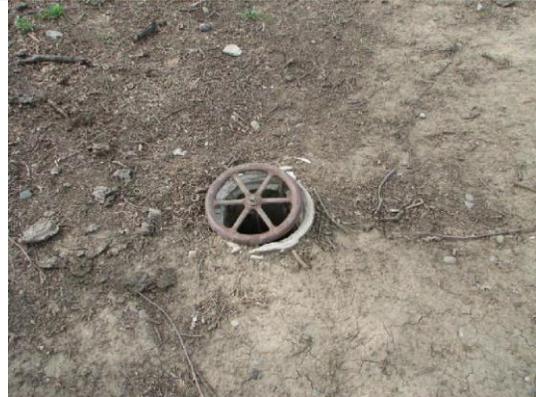
Photo 1 of 2 : UCIP_SP_2016_41072_60468.jpg

LM Start	2.09	Rating **	M	Issue No.	48
LM End	2.09	Issue Type +	En	Location *	LS
Category	Supplemental			GPS Latitude/Longitude	
				Start	End
Item	DWR UCIP Field Study			38.515440 °	38.515440 °
				-121.694920 °	-121.694920 °
DWR ID					
Comment Code					
Inspector Comment					
FS_ID:41072 DS_ID:16624 EP_NO: 10268 Repair Type: Non-Urgent Crossing Status: Found UCIP Comments: It is apparent that there is an irrigation pipe sleeved through the 25-inch pipe, but size cannot be determined. FIELD_STRUCT_DESC: 24-inch irrigation pipe through the levee 13.0 feet below the crown. Gate valve on landward side in 10-inch concrete standpipe. 36-inch standpipe on WS toe. Headwall on LS toe. (ABO No. 10268 - DOW). FS Date: 4/10/2014 2:45:00 PM

gate valve on LS toe in 10-inch standpipe

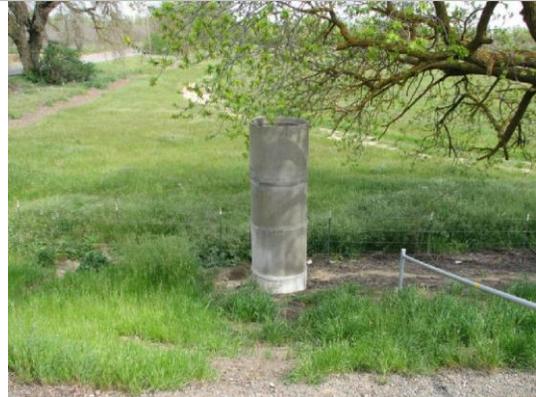
Photo 2 of 2 : UCIP_SP_2016_41072_60471.jpg

LM Start	2.09	Rating **	M	Issue No.	48 (cont)
LM End	2.09	Issue Type +	En	Location *	LS

36-inch standpipe WS toe

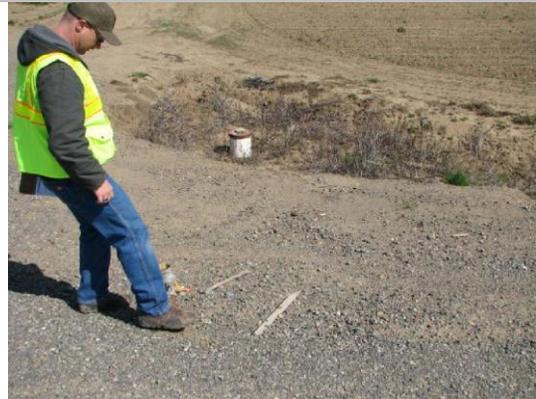
Photo 1 of 1 : UCIP_SP_2016_33392_60454.jpg

LM Start	3.18	Rating **	M	Issue No.	45
LM End	3.18	Issue Type +	En	Location *	LS
Category	Supplemental			GPS Latitude/Longitude	
				Start	End
Item	DWR UCIP Field Study			38.515161 °	38.515161 °
				-121.713634 °	-121.713634 °
DWR ID					
Comment Code					
Inspector Comment					
FS_ID:33392 DS_ID:16627 EP_NO: 2273A Repair Type: Non-Urgent Crossing Status: Indicator Found UCIP Comments: WS shoulder air vent looks broken and needs marker FIELD_STRUCT_DESC: 1 of 2: 18-inch irrigation pipe through the levee 2.0 feet below the crown. Pump on well on landward side. 18-inch standpipe on WS toe. Fresno valve on LS toe and air vent on WS shoulder. 36-inch standpipe on landward side. (Permit No. 2273-A - Schoeningh) FS Date: 4/10/2014 2:43:17 PM

WS shoulder showing air vent with no sign and 18-inch standpipe at WS toe.

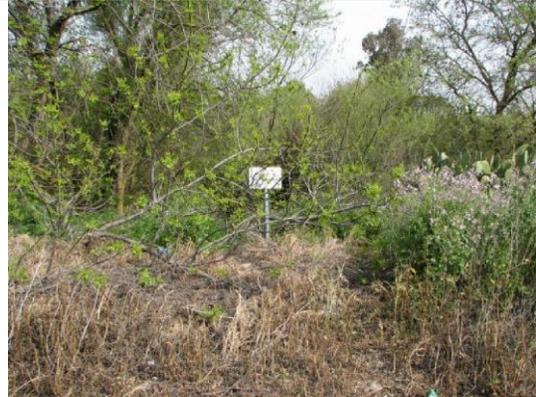
Photo 1 of 2 : UCIP_SP_2016_33377_60433.jpg

LM Start	4.17	Rating **	M	Issue No.	44
LM End	4.17	Issue Type +	En	Location *	WS
Category	Supplemental			GPS Latitude/Longitude	
				Start	End
Item	DWR UCIP Field Study			38.515780 °	38.515780 °
				-121.731950 °	-121.731950 °
DWR ID					
Comment Code					
Inspector Comment					
FS_ID:33377 DS_ID:16630 EP_NO: 10820 Repair Type: Non-Urgent Crossing Status: Indicator Found UCIP Comments: Signs for pipeline need to be updated to state Gas line. Current markers are insufficient. FIELD_STRUCT_DESC: 4-inch natural gas pipeline across the channel and levees of Putah Creek approximately 1/2 mile downstream from Davis Road. Installed 2 feet below crown. (Permit No. 10820) FS Date: 4/10/2014 2:39:19 PM

WS marker 320 feet north of levee at stream bank.

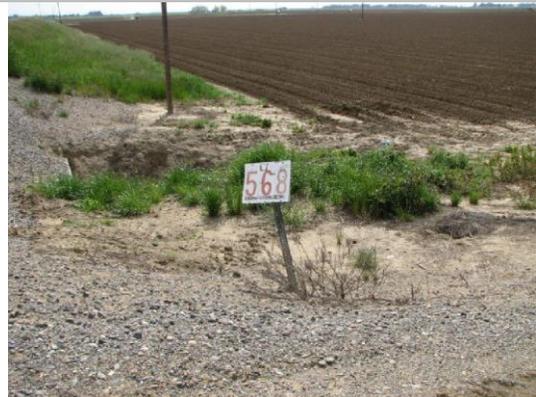
Photo 2 of 2 : UCIP_SP_2016_33377_60432.jpg

LM Start	4.17	Rating **	M	Issue No.	44 (cont)
LM End	4.17	Issue Type +	En	Location *	WS

LS marker on east side of access ramp.

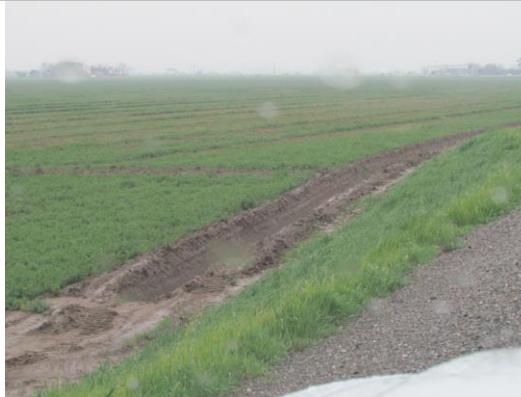
Photo 1 of 1 : SP_2016_ST0007_283_24_20160517_00022.jpg

Irrigation ditch within the 10-foot easement of the landside levee toe.

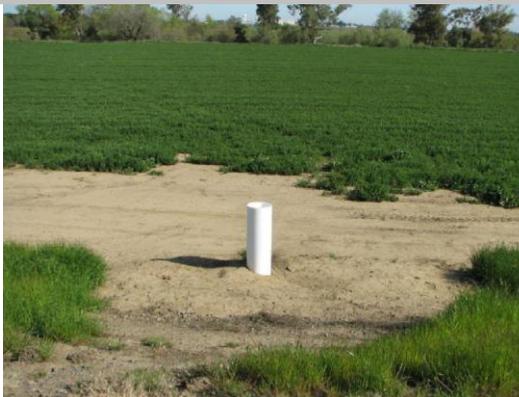
Photo 1 of 1 : UCIP_SP_2016_41074_60419.jpg

LM Start	5.07	Rating **	M	Issue No.	49
LM End	5.07	Issue Type +	En	Location *	LS
Category	Supplemental			GPS Latitude/Longitude	
				Start	End
Item	DWR UCIP Field Study			38.515332 °	38.515332 °
				-121.748533 °	-121.748533 °
DWR ID					
Comment Code					
Inspector Comment					
FS_ID:41074 DS_ID:16632 EP_NO: 10279 Repair Type: Non-Urgent Crossing Status: Indicator Found UCIP Comments: Pipe and headwalls are completely buried on both sides of levee. 15-inch pipe permitted to sleeve through the 24-inch CMP. Indication that 15-inch pipe is at crossing. FIELD_STRUCT_DESC: 24-inch pipe through the levee 10.0 feet below the crown. Slide gate on waterward end. Concrete headwall on landward end. (ABO No. 10279 - Watkins) FS Date: 4/10/2014 2:37:00 PM

15-inch standpipe at location where may run through 24-inch SD.

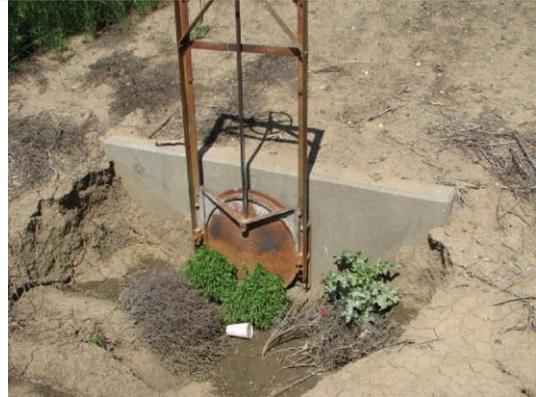
Photo 1 of 2 : UCIP_SP_2016_42959_60374.jpg

LS slide gate

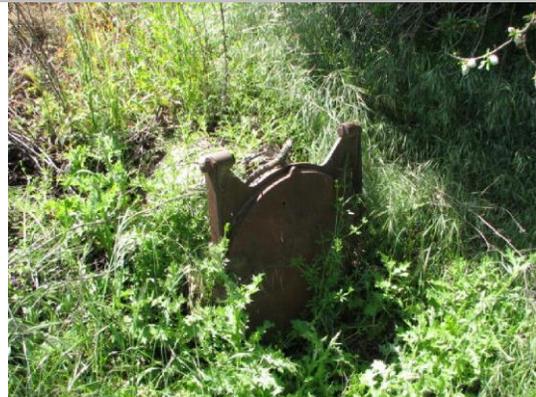
Photo 2 of 2 : UCIP_SP_2016_42959_60373.jpg

LM Start	6.34	Rating **	M	Issue No.	50 (cont)
LM End	6.34	Issue Type +	En	Location *	LS

WS flap gate

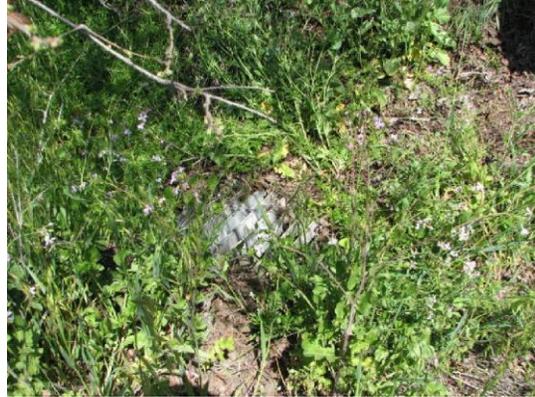
Photo 1 of 2 : UCIP_SP_2016_33348_60367.jpg

Dropinlet at LS toe.

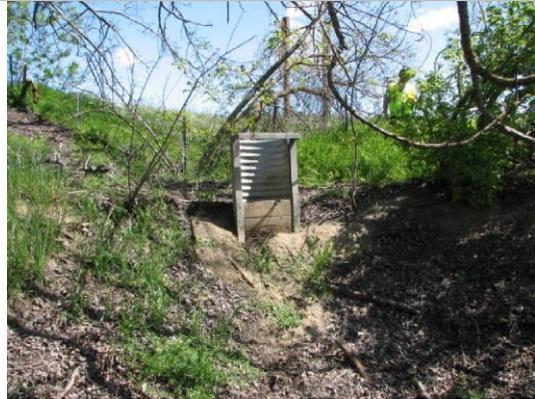
Photo 2 of 2 : UCIP_SP_2016_33348_60370.jpg

LM Start	6.44	Rating **	M	Issue No.	40 (cont)
LM End	6.44	Issue Type +	En	Location *	LS

Weir inlet at pond on LS toe.

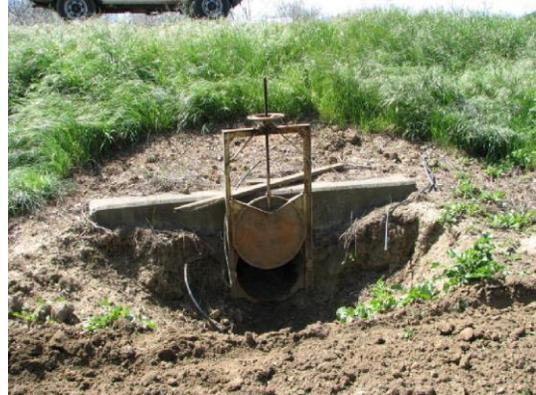
Photo 1 of 2 : UCIP_SP_2016_33346_60364.jpg

WS slide gate showing soil plug

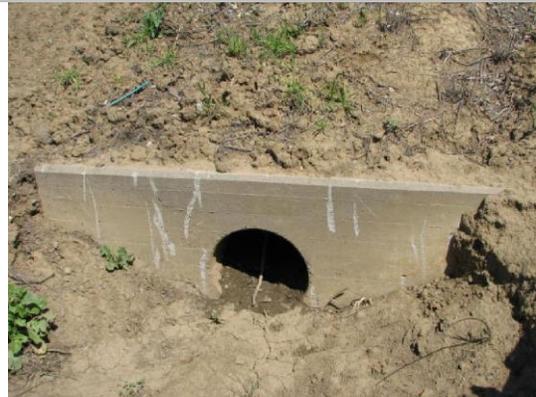
Photo 2 of 2 : UCIP_SP_2016_33346_60363.jpg

LM Start	6.65	Rating **	M	Issue No.	47 (cont)
LM End	6.65	Issue Type +	En	Location *	LS

LS headwall showing soil plug
