**Flood Control Project Maintenance
Levee Inspections**

**Fall 2015 Levee Maintenance Deficiency Summary Report
Overall LMA & Unit Ratings, including USACE Erosion Survey**

Sacramento River Basin

Sutter Maintenance Yard Tisdale Bypass

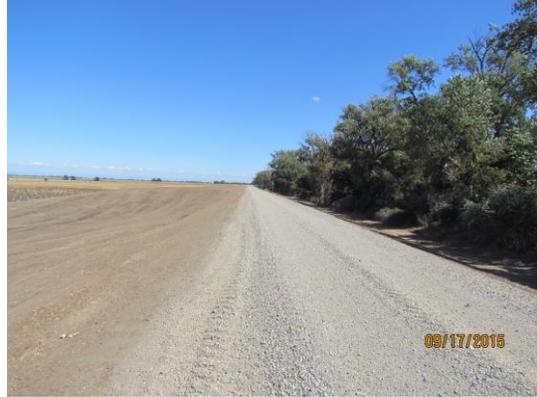
Photo 1 of 1 : FA_2015_ST0009_286_7_20151013_00004.jpg

LM Start	1.27	Rating **	A	Issue No.	7
LM End	1.27	Issue Type +	Ma	Location *	LS
Category	Earthen Levee		GPS Latitude/Longitude		
			Start	End	
Item	Vegetation		39.028268 °	39.028268 °	
			-121.798585 °	-121.798585 °	
DWR ID	DWR_ST0009_01_f_2015_7				
Action/Comments					
Control annual grass and weeds on the levee slopes and easements. Inspector Comments: Sutter Yard Burned and dragged both slopes.

View of the levee slope with no vegetation.

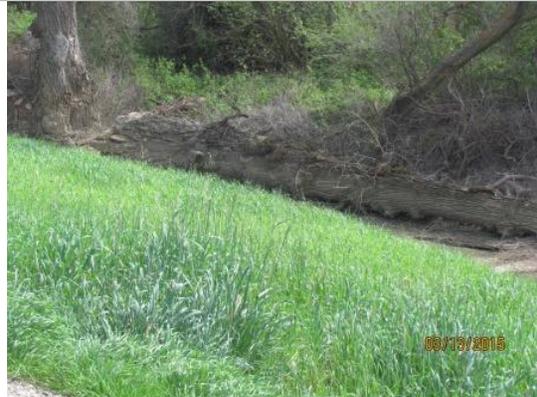
Photo 1 of 1 : FA_2015_ST0009_286_6_20150910_00002.jpg

LM Start	1.50	Rating **	M	Issue No.	6
LM End	1.50	Issue Type +	En	Location *	WS
Category	Earthen Levee		GPS Latitude/Longitude		
			Start	End	
Item	Encroachments		39.028268 °	39.028268 °	
			-121.794308 °	-121.794308 °	
DWR ID	DWR_ST0009_01_s_2015_6				
Action/Comments					
Tree or limb Inspector Comments: Remove the tree from the waterside toe.

View of the tree that is along the waterside toe.

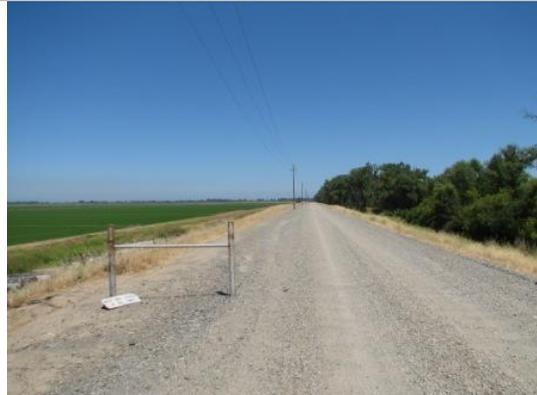
Photo 1 of 1 : FA_2015_ST0009_286_3_20150910_00001.jpg

LM Start	2.19	Rating **	M	Issue No.	3
LM End	4.11	Issue Type +	En	Location *	LS
Category	Earthen Levee		GPS Latitude/Longitude		
			Start	End	
Item	Encroachments		39.028173 °	39.028012 °	
			-121.781475 °	-121.745665 °	
DWR ID	DWR_ST0009_01_s_2012_3				
Action/Comments					
Pole

View of the PG&E poles along the landside crown of the levee.

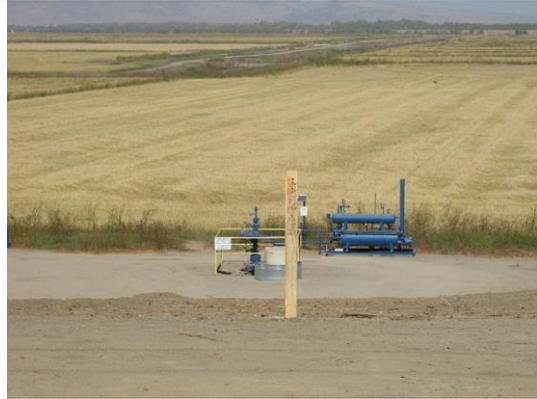
Photo 1 of 1 : UCIP_FA_2015_5618.jpg

LM Start	3.65	Rating **	M	Issue No.	8
LM End	3.65	Issue Type +	En	Location *	LS
Category	Supplemental			GPS Latitude/Longitude	
				Start	End
Item	DWR UCIP Field Study			39.027911 °	39.027911 °
				-121.754224 °	-121.754224 °
DWR ID					
Action/Comments					
Inspector Comments: FS_ID:45126 DS_ID:16590 EP_NO: 14740 FS_HLM: 3.64 Repair Type: Non-Urgent Crossing Status: Indicator Found UCIP Comments: 5/7/2015 Marker on WS shoulder missing.5/20/2013 Carsonite marker on WS shoulder missing and should be replaced.10/30/2013 Same as last inspection.5/12/2014 Same as last inspection.11/13/2014 Same as last inspection. FIELD_STRUCT_DESC: 4-inch pipe through levee and under channel 2.5 feet below crown. Carsonite signes on both LS and WS shoulder. Gas Wells 200-feet off of LS toe. (Permit No. 14740 - Nahama and Weagant Energy Co.) Drawings available. FS Date: 05/11/2015

Carsonite sign on LS shoulder with view of gas well in background.

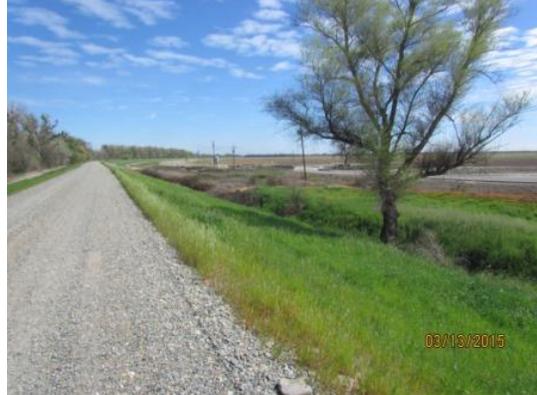
Photo 1 of 1 : FA_2015_ST0009_287_1_20150910_00001.jpg

LM Start	0.11	Rating **	M	Issue No.	1
LM End	0.26	Issue Type +	En	Location *	LS
Category	Earthen Levee		GPS Latitude/Longitude		
			Start	End	
Item	Encroachments		39.023760 °	39.024559 °	
			-121.818875 °	-121.816344 °	
DWR ID	DWR_ST0009_02_s_2012_1				
Action/Comments					
Ditch Inspector Comments: Monitor the ditch for erosion.

View of the agricultural ditch along the landside toe.

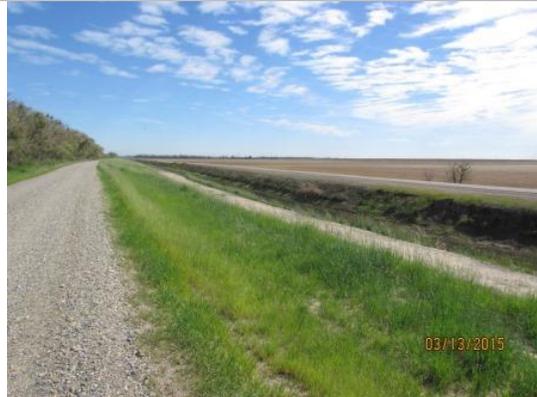
Photo 1 of 1 : FA_2015_ST0009_287_2_20150910_00002.jpg

LM Start	0.52	Rating **	M	Issue No.	2
LM End	1.74	Issue Type +	En	Location *	LS
Category	Earthen Levee		GPS Latitude/Longitude		
			Start	End	
Item	Encroachments		39.025539 °	39.025398 °	
			-121.811540 °	-121.789006 °	
DWR ID	DWR_ST0009_02_s_2012_2				
Action/Comments					
Ditch Inspector Comments: Monitor the ditch for erosion.

View of the agriculture ditch next to the landside toe.

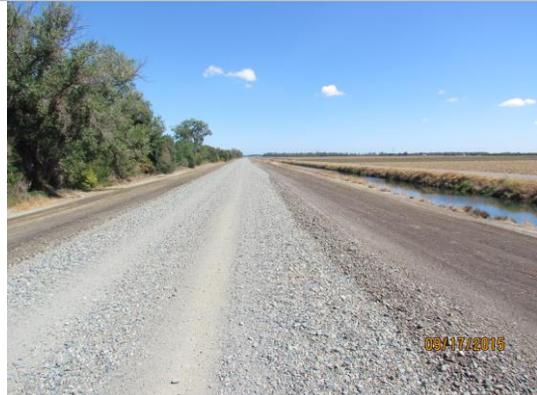
Photo 1 of 1 : FA_2015_ST0009_287_8_20151013_00007.jpg

LM Start	0.91	Rating **	A	Issue No.	8
LM End	0.91	Issue Type +	Ma	Location *	LS
Category	Earthen Levee		GPS Latitude/Longitude		
			Start	End	
Item	Vegetation		39.025587 °	39.025587 °	
			-121.804295 °	-121.804295 °	
DWR ID	DWR_ST0009_02_f_2015_8				
Action/Comments					
Control annual grass and weeds on the levee slopes and easements. Inspector Comments: Sutter Yard burned and dragged both slopes.

View of the levee slopes with no vegetation.

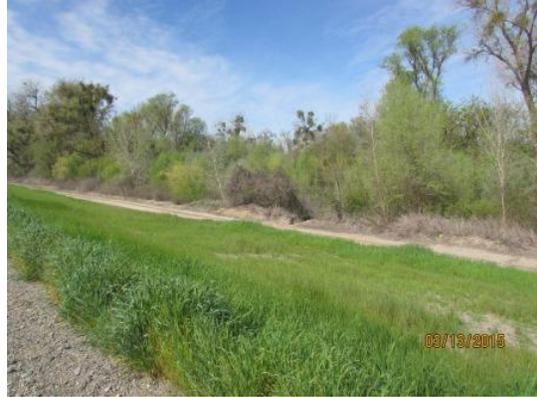
Photo 1 of 1 : FA_2015_ST0009_287_3_20150910_00003.jpg

LM Start	1.01	Rating **	M	Issue No.	3
LM End	1.01	Issue Type +	Ma	Location *	WS
Category	Earthen Levee			GPS Latitude/Longitude	
				Start	End
Item	Erosion / Bank Caving			39.025542 °	39.025542 °
				-121.802468 °	-121.802468 °
DWR ID	DWR_ST0009_02_s_2012_3				
Action/Comments					
Note and monitor erosion site. Inspector Comments: Sutter Yard needs to monitor the erosion.

View of the erosion along the waterside berm.

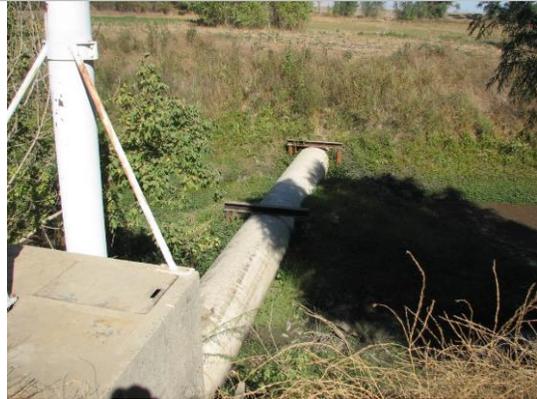
Photo 1 of 3 : UCIP_FA_2015_5342.jpg

LM Start	1.14	Rating **	M	Issue No.	291
LM End	1.14	Issue Type +	En	Location *	WS
Category	Supplemental			GPS Latitude/Longitude	
				Start	End
Item	DWR UCIP Field Study			39.025503 °	39.025503 °
				-121.800053 °	-121.800053 °
DWR ID					
Action/Comments					
Inspector Comments: FS_ID:45131 DS_ID:16594 EP_NO: 267 FS_HLM: 1.141 Repair Type: Non-Urgent Crossing Status: Found UCIP Comments: 5/7/2015 Burrowing near WS toe stil present. Burrowing along downstream side of concrete vault on WS Toe. May need to be grouted. 5/20/2013 Same as last inspection. 10/30/2013 Same as last inspection. 5/12/2014 Same as last inspection. 11/13/2014 Same as last inspection. FIELD_STRUCT_DESC: 54-inch concrete pipe through levee, 29.5 feet below the crown. Slide gates on both ends. Waterward end gate in 5-foot by 6-foot concrete box. Landward end gate in concrete "U" headwall. Siphon pipe under and across bypass, steel concrete encased. (Permit No. 267 & 290 - Sutter Basin Water Co.) FS Date: 05/11/2015

Concrete box, vent, and 54-inch steel pipe in WS toe.

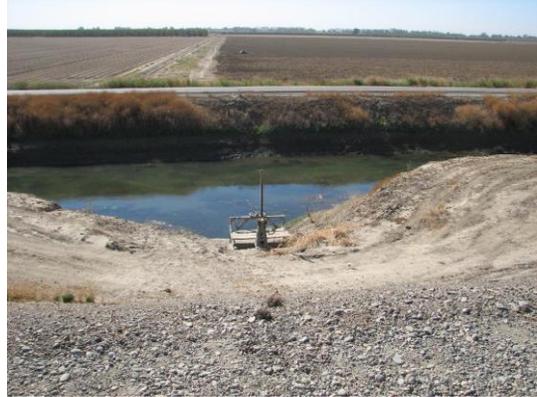
Photo 2 of 3 : UCIP_FA_2015_5343.jpg

LM Start	1.14	Rating **	M	Issue No.	291 (cont)
LM End	1.14	Issue Type +	En	Location *	WS
Category	Supplemental			GPS Latitude/Longitude	
				Start	End
Item	DWR UCIP Field Study			39.025503 °	39.025503 °
				-121.800053 °	-121.800053 °
DWR ID					
Action/Comments					
Inspector Comments: FS_ID:45131 DS_ID:16594 EP_NO: 267 FS_HLM: 1.141 Repair Type: Non-Urgent Crossing Status: Found UCIP Comments: 5/7/2015 Burrowing near WS toe stil present. Burrowing along downstream side of concrete vault on WS Toe. May need to be grouted. 5/20/2013 Same as last inspection. 10/30/2013 Same as last inspection. 5/12/2014 Same as last inspection. 11/13/2014 Same as last inspection. FIELD_STRUCT_DESC: 54-inch concrete pipe through levee, 29.5 feet below the crown. Slide gates on both ends. Waterward end gate in 5-foot by 6-foot concrete box. Landward end gate in concrete "U" headwall. Siphon pipe under and across bypass, steel concrete encased. (Permit No. 267 & 290 - Sutter Basin Water Co.) FS Date: 05/11/2015

Slide gate at concrete outlet on LS toe.

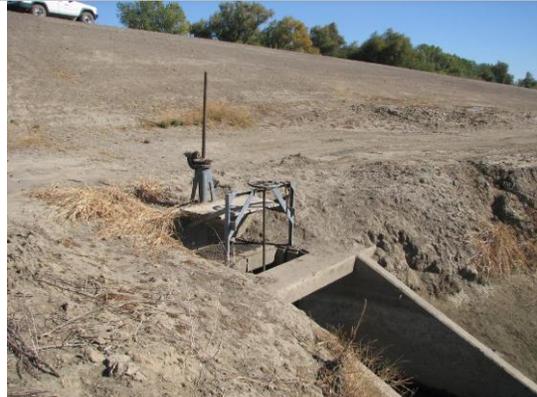
Photo 3 of 3 : UCIP_FA_2015_5344.jpg

Slide gate at concrete outlet on LS toe.

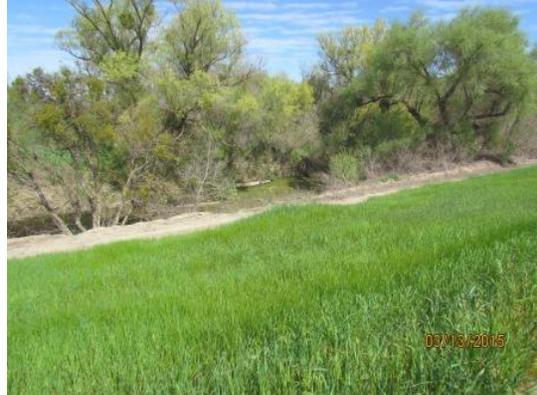
Photo 1 of 1 : FA_2015_ST0009_287_290_20150910_00006.jpg

LM Start	1.19	Rating **	M	Issue No.	290
LM End	1.19	Issue Type +	Ma	Location *	WS
Category	Earthen Levee			GPS Latitude/Longitude	
				Start	End
Item	Erosion / Bank Caving			39.025490 °	39.025490 °
				-121.799240 °	-121.799240 °
DWR ID	DWR_ST0009_02_s_ 2015_290				
Action/Comments					
Note and monitor erosion site. Inspector Comments: Sutter Yard needs to monitor the erosion along the berm.

View of the erosion along the waterside berm.

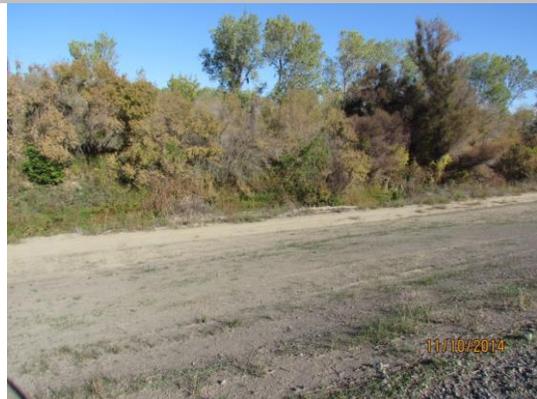
Photo 1 of 1 : FA_2015_ST0009_287_4_20150910_00004.jpg

LM Start	1.29	Rating **	M	Issue No.	4
LM End	1.29	Issue Type +	Ma	Location *	WS
Category	Earthen Levee			GPS Latitude/Longitude	
				Start	End
Item	Erosion / Bank Caving			39.025478 °	39.025478 °
				-121.797232 °	-121.797232 °
DWR ID	DWR_ST0009_02_s_ 2013_4				
Action/Comments					
Schedule repair of erosion site prior to the next inspection. Inspector Comments: Sutter Yard needs to monitor the erosion.

View of the erosion along the waterside berm.

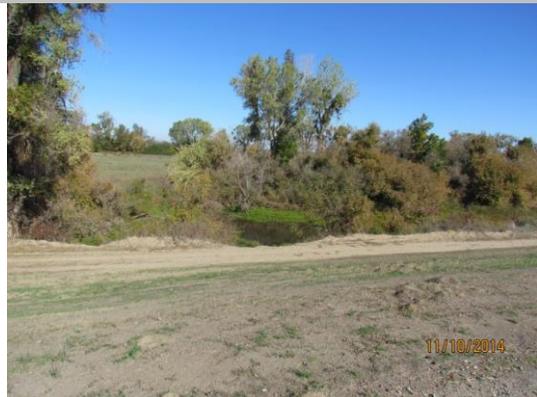
Photo 1 of 1 : FA_2015_ST0009_287_5_20150910_00005.jpg

LM Start	1.50	Rating **	M	Issue No.	5
LM End	1.50	Issue Type +	Ma	Location *	WS
Category	Earthen Levee			GPS Latitude/Longitude	
				Start	End
Item	Erosion / Bank Caving			39.025446 °	39.025446 °
				-121.793347 °	-121.793347 °
DWR ID	DWR_ST0009_02_s_ 2013_5				
Action/Comments					
Schedule repair of erosion site prior to the next inspection. Inspector Comments: Sutter Yard needs to monitor the erosion.

View of the erosion along the waterside berm.

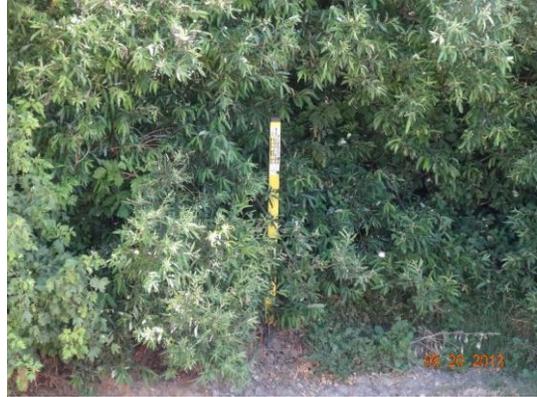
Photo 1 of 3 : UCIP_FA_2015_5174.jpg

Inspector Comments: FS_ID:45125
 DS_ID:23099
 EP_NO: N/A
 FS_HLM: 4.206
 Repair Type: Non-Urgent
 Crossing Status: Found
 UCIP Comments: 5/7/2015 Crossing is in good condition. No noticeable issues to report. Need to identify permit for crossing. 10/30/2013 Same as last inspection. 5/12/2014 Same as last inspection. 11/13/2014 Same as last inspection.
 FIELD_STRUCT_DESC: Natural gas pipeline markers on LS shoulder and toe and WS shoulder and toe. No photos available.
 FS Date: 05/11/2015

Marker on WS toe

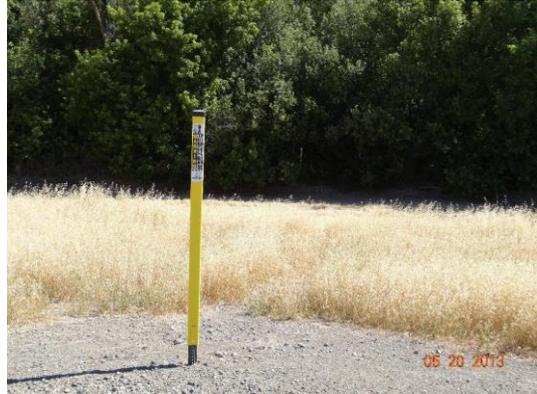
Photo 2 of 3 : UCIP_FA_2015_5175.jpg

Marker on WS shoulder

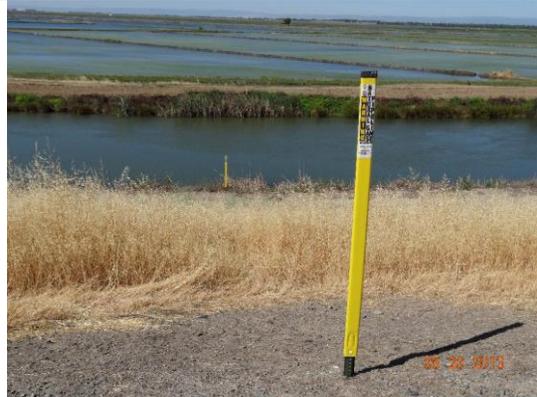
Photo 3 of 3 : UCIP_FA_2015_5176.jpg

LM Start	4.20	Rating **	M	Issue No.	292 (cont)
LM End	4.20	Issue Type +	En	Location *	WS
Category	Supplemental			GPS Latitude/Longitude	
				Start	End
Item	DWR UCIP Field Study			39.024079 °	39.024079 °
				-121.743420 °	-121.743420 °
DWR ID					
Action/Comments					
Inspector Comments: FS_ID:45125 DS_ID:23099 EP_NO: N/A FS_HLM: 4.206 Repair Type: Non-Urgent Crossing Status: Found

Marker on LS shoulder and toe
