**Flood Control Project Maintenance  
Levee Inspections  
LMA District Cover Sheet  
Spring 2013 Levee Inspection Results**

**Butte County Public Works Department Butte County Public Works**

**Levee Inspection Report By Mile - Spring 2013**

Waterway	Bank	Unit Miles	Inspection Start/End	Inspector
Unit No. 01 Mud Creek	Right	7.29	04/11/2013 04/11/2013	Bob Duffey

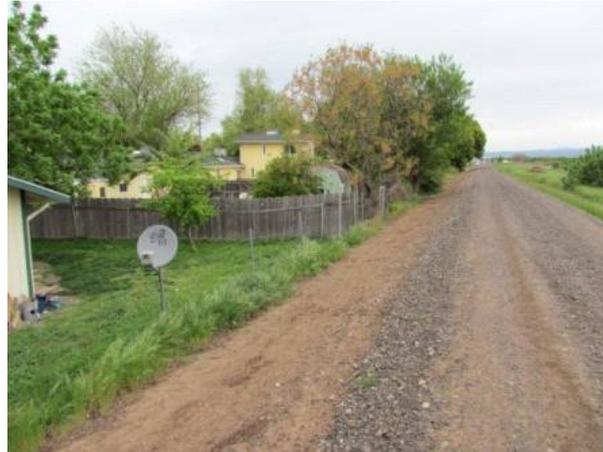
Levee Mile Report Line	4
Start Levee Mile	2.06
End Levee Mile	2.10
Location	Land Side
Category	
Item	Encroachments
View of the fences along the L/S toe.	
rduffey_s_20130225_123.jpg

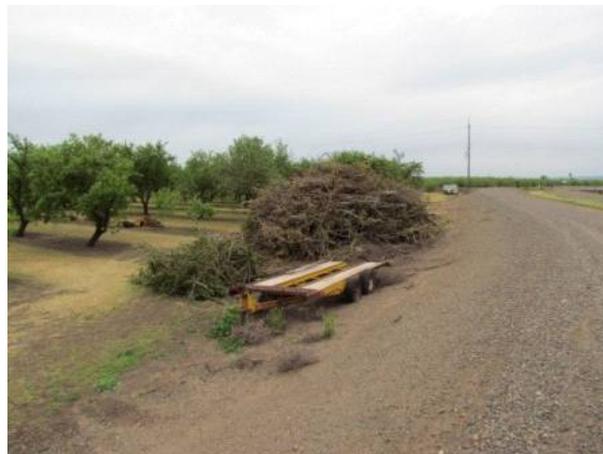
Levee Mile Report Line	7
Start Levee Mile	3.00
End Levee Mile	3.00
Location	Land Side
Category	
Item	Encroachments
View of the pruning pile along the L/S toe.	
rduffey_s_20130225_122.jpg

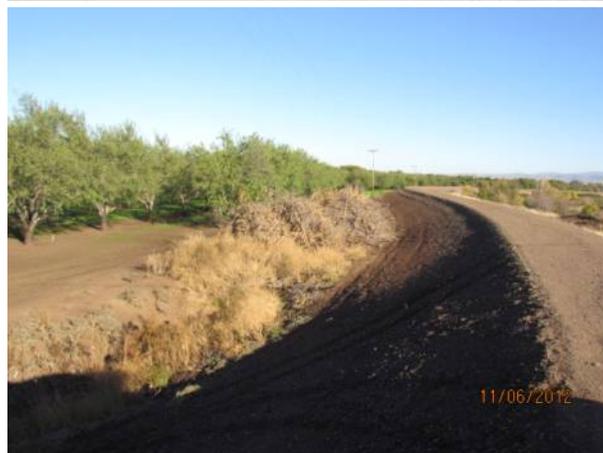
Levee Mile Report Line	11
Start Levee Mile	4.58
End Levee Mile	4.58
Location	Land Side
Category	
Item	Encroachments
View of the brush pile along landside toe.	
rduffey_s_20130225_124.JPG

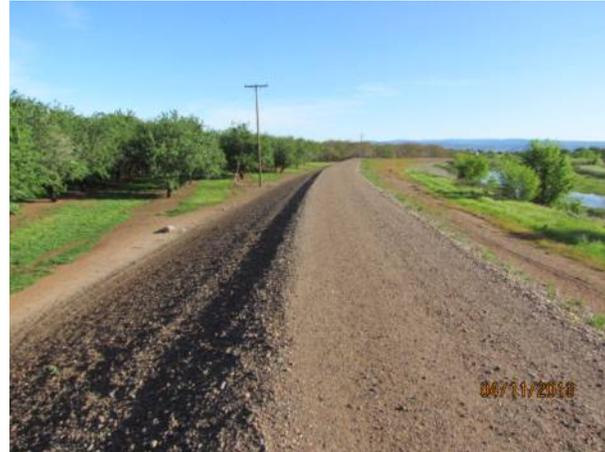
Levee Mile Report Line	12
Start Levee Mile	4.67
End Levee Mile	4.67
Location	Land Side
Category	
Item	Vegetation
View of the levee with no vegetation on both slopes.	
rduffey_s_20130429_368.JPG

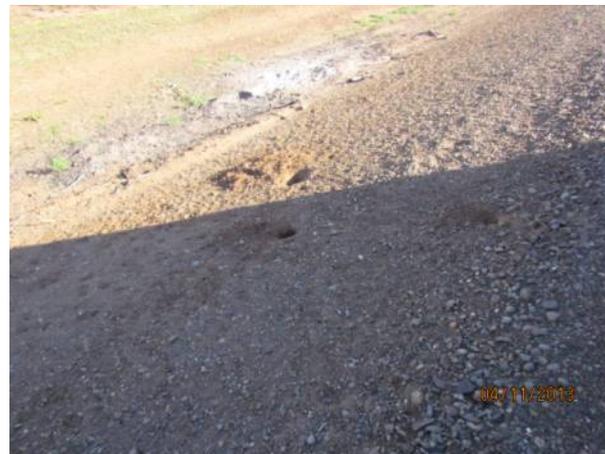
Levee Mile Report Line	13
Start Levee Mile	4.82
End Levee Mile	4.82
Location	Land Side
Category	
Item	Animal Control
View of the rodent holes along the landside slope.	
rduffey_s_20130429_369.JPG

DWR ID: DWR_NA0003_01_s_2013_11										
13	4.82	4.82		Animal Control	LS	M Ma	A1 : Exterminate rodents and backfill and compact or grout burrows.	39.779128 ° -121.892759 °	39.779128 ° -121.892759 °	12 Y
DWR ID: DWR_NA0003_01_s_2013_12										
14	4.91	4.91		Encroachments	LS	M En	PR : Prunings	39.780068 ° -121.891469 °	39.780068 ° -121.891469 °	13 Y
DWR ID: DWR_NA0003_01_s_2013_13

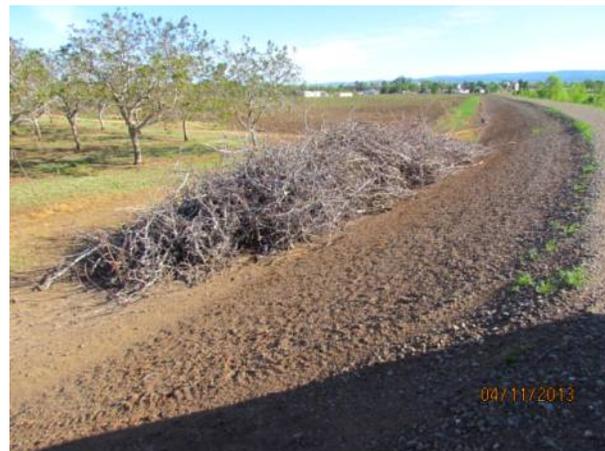
Levee Mile Report Line	14
Start Levee Mile	4.91
End Levee Mile	4.91
Location	Land Side
Category	
Item	Encroachments
View of the prunings along the landside slope.	
rduffey_s_20130429_370.JPG

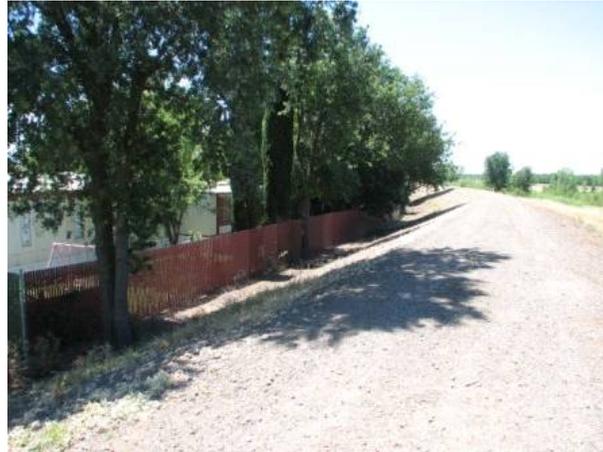
Levee Mile Report Line	1
Start Levee Mile	1.58
End Levee Mile	1.90
Location	Land Side
Category	
Item	Encroachments
View of the fence along the landside toe of the levee.	
rduffey_s_20130225_126.jpg

LMR No.	Levee Mile		Category	Item	* Location	+ Rating	Action/Comment	GPS Latitude/Longitude		Issue No. Photo
	Start	End						Start	End	
1	1.58	1.90	Encroachments	LS	U	En	FE : Fence	39.782773 ° -121.888178 °	39.778972 ° -121.891563 °	3 Y
DWR ID: DWR_NA0003_02_s_2012_3										
2	3.42	3.42	Encroachments	LS	M	Ma	PR : Prunings	39.763208 ° -121.908517 °	39.763208 ° -121.908517 °	5 Y
DWR ID: DWR_NA0003_02_f_2012_5										
3	3.45	3.45	Animal Control	CR	M	Ma	A3 : No rodents visible, but rodent burrows visible; need to backfill and compact or grout burrows.	39.762853 ° -121.908653 °	39.762853 ° -121.908653 °	6 Y
DWR ID: DWR_NA0003_02_s_2013_6										
4	4.70	4.70	Encroachments	LS	C	En	PR : Prunings	39.749727 ° -121.917112 °	39.749727 ° -121.917112 °	1
DWR ID: DWR_NA0003_02_s_2012_1										
5	6.02	6.02	Encroachments	LS	M	En	PR : Prunings	39.736652 ° -121.932053 °	39.736652 ° -121.932053 °	7 Y
DWR ID: DWR_NA0003_02_s_2013_7

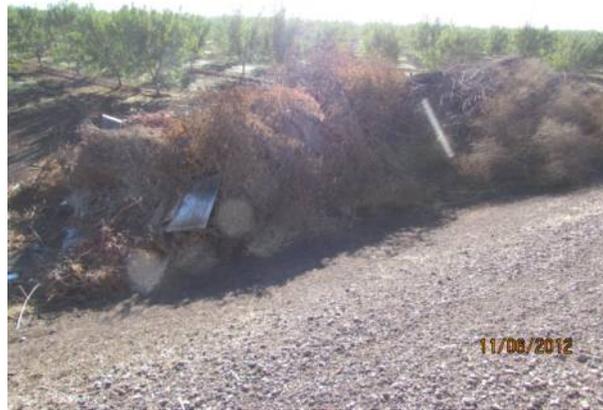
Levee Mile Report Line	2
Start Levee Mile	3.42
End Levee Mile	3.42
Location	Land Side
Category	
Item	Encroachments
View of the brush pile along landside toe.	
rduffey_s_20130225_127.JPG

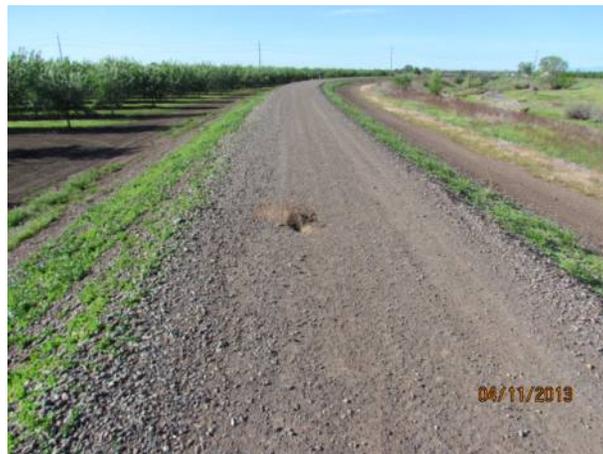
Levee Mile Report Line	3
Start Levee Mile	3.45
End Levee Mile	3.45
Location	Crown
Category	
Item	Animal Control
View of the rodent hole in the crown roadway.	
rduffey_s_20130429_371.JPG

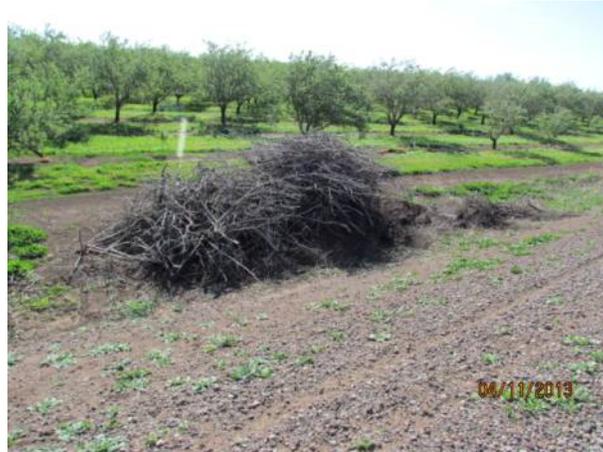
Levee Mile Report Line	5
Start Levee Mile	6.02
End Levee Mile	6.02
Location	Land Side
Category	
Item	Encroachments
View of the prunings along the landside toe.	
rduffey_s_20130429_373.JPG

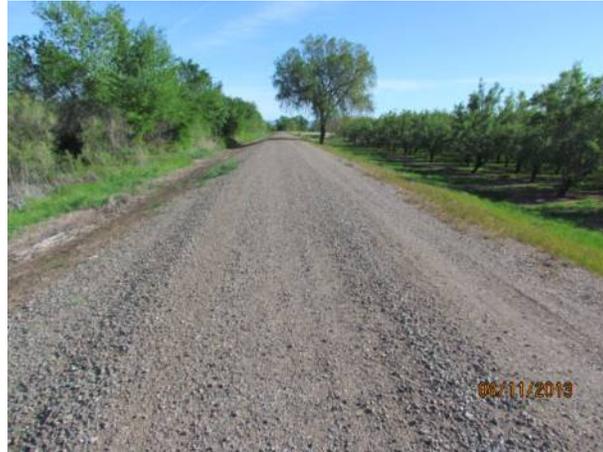
Levee Mile Report Line	1
Start Levee Mile	0.04
End Levee Mile	0.04
Location	Land Side
Category	
Item	Vegetation
View of the levee slopes with no vegetation.	
rduffey_s_20130429_374.JPG

LMIR No.	Levee Mile		Category	Item	* Location	+ Rating	Action/Comment	GPS Latitude/Longitude		Issue No. Photo
	Start	End						Start	End	
1	0.04	0.04		Vegetation	LS	A	V1 : Control annual grass and weeds on the levee slopes and easements.	°	°	3
					Ma			°	°	Y

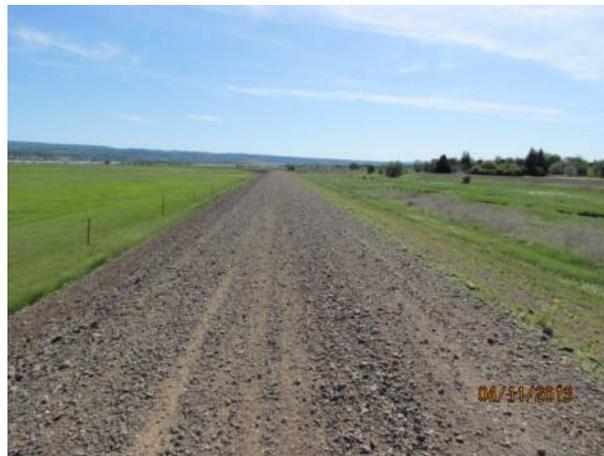
Levee Mile Report Line	2
Start Levee Mile	1.38
End Levee Mile	1.38
Location	Land Side
Category	
Item	Vegetation
View of the levee slopes with no vegetation.	
rduffey_s_20130429_375.JPG

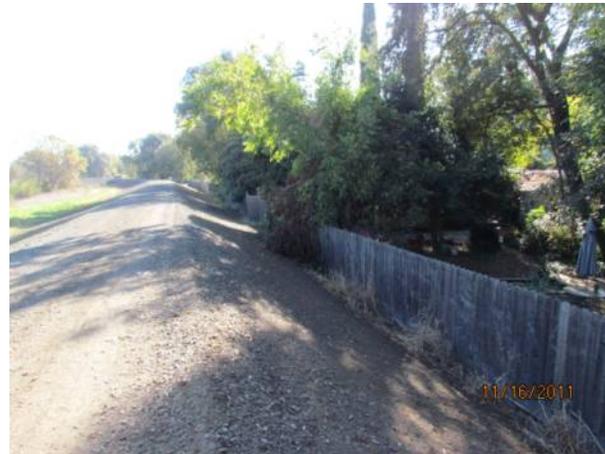
Levee Mile Report Line	2
Start Levee Mile	1.16
End Levee Mile	1.27
Location	Land Side
Category	
Item	Encroachments
View of the fence along the L/S toe.	
rduffey_s_20130225_131.jpg

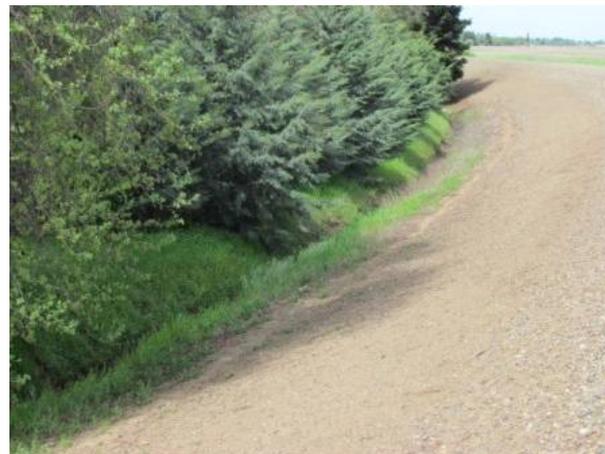
Levee Mile Report Line	3
Start Levee Mile	1.32
End Levee Mile	1.40
Location	Land Side
Category	
Item	Encroachments
View of AG ditch at the L/S toe.	
rduffey_s_20130225_130.jpg

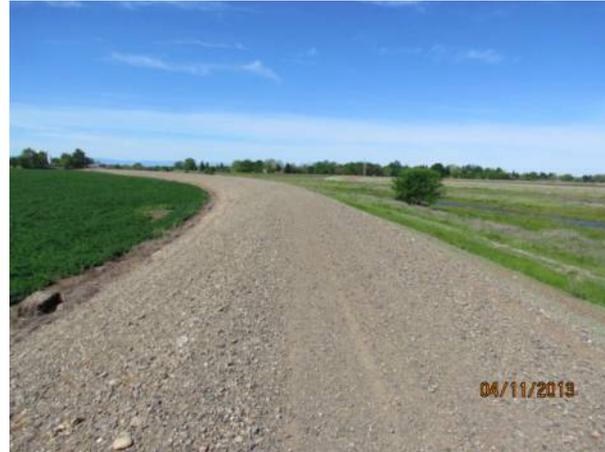
Levee Mile Report Line	4
Start Levee Mile	2.72
End Levee Mile	2.72
Location	Land Side
Category	
Item	Vegetation
View of the levee slopes with no vegetation.	
rduffey_s_20130429_376.JPG

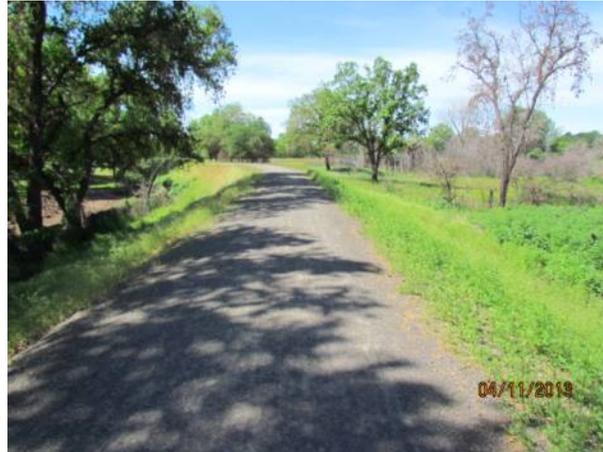
Levee Mile Report Line	1
Start Levee Mile	0.34
End Levee Mile	0.34
Location	Land Side
Category	
Item	Vegetation
View of the native grasses on both levee slopes.	
rduffey_s_20130429_377.JPG
