**Flood Control Project Maintenance
Levee Inspections
LMA District Cover Sheet
Spring 2012 Levee Inspection Results**

California Department of Fish and Game Shea Levee

Levee Inspection Report By Mile - Spring 2012

Waterway				Bank	Unit Miles	Inspection Start/End	Inspector
Unit No. 01 Sacramento River				Left	0.30	04/09/2012 04/09/2012	Bob Duffey

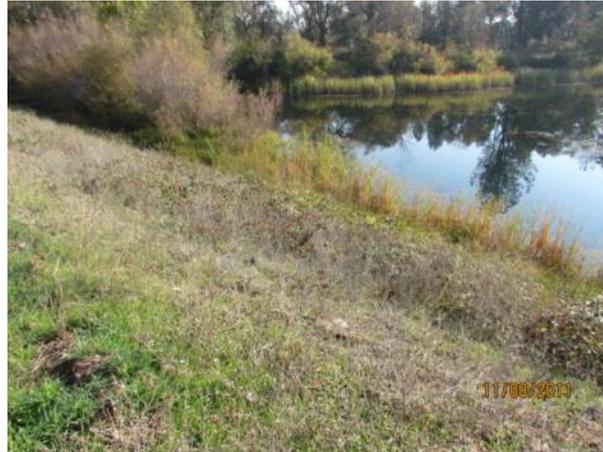
Levee Mile Report Line	4
Start Levee Mile	0.02
End Levee Mile	0.06
Location	Land Side
Category	Earthen Levee
Item	Vegetation
View of the berries vine along the L/S slope.	
rduffey_s_20120312_394.jpg

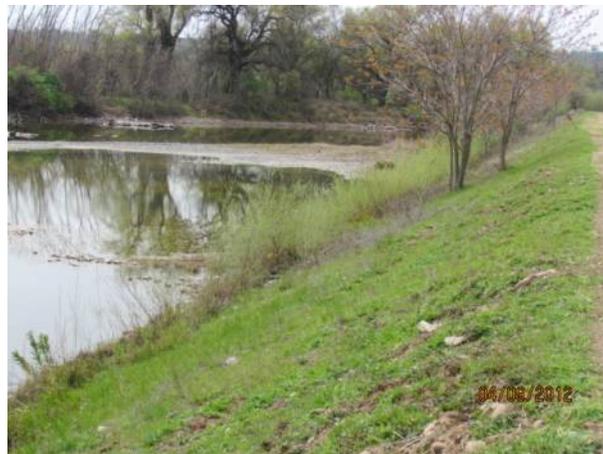
Levee Mile Report Line	5
Start Levee Mile	0.08
End Levee Mile	0.21
Location	Land Side
Category	Earthen Levee
Item	Vegetation
View of the vegetation that needs to be removed from the slope of the levee.	
rduffey_s_20120416_586.jpg

LMIR No.	Levee Mile		Category	Item	* Location	+ Rating	Action/Comment	GPS Latitude/Longitude		Issue No. Photo
	Start	End						Start	End	
1			Earthen Levee	Operations & Maintenance Manuals	LS	A Ma		°	°	6
								DWR ID: DWR_NA0018_01_s_2012_6		
2			Earthen Levee	Emergency Supplies & Equipment	LS	A Ma		°	°	7
								DWR ID: DWR_NA0018_01_s_2012_7		
3			Earthen Levee	Flood Preparedness & Training	LS	M Ma	Inspector Comments: LMA has not completed any training and does not have an available flood plan.	°	°	8
								DWR ID: DWR_NA0018_01_s_2012_8		
4	0.02	0.06	Earthen Levee	Vegetation	LS	M Ma	V2 : Remove the wild growth other than native grasses from the levee slopes.	40.511185 ° -122.360553 °	40.510670 ° -122.361203 °	1 Y
								DWR ID: DWR_NA0018_01_s_2012_1		
5	0.08	0.21	Earthen Levee	Vegetation	LS	M Ma	V2 : Remove the wild growth other than native grasses from the levee slopes.	40.510671 ° -122.360944 °	40.509146 ° -122.362499 °	5 Y

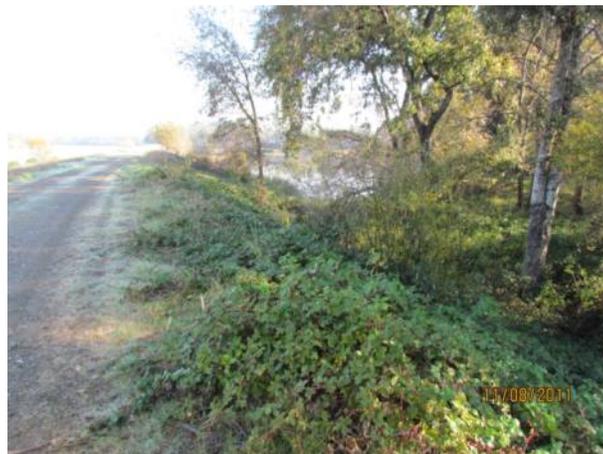
Levee Mile Report Line	6
Start Levee Mile	0.25
End Levee Mile	0.30
Location	Land Side
Category	Earthen Levee
Item	Vegetation
View of the vegetation along the L/S slope.	
rduffey_s_20120312_395.jpg

DWR ID: DWR_NA0018_01_s_2012_5		
6	0.25	0.30	Earthen Levee	Vegetation	LS	M Ma	V2 : Remove the wild growth other than native grasses from the levee slopes.	40.508138 ° -122.363480 °	40.508138 ° -122.363480 °	2 Y
								DWR ID: DWR_NA0018_01_s_2012_2
