**Flood Control Project Maintenance
Levee Inspections**

Maintenance Issue Types Only, Levee Inspection Report By Mile - Spring 2015

Reclamation District No. 2094 Wathal

Waterway	Bank	Unit Miles	Inspection Start/End	Inspector
Unit No. 01 San Joaquin River	Right	2.78	05/07/2015 05/13/2015	Maksim Khashchuk

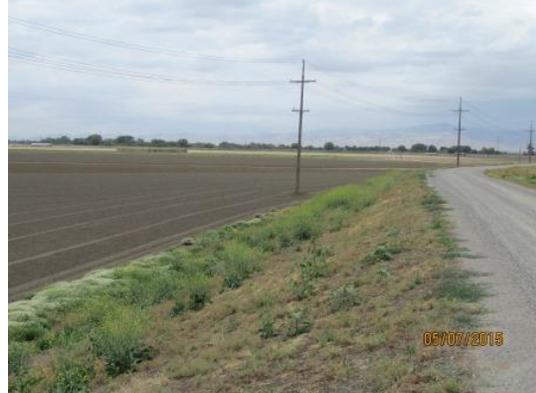
Photo 1 of 1 : SP_2015_RD2094_320_6_20150511_00005.jpg

LM Start	0.86	Rating **	M	Issue No.	6
LM End	0.91	Issue Type +	Ma	Location *	LS
Category	Earthen Levee		GPS Latitude/Longitude		
			Start	End	
Item	Vegetation		37.764988 °	37.764199 °	
			-121.293298 °	-121.293544 °	
DWR ID	DWR_RD2094_01_s_2015_6				
Action/Comments					
Control annual grass and weeds on the levee slopes and easements.

View of the vegetation on the landside levee slope.

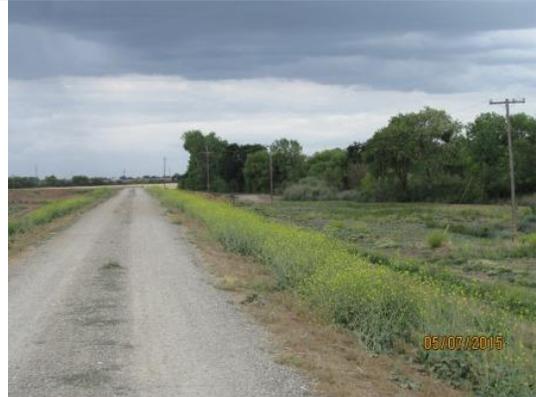
Photo 1 of 1 : SP_2015_RD2094_321_1_20150511_00001.jpg

LM Start	0.02	Rating **	M	Issue No.	1
LM End	0.02	Issue Type +	Ma	Location *	WS
Category	Earthen Levee		GPS Latitude/Longitude		
			Start	End	
Item	Vegetation		37.759373 °	37.759373 °	
			-121.299962 °	-121.299962 °	
DWR ID	DWR_RD2094_02_s_2015_1				
Action/Comments					
Control annual grass and weeds on the levee slopes and easements.

View of the vegetation on the waterside levee slope.
