Rim Incident

Rim Fire: Field Assessments

- During and post-fire on the ground observations
- Limnology and chemistry sampling in Hetch Hetchy

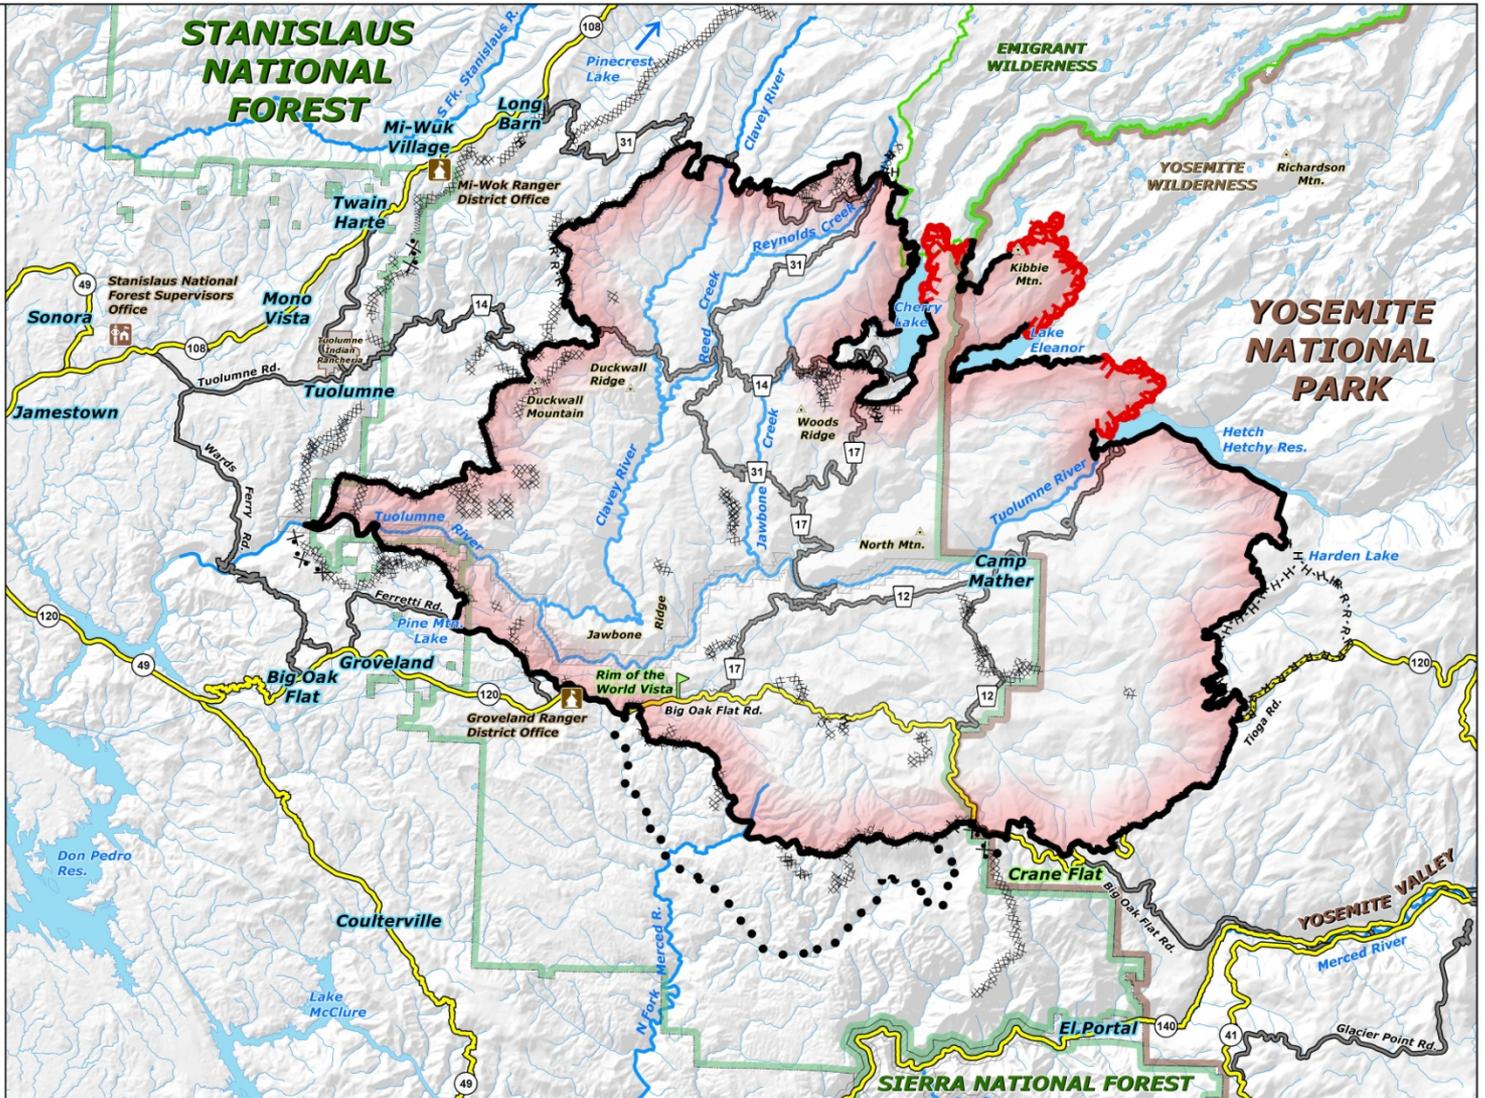
Public Information Map

September 17, 2013

256,569 Acres

Approx. perimeter as of 9/16 @ 1400 hrs
NAD83 UTM Zone 11N

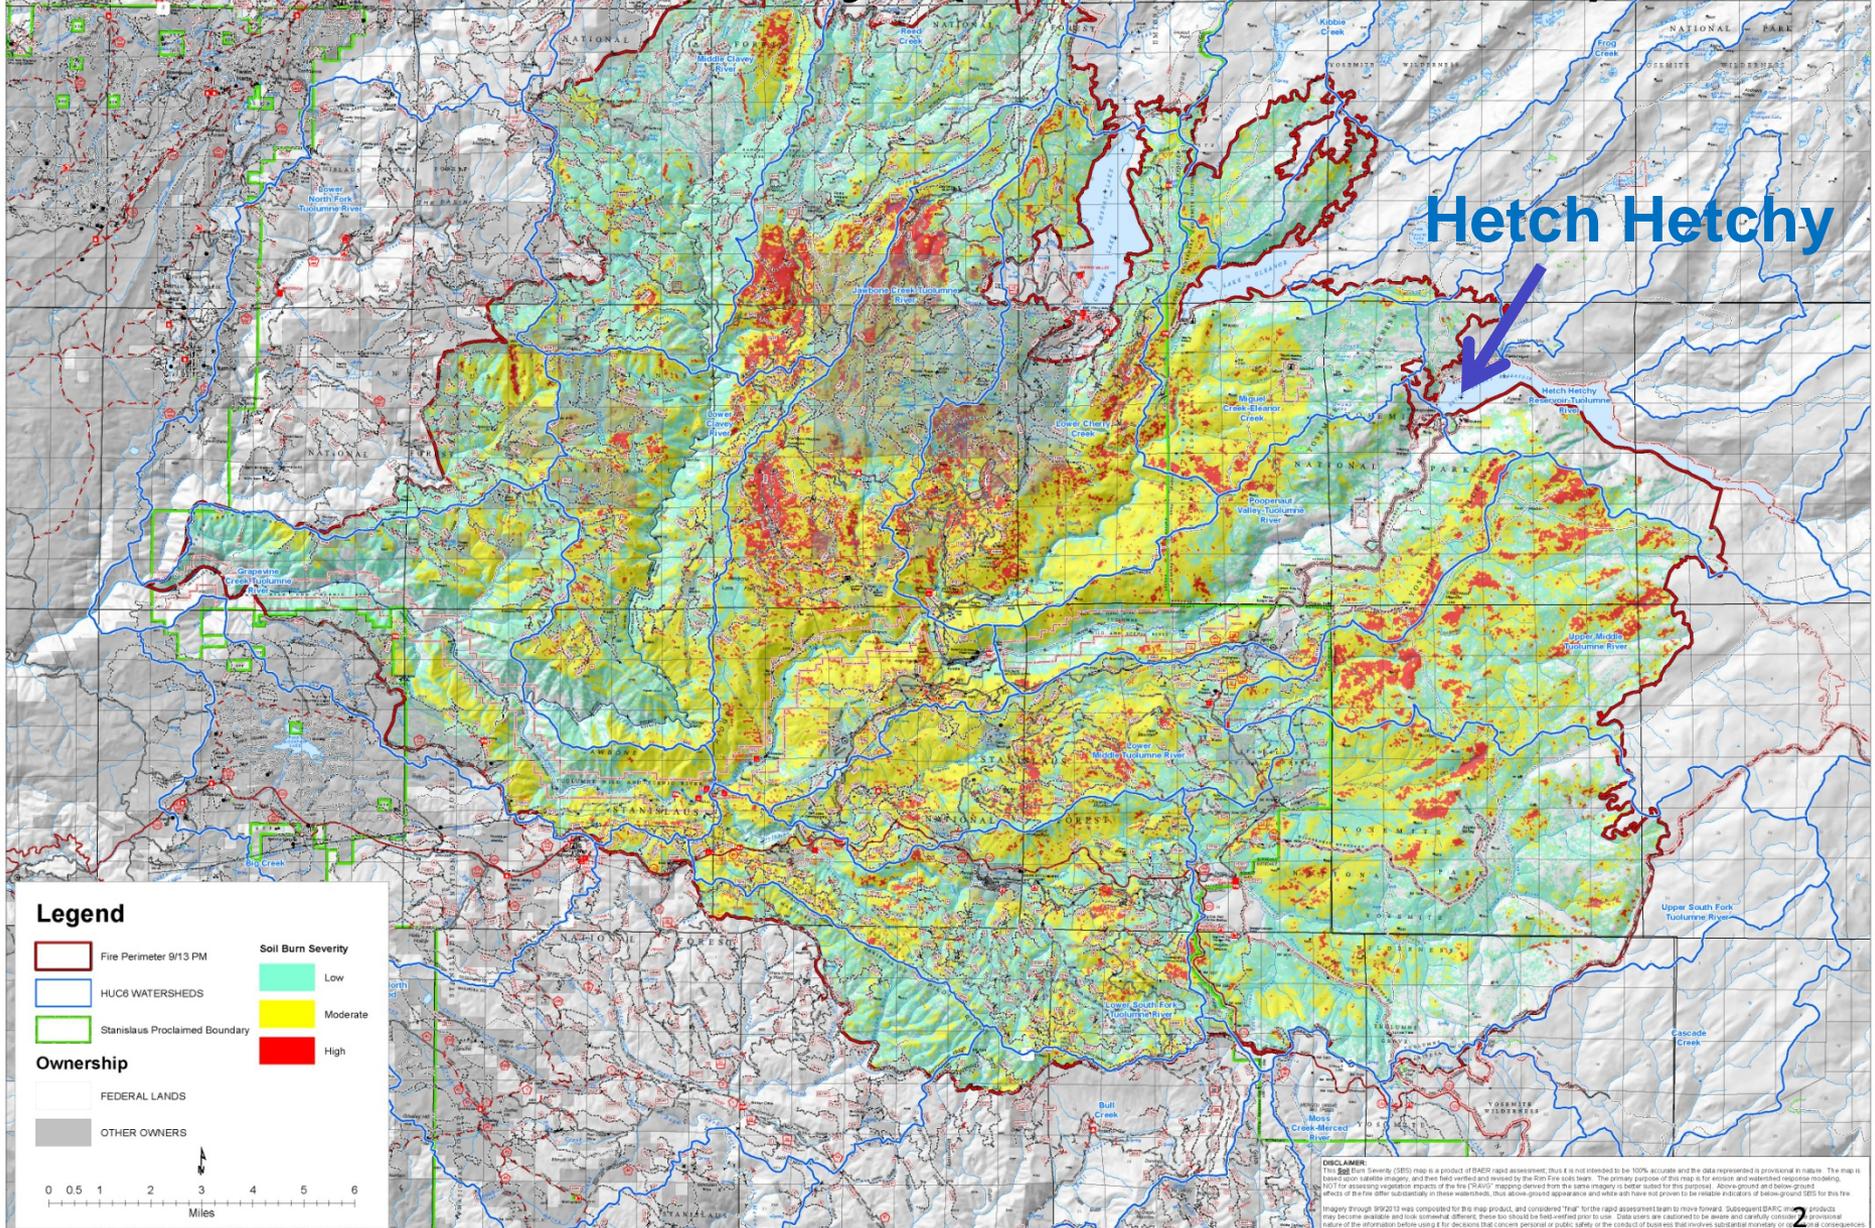
Burn Severity (BAER team)

DISCLAIMER:
 The Soil Burn Severity (SBS) map is a product of BAER rapid assessment, thus it is not intended to be 100% accurate and the data represented is provisional in nature. The map is based upon satellite imagery, and then field verified and revised by the Fire Five soils team. The primary purpose of this map is for erosion and watershed response modeling, NOT for assessing regulatory impacts of the fire "footprint" mapping derived from the same imagery in order to determine above-ground and below-ground effects of the fire other than what is shown in the map. Thus, above-ground appearance and white ash have not proven to be reliable indicators of below-ground SBS for this fire. Imagery through 9/12/2013 was compiled for this map product, and considered "final" for the rapid assessment team to move forward. Subsequent BAER fire products may become available and have somewhat different, more up-to-date, field-verified data. Data users are cautioned to be aware and verify critical regulatory values of the information before using it for decisions that concern personal or public safety. The conduct of business that involves substantial monetary or other consequences further information concerning the accuracy and appropriate uses of these data may be obtained from the Forest Service Soil Scientist David Young at 530.225.2442.

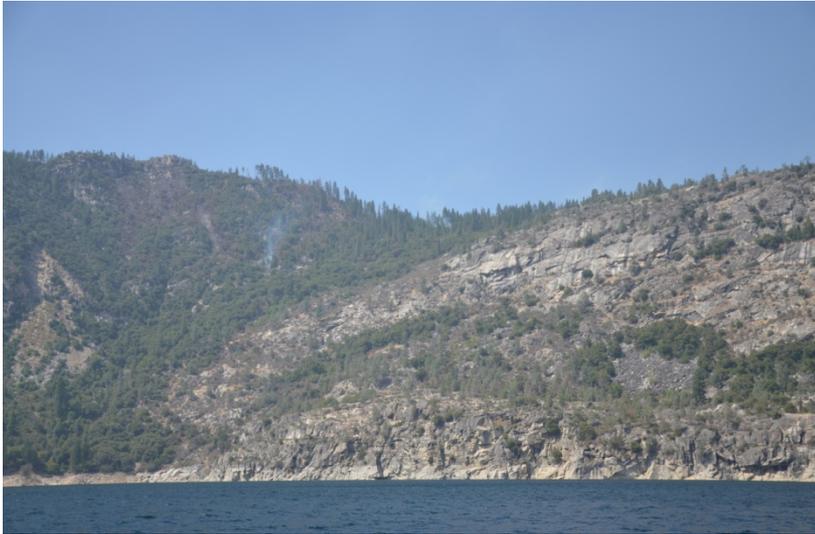
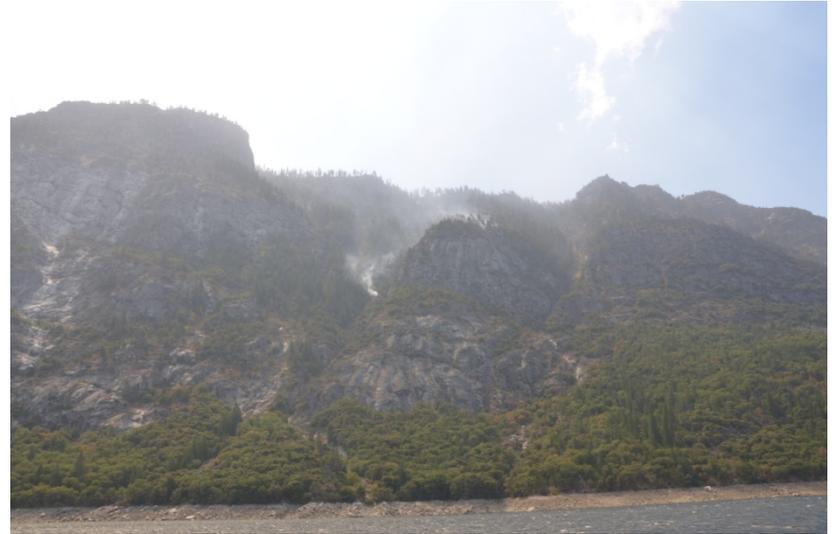
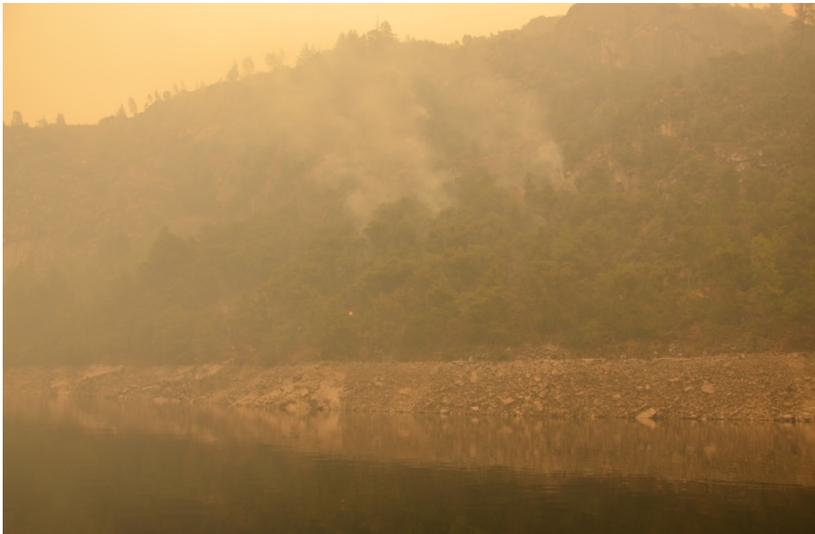
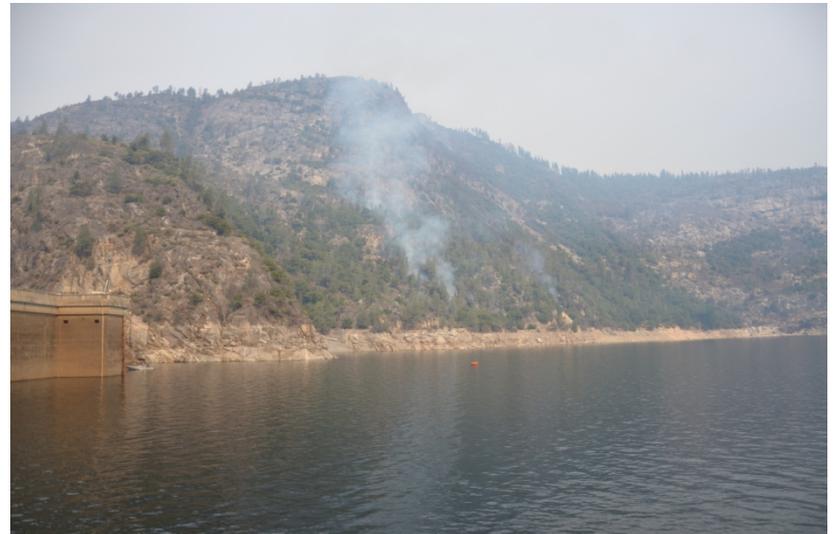
Isolated Spot fires – 8/30, 9/5,

More Widespread Understory Burn 9/17

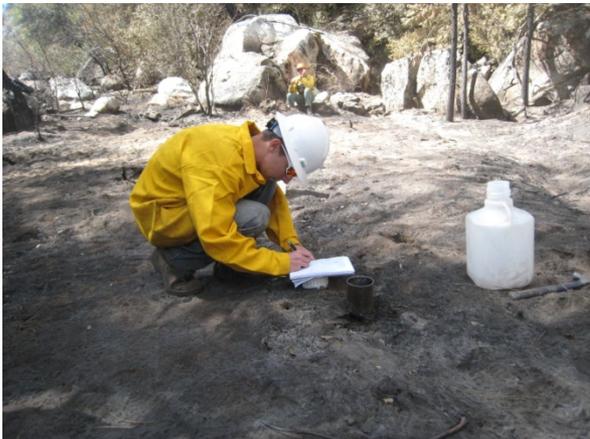
Hydrophobicity and Infiltration Tests

- Tests show that infiltration rates are typical for soil texture
 - 3-8 inches per hour
 - Some decrease from measured rates at unburned areas
 - Well below precipitation rates
- Tests show soil rates extremely hydrophobic
 - Water drops sit on soil surface > 2 minutes
 - Surface of mineral soil, rather than overlaying organic layer
 - Soils are naturally hydrophobic due to soil /vegetation properties
 - Infiltration tests show hydrophobicity effects lessen under wetted soils

Location	Burn Intensity	Infiltration Rate	Hydrophobicity
Hetch Hetchy South Shore	Light	7.6 in/hr	Extreme
Hetch Hetchy North Shore (1)	High	7.7 in/hr	Extreme
Hetch Hetchy North Shore (2)	High	3.0 in/hr	Extreme
Hetch Hetchy No Burn (1)	None	19.3 in/hr	High/Extreme
Hetch Hetchy No Burn (2)	None	12.1 in/hr	High/Extreme
