Flood Control Project Maintenance
Levee Inspections

Fall 2016 Levee Maintenance Deficiency Summary Report

Sutter Maintenance Yard Maintenance Area 0007

Levee Inspection Report By Mile - Fall 2016

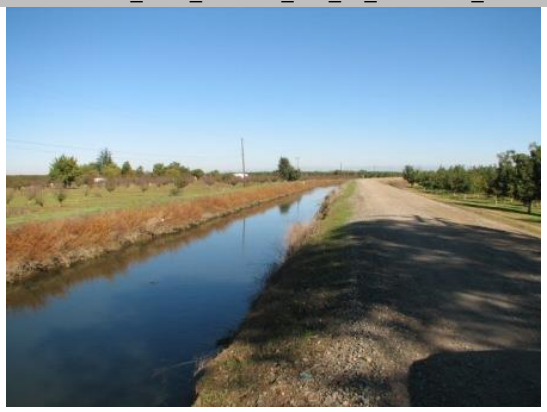
Photo 2 of 2 : FA_2016_MA0007_200_42_20160906_00007.jpg

LM Start	**0.03**	Rating **	M	Issue No.	**42 (cont)**
LM End	**1.72**	Issue Type +	Ma	Location *	LS

Agricultural ditch landside slope and toe.

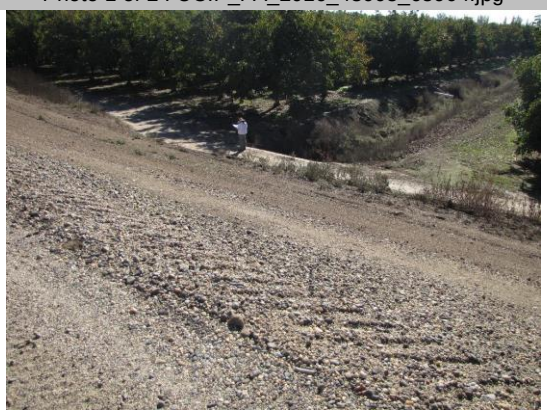
Photo 1 of 2 : UCIP_FA_2016_48005_65904.jpg

FIELD_STRUCT_DESC: 1 of 2: 60-inch corrugated metal drainage pipe (downstream pipe) through the levee, 23.4 feet below the crown. Concrete headwalls on both the waterside (WS) and landside (LS) ends. Flap gate on the WS end. Ditch at WS outlet. [Additional Reference(s): DWR Levee Log, 2005. USACE Sacramento O&M Manual 152, March 1957 (Station 195+80)]
FS Date: 5/16/2016 10:29:00 AM

View of WS. Concrete headwall located at levee toe.

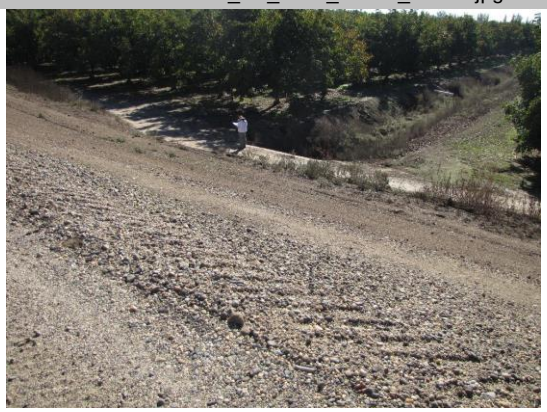
Photo 1 of 2 : UCIP_FA_2016_48006_65911.jpg

FS_ID:48006
DS_ID:17013
EP_NO: N/A
Repair Type: Non-Urgent
Crossing Status: Found
UCIP Comments: 5/16/2016 Feather River West Levee Improvement Project--Levee currently under construction. Crossing, referenced as STA 1961+10, will be removed as indicated in the project Plans for Construction of Feather River West Levee Project, Project Area A, Feather River West Levee Improvement Plans, Sta 1765+00 to 2368+26, Volume 3 of 5. The 2-60 inch pipes will be replaced with a single 36-inch pipe.6/10/2015 Sediment still blocking the flap gates on WS. LS inlet ebing overgrown by vegetation in the ditch.12/29/2014 Same as last inspection.5/19/2014 Same as last inspection.11/7/2013 Same as last inspection.5/13/2013 SBFCA project recommends relacing in accordance with title 23.5/10/2013 Same as last inspection.11/5/2012 Sediment blocking flap gate--need to remove sediment to make flap gates operational.
FIELD_STRUCT_DESC: 2 of 2: 60-inch corrugated metal drainage pipe (upstream pipe) through the levee, 23.4 feet below the crown. Concrete headwalls on both the waterside (WS) and landside (LS) ends. Flap gate on the WS end. Ditch located at WS outlet. (USACE O&M Manual, 1957) [Additional Reference(s): DWR Levee Log, 2005. USACE Sacramento O&M Manual 152, March 1957 (Station 195+80)]

View of WS with clear slope.

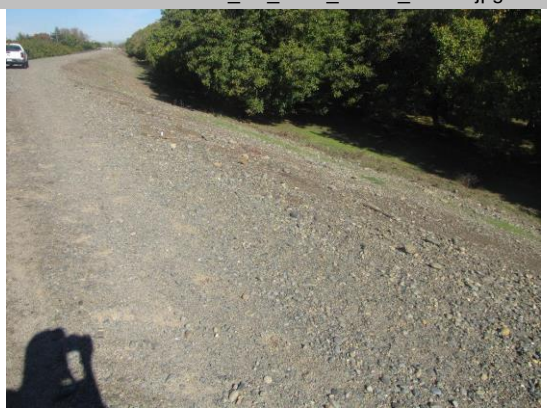
Photo 2 of 2 : UCIP_FA_2016_48007_65922.jpg

FS_ID:48007
DS_ID:16960
EP_NO: 17895
Repair Type: Non-Urgent
Crossing Status: Indicator Found
UCIP Comments: 5/16/2016 Feather River West Levee Improvement Project--Levee currently under construction. Crossing, referenced as STA 2084+03, will be removed and replaced as indicated in the project Plans for Construction of Feather River West Levee Project, Project Area A, Feather River West Levee Improvement Plans, Sta 1765+00 to 2368+26, Volume 3 of 5.6/10/2015 Minor erosin still present near air vent.12/30/2014 Same as last inspection.5/19/2014 Same as last inspection.11/7/2013 Same as last inspection.11/5/2012 localized erosion at air vent located on WS shoulder; this crossing appears to have leaking at the air vent--will need to determine reason for erosion at air vent (vehicles going over vent?); also recommend installing utility marker.
FIELD_STRUCT_DESC: 5-inch steel irrigation pipe through the right (west) bank levee at an unknown depth below the crown. Pipe connects to existing pipe within the overflow area of the Feather River. (Permit No. 17895, 2005 - John Kucek)

View of WS and levee crown looking upstream towards crossing.

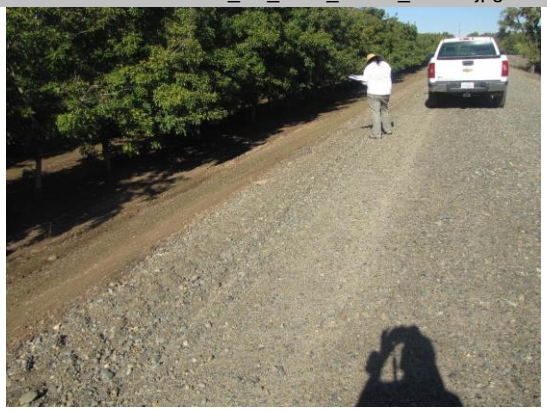
Photo 2 of 2 : UCIP_FA_2016_47874_65937.jpg

LM Start	**8.64**	Rating **	M	Issue No.	**75 (cont)**
LM End	**8.64**	Issue Type +	En	Location *	LS

View of LS and levee crown looking upstream at crossing. Staff is standing adjacent to cavity located on LS shoulder.

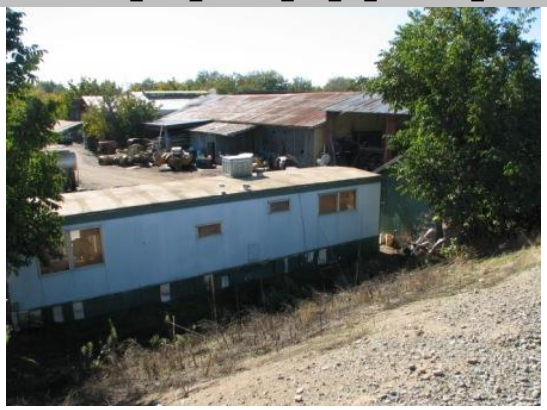
Photo 1 of 1 : FA_2016_MA0007_200_45_20160906_00009.jpg

This photo shows a building at the landside toe.

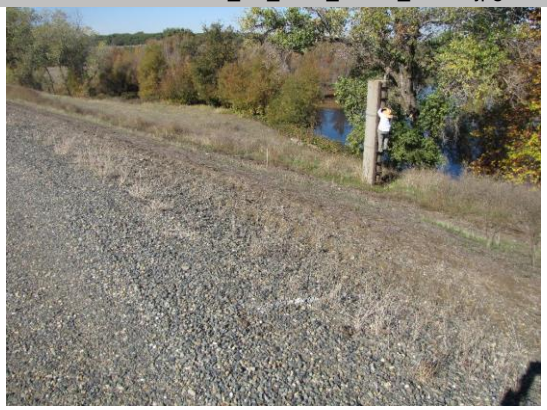
Photo 2 of 2 : UCIP_FA_2016_47990_65945.jpg

FS_ID:47990
DS_ID:16947
EP_NO: N/A
Repair Type: Non-Urgent
Crossing Status: Indicator Found
UCIP Comments: 5/16/2016 Feather River West Levee Improvement Project--Levee currently under construction. Crossing, referenced as STA 2201+87, will be removed and replaced as indicated in the project Plans for Construction of Feather River West Levee Project, Project Area A, Feather River West Levee Improvement Plans, Sta 1765+00 to 2368+26, Volume 3 of 5.6/11/2015 Abandoned crossing. SBFCA project recommends removal.12/30/2014 Same as last inspection.5/20/2014 Same as last inspection.11/7/2013 Same as last inspection.5/13/2013 SBFCA project recommends removal.5/10/2013 Same as last inspection.11/5/2012 Crossing appears to be abandoned; slide gate located inside concrete standpipe is buried with trash; no other features were visible during inspection. This crossing needs to be properly abandoned.
FIELD_STRUCT_DESC: *ABANDONED* 10-inch reinforced concrete encased steel irrigation pipe through the levee, 14.5 feet below the crown. Slide gate in 24-inch concrete standpipe at the waterside (WS) toe. [Additional Reference(s): DWR Levee Log, 2005. USACE Sacramento O&M Manual 152, March 1957 (Station 437+30)]

View of WS shoulder and slope looking upstream at crossing.

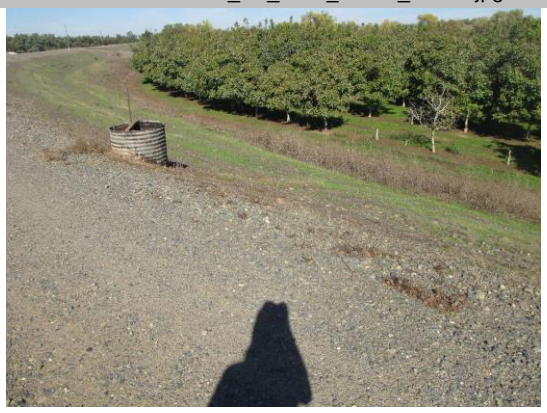
Photo 2 of 2 : UCIP_FA_2016_47993_65969.jpg

LM Start	**11.01**	Rating **	M	Issue No.	**85 (cont)**
LM End	**11.01**	Issue Type +	En	Location *	LS

View of WS looking upstream at crossing. CMP riser located on WS shoulder.

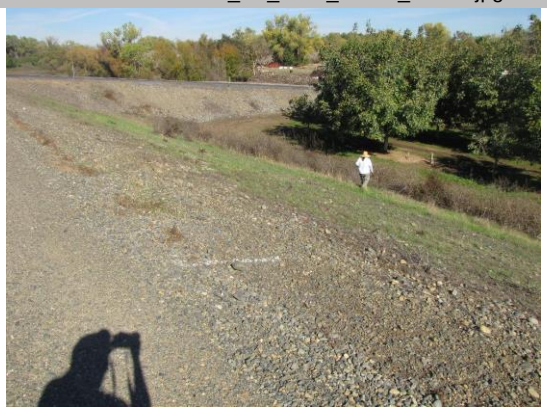
Photo 2 of 2 : UCIP_FA_2016_47958_65973.jpg

LM Start	**11.08**	Rating **	M	Issue No.	**87 (cont)**
LM End	**11.08**	Issue Type +	En	Location *	LS

View of WS looking upstream at crossing.
