Flood Control Project Maintenance
Levee Inspections

Spring 2017 Levee Inspection Results

Sutter Maintenance Yard Maintenance Area 0017

Waterway	Bank	Unit Miles
Unit No. 01 Lake County Sutter Maintenance Yard - Middle Creek	Left	3.87

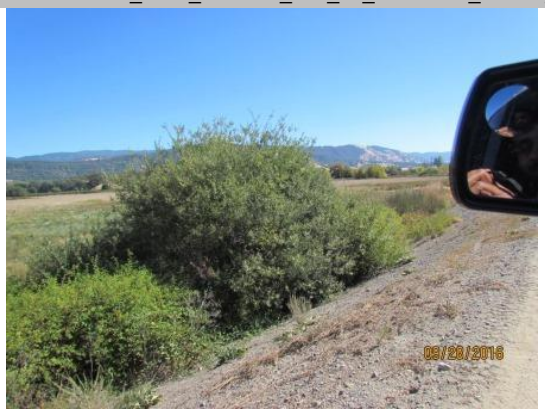
Photo 1 of 1 : SP_2017_MA0017_339_15_20170315_00003.jpg

Large bushes and brambles covering wire fence, limiting visibility and access.

View of the large bushes limiting visibility and access.

V2 : Remove the wild growth other than native grasses from the levee slopes.

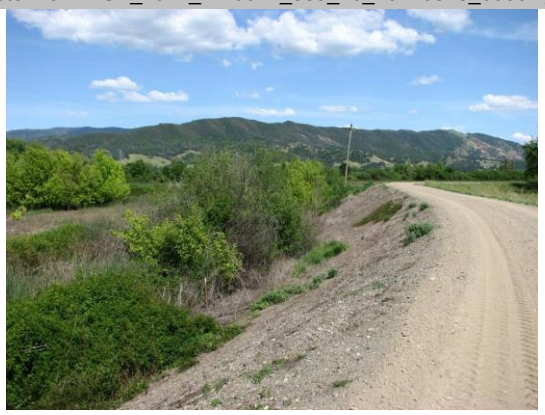
Photo 1 of 1 : SP_2017_MA0017_339_16_20170315_00004.jpg

Large bushes and brambles growing on wire fence on LS toe limiting visibility and access.

5/2/2016: Remove or trim dense vegetation growing on fence to allow visibility and access to L/S toe.

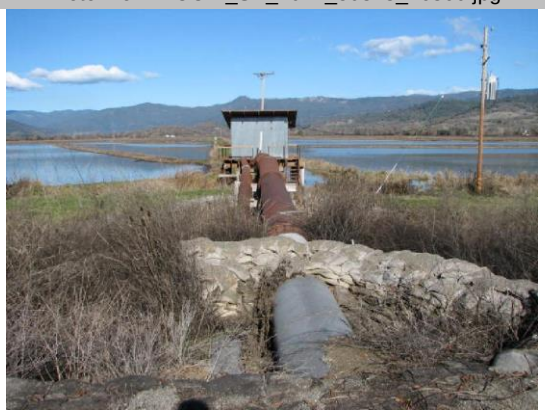
Photo 1 of 2 : UCIP_SP_2017_50818_46860.jpg

FS_ID:50818
DS_ID:847
EP_NO: 11469
Repair Type: Non-Urgent
Crossing Status: Found
UCIP Comments: 10/19/2016 Sack ring still in place. (DWR Sutter Yard- AFreitag)6/14/2016 Sack ring is still built up underneath the pipes.4/23/2015 Sack ring is still built up underneath the pipes.7/3/2014 Same as last inspection.12/23/2013 Same as last inspection.8/2/2013 Same as last inspection.12/13/2012 flood fight materials-ring levees around both LS and WS slopes at pipe crossing. This may or may not be an issue.
FIELD_STRUCT_DESC: 1 of 2: 16-inch steel drainage pipe through the levee, 5 feet below the crown. Drainage pumping plant on the landside (LS). Flap gate on the waterside (WS) end. (Automatic Board Order (ABO) issued as Permit No. 11469, 1975 - RD 2070). [Additional Reference(s): DWR Levee Log, 2005. USACE Sacramento O&M Manual 506.3, August 1961, (HLM 5.43)].
FS Date: 11/21/2016 12:11:57 PM

Pumping plant, pipes, and ring levees on LS toe.

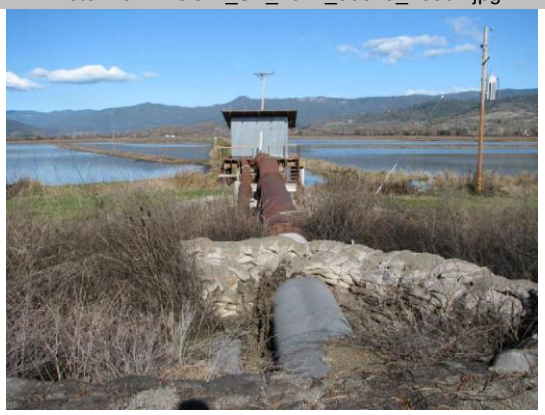
Photo 1 of 2 : UCIP_SP_2017_50819_46864.jpg

FS_ID:50819
DS_ID:853
EP_NO: 11469
Repair Type: Non-Urgent
Crossing Status: Found
UCIP Comments: 10/19/2016 Sack ring still in place. (DWR Sutter Yard- AFreitag)6/14/2016 Sack ring is still built up underneath the pipes.4/23/2015 Sack ring still built up underneath the pipes.7/3/2014 Same as last inspection.12/23/2013 Same as last inspection.8/2/2013 Same as last inspection.12/13/2012 flood fight materials-ring levees around both LS and WS slopes at pipe crossing. This may or may not be an issue.
FIELD_STRUCT_DESC: 2 of 2: 36-inch steel drainage pipe through the levee, 5 feet below the crown. Flap gate and air vent on the waterside (WS) slope. (Automatic Board Order (ABO) issued as Permit No. 11469, 1975 - RD 2070). [Additional Reference(s): DWR Levee Log, 2005. USACE Sacramento O&M Manual 506.3, August 1961, (HLM 5.43)].
FS Date: 11/21/2016 12:12:31 PM

Pipes and pump house on LS toe with ring levees.

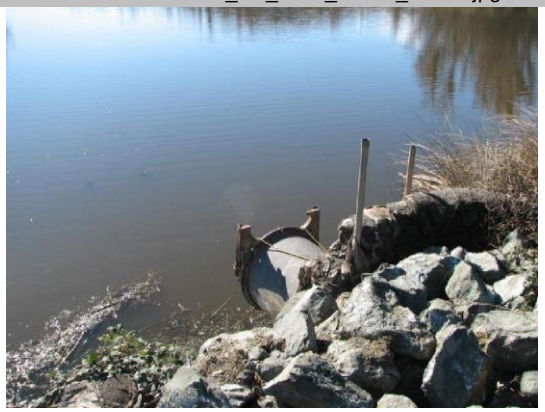
Photo 2 of 2 : UCIP_SP_2017_50819_46863.jpg

Pipe, flap gate, air vent, and sandbags on WS slope.
