Flood Control Project Maintenance
Levee Inspections

Spring 2017 Levee Inspection Results

Knights Landing Ridge Drainage District

Levee Inspection Report By Mile - Spring 2017

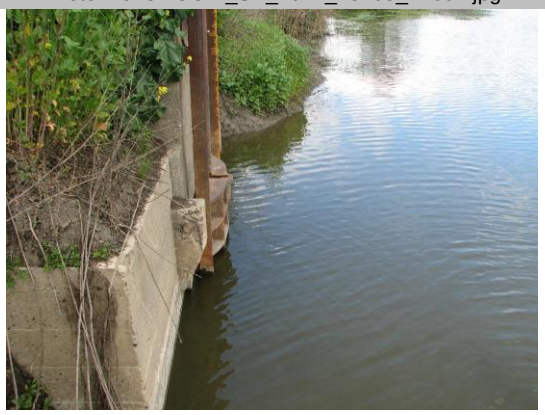
Photo 1 of 3 : UCIP_SP_2017_13205_21602.jpg

FS_ID:13205
DS_ID:19391
EP_NO: 9307
Repair Type: Non-Urgent
Crossing Status: Found
UCIP Comments: Walkway to actuater slide gate is missing. No method of actuating slide gate.
FIELD_STRUCT_DESC: 2 of 2: 4-foot x 4-foot concrete box culvert through the levee, 23 feet below the crown. Walkway to slide gate on the waterside end, concrete headwalls on both ends. Service pole and anchor at landward toe. Concrete headwalls on both ends (Permit No. 9307- Lowe).
FS Date: 4/5/2013

Slide gate and concrete headwall on WS toe.

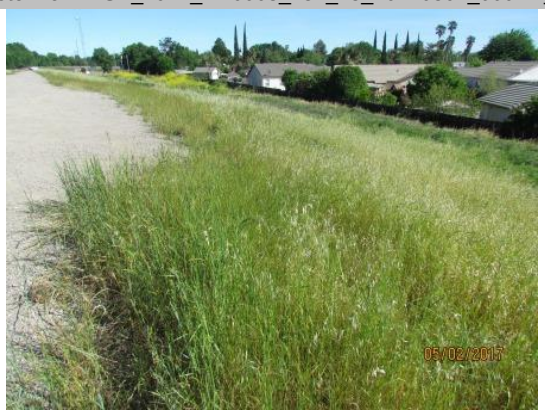
Photo 1 of 1 : SP_2017_NA0008_257_15_20170502_00027.jpg

Tall grass on landside levee slope, blocking visibility. Spring 2017.
