Flood Control Project Maintenance
Levee Inspections

Maintenance Issue Types Only, Levee Inspection Report By Mile - Spring 2017

Yolo County Service Area 6

Waterway	Bank	Unit Miles	Inspection Start/End	Inspector
Unit No. 01 Right Bank of Sacramento River at Knights Landing	Right	5.87	05/01/2017 05/01/2017	Zach Jojola

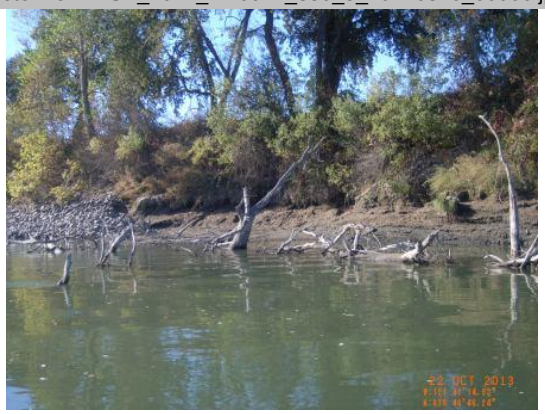
Photo 1 of 1 : SP_2017_NA0022_350_5_20170320_00006.jpg

2006 - Short section is into the levee toe, rest is near the levee toe. Mass failure and fluvial erosion of depositional material. Rock at the upstream and downstream ends. 2011 - Minor new erosion. 2012 - Slope continues to steepen, tree roots have become exposed, and new eddy formed. 2015: No observed changes. [2015 Site ID: SAC_86-9_R]

USACE 2013 Photo #1

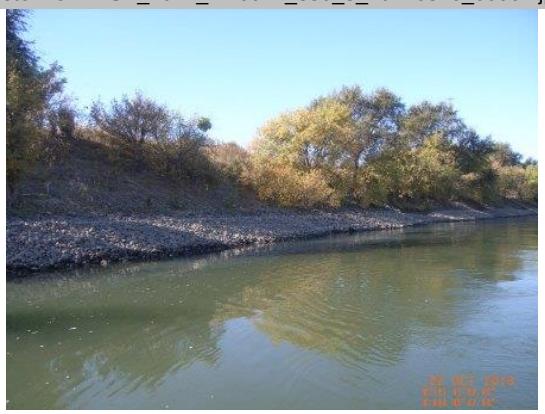
Photo 1 of 1 : SP_2017_NA0022_350_3_20170320_00002.jpg

2009 - Erosion into the levee toe. Some cobbles have been dumped into the erosion pockets. 2010 - Old cobble site starting to unravel. 2012 - Slope continues to steepen and new animal holes. 2013 - Downstream cobble is unraveling. 2015: No observed changes. [2015 Site ID: SAC_85-4_R]

USACE 2013 Photo #1

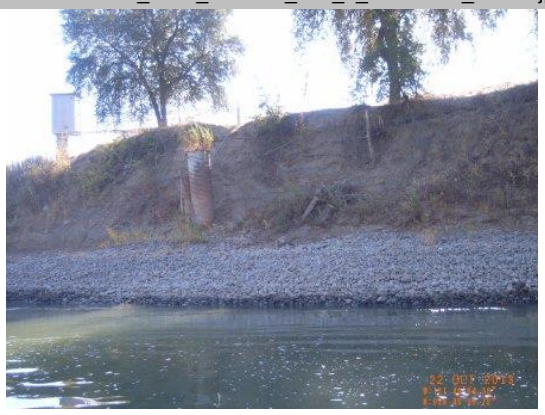
Photo 2 of 3 : SP_2017_NA0022_350_4_20170320_00004.jpg

2006 - Approximately 18 to 20 ft of bank near levee at the corner of the levee and the Freemont Weir. Vertical bank with undercutting/mass failure. 2007 - Staked at top of bank for monitoring. 2011 - Site has become significantly worse with more of the toe and lower bank eroded. Many trees have fallen since last year. 2012 - Site looks worse with more ersion around trees. 2013 - Additional erosion into the toe. 2015: Site extended upstream about 500 ft to account for eroding bank. [2015 Site ID: SAC_83-9_R]

USACE 2013 Photo #2
