Flood Control Project Maintenance
Levee Inspections

Spring 2017 Levee Inspection Results

Reclamation District No. 0108 River Farms

Waterway	Bank	Unit Miles
Unit No. 01 Colusa Basin Drain	Left	20.64

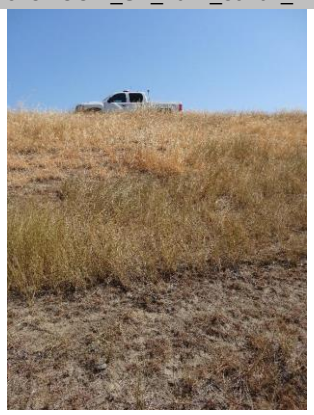
Photo 3 of 3 : UCIP_SP_2017_39707_71680.jpg

FS_ID:39707
DS_ID:24875
EP_NO: N/A
Repair Type: Non-Urgent
Crossing Status: Indicator Found
UCIP Comments: No signs of pipe visible--need to contact owner to obtain permit number authorizing work. If crossing is no longer used by owner, the owner will need to coordinate with DWR Inspector and CVFPB to remove crossing according to Title 23 requirements. Dense vegetation limits the inspector's visibility to identify signs of pipe failure (leaks) along the slope. Recommend removing vegetation along pipe alignment to conduct proper inspection of structure.
FIELD_STRUCT_DESC: Corrugated Metal (CM) pipe riser located on waterward side. Riser is filled with trash and deris. Unable to determine if crossing exists at this location.
FS Date: 3/18/2014

View of waterward slope.

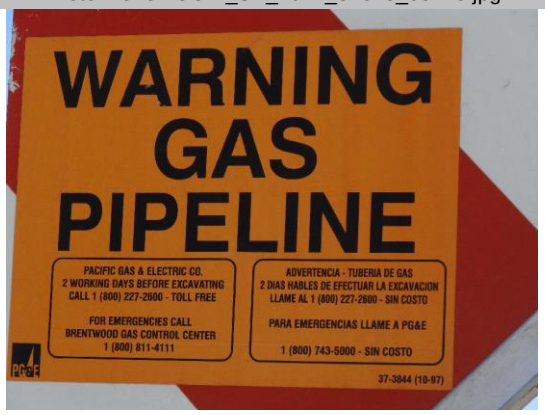
Photo 2 of 3 : UCIP_SP_2017_37623_68245.jpg

FS_ID:37623
DS_ID:17942
EP_NO: 3800
Repair Type: Non-Urgent
Crossing Status: Indicator Found
UCIP Comments: Need to contact owner--marker missing on waterward side.
FIELD_STRUCT_DESC: 20-inch concrete encased gas line through levee, 3.0 feet below the crown. Crossing appears to be angled through levee (App. 3800-PG&E) Small rock revetment on the waterward slope. (unable to locate) Gas well approximately 1,000 feet from landward toe.
FS Date: 6/10/2014

Contact information for gas line going through levee.
