Flood Control Project Maintenance
Levee Inspections

Maintenance Issue Types Only, Levee Inspection Report By Mile - Spring 2017

Reclamation District No. 0556 Upper Andrus

Waterway	Bank	Unit Miles	Inspection Start/End	Inspector
Unit No. 01 Georgiana Slough	Right	5.48	04/19/2017 04/19/2017	Herman Phillips

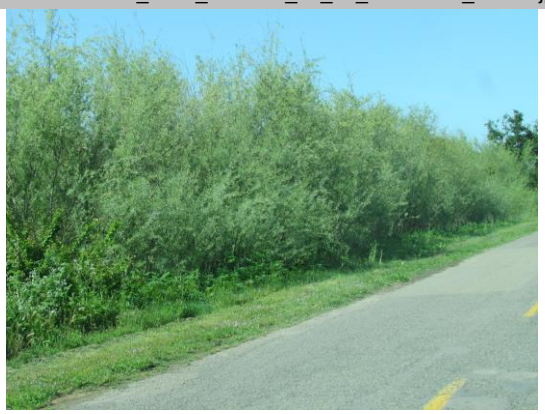
Photo 1 of 1 : SP_2017_RD0556_18_74_20170517_00060.jpg

This arundo needs to be removed, this vegetation completely blocks the view of the waterside slope, shoulder and toe.

RD 556 Unit 1 waterside levee mile 1.74-2.29.

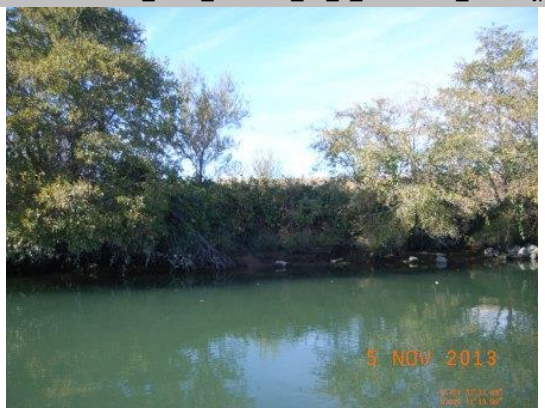
Photo 1 of 1 : SP_2017_RD0556_18_1_20170404_00001.jpg

1997 - Toe damaged rock. 1999 - One pocket filled with gravel. 2000 - Eroding beach with some biotech rolls and stakes; some gravel on slope. 2001 - Staked, low fascine walls at bankline. 2005 - Stone revetment in between pockets. 2006 - New rock on upper slope behind brush boxes at the upstream end, Stone is sliding off the hard toe. 2015: Last observed in 2013. [2015 Site ID: GEO_7-0_R]

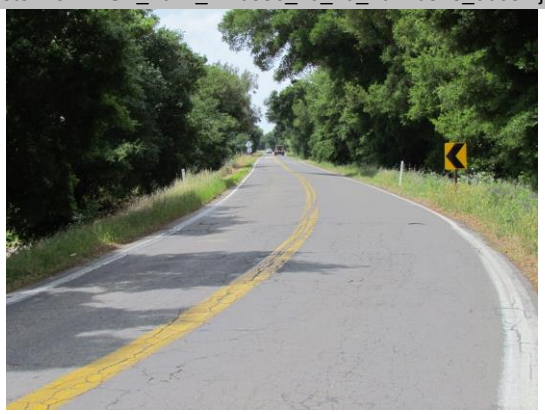
Photo 1 of 1 : SP_2017_RD0556_19_29_20170523_00054.jpg

RD 556 Unit 2 from levee mile 0.00-5.71.

Control the wild vegetation and wild tree growth from the landside slope and shoulder heading downstream

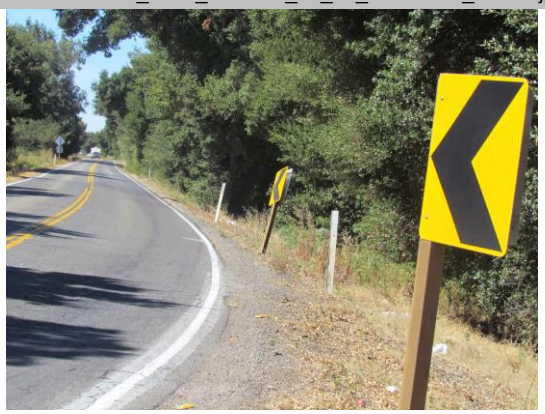
Photo 1 of 1 : SP_2017_RD0556_19_82_20170404_00015.jpg

Waterside levee slope and shoulder is covered with wild tree growth and other unsatisfactory vegetation.

RD 556 Unit 2 looking downstream of waterside slope.

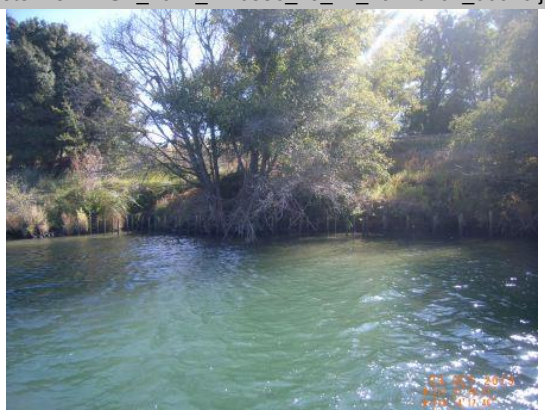
Photo 1 of 1 : SP_2017_RD0556_19_12_20170404_00010.jpg

2002 - Two rocked sections (150 ft long) at the downstream end. 2005 - Lots of old brush boxes, some with established vegetation in the area behind the boxes. 2006 - Some small spots fixed with stone. 2009 - Minimal new erosion, rock in the middle of the reach may be new. 2011 - Minor new erosion at the toe. 2013 - Minor new erosion. 2015: Site is currently under construction. [2015 Site ID: SAC_26-0_L]

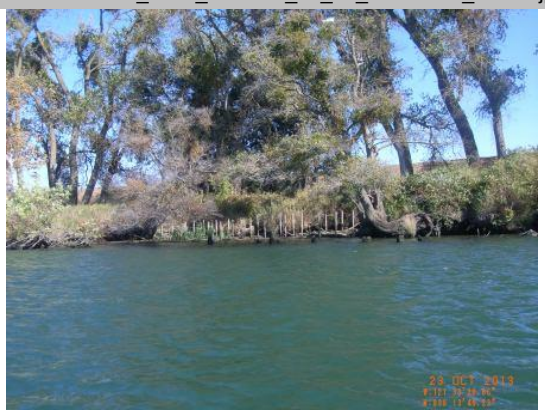
Photo 1 of 1 : SP_2017_RD0556_19_11_20170404_00009.jpg

1997 - Few scallops in berm, some getting close to levee toe. 2005 - Brush boxes present. 2012 - More erosion of the toe since last year. 2015: No observed changes. [2015 Site ID: SAC_23-3_L]

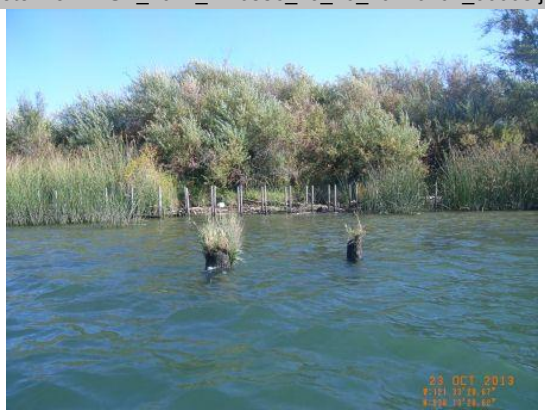
Photo 1 of 1 : SP_2017_RD0556_19_10_20170404_00008.jpg

2000 - Recently fallen cottonwood at the downstream end. 2005 - Empty brush boxes. 2011 - A few trees have fallen since last year. 2012 - Potential new tree popout since last year. 2013 - New erosion at downstream end of site and a recent tree pop-out observed. 2015: No observed changes. [2015 Site ID: SAC_23-2_L]

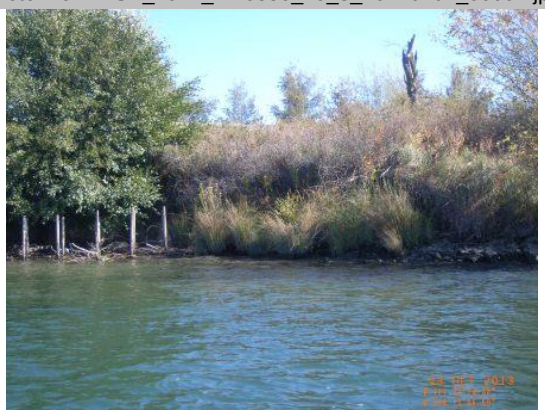
Photo 1 of 1 : SP_2017_RD0556_19_8_20170404_00007.jpg

1997 - Scallops into berm and very close to levee toe. 2005 - Brush boxes present. 2011 - New toe scour and freshly fallen tree. 2012 - New tree popout has taken significant portion of soil out of the levee. 2015: No observed changes. [2015 Site ID: SAC_22-7_L]

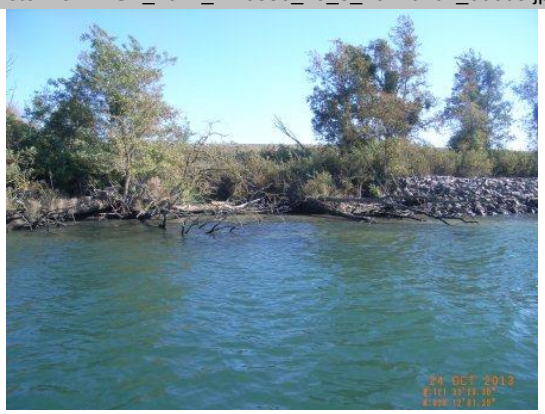
Photo 1 of 1 : SP_2017_RD0556_19_3_20170404_00003.jpg

1999 - Downstream 140 ft repaired with rock. 2010 - Lots of woody debris, but no changes to site. 2015: Site extended upstream due to erosion pockets. [2015 Site ID: SAC_21-5_L]
