Flood Control Project Maintenance
Levee Inspections

Fall 2016 Levee Maintenance Deficiency Summary Report

Reclamation District No. 2089 Stark

Levee Inspection Report By Mile - Fall 2016

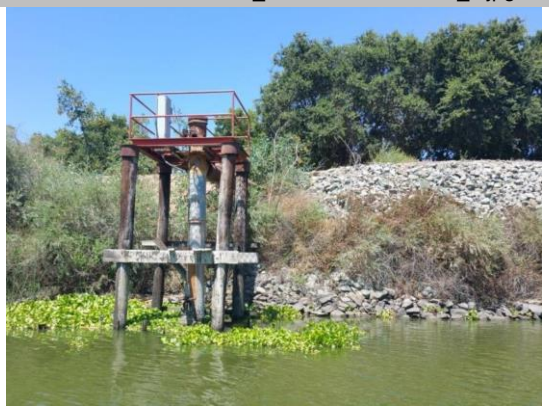
Photo 1 of 2 : SJR2016_RD2089U01RM29.8_1.jpg

07/25/2016: No significant change observed.
06/25/2015: No significant change observed.
07/02/2014: No significant change observed.
08/13/2013: No significant change observed.
08/07/2012: The site has been visited by boat survey. No significant change observed
08/23/2011: The site shows loose material around the pipe crossing. The operation of the pipe might have caused an impact on the levee.
[2016 Site ID:RD2089U01RM29.8]

Front view of the site. Note the irrigation pipe on the site.

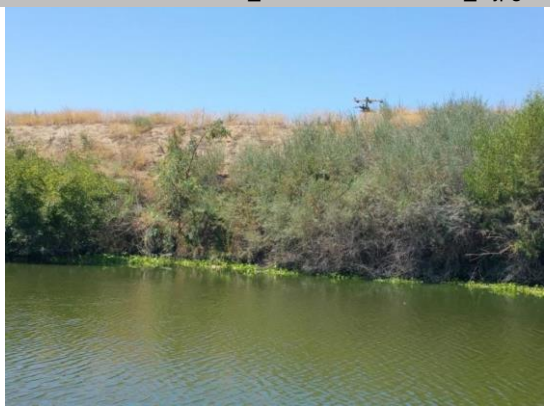
Photo 1 of 1 : SJR2016_RD2089U01RM29.61_2.jpg

07/25/2016: No significant change observed.
06/25/2015: No significant change observed.
07/02/2014: No significant change observed.
08/13/2013: No significant change observed.
08/07/2012: The site has been visited by boat survey. No significant change observed
08/23/2011: The 5-foot vertical scarp shows no significant change from the last year inspection. No new erosion activities observed. Dense white willow trees on site.
09/07/2010: It was difficult to view the erosion due to the thick Willow thickets and other vegetation at the water line. At the time of the inspection, there were no signs of repair on site. As noted during the last survey, there is a 5-foot vertical scarp along the lower slope that may be subjected to high flow velocities.
08/05/2010: Recommended for repair, per CLRO; "Erosion of this site may be subjective to rapid rates of erosion."
09/28/2009: No major change observed; 5-foot vertical scarp is immediately downstream of where berm has tapered; site is recommended as local maintenance issue, per CLRO CES Evaluation 2008 Report; Site # is the same as RM29.6, LM0.60; previously rated "U".

11/05/2008: No change observed; rodent holes on lower slope; wide levee crown. [2016 Site ID:RD2089U01RM29.61]

Front view of the site. Note the very dense white willow thickets on site.

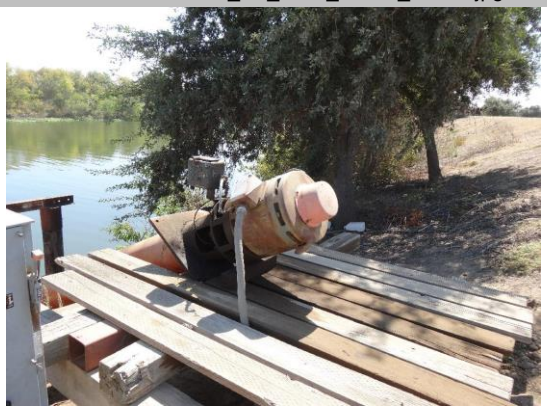
Photo 1 of 2 : UCIP_FA_2016_21587_36635.jpg

FS_ID:21587
DS_ID:23043
EP_NO: 3385
Repair Type: Non-Urgent
Crossing Status: Found
UCIP Comments: - powerline on landside.- electric control box on waterside.- waterside slope erosion under pump platform.
FIELD_STRUCT_DESC: 16-inch pipe through the levee, 5.5 feet below the crown, slant pump in pump house on the waterward slope. Siphon breaker on the landward slope. (App. No. 3385-Elinore Lawrence). Originally included in O+M (1968)
FS Date: 9/12/2013

WS view: slant pump on wooden platform. Oil leaks from the pump.

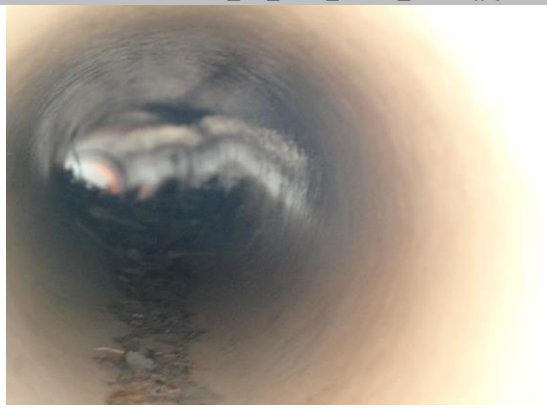
Photo 2 of 2 : UCIP_FA_2016_50737_36610.jpg

FS_ID:50737
DS_ID:24667
EP_NO: N/A
Repair Type: Urgent
Crossing Status: Found
UCIP Comments: 11/15/2016 Same as last inspection. (K. Fazel - UCIP)09/12/2013:- if abandoned, it needs proper abandonment. Pipe damaged and open on both ends. (P. Amatya - DWR)
FIELD_STRUCT_DESC: *ABANDONED* 6-inch polyvinyl chloride (PVC) irrigation pipe through the levee, 2 feet below the crown. Pipe was installed due to pump failure but never removed. Field study discovered pipe.
FS Date: 11/15/2016

WS view: inside view of pvc pipe. Sediments found inside the pipe.

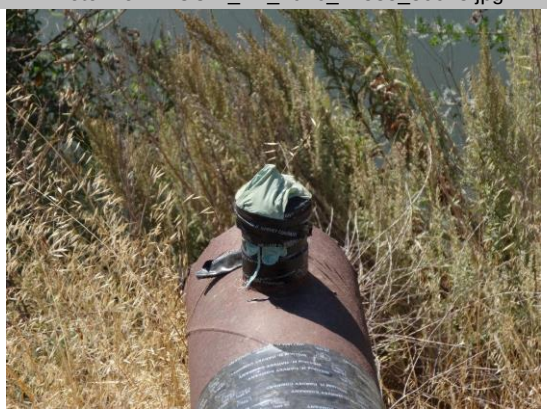
Photo 2 of 2 : UCIP_FA_2016_21585_36623.jpg

FS_ID:21585
DS_ID:23045
EP_NO: N/A
Repair Type: Non-Urgent
Crossing Status: Found
UCIP Comments: - siphon breaker needs repair.
FIELD_STRUCT_DESC: 10-inch steel pipe through the levee, 2.4 feet below the crown. Pump in drain ditch on the landward side. Siphon breaker on the waterward shoulder.
FS Date: 9/12/2013

WS view: exposed steel pipe with siphon breaker. Looks siphon breaker needs repair.
