Flood Control Project Maintenance
Levee Inspections

Maintenance Issue Types Only, Levee Inspection Report By Mile - Fall 2018

Levee District No. 0003 (Glenn County)

Waterway	Bank	Unit Miles	Inspection Start/End	Inspector
Unit No. 01 Glenn County Sacramento River	Left	11.97	09/06/2018 09/06/2018	Bob Duffey

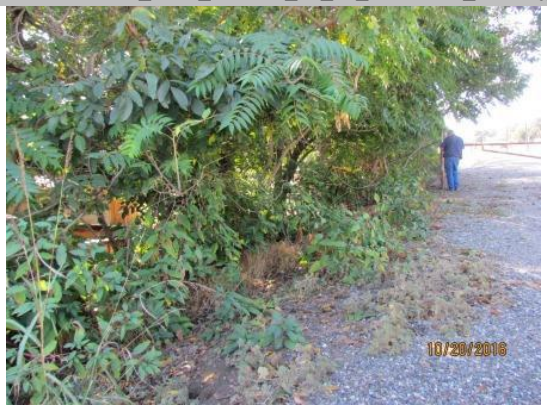
Photo 1 of 1 : FA_2018_LD0003_27_35_20180905_00019.jpg

View of the trees that are hanging over the landside slope of the levee.

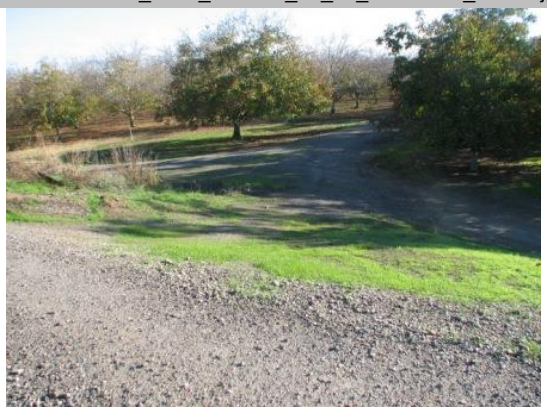
Photo 1 of 1 : FA_2018_LD0003_27_14_20180905_00012.jpg

View of the vehicle erosion along the landside slope.

S3 : Repair the levee slope damaged by vehicle traffic and prevent access where possible.

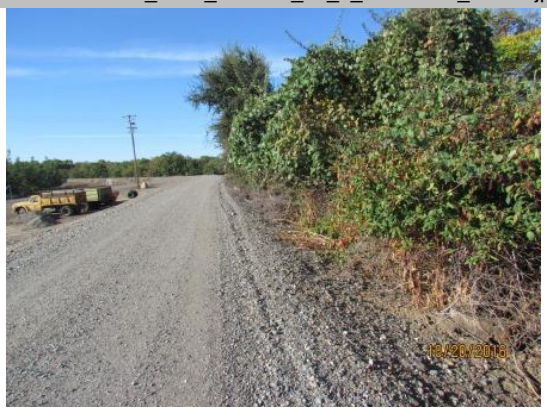
Photo 1 of 1 : FA_2018_LD0003_27_5_20180905_00003.jpg

View of the dense vegetation along the waterside slope.
