Flood Control Project Maintenance
Levee Inspections

Spring 2020 Levee Inspection Results

Reclamation District No. 0537 Lovdal

Waterway	Bank	Unit Miles
Unit No. 01 Sacramento River	Right	4.74

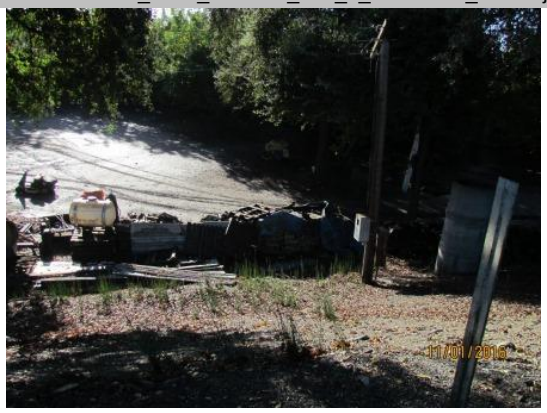
Photo 2 of 2 : SP_2020_RD0537_173_6_20200228_00003.jpg

Equipment at the landside toe.

View of equipment at landside toe. Fall 2016.

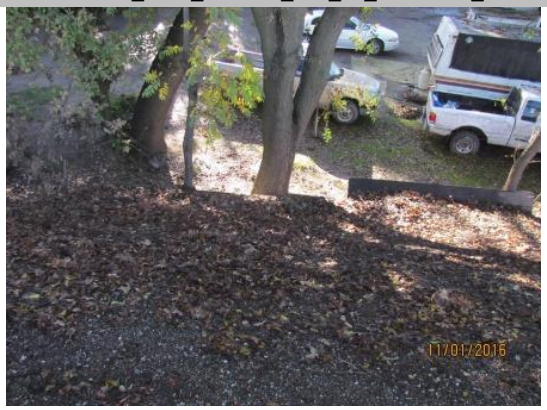
Photo 3 of 3 : SP_2020_RD0537_173_50_20200228_00032.jpg

View of the retaining wall at the levee toe on the landward side of the levee looking downstream. The wall is partially broken. Fall 2015.

View of the site. Fall 2016.

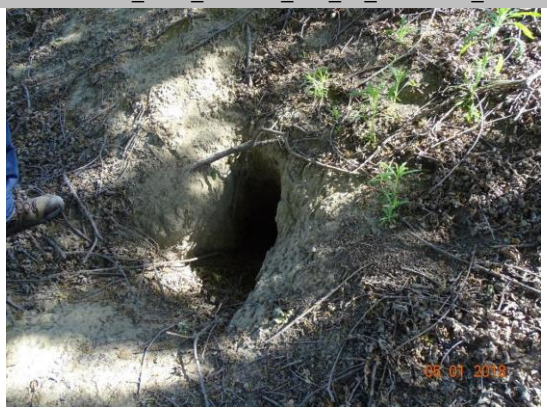
Photo 2 of 2 : SP_2020_RD0537_173_37_20200228_00024.jpg

Additional rodent hole on the landside slope. Spring 2018.

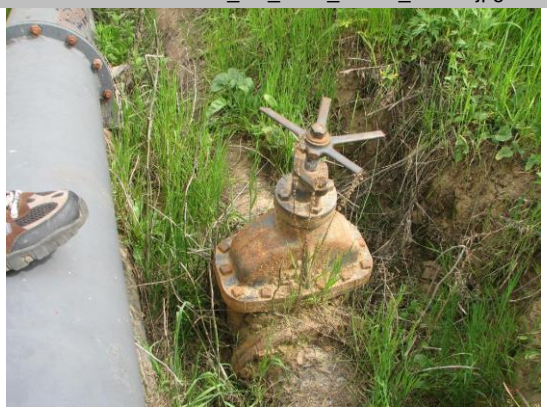
Photo 3 of 3 : UCIP_SP_2020_46806_17036.jpg

DS_ID:180
FS_ID:46806
EP_NO: 4656
Repair Type: Non-Urgent
Crossing Status: Found
UCIP Comments: Broken gate valve handle on waste pipe.
FIELD_STRUCT_DESC: 12-inch steel irrigation discharge pipe through the levee, 7 feet below the crown. Slant pump column on the riverbank. Timber walkway mounted on a pile structure across the berm to the pump. Siphon breaker in a corrugated metal pipe (CMP) riser on the landside (LS) slope. Concrete pipe riser on the LS. 6-inch waste line down the waterside (WS) bank with a gate valve. (Plans to install a new steel pipe through an existing pipe and to grout the annular space between the pipes through the levee authorized under Permit No. 4656, 1964 - Beatty H. Ramsay, MD). [Additional Reference(s): DWR Levee Log, 2004].
FS Date: 3/18/2013

WS- main pipe and waste pipe with gate valve

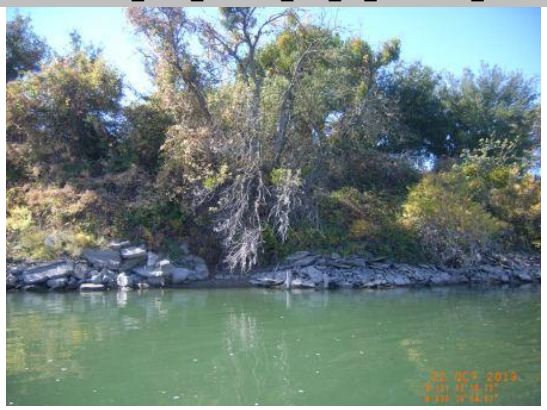
Photo 1 of 1 : SP_2020_RD0537_173_19_20200228_00012.jpg

2017 Site ID: SAC 62.9 R
Status: Eroding
2017 Field Notes: Fresh erosion pocket near downstream end.
Site History: 1997 - This may have been a cobble rehabilitation site to the 1957 cobble that was place all the way to the I-80 Bridge. 2000 - Local damage induced by human use. 2003 - Site is still very close to the levee and into the levee toe. 2011 - One new tree has fallen. 2015 - Sites 62.9 and 63 were combined into one site.
