**Flood Control Project Maintenance**
**Levee Inspections**

# Fall 2019 Levee Maintenance Deficiency Summary Report

## Overall LMA & Unit Ratings, including USACE Erosion Survey

### *Sacramento River Basin*

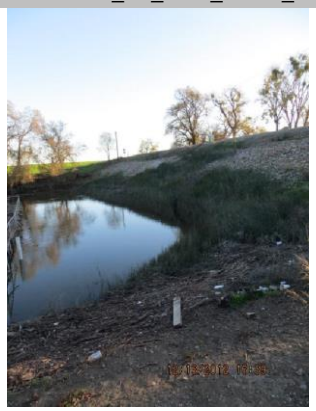
Photo 3 of 3 : UCIP_FA_2019_56003_46923.jpg

LS view: overview towards levee slope.

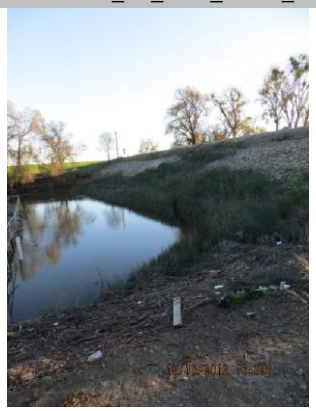
Photo 3 of 3 : UCIP_FA_2019_56004_46925.jpg

LS view: overview towards levee slope.

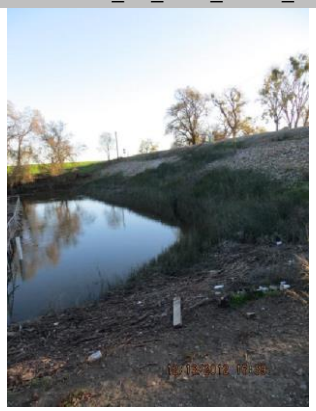
Photo 3 of 3 : UCIP_FA_2019_56005_46930.jpg

LS view: overview towards levee slope.

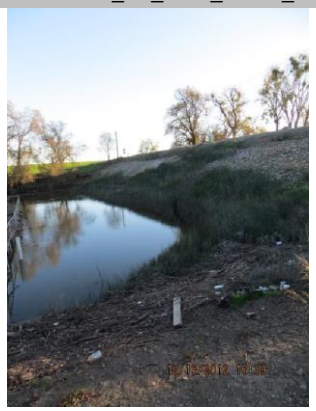
Photo 3 of 3 : UCIP_FA_2019_56006_46936.jpg

LS view: overview towards levee slope.

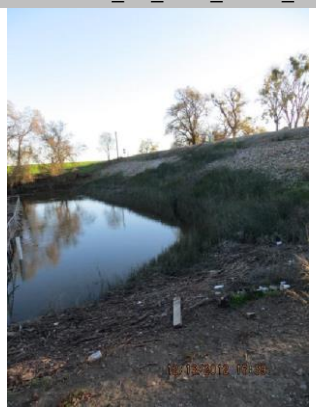
Photo 3 of 3 : UCIP_FA_2019_56007_46944.jpg

LS view: overview towards levee slope.

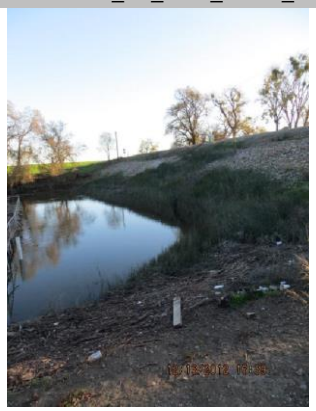
Photo 3 of 3 : UCIP_FA_2019_56008_46945.jpg

LS view: overview towards levee slope.

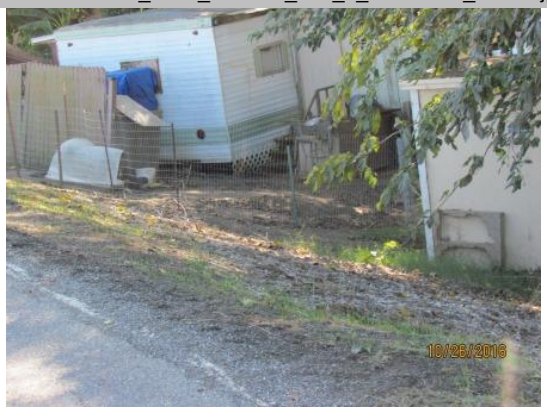
Photo 1 of 1 : FA_2019_ST0003_264_3_20190822_00002.jpg

View of the trailers and building on the waterside.

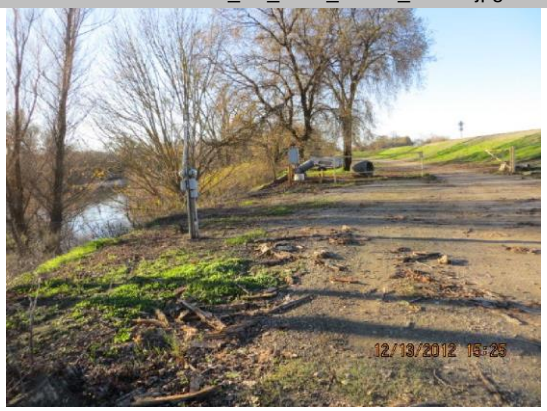
Photo 1 of 3 : UCIP_FA_2019_56009_46951.jpg

WS view: overview

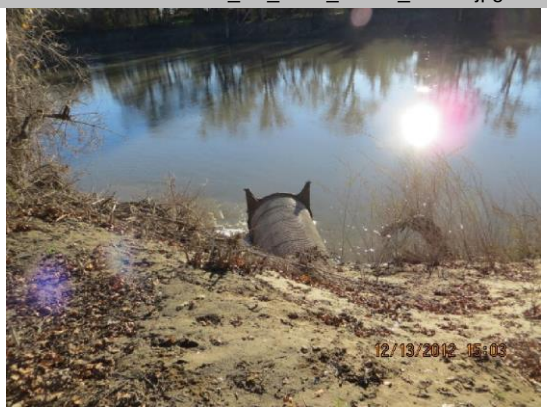
Photo 1 of 3 : UCIP_FA_2019_56010_46962.jpg

WS view: overview towards CMP sewer pipe

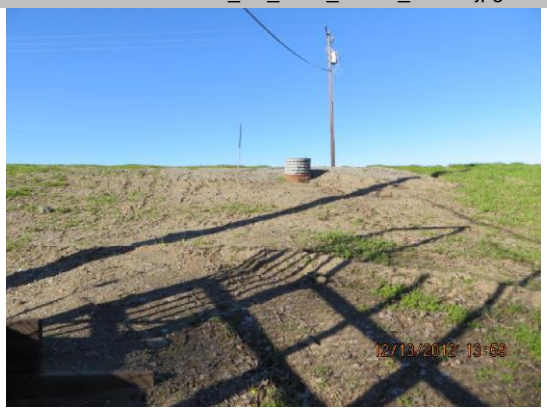
Photo 2 of 3 : UCIP_FA_2019_56014_46997.jpg

WS view: overview of CMP riser

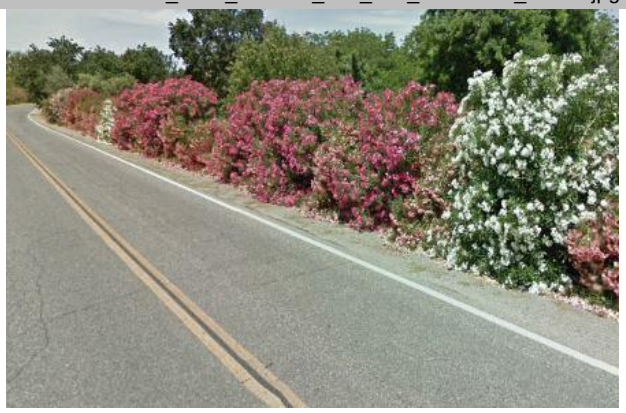
Photo 1 of 1 : FA_2019_ST0003_264_159_20191017_00241.jpg

View of the landscaping completely blocking visibility and access to the landside slope.

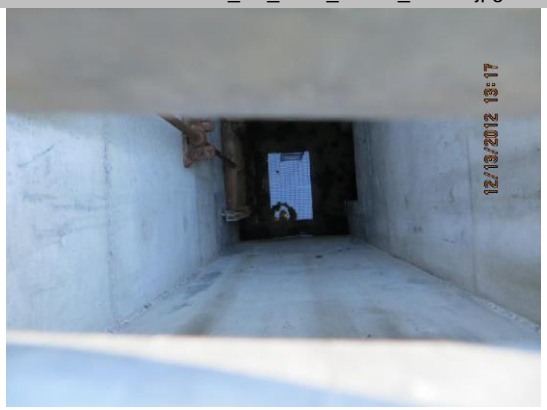
Photo 3 of 3 : UCIP_FA_2019_56018_47025.jpg

WS view: slide gate inside concrete surg tank

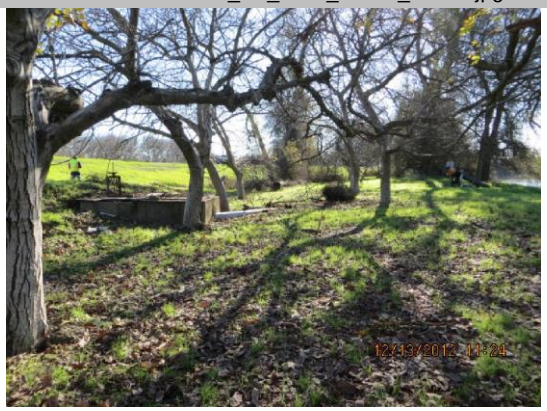
Photo 1 of 3 : UCIP_FA_2019_56026_47063.jpg

WS view: overview

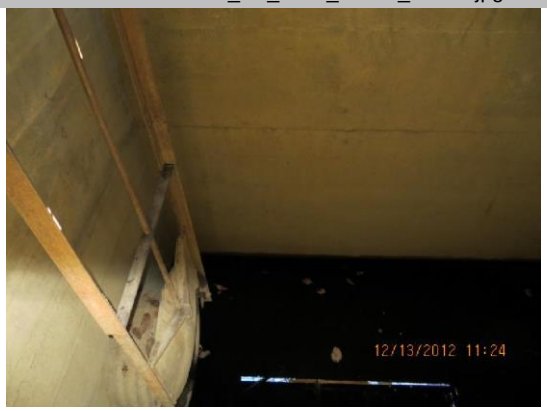
Photo 3 of 3 : UCIP_FA_2019_56026_47060.jpg

WS view: inside concrete surg box

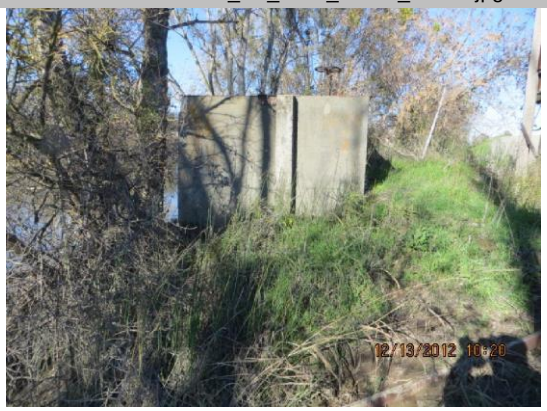
Photo 3 of 3 : UCIP_FA_2019_56070_47085.jpg

WS view: concrete surge box

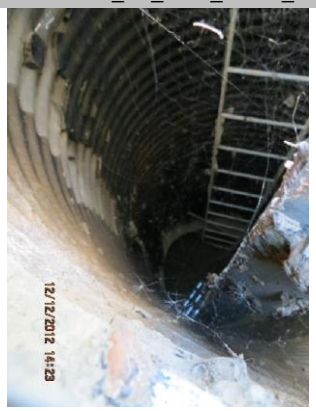
Photo 3 of 3 : UCIP_FA_2019_55526_47105.jpg

WS view: inside CMP riser

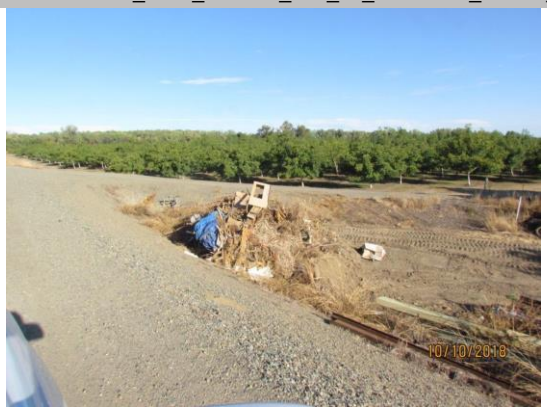
Photo 1 of 1 : FA_2019_ST0003_264_87_20190822_00018.jpg

View of the prunings and garbage along the landside toe.

Remove the prunings and garbage from the landside toe.

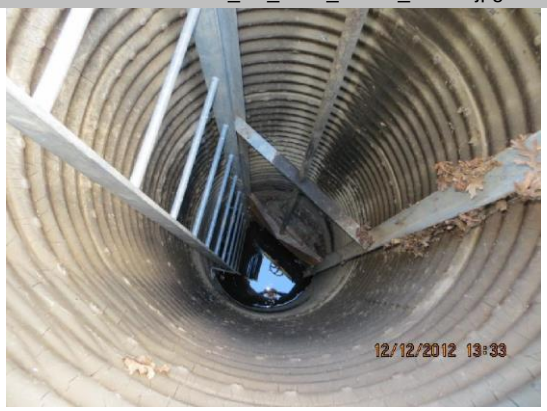
Photo 2 of 3 : UCIP_FA_2019_55534_47135.jpg

WS view: inside CMP riser

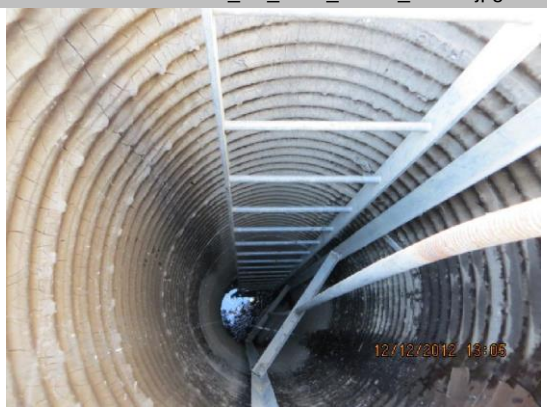
Photo 2 of 3 : UCIP_FA_2019_55536_47156.jpg

WS view: inside CMP riser

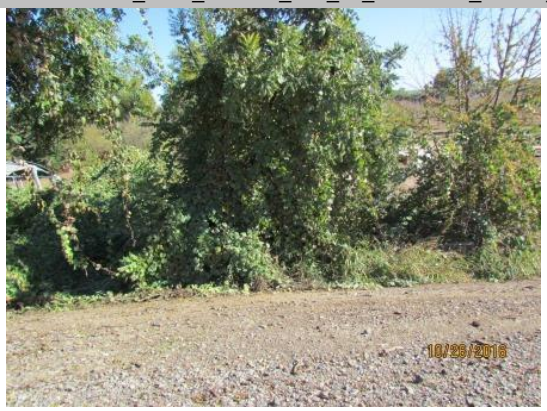
Photo 1 of 1 : FA_2019_ST0003_264_99_20190822_00025.jpg

View of the overgrown vegetation along the landside slope.

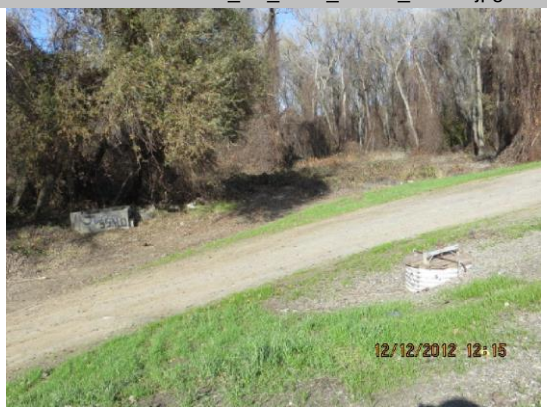
Photo 1 of 3 : UCIP_FA_2019_55542_47189.jpg

WS view: overview

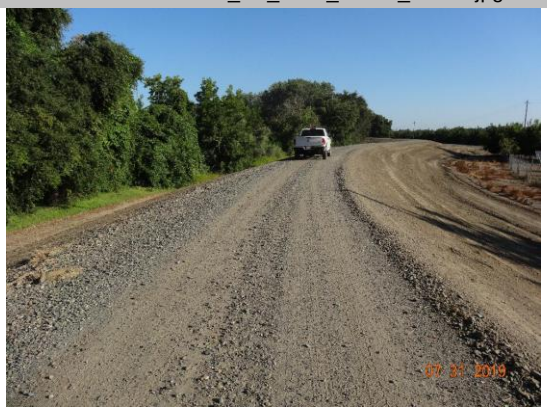
Photo 1 of 3 : UCIP_FA_2019_55544_81876.jpg

Overview of levee looking u/s towards where pipe should be buried.

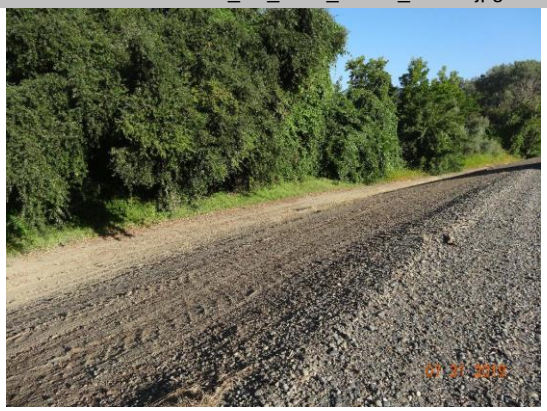
Photo 3 of 3 : UCIP_FA_2019_55544_81878.jpg

WS view: overview of WS.

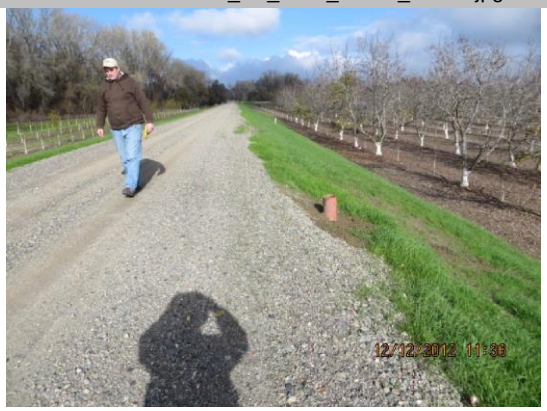
Photo 1 of 3 : UCIP_FA_2019_55549_47206.jpg

WS view: overview

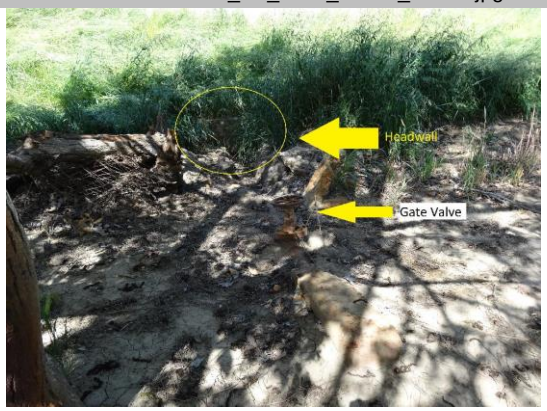
Photo 3 of 3 : UCIP_FA_2019_56040_75051.jpg

LS view of toe: corroded pipe and gate valve; concrete headwall

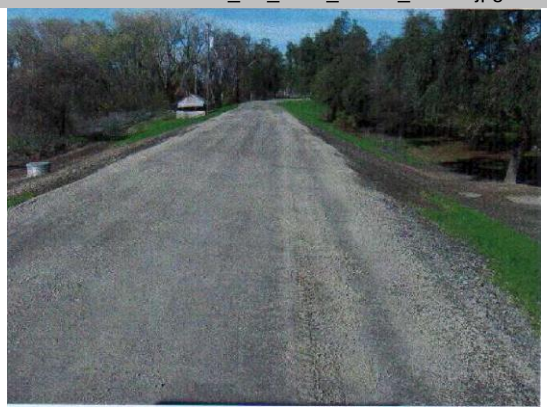
Photo 1 of 3 : UCIP_FA_2019_55560_75194.jpg

Permit No. 17860 (Nov 2004): looking upstream after removal of levee section for replacement of 18-inch pipe

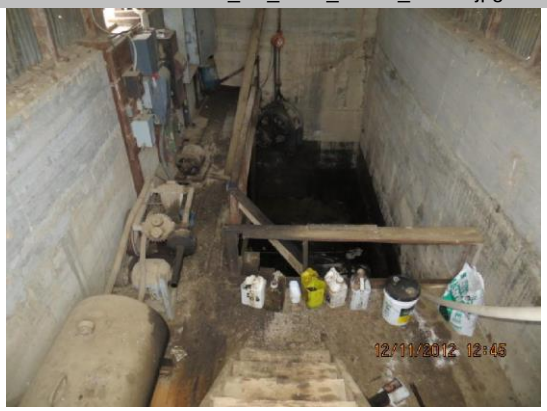
Photo 3 of 3 : UCIP_FA_2019_55561_47275.jpg

WS view: inside pump house, switch panel on wall

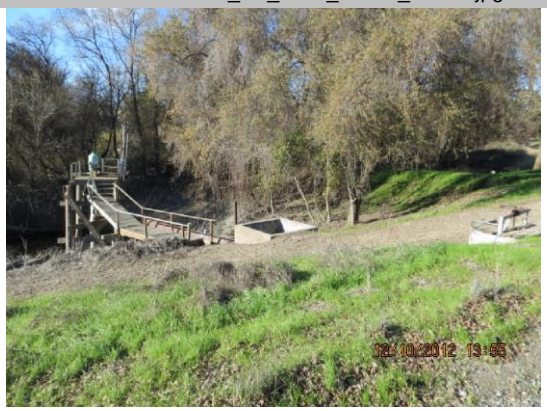
Photo 1 of 3 : UCIP_FA_2019_55578_47352.jpg

WS view: pump, walkway, surge box, & CMP riser

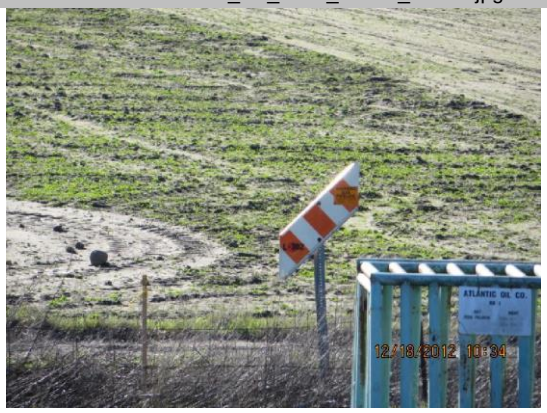
Photo 2 of 3 : UCIP_FA_2019_55624_47475.jpg

LS view: gasline indicator about 100 ft away from the levee.

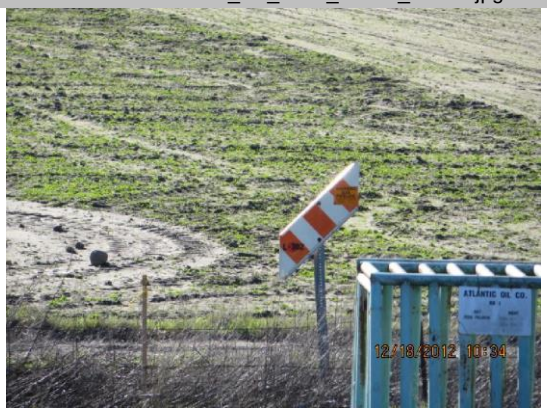
Photo 2 of 3 : UCIP_FA_2019_55625_47467.jpg

LS view: gasline indicator about 100 ft away

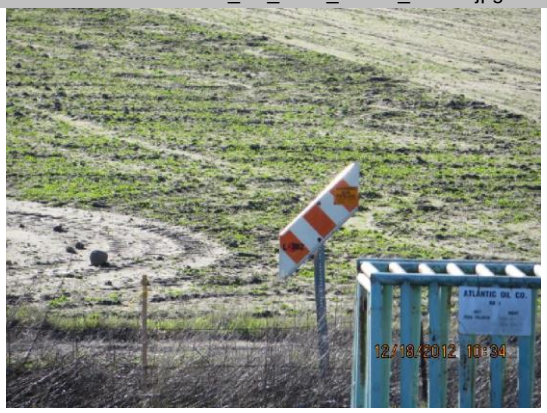
Photo 2 of 3 : UCIP_FA_2019_55626_47471.jpg

LS view: gasline indicator about 100 ft away from the levee

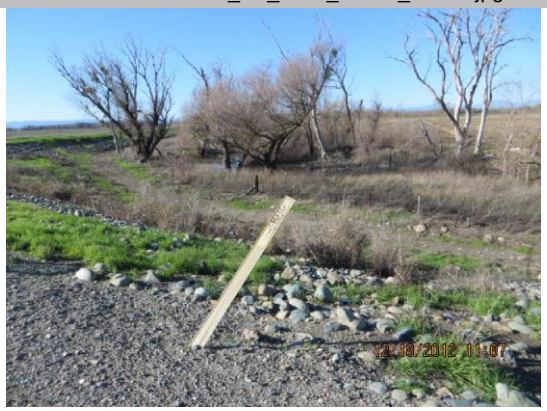
Photo 1 of 3 : UCIP_FA_2019_55628_47482.jpg

DS_ID:17556
FS_ID:55628
EP_NO: 15821
Repair Type: Non-Urgent
Crossing Status: Indicator Found
UCIP Comments: 08/05/2019 Crossing has been updated from No Action Needed to Non-Urgent; need maintenance records to determine current status of line. (O. Magana - DWR UCIP)06/03/2016 Crossing appears to be in good condition.04/06/2015 Same as last inspection. May need to add additional gas line markers.07/07/2014 Same as last inspection.12/19/2013 Same as last inspection.07/22/2013 Same as last inspection.
FIELD_STRUCT_DESC: 1 of 3. 4-inch natural gas pipeline under both levees. 12-inch distance between the pipes and two inches on either side of the trench. A gas line marker found on the landside (LS) for all 3 gas lines. (Permit No. 15821, 1991 - Phoenix Oil & Gas).
FS Date: 8/5/2019 3:26:00 PM

LS view: gasline indicator

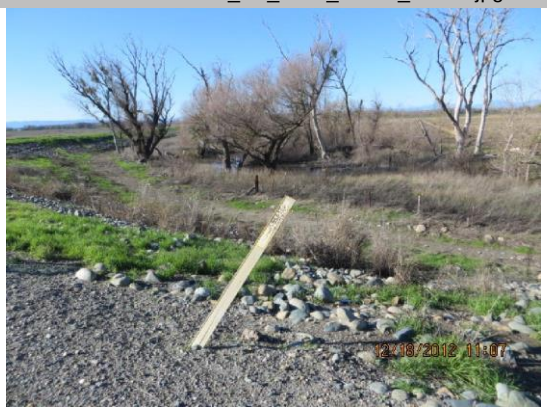
Photo 1 of 3 : UCIP_FA_2019_55629_47484.jpg

DS_ID:17557
FS_ID:55629
EP_NO: 15821
Repair Type: Non-Urgent
Crossing Status: Indicator Found
UCIP Comments: 08/05/2019 Crossing has been updated from No Action Needed to Non-Urgent; need maintenance records to determine current status of line. (O. Magana - DWR UCIP)06/03/2016 Crossing appears to be in good condition.04/06/2015 Same as last inspection. May need to add additional gas line markers.07/07/2014 Same as last inspection.12/19/2013 Same as last inspection.07/22/2013 Same as last inspection.
FIELD_STRUCT_DESC: 2 of 3. 4-inch natural gas pipeline under both levees. 12-inch distance between the pipes and two inches on either side of the trench. A gas line marker found on the landside (LS) for all 3 gas lines. (Permit No. 15821, 1991 - Phoenix Oil & Gas).
FS Date: 8/5/2019 3:27:00 PM

LS view: gasline indicator

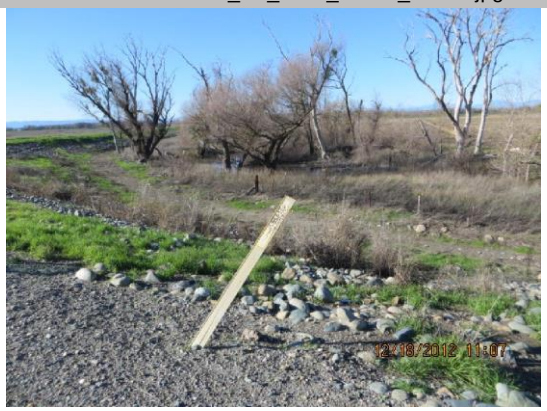
Photo 1 of 3 : UCIP_FA_2019_55630_47486.jpg

DS_ID:17558
FS_ID:55630
EP_NO: 15821
Repair Type: Non-Urgent
Crossing Status: Indicator Found
UCIP Comments: 08/05/2019 Crossing has been updated from No Action Needed to Non-Urgent; need maintenance records to determine current status of line. (O. Magana - DWR UCIP)06/03/2016 Crossing appears to be in good condition.04/06/2015 Same as last inspection. May need to add additional gas line markers.07/07/2014 Same as last inspection.12/19/2013 Same as last inspection.07/22/2013 Same as last inspection.
FIELD_STRUCT_DESC: 3 of 3. 4-inch natural gas pipeline under both levees. 12-inch distance between the pipes and two inches on either side of the trench. A gas line marker found on the landside (LS) for all 3 gas lines. (Permit No. 15821, 1991 - Phoenix Oil & Gas).
FS Date: 8/5/2019 3:29:00 PM

LS view: gasline indicator
