Field Work Renovations and Upgrades

Bryan Prestel

The Gap (FRW)

Kaweah Delta Watershed

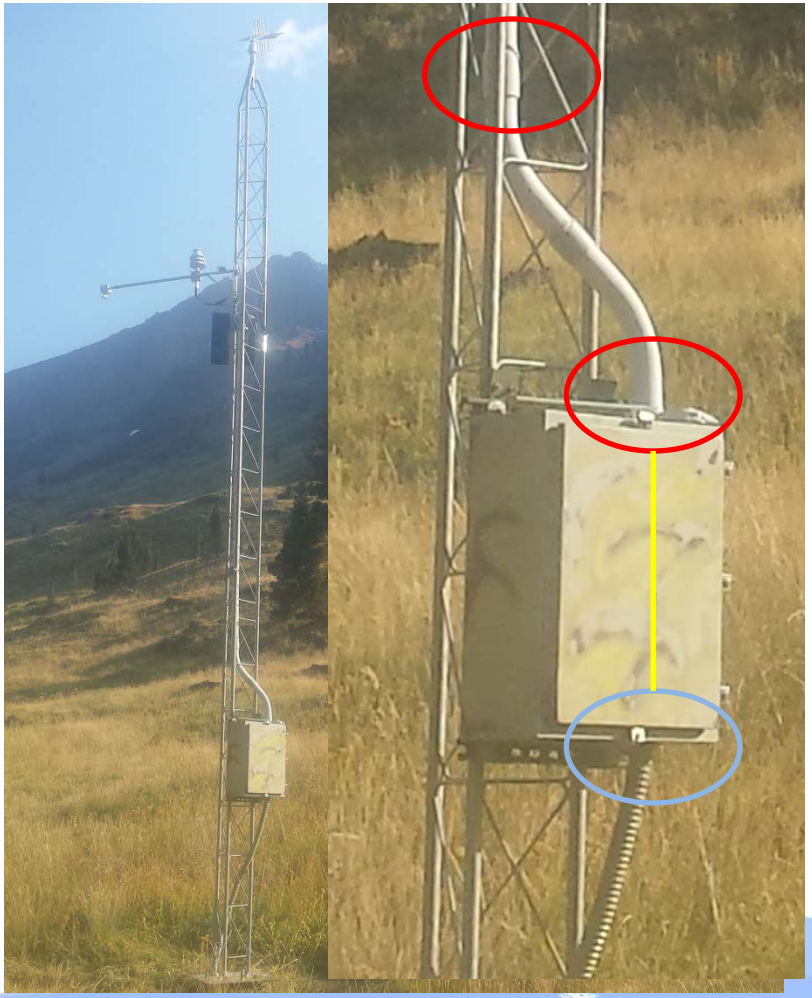
Farewell Gap (FRW) Cont.

Error: Root Cause – Water intrusion

Effect: Station Failure due to PWR Bus Short/Blown Fuse

How did this happen?

- Submersible Pressure Transducer in a NEMA 4x Box.
