**Flood Control Project Maintenance  
Levee Inspections**  
**LMA District Cover Sheet**  
**Spring 2016 Levee Inspection Results**

**Levee District No. 0001 (Glenn County)**

**Spring 2016 Levee Inspection Results**

**Levee Inspection Report By Mile - Spring 2016**

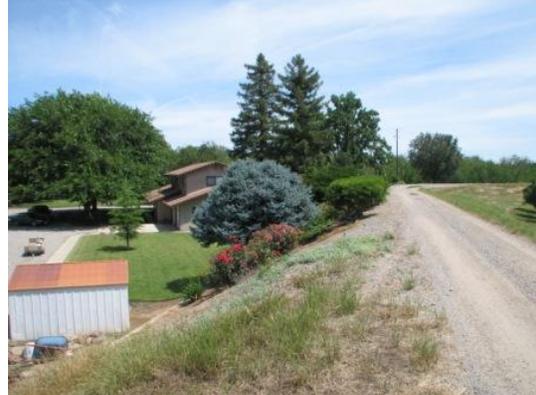
Photo 1 of 1 : SP\_2016\_LD0001G\_432\_6\_20160316\_00003.jpg

LM Start	<b>1.32</b>	Rating **	M	Issue No.	<b>6</b>
LM End	<b>1.36</b>	Issue Type +	En	Location *	LS
Category	Earthen Levee		GPS Latitude/Longitude		
			Start	End	
Item	Vegetation		39.494828 °	39.495330 °	
			-122.017632 °	-122.017163 °	
DWR ID	DWR_LD0001G_01_s_2012_6				
Comment Code					
V6 : Landscaping					
Inspector Comment					
Landscaping Permit No. 13057

View of the permitted landscape on the landside slope of the levee.

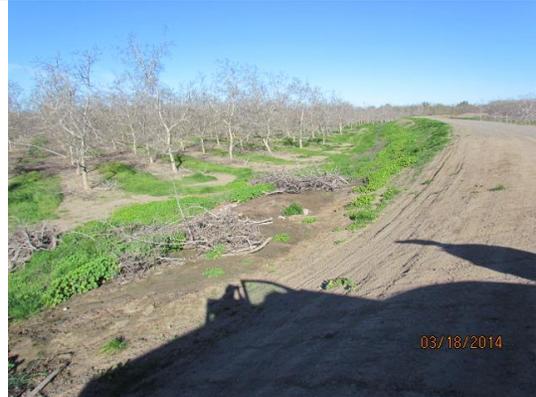
Photo 1 of 1 : SP\_2016\_LD0001G\_432\_45\_20160316\_00013.jpg

LM Start	<b>3.04</b>	Rating **	M	Issue No.	<b>45</b>
LM End	<b>3.04</b>	Issue Type +	En	Location *	LS
Category	Earthen Levee		GPS Latitude/Longitude		
			Start	End	
Item	Encroachments		39.512914 °	39.512914 °	
			-122.009063 °	-122.009063 °	
DWR ID	DWR_LD0001G_01_s_2014_45				
Comment Code					
PR : Prunings					
Inspector Comment

View of the removed prunings from the l/s slope.

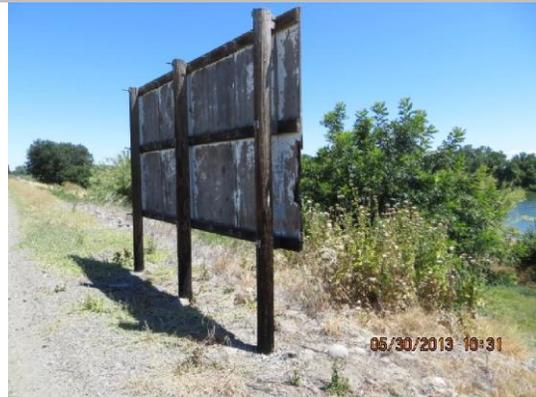
Photo 2 of 2 : UCIP\_SP\_2016\_14352\_23608.jpg

LM Start	<b>6.18</b>	Rating **	M	Issue No.	<b>412</b>
LM End	<b>6.18</b>	Issue Type +	En	Location *	LS
Category	Supplemental			GPS Latitude/Longitude	
				Start	End
Item	DWR UCIP Field Study			39.549911 °	39.549911 °
				-122.002102 °	-122.002102 °
DWR ID					
Comment Code					
Inspector Comment					
FS_ID:14352 DS_ID:22911 EP_NO: 5118 Repair Type: Non-Urgent Crossing Status: Indicator Found UCIP Comments: New gasline markers should be installed as existing signage has been sun faded FIELD_STRUCT_DESC: 1 of 2: 12.75-inch high pressure gas line through levee 3.0 feet below crown (Permit No. 5118, 1965). FS Date: 5/30/2013

Gasline sign on WS shoulder.

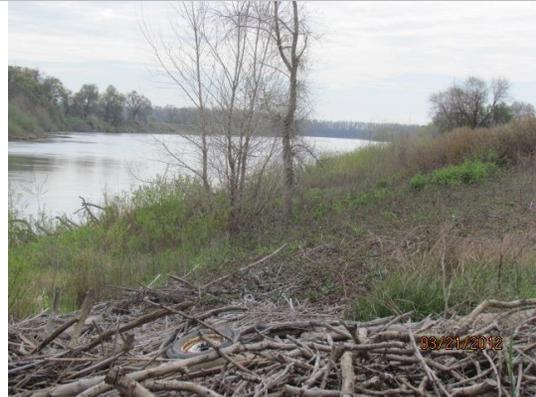
Photo 1 of 1 : SP\_2016\_LD0001G\_432\_10\_20160316\_00006.jpg

LM Start	<b>6.38</b>	Rating **	A/W	Issue No.	<b>10</b>
LM End	<b>6.64</b>	Issue Type +	Ma	Location *	WS
Category	Earthen Levee		GPS Latitude/Longitude		
			Start	End	
Item	Vegetation		39.552691 °	39.556459 °	
			-122.003063 °	-122.003831 °	
DWR ID	DWR_LD0001G_01_s_2012_10				
Comment Code					
V8 : Environmental Requirements.					
Inspector Comment

View of the Army Corps of Engineers mitigation site.

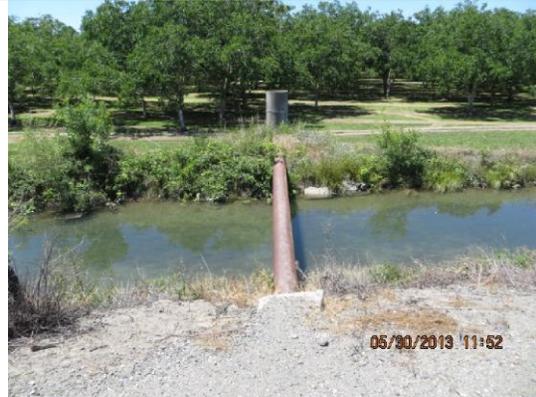
Photo 1 of 2 : UCIP\_SP\_2016\_14384\_23664.jpg

LM Start	<b>6.90</b>	Rating **	M	Issue No.	<b>414</b>
LM End	<b>6.90</b>	Issue Type +	En	Location *	LS
Category	Supplemental			GPS Latitude/Longitude	
				Start	End
Item	DWR UCIP Field Study			39.560072 °	39.560072 °
				-122.005039 °	-122.005039 °
DWR ID					
Comment Code					
Inspector Comment					
FS_ID:14384 DS_ID:22917 EP_NO: 9702 Repair Type: Non-Urgent Crossing Status: Found UCIP Comments: Abandoned and should be done so properly. FIELD_STRUCT_DESC: 20-inch concrete encased steel pipe through levee 7.2 feet below crown. Slant pump on waterward bank. Slide gate in 36-inch concrete standpipe on waterward berm (ABO No. 9702, 1974). Originally included in the 1960 O&M manual. FS Date: 5/30/2013

Pipe on LS toe with concrete standpipe visible.

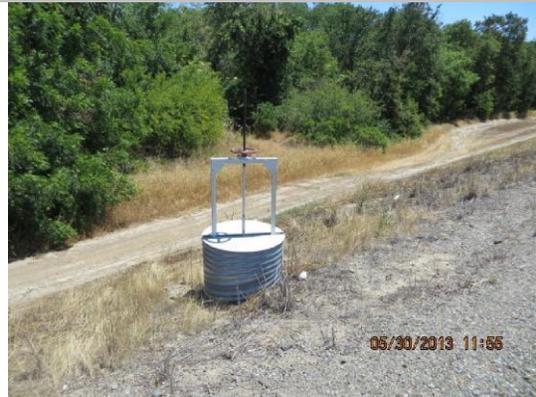
Photo 2 of 2 : UCIP\_SP\_2016\_14384\_23663.jpg

LM Start	<b>6.90</b>	Rating **	M	Issue No.	<b>414 (cont)</b>
LM End	<b>6.90</b>	Issue Type +	En	Location *	LS

Slide gate in 36-inch CMP standpipe on WS slope

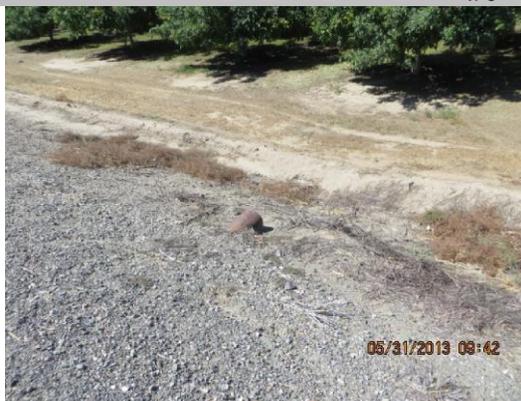
Photo 1 of 2 : UCIP\_SP\_2016\_43096\_23668.jpg

LM Start	<b>8.47</b>	Rating **	U	Issue No.	<b>417</b>
LM End	<b>8.47</b>	Issue Type +	En	Location *	WS
Category	Supplemental		GPS Latitude/Longitude		
			Start	End	
Item	DWR UCIP Field Study		39.582275 °	39.582275 °	
			-122.007449 °	-122.007449 °	
DWR ID					
Comment Code					
Inspector Comment					
FS_ID:43096 DS_ID:22918 EP_NO: 9563 Repair Type: Urgent Crossing Status: Found UCIP Comments: Pipe open on both ends and damaged on WS slope. Pipe should be abandoned properly if appropriate. FIELD_STRUCT_DESC: *Abandoned* 12-inch pipe through levee 5.0 feet below crown. Pipe open on both ends. One corrugated metal cutoff wall (ABO No. 9563, 1974). Originally included in the 1960 O&M manual. FS Date: 5/31/2013

Pipe on LS slope.

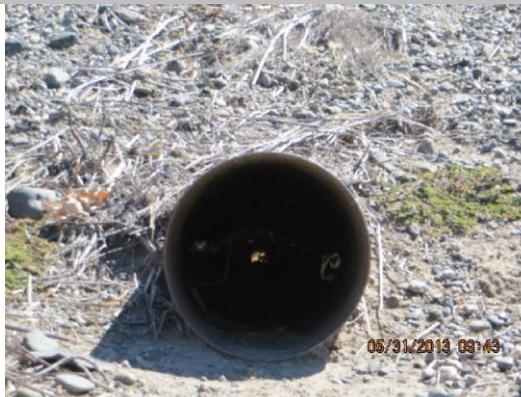
Photo 2 of 2 : UCIP\_SP\_2016\_43096\_23667.jpg

LM Start	<b>8.47</b>	Rating **	U	Issue No.	<b>417 (cont)</b>
LM End	<b>8.47</b>	Issue Type +	En	Location *	WS
Category	Supplemental			GPS Latitude/Longitude	
				Start	End
Item	DWR UCIP Field Study			39.582275 °	39.582275 °
				-122.007449 °	-122.007449 °
DWR ID					
Comment Code					
Inspector Comment					
FS_ID:43096 DS_ID:22918 EP_NO: 9563 Repair Type: Urgent Crossing Status: Found UCIP Comments: Pipe open on both ends and damaged on WS slope. Pipe should be abandoned properly if appropriate. FIELD_STRUCT_DESC: *Abandoned* 12-inch pipe through levee 5.0 feet below crown. Pipe open on both ends. One corrugated metal cutoff wall (ABO No. 9563, 1974). Originally included in the 1960 O&M manual. FS Date: 5/31/2013

Pipe on LS slope.

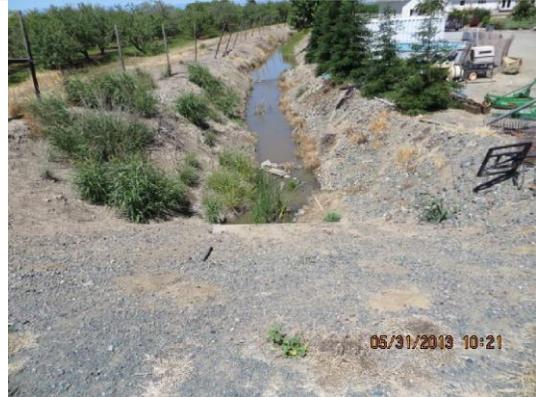
Photo 1 of 2 : UCIP\_SP\_2016\_14389\_23686.jpg

LM Start	<b>9.49</b>	Rating **	M	Issue No.	<b>415</b>
LM End	<b>9.49</b>	Issue Type +	En	Location *	LS
Category	Supplemental			GPS Latitude/Longitude	
				Start	End
Item	DWR UCIP Field Study			39.596012 °	39.596012 °
				-122.002638 °	-122.002638 °
DWR ID					
Comment Code					
Inspector Comment					
FS_ID:14389 DS_ID:22920 EP_NO: 9560 Repair Type: Non-Urgent Crossing Status: Found UCIP Comments: Heavy rust along springline of pipe. Pipe has slight deformation at centerline of levee, not noticable on crown. FIELD_STRUCT_DESC: 72-inch corrugated metal pipe through levee 15.0 feet below crown. Flap Gate on waterward end. Slide gate in 8' diameter corrugated metal pipe riser on waterward slope. Concrete headwalls on both ends. Two corrugated metal cutoff walls (ABO No. 9560, 1974). Originally included in the 1960 O&M manual. FS Date: 5/31/2013

Pipe and headwall at LS toe.

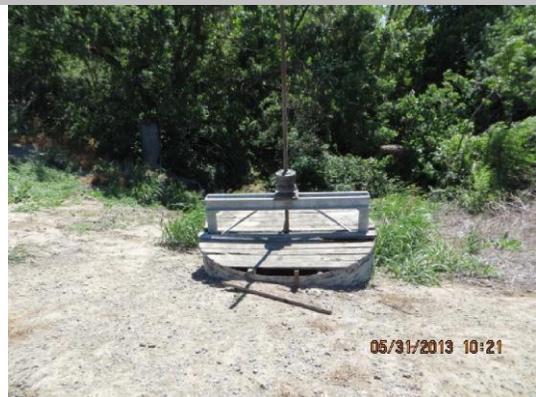
Photo 2 of 2 : UCIP\_SP\_2016\_14389\_23685.jpg

LM Start	<b>9.49</b>	Rating **	M	Issue No.	<b>415 (cont)</b>
LM End	<b>9.49</b>	Issue Type +	En	Location *	LS

Slide gate in 8-foot diameter CMP riser on WS slope.

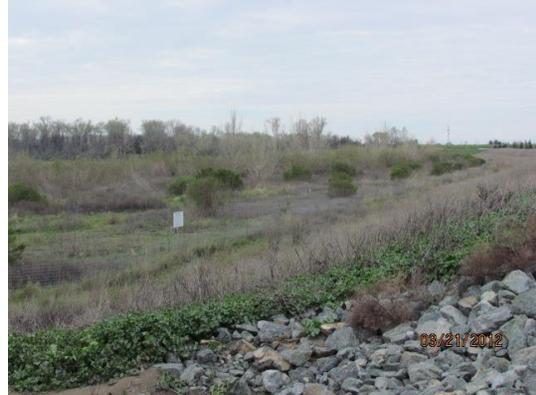
Photo 1 of 1 : SP\_2016\_LD0001G\_432\_8\_20160316\_00005.jpg

LM Start	<b>9.50</b>	Rating **	A/W	Issue No.	<b>8</b>
LM End	<b>10.40</b>	Issue Type +	Ma	Location *	WS
Category	Earthen Levee		GPS Latitude/Longitude		
			Start	End	
Item	Vegetation		39.596192°	39.607288°	
			-122.002573°	-121.994565°	
DWR ID	DWR_LD0001G_01_s_2012_8				
Comment Code					
V8 : Environmental Requirements.					
Inspector Comment

View of the Army Corps of Engineers mitigation site.

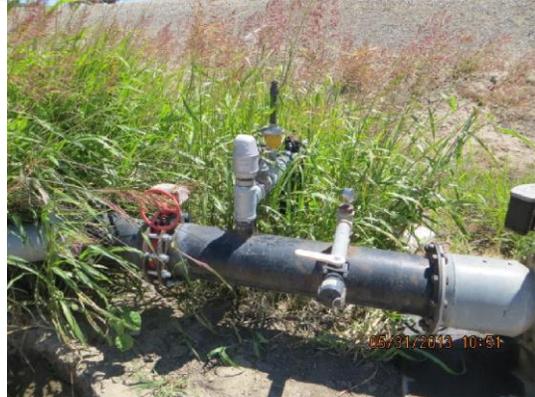
Photo 1 of 2 : UCIP\_SP\_2016\_16205\_27333.jpg

LM Start	<b>10.20</b>	Rating **	M	Issue No.	<b>397</b>
LM End	<b>10.20</b>	Issue Type +	En	Location *	LS
Category	Supplemental			GPS Latitude/Longitude	
				Start	End
Item	DWR UCIP Field Study			39.604696 °	39.604696 °
				-121.996265 °	-121.996265 °
DWR ID					
Comment Code					
Inspector Comment					
FS_ID:16205 DS_ID:23148 EP_NO: N/A Repair Type: Non-Urgent Crossing Status: Found UCIP Comments: Need to determine Permit No. for crossing. FIELD_STRUCT_DESC: 6-inch steel conduit through the levee 8-inches below the crown. Pump, vent, filter, and siphon breaker on LS toe. toe. 4-inch PVC irrigation line sleeved through conduit for vegetation rehabilitation on WS slope. FS Date: 5/31/2013

Pump with siphon breaker, vent and filter on LS toe.

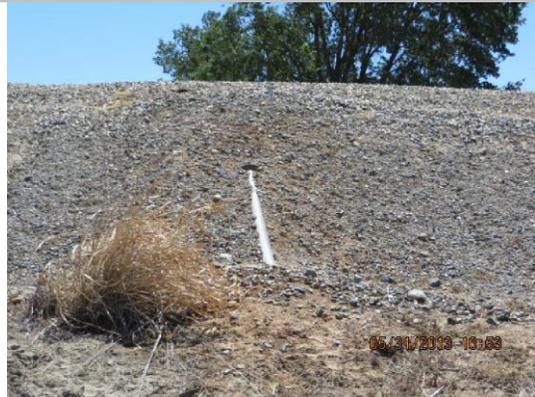
Photo 2 of 2 : UCIP\_SP\_2016\_16205\_27332.jpg

LM Start	<b>10.20</b>	Rating **	M	Issue No.	<b>397 (cont)</b>
LM End	<b>10.20</b>	Issue Type +	En	Location *	LS

Pipe on LS slope.

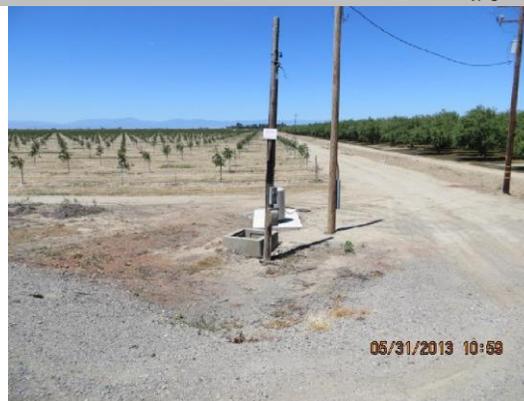
Photo 1 of 2 : UCIP\_SP\_2016\_14561\_23989.jpg

LM Start	<b>10.41</b>	Rating **	M	Issue No.	<b>400</b>
LM End	<b>10.41</b>	Issue Type +	En	Location *	LS
Category	Supplemental			GPS Latitude/Longitude	
				Start	End
Item	DWR UCIP Field Study			39.607474 °	39.607474 °
				-121.994410 °	-121.994410 °
DWR ID					
Comment Code					
Inspector Comment					
FS_ID:14561 DS_ID:22923 EP_NO: 9557 Repair Type: Non-Urgent Crossing Status: Found UCIP Comments: This pipe appears abandoned and should be done so properly. FIELD_STRUCT_DESC: 1 of 2: 10-inch pipe through levee 3.7 feet below crown. Pump on bank. Siphon breaker on waterward berm. One corrugated metal cutoff wall. Concrete distribution box at toe of landward slope (ABO No. 9557, 1974). Originally included in the 1960 O&M manual. FS Date: 5/31/2013

Concrete distribution box at LS toe.

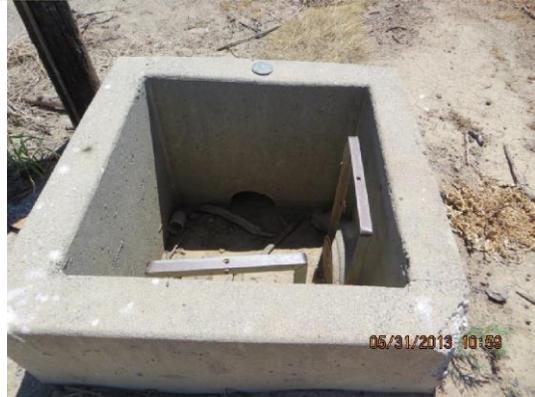
Photo 2 of 2 : UCIP\_SP\_2016\_14561\_23988.jpg

LM Start	<b>10.41</b>	Rating **	M	Issue No.	<b>400 (cont)</b>
LM End	<b>10.41</b>	Issue Type +	En	Location *	LS
Category	Supplemental			GPS Latitude/Longitude	
				Start	End
Item	DWR UCIP Field Study			39.607474 °	39.607474 °
				-121.994410 °	-121.994410 °
DWR ID					
Comment Code					
Inspector Comment					
FS_ID:14561 DS_ID:22923 EP_NO: 9557 Repair Type: Non-Urgent Crossing Status: Found UCIP Comments: This pipe appears abandoned and should be done so properly. FIELD_STRUCT_DESC: 1 of 2: 10-inch pipe through levee 3.7 feet below crown. Pump on bank. Siphon breaker on waterward berm. One corrugated metal cutoff wall. Concrete distribution box at toe of landward slope (ABO No. 9557, 1974). Originally included in the 1960 O&M manual. FS Date: 5/31/2013

Concrete distribution box at LS toe with outlet from pipe through levee.

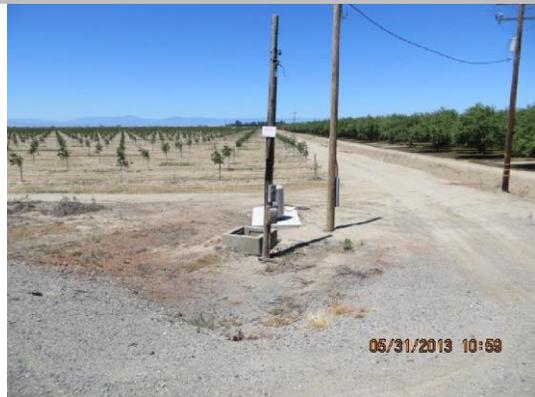
Photo 1 of 2 : UCIP\_SP\_2016\_14562\_23991.jpg

LM Start	<b>10.41</b>	Rating **	M	Issue No.	<b>401</b>
LM End	<b>10.41</b>	Issue Type +	En	Location *	LS
Category	Supplemental			GPS Latitude/Longitude	
				Start	End
Item	DWR UCIP Field Study			39.607474 °	39.607474 °
				-121.994410 °	-121.994410 °
DWR ID					
Comment Code					
Inspector Comment					
FS_ID:14562 DS_ID:22938 EP_NO: 9557 Repair Type: Non-Urgent Crossing Status: Found UCIP Comments: Abandoned and should be done so properly. FIELD_STRUCT_DESC: 2 of 2: 1.5 inch galvanized iron electrical conduit through the levee 3.0 feet below the crown (ABO No. 9557, 1974). Originally included in the 1960 O&M manual. FS Date: 5/31/2013

Source at JP next to concrete distribution box at LS toe.

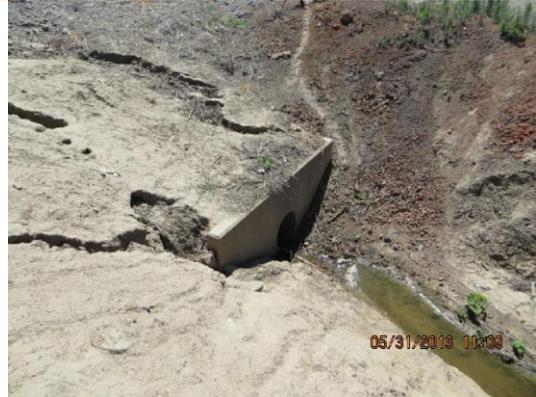
Photo 2 of 2 : UCIP\_SP\_2016\_41784\_24005.jpg

LM Start	<b>10.43</b>	Rating **	U	Issue No.	<b>418 (cont)</b>
LM End	<b>10.43</b>	Issue Type +	En	Location *	LS
Category	Supplemental			GPS Latitude/Longitude	
				Start	End
Item	DWR UCIP Field Study			39.607688 °	39.607688 °
				-121.994278 °	-121.994278 °
DWR ID					
Comment Code					
Inspector Comment					
FS_ID:41784 DS_ID:22924 EP_NO: 9556 Repair Type: Urgent Crossing Status: Found UCIP Comments: Flap gate dissabled in open position. Pipe rusted through at WS toe upstream of Flapgate. FIELD_STRUCT_DESC: 24-inch corrugated metal pipe through levee 15.0 feet below crown. Flap gate on waterward end. Slide gate in CMP riser on waterward slope. Two CM cutoff walls. Concrete headwall on landside and under outlet at WS toe (ABO No. 9556, 1974). Originally included in the 1960 O&M manual. FS Date: 5/31/2013

Concrete headwall and pipe at LS toe.

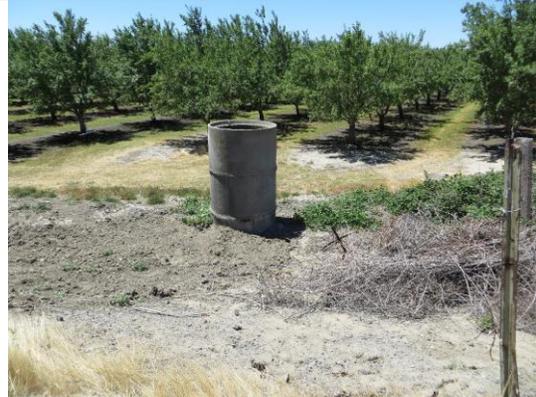
Photo 1 of 2 : UCIP\_SP\_2016\_14567\_24017.jpg

LM Start	<b>11.76</b>	Rating **	M	Issue No.	<b>409</b>
LM End	<b>11.76</b>	Issue Type +	En	Location *	LS
Category	Supplemental			GPS Latitude/Longitude	
				Start	End
Item	DWR UCIP Field Study			39.625463 °	39.625463 °
				-122.000658 °	-122.000658 °
DWR ID					
Comment Code					
Inspector Comment					
FS_ID:14567 DS_ID:22927 EP_NO: 9554 Repair Type: Non-Urgent Crossing Status: Found UCIP Comments: Erosion and sloughing on LS slope possibly due to rodent activity in area. FIELD_STRUCT_DESC: 24-inch corrugated metal pipe through levee 11.0 feet below crown. Slide gate in 36-inch corrugated metal pipe riser on waterward slope. 48-inch concrete standpipe on landward toe. Two corrugated metal cutoff walls (ABO No. 9554, 1974). Originally included in the 1960 O&M manual. FS Date: 5/31/2013

Concrete standpipe on LS toe.

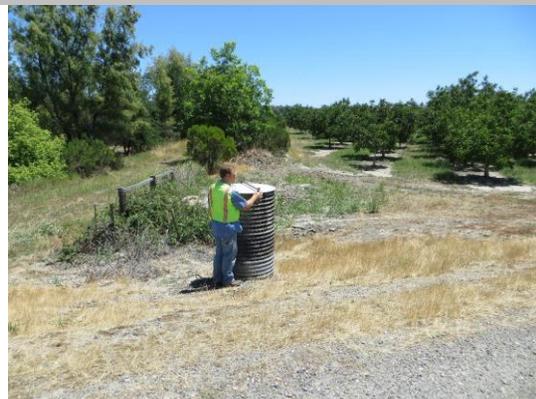
Photo 2 of 2 : UCIP\_SP\_2016\_14567\_24016.jpg

LM Start	<b>11.76</b>	Rating **	M	Issue No.	<b>409 (cont)</b>
LM End	<b>11.76</b>	Issue Type +	En	Location *	LS

Slide gate in CMP riser on WS toe.

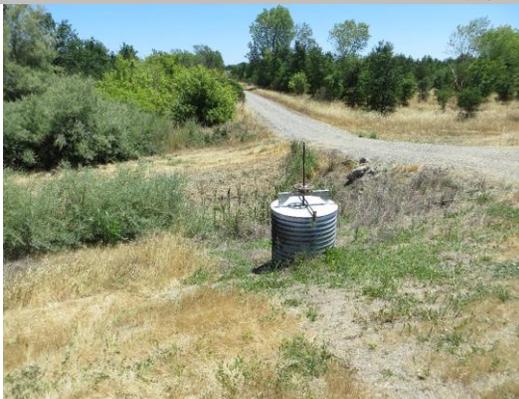
Photo 1 of 2 : UCIP\_SP\_2016\_14569\_24026.jpg

LM Start	<b>11.87</b>	Rating **	M	Issue No.	<b>410</b>
LM End	<b>11.87</b>	Issue Type +	En	Location *	LS
Category	Supplemental			GPS Latitude/Longitude	
				Start	End
Item	DWR UCIP Field Study			39.626918 °	39.626918 °
				-122.001421 °	-122.001421 °
DWR ID					
Comment Code					
Inspector Comment					
FS_ID:14569 DS_ID:22928 EP_NO: 9554 Repair Type: Non-Urgent Crossing Status: Found UCIP Comments: Flap gate heavily corroded. Good candidate for video inspection. Vegetation interfering with inlet. FIELD_STRUCT_DESC: 24-inch corrugated metal pipe through levee 7.0 feet below crown. Flap gate on waterward end. Slide gate in 36-inch corrugated metal pipe riser on waterward slope. Concrete headwalls on both ends. Two corrugated metal cutoff walls (ABO No. 9554, 1974). Originally included in the 1960 O&M manual. FS Date: 5/31/2013

Slidegate in 36-inch CMP riser on WS slope.

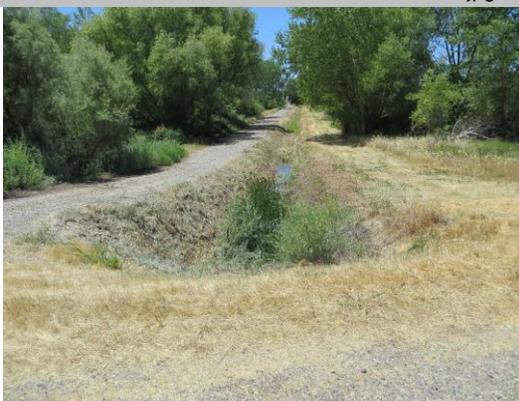
Photo 2 of 2 : UCIP\_SP\_2016\_14569\_24025.jpg

Drainage channel on LS toe.
