**Flood Control Project Maintenance  
Levee Inspections**

## Maintenance Issue Types Only, Levee Inspection Report By Mile - Spring 2017

### Levee District No. 0001 (Glenn County)

Waterway	Bank	Unit Miles	Inspection Start/End	Inspector
Unit No. 01 Sacramento River	Right	12.23	03/28/2017 03/28/2017	Bob Duffey

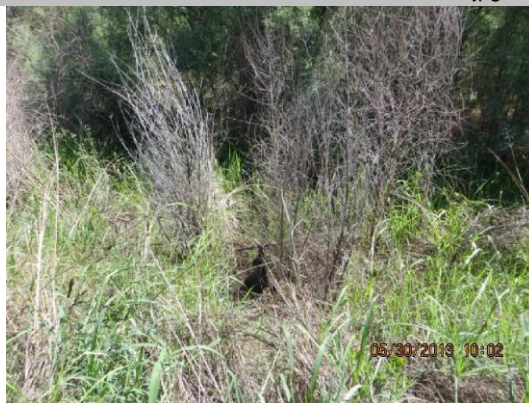
Photo 3 of 3 : UCIP\_SP\_2017\_14346\_23599.jpg

LM Start	5.51	Rating **	A/W	Issue No.	406 (cont)	
LM End	5.51	Issue Type +	Ma	Location *	LS	
Category	Supplemental			GPS Latitude/Longitude		
				Start		End
Item	DWR UCIP LMA Responsibility			39.540546 °		39.540546 °
				-121.998981 °		-121.998981 °
DWR ID						
Comment Code						
Inspector Comment						
FS_ID:14346 DS_ID:22907 EP_NO: 344 Repair Type: No Action Needed Crossing Status: Found UCIP Comments: FIELD_STRUCT_DESC: 12-inch pipe through levee 6.5 feet below crown. Gate valve at toe of waterward slope. Air vent and pump at LS toe. (ABO No. 9566, 1974) (App. No. 344-Giesbrecht) Originally included in the 1960 O&M manual. [Additional Reference(s): DWR Levee Log, 1992. USACE Sacramento O&M Manual Unit 140, May 1960, (HLM 5.61)]. FS Date: 5/30/2013

Gate valve on WS toe.

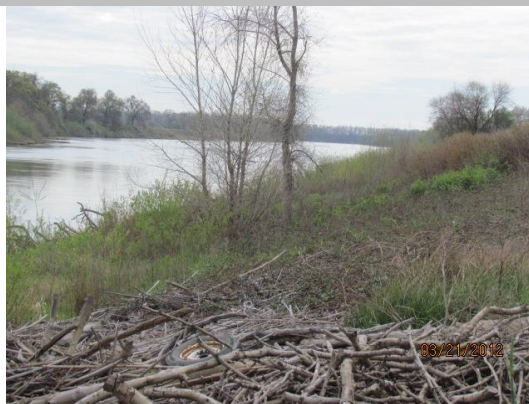
Photo 1 of 1 : SP\_2017\_LD0001G\_432\_10\_20170315\_00005.jpg

LM Start	6.38	Rating **	A/W	Issue No.	10
LM End	6.64	Issue Type +	Ma	Location *	WS
Category	Earthen Levee			GPS Latitude/Longitude	
				Start	End
Item	Vegetation			39.552691 °	39.556459 °
				-122.003063 °	-122.003831 °
DWR ID	DWR_LD0001G_01_s_2012_10				
Comment Code					
V8 : Environmental Requirements.					
Inspector Comment

View of the Army Corps of Engineers mitigation site.

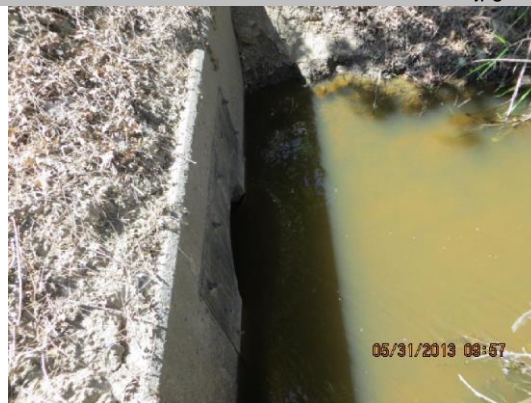
Photo 1 of 3 : UCIP\_SP\_2017\_16226\_27356.jpg

FS\_ID:16226  
DS\_ID:22919  
EP\_NO: 9562  
Repair Type: No Action Needed  
Crossing Status: Found  
UCIP Comments:  
FIELD\_STRUCT\_DESC: 24-inch drainage pipe with 3/8-inch wall epoxy coated steel sleeved through existing 30-inch corrugated metal pipe through the levee, 15 feet below the crown. Flap gate located on the waterside (WS) end. Slide gate in 44-inch corrugated metal pipe (CMP) riser on WS slope. Concrete headwalls on both ends. Two corrugated metal cutoff walls. (24-inch pipe was authorized under Permit No. 9562-1, 2011 - Levee District No. 1 - Glenn County; original 30-inch pipe was authorized under Automatic Board Order (ABO) issued as Permit No. 9562, 1974 - L. R. Henrich). [Additional Reference(s): DWR Levee Log, 1992. USACE Sacramento O&M Manual Unit 140, May 1960, (HLM 8.98)].  
FS Date: 5/31/2013

Concrete headwall on LS toe.

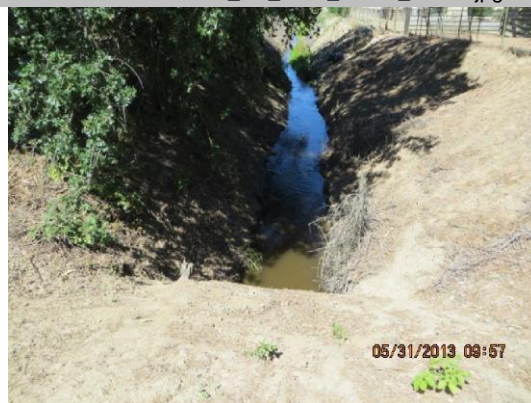
Photo 2 of 3 : UCIP\_SP\_2017\_16226\_27355.jpg

Drainage swale terminates at Concrete headwall for pipe.

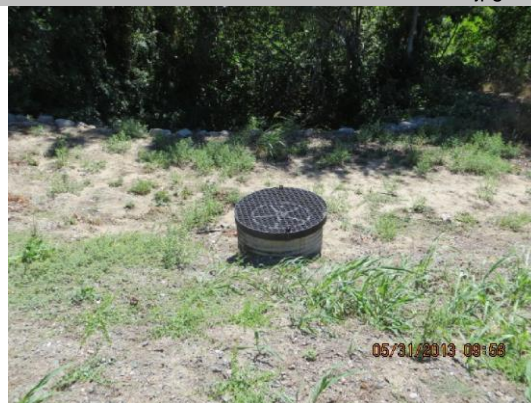
Photo 3 of 3 : UCIP\_SP\_2017\_16226\_27354.jpg

Comment Code					
Inspector Comment					
FS_ID:16226 DS_ID:22919 EP_NO: 9562 Repair Type: No Action Needed Crossing Status: Found UCIP Comments: FIELD_STRUCT_DESC: 24-inch drainage pipe with 3/8-inch wall epoxy coated steel sleeved through existing 30-inch corrugated metal pipe through the levee, 15 feet below the crown. Flap gate located on the waterside (WS) end. Slide gate in 44-inch corrugated metal pipe (CMP) riser on WS slope. Concrete headwalls on both ends. Two corrugated metal cutoff walls. (24-inch pipe was authorized under Permit No. 9562-1, 2011 - Levee District No. 1 - Glenn County; original 30-inch pipe was authorized under Automatic Board Order (ABO) issued as Permit No. 9562, 1974 - L. R. Henrich). [Additional Reference(s): DWR Levee Log, 1992. USACE Sacramento O&M Manual Unit 140, May 1960, (HLM 8.98)]. FS Date: 5/31/2013

Slide gate in 44-inch CMP riser on WS slope.

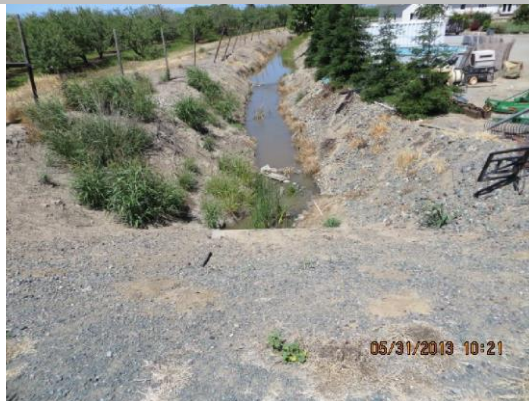
Photo 1 of 3 : UCIP\_SP\_2017\_14389\_23686.jpg

FS\_ID:14389  
DS\_ID:22920  
EP\_NO: 9560  
Repair Type: Non-Urgent  
Crossing Status: Found  
UCIP Comments: Heavy rust along springline of pipe. Pipe has slight deformation at centerline of levee, not noticable on crown.  
FIELD\_STRUCT\_DESC: 72-inch corrugated metal drainage pipe through levee, 15 feet below crown. Flap gate located on the waterside (WS) end. Slide gate in 8-inch corrugated metal pipe (CMP) riser on WS slope. Concrete headwalls on both ends. Two corrugated metal cutoff walls. (72-inch pipe authorized under Automatic Board Order (ABO) issued under Permit No. 9560, 1974 - J. & L. Friesen).  
[Additional Reference(s): DWR Levee Log, 1992. USACE Sacramento O&M Manual Unit 140, May 1960, (HLM 9.64)].  
FS Date: 5/31/2013

Pipe and headwall at LS toe.

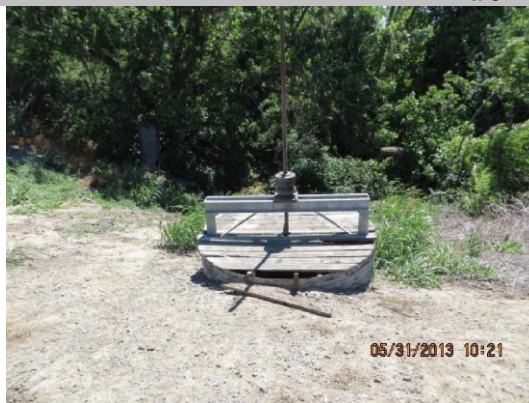
Photo 2 of 3 : UCIP\_SP\_2017\_14389\_23685.jpg

Slide gate in 8-foot diameter CMP riser on WS slope.

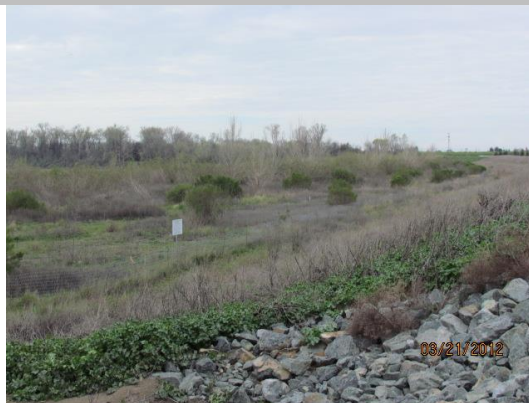
Photo 1 of 1 : SP\_2017\_LD0001G\_432\_8\_20170315\_00004.jpg

LM Start	9.50	Rating **	A/W	Issue No.	8
LM End	10.40	Issue Type +	Ma	Location *	WS
Category	Earthen Levee			GPS Latitude/Longitude	
				Start	End
Item	Vegetation			39.596192 °	39.607288 °
				-122.002573 °	-121.994565 °
DWR ID	DWR_LD0001G_01_s_2012_8				
Comment Code					
V8 : Environmental Requirements.					
Inspector Comment

View of the Army Corps of Engineers mitigation site.

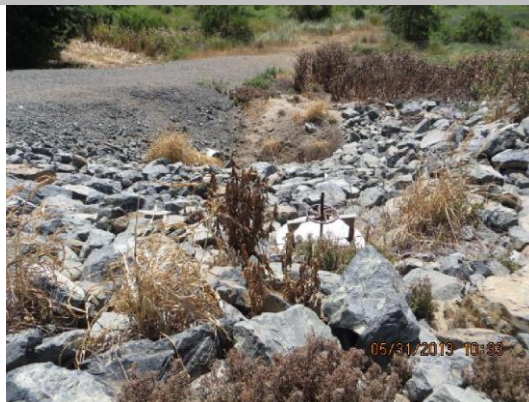
Photo 1 of 3 : UCIP\_SP\_2017\_14390\_23690.jpg

Comment Code					
Inspector Comment					
FS_ID:14390 DS_ID:22921 EP_NO: 9559 Repair Type: No Action Needed Crossing Status: Found UCIP Comments: FIELD_STRUCT_DESC: 24-inch corrugated metal drainage pipe through levee, 11 feet below crown. Flap gate is located on the waterside (WS) end. Slide gate in 36-inch corrugated metal pipe riser on WS slope. Concrete headwalls on both ends. Two corrugated metal cutoff walls. (24-inch pipe authorized under Automatic Board Order (ABO) issued as Permit No. 9559, 1974 - D. & M. Giesbrecht). [Additional Reference(s): DWR Levee Log, 1992. USACE Sacramento O&M Manual Unit 140, May 1960, (HLM 10.05)]. FS Date: 5/31/2013

Slide gate in 36-inch CMP riser on WS slope.

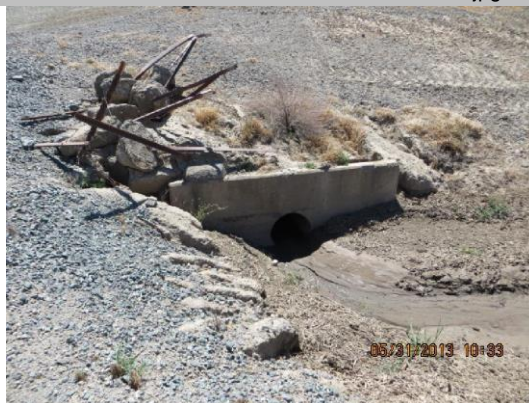
Photo 2 of 3 : UCIP\_SP\_2017\_14390\_23689.jpg

FS\_ID:14390  
DS\_ID:22921  
EP\_NO: 9559  
Repair Type: No Action Needed  
Crossing Status: Found  
UCIP Comments:  
FIELD\_STRUCT\_DESC: 24-inch corrugated metal drainage pipe through levee, 11 feet below crown. Flap gate is located on the waterside (WS) end. Slide gate in 36-inch corrugated metal pipe riser on WS slope. Concrete headwalls on both ends. Two corrugated metal cutoff walls. (24-inch pipe authorized under Automatic Board Order (ABO) issued as Permit No. 9559, 1974 - D. & M. Giesbrecht).  
[Additional Reference(s): DWR Levee Log, 1992. USACE Sacramento O&M Manual Unit 140, May 1960, (HLM 10.05)].  
FS Date: 5/31/2013

Concrete headwall and pipe at LS toe.

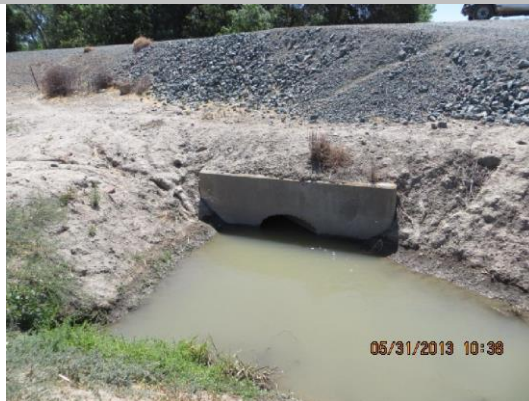
Photo 1 of 3 : UCIP\_SP\_2017\_14559\_23986.jpg

FS\_ID:14559  
DS\_ID:22922  
EP\_NO: 9558  
Repair Type: No Action Needed  
Crossing Status: Found  
UCIP Comments:  
FIELD\_STRUCT\_DESC: 24-inch corrugated metal drainage pipe through levee, 11 feet below crown. Flap gate is located on waterside (WS) end. Slide gate in 36-inch corrugated metal pipe riser on WS slope. Two corrugated metal cutoff walls. Concrete headwalls on both ends. (24-inch pipe authorized under Automatic Board Order (ABO) issued as Permit No. 9558, 1974 - D. Geis). Originally included in the 1960 O&M manual. [Additional Reference(s): DWR Levee Log, 1992. USACE Sacramento O&M Manual Unit 140, May 1960, (HLM 10.08)].  
FS Date: 5/31/2013 8:43:01 AM

Pipe and headwall on LS toe.

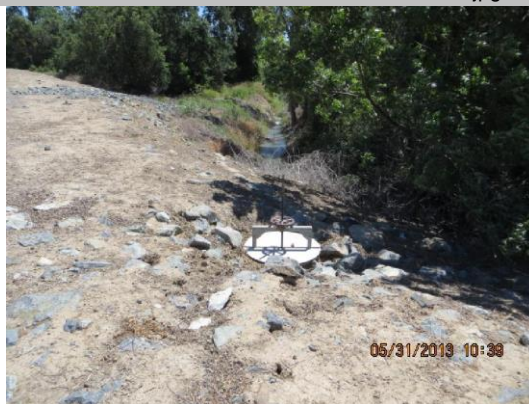
Photo 2 of 3 : UCIP\_SP\_2017\_14559\_23985.jpg

Slide gate in 36-inch CMP riser on WS slope.

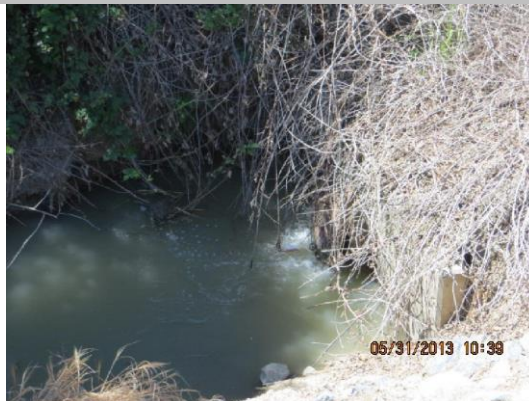
Photo 3 of 3 : UCIP\_SP\_2017\_14559\_23984.jpg

Comment Code					
Inspector Comment					
FS_ID:14559 DS_ID:22922 EP_NO: 9558 Repair Type: No Action Needed Crossing Status: Found UCIP Comments: FIELD_STRUCT_DESC: 24-inch corrugated metal drainage pipe through levee, 11 feet below crown. Flap gate is located on waterside (WS) end. Slide gate in 36-inch corrugated metal pipe riser on WS slope. Two corrugated metal cutoff walls. Concrete headwalls on both ends. (24-inch pipe authorized under Automatic Board Order (ABO) issued as Permit No. 9558, 1974 - D. Geis). Originally included in the 1960 O&M manual. [Additional Reference(s): DWR Levee Log, 1992. USACE Sacramento O&M Manual Unit 140, May 1960, (HLM 10.08)]. FS Date: 5/31/2013 8:43:01 AM

Pipe, flapgate, and headwall on WS toe.

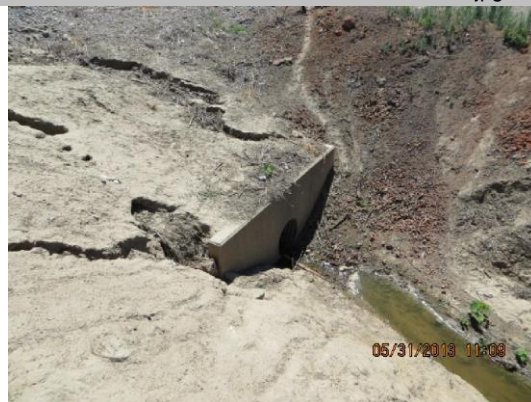
Photo 2 of 3 : UCIP\_SP\_2017\_51286\_24005.jpg

FS\_ID:51286  
DS\_ID:22924  
EP\_NO: 9556  
Repair Type: Urgent  
Crossing Status: Found  
UCIP Comments: 12/21/2016 same as last inspection flap gate disabled in open position. Surface erosion observed on LS slope. Recommend repair on WS flap gate to be able to close flap gate. (O. Magana - DWR UCIP)05/31/2013 Flap gate dissabled in open position. Pipe rusted through at WS toe upstream of Flapgate. (W. Wylie - DWR UCIP)  
FIELD\_STRUCT\_DESC: 24-inch corrugated metal drainage pipe through levee, 15 feet below crown. Flap gate is located on the waterside (WS) end. Slide gate is inside a corrugated metal pipe (CMP) riser located on the WS slope. Two CM cutoff walls. Concrete headwall is located on LS and under outlet at the WS toe. (24-inch pipe authorized under Automatic Board Order (ABO) issued as Permit No. 9556, 1974 - E. R & M. R. Cooper). [Additional Reference(s): DWR Levee Log, 1992. USACE Sacramento O&M Manual Unit 140, May 1960, (HLM 10.59)].

Concrete headwall and pipe at LS toe.

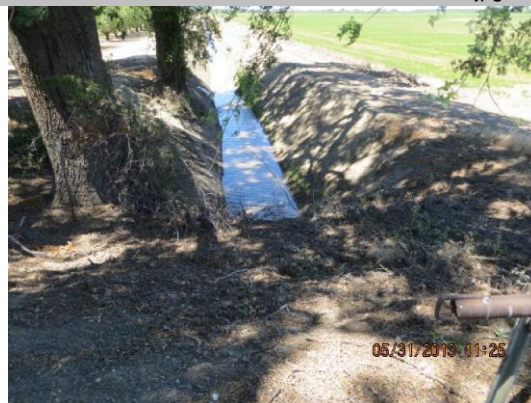
Photo 1 of 3 : UCIP\_SP\_2017\_14565\_24009.jpg

FS\_ID:14565  
DS\_ID:22925  
EP\_NO: 9556  
Repair Type: No Action Needed  
Crossing Status: Found  
UCIP Comments:  
FIELD\_STRUCT\_DESC: 48-inch corrugated metal drainage pipe of unknown material through levee, 11 feet below crown. Flap gate on waterside (Ws) end. Concrete headwall on both ends. Slide gate in 60-inch diameter corrugated metal pipe (CMP) riser on WS slope (48-inch authorized under Automatic Board Order (ABO) issued under Permit No. 9556, 1974 - E. R. & M. R. Cooper). [Additional Reference(s): DWR Levee Log, 1992. USACE Sacramento O&M Manual Unit 140, May 1960, (HLM 11.17)].  
FS Date: 5/31/2013

Drainage ditch on LS toe.

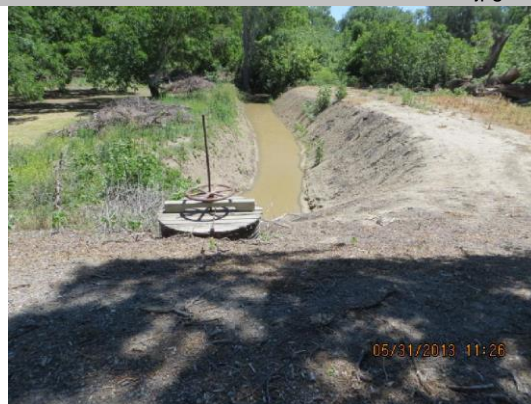
Photo 2 of 3 : UCIP\_SP\_2017\_14565\_24008.jpg

Slide gate in 60-inch CMP riser on WS slope.

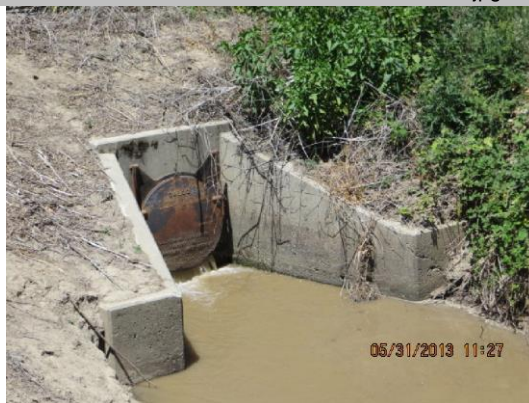
Photo 3 of 3 : UCIP\_SP\_2017\_14565\_24007.jpg

Item	DWR UCIP LMA Responsibility			39.616041 °	39.616041 °
				-121.994450 °	-121.994450 °
DWR ID					
Comment Code					
Inspector Comment					
FS_ID:14565 DS_ID:22925 EP_NO: 9556 Repair Type: No Action Needed Crossing Status: Found UCIP Comments: FIELD_STRUCT_DESC: 48-inch corrugated metal drainage pipe of unknown material through levee, 11 feet below crown. Flap gate on waterside (Ws) end. Concrete headwall on both ends. Slide gate in 60-inch diameter corrugated metal pipe (CMP) riser on WS slope (48-inch authorized under Automatic Board Order (ABO) issued under Permit No. 9556, 1974 - E. R. & M. R. Cooper). [Additional Reference(s): DWR Levee Log, 1992. USACE Sacramento O&M Manual Unit 140, May 1960, (HLM 11.17)]. FS Date: 5/31/2013

Flap gate and concrete headwall on WS toe.

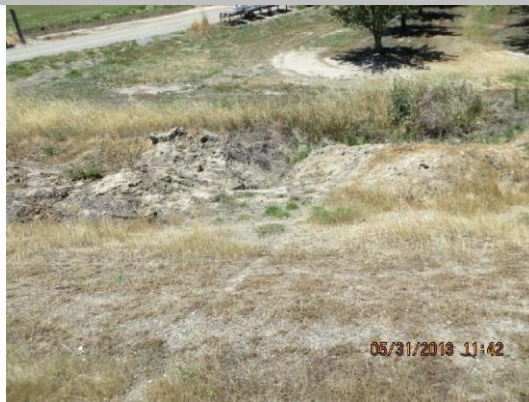
Photo 1 of 3 : UCIP\_SP\_2017\_14566\_24013.jpg

LM Start	11.64	Rating **	A/W	Issue No.	422
LM End	11.64	Issue Type +	Ma	Location *	WS
Category	Supplemental			GPS Latitude/Longitude	
				Start	End
Item	DWR UCIP LMA Responsibility			39.623874 °	39.623874 °
				-121.999813 °	-121.999813 °
DWR ID					
Comment Code					
Inspector Comment					
FS_ID:14566 DS_ID:22926 EP_NO: 9555 Repair Type: No Action Needed Crossing Status: Found UCIP Comments: FIELD_STRUCT_DESC: 24-inch corrugated metal drainage pipe through levee, 8.5 feet below crown. Flap gate on waterside (WS) slope. U-shaped concrete headwalls on both ends. Two corrugated metal cutoff walls. (24-inch pipe authorized under Automatic Board Order (ABO) issued as Permit No. 9555, 1974 - F. S. Reager). [Additional Reference(s): DWR Levee Log, 1992. USACE Sacramento O&M Manual Unit 140, May 1960, (HLM 11.81)]. FS Date: 5/31/2013

Concrete headwall on LS toe.

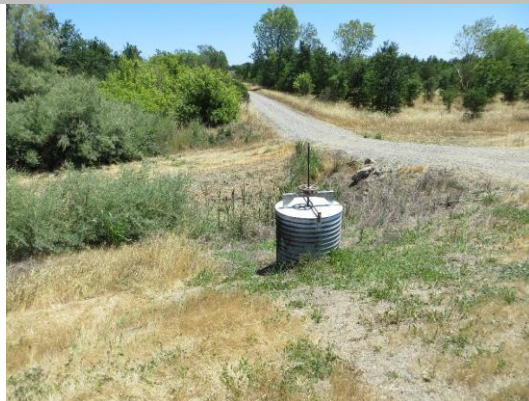
Photo 1 of 3 : UCIP\_SP\_2017\_14569\_24026.jpg

FS\_ID:14569  
DS\_ID:22928  
EP\_NO: 9554  
Repair Type: Non-Urgent  
Crossing Status: Found  
UCIP Comments: Flap gate heavily corroded. Good candidate for video inspection. Vegetation interfering with inlet.  
FIELD\_STRUCT\_DESC: 24-inch corrugated metal drainage pipe through levee, 7 feet below crown. Flap gate on waterside (WS) end. Slide gate in 36-inch corrugated metal pipe riser on WS slope. Concrete headwalls on both ends. Two corrugated metal cutoff walls. (24-inch pipe authorized under Automatic Board Order (ABO) issued as Permit No. 9554, 1974 - T. H. Reed). [Additional Reference(s): DWR Levee Log, 1992. USACE Sacramento O&M Manual Unit 140, May 1960, (HLM 12.04)].  
FS Date: 5/31/2013

Slidegate in 36-inch CMP riser on WS slope.

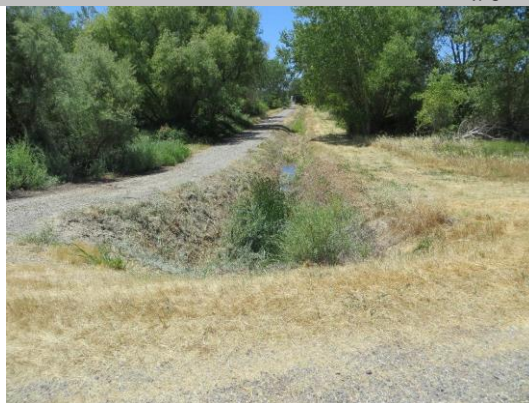
Photo 2 of 3 : UCIP\_SP\_2017\_14569\_24025.jpg

Drainage channel on LS toe.

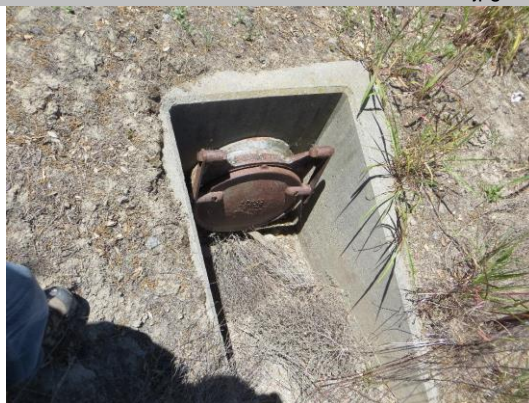
Photo 1 of 3 : UCIP\_SP\_2017\_14570\_24029.jpg

LM Start	12.13	Rating **	A/W	Issue No.	425
LM End	12.13	Issue Type +	Ma	Location *	LS
Category	Supplemental			GPS Latitude/Longitude	
				Start	End
Item	DWR UCIP LMA Responsibility			39.630451 °	39.630451 °
				-122.002737 °	-122.002737 °
DWR ID					
Comment Code					
Inspector Comment					
FS_ID:14570 DS_ID:22929 EP_NO: 9554 Repair Type: No Action Needed Crossing Status: Found UCIP Comments: FIELD_STRUCT_DESC: 24-inch corrugated metal drainage pipe through levee, 7 feet below crown. Flap gate on waterside (WS) end. Slide gate in 36-inch corrugated metal pipe (CMP) riser on WS slope. U-shaped concrete headwalls on both ends. (24-inch pipe authorized under Automatic Board Order (ABO) issued under Permit No. 9554, 1974 - T. H. Reed). [Additional Reference(s): DWR Levee Log, 1992. USACE Sacramento O&M Manual Unit 140, May 1960, (HLM 12.29)]. FS Date: 5/31/2013

Flapgate and U-shaped concrete headwall on WS toe.

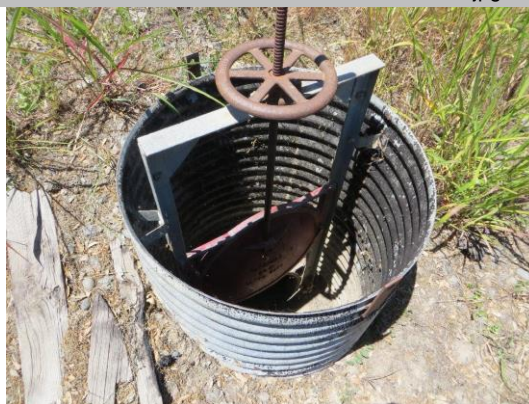
Photo 2 of 3 : UCIP\_SP\_2017\_14570\_24028.jpg

Slidegate in 36-inch CMP riser on WS slope.

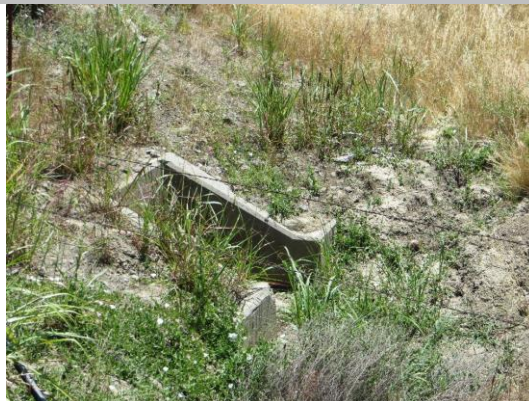
Photo 3 of 3 : UCIP\_SP\_2017\_14570\_24027.jpg

LM Start	12.13	Rating **	A/W	Issue No.	425 (cont)
LM End	12.13	Issue Type +	Ma	Location *	LS
Category	Supplemental			GPS Latitude/Longitude	
				Start	End
Item	DWR UCIP LMA Responsibility			39.630451 °	39.630451 °
				-122.002737 °	-122.002737 °
DWR ID					
Comment Code					
Inspector Comment					
FS_ID:14570 DS_ID:22929 EP_NO: 9554 Repair Type: No Action Needed Crossing Status: Found UCIP Comments: FIELD_STRUCT_DESC: 24-inch corrugated metal drainage pipe through levee, 7 feet below crown. Flap gate on waterside (WS) end. Slide gate in 36-inch corrugated metal pipe (CMP) riser on WS slope. U-shaped concrete headwalls on both ends. (24-inch pipe authorized under Automatic Board Order (ABO) issued under Permit No. 9554, 1974 - T. H. Reed). [Additional Reference(s): DWR Levee Log, 1992. USACE Sacramento O&M Manual Unit 140, May 1960, (HLM 12.29)]. FS Date: 5/31/2013

U-shaped concrete headwall on LS toe.
