## Flood Control Project Maintenance Levee Inspections

### Fall 2022 Levee Maintenance Deficiency Summary Report

#### Sacramento River Basin

**Levee District No. 0002 (Glenn County)**

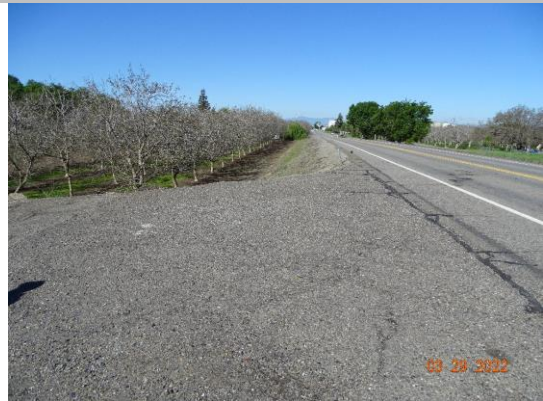
Photo 3 of 3 : UCIP\_FA\_2022\_75855\_113914.jpg

LM Start	<b>3.37</b>	Rating **	M	Issue No.	<b>56 (cont)</b>
LM End	<b>3.37</b>	Issue Type +	En	Location *

Land-Side: View of levee slope looking from crown

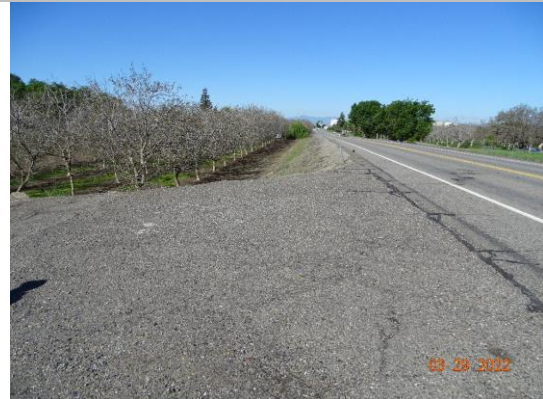
Photo 3 of 3 : UCIP\_FA\_2022\_75856\_113916.jpg

LM Start	3.37	Rating **	M	Issue No.	57 (cont)
LM End	3.37	Issue Type +	En	Location *	
Category	Supplemental			GPS Latitude/Longitude	
				Start	End
Item	DWR UCIP Field Study			39.456720 °	39.456720 °
				-122.009630 °	-122.009630 °
DWR ID	21175

Land-Side: View of levee slope looking from crown
