**Flood Control Project Maintenance
Levee Inspections**

Fall 2015 Levee Maintenance Deficiency Summary Report

Sacramento River Basin

Levee District No. 0003 (Glenn County)

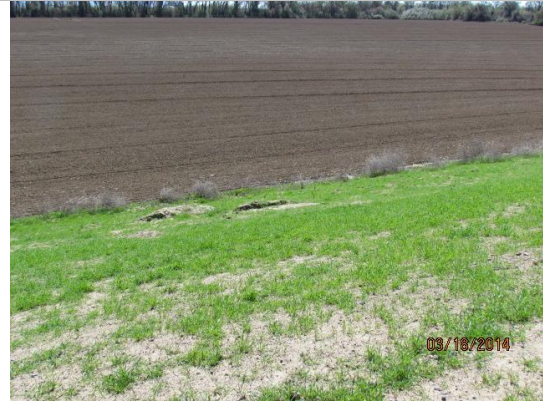
Photo 1 of 1 : FA_2015_LD0003_27_55_20150910_00025.jpg

LM Start	0.69	Rating **	M	Issue No.	55
LM End	0.69	Issue Type +	Ma	Location *	WS
Category	Earthen Levee			GPS Latitude/Longitude	
				Start	End
Item	Animal Control			39.388716 °	39.388716 °
				-121.997774 °	-121.997774 °
DWR ID	DWR_LD0003_01_s _ 2014_55				
Action/Comments					
Exterminate rodents and backfill and compact or grout burrows.

View of the rodent activity along the w/s slope.

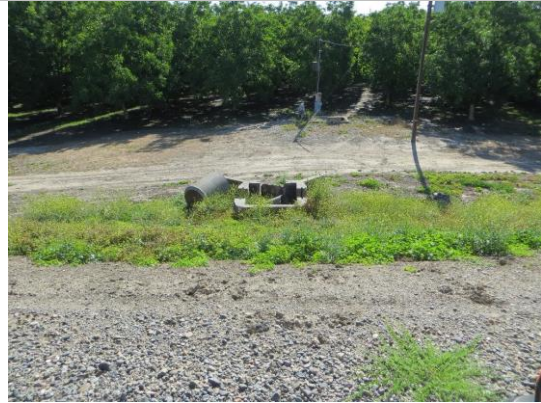
Photo 1 of 3 : UCIP_FA_2015_0967.jpg

Inspector Comments: FS_ID:14573
 DS_ID:18830
 EP_NO: 9930
 FS_HLM: 1.496
 Repair Type: Non-Urgent
 Crossing Status: Found
 UCIP Comments: Steel plate welded over WS end of pipe. Slide gate at WS toe missing. Appears abandoned.
 FIELD_STRUCT_DESC: 24-inch corrugated metal pipe through the levee 14.5 feet below the crown slide gate on waterward end, 7'X9' concrete diversion box at landward toe (ABO No. 9930-Steel Ranch). Originally included in O+M manual (1960).
 FS Date: 06/04/2013

Distribution box on LS toe.

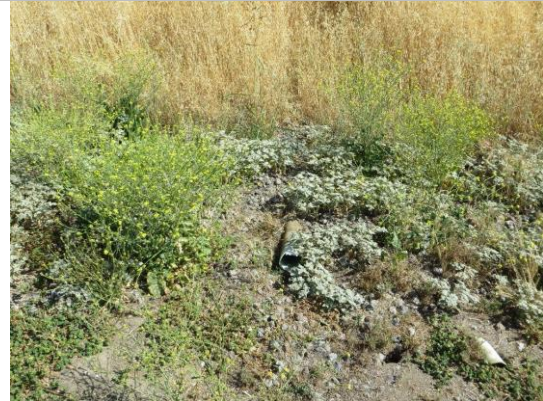
Photo 1 of 3 : UCIP_FA_2015_0654.jpg

LM Start	2.10	Rating **	M	Issue No.	86
LM End	2.10	Issue Type +	En	Location *	WS
Category	Supplemental			GPS Latitude/Longitude	
				Start	End
Item	DWR UCIP Field Study			39.406353 °	39.406353
				-122.000674 °	-122.000674
DWR ID					
Action/Comments					
Inspector Comments: FS_ID:15144 DS_ID:23151 EP_NO: N/A FS_HLM: 2.134 Repair Type: Non-Urgent Crossing Status: Found

3-inch drain on WS toe (purpose unclear).

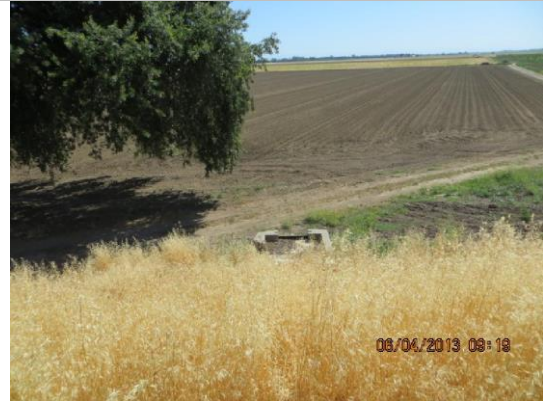
Photo 1 of 2 : UCIP_FA_2015_1005.jpg

Distribution box on LS toe.

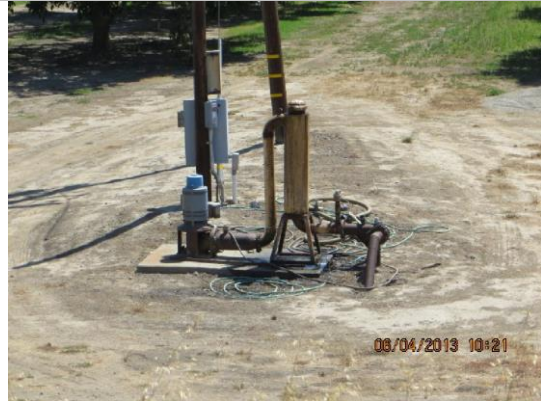
Photo 1 of 3 : UCIP_FA_2015_0657.jpg

LM Start	4.96	Rating **	M	Issue No.	89
LM End	4.96	Issue Type +	En	Location *	LS
Category	Supplemental			GPS Latitude/Longitude	
				Start	End
Item	DWR UCIP Field Study			39.439791 °	39.439791 °
				-121.989825 °	-121.989825 °
DWR ID					
Action/Comments					
Inspector Comments: FS_ID:15163 DS_ID:23152 EP_NO: N/A FS_HLM: 5.051 Repair Type: Non-Urgent Crossing Status: Found UCIP Comments: No permit identified for this crossing. FIELD_STRUCT_DESC: 4-inch steel irrigation pipe through the levee at an unknown depth. Pump, vent, and shutoff valve off LS toe. Possible shutoff valve off WS toe. FS Date: 06/04/2013

Pumping plant off LS toe.

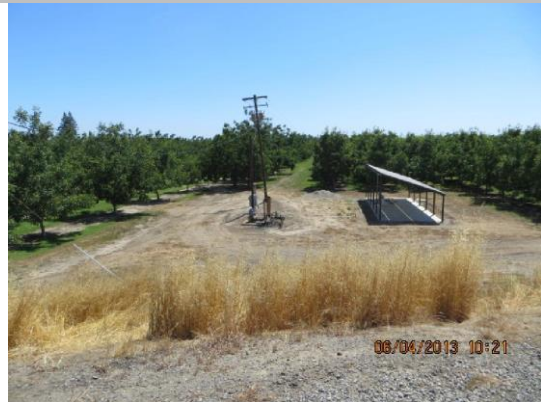
Photo 2 of 3 : UCIP_FA_2015_0658.jpg

Pumping plant off LS toe.

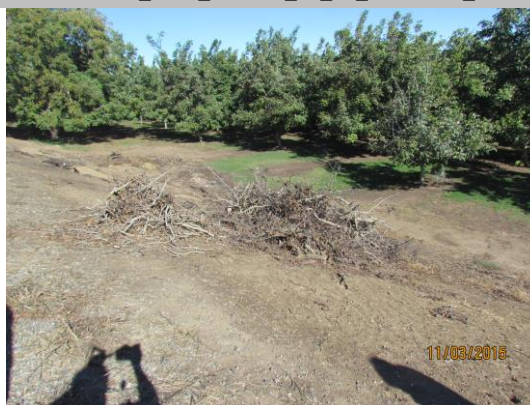
Photo 1 of 1 : FA_2015_LD0003_27_69_20151118_00062.jpg

LM Start	5.06	Rating **	M	Issue No.	69
LM End	5.06	Issue Type +	Ma	Location *	LS
Category	Earthen Levee			GPS Latitude/Longitude	
				Start	End
Item	Encroachments			39.441057 °	39.441057 °
				-121.990458 °	-121.990458 °
DWR ID	DWR_LD0003_01_f_2015_69				
Action/Comments					
Prunings					
Inspector Comments: Remove prunings from LS slope.

View of the prunings along the landside slope.

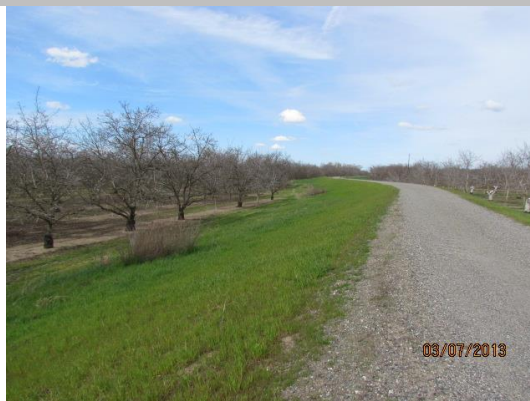
Photo 1 of 2 : FA_2015_LD0003_27_21_20150910_00011.jpg

LM Start	5.06	Rating **	U	Issue No.	21
LM End	5.25	Issue Type +	Ma	Location *	LS
Category	Earthen Levee			GPS Latitude/Longitude	
				Start	End
Item	Animal Control			39.441128 °	39.443793 °
				-121.990475 °	-121.991297 °
DWR ID	DWR_LD0003_01_f_2015_21				
Action/Comments					
No rodents visible, but rodent burrows visible; need to backfill and compact or grout burrows. Inspector Comments: Remove the rodent holes along the landside slope.

View of no rodent activity.

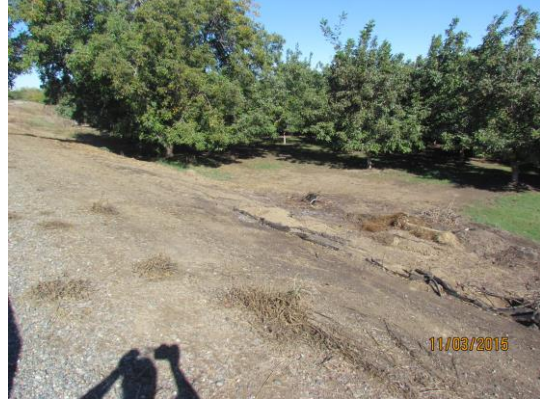
Photo 2 of 2 : FA_2015_LD0003_27_21_20151118_00063.jpg

LM Start	5.06	Rating **	U	Issue No.	21 (cont)	
LM End	5.25	Issue Type +	Ma	Location *	LS	
Category	Earthen Levee			GPS Latitude/Longitude		
				Start		End
Item	Animal Control			39.441128 °		39.443793 °
				-121.990475 °		-121.991297 °
DWR ID	DWR_LD0003_01_f_2015_21					
Action/Comments						
No rodents visible, but rodent burrows visible; need to backfill and compact or grout burrows. Inspector Comments: Remove the rodent holes along the landside slope.

View of the rodent holes along the landside slope.

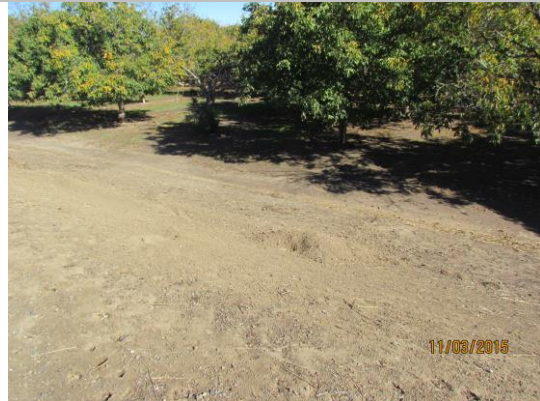
Photo 1 of 1 : FA_2015_LD0003_27_70_20151118_00064.jpg

LM Start	5.39	Rating **	U	Issue No.	70
LM End	5.39	Issue Type +	Ma	Location *	LS
Category	Earthen Levee			GPS Latitude/Longitude	
				Start	End
Item	Animal Control			39.445808 °	39.445808 °
				-121.991552 °	-121.991552 °
DWR ID	DWR_LD0003_01_f_2015_70				
Action/Comments					
No rodents visible, but rodent burrows visible; need to backfill and compact or grout burrows. Inspector Comments: Remove the rodent holes along the landside slope.

View of the rodent holes along the landside slope.

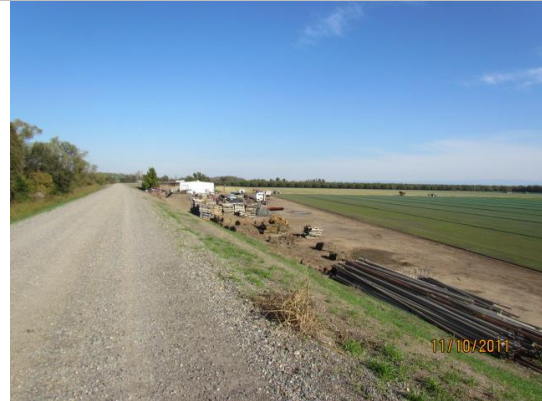
Photo 1 of 1 : FA_2015_LD0003_27_25_20150910_00012.jpg

LM Start	5.77	Rating **	M	Issue No.	25
LM End	5.88	Issue Type +	Ma	Location *	LS
Category	Earthen Levee			GPS Latitude/Longitude	
				Start	End
Item	Encroachments			39.451293 °	39.452872 °
				-121.992370 °	-121.992897 °
DWR ID	DWR_LD0003_01_s_2012_25				
Action/Comments					
Abandoned vehicles

View of the equipment along the L/S toe.

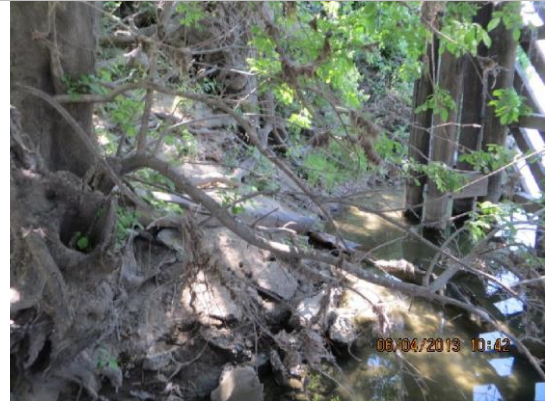
Photo 1 of 3 : UCIP_FA_2015_1088.jpg

14-inch Pipe debris on WS toe.

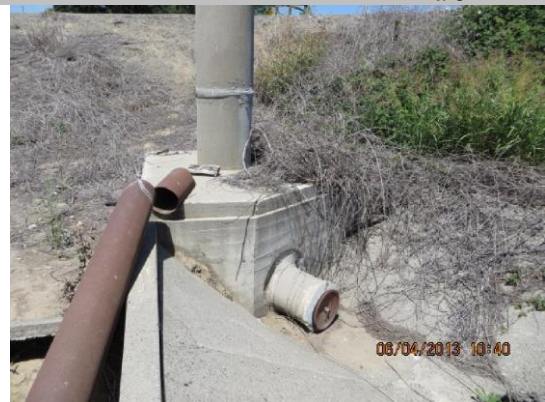
Photo 2 of 3 : UCIP_FA_2015_1089.jpg

Concrete standpipe and channel on LS toe.

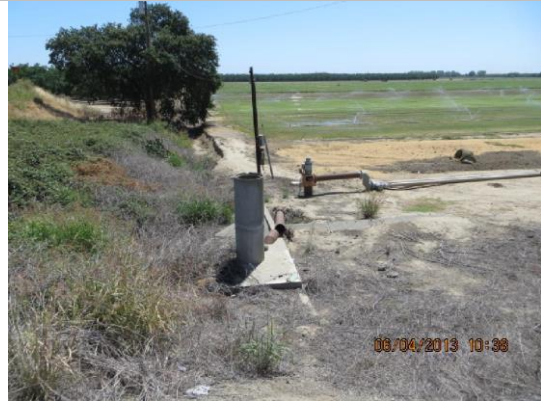
Photo 3 of 3 : UCIP_FA_2015_1090.jpg

LM Start	6.19	Rating **	M	Issue No.	90 (cont)
LM End	6.19	Issue Type +	En	Location *	LS
Category	Supplemental			GPS Latitude/Longitude	
				Start	End
Item	DWR UCIP Field Study			39.457170 °	39.457170 °
				-121.993836 °	-121.993836 °
DWR ID					
Action/Comments					
Inspector Comments: FS_ID:14643					
DS_ID:18846					
EP_NO: N/A					
FS_HLM: 6.299					
Repair Type: Non-Urgent					
Crossing Status: Found

Concrete standpipe on LS toe.

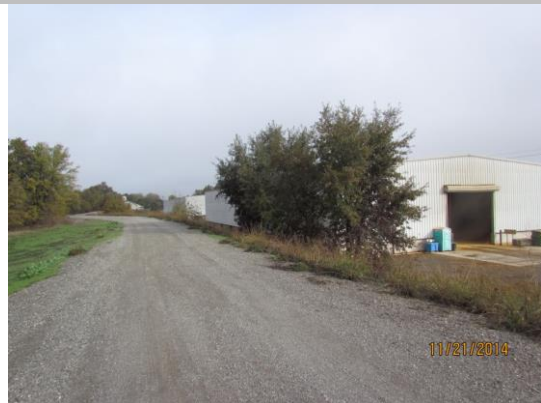
Photo 1 of 1 : FA_2015_LD0003_27_7_20150910_00005.jpg

LM Start	6.24	Rating **	M	Issue No.	7
LM End	6.38	Issue Type +	Ma	Location *	LS
Category	Earthen Levee			GPS Latitude/Longitude	
				Start	End
Item	Trim / Thin Trees			39.457968 °	39.459955 °
				-121.993712 °	-121.993512 °
DWR ID	DWR_LD0003_01_s_2012_7				
Action/Comments					
Trim trees to at least five feet above ground level.

Trim the trees 5 feet for better visibility.

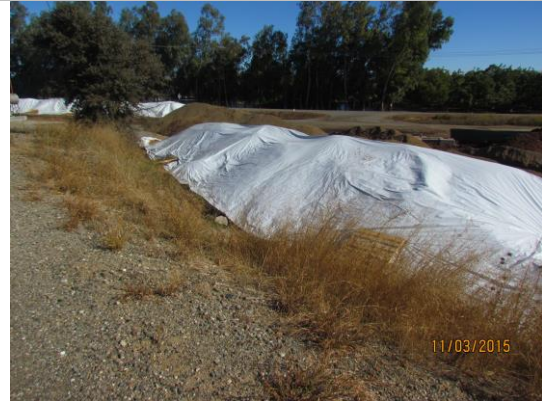
Photo 1 of 1 : FA_2015_LD0003_27_73_20151118_00067.jpg

LM Start	6.38	Rating **	U	Issue No.	73
LM End	6.38	Issue Type +	En	Location *	LS
Category	Earthen Levee			GPS Latitude/Longitude	
				Start	End
Item	Encroachments			39.459955 °	39.459955 °
				-121.993512 °	-121.993512 °
DWR ID	DWR_LD0003_01_f_2015_73				
Action/Comments					
Material					
Inspector Comments: Feed product pile at toe of levee should be moved at least 10-feet off LS toe.

View of the feed product stored along the landside toe.

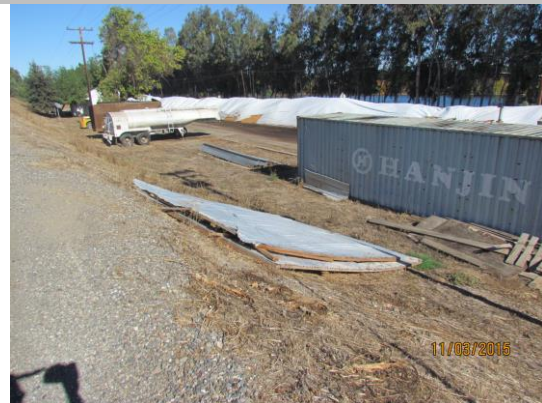
Photo 1 of 1 : FA_2015_LD0003_27_74_20151118_00068.jpg

LM Start	6.43	Rating **	U	Issue No.	74
LM End	6.43	Issue Type +	En	Location *	LS
Category	Earthen Levee			GPS Latitude/Longitude	
				Start	End
Item	Encroachments			39.460563 °	39.460563
				-121.993195 °	-121.993195
DWR ID	DWR_LD0003_01_f_2015_74				
Action/Comments					
Debris					
Inspector Comments: Remove the metal roof from the landside slope.

View of the metal roof laying on the landside slope.

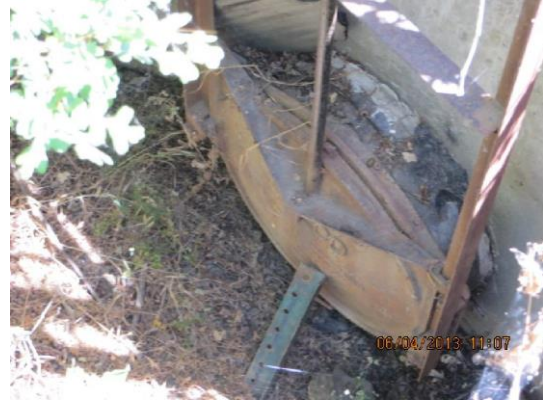
Photo 1 of 3 : UCIP_FA_2015_1091.jpg

Slidegate inside concrete box on WS slope.

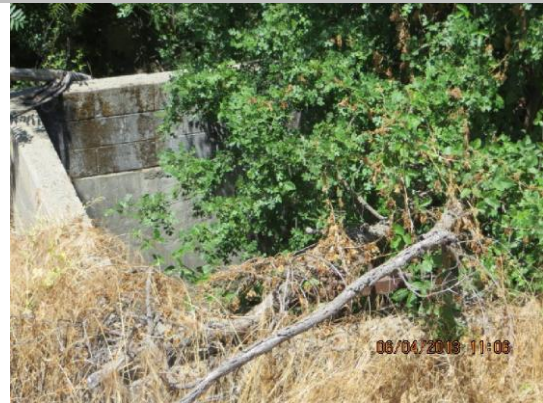
Photo 2 of 3 : UCIP_FA_2015_1092.jpg

7'X12' Concrete box with flap gate and slide gate on WS slope.

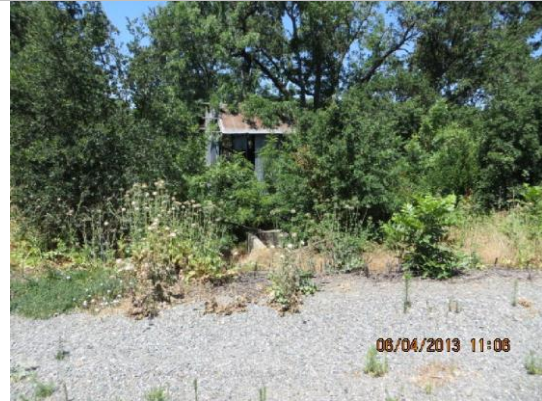
Photo 3 of 3 : UCIP_FA_2015_1093.jpg

LM Start	6.54	Rating **	M	Issue No.	91 (cont)
LM End	6.54	Issue Type +	En	Location *	LS
Category	Supplemental			GPS Latitude/Longitude	
				Start	End
Item	DWR UCIP Field Study			39.462146 °	39.462146 °
				-121.992832 °	-121.992832 °
DWR ID					
Action/Comments					
Inspector Comments: FS_ID:14664					
DS_ID:18834					
EP_NO: 9906					
FS_HLM: 6.662					
Repair Type: Non-Urgent					
Crossing Status: Found

Pumphouse and 7'X12' concrete box on WS slope.

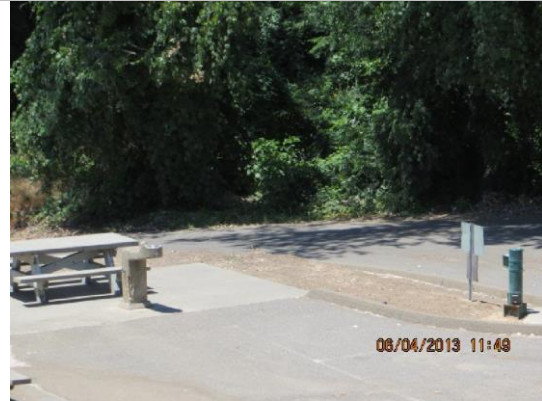
Photo 1 of 3 : UCIP_FA_2015_0873.jpg

Possible reason for water service (water fountain).

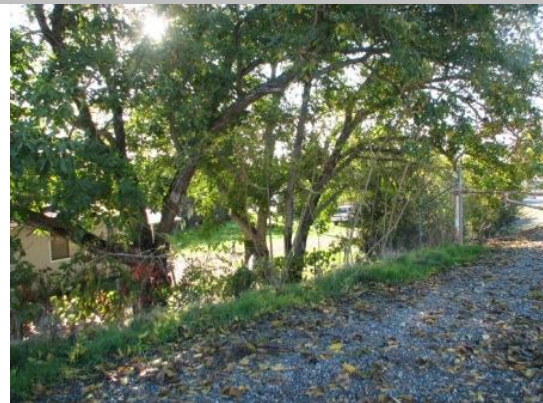
Photo 1 of 1 : FA_2015_LD0003_27_35_20150910_00018.jpg

LM Start	6.75	Rating **	M	Issue No.	35
LM End	6.75	Issue Type +	Ma	Location *	LS
Category	Earthen Levee			GPS Latitude/Longitude	
				Start	End
Item	Trim / Thin Trees			39.465013 °	39.465013 °
				-121.991455 °	-121.991455 °
DWR ID	DWR_LD0003_01_s_2012_35				
Action/Comments					
Trim trees to at least five feet above ground level.

View of the trees that are hanging over the landside slope of the levee.

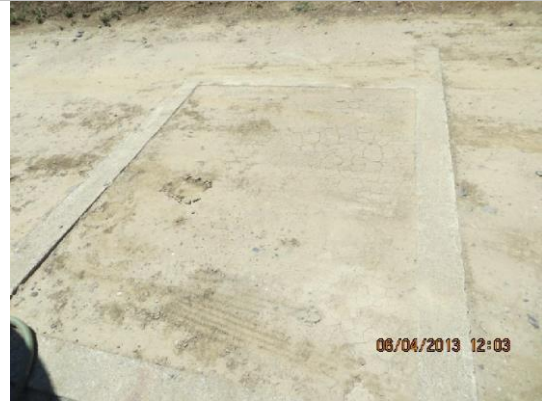
Photo 1 of 2 : UCIP_FA_2015_1094.jpg

Soil filled concrete distribution box on LS toe.

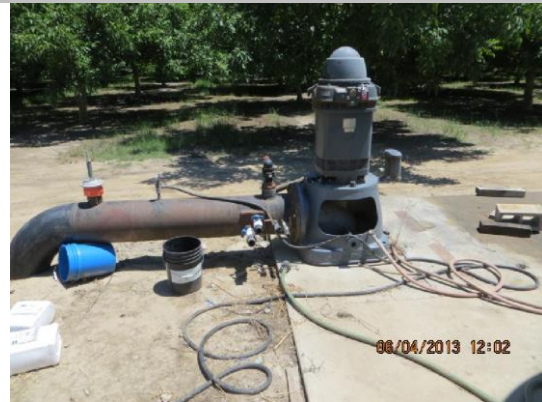
Photo 2 of 2 : UCIP_FA_2015_1095.jpg

Pump located on LS toe next to concrete distribution box.

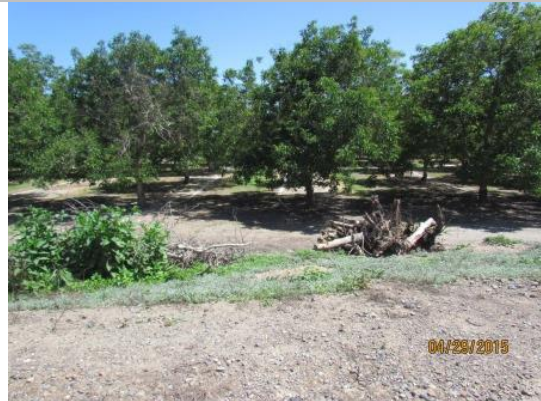
Photo 1 of 1 : FA_2015_LD0003_27_37_20150910_00019.jpg

LM Start	7.36	Rating **	M	Issue No.	37
LM End	7.36	Issue Type +	En	Location *	LS
Category	Earthen Levee			GPS Latitude/Longitude	
				Start	End
Item	Encroachments			39.473793 °	39.473793 °
				-121.991208 °	-121.991208 °
DWR ID	DWR_LD0003_01_s_2012_37				
Action/Comments					
Prunings					
Inspector Comments: Remove the prunings from the landside slope.

View of the prunings along the landside slope.

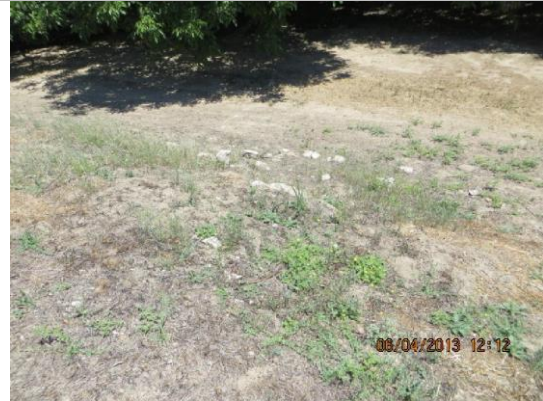
Photo 1 of 3 : UCIP_FA_2015_1096.jpg

LM Start	7.60	Rating **	M	Issue No.	94
LM End	7.60	Issue Type +	En	Location *	LS
Category	Supplemental			GPS Latitude/Longitude	
				Start	End
Item	DWR UCIP Field Study			39.477223 °	39.477223 °
				-121.991021 °	-121.991021 °
DWR ID					
Action/Comments					
Inspector Comments: FS_ID:14687					
DS_ID:18837					
EP_NO: N/A					
FS_HLM: 7.746					
Repair Type: Non-Urgent					
Crossing Status: Found					
UCIP Comments: Verify pipe was abandoned properly					
FIELD_STRUCT_DESC: 18-inch steel irrigation pipe through the levee					
14.7 feet below the crown. Pump and pipe visible at edge of pond off					
WS toe (Kaiser-Aetna)					
FS Date: 06/04/2013

Remnants of concrete distribution box on LS toe.

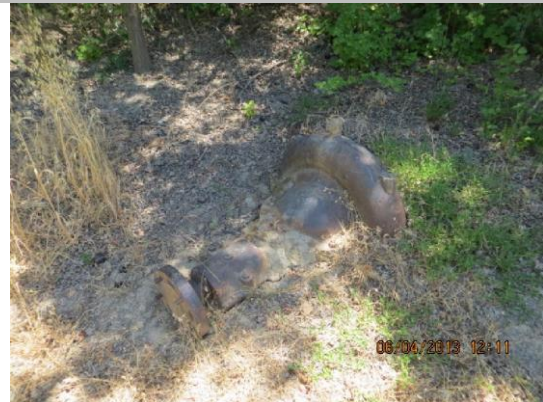
Photo 2 of 3 : UCIP_FA_2015_1097.jpg

Pump visible off WS toe, next to pond.

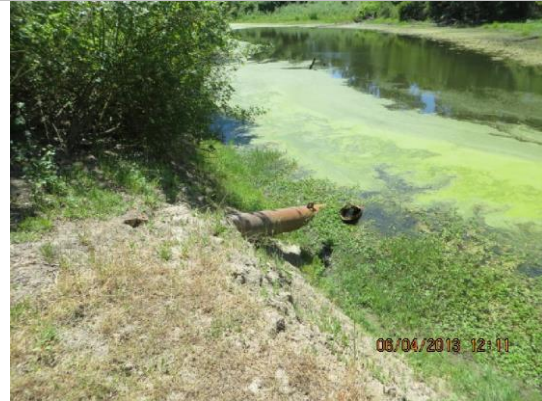
Photo 3 of 3 : UCIP_FA_2015_1098.jpg

Pipe visible at pond off WS toe.

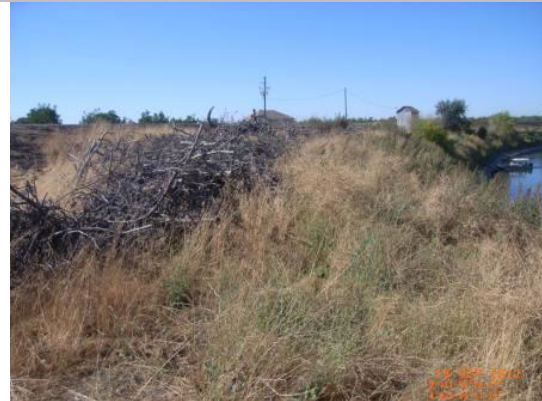
Photo 1 of 1 : FA_2015_LD0003_27_60_20150910_00027.jpg

LM Start	7.68	Rating **	M	Issue No.	60
LM End	7.68	Issue Type +	Ma	Location *	LS
Category	Earthen Levee			GPS Latitude/Longitude	
				Start	End
Item	Encroachments			39.478464 °	39.478464 °
				-121.990686 °	-121.990686 °
DWR ID	DWR_LD0003_01_f_2013_60				
Action/Comments					
Prunings

View of the prunings along the landside toe.

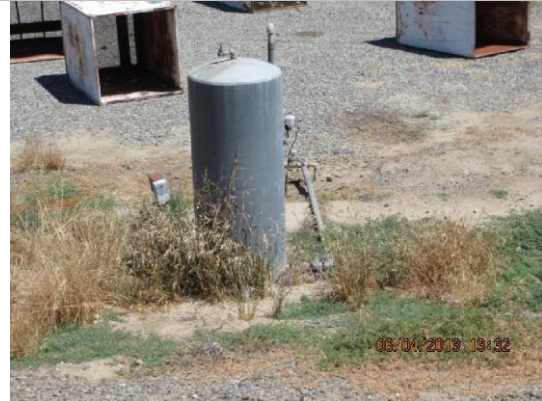
Photo 1 of 3 : UCIP_FA_2015_1099.jpg

LM Start	9.13	Rating **	M	Issue No.	95
LM End	9.13	Issue Type +	En	Location *	LS
Category	Supplemental			GPS Latitude/Longitude	
				Start	End
Item	DWR UCIP Field Study			39.497575 °	39.497575 °
				-121.987548 °	-121.987548 °
DWR ID					
Action/Comments					
Inspector Comments: FS_ID:14688					
DS_ID:18838					
EP_NO: 1623					
FS_HLM: 9.319					
Repair Type: Non-Urgent					
Crossing Status: Found					
UCIP Comments: Abandoned and should be done so properly.					
FIELD_STRUCT_DESC: 1.5-inch galvanized iron pipe through the					
levee 8.0 feet below the crown (Permit No.1623-Holgersoo).					
FS Date: 06/04/2013

Water tank, pump, and well head on LS toe.

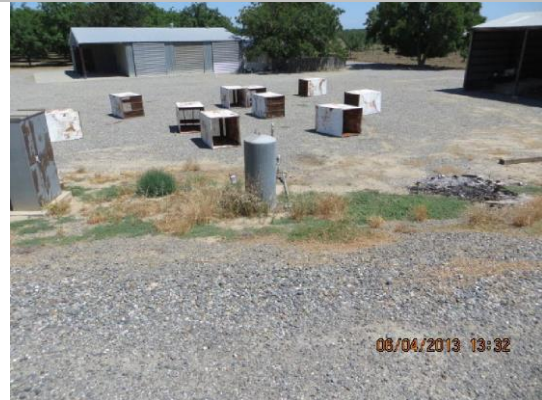
Photo 2 of 3 : UCIP_FA_2015_1100.jpg

Water tank, pump, and well head on LS toe.

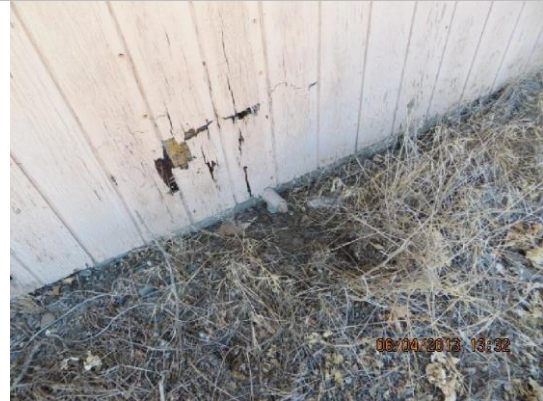
Photo 3 of 3 : UCIP_FA_2015_1101.jpg

Pipe at side of building on WS shoulder.

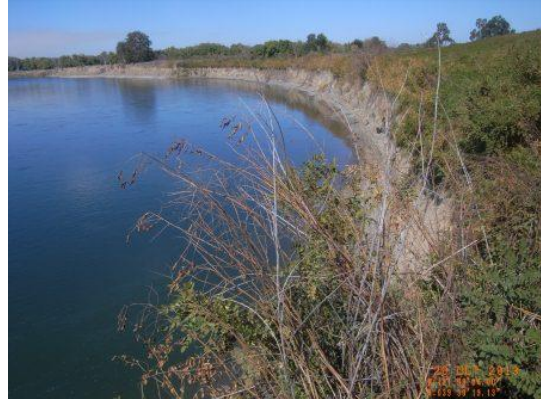
Photo 1 of 3 : USACE2013A_SAC_172-0_L_10.jpg

LM Start	9.61	Rating **	M	Issue No.	10
LM End	9.88	Issue Type +	Ma	Location *	WS
Category	Supplemental			GPS Latitude/Longitude	
				Start	End
Item	2015 USACE Erosion Survey, DRAFT			39.504388 °	39.508117 °
				-121.985301 °	-121.986562 °
DWR ID					
Action/Comments					
Inspector Comments: 2007 - Getting close to the levee. Bank is clayey silt with clayey/silty toe. 2008 - Looks a little worse at the upstream end. 2009 - Some new erosion and slumping. 2010 - Some new erosion upstream of site, actively eroding at low flow. New bank swallow colony noted. 2011 - Significant erosion since last year, with an estimated 10 to 15 feet of berm lost. Large sections of the bank have slumped off. 2012 - Part of the site appears to be stabilizing, but still minor slumping in other locations. 2013 - Minor new erosion at toe. 2015: Last observed in 2013. [2015 Site ID: SAC_172-0_L]

USACE 2013 Photo #1

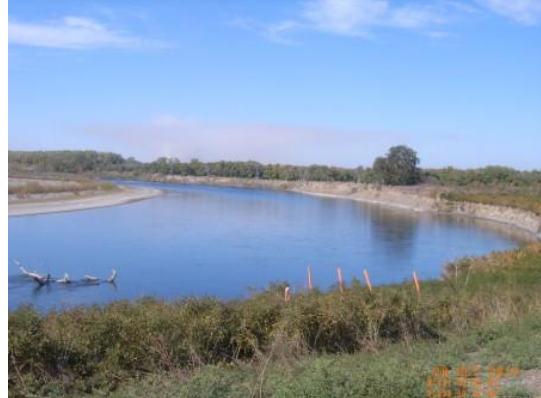
Photo 2 of 3 : USACE2013A_SAC_172-0_L_3.jpg

USACE 2013 Photo #2

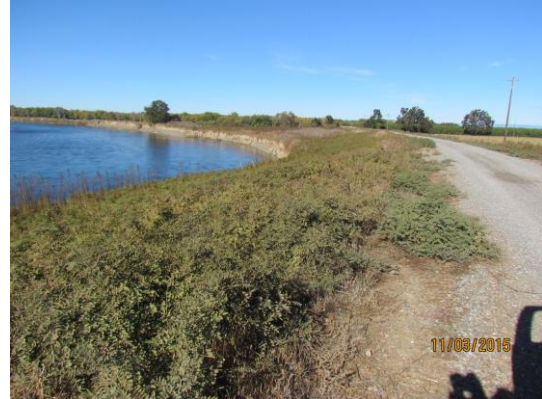
Photo 1 of 1 : FA_2015_LD0003_27_80_20151118_00077.jpg

LM Start	9.64	Rating **	U	Issue No.	80
LM End	9.88	Issue Type +	Ma	Location *	WS
Category	Earthen Levee			GPS Latitude/Longitude	
				Start	End
Item	Vegetation			39.504682 °	39.508065 °
				-121.984465 °	-121.984030 °
DWR ID	DWR_LD0003_01_f_2015_80				
Action/Comments					
Control annual grass and weeds on the levee slopes and easements. Inspector Comments: Clear vegetation from levee slopes.

View of the vegetation along the waterside slope and toe.

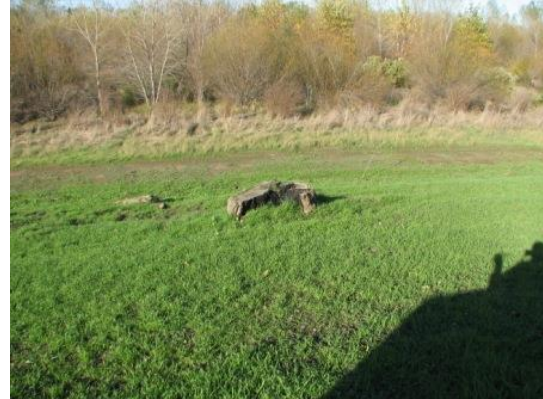
Photo 1 of 1 : FA_2015_LD0003_27_30_20150910_00017.jpg

LM Start	10.67	Rating **	N	Issue No.	30
LM End	10.67	Issue Type +	Ma	Location *	WS
Category	Earthen Levee			GPS Latitude/Longitude	
				Start	End
Item	Trim / Thin Trees			39.517715 °	39.517715
				-121.979155 °	-121.979155
DWR ID	DWR_LD0003_01_s_2012_30				
Action/Comments					
Tree stumps.

View of the stump along the slope.

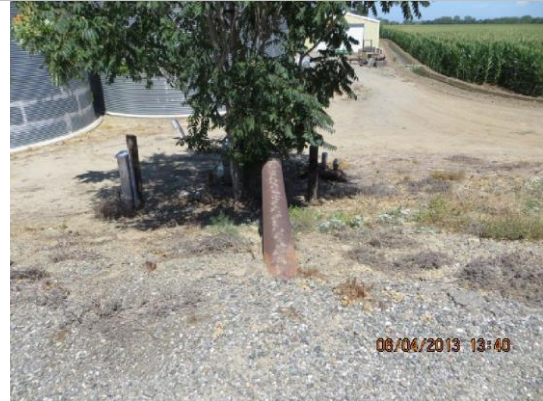
Photo 1 of 3 : UCIP_FA_2015_1102.jpg

Inspector Comments: FS_ID:14690
 DS_ID:18832
 EP_NO: 3193
 FS_HLM: 11.203
 Repair Type: Non-Urgent
 Crossing Status: Found
 UCIP Comments: Pipe appears abandoned and should be done so properly.
 FIELD_STRUCT_DESC: 10-inch steel pipe through levee at crown elevation. 5.5-inch pipe extended out on waterward end, supplying water tanks at landward toe. Discharge into metal tank covered at landward toe. Pump and meter on landward side (Permit No. 3193- T. Southam). Design drawings available in permit.
 FS Date: 06/04/2013

10-inch pipe on LS.

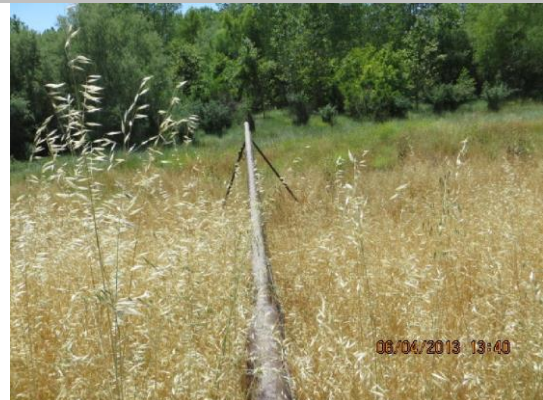
Photo 2 of 3 : UCIP_FA_2015_1103.jpg

Pipe on WS shoulder.

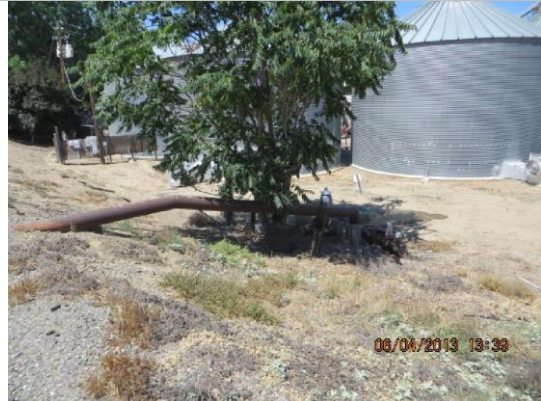
Photo 3 of 3 : UCIP_FA_2015_1104.jpg

10-inch pipe and pump on LS.
