**Flood Control Project Maintenance
Levee Inspections**

Fall 2016 Levee Maintenance Deficiency Summary Report

Levee District No. 0003 (Glenn County)

Fall 2016 Levee Inspection Results

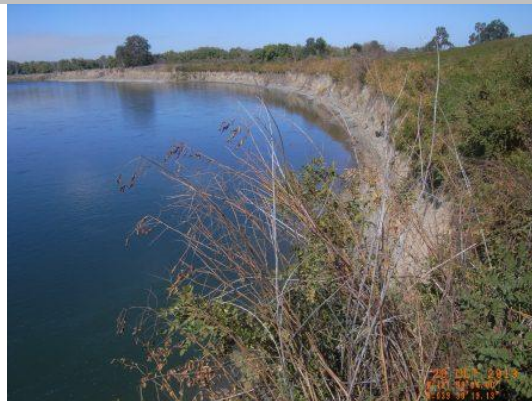
Photo 1 of 3 : FA_2016_LD0003_27_10_20160823_00006.jpg

Comment Code					
Inspector Comment					
2007 - Getting close to the levee. Bank is clayey silt with clayey/silty toe. 2008 - Looks a little worse at the upstream end. 2009 - Some new erosion and slumping. 2010 - Some new erosion upstream of site, actively eroding at low flow. New bank swallow colony noted. 2011 - Significant erosion since last year, with an estimated 10 to 15 feet of berm lost. Large sections of the bank have slumped off. 2012 - Part of the site appears to be stabilizing, but still minor slumping in other locations. 2013 - Minor new erosion at toe. 2015: Last observed in 2013. [2015 Site ID: SAC_172-0_L] On 3/25/2016, recent high water caused river to erode to within 10-20 feet of levee toe. Appears still somewhat active.

USACE 2013 Photo #1

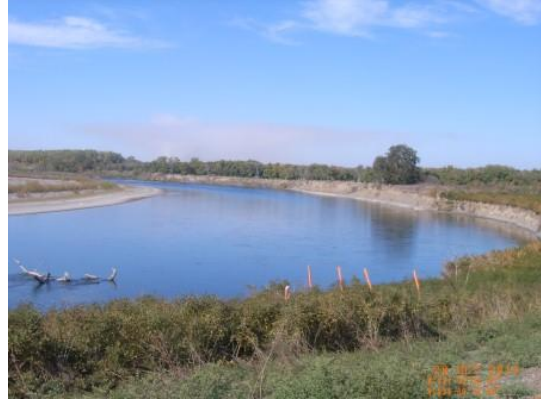
Photo 2 of 3 : FA_2016_LD0003_27_10_20160823_00007.jpg

2007 - Getting close to the levee. Bank is clayey silt with clayey/silty toe. 2008 - Looks a little worse at the upstream end. 2009 - Some new erosion and slumping. 2010 - Some new erosion upstream of site, actively eroding at low flow. New bank swallow colony noted. 2011 - Significant erosion since last year, with an estimated 10 to 15 feet of berm lost. Large sections of the bank have slumped off. 2012 - Part of the site appears to be stabilizing, but still minor slumping in other locations. 2013 - Minor new erosion at toe. 2015: Last observed in 2013. [2015 Site ID: SAC_172-0_L] On 3/25/2016, recent high water caused river to erode to within 10-20 feet of levee toe. Appears still somewhat active.

LM Start	9.61	Rating **	M	Issue No.	10 (cont)
LM End	9.88	Issue Type +	Ma	Location *	WS

USACE 2013 Photo #2

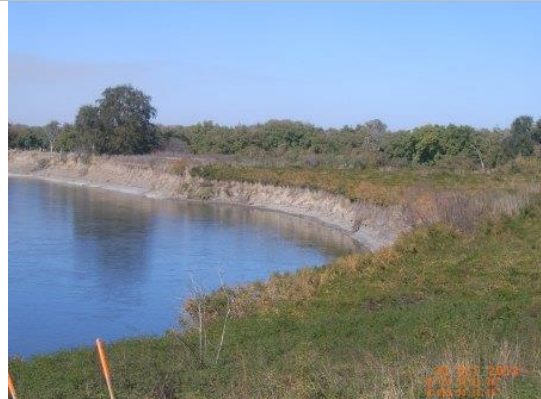
Photo 3 of 3 : FA_2016_LD0003_27_10_20160823_00008.jpg

USACE 2013 Photo #3
