**Flood Control Project Maintenance
Levee Inspections**

Fall 2017 Levee Maintenance Deficiency Summary Report

**Flood Control Project Maintenance
Levee Inspections****LMA District Cover Sheet
Fall 2017 Levee Inspection Results****Levee District No. 0003 (Glenn County)**

Levee District No. 0003 (Glenn County)

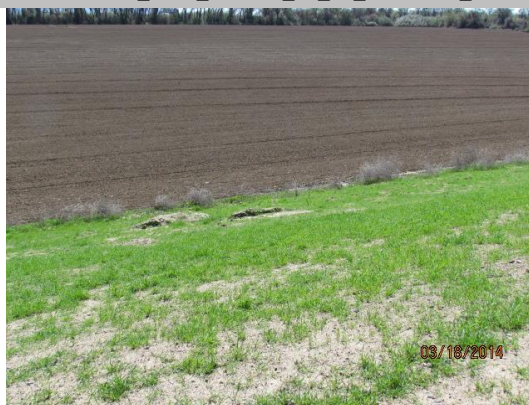
Photo 1 of 1 : FA_2017_LD0003_27_55_20170911_00037.jpg

LM Start	0.69	Rating **	M	Issue No.	55
LM End	0.69	Issue Type +	Ma	Location *	WS
Category	Earthen Levee			GPS Latitude/Longitude	
				Start	End
Item	Animal Control			39.388716 °	39.388716 °
				-121.997774 °	-121.997774 °
DWR ID	DWR_LD0003_01_s _ 2014_55				
Comment Code					
A1 : Exterminate rodents and backfill and compact or grout burrows.					
Inspector Comment

View of the rodent activity along the waterside slope.

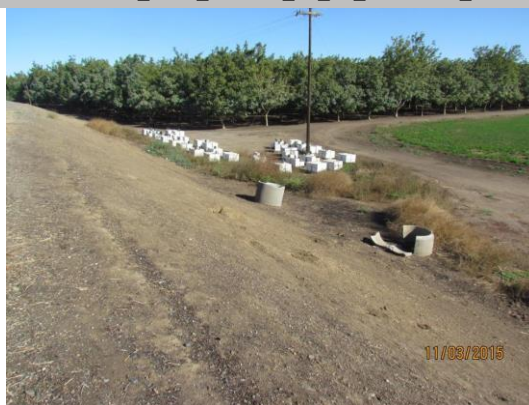
Photo 1 of 1 : FA_2017_LD0003_27_52_20170911_00035.jpg

LM Start	1.21	Rating **	M	Issue No.	52
LM End	1.21	Issue Type +	Ma	Location *	LS
Category	Earthen Levee			GPS Latitude/Longitude	
				Start	End
Item	Animal Control			39.394010 °	39.394010 °
				-122.000977 °	-122.000977 °
DWR ID	DWR_LD0003_01_f_2015_52				
Comment Code					
A3 : No rodents visible, but rodent burrows visible; need to backfill and compact or grout burrows.					
Inspector Comment

View of the rodent holes along the landside slope.

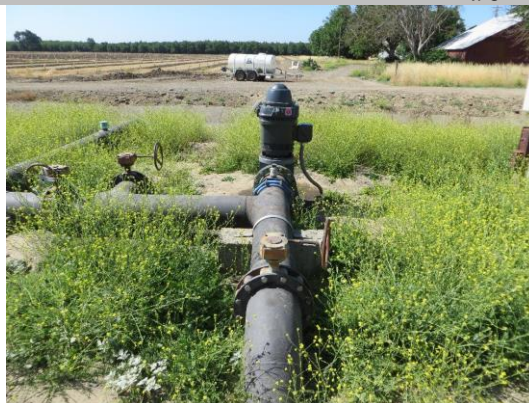
Photo 2 of 3 : UCIP_FA_2017_15144_24882.jpg

Pump and butterfly valve off LS toe.

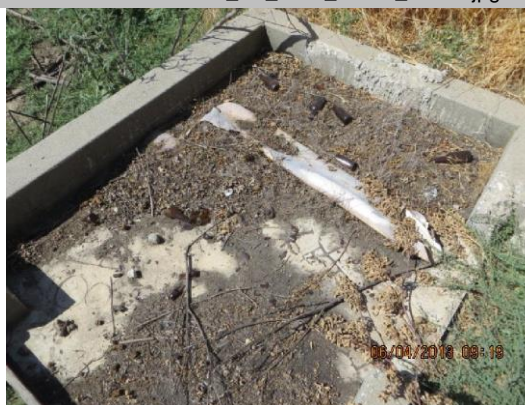
Photo 1 of 2 : UCIP_FA_2017_14584_24081.jpg

LM Start	2.98	Rating **	M	Issue No.	111
LM End	2.98	Issue Type +	En	Location *	
Category	Supplemental			GPS Latitude/Longitude	
				Start	End
Item	DWR UCIP Field Study			39.412827 °	39.412827 °
				-121.991427 °	-121.991427 °
DWR ID					
Comment Code					
Inspector Comment					
FS_ID:14584 DS_ID:18829 EP_NO: 9919 Repair Type: Non-Urgent Crossing Status: Indicator Found UCIP Comments: Appears abandoned. Verify it was done corectly. FIELD_STRUCT_DESC: *ABANDONED* 24-inch corrugated metal irrigation pipe through the levee, 16 feet below the crown. Slide gate on the waterside (WS) end. 5-foot by 7-foot concrete distribution box at landside (LS) toe is filled with grout. (Automatic Board Order (ABO) issued as Permit No. 9919, 1974 - Roy and Annie Mills). [Additional Reference(s): DWR Levee Log, 1992. USACE Sacramento O&M Manual 136, March 1960 (HLM 23.43)]. FS Date: 6/4/2013

5'X7' concrete distribution box filled in with grout.

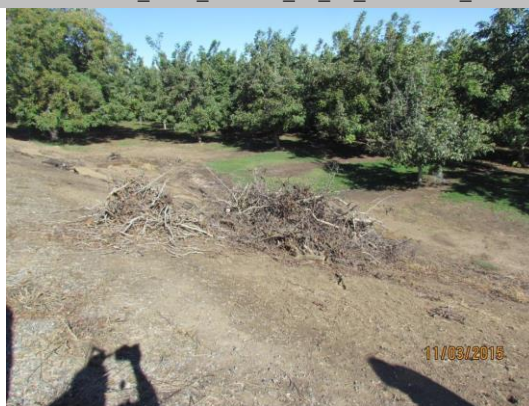
Photo 1 of 1 : FA_2017_LD0003_27_69_20170911_00047.jpg

LM Start	5.06	Rating **	M	Issue No.	69
LM End	5.06	Issue Type +	Ma	Location *	LS
Category	Earthen Levee			GPS Latitude/Longitude	
				Start	End
Item	Encroachments			39.441057 °	39.441057 °
				-121.990458 °	-121.990458 °
DWR ID	DWR_LD0003_01_f_2015_69				
Comment Code					
PR : Prunings					
Inspector Comment					
Remove the prunings from the landside slope.

View of the prunings along the landside slope.

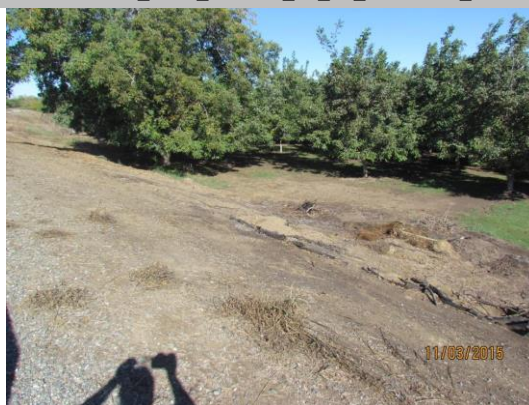
Photo 1 of 1 : FA_2017_LD0003_27_21_20170911_00014.jpg

LM Start	5.06	Rating **	U	Issue No.	21
LM End	5.25	Issue Type +	Ma	Location *	LS
Category	Earthen Levee			GPS Latitude/Longitude	
				Start	End
Item	Animal Control			39.441128 °	39.443793 °
				-121.990475 °	-121.991297 °
DWR ID	DWR_LD0003_01_f_2015_21				
Comment Code					
A3 : No rodents visible, but rodent burrows visible; need to backfill and compact or grout burrows.					
Inspector Comment

View of the rodent holes along the landside slope.

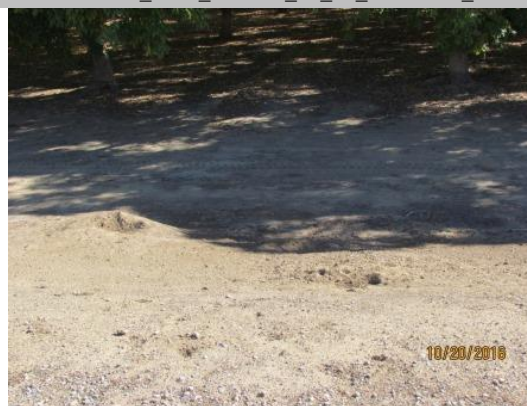
Photo 1 of 1 : FA_2017_LD0003_27_62_20170911_00041.jpg

LM Start	5.53	Rating **	U	Issue No.	62
LM End	5.62	Issue Type +	Ma	Location *	LS
Category	Earthen Levee			GPS Latitude/Longitude	
				Start	End
Item	Animal Control			39.447900 °	39.449115 °
				-121.991748 °	-121.991873 °
DWR ID	DWR_LD0003_01_f_2013_62				
Comment Code					
A3 : No rodents visible, but rodent burrows visible; need to backfill and compact or grout burrows.					
Inspector Comment

View of the rodent holes along the landside slope.

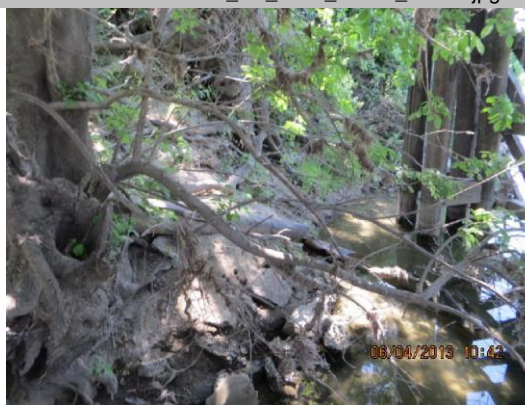
Photo 3 of 3 : UCIP_FA_2017_14643_24140.jpg

14-inch Pipe debris on WS toe.

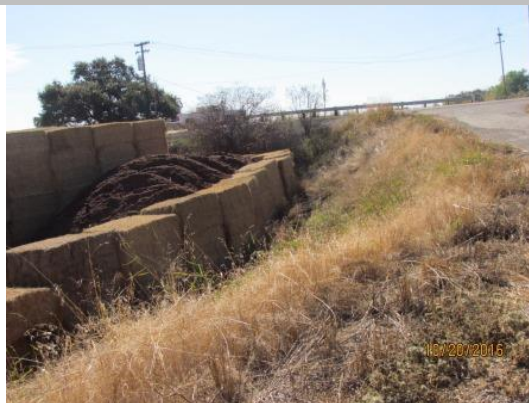
Photo 1 of 1 : FA_2017_LD0003_27_99_20170911_00063.jpg

LM Start	6.22	Rating **	U	Issue No.	99
LM End	6.22	Issue Type +	En	Location *	LS
Category	Earthen Levee			GPS Latitude/Longitude	
				Start	End
Item	Encroachments			39.457648 °	39.457648 °
				-121.993767 °	-121.993767 °
DWR ID	DWR_LD0003_01_f_2016_99				
Comment Code					
DE : Debris					
Inspector Comment					
Straw bales at the landside toe.

View of the straw bales along the landside toe.

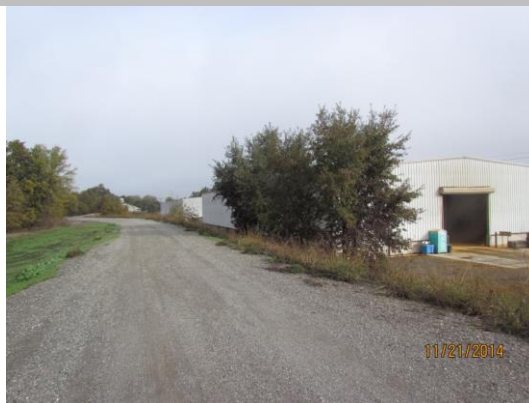
Photo 1 of 1 : FA_2017_LD0003_27_7_20170911_00005.jpg

LM Start	6.24	Rating **	M	Issue No.	7
LM End	6.38	Issue Type +	Ma	Location *	LS
Category	Earthen Levee			GPS Latitude/Longitude	
				Start	End
Item	Trim / Thin Trees			39.457968 °	39.459955 °
				-121.993712 °	-121.993512 °
DWR ID	DWR_LD0003_01_s_2012_7				
Comment Code					
T1 : Trim trees to at least five feet above ground level.					
Inspector Comment

Trim the trees 5 feet for better visibility.

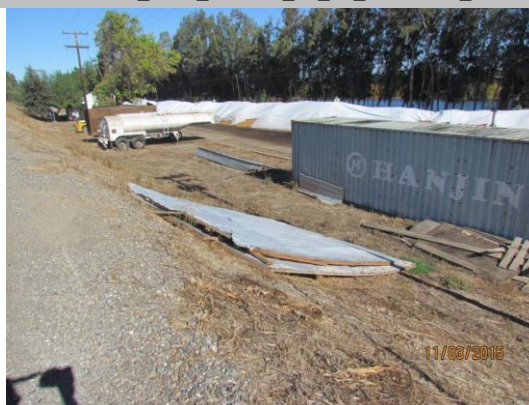
Photo 1 of 1 : FA_2017_LD0003_27_74_20170911_00051.jpg

LM Start	6.43	Rating **	U	Issue No.	74
LM End	6.43	Issue Type +	En	Location *	LS
Category	Earthen Levee			GPS Latitude/Longitude	
				Start	End
Item	Encroachments			39.460563 °	39.460563 °
				-121.993195 °	-121.993195 °
DWR ID	DWR_LD0003_01_f_2015_74				
Comment Code					
DE : Debris					
Inspector Comment					
Remove the metal roof from the landside slope.

View of the metal roof laying on the landside slope.

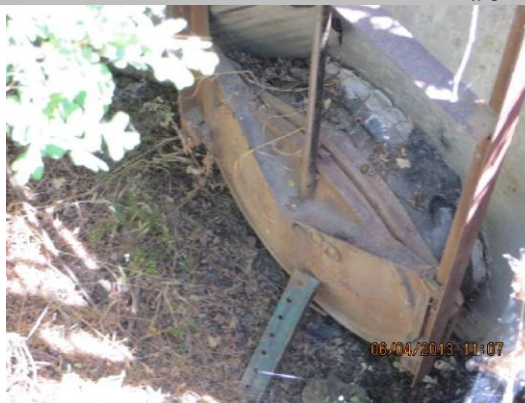
Photo 3 of 3 : UCIP_FA_2017_14664_24160.jpg

Comment Code						
Inspector Comment						
FS_ID:14664 DS_ID:18834 EP_NO: 9906 Repair Type: Non-Urgent Crossing Status: Found UCIP Comments: Pipe appears to be abandoned and should be done so properly. FIELD_STRUCT_DESC: 24-inch steel irrigation pipe through the levee, 13 feet below the crown. Slide gate on the waterside (WS) end. Pump house on berm. Slide gate in 7-foot by 12-foot concrete pit on the WS with flap gate on pipe from pump house. Pipe discharges into irrigation ditch on landward side. (Automatic Board Order (ABO) issued as Permit No. 9906, 1974 - Jeanette S. Clare). [Additional Reference(s): DWR Levee Log, 1992. USACE Sacramento O&M Manual 138, July 1955 (Station 1148+70)]. FS Date: 6/4/2013

Slidegate inside concrete box on WS slope.

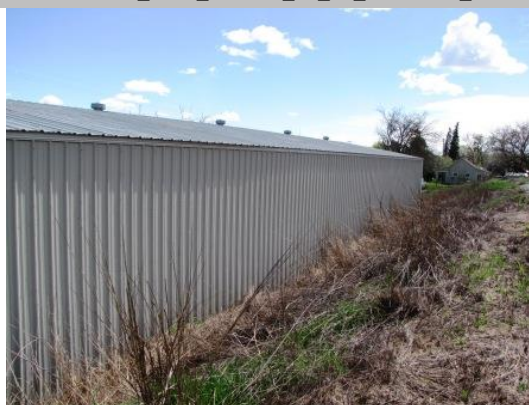
Photo 1 of 1 : FA_2017_LD0003_27_42_20170911_00022.jpg

LM Start	6.79	Rating **	M	Issue No.	42
LM End	6.79	Issue Type +	En	Location *	LS
Category	Earthen Levee			GPS Latitude/Longitude	
				Start	End
Item	Encroachments			39.465567 °	39.465595 °
				-121.991415 °	-121.991412 °
DWR ID	DWR_LD0003_01_s_2012_42				
Comment Code					
BU : Building					
Inspector Comment

View of the building along the landside toe.

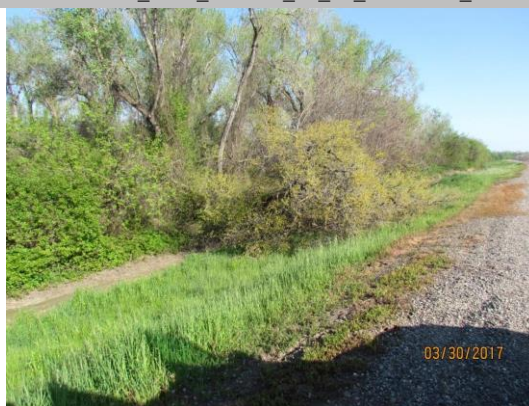
Photo 1 of 1 : FA_2017_LD0003_27_47_20170911_00025.jpg

LM Start	6.91	Rating **	M	Issue No.	47
LM End	6.91	Issue Type +	En	Location *	WS
Category	Earthen Levee			GPS Latitude/Longitude	
				Start	End
Item	Encroachments			39.467358 °	39.467358 °
				-121.991333 °	-121.991333 °
DWR ID	DWR_LD0003_01_s_2017_47				
Comment Code					
TR : Tree or limb					
Inspector Comment					
Remove the tree from the waterside slope and toe.

View of the tree on the waterside slope and toe.

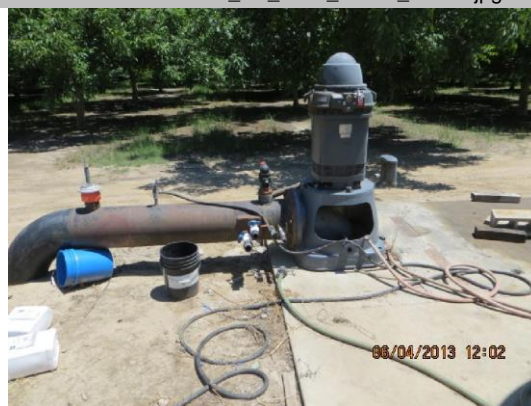
Photo 1 of 2 : UCIP_FA_2017_14686_24184.jpg

Pump located on LS toe next to concrete distribution box.

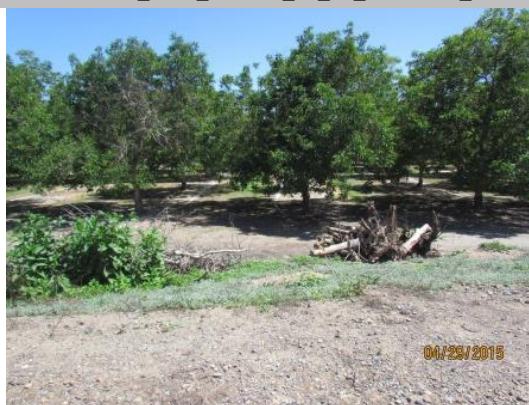
Photo 1 of 1 : FA_2017_LD0003_27_37_20170911_00020.jpg

LM Start	7.36	Rating **	M	Issue No.	37
LM End	7.36	Issue Type +	En	Location *	LS
Category	Earthen Levee			GPS Latitude/Longitude	
				Start	End
Item	Encroachments			39.473793 °	39.473793 °
				-121.991208 °	-121.991208 °
DWR ID	DWR_LD0003_01_s_2012_37				
Comment Code					
PR : Prunings					
Inspector Comment					
Remove the prunings from the landside slope.

View of the prunings along the landside slope.

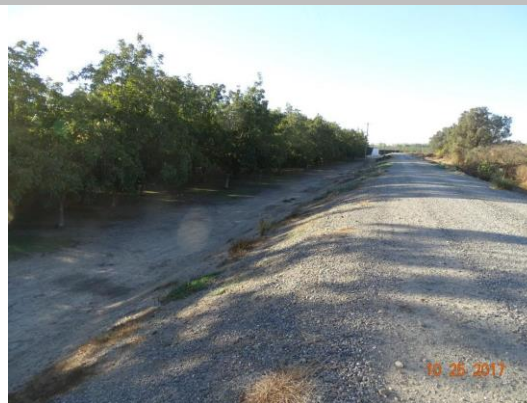
Photo 1 of 1 : FA_2017_LD0003_27_85_20171030_00108.jpg

LM Start	9.37	Rating **	M	Issue No.	85
LM End	9.62	Issue Type +	En	Location *	LS
Category	Earthen Levee			GPS Latitude/Longitude	
				Start	End
Item	Encroachments			39.500790 °	39.504310 °
				-121.985930 °	-121.984580 °
DWR ID	DWR_LD0003_01_s_2016_85				
Comment Code					
FE : Fence					
Inspector Comment					
The fence was removed from the landside toe.

View of the removed fence from the landside toe.

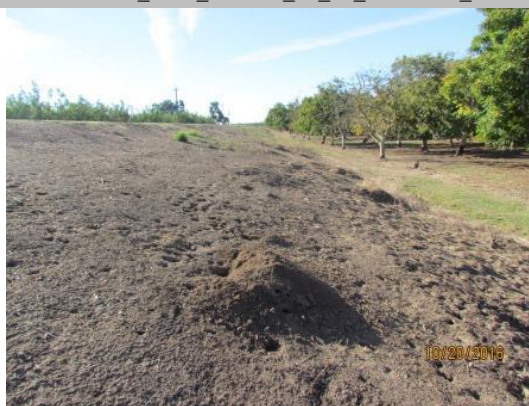
Photo 1 of 1 : FA_2017_LD0003_27_93_20170911_00058.jpg

View of the rodent holes along the waterside slope.

LM Start	9.94	Rating **	M	Issue No.	93
LM End	10.03	Issue Type +	Ma	Location *	WS
Category	Earthen Levee			GPS Latitude/Longitude	
				Start	End
Item	Animal Control			39.508912 °	39.510199 °
				-121.983989 °	-121.983912 °
DWR ID	DWR_LD0003_01_f_2016_93				
Comment Code					
A1 : Exterminate rodents and backfill and compact or grout burrows.					
Inspector Comment

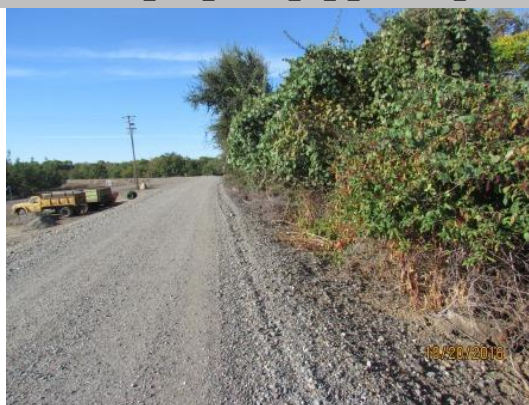
Photo 1 of 1 : FA_2017_LD0003_27_5_20170911_00003.jpg

View of the dense vegetation along the waterside slope.

LM Start	10.14	Rating **	M	Issue No.	5
LM End	10.24	Issue Type +	Ma	Location *	WS
Category	Earthen Levee			GPS Latitude/Longitude	
				Start	End
Item	Trim / Thin Trees			39.511788 °	39.512395 °
				-121.983750 °	-121.981975 °
DWR ID	DWR_LD0003_01_s_2012_5				
Comment Code					
T2 : Thin trees to allow visibility of the ground and room to flood fight.					
Inspector Comment

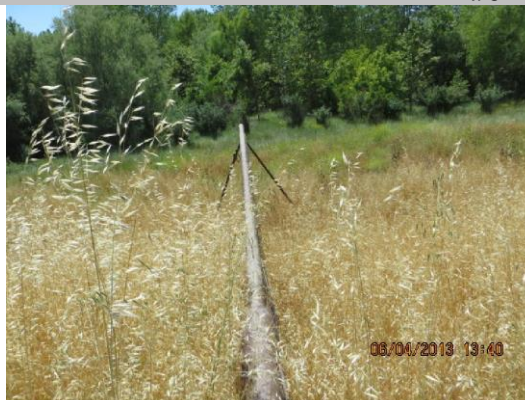
Photo 2 of 3 : UCIP_FA_2017_14690_24192.jpg

LM Start	10.96	Rating **	M	Issue No.	120 (cont)	
LM End	10.96	Issue Type +	En	Location *		
Category	Supplemental			GPS Latitude/Longitude		
				Start		End
Item	DWR UCIP Field Study			39.521780 °		39.521780 °
				-121.979014 °		-121.979014 °
DWR ID						
Comment Code						
Inspector Comment						
FS_ID:14690 DS_ID:18832 EP_NO: 3193 Repair Type: Non-Urgent Crossing Status: Found UCIP Comments: Pipe appears abandoned and should be done so properly. FIELD_STRUCT_DESC: 10-inch steel irrigation pipe through levee at crown elevation. 5.5-inch pipe extended out on waterside (WS) end, supplying water tanks at landward toe. Discharges into metal tank covered at landward toe. Pump and meter on landward side. (Permit No. 3193, Year Unknown - Romaine Southam, design drawings available in permit). [Additional Reference(s): DWR Levee Log, 1992]. FS Date: 6/4/2013

Pipe on WS shoulder.

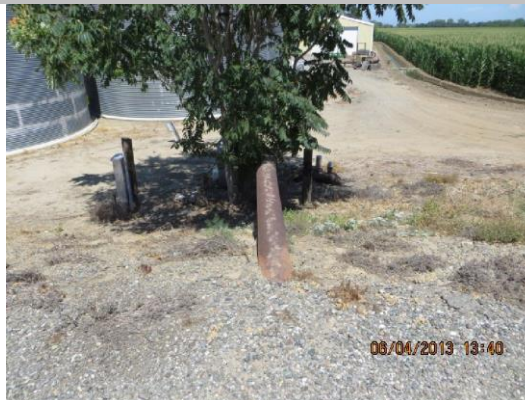
Photo 3 of 3 : UCIP_FA_2017_14690_24191.jpg

10-inch pipe on LS.

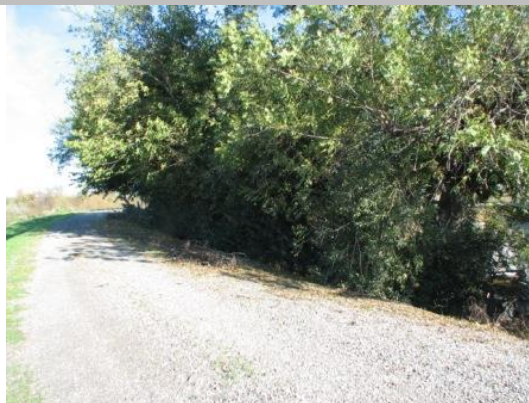
Photo 1 of 1 : FA_2017_LD0003_27_4_20170911_00002.jpg

LM Start	10.98	Rating **	U	Issue No.	4
LM End	11.01	Issue Type +	En	Location *	LS
Category	Earthen Levee			GPS Latitude/Longitude	
				Start	End
Item	Vegetation			39.522058 °	39.522480 °
				-121.979133 °	-121.979200 °
DWR ID	DWR_LD0003_01_s_2012_4				
Comment Code					
V6 : Landscaping					
Inspector Comment

View of the trees along the landside slope.
