**Flood Control Project Maintenance
Levee Inspections**

Fall 2018 Levee Maintenance Deficiency Summary Report

Sacramento River Basin

**Flood Control Project Maintenance
Levee Inspections****LMA District Cover Sheet****Fall 2018 Levee Inspection Results****Levee District No. 0003 (Glenn County)**

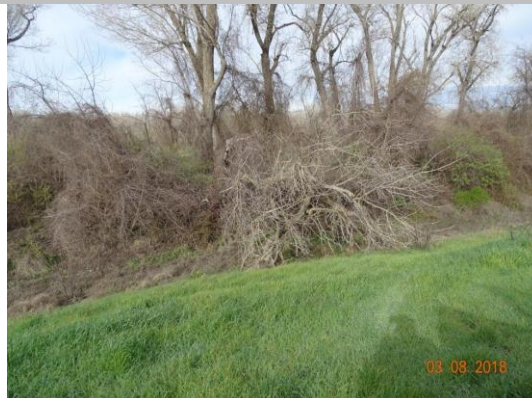
Photo 1 of 1 : FA_2018_LD0003_27_43_20180905_00022.jpg

LM Start	1.34	Rating **	M	Issue No.	43
LM End	1.34	Issue Type +	Ma	Location *	WS
Category	Earthen Levee			GPS Latitude/Longitude	
				Start	End
Item	Encroachments			39.395903 °	39.395903 °
				-122.001490 °	-122.001490 °
DWR ID	DWR_LD0003_01_s_2018_43				
Comment Code					
TR : Tree or limb					
Inspector Comment					
Remove the tree from the slope and toe.

View of the tree down on the slope and toe.

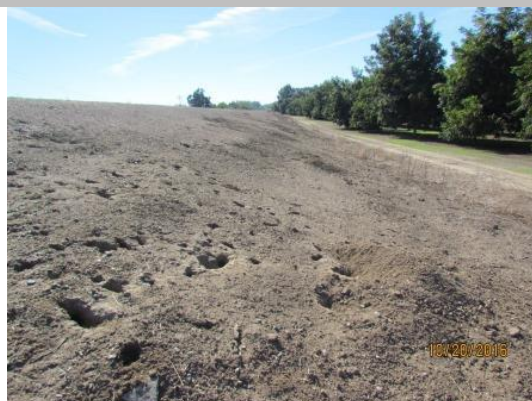
Photo 1 of 1 : FA_2018_LD0003_27_103_20180905_00063.jpg

LM Start	1.83	Rating **	U	Issue No.	103
LM End	2.35	Issue Type +	Ma	Location *	WS
Category	Earthen Levee			GPS Latitude/Longitude	
				Start	End
Item	Animal Control			39.402851 °	39.406414 °
				-122.001958 °	-121.995993 °
DWR ID	DWR_LD0003_01_f_2016_103				
Comment Code					
A1 : Exterminate rodents and backfill and compact or grout burrows.					
Inspector Comment

View of the rodent holes along the waterside slope.

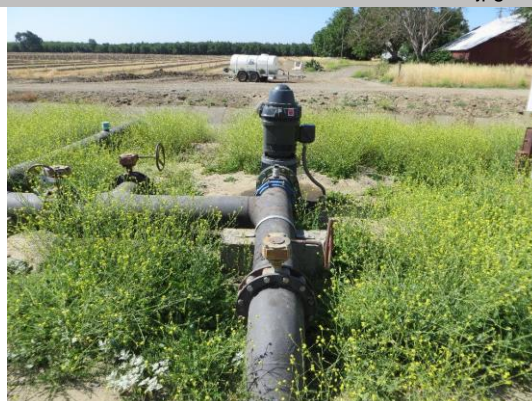
Photo 2 of 3 : UCIP_FA_2018_15144_24882.jpg

FS_ID:15144
DS_ID:23151
EP_NO: N/A
Repair Type: Non-Urgent
Crossing Status: Found
UCIP Comments: No permit identified for this crossing.
FIELD_STRUCT_DESC: 12-inch steel irrigation pipe through the levee, 3.5 feet below the crown. Pump, butterfly valve, and JP/meter at channel on landside (LS) toe. Siphon breaker inside a 12-inch steel riser unit on the LS shoulder. 3-inch plastic drain on the waterside (WS) toe.
FS Date: 6/4/2013

Pump and butterfly valve off LS toe.

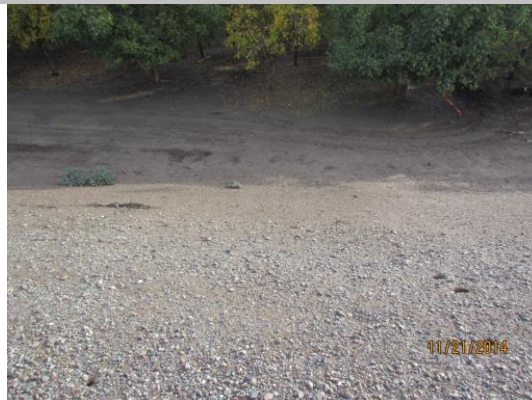
Photo 1 of 1 : FA_2018_LD0003_27_13_20180905_00011.jpg

LM Start	2.35	Rating **	M	Issue No.	13
LM End	2.52	Issue Type +	Ma	Location *	WS
Category	Earthen Levee			GPS Latitude/Longitude	
				Start	End
Item	Animal Control			39.406413 °	39.407248 °
				-121.995993 °	-121.993177 °
DWR ID	DWR_LD0003_01_s_2012_13				
Comment Code					
A3 : No rodents visible, but rodent burrows visible; need to backfill and compact or grout burrows.					
Inspector Comment

View of the rodent holes along the waterside slope.

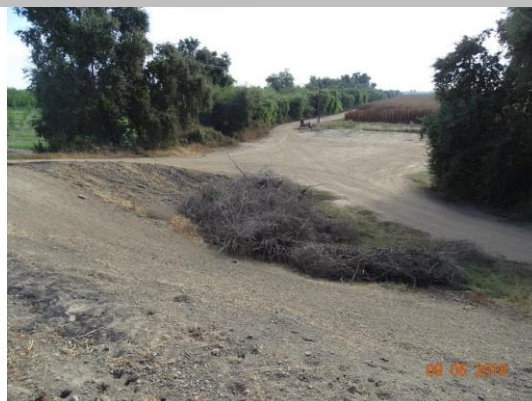
Photo 1 of 1 : FA_2018_LD0003_27_41_20181001_00105.jpg

LM Start	2.75	Rating **	M	Issue No.	41
LM End	2.75	Issue Type +	En	Location *	LS
Category	Earthen Levee			GPS Latitude/Longitude	
				Start	End
Item	Encroachments			39.409698 °	39.409698 °
				-121.990458 °	-121.990458 °
DWR ID	DWR_LD0003_01_f_2018_41				
Comment Code					
PR : Prunings					
Inspector Comment					
Remove the prunings from the landside toe.

View of the prunings along the landside toe.

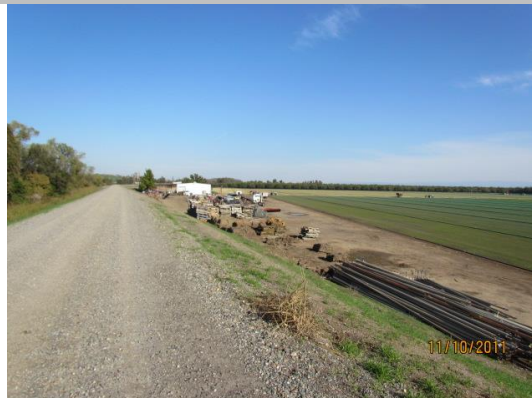
Photo 1 of 1 : FA_2018_LD0003_27_25_20180905_00015.jpg

LM Start	5.77	Rating **	M	Issue No.	25
LM End	5.88	Issue Type +	En	Location *	LS
Category	Earthen Levee			GPS Latitude/Longitude	
				Start	End
Item	Encroachments			39.451293 °	39.452872 °
				-121.992370 °	-121.992897 °
DWR ID	DWR_LD0003_01_s_2012_25				
Comment Code					
AV : Abandoned vehicles					
Inspector Comment

View of the equipment along the landside toe.

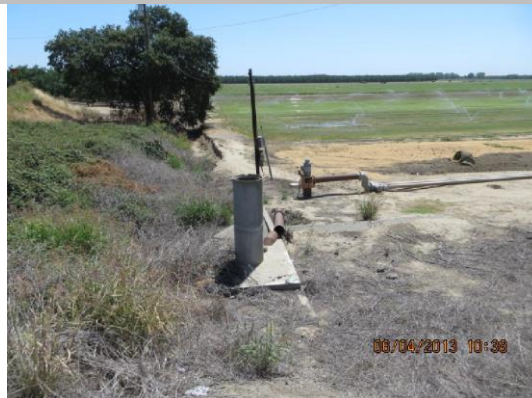
Photo 1 of 3 : UCIP_FA_2018_14643_24142.jpg

Concrete standpipe on LS toe.

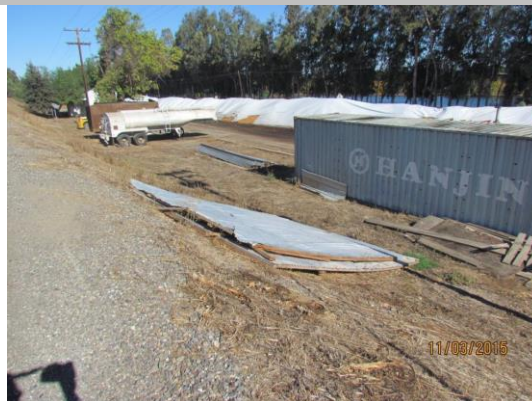
Photo 1 of 1 : FA_2018_LD0003_27_74_20180905_00051.jpg

LM Start	6.43	Rating **	U	Issue No.	74
LM End	6.43	Issue Type +	En	Location *	LS
Category	Earthen Levee			GPS Latitude/Longitude	
				Start	End
Item	Encroachments			39.460563 °	39.460563 °
				-121.993195 °	-121.993195 °
DWR ID	DWR_LD0003_01_f_2015_74				
Comment Code					
DE : Debris					
Inspector Comment					
Remove the metal roof from the landside slope.

View of the metal roof laying on the landside slope.

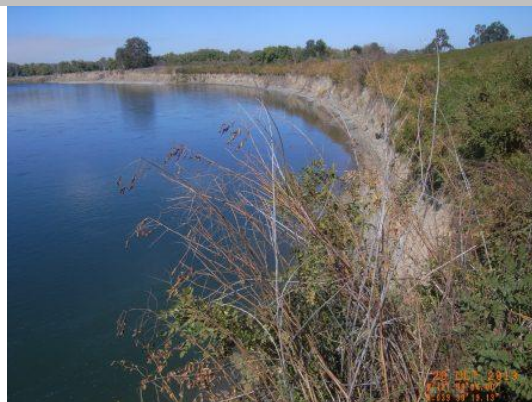
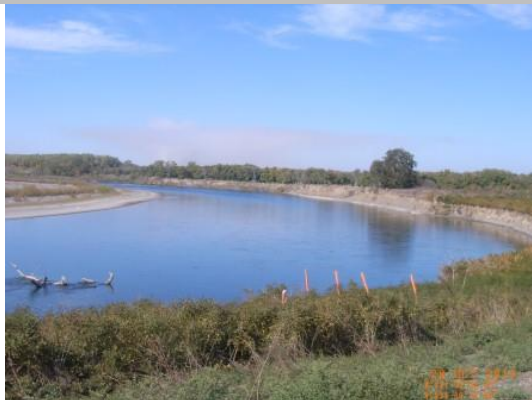
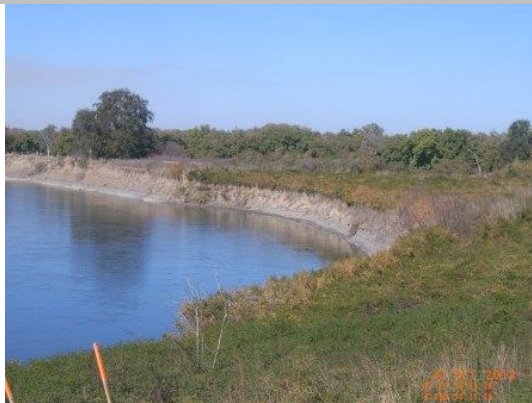
Comment Code					
Inspector Comment					
2017 Site ID: SAC 172.0 L					
Status: Critical					
2017 Field Notes: Significant erosion in last year. Erosion is entering levee prism, at current erosion rate, one more large storm and the levee will be comprised. Upgraded to critical.					
Site History: 2007 - Getting close to the levee. Bank is clayey silt with clayey/silty toe. 2008 - Looks a little worse at the upstream end. 2009 - Some new erosion and slumping. 2010 - Some new erosion upstream of site, actively eroding at low flow. New bank swallow colony noted. 2011 - Significant erosion since last year, with an estimated 10 to 15 feet of berm lost. Large sections of the bank have slumped off. 2012 - Part of the site appears to be stabilizing, but still minor slumping in other locations. 2013 - Minor new erosion at toe.
