**Flood Control Project Maintenance  
Levee Inspections**

**Fall 2019 Levee Maintenance Deficiency Summary Report**

**Flood Control Project Maintenance  
Levee Inspections****LMA District Cover Sheet****Fall 2019 Levee Inspection Results****Levee District No. 0003 (Glenn County)**

**Levee District No. 0003 (Glenn County)**

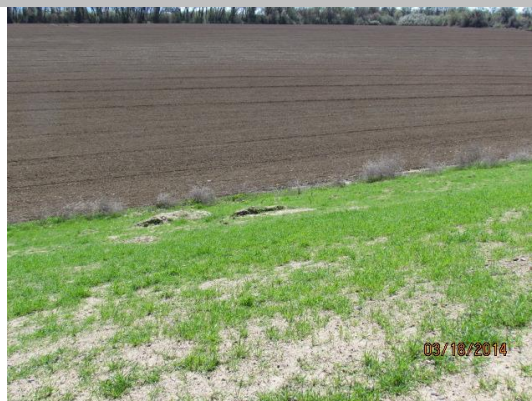
Photo 1 of 1 : FA\_2019\_LD0003\_27\_55\_20190822\_00019.jpg

LM Start	0.69	Rating **	M	Issue No.	55
LM End	0.69	Issue Type +	Ma	Location *	WS
Category	Earthen Levee			GPS Latitude/Longitude	
				Start	End
Item	Animal Control			39.388716°	39.388716°
				-121.997774°	-121.997774°
DWR ID	DWR_LD0003_01_s_2014_55				
Comment Code					
A1 : Exterminate rodents and backfill and compact or grout burrows.					
Inspector Comment

View of the rodent activity along the waterside slope.

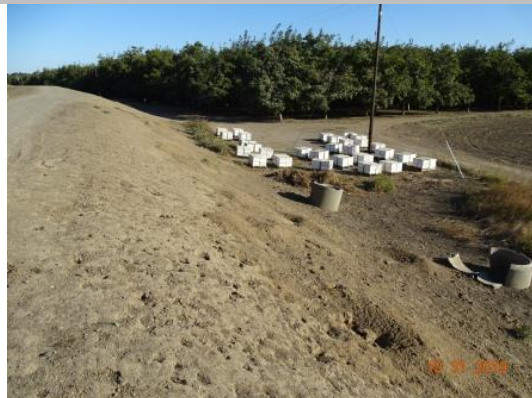
Photo 1 of 1 : FA\_2019\_LD0003\_27\_52\_20191101\_00099.jpg

LM Start	1.20	Rating **	U	Issue No.	52
LM End	1.21	Issue Type +	Ma	Location *	LS
Category	Earthen Levee			GPS Latitude/Longitude	
				Start	End
Item	Animal Control			39.393983 °	39.394010 °
				-122.000978 °	-122.000977 °
DWR ID	DWR_LD0003_01_f_2015_52				
Comment Code					
A3 : No rodents visible, but rodent burrows visible; need to backfill and compact or grout burrows.					
Inspector Comment

View of the rodent burrows along the landside slope. Fall 2019.

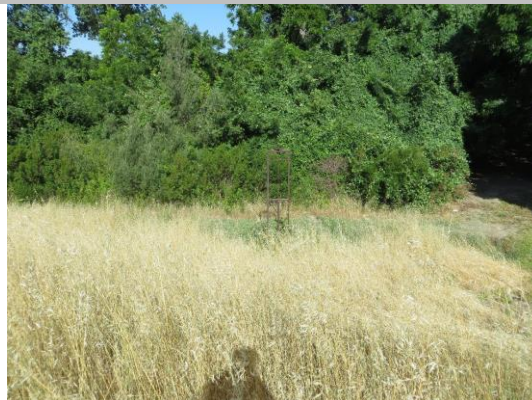
Photo 1 of 2 : UCIP\_FA\_2019\_14576\_24052.jpg

LM Start	1.58	Rating **	M	Issue No.	132
LM End	1.58	Issue Type +	En	Location *	
Category	Supplemental			GPS Latitude/Longitude	
				Start	End
Item	DRAFT DWR UCIP Field Study			39.399330 °	39.399330 °
				-122.002402 °	-122.002402 °
DWR ID	18823				
Comment Code					
Inspector Comment					
DS_ID:18823 FS_ID:14576 EP_NO: 9931 Repair Type: Non-Urgent Crossing Status: Found UCIP Comments: Appears abandoned. Pipe burried at slide gate on WS toe. FIELD_STRUCT_DESC: 24-inch corrugated metal irrigation pipe through the levee, 15 feet below the crown. Slide gate on the waterside (WS) end. 6-foot by 7-foot concrete distribution box on the landside (LS) toe. (Automatic Board Order (ABO) issued as Permit No. 9931, 1974 - Lowell F. Steel). [Additional Reference(s): DWR Levee Log, 1992. USACE Sacramento O&M Manual 136, March 1960 (HLM 22.00)]. FS Date: 6/4/2013

Slide gate at WS toe.

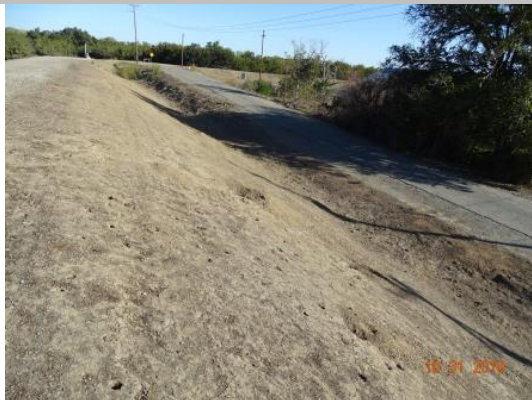
Photo 1 of 1 : FA\_2019\_LD0003\_27\_36\_20191101\_00101.jpg

LM Start	2.00	Rating **	U	Issue No.	36
LM End	2.03	Issue Type +	Ma	Location *	LS
Category	Earthen Levee			GPS Latitude/Longitude	
				Start	End
Item	Animal Control			39.405288 °	39.405750 °
				-122.001633 °	-122.001583 °
DWR ID	DWR_LD0003_01_f_2019_36				
Comment Code					
A3 : No rodents visible, but rodent burrows visible; need to backfill and compact or grout burrows.					
Inspector Comment

View of the rodent burrows along the landside slope. Fall 2019.

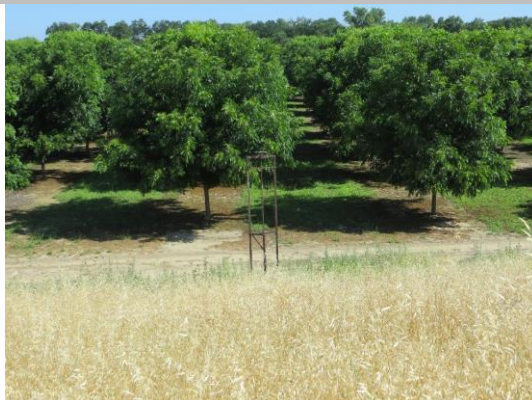
Photo 1 of 3 : UCIP\_FA\_2019\_14582\_24076.jpg

LM Start	2.38	Rating **	M	Issue No.	135
LM End	2.38	Issue Type +	En	Location *	
Category	Supplemental			GPS Latitude/Longitude	
				Start	End
Item	DRAFT DWR UCIP Field Study			39.406471 °	39.406471 °
				-121.995551 °	-121.995551 °
DWR ID	18827				
Comment Code					
Inspector Comment					
DS_ID:18827 FS_ID:14582 EP_NO: 9936 Repair Type: Non-Urgent Crossing Status: Found UCIP Comments: Appears abandoned. Pipe burried on WS and blocked with tin and soil on the LS. FIELD_STRUCT_DESC: 24-inch corrugated metal irrigation pipe through the levee, 18.3 feet below crown. Slide gate on the waterside (WS) end. 5-foot by 7-foot concrete distribution box at the landside (LS) toe. (Automatic Board Order (ABO) issued as Permit No. 9936, 1974 - J. A. and Florence Watt). [Additional Reference(s): DWR Levee Log, 1992. USACE Sacramento O&M Manual 136, March 1960 (HLM 22.82)]. FS Date: 6/4/2013

Slide gate at WS toe.

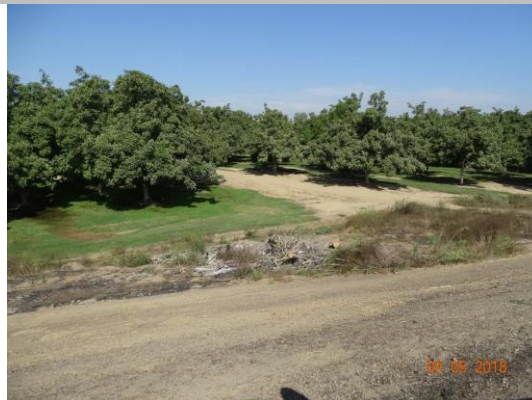
Photo 1 of 1 : FA\_2019\_LD0003\_27\_69\_20190822\_00030.jpg

LM Start	4.11	Rating **	M	Issue No.	69
LM End	4.11	Issue Type +	En	Location *	WS
Category	Earthen Levee			GPS Latitude/Longitude	
				Start	End
Item	Encroachments			39.427917 °	39.427917 °
				-121.987947 °	-121.987947 °
DWR ID	DWR_LD0003_01_f_2018_69				
Comment Code					
PR : Prunings					
Inspector Comment					
Remove the prunings from the waterside toe.

View of the prunings along the waterside toe.

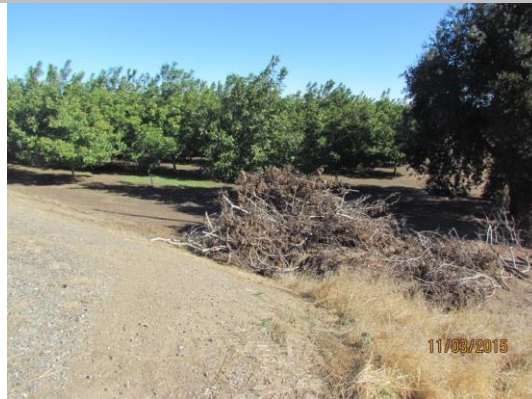
Photo 1 of 1 : FA\_2019\_LD0003\_27\_66\_20190822\_00027.jpg

LM Start	4.33	Rating **	M	Issue No.	66
LM End	4.33	Issue Type +	En	Location *	LS
Category	Earthen Levee			GPS Latitude/Longitude	
				Start	End
Item	Encroachments			39.430927 °	39.430927 °
				-121.987142 °	-121.987142 °
DWR ID	DWR_LD0003_01_f_2015_66				
Comment Code					
PR : Prunings					
Inspector Comment					
Remove the prunings from the landside slope.

View of the prunings along the landside toe.

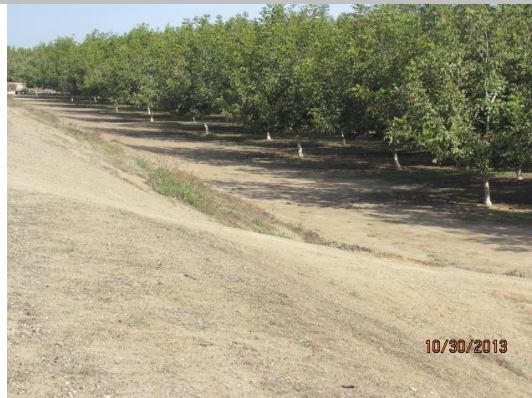
Photo 1 of 1 : FA\_2019\_LD0003\_27\_64\_20190822\_00025.jpg

LM Start	4.63	Rating **	M	Issue No.	64
LM End	4.68	Issue Type +	Ma	Location *	LS
Category	Earthen Levee			GPS Latitude/Longitude	
				Start	End
Item	Animal Control			39.435205 °	39.435855 °
				-121.988097 °	-121.988252 °
DWR ID	DWR_LD0003_01_f_2013_64				
Comment Code					
A3 : No rodents visible, but rodent burrows visible; need to backfill and compact or grout burrows.					
Inspector Comment

View of the rodent activity along the landside slope.

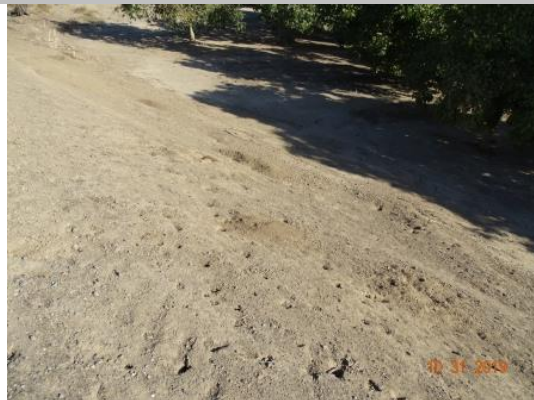
Photo 1 of 1 : FA\_2019\_LD0003\_27\_96\_20191101\_00104.jpg

LM Start	<b>5.20</b>	Rating **	U	Issue No.	<b>96</b>							
LM End	<b>5.20</b>	Issue Type +	Ma	Location *	LS							
Category	Earthen Levee		GPS Latitude/Longitude									
			Start	End								
Item	Animal Control		39.443166°	39.443166°								
			-121.991060°	-121.991060°								
DWR ID	DWR_LD0003_01_f_2019_96											
Comment Code												
A3 : No rodents visible, but rodent burrows visible; need to backfill and compact or grout burrows.												
Inspector Comment

View of the rodent burrows on the landside slope. Fall 2019.

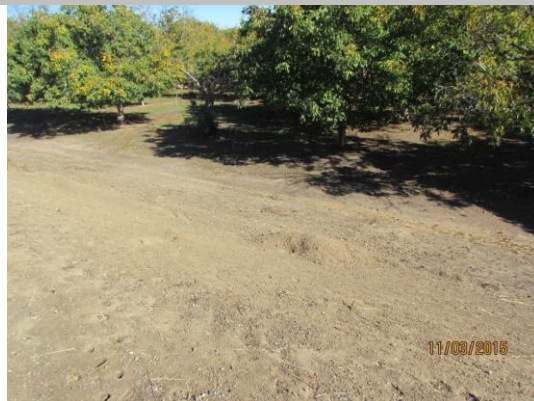
Photo 1 of 1 : FA\_2019\_LD0003\_27\_70\_20190822\_00031.jpg

LM Start	<b>5.38</b>	Rating **	U	Issue No.	<b>70</b>							
LM End	<b>5.40</b>	Issue Type +	Ma	Location *	LS							
Category	Earthen Levee		GPS Latitude/Longitude									
			Start	End								
Item	Animal Control		39.445619°	39.446008°								
			-121.991510°	-121.991532°								
DWR ID	DWR_LD0003_01_f_2015_70											
Comment Code												
A3 : No rodents visible, but rodent burrows visible; need to backfill and compact or grout burrows.												
Inspector Comment

View of the rodent holes along the landside slope.

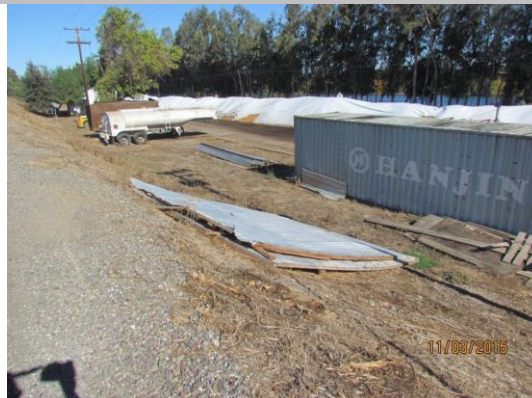
Photo 1 of 1 : FA\_2019\_LD0003\_27\_74\_20190822\_00034.jpg

LM Start	6.41	Rating **	M	Issue No.	74
LM End	6.41	Issue Type +	En	Location *	LS
Category	Earthen Levee			GPS Latitude/Longitude	
				Start	End
Item	Encroachments			39.460363 °	39.460363 °
				-121.993264 °	-121.993264 °
DWR ID	DWR_LD0003_01_f_2015_74				
Comment Code					
DE : Debris					
Inspector Comment					
Remove the metal roof from the landside slope.

View of the metal roof laying on the landside slope.

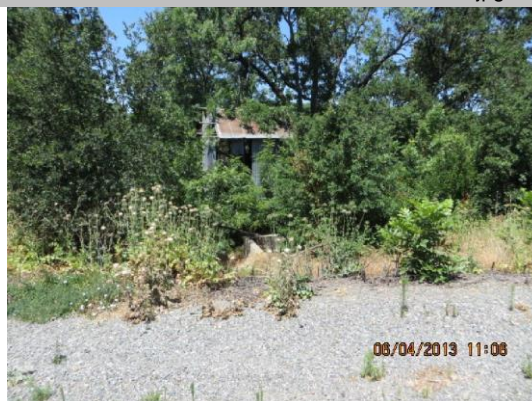
Photo 1 of 3 : UCIP\_FA\_2019\_14664\_24162.jpg

Pumphouse and 7'X12' concrete box on WS slope.

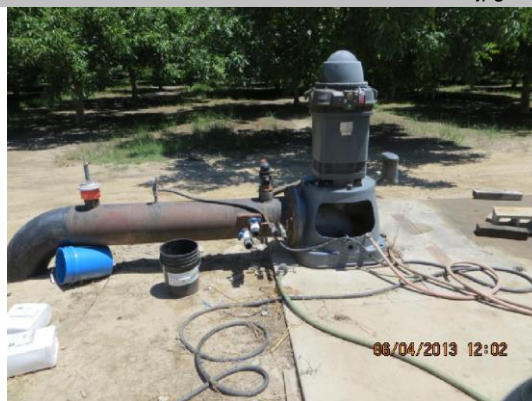
Photo 1 of 2 : UCIP\_FA\_2019\_14686\_24184.jpg

Pump located on LS toe next to concrete distribution box.

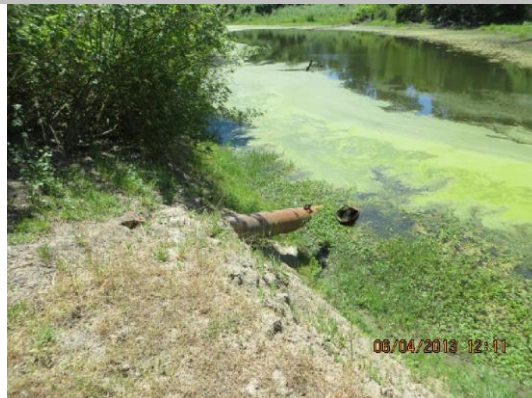
Photo 1 of 3 : UCIP\_FA\_2019\_14687\_24187.jpg

Pipe visible at pond off WS toe.

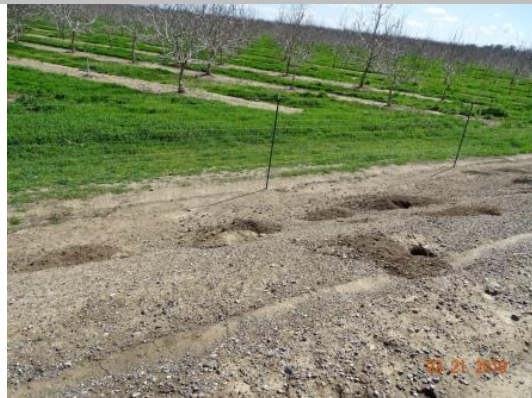
Photo 1 of 1 : FA\_2019\_LD0003\_27\_124\_20190822\_00057.jpg

LM Start	9.03	Rating **	U	Issue No.	124
LM End	9.03	Issue Type +	Ma	Location *	LS
Category	Earthen Levee			GPS Latitude/Longitude	
				Start	End
Item	Animal Control			39.496442°	39.496442°
				-121.988539°	-121.988539°
DWR ID	DWR_LD0003_01_s_2019_124				
Comment Code					
A1 : Exterminate rodents and backfill and compact or grout burrows.					
Inspector Comment

View of multiple large rodent holes on the landside slope, facing downstream. (Spring 2019)

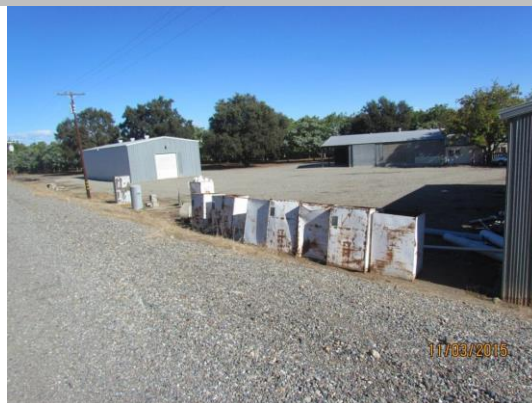
Photo 1 of 1 : FA\_2019\_LD0003\_27\_77\_20190822\_00037.jpg

LM Start	9.12	Rating **	M	Issue No.	77
LM End	9.12	Issue Type +	En	Location *	LS
Category	Earthen Levee			GPS Latitude/Longitude	
				Start	End
Item	Encroachments			39.497452 °	39.497452 °
				-121.987673 °	-121.987673 °
DWR ID	DWR_LD0003_01_f_2015_77				
Comment Code					
EQ : Equipment					
Inspector Comment					
Remove the metal boxes from the landside toe.

View of the metal boxes along the landside toe.

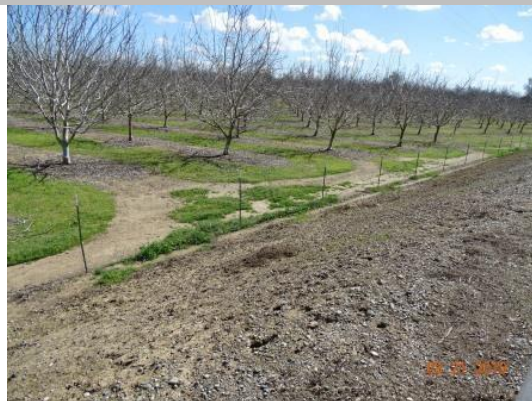
Photo 1 of 1 : FA\_2019\_LD0003\_27\_125\_20190822\_00058.jpg

LM Start	9.50	Rating **	U	Issue No.	125
LM End	9.50	Issue Type +	Ma	Location *	LS
Category	Earthen Levee			GPS Latitude/Longitude	
				Start	End
Item	Animal Control			39.502635 °	39.502635 °
				-121.985245 °	-121.985245 °
DWR ID	DWR_LD0003_01_s_2019_125				
Comment Code					
A1 : Exterminate rodents and backfill and compact or grout burrows.					
Inspector Comment

View of the rodent holes along the landside slope, facing downstream.  
(Spring 2019)

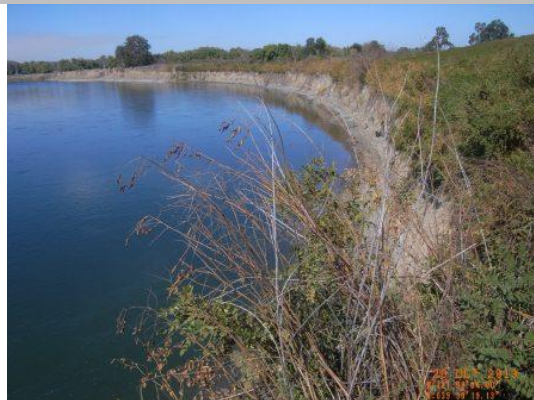
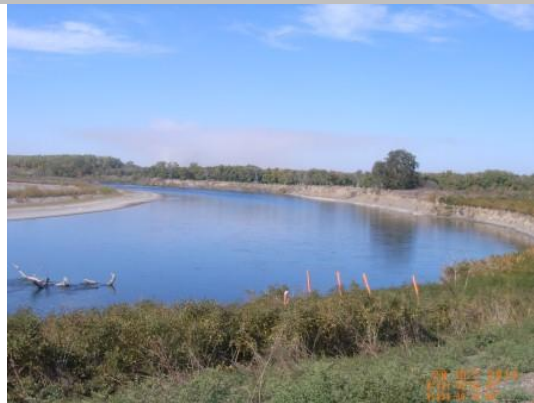
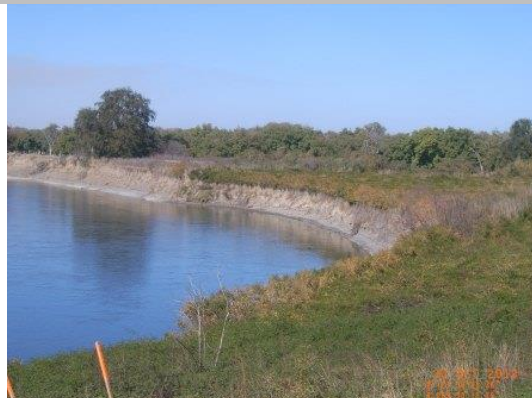
Photo 1 of 3 : FA\_2019\_LD0003\_27\_106\_20190822\_00049.jpg

Comment Code					
Inspector Comment					
2017 Site ID: SAC 172.0 L					
Status: Critical					
2017 Field Notes: Significant erosion in last year. Erosion is entering levee prism, at current erosion rate, one more large storm and the levee will be comprised. Upgraded to critical.					
Site History: 2007 - Getting close to the levee. Bank is clayey silt with clayey/silty toe. 2008 - Looks a little worse at the upstream end. 2009 - Some new erosion and slumping. 2010 - Some new erosion upstream of site, actively eroding at low flow. New bank swallow colony noted.					
2011 - Significant erosion since last year, with an estimated 10 to 15 feet of berm lost. Large sections of the bank have slumped off. 2012 - Part of the site appears to be stabilizing, but still minor slumping in other locations. 2013 - Minor new erosion at toe.

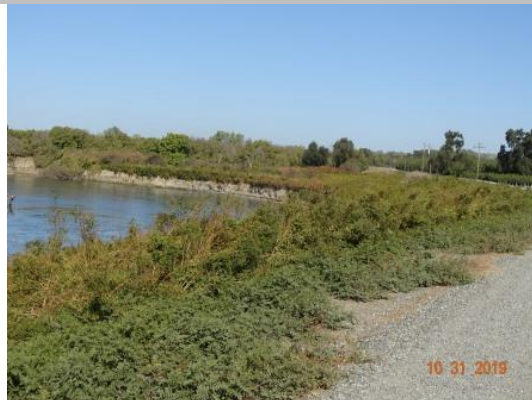
Photo 1 of 1 : FA\_2019\_LD0003\_27\_126\_20191101\_00105.jpg

LM Start	9.64	Rating **	U	Issue No.	126
LM End	9.91	Issue Type +	Ma	Location *	WS
Category	Earthen Levee			GPS Latitude/Longitude	
				Start	End
Item	Vegetation			39.504584 °	39.508475 °
				-121.984522 °	-121.984004 °
DWR ID	DWR_LD0003_01_s_2019_126				
Comment Code					
V2 : Remove the wild growth other than native grasses from the levee slopes.					
Inspector Comment

View of the wild growth along the waterside slope. Fall 2019.
