Flood Control Project Maintenance Levee Inspections

Fall 2021 Levee Maintenance Deficiency Summary Report

Sacramento River Basin

Levee District No. 0003 (Glenn County)

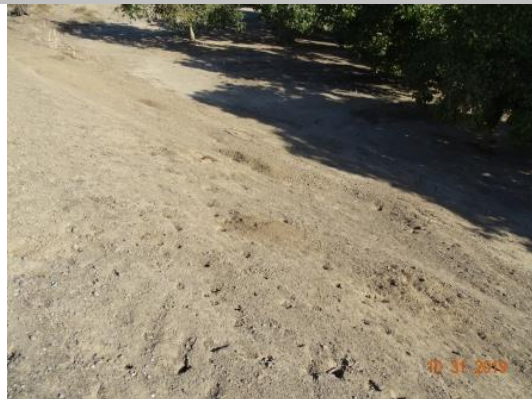
Photo 1 of 1 : FA_2021_LD0003_27_96_20210928_00035.jpg

LM Start	5.19	Rating **	U	Issue No.	96
LM End	5.20	Issue Type +	Ma	Location *	LS
Category	Earthen Levee			GPS Latitude/Longitude	
				Start	End
Item	Animal Control			39.442910 °	39.443166 °
				-121.990941 °	-121.991060 °
DWR ID	DWR_LD0003_01_f_2019_96				
Comment Code					
A3 : No rodents visible, but rodent burrows visible; need to backfill and compact or grout burrows.					
Inspector Comment

View of the rodent burrows on the landside slope. Fall 2019.

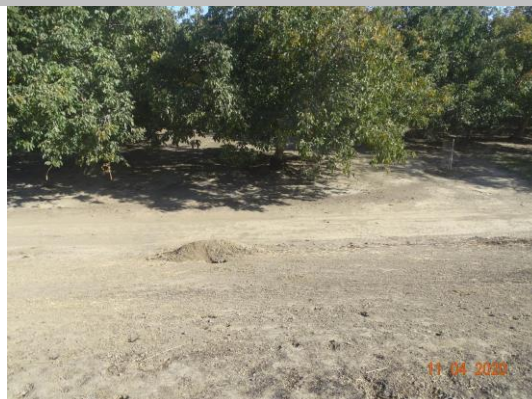
Photo 1 of 1 : FA_2021_LD0003_27_70_20210928_00024.jpg

LM Start	5.38	Rating **	U	Issue No.	70
LM End	5.40	Issue Type +	Ma	Location *	LS
Category	Earthen Levee			GPS Latitude/Longitude	
				Start	End
Item	Animal Control			39.445619 °	39.446008 °
				-121.991510 °	-121.991532 °
DWR ID	DWR_LD0003_01_f_2015_70				
Comment Code					
A3 : No rodents visible, but rodent burrows visible; need to backfill and compact or grout burrows.					
Inspector Comment

View of the rodent activity along the landside slope. Fall 2020.

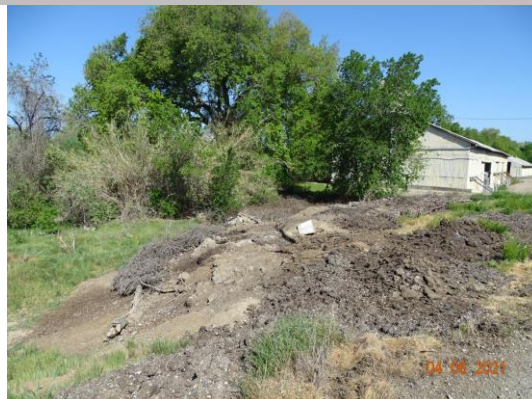
Photo 1 of 1 : FA_2021_LD0003_27_32_20210928_00010.jpg

LM Start	6.40	Rating **	U	Issue No.	32
LM End	6.40	Issue Type +	En	Location *	WS
Category	Earthen Levee			GPS Latitude/Longitude	
				Start	End
Item	Encroachments			39.460234 °	39.460234 °
				-121.993359 °	-121.993359 °
DWR ID	DWR_LD0003_01_s _ 2021_32				
Comment Code					
MA : Material					
Inspector Comment

View of the pile of materials and prunings along the waterside slope and toe. Spring 2021.

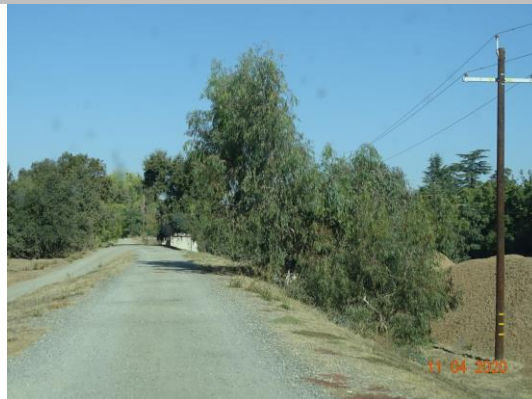
Photo 1 of 1 : FA_2021_LD0003_27_84_20210928_00030.jpg

LM Start	6.50	Rating **	M	Issue No.	84
LM End	6.50	Issue Type +	Ma	Location *	LS
Category	Earthen Levee			GPS Latitude/Longitude	
				Start	End
Item	Trim / Thin Trees			39.461610 °	39.461610 °
				-121.992950 °	-121.992950 °
DWR ID	DWR_LD0003_01_s _ 2016_84				
Comment Code					
T1 : Trim trees to at least five feet above ground level.					
Inspector Comment

View of the trees that require trimming along the landside slope and toe.
Fall 2020.

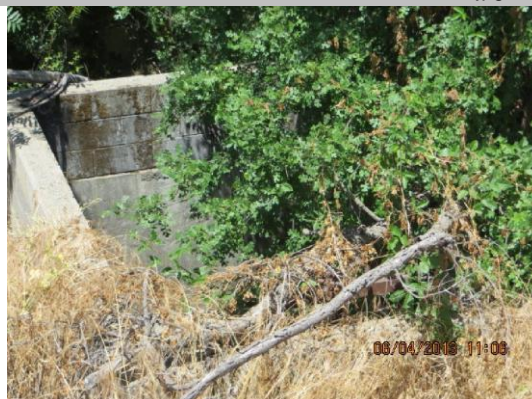
Photo 2 of 3 : UCIP_FA_2021_14664_24161.jpg

Comment Code						
Inspector Comment						
DS_ID:18834 FS_ID:14664 EP_NO: 9906 Repair Type: Non-Urgent EVAL Issue: Crossing Status: Found UCIP Comments: Pipe appears to be abandoned and should be done so properly. FIELD_STRUCT_DESC: 24-inch steel irrigation pipe through the levee, 13 feet below the crown. Slide gate on the waterside (WS) end. Pump house on berm. Slide gate in 7-foot by 12-foot concrete pit on the WS with flap gate on pipe from pump house. Pipe discharges into irrigation ditch on landward side. (Automatic Board Order (ABO) issued as Permit No. 9906, 1974 - Jeanette S. Clare). [Additional Reference(s): DWR Levee Log, 1992. USACE Sacramento O&M Manual 138, July 1955 (Station 1148+70)]. FS Date: 6/4/2013

LM Start	6.54	Rating **	M	Issue No.	139 (cont)
LM End	6.54	Issue Type +	En	Location *	
Category	Supplemental		GPS Latitude/Longitude		
			Start	End	
Item	DWR UCIP Field Study		39.462146 °	39.462146 °	
			-121.992832 °	-121.992832 °	
DWR ID	18834

7'X12' Concrete box with flap gate and slide gate on WS slope.

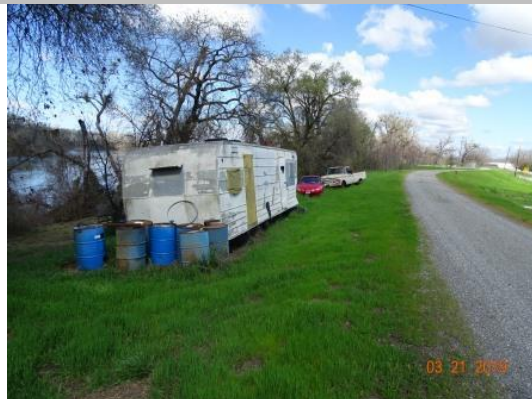
Photo 2 of 2 : FA_2021_LD0003_27_115_20210928_00040.jpg

LM Start	6.57	Rating **	U	Issue No.	115 (cont)
LM End	6.61	Issue Type +	En	Location *	WS
Category	Earthen Levee			GPS Latitude/Longitude	
				Start	End
Item	Encroachments			39.462864 °	39.463182 °
				-121.992703 °	-121.992655 °
DWR ID	DWR_LD0003_01_s _ 2019_115

View of an abandoned RV, cars and drums on the waterside slope, facing upstream.

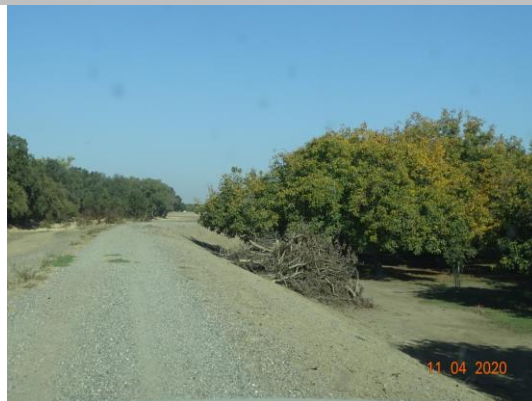
Photo 1 of 1 : FA_2021_LD0003_27_60_20210928_00019.jpg

LM Start	7.68	Rating **	M	Issue No.	60
LM End	7.68	Issue Type +	En	Location *	LS
Category	Earthen Levee			GPS Latitude/Longitude	
				Start	End
Item	Encroachments			39.478464 °	39.478464 °
				-121.990686 °	-121.990686 °
DWR ID	DWR_LD0003_01_f_2013_60				
Comment Code					
PR : Prunings					
Inspector Comment

View of the prunings along the landside toe. Fall 2020.

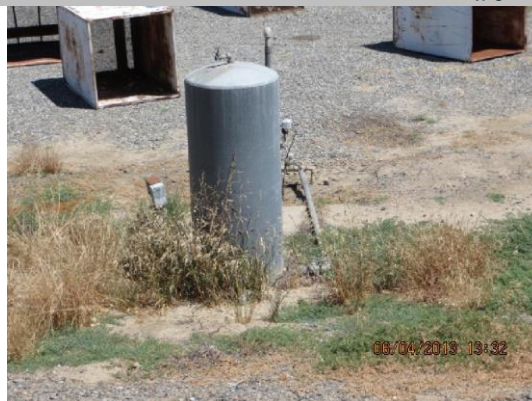
Photo 3 of 3 : UCIP_FA_2021_14688_24188.jpg

LM Start	9.13	Rating **	M	Issue No.	143 (cont)
LM End	9.13	Issue Type +	En	Location *	
Category	Supplemental		GPS Latitude/Longitude		
			Start	End	
Item	DWR UCIP Field Study		39.497575 °	39.497575 °	
			-121.987548 °	-121.987548 °	
DWR ID	18838

Water tank, pump, and well head on LS toe.

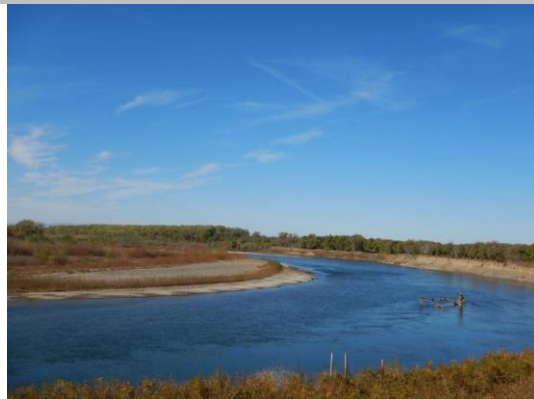
Photo 2 of 2 : FA_2021_LD0003_27_72_20211218_37.jpg

LM Start	9.61	Rating **	M	Issue No.	72 (cont)
LM End	9.88	Issue Type +	Ma	Location *	WS
Category	Supplemental			GPS Latitude/Longitude	
				Start	End
Item	2018 USACE Erosion Survey			39.504388 °	39.508117 °
				-121.985301 °	-121.986562 °
DWR ID

USACE 2018 Erosion Photo #2

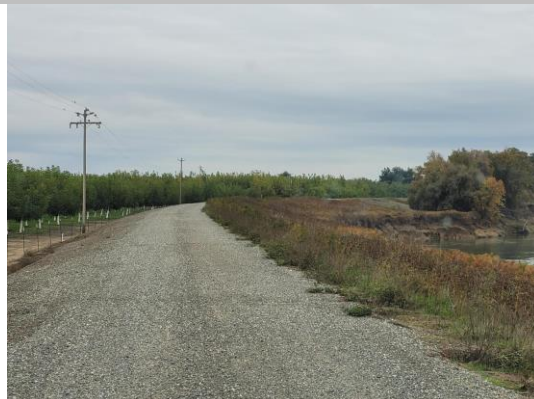
Photo 1 of 1 : FA_2021_LD0003_27_50_20211101_00086.jpg

LM Start	9.66	Rating **	U	Issue No.	50
LM End	9.87	Issue Type +	Ma	Location *	WS
Category	Earthen Levee			GPS Latitude/Longitude	
				Start	End
Item	Vegetation			39.504825 °	39.507909 °
				-121.984385 °	-121.984027 °
DWR ID	DWR_LD0003_01_f_2021_50				
Comment Code					
V2 : Remove the wild growth other than native grasses from the levee slopes.					
Inspector Comment

View of the vegetation along the waterside slope. Fall 2021.
