**Flood Control Project Maintenance
Levee Inspections
Fall 2022 Levee Maintenance Deficiency Summary Report**

Sacramento River Basin

Levee District No. 0003 (Glenn County)

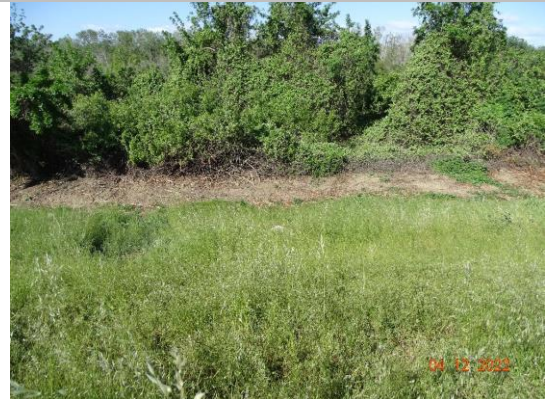
Photo 2 of 3 : UCIP_FA_2022_75909_114045.jpg

LM Start	1.47	Rating **	M	Issue No.	131 (cont)
LM End	1.47	Issue Type +	En	Location *	
Category	Supplemental		GPS Latitude/Longitude		
			Start	End	
Item	DWR UCIP Field Study		39.397780 °	39.397780 °	
			-122.002074 °	-122.002074 °	
DWR ID	18830

Water-Side: View of levee slope looking from crown

DS_ID:18823
FS_ID:75910
EP_NO: 9931
Repair Type: Non-Urgent
EVAL Issue: 5, Pipe Damage
Crossing Status: Found
UCIP Comments: 04/12/2022 Record remains Non-Urgent. DMP internal video inspection has found pipe integrity issues. LOF of crossing is greater than or equal to 4.1 and less than 5. Crossing will be monitored until funding becomes available for rehabilitation. Crossing appears abandoned. Abandoned concrete box at landside toe, slide gate at waterside toe buried in soil. No permit has been identified authorizing pipe. Need to have CVFPB review ABO and determine current owner. (O.Yakimov - DWR UCIP)
06/04/2013 Appears abandoned. Pipe buried at slide gate on WS toe. (W.Wylie - DWR UCIP)
FIELD_STRUCT_DESC: 24-inch corrugated metal irrigation pipe through the levee, 15 feet below the crown. Slide gate on the waterside (WS) end. 6-foot by 7-foot concrete distribution box on the landside (LS) toe. (Automatic Board Order (ABO) issued as Permit No. 9931, 1974 - Lowell F. Steel). [Additional Reference(s): DWR Levee Log, 1992. USACE Sacramento O&M Manual 136, March 1960 (HLM 22.00)].

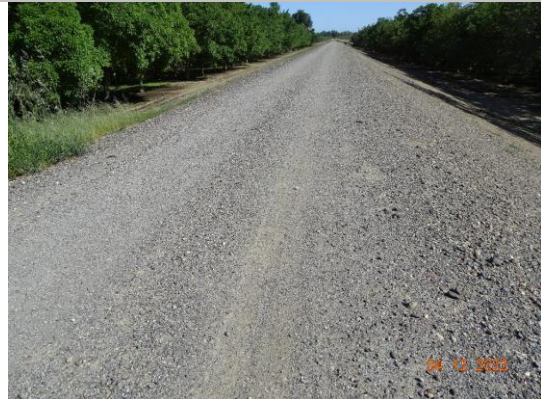
Photo 1 of 3 : UCIP_FA_2022_75910_114049.jpg

LM Start	1.58	Rating **	M	Issue No.	132 (cont)
LM End	1.58	Issue Type +	En	Location *

Top of Levee: View of levee crown looking downstream

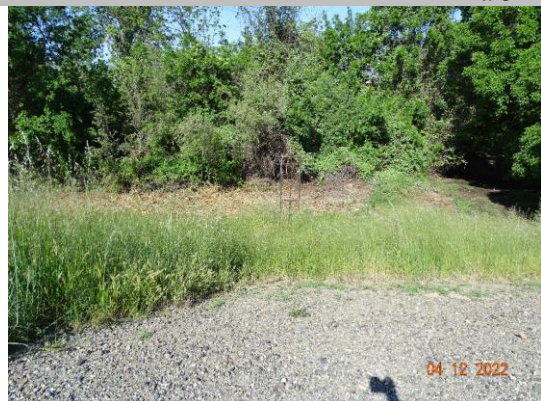
Photo 2 of 3 : UCIP_FA_2022_75910_114051.jpg

Water-Side: View of levee slope looking from crown

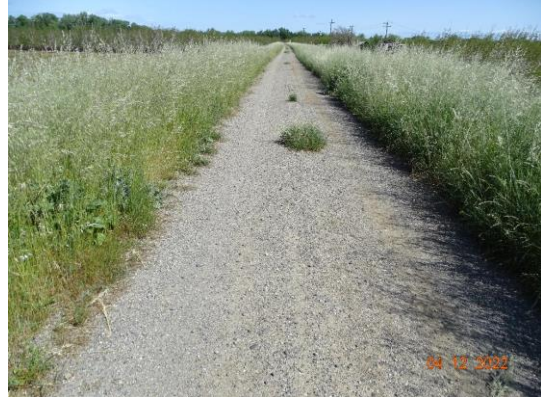
Photo 1 of 3 : UCIP_FA_2022_75911_114054.jpg

Comment Code						
Inspector Comment						
DS_ID:18825 FS_ID:75911 EP_NO: 9935 Repair Type: Non-Urgent EVAL Issue: 5, Pipe Damage Crossing Status: Found UCIP Comments: 04/12/2022 Record remains Non-Urgent. DMP internal video inspection has found pipe integrity issues. LOF of crossing is greater than or equal to 4.1 and less than 5. Crossing will be monitored until funding becomes available for rehabilitation. Crossing appears abandoned. Abandoned slide gate at waterside toe, abandoned concrete box on road shoulder. No permit has been identified authorizing pipe. Need to have CVFPB review ABO and determine current owner. (O.Yakimov - DWR UCIP) 06/04/2013 Appears abandoned. Pipe buried on WS toe. Debris and steel plate blocking inlet on LS. (W.Wylie - DWR UCIP) FIELD_STRUCT_DESC: 24-inch corrugated metal irrigation pipe through the levee and beneath the roadway, 18 feet below the crown. Slide gate on the waterside (WS) end. (Automatic Board Order (ABO) issued as Permit No. 9935, 1974 - Florence Watt). [Additional Reference(s): DWR Levee Log, 1992. USACE Sacramento O&M Manual 136, March 1960 (HLM 22.30)]. FS Date: 4/12/2022 8:09:01 AM

LM Start	1.87	Rating **	M	Issue No.	133 (cont)
LM End	1.87	Issue Type +	En	Location *

Top of Levee: View of levee crown looking upstream

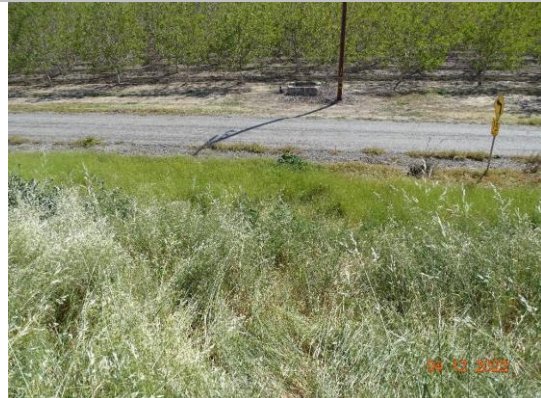
Photo 2 of 3 : UCIP_FA_2022_75911_114055.jpg

Land-Side: View of levee slope looking from crown, concrete distribution box on road shoulder

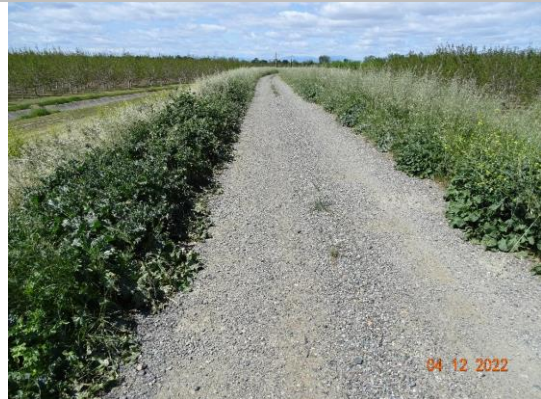
Photo 1 of 3 : UCIP_FA_2022_75922_114120.jpg

Comment Code						
Inspector Comment						
DS_ID:18826 FS_ID:75922 EP_NO: 2045 Repair Type: Non-Urgent EVAL Issue: 11, Maintenance Compliance Issue Crossing Status: Indicator Found UCIP Comments: 04/12/2022 Record updated from No Action Needed to Non-Urgent. No inspection records were available to determine status of line through the levee. Gas line sign on levee crown was removed. No markers on waterside found. Recommend owner to install additional markers. (O.Yakimov - DWR UCIP) FIELD_STRUCT_DESC: 12.75-inch steel high pressure gas line through the levee, 2 feet below the crown, PG&E. Concrete cutoff wall. Shutoff valve on LS toe. Gas line marker at irrigation canal on LS. (Permit. No. 2045, 1955 - PG&E). [Additional Reference(s): DWR Levee Log, 1992]. FS Date: 4/12/2022 1:22:02 PM

LM Start	2.37	Rating **	M	Issue No.	135 (cont)
LM End	2.37	Issue Type +	En	Location *

Top of Levee: View of levee crown looking downstream

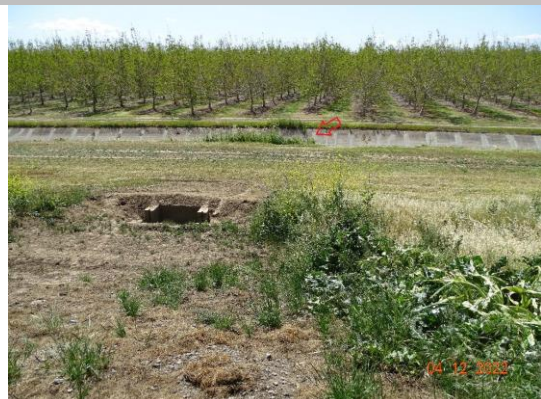
Photo 2 of 3 : UCIP_FA_2022_75922_114121.jpg

Land-Side: View of levee slope looking from crown. Arrow shows location of marker

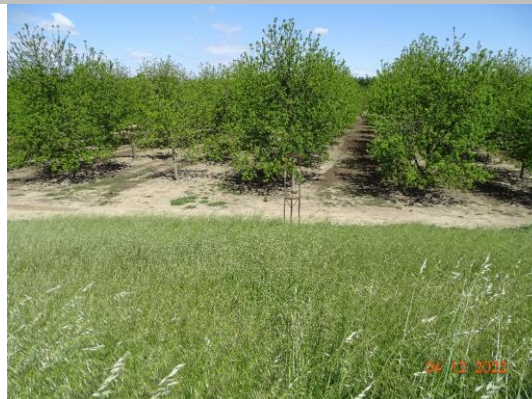
Photo 2 of 3 : UCIP_FA_2022_75924_114123.jpg

LM Start	2.38	Rating **	M	Issue No.	136 (cont)
LM End	2.38	Issue Type +	En	Location *	
Category	Supplemental		GPS Latitude/Longitude		
			Start	End	
Item	DWR UCIP Field Study		39.406471 °	39.406471 °	
			-121.995551 °	-121.995551 °	
DWR ID	18827

Water-Side: View of levee slope looking from crown. Abandoned slide gate at levee toe

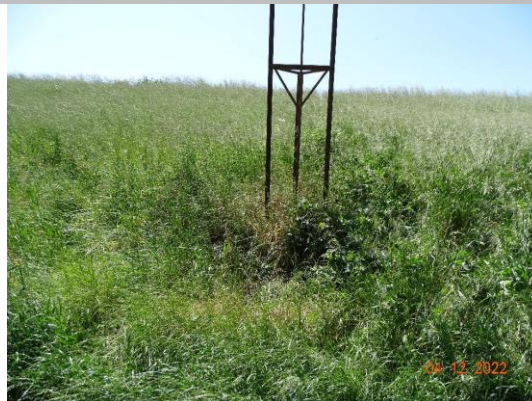
Photo 3 of 3 : UCIP_FA_2022_75924_114127.jpg

LM Start	2.38	Rating **	M	Issue No.	136 (cont)
LM End	2.38	Issue Type +	En	Location *

Water-Side: Buried in soil slide gate at levee toe

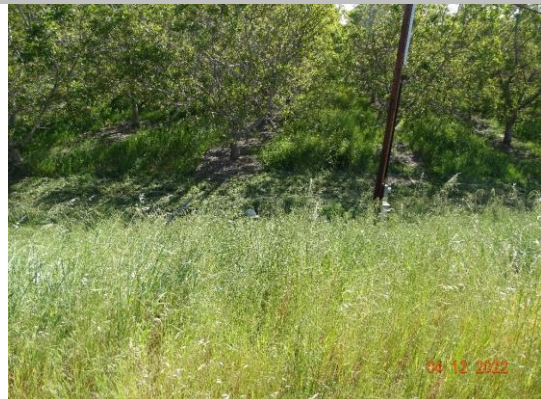
Photo 1 of 3 : UCIP_FA_2022_75931_114149.jpg

Comment Code					
Inspector Comment					
DS_ID:18822 FS_ID:75931 EP_NO: 9915 Repair Type: Non-Urgent EVAL Issue: 10, Unauthorized Modification or Non-Compliant Permit Crossing Status: Found UCIP Comments: 04/12/2022 Record updated from No Action Needed to Non-Urgent. Unauthorized encroachment recorded in Levee Log. Unauthorized pipe material used: PVC pipe through the levee. (O.Yakimov - DWR UCIP) FIELD_STRUCT_DESC: 3-inch polyvinyl chloride (PVC) irrigation pipe through the levee, at an unknown depth. Water well, shutoff valve, vent, power pole, and meter at the landside (LS) toe. Guy wire anchor in the LS slope. (Well and pump at the landward toe [HLM 5.11] authorized under Automatic Board Order (ABO) issued as Permit No. 9915, 1974 - B. J. and Edward Gordon). FS Date: 4/12/2022 3:14:31 PM

Land-Side: View of levee slope looking from crown

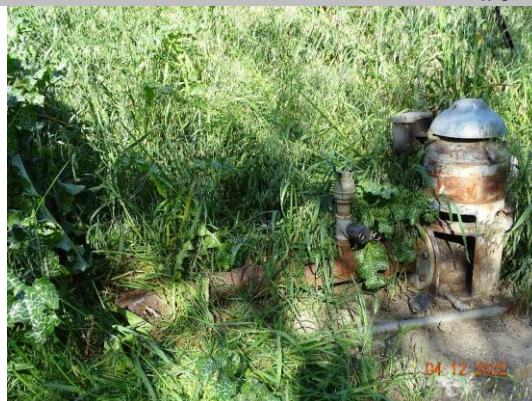
Photo 2 of 3 : UCIP_FA_2022_75931_114151.jpg

LM Start	5.01	Rating **	M	Issue No.	137 (cont)
LM End	5.01	Issue Type +	En	Location *	
Category	Supplemental		GPS Latitude/Longitude		
			Start	End	
Item	DWR UCIP Field Study		39.440425 °	39.440425 °	
			-121.990160 °	-121.990160 °	
DWR ID	18822

Land-Side: Water well at levee toe. PVC pipe is entering levee slope

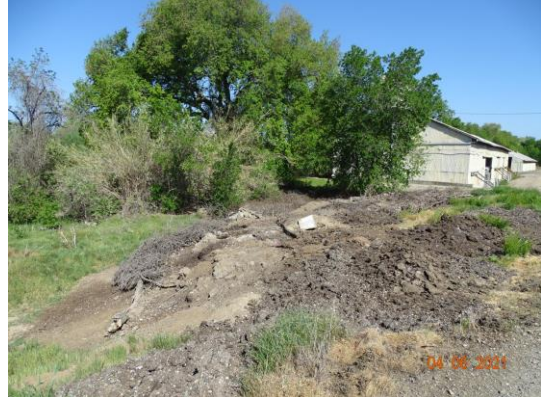
Photo 1 of 1 : FA_2022_LD0003_27_32_20220906_00009.jpg

LM Start	6.40	Rating **	U	Issue No.	32
LM End	6.40	Issue Type +	En	Location *	WS
Category	Earthen Levee			GPS Latitude/Longitude	
				Start	End
Item	Encroachments			39.460234 °	39.460234 °
				-121.993359 °	-121.993359 °
DWR ID	DWR_LD0003_01_s _ 2021_32				
Comment Code					
MA : Material					
Inspector Comment

View of the pile of materials and prunings along the waterside slope and toe. Spring 2021.

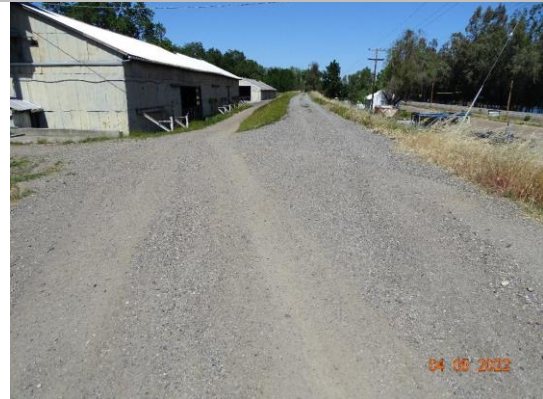
Photo 1 of 3 : UCIP_FA_2022_75950_114197.jpg

Comment Code					
Inspector Comment					
DS_ID:18845 FS_ID:75950 EP_NO: N/A Repair Type: No Action Needed EVAL Issue: Crossing Status: Not Found UCIP Comments: 04/05/2022 Record updated from No Action Needed to Non-Urgent. Crossing not found. Geophysical study indicates possible presence of pipe through levee. Owner needs to coordinate with the CVFPB to remove or abandon crossing according to Title 23 requirements. Coordinates updated to match geophysical report. No permit has been identified authorizing pipe. (O.Yakimov - DWR UCIP) 06/04/2013 Not found. (W.Wylie - DWR UCIP) FIELD_STRUCT_DESC: 10-inch corrugated metal drainage pipe through the levee, at an unknown depth, not found. A Calco Model 100 Gate installed on the waterside (WS), not found. [Additional Reference(s): USACE Sacramento O&M Manual 138, July 1955 (Station 1142+10)]. FS Date: 4/5/2022 9:14:47 AM

Top of Levee: View of levee crown looking upstream

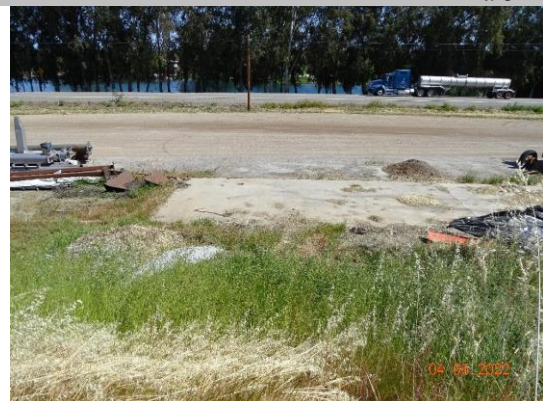
Photo 2 of 3 : UCIP_FA_2022_75950_114193.jpg

LM Start	6.42	Rating **	A/W	Issue No.	138 (cont)
LM End	6.42	Issue Type +	Ma	Location *

Land-Side: View of levee slope looking from crown

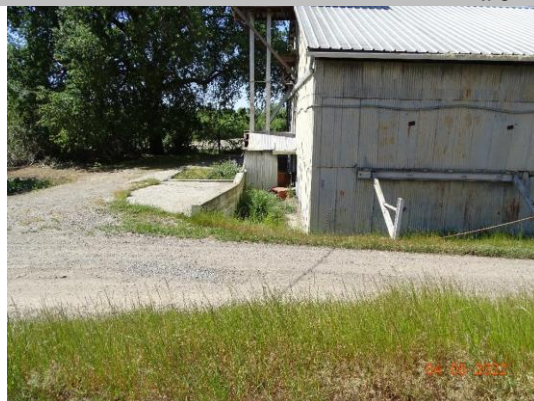
Photo 3 of 3 : UCIP_FA_2022_75950_114194.jpg

LM Start	6.42	Rating **	A/W	Issue No.	138 (cont)
LM End	6.42	Issue Type +	Ma	Location *	
Category	Supplemental			GPS Latitude/Longitude	
				Start	End
Item	DWR UCIP LMA Responsibility			39.460595 °	39.460595 °
				-121.993174 °	-121.993174 °
DWR ID	18845

Water-Side: View of levee slope looking from crown at the site where geophysical survey suggests the pipe

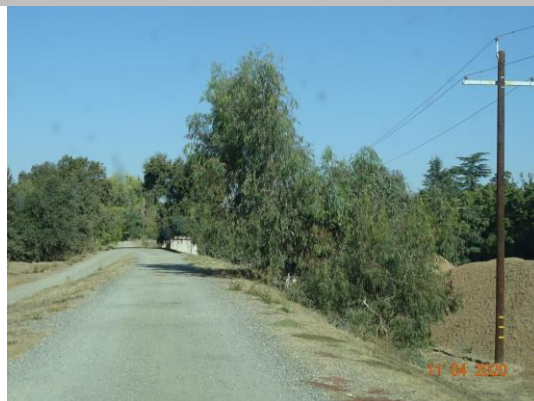
Photo 1 of 1 : FA_2022_LD0003_27_84_20220906_00033.jpg

LM Start	6.50	Rating **	M	Issue No.	84
LM End	6.50	Issue Type +	Ma	Location *	LS
Category	Earthen Levee			GPS Latitude/Longitude	
				Start	End
Item	Trim / Thin Trees			39.461610 °	39.461610 °
				-121.992950 °	-121.992950 °
DWR ID	DWR_LD0003_01_s_2016_84				
Comment Code					
T1 : Trim and thin trees to at least five feet above ground level to allow visibility of the ground and room to flood fight.					
Inspector Comment

View of the trees that require trimming along the landside slope and toe. Fall 2020.

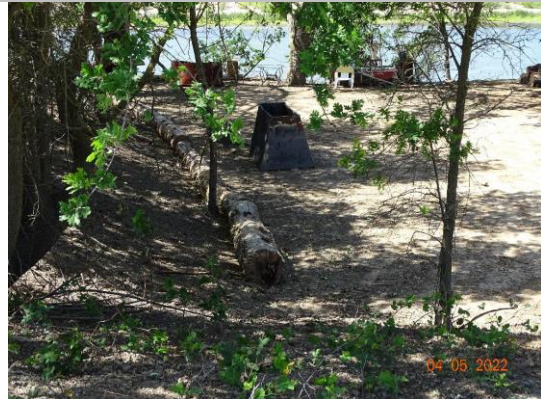
Photo 2 of 3 : UCIP_FA_2022_75961_114236.jpg

LM Start	6.55	Rating **	M	Issue No.	139 (cont)
LM End	6.55	Issue Type +	Ma	Location *	
Category	Supplemental		GPS Latitude/Longitude		
			Start	End	
Item	DWR UCIP LMA Responsibility		39.462215 °	39.462215 °	
			-121.992802 °	-121.992802 °	
DWR ID	18844

Water-Side: View of levee slope looking from crown

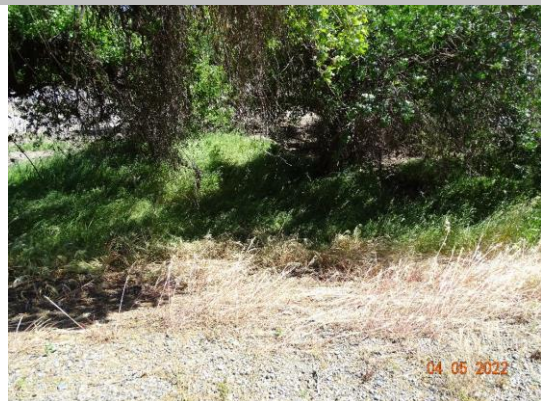
Photo 3 of 3 : UCIP_FA_2022_75961_114235.jpg

LM Start	6.55	Rating **	M	Issue No.	139 (cont)
LM End	6.55	Issue Type +	Ma	Location *

Land-Side: View of levee slope looking from crown

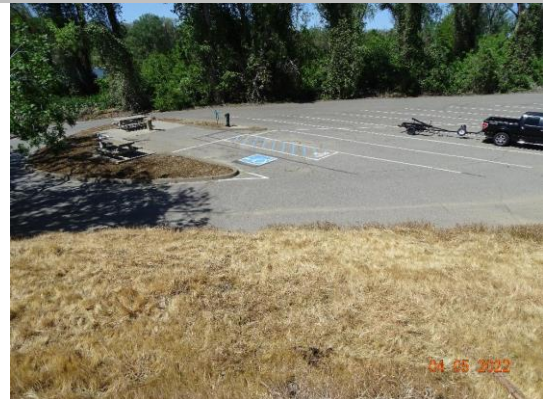
Photo 1 of 3 : UCIP_FA_2022_75967_114257.jpg

LM Start	6.72	Rating **	U	Issue No.	140 (cont)
LM End	6.72	Issue Type +	En	Location *

Water-Side: View of levee slope looking from crown

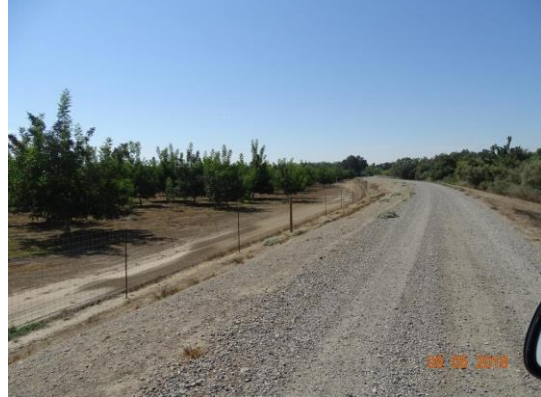
Photo 1 of 1 : FA_2022_LD0003_27_85_20220906_00034.jpg

LM Start	8.79	Rating **	M	Issue No.	85
LM End	9.09	Issue Type +	En	Location *	LS
Category	Earthen Levee			GPS Latitude/Longitude	
				Start	End
Item	Encroachments			39.493498 °	39.497052 °
				-121.990820 °	-121.987823 °
DWR ID	DWR_LD0003_01_f _ 2018_85				
Comment Code					
FE : Fence					
Inspector Comment					
Temporary fence from landside toe should be removed.

View of the fence along the landside toe.

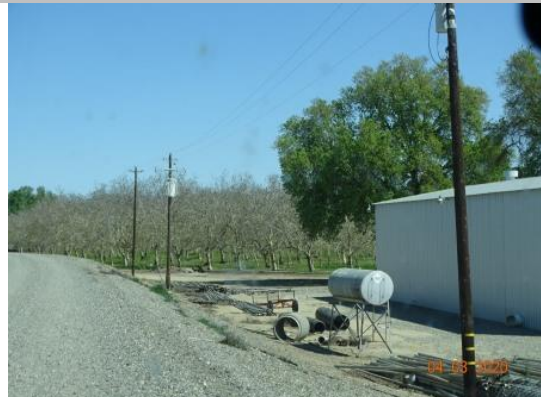
Photo 1 of 1 : FA_2022_LD0003_27_77_20220906_00030.jpg

LM Start	9.12	Rating **	M	Issue No.	77
LM End	9.12	Issue Type +	En	Location *	LS
Category	Earthen Levee			GPS Latitude/Longitude	
				Start	End
Item	Encroachments			39.497452 °	39.497452 °
				-121.987673 °	-121.987673 °
DWR ID	DWR_LD0003_01_s_2022_77				
Comment Code					
EQ : Equipment					
Inspector Comment

View of the equipment along the landside toe. Spring 2020.

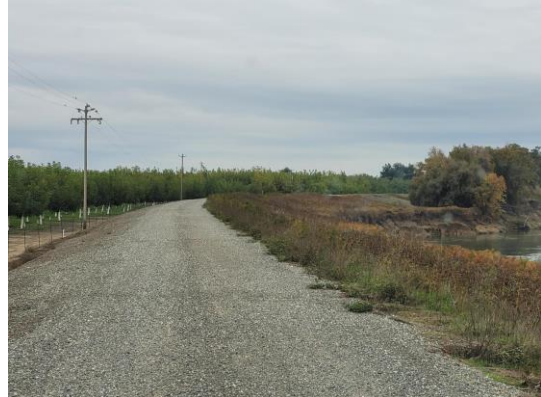
Photo 1 of 1 : FA_2022_LD0003_27_50_20220906_00016.jpg

LM Start	9.66	Rating **	U	Issue No.	50
LM End	9.87	Issue Type +	Ma	Location *	WS
Category	Earthen Levee			GPS Latitude/Longitude	
				Start	End
Item	Vegetation			39.504825 °	39.507909 °
				-121.984385 °	-121.984027 °
DWR ID	DWR_LD0003_01_f_2021_50				
Comment Code					
V2 : Remove the wild growth and woody vegetation other than native grasses from the levee slopes.					
Inspector Comment

View of the vegetation along the waterside slope. Fall 2021.
