**Flood Control Project Maintenance
Levee Inspections
Fall 2023 Levee Maintenance Deficiency Summary Report**

Sacramento River Basin

Levee District No. 0003 (Glenn County)

Waterway			Bank	Unit Miles
Unit No. 01 Glenn County Sacramento River			Left	11.97
	Spring (March - May)	Summer (June - August)	(September - November) Fall	Winter (December - February)
Unit Maintenance Rating (Fall Only)			U	
Date of Inspection	5/11/2023 - 5/11/2023		10/4/2023 - 10/4/2023	
DWR Inspector	Makar Sokol		Makar Sokol	
Accompanied By

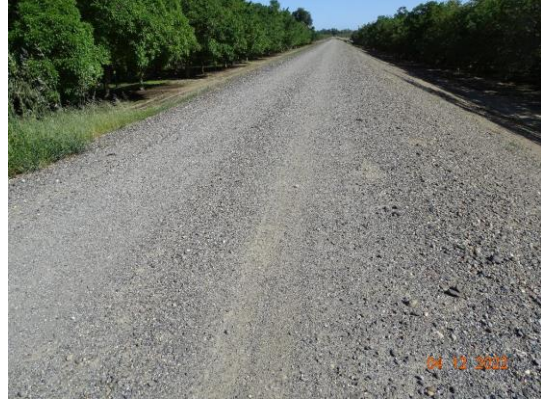
Photo 1 of 3 : UCIP_FA_2023_75910_114049.jpg

Top of Levee: View of levee crown looking downstream

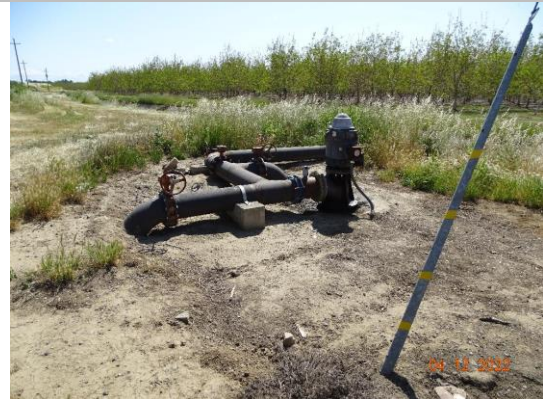
Photo 2 of 3 : UCIP_FA_2023_75921_114114.jpg

Comment Code						
Inspector Comment						
DS_ID:23151 FS_ID:75921 EP_NO: N/A Repair Type: Non-Urgent EVAL Issue: 11, Maintenance Compliance Issue Crossing Status: Found UCIP Comments: 04/12/2022 Record remains Non-Urgent. No permit has been found authorizing this pipe through the levee. Steel riser on landside shoulder was knocked down and needs repair. (O.Yakimov - DWR UCIP) 06/04/2013 No permit identified for this crossing. (W.Wylie - DWR UCIP) FIELD_STRUCT_DESC: 12-inch steel irrigation pipe through the levee, 3.5 feet below the crown. Agricultural water well, butterfly valve, and JP/meter at channel on landside (LS) toe. Three discharge pipes are coming from the well: towards orchard on LS, to fill LS irrigation canal, and through the levee. Siphon breaker inside a 12-inch steel riser unit on the LS shoulder. 3-inch plastic drain on the waterside (WS) toe. FS Date: 4/12/2022 1:11:30 PM

Land-Side: Agricultural well on levee berm

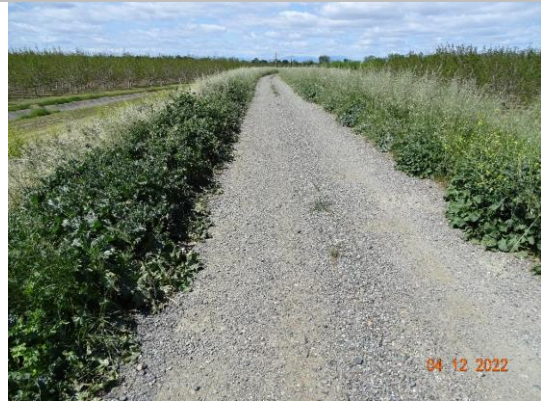
Photo 1 of 3 : UCIP_FA_2023_75922_114120.jpg

Comment Code					
Inspector Comment					
DS_ID:18826 FS_ID:75922 EP_NO: 2045 Repair Type: Non-Urgent EVAL Issue: 11, Maintenance Compliance Issue Crossing Status: Indicator Found UCIP Comments: 04/12/2022 Record updated from No Action Needed to Non-Urgent. No inspection records were available to determine status of line through the levee. Gas line sign on levee crown was removed. No markers on waterside found. Recommend owner to install additional markers. (O.Yakimov - DWR UCIP) FIELD_STRUCT_DESC: 12.75-inch steel high pressure gas line through the levee, 2 feet below the crown, PG&E. Concrete cutoff wall. Shutoff valve on LS toe. Gas line marker at irrigation canal on LS. (Permit. No. 2045, 1955 - PG&E). [Additional Reference(s): DWR Levee Log, 1992]. FS Date: 4/12/2022 1:22:02 PM

Top of Levee: View of levee crown looking downstream

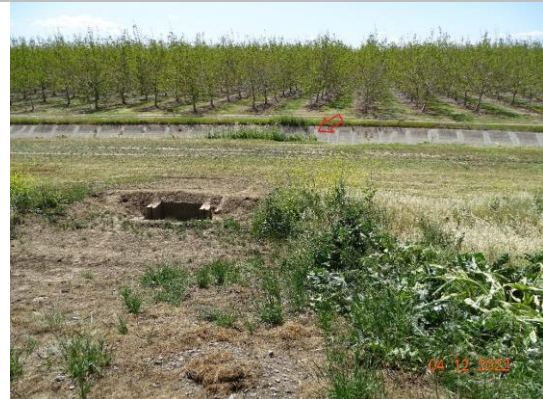
Photo 2 of 3 : UCIP_FA_2023_75922_114121.jpg

Land-Side: View of levee slope looking from crown. Arrow shows location of marker

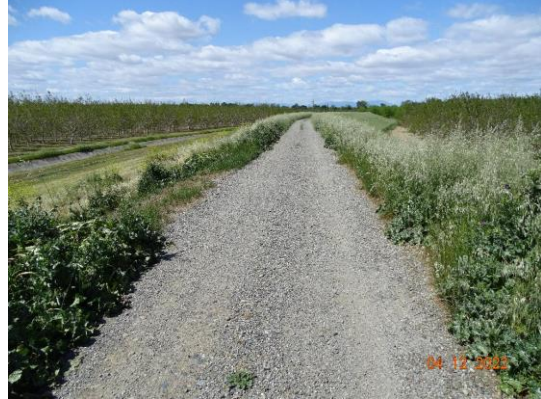
Photo 1 of 3 : UCIP_FA_2023_75924_114122.jpg

DS_ID:18827
FS_ID:75924
EP_NO: 9936
Repair Type: Non-Urgent
EVAL Issue: 5, Pipe Damage
Crossing Status: Found
UCIP Comments: 04/12/2022 Record remains Non-Urgent. DMP internal video inspection has found pipe integrity issues. LOF of crossing is greater than or equal to 4.1 and less than 5. Crossing will be monitored until funding becomes available for rehabilitation. Crossing appears abandoned. DMP cleared from soil concrete distribution box on landside berm that appears abandoned. Abandoned and buried in soil slide gate at waterside toe. No permit has been identified authorizing pipe. Need to have CVFPB review ABO and determine current owner. (O.Yakimov - DWR UCIP)
06/04/2013 Appears abandoned. Pipe buried on WS and blocked with tin and soil on the LS. (W.Wylie - DWR UCIP)
FIELD_STRUCT_DESC: 24-inch corrugated metal irrigation pipe through the levee, 18.3 feet below crown. Slide gate on the waterside (WS) end. 5-foot by 7-foot concrete distribution box at the landside (LS) toe. (Automatic Board Order (ABO) issued as Permit No. 9936, 1974 - J. A. and Florence Watt). [Additional Reference(s): DWR Levee Log, 1992. USACE Sacramento O&M Manual 136, March 1960 (HLM 22.82)].

Top of Levee: View of levee crown looking downstream

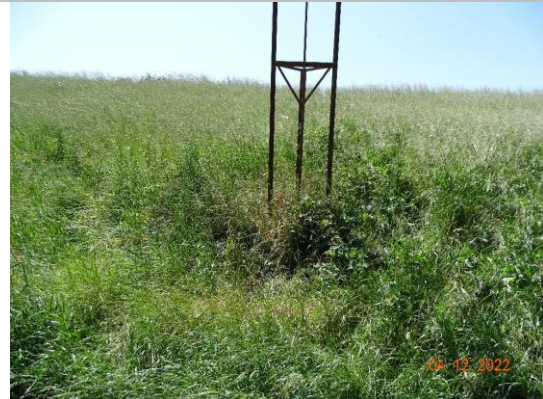
Photo 3 of 3 : UCIP_FA_2023_75924_114127.jpg

Water-Side: Buried in soil slide gate at levee toe

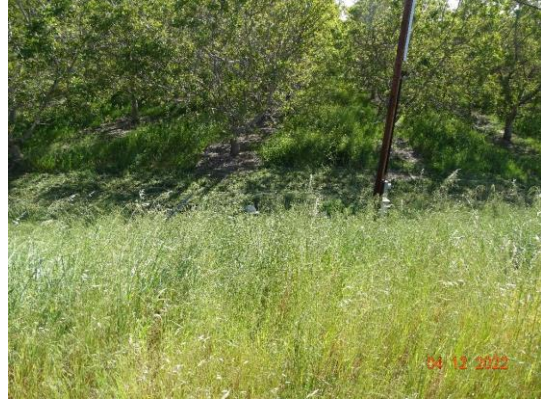
Photo 1 of 3 : UCIP_FA_2023_75931_114149.jpg

DS_ID:18822
FS_ID:75931
EP_NO: 9915
Repair Type: Non-Urgent
EVAL Issue: 10, Unauthorized Modification or Non-Compliant Permit
Crossing Status: Found
UCIP Comments: 04/12/2022 Record updated from No Action Needed to Non-Urgent. Unauthorized encroachment recorded in Levee Log.
Unauthorized pipe material used: PVC pipe through the levee.
(O.Yakimov - DWR UCIP)

Land-Side: View of levee slope looking from crown

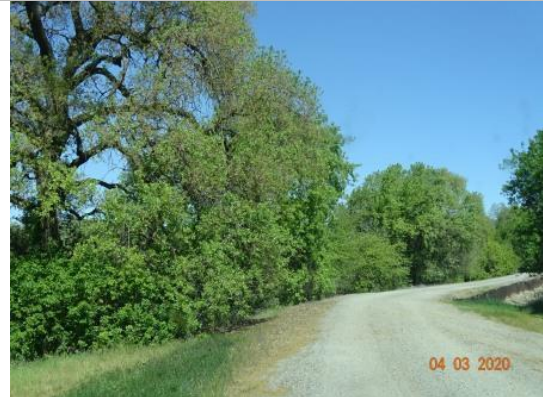
Photo 1 of 1 : FA_2023_LD0003_27_48_20231002_00015.jpg

LM Start	6.29	Rating **	M	Issue No.	48
LM End	6.37	Issue Type +	Ma	Location *	WS
Category	Earthen Levee			GPS Latitude/Longitude	
				Start	End
Item	Trim / Thin Trees			39.458587°	39.459862°
				-121.993777°	-121.993635°
DWR ID	DWR_LD0003_01_s_2012_48				
Comment Code					
T1 : Trim and thin trees to at least five feet above ground level to allow visibility of the ground and room to flood fight.					
Inspector Comment

View of the trees that need to be trimmed to at least 5 feet above the ground. Spring 2020.

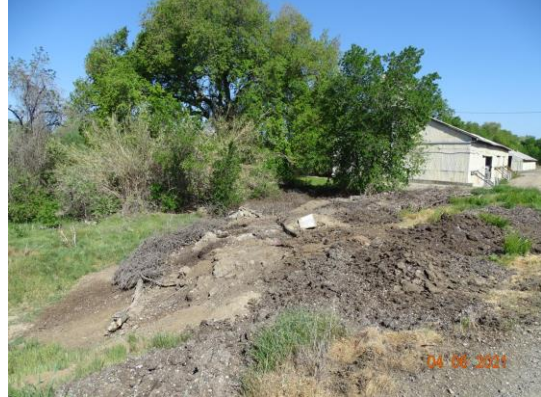
Photo 1 of 1 : FA_2023_LD0003_27_32_20231002_00010.jpg

LM Start	6.40	Rating **	U	Issue No.	32
LM End	6.40	Issue Type +	En	Location *	WS
Category	Earthen Levee			GPS Latitude/Longitude	
				Start	End
Item	Encroachments			39.460234°	39.460234°
				-121.993359°	-121.993359°
DWR ID	DWR_LD0003_01_s_2021_32				
Comment Code					
MA : Material					
Inspector Comment

View of the pile of materials and prunings along the waterside slope and toe. Spring 2021.

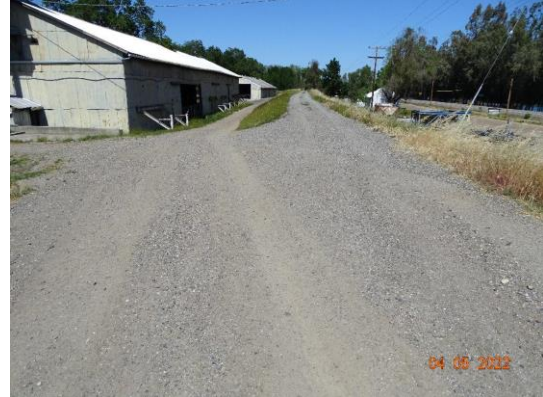
Photo 1 of 3 : UCIP_FA_2023_75950_114197.jpg

Comment Code					
Inspector Comment					
DS_ID:18845 FS_ID:75950 EP_NO: N/A Repair Type: No Action Needed EVAL Issue: Crossing Status: Not Found UCIP Comments: 04/05/2022 Record updated from No Action Needed to Non-Urgent. Crossing not found. Geophysical study indicates possible presence of pipe through levee. Owner needs to coordinate with the CVFPB to remove or abandon crossing according to Title 23 requirements. Coordinates updated to match geophysical report. No permit has been identified authorizing pipe. (O.Yakimov - DWR UCIP) 06/04/2013 Not found. (W.Wylie - DWR UCIP) FIELD_STRUCT_DESC: 10-inch corrugated metal drainage pipe through the levee, at an unknown depth, not found. A Calco Model 100 Gate installed on the waterside (WS), not found. [Additional Reference(s): USACE Sacramento O&M Manual 138, July 1955 (Station 1142+10)]. FS Date: 4/5/2022 9:14:47 AM

Top of Levee: View of levee crown looking upstream

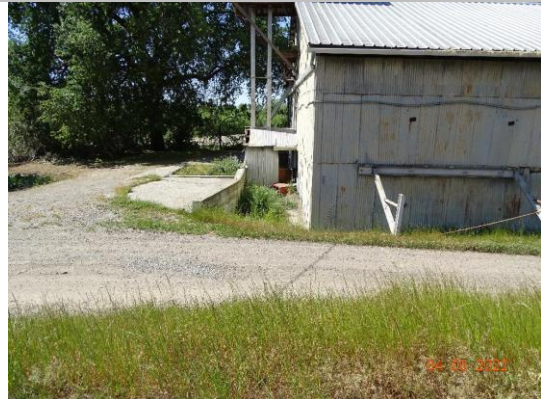
Photo 3 of 3 : UCIP_FA_2023_75950_114194.jpg

Water-Side: View of levee slope looking from crown at the site where geophysical survey suggests the pipe

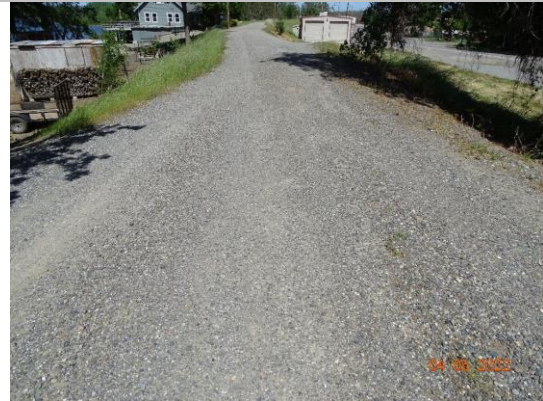
Photo 1 of 3 : UCIP_FA_2023_75961_114237.jpg

Comment Code						
Inspector Comment						
DS_ID:18844 FS_ID:75961 EP_NO: N/A Repair Type: Non-Urgent EVAL Issue: Crossing Status: Not Found UCIP Comments: 04/05/2022 Record updated from No Action Needed to Non-Urgent. Crossing not found. Geophysical results did not confirm presence of pipe through levee. Record will remain in UCIP's inspection records until future Levee Improvement Project can confirm no crossing was found through the levee. No permit has been identified authorizing pipe. (O.Yakimov - DWR UCIP) 06/04/2013 Unable to locate. (G.Wylie - DWR UCIP) FIELD_STRUCT_DESC: 10-inch corrugated metal drainage pipe through the levee, at an unknown depth, not found. A Calco Model 100 gate installed on the waterside (WS), not found. [Additional Reference(s): USACE Sacramento O&M Manual 138, July 1955 (Station 1149+00)]. FS Date: 4/5/2022 1:35:11 PM

Top of Levee: View of levee crown looking upstream

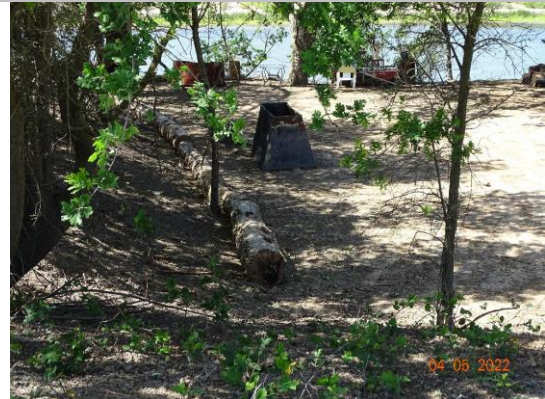
Photo 2 of 3 : UCIP_FA_2023_75961_114236.jpg

Water-Side: View of levee slope looking from crown

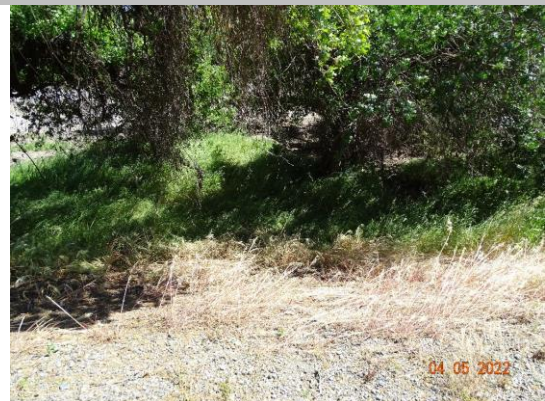
Photo 3 of 3 : UCIP_FA_2023_75961_114235.jpg

Land-Side: View of levee slope looking from crown

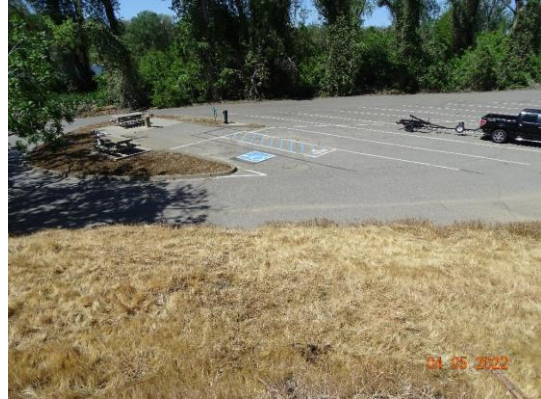
Photo 1 of 3 : UCIP_FA_2023_75967_114257.jpg

Water-Side: View of levee slope looking from crown

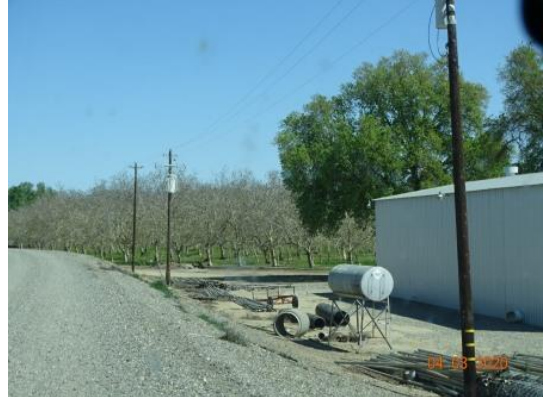
Photo 1 of 1 : FA_2023_LD0003_27_77_20231002_00027.jpg

LM Start	9.12	Rating **	M	Issue No.	77
LM End	9.12	Issue Type +	En	Location *	LS
Category	Earthen Levee			GPS Latitude/Longitude	
				Start	End
Item	Encroachments			39.497452°	39.497452°
				-121.987673°	-121.987673°
DWR ID	DWR_LD0003_01_s_2022_77				
Comment Code					
EQ : Equipment					
Inspector Comment

View of the equipment along the landside toe. Spring 2020.

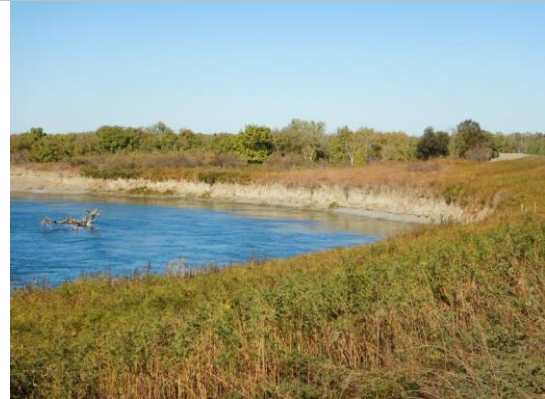
Photo 1 of 2 : FA_2023_LD0003_27_72_20231002_00024.jpg

LM Start	9.61	Rating **	M	Issue No.	72 (cont)
LM End	9.88	Issue Type +	Ma	Location *	WS

USACE 2018 Erosion Photo #1

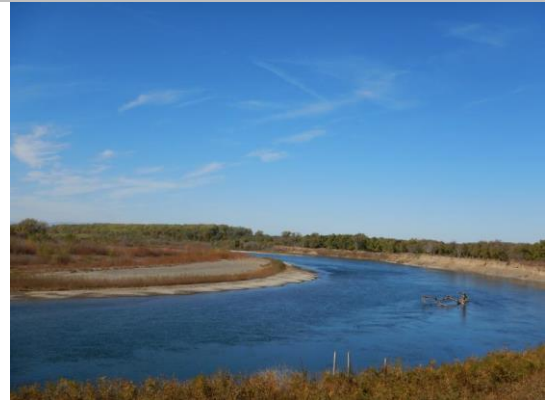
Photo 2 of 2 : FA_2023_LD0003_27_72_20231002_00025.jpg

USACE 2018 Erosion Photo #2
