**Flood Control Project Maintenance
Levee Inspections**
LMA District Cover Sheet
Spring 2016 Levee Inspection Results

Levee District No. 0003 (Glenn County)

Spring 2016 Levee Inspection Results

Waterway	Bank	Unit Miles
Unit No. 01 Glenn County Sacramento River	Left	11.97

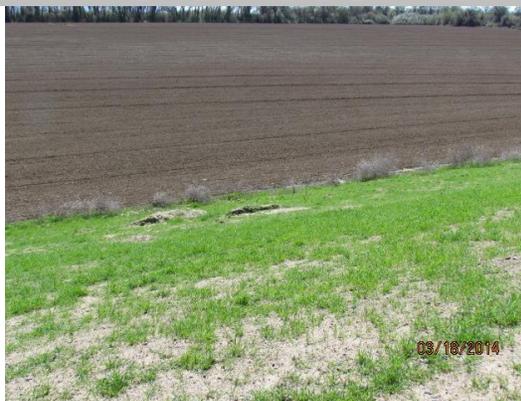
Photo 1 of 1 : SP_2016_LD0003_27_55_20160324_00032.jpg

LM Start	0.69	Rating **	M	Issue No.	55
LM End	0.69	Issue Type +	Ma	Location *	WS
Category	Earthen Levee		GPS Latitude/Longitude		
			Start	End	
Item	Animal Control		39.388716 °	39.388716 °	
			-121.997774 °	-121.997774 °	
DWR ID	DWR_LD0003_01_s_2014_55				
Comment Code					
A1 : Exterminate rodents and backfill and compact or grout burrows.					
Inspector Comment

View of the rodent activity along the w/s slope.

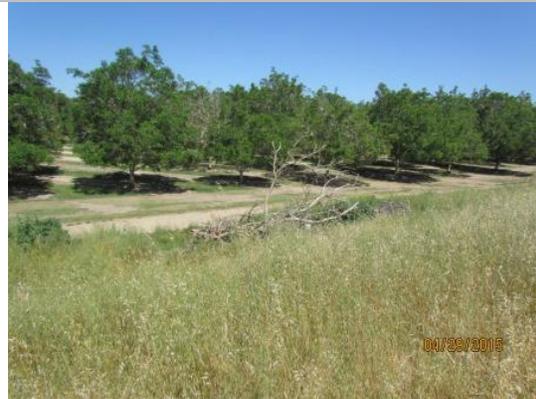
Photo 1 of 1 : SP_2016_LD0003_27_43_20160324_00022.jpg

View of the prunings along the waterside slope.

LM Start	3.98	Rating **	M	Issue No.	43
LM End	3.98	Issue Type +	En	Location *	WS
Category	Earthen Levee		GPS Latitude/Longitude		
			Start	End	
Item	Encroachments		39.426325 °	39.426325 °	
			-121.989198 °	-121.989198 °	
DWR ID	DWR_LD0003_01_s_2015_43				
Comment Code					
PR : Prunings					
Inspector Comment					
Remove the prunings from the waterside slope.

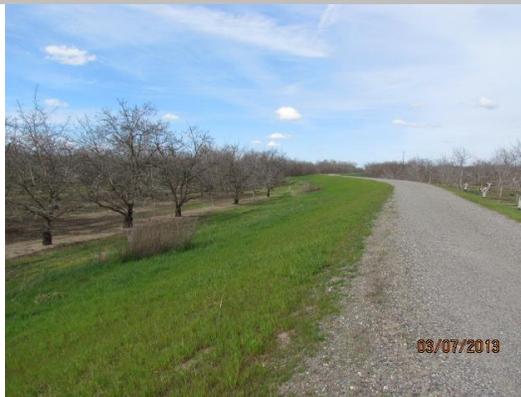
Photo 1 of 2 : SP_2016_LD0003_27_21_20160324_00014.jpg

View of no rodent activity.

LM Start	5.06	Rating **	U	Issue No.	21
LM End	5.25	Issue Type +	Ma	Location *	LS
Category	Earthen Levee			GPS Latitude/Longitude	
				Start	End
Item	Animal Control			39.441128 °	39.443793 °
				-121.990475 °	-121.991297 °
DWR ID	DWR_LD0003_01_f_2015_21				
Comment Code					
A3 : No rodents visible, but rodent burrows visible; need to backfill and compact or grout burrows.					
Inspector Comment					
Remove the rodent holes along the landside slope.

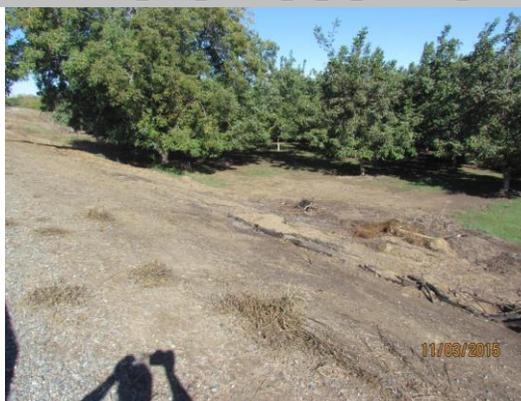
Photo 2 of 2 : SP_2016_LD0003_27_21_20160324_00015.jpg

View of the rodent holes along the landside slope.

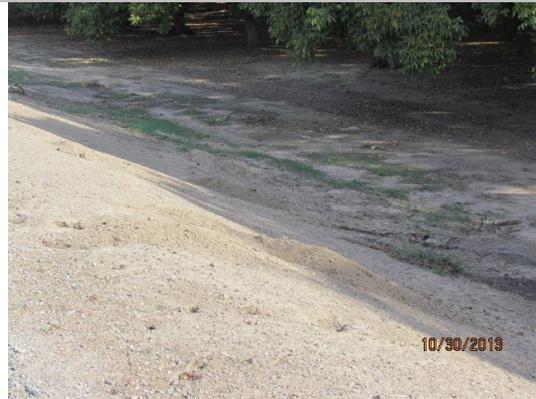
Photo 1 of 1 : SP_2016_LD0003_27_62_20160324_00038.jpg

LM Start	5.53	Rating **	U	Issue No.	62
LM End	5.62	Issue Type +	Ma	Location *	LS
Category	Earthen Levee		GPS Latitude/Longitude		
			Start	End	
Item	Animal Control		39.447900 °	39.449115 °	
			-121.991748 °	-121.991873 °	
DWR ID	DWR_LD0003_01_f_2013_62				
Comment Code					
A3 : No rodents visible, but rodent burrows visible; need to backfill and compact or grout burrows.					
Inspector Comment

View of the rodent holes along the landside slope.

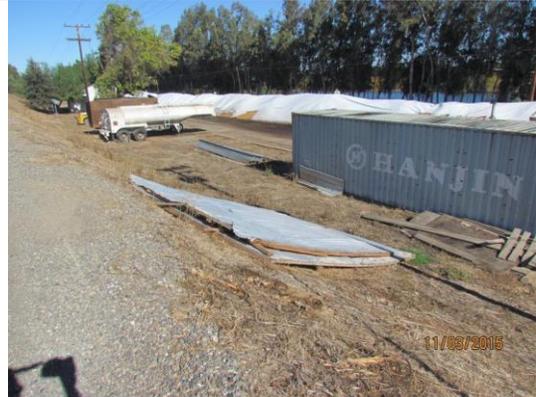
Photo 1 of 1 : SP_2016_LD0003_27_74_20160324_00049.jpg

View of the metal roof laying on the landside slope.

LM Start	6.43	Rating **	U	Issue No.	74
LM End	6.43	Issue Type +	En	Location *	LS
Category	Earthen Levee		GPS Latitude/Longitude		
			Start	End	
Item	Encroachments		39.460563 °	39.460563 °	
			-121.993195 °	-121.993195 °	
DWR ID	DWR_LD0003_01_f_2015_74				
Comment Code					
DE : Debris					
Inspector Comment					
Remove the metal roof from the landside slope.

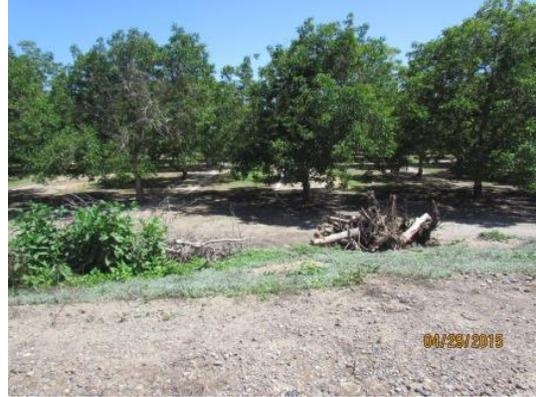
Photo 1 of 1 : SP_2016_LD0003_27_37_20160324_00020.jpg

View of the prunings along the landside slope.

LM Start	7.36	Rating **	M	Issue No.	37
LM End	7.36	Issue Type +	En	Location *	LS
Category	Earthen Levee		GPS Latitude/Longitude		
			Start	End	
Item	Encroachments		39.473793 °	39.473793 °	
			-121.991208 °	-121.991208 °	
DWR ID	DWR_LD0003_01_s_2012_37				
Comment Code					
PR : Prunings					
Inspector Comment					
Remove the prunings from the landside slope.

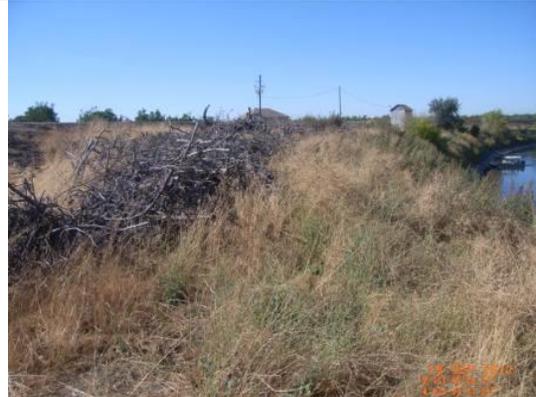
Photo 1 of 1 : SP_2016_LD0003_27_60_20160324_00036.jpg

LM Start	7.68	Rating **	M	Issue No.	60
LM End	7.68	Issue Type +	Ma	Location *	LS
Category	Earthen Levee		GPS Latitude/Longitude		
			Start	End	
Item	Encroachments		39.478464 °	39.478464 °	
			-121.990686 °	-121.990686 °	
DWR ID	DWR_LD0003_01_f_2013_60				
Comment Code					
PR : Prunings					
Inspector Comment

View of the prunings along the landside toe.

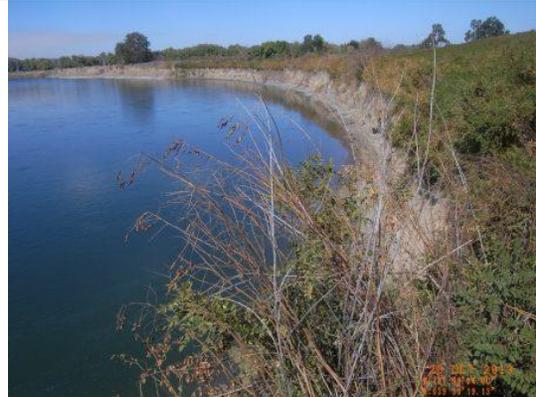
Photo 1 of 3 : SP_2016_LD0003_27_10_20160324_00006.jpg

Comment Code					
Inspector Comment					
2007 - Getting close to the levee. Bank is clayey silt with clayey/silty toe. 2008 - Looks a little worse at the upstream end. 2009 - Some new erosion and slumping. 2010 - Some new erosion upstream of site, actively eroding at low flow. New bank swallow colony noted. 2011 - Significant erosion since last year, with an estimated 10 to 15 feet of berm lost. Large sections of the bank have slumped off. 2012 - Part of the site appears to be stabilizing, but still minor slumping in other locations. 2013 - Minor new erosion at toe. 2015: Last observed in 2013. [2015 Site ID: SAC_172-0_L] On 3/25/2016, recent high water caused river to erode to within 10-20 feet of levee toe. Appears still somewhat active.

USACE 2013 Photo #1

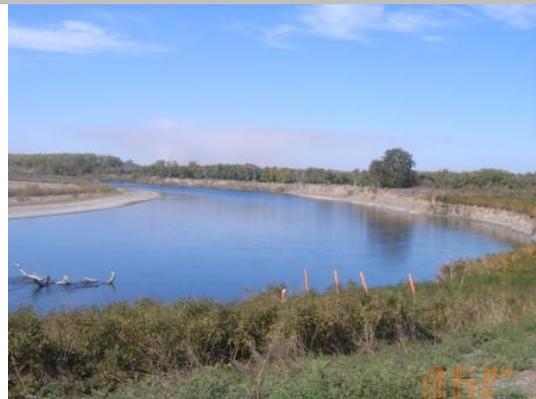
Photo 2 of 3 : SP_2016_LD0003_27_10_20160324_00007.jpg

USACE 2013 Photo #2

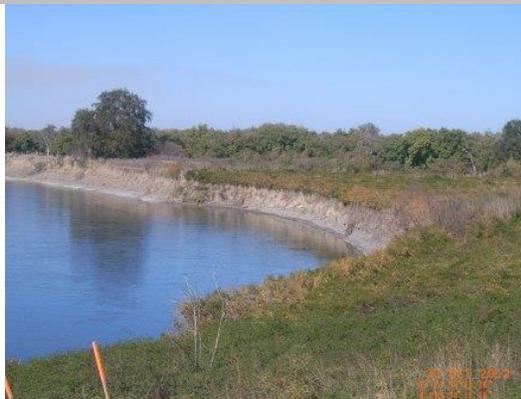
Photo 3 of 3 : SP_2016_LD0003_27_10_20160324_00008.jpg

Comment Code					
Inspector Comment					
2007 - Getting close to the levee. Bank is clayey silt with clayey/silty toe. 2008 - Looks a little worse at the upstream end. 2009 - Some new erosion and slumping. 2010 - Some new erosion upstream of site, actively eroding at low flow. New bank swallow colony noted. 2011 - Significant erosion since last year, with an estimated 10 to 15 feet of berm lost. Large sections of the bank have slumped off. 2012 - Part of the site appears to be stabilizing, but still minor slumping in other locations. 2013 - Minor new erosion at toe. 2015: Last observed in 2013. [2015 Site ID: SAC_172-0_L] On 3/25/2016, recent high water caused river to erode to within 10-20 feet of levee toe. Appears still somewhat active.

USACE 2013 Photo #3

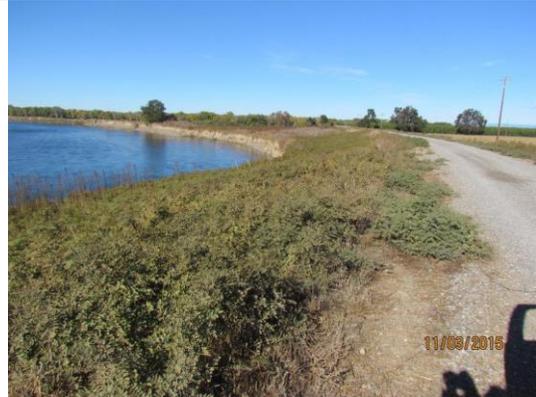
Photo 1 of 1 : SP_2016_LD0003_27_80_20160324_00055.jpg

View of the vegetation along the waterside slope and toe.

LM Start	9.64	Rating **	U	Issue No.	80
LM End	9.88	Issue Type +	Ma	Location *	WS
Category	Earthen Levee		GPS Latitude/Longitude		
			Start	End	
Item	Vegetation		39.504682 °	39.508065 °	
			-121.984465 °	-121.984030 °	
DWR ID	DWR_LD0003_01_f_2015_80				
Comment Code					
V1 : Control annual grass and weeds on the levee slopes and easements.					
Inspector Comment					
Clear vegetation from levee slopes.

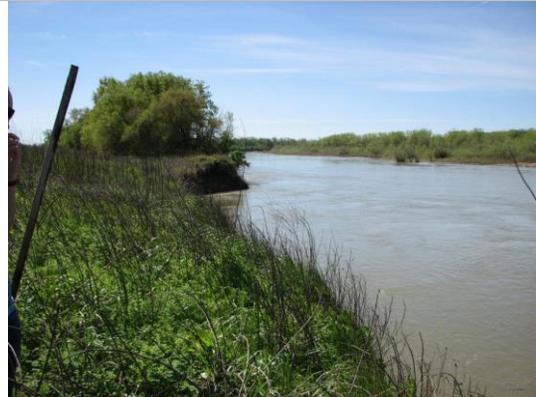
Photo 3 of 4 : SP_2016_LD0003_27_50_20160411_00103.jpg

View of erosion along the waterside toe, downstream. Same site as the USACE erosion issue. Photo 3/25/2016

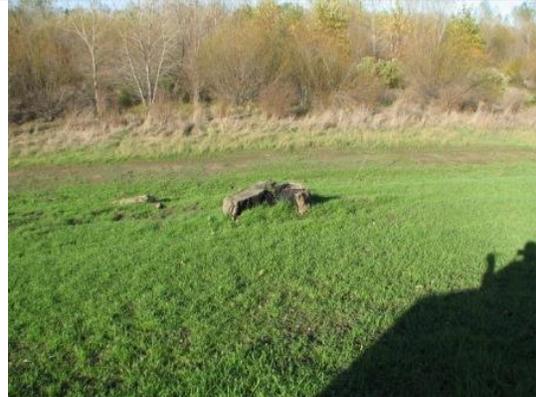
Photo 1 of 1 : SP_2016_LD0003_27_30_20160324_00018.jpg

LM Start	10.67	Rating **	N	Issue No.	30
LM End	10.67	Issue Type +	Ma	Location *	WS
Category	Earthen Levee		GPS Latitude/Longitude		
			Start	End	
Item	Trim / Thin Trees		39.517715 °	39.517715 °	
			-121.979155 °	-121.979155 °	
DWR ID	DWR_LD0003_01_s_2012_30				
Comment Code					
T5 : Tree stumps.					
Inspector Comment

View of the stump along the slope.
