**Flood Control Project Maintenance
Levee Inspections**

Fall 2013 Levee Maintenance Deficiency Summary Report

Sacramento River Basin

Sutter Maintenance Yard Maintenance Area 0001

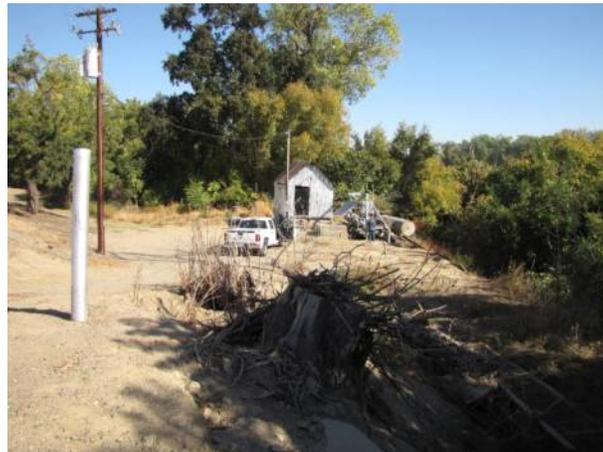
Levee Mile Report Line	18
Start Levee Mile	1.20
End Levee Mile	1.20
Location	Land Side
Category	Supplemental
Item	DWR UCIP Field Study
Other appurtances associated with crossing- Structure, pump, distribution box, and power pole located on WS bank.	
UCIP_4869.jpg

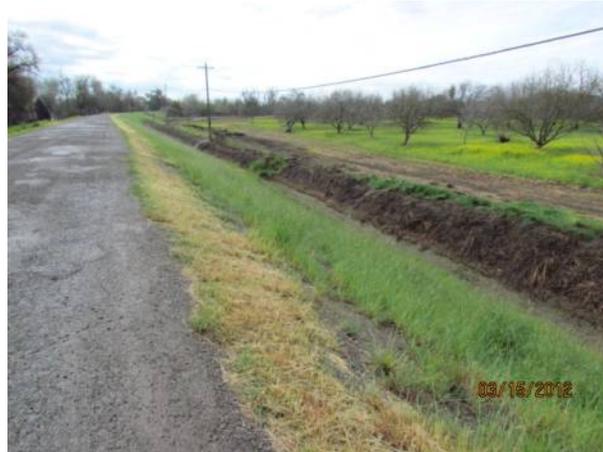
View of ag. ditch along the L/S toe.

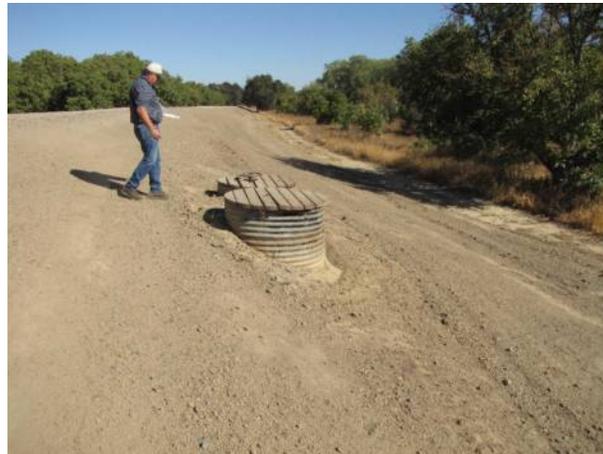
Levee Mile Report Line	25
Start Levee Mile	1.96
End Levee Mile	1.96
Location	Land Side
Category	Supplemental
Item	DWR UCIP Field Study

CMP riser located on waterward slope.

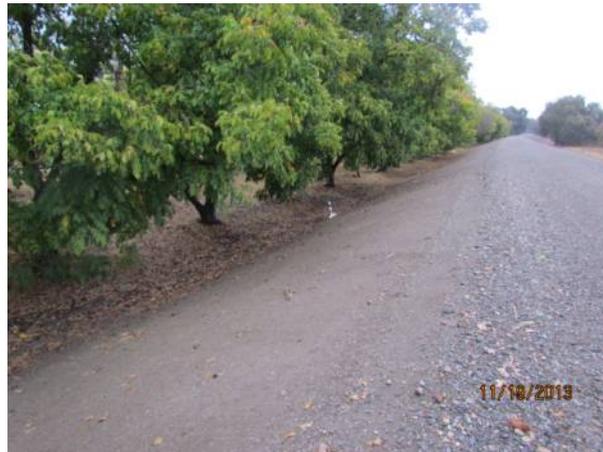
Levee Mile Report Line	39
Start Levee Mile	2.03
End Levee Mile	2.03
Location	Land Side
Category	Earthen Levee
Item	Animal Control

View of the grouted rodent holes and the bait station.

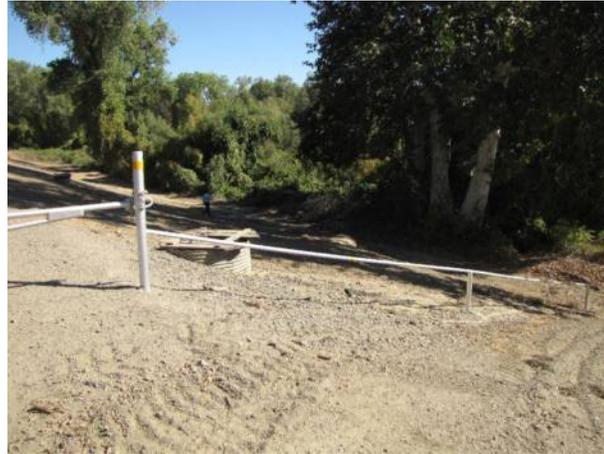
View of waterward side looking at slope and channel.

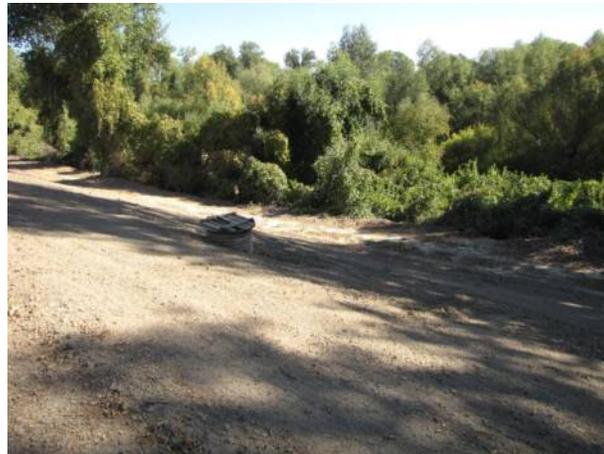
Levee Mile Report Line	54
Start Levee Mile	2.30
End Levee Mile	2.30
Location	Land Side
Category	Supplemental
Item	DWR UCIP Field Study

View of waterward slope and toe.

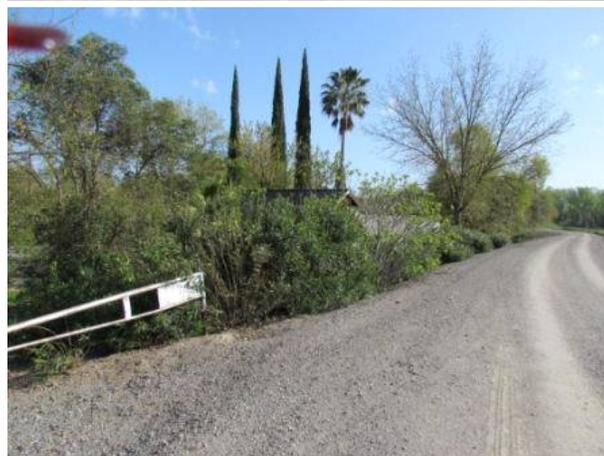
Levee Mile Report Line	55
Start Levee Mile	2.58
End Levee Mile	2.60
Location	Land Side
Category	Earthen Levee
Item	Encroachments

View of the house next to the levee.

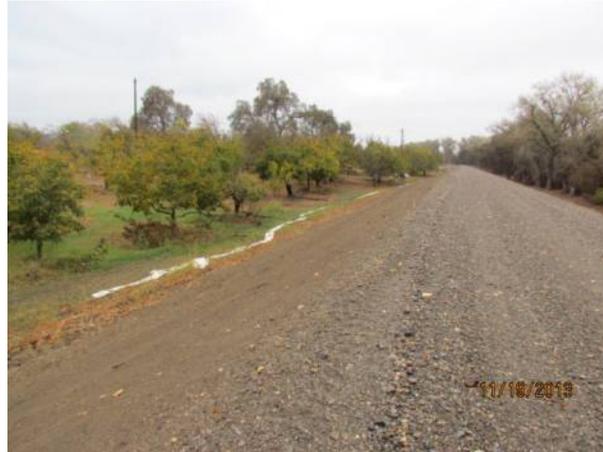
View of the grouted rodent holes.

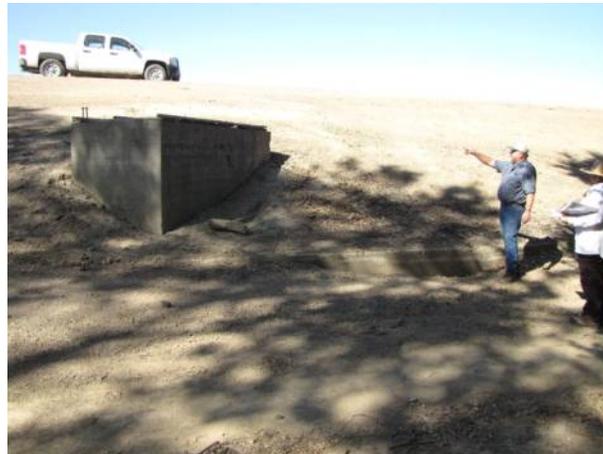
Levee Mile Report Line	60
Start Levee Mile	2.87
End Levee Mile	2.87
Location	Land Side
Category	Supplemental
Item	DWR UCIP Field Study

View of concrete distribution box and headwall located on waterward side.

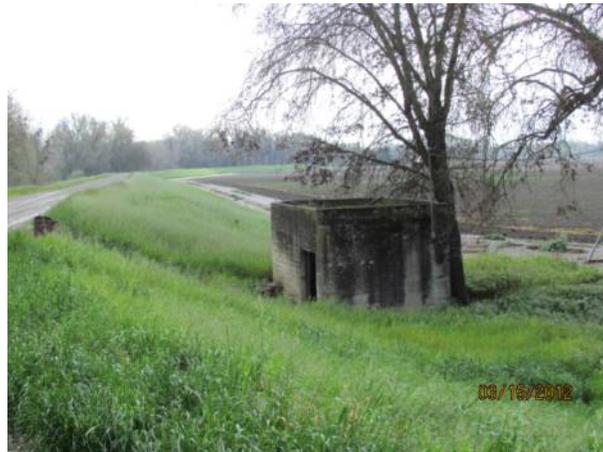
Levee Mile Report Line	70
Start Levee Mile	3.10
End Levee Mile	3.78
Location	Land Side
Category	Earthen Levee
Item	Encroachments

View of the ag. ditch & concrete building along the L/S toe.

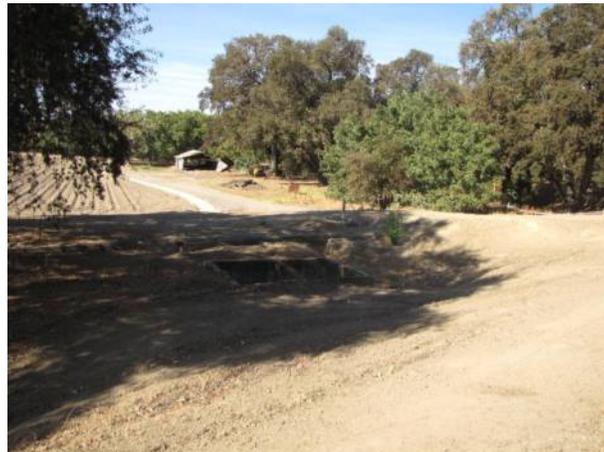
Levee Mile Report Line	87
Start Levee Mile	3.79
End Levee Mile	3.79
Location	Land Side
Category	Supplemental
Item	DWR UCIP Field Study
Concrete distribution box located on landward side.	
UCIP_4241.jpg

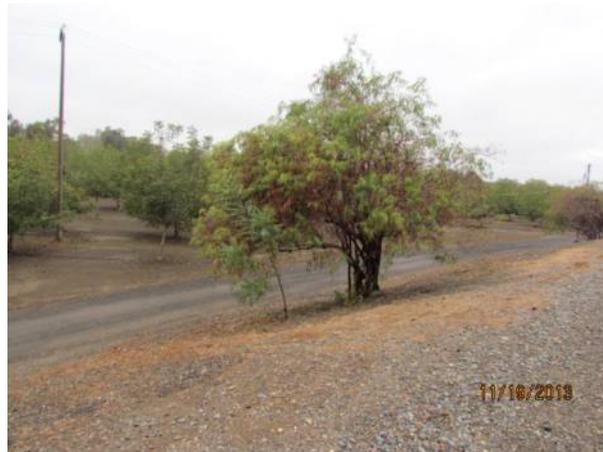
Levee Mile Report Line	109
Start Levee Mile	3.96
End Levee Mile	3.96
Location	Land Side
Category	Earthen Levee
Item	Vegetation
View of the elderberry on the landside slope.	
rduffey_f_20131122_181.JPG

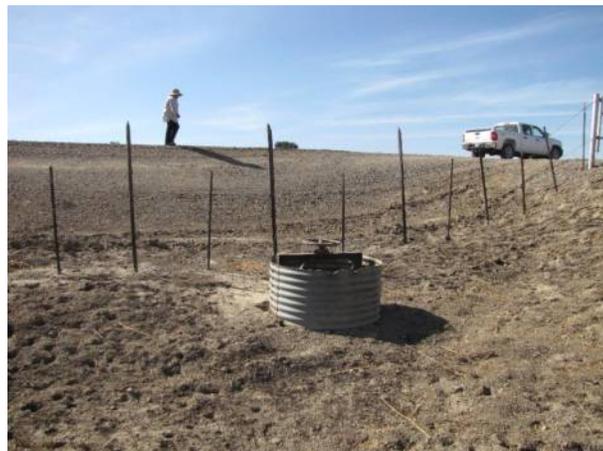
Levee Mile Report Line	122
Start Levee Mile	4.75
End Levee Mile	4.75
Location	Water Side
Category	Supplemental
Item	DWR UCIP Field Study
Riser with slide gate located on waterward toe.	
UCIP_9303.jpg

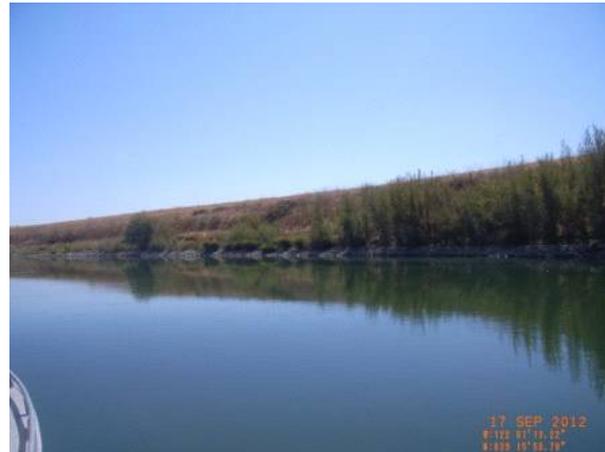
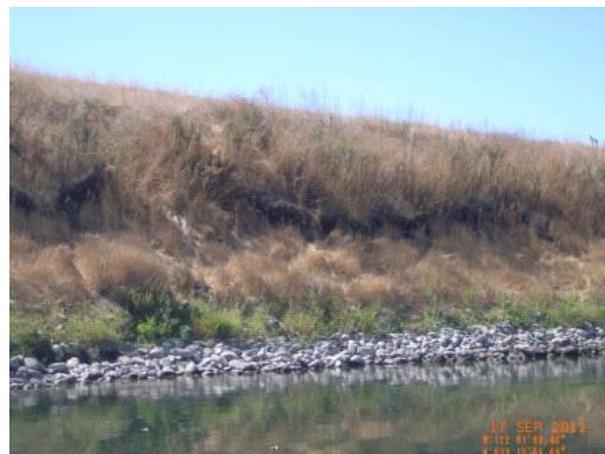
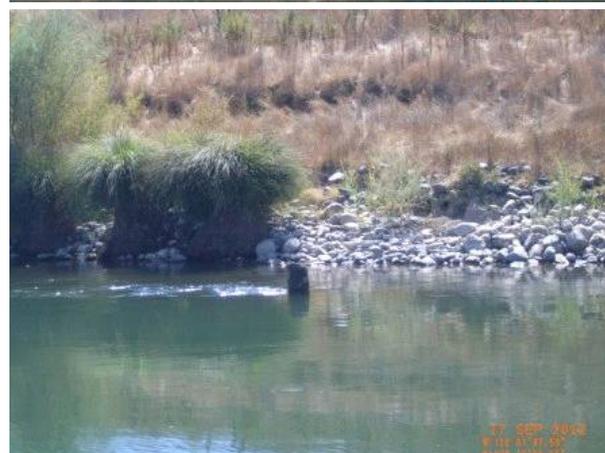
Levee Mile Report Line	127
Start Levee Mile	5.00
End Levee Mile	5.38
Location	Water Side
Category	Supplemental
Item	USACE Erosion Survey
USACE 2012 Photo #1	
USACE2013_SAC_151-0_R_1.jpg

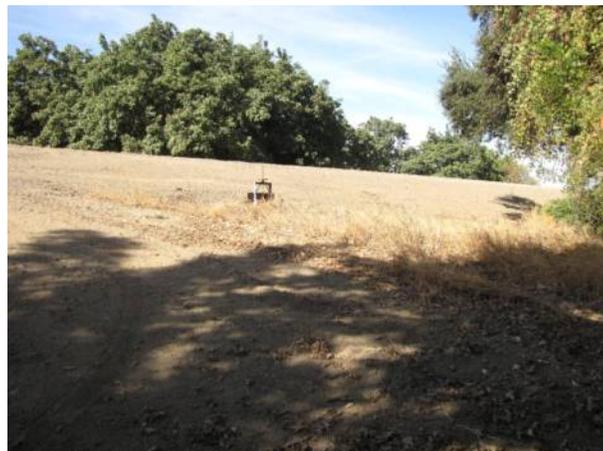
Levee Mile Report Line	136
Start Levee Mile	5.84
End Levee Mile	5.84
Location	Water Side
Category	Supplemental
Item	DWR UCIP Field Study
View of waterward slope and access road. Slide gate is second crossing at this location.	
UCIP_4614.jpg

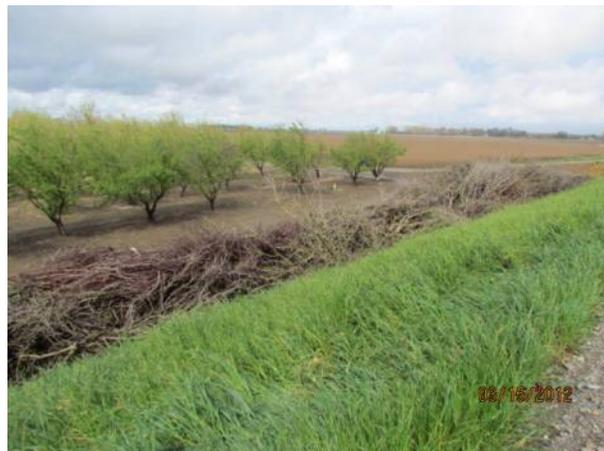
Levee Mile Report Line	159
Start Levee Mile	6.51
End Levee Mile	6.51
Location	Land Side
Category	Earthen Levee
Item	Encroachments
View of the prunings along the L/S toe.	
rduffey_f_20130919_740.jpg

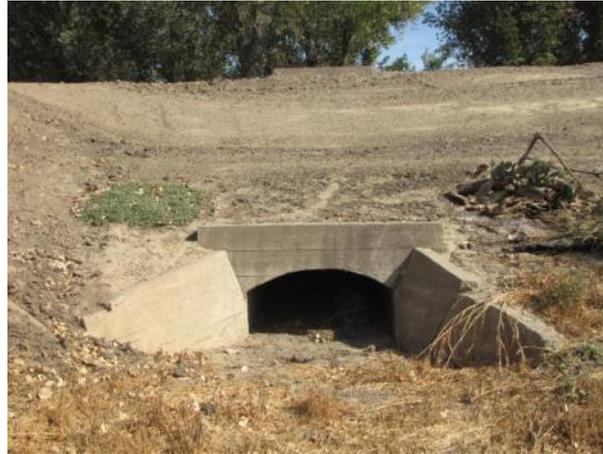
View of structure located in landward side.

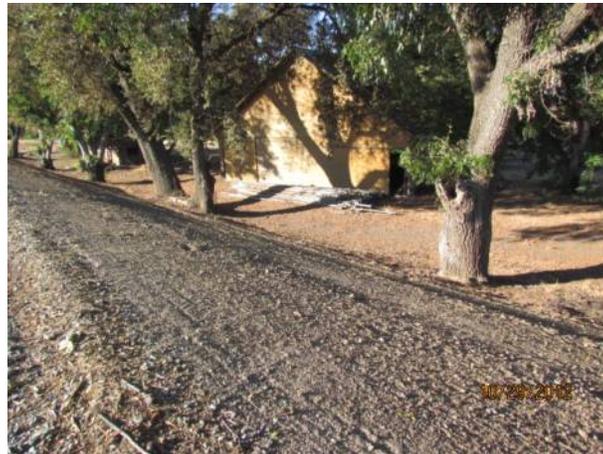
Levee Mile Report Line	167
Start Levee Mile	6.85
End Levee Mile	6.85
Location	Land Side
Category	Earthen Levee
Item	Animal Control

View of the levee with no rodent holes.

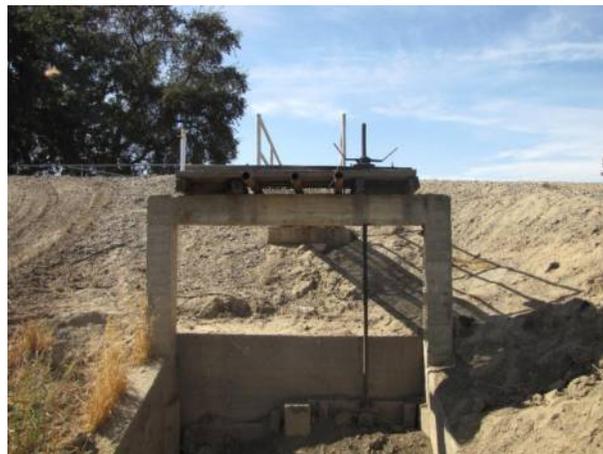
Levee Mile Report Line	176
Start Levee Mile	7.14
End Levee Mile	7.14
Location	Land Side
Category	Supplemental
Item	DWR UCIP Field Study

Only 1 slide gate remains, 2nd slide gate has been removed.

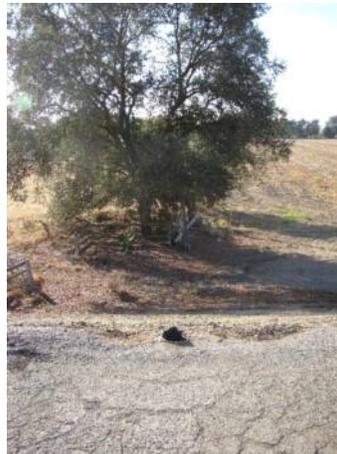
Levee Mile Report Line	195
Start Levee Mile	7.74
End Levee Mile	7.74
Location	Land Side
Category	Supplemental
Item	DWR UCIP Field Study

View of landward side with appurtenances present on levee shoulder.

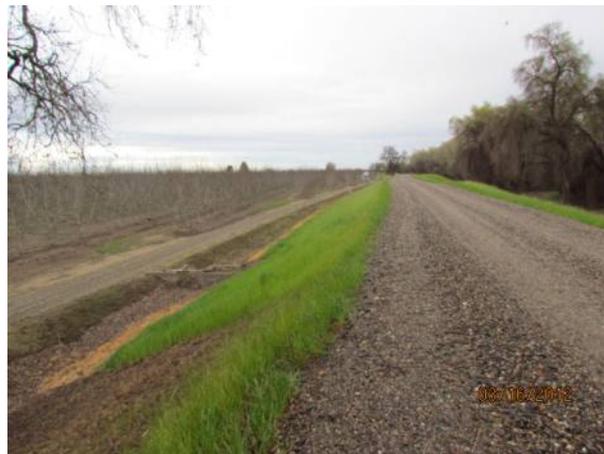
Levee Mile Report Line	198
Start Levee Mile	8.94
End Levee Mile	9.39
Location	Land Side
Category	Earthen Levee
Item	Encroachments

View of the ag. ditch along the L/S toe.

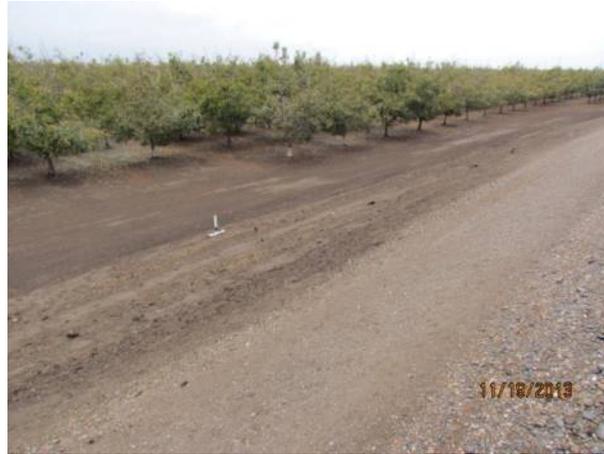
Levee Mile Report Line	204
Start Levee Mile	9.54
End Levee Mile	9.54
Location	Land Side
Category	Earthen Levee
Item	Animal Control
View of the grouted rodent holes and the bait station.	
rduffey_f_20131122_182.JPG

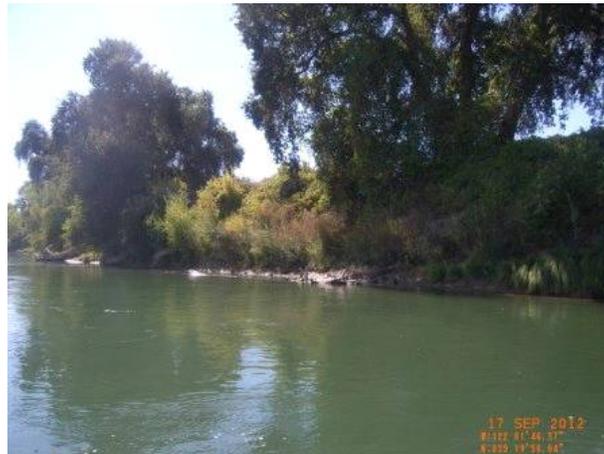
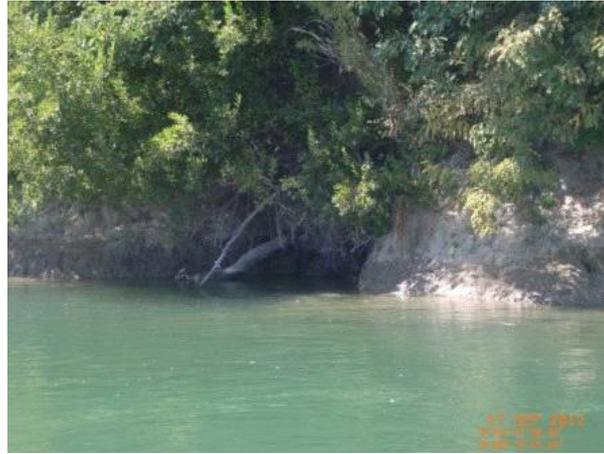
Levee Mile Report Line	205
Start Levee Mile	10.30
End Levee Mile	10.38
Location	Water Side
Category	Supplemental
Item	USACE Erosion Survey
USACE 2012 Photo #1	
USACE2013_SAC_157-7_R_1.jpg

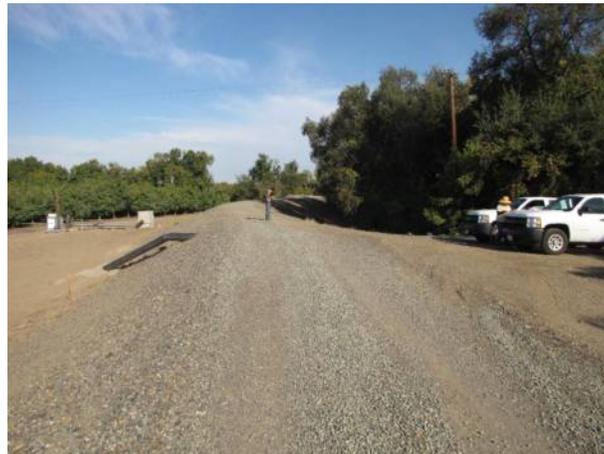
Levee Mile Report Line	213
Start Levee Mile	10.31
End Levee Mile	10.31
Location	Water Side
Category	Supplemental
Item	DWR UCIP Field Study
Overview of levee crown looking upstream. This crossing is located near the concrete distribution box.	
UCIP_4001.jpg

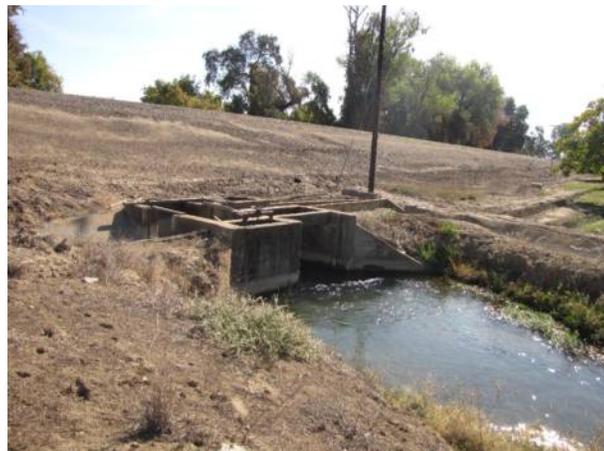
Levee Mile Report Line	258
Start Levee Mile	11.43
End Levee Mile	11.43
Location	Water Side
Category	Supplemental
Item	DWR UCIP Field Study
View of concrete distribution box located on landward toe.	
UCIP_4836.jpg

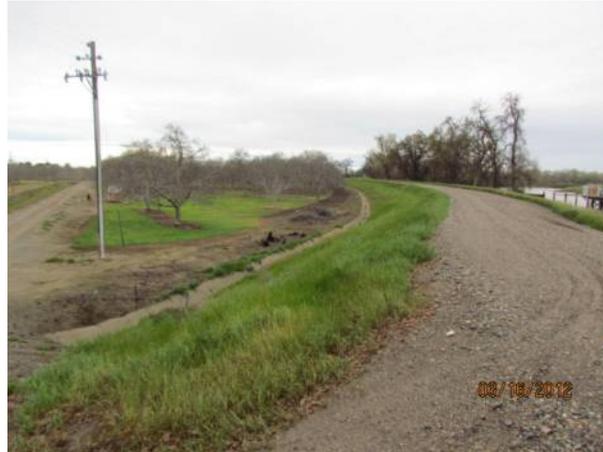
View of the ag. ditch along the L/S toe.

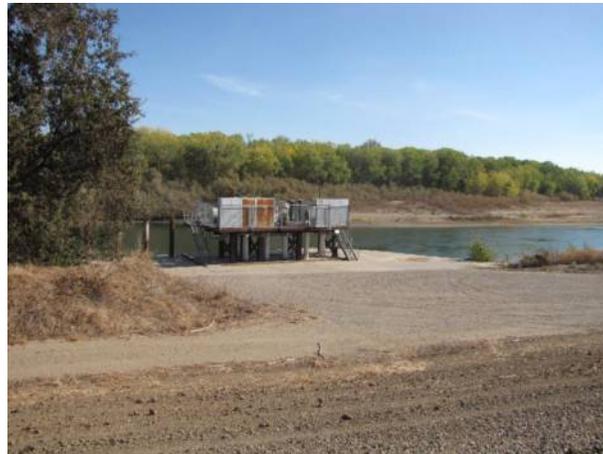
Levee Mile Report Line	283
Start Levee Mile	11.51
End Levee Mile	11.51
Location	Land Side
Category	Supplemental
Item	DWR UCIP Field Study

Pump station located on waterward side.

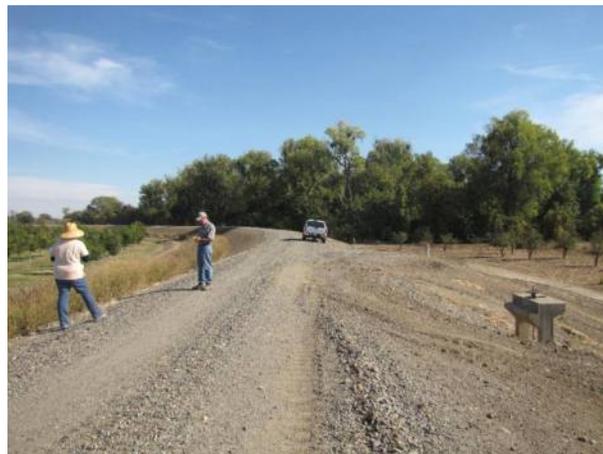
Levee Mile Report Line	293
Start Levee Mile	12.96
End Levee Mile	12.96
Location	Land Side
Category	Supplemental
Item	DWR UCIP Field Study

Overview of levee crown looking downstream at crossing.

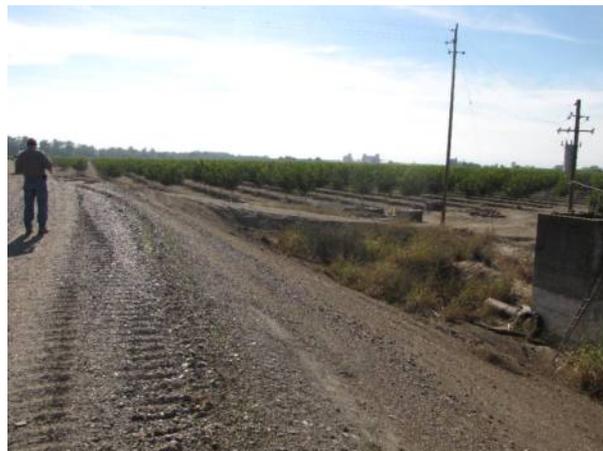
Levee Mile Report Line	314
Start Levee Mile	13.76
End Levee Mile	13.76
Location	Land Side
Category	Supplemental
Item	DWR UCIP Field Study
View of landward side looking downstream at crossing.	
UCIP_4965.jpg

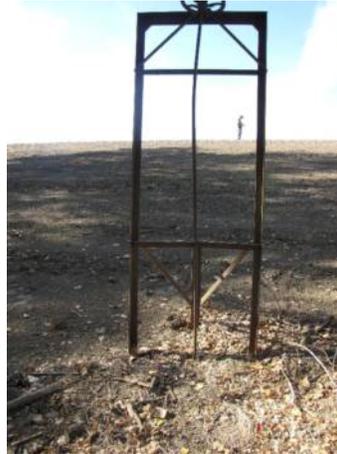
UCIP_4085.jpg

Slide gate buried-non-functional.

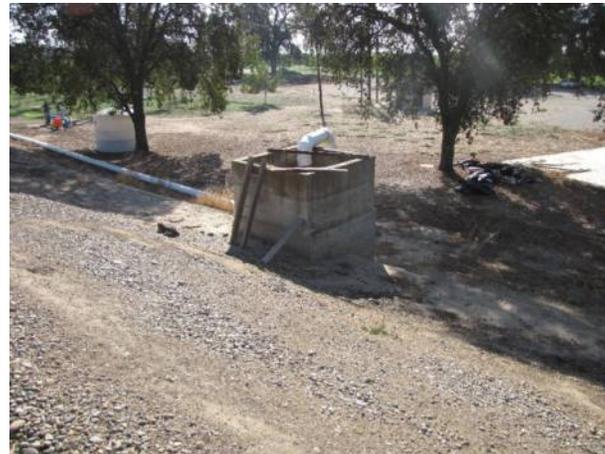
UCIP_4968.jpg

Concrete distribution box located on landward toe.

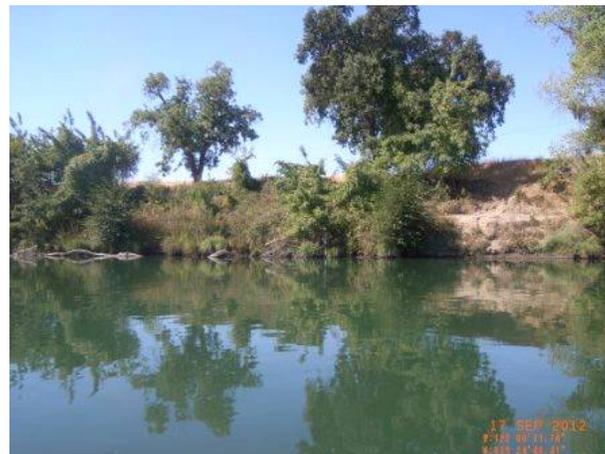
USACE2013_SAC_164-3_R_1.jpg

Levee Mile Report Line	329
Start Levee Mile	16.49
End Levee Mile	16.69
Location	Water Side
Category	Supplemental
Item	USACE Erosion Survey

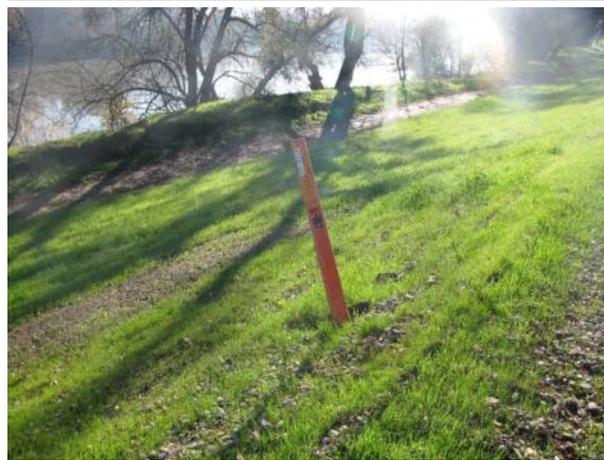
UCIP_9468.jpg

Damage marker located on waterward slope.
