**Flood Control Project Maintenance
Levee Inspections****LMA District Cover Sheet****Spring 2013 Levee Inspection Results****Sutter Maintenance Yard Maintenance Area 0001**

Spring 2013 Levee Inspection Results

Sutter Maintenance Yard Maintenance Area 0001

Waterway			Bank	Unit Miles
Unit No. 01 Sacramento River			Right	17.12
	Spring (March - May)	Summer (June - August)	(September - November) Fall	Winter (December - February)
Unit Maintenance Rating (Fall Only)				
Date of Inspection	03/14/2013 - 03/14/2013			
DWR Inspector	Bob Duffey			
Accompanied By	Bryan Reniff Sutter Maintenance Yard

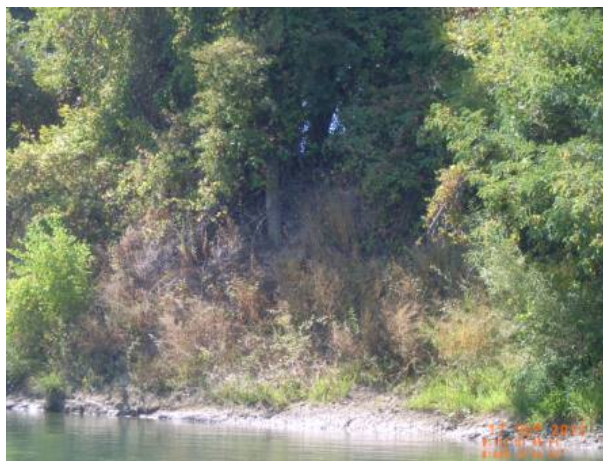
USACE 2012 Photo #3

Levee Mile Report Line	23
Start Levee Mile	10.30
End Levee Mile	10.38
Location	Water Side
Category	Supplemental
Item	USACE Erosion Survey
