**Flood Control Project Maintenance  
Levee Inspections**  
**LMA District Cover Sheet**  
**Spring 2016 Levee Inspection Results**

**Sutter Maintenance Yard Maintenance Area 0001**

**Spring 2016 Levee Inspection Results**

Waterway		Bank	Unit Miles
Unit No. 01 Sacramento River		Right	16.76

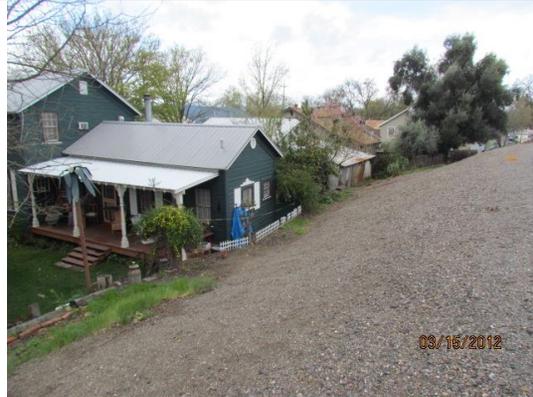
Photo 1 of 1 : SP\_2016\_MA0001\_297\_2\_20160316\_00001.jpg

LM Start	<b>0.04</b>	Rating **	U	Issue No.	<b>2</b>
LM End	<b>0.23</b>	Issue Type +	En	Location *	LS
Category	Earthen Levee			GPS Latitude/Longitude	
				Start	End
Item	Encroachments			39.213988 °	39.215198 °
				-122.001537 °	-122.004775 °
DWR ID	DWR_MA0001_01_s_2012_2				
Comment Code					
BU : Building					
Inspector Comment

View of the building along the L/S toe.

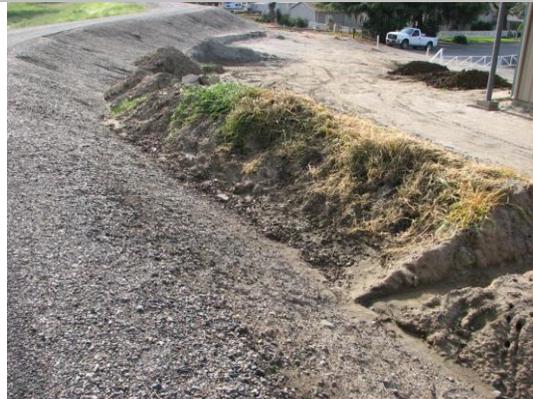
Photo 1 of 1 : SP\_2016\_MA0001\_297\_73\_20160405\_00142.jpg

LM Start	<b>0.32</b>	Rating **	M	Issue No.	<b>73</b>
LM End	<b>0.32</b>	Issue Type +	En	Location *	LS
Category	Earthen Levee			GPS Latitude/Longitude	
				Start	End
Item	Encroachments			39.215834 °	39.215834 °
				-122.006222 °	-122.006222 °
DWR ID	DWR_MA0001_01_s_2016_73				
Comment Code					
DE : Debris					
Inspector Comment					
soil pile with weeds and concrete wash out.

Soil pile with weeds obstructing access

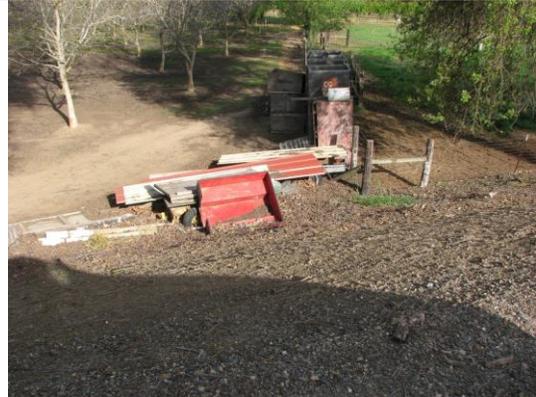
Photo 1 of 1 : SP\_2016\_MA0001\_297\_80\_20160405\_00143.jpg

LM Start	<b>2.25</b>	Rating **	M	Issue No.	<b>80</b>
LM End	<b>2.25</b>	Issue Type +	En	Location *	LS
Category	Earthen Levee		GPS Latitude/Longitude		
			Start	End	
Item	Encroachments		39.236211 °	39.236211 °	
			-122.012775 °	-122.012775 °	
DWR ID	DWR_MA0001_01_s_2016_80				
Comment Code					
DE : Debris					
Inspector Comment					
metal roofing and other debris.

Equipment and debris obstructing access

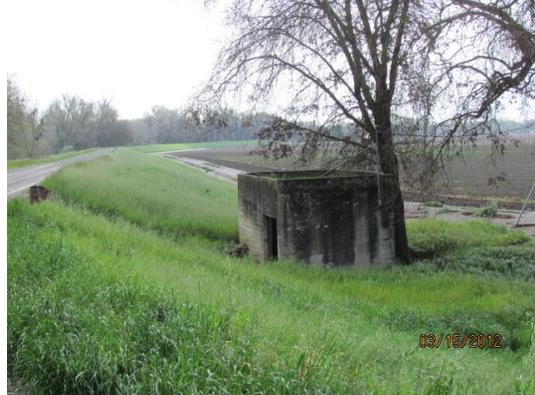
Photo 1 of 1 : SP\_2016\_MA0001\_297\_5\_20160316\_00003.jpg

LM Start	<b>3.05</b>	Rating **	U	Issue No.	<b>5</b>
LM End	<b>3.70</b>	Issue Type +	En	Location *	LS
Category	Earthen Levee			GPS Latitude/Longitude	
				Start	End
Item	Encroachments			39.246822 °	39.256054 °
				-122.008146 °	-122.009808 °
DWR ID	DWR_MA0001_01_s_2012_5				
Comment Code					
DT : Ditch					
Inspector Comment

View of the ag. ditch & concrete building along the L/S toe.

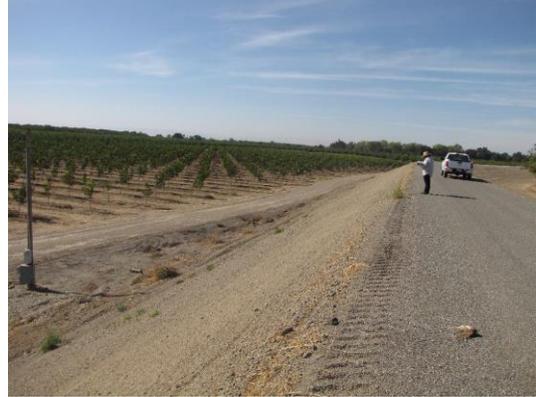
Photo 2 of 2 : UCIP\_SP\_2016\_47569\_70149.jpg

Item	DWR UCIP Field Study			39.264924 °	39.264924 °
				-122.015887 °	-122.015887 °
DWR ID					
Comment Code					
Inspector Comment					
<p>FS_ID:47569                  DS_ID:16420                  EP_NO: 4903                  Repair Type: Non-Urgent                  Crossing Status: Indicator Found                  UCIP Comments: 4/25/2016 Appears to be an abandoned crossing.4/20/2015 Suspect that pump on LS is a well pump and has nothing to do with this crossing.6/18/2014 Same as last inspection.12/17/2013 Same as last inspection.7/18/2013 Same as last inspection.10/19/2012 Unable to locate siphon breaker, pump on LS; unable to tell if pump system is part of appurtenances. This crossing was listed in the USACE Periodic Inspection as ID# USACE_CESPK_MA1C_2010_p_0233 for utility pole and 8 inch steel riser located on landward toe.                  FIELD_STRUCT_DESC: 12-inch irrigation pipe through the levee approximately 18-20 feet below the crown. Siphon breaker in 24-inch corrugated metal pipe (CMP) riser on the landside (LS) shoulder--not found. 3-inch electrical conduit through the levee.--not found. Utility pole visible on LS. No appurtenances visible on waterside (WS). (Permit No. 4903,A-1966, Zumwalt) Well station visible on LS.                  FS Date: 5/4/2016 2:25:00 PM</p>

View of levee crown looking upstream at crossing.

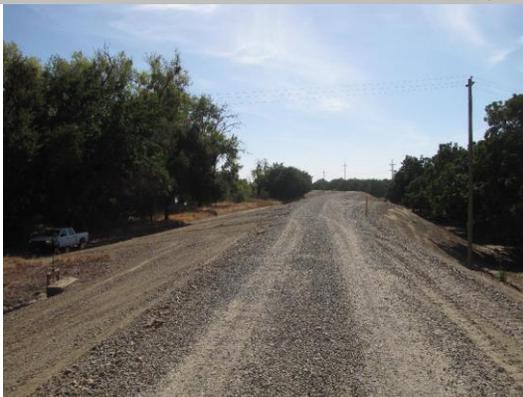
Photo 1 of 2 : UCIP\_SP\_2016\_47570\_70154.jpg

LM Start	<b>5.72</b>	Rating **	M	Issue No.	<b>665 (cont)</b>
LM End	<b>5.72</b>	Issue Type +	En	Location *	WS

Overview of levee crown looking downstream at crossing.

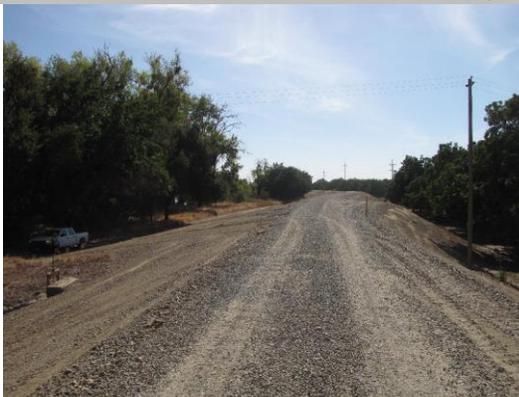
Photo 1 of 2 : UCIP\_SP\_2016\_47571\_70162.jpg

Item	DWR UCIP Field Study			39.272069 °	39.272069 °
				-122.023240 °	-122.023240 °
DWR ID					
Comment Code					
Inspector Comment					
FS_ID:47571 DS_ID:17569 EP_NO: 9476 Repair Type: Non-Urgent Crossing Status: Found UCIP Comments: 4/25/2016 WS entry still blocked and wingwalls still cracked.4/20/2015 WS entry still blocked and wingwalls still cracked.6/18/2014 Same as last inspection.12/17/2013 Same as last inspection.7/18/2013 Same as last inspection.10/19/2012 blocked, no entry on WS. This crossing was listed in the USACE Periodic Inspection as ID# USACE_CESPK_MA1C_2010_p_0247 for u/s and d/s wing wall shows some cracking and tilting. FIELD_STRUCT_DESC: 2 of 2: 36-inch irrigation corrugated metal pipe (CMP) (15 feet long) and concrete box culvert through the levee at an unknown depth. Slide gate located on waterside (WS). Concrete headwall visible on landside (LS) toe. Structure was retained under an automatic board order (ABO) issued as Permit No. 9476. (Permit No. 9476-1974, Howard C. & Nadine M. Ohliger) FS Date: 5/4/2016 2:33:00 PM

View of levee crown looking downstream at crossing.

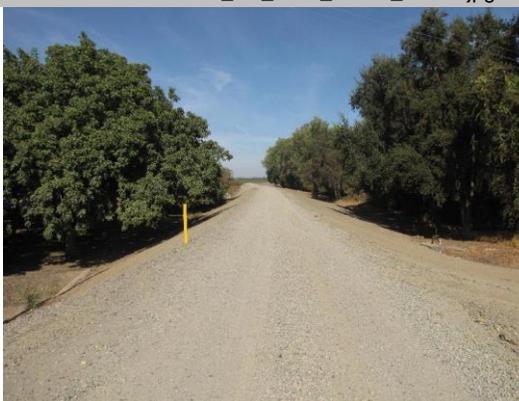
Photo 2 of 2 : UCIP\_SP\_2016\_47571\_70161.jpg

View of levee crown looking upstream at crossing.

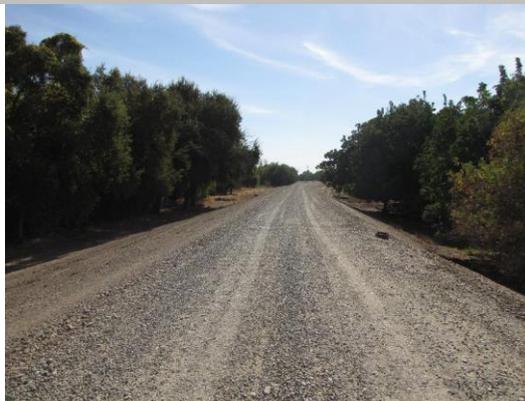
Photo 1 of 2 : UCIP\_SP\_2016\_47573\_70167.jpg

Item	DWR UCIP Field Study			39.272829 °	39.272829 °
				-122.023282 °	-122.023282 °
DWR ID					
Comment Code					
Inspector Comment					
FS_ID:47573 DS_ID:16418 EP_NO: 6263 Repair Type: Non-Urgent Crossing Status: Found UCIP Comments: 4/25/2016 Pressure gauge and valve were added to pipe near the siphon breaker on LS shoulder.4/20/2015 Modifications are being made to pipe near the LS shoulder. Not sure what all exactly is being done.6/23/2014 Same as last inspection. 12/17/2013 Same as last inspection.7/18/2013 Debris cleared from in front of LS standpipe.10/19/2012 Remove debris from landward side see photo 2. This crossing was listed in the USACE Periodic Inspection as ID# USACE_CESPK_MA1C_2010_p_0249 however, unable to determine why crossing was marked "U". FIELD_STRUCT_DESC: 18-inch steel irrigation pipe through the levee 2 feet below the top of levee. Siphon breaker on landside (LS) shoulder. Corrugated metal pipe (CMP) riser located on LS connects with concrete V-ditch. Dual slant pumps and gate valves on the bank approximately 215 feet from waterside (WS) toe. Pumps feed into single 18-inch steel pipe. 2-inch electric conduit buried in the same trench as irrigation pipe. (Permit No. 6263-1968, C. Tuttle) FS Date: 5/4/2016 2:34:00 PM

Overview of levee crown looking downstream at crossing.

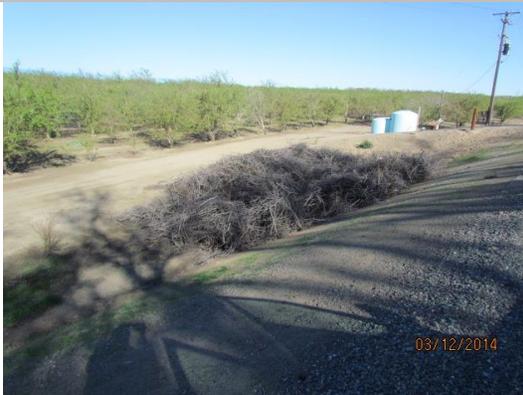
Photo 1 of 1 : SP\_2016\_MA0001\_297\_76\_20160316\_00019.jpg

LM Start	<b>6.20</b>	Rating **	M	Issue No.	<b>76</b>
LM End	<b>6.20</b>	Issue Type +	En	Location *	LS
Category	Earthen Levee		GPS Latitude/Longitude		
			Start	End	
Item	Encroachments		39.278917 °	39.278917 °	
			-122.022595 °	-122.022595 °	
DWR ID	DWR_MA0001_01_s_2014_76				
Comment Code					
PR : Prunings					
Inspector Comment

View of the prunings along the landside toe.

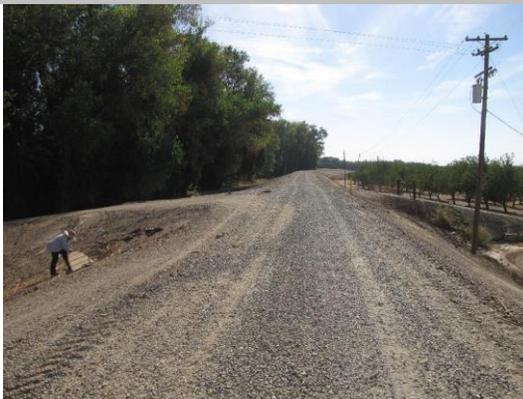
Photo 1 of 2 : UCIP\_SP\_2016\_47574\_70174.jpg

Item	DWR UCIP Field Study		39.279462 °	39.279462 °	
			-122.022461 °	-122.022461 °	
DWR ID					
Comment Code					
Inspector Comment					
<p>FS_ID:47574                  DS_ID:16446                  EP_NO: 4203                  Repair Type: Urgent                  Crossing Status: Found                  UCIP Comments: 4/25/2016 5 inch pvc pipe running through crossing has been cut out to allow the slide gate to close.4/20/2015 5inch pvc is still present blocking slide gate from closing. WS end of pipe has been exposed so there is no way to stop water from flowing through pipe during highwater times.6/23/2014 Same as last inspection. There is no way to stop water from flowing though pipe during high water times.12/17/2013 Same as last inspection.7/18/2013 Same as last inspection.10/19/2012 Unauthorized 5 inch PVC pipe running through 36 inch crossing. 5 inch PVC crossing prevents slide gate from closing during high water. Debris and sediment inside riser. This crossing was listed in the USACE Periodic Inspection as ID# USACE_CESPK_MA1C_2010_p_0258 for 5 inch PVC pipe running through culvert.                  FIELD_STRUCT_DESC: 36-inch drainage pipe through the levee at approximately 14-16 feet below levee crown. Slide gate in corrugated metal pipe (CMP) riser on the waterside (WS) slope. Pipe also visible on landside (LS). This entry matches the Drainage and Irrigation Structure referenced in O&amp;M manual (Station 331+31).                  FS Date: 5/4/2016 2:36:00 PM</p>

Overview of levee crown looking downstream at crossing.

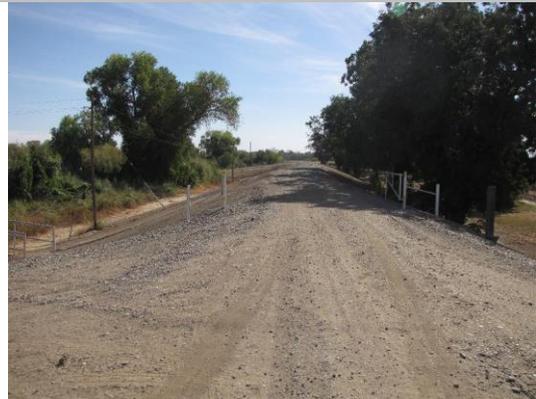
Photo 1 of 2 : UCIP\_SP\_2016\_47618\_70188.jpg

Overview of levee crown looking downstream at crossing.

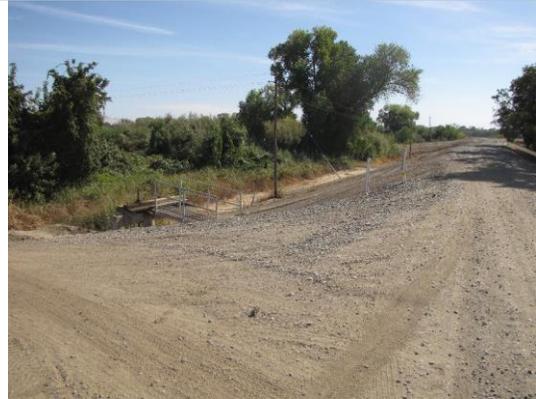
Photo 2 of 2 : UCIP\_SP\_2016\_47618\_70187.jpg

WS-walkway and concrete headwall.

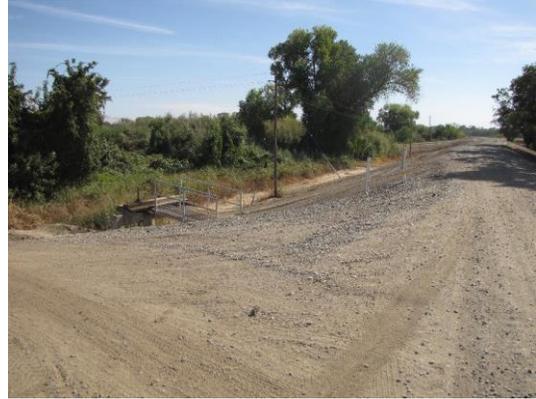
Photo 2 of 2 : UCIP\_SP\_2016\_47577\_70193.jpg

WS-walkway and concrete headwall.

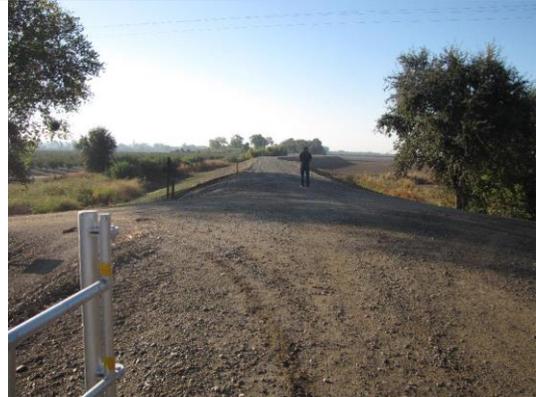
Photo 1 of 2 : UCIP\_SP\_2016\_47578\_70202.jpg

Item	DWR UCIP Field Study			39.294074 °	39.294074 °
				-122.021435 °	-122.021435 °
DWR ID					
Comment Code					
Inspector Comment					
<p>FS_ID:47578                  DS_ID:16456                  EP_NO: N/A                  Repair Type: Non-Urgent                  Crossing Status: Found                  UCIP Comments: 4/25/2016 Second slide gate was held open to allow water to flow through to the LS ditch.4/20/2015 Same as last inspection. Rebar pin was still inplace holding the gate opened.6/23/2014 Same as last inspection.12/17/2013 Same as last inspection.7/18/2013 Same as last inspection.10/30/2012 Sediment and debris on waterward and landward side. This crossing was listed in the USACE Periodic Inspection as ID# USACE_CESPK_MA1C_2010_p_0293 for wooden slide gate held open by a piece of rebar acting as a pin.                  FIELD_STRUCT_DESC: 5 foot by 6 foot concrete box irrigation culvert through the levee and access ramp at approximately 12-15 feet below the crown. Two wooden slide gates on waterside (WS) end. Concrete v-ditch along landside (LS) toe. This entry matches the Drainage and Irrigation Structure referenced in O&amp;M manual (Station 385+33.5).                  FS Date: 5/4/2016 2:45:00 PM</p>

Overview of levee crown looking downstream at crossing.

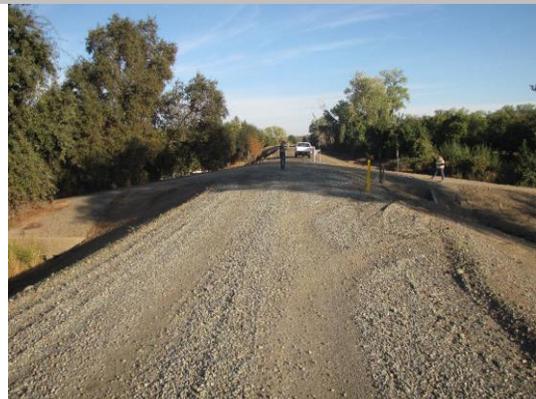
Photo 2 of 2 : UCIP\_SP\_2016\_47578\_70204.jpg

Overview of levee crown looking upstream at crossing.

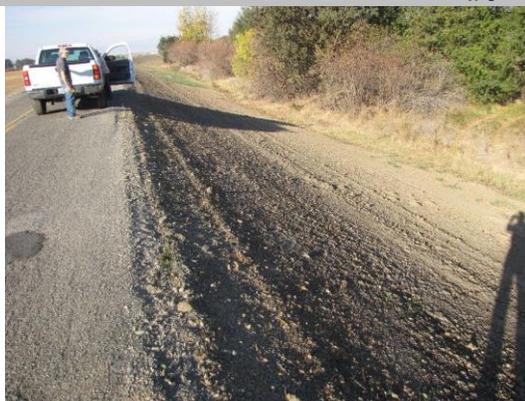
Photo 1 of 2 : UCIP\_SP\_2016\_47579\_70209.jpg

Item	DWR UCIP Field Study			39.297384 °	39.297384 °
				-122.022989 °	-122.022989 °
DWR ID					
Comment Code					
Inspector Comment					
FS_ID:47579 DS_ID:16455 EP_NO: 12334 Repair Type: Non-Urgent Crossing Status: Found UCIP Comments: 4/25/2016 No LS inlet found4/20/2015 Same as last inspection.6/23/2014 Same as last inspection.12/17/2013 Same as last inspection.7/18/2013 Same as last inspection.10/30/2012 Siphon breaker housing unit is bent and has debris inside. LS outlet not found. FIELD_STRUCT_DESC: 10-inch irrigation steel pipe through levee, 3 feet below the crown. Centrifugal pump on the waterside (WS) bank. Siphon breaker on landside (LS) shoulder of the levee. (Permit No. 12334-1978, Jean James) FS Date: 5/4/2016 2:47:00 PM

View of WS-no features on levee shoulder or slope.

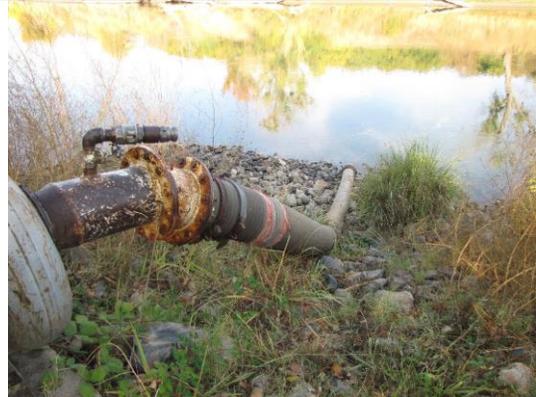
Photo 2 of 2 : UCIP\_SP\_2016\_47579\_70210.jpg

Item	DWR UCIP Field Study			39.297384 °	39.297384 °
				-122.022989 °	-122.022989 °
DWR ID					
Comment Code					
Inspector Comment					
FS_ID:47579 DS_ID:16455 EP_NO: 12334 Repair Type: Non-Urgent Crossing Status: Found UCIP Comments: 4/25/2016 No LS inlet found4/20/2015 Same as last inspection.6/23/2014 Same as last inspection.12/17/2013 Same as last inspection.7/18/2013 Same as last inspection.10/30/2012 Siphon breaker housing unit is bent and has debris inside. LS outlet not found. FIELD_STRUCT_DESC: 10-inch irrigation steel pipe through levee, 3 feet below the crown. Centrifugal pump on the waterside (WS) bank. Siphon breaker on landside (LS) shoulder of the levee. (Permit No. 12334-1978, Jean James) FS Date: 5/4/2016 2:47:00 PM

Pump located on WS bank.

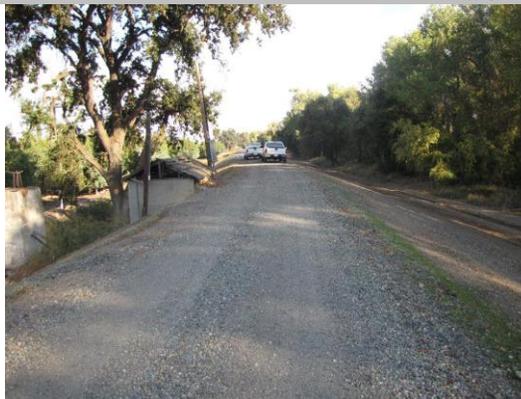
Photo 2 of 2 : UCIP\_SP\_2016\_47580\_70217.jpg

Item	DWR UCIP Field Study			39.311103 °	39.311103 °
				-122.030541 °	-122.030541 °
DWR ID					
Comment Code					
Inspector Comment					
<p>FS_ID:47580                  DS_ID:16454                  EP_NO: 9466                  Repair Type: Non-Urgent                  Crossing Status: Found                  UCIP Comments: 4/25/2016 Crossing appears to be abandoned. Power lines cut from the panels inside the concrete structure on LS.4/20/2015 Same as last inspection.6/23/2014 Same as last inspection.12/17/2013 Same as last inspection.7/18/2013 Same as last inspection.10/30/2012 No access to inspect slide gate on LS. Roof of pumping house deteriorating and debris scattered on LS. WS crossing not found. This crossing was listed in the USACE Periodic Inspection as ID# USACE_CESPK_MA1C_2010_p_345 no issues recorded.                  FIELD_STRUCT_DESC: *ABANDONED* 24-inch steel pipe through the levee at approximately 8-10 feet below the crown. Slide gate in concrete riser on the landside (LS) slope. Pump house encroaches into the LS slope. Two service poles on the LS shoulder. No visible appurtenances found on waterside (WS) toe. Power source cut on LS. Structure was retained under an automatic board order (ABO) issued as Permit No. 9466. (Permit No. 9466-1974, Roman Catholic Bishop of Sacramento)                  FS Date: 5/4/2016 2:51:00 PM</p>

Overview of levee crown looking upstream at crossing.

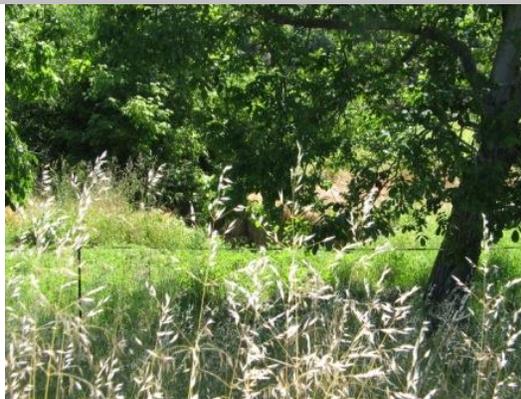
Photo 1 of 1 : SP\_2016\_MA0001\_297\_18\_20160316\_00009.jpg

LM Start	<b>10.13</b>	Rating **	M	Issue No.	<b>18</b>
LM End	<b>10.13</b>	Issue Type +	Ma	Location *	WS
Category	Earthen Levee			GPS Latitude/Longitude	
				Start	End
Item	Erosion / Bank Caving			39.328697 °	39.328697 °
				-122.029262 °	-122.029262 °
DWR ID	DWR_MA0001_01_s_2012_18				
Comment Code					
E1 : Note and monitor erosion site.					
Inspector Comment					
Monitor the erosion site.

View of the erosion along the waterside of the levee.

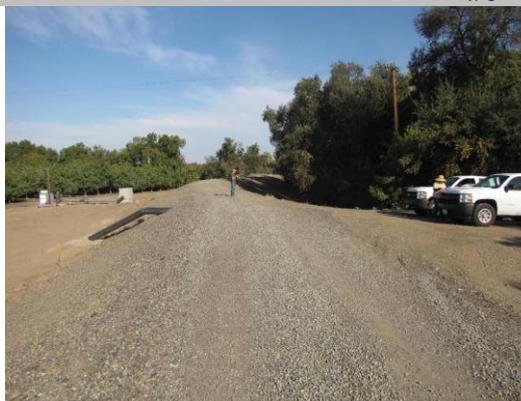
Photo 1 of 2 : UCIP\_SP\_2016\_47614\_70246.jpg

Item	DWR UCIP Field Study			39.329749 °	39.329749 °
				-122.029602 °	-122.029602 °
DWR ID					
Comment Code					
Inspector Comment					
FS_ID:47614 DS_ID:16453 EP_NO: N/A Repair Type: Urgent Crossing Status: Found UCIP Comments: 4/25/2016 Erosion still present by the WS pipes.4/20/2015 Erosion happening near WS shoulder where the pipes enter the levee. May just be caused by rain runoff.6/23/2014 Same as last inspection.12/17/2013 Same as last inspection.7/18/2013 Same as last inspection.10/30/2012 Landward side has been completely altered. Need to find permit for new work. FIELD_STRUCT_DESC: 24-inch steel pipe through levee at approximately 15-20 feet below the crown. Gate valve on the waterside (WS) end. Dual 14-inch line visible on landside (LS). (USACE, 1955) This entry matches the Drainage and Irrigation Structure referenced in O&M manual (538+42). FS Date: 5/4/2016 2:56:00 PM

Overview of levee crown looking upstream at multiple crossings.

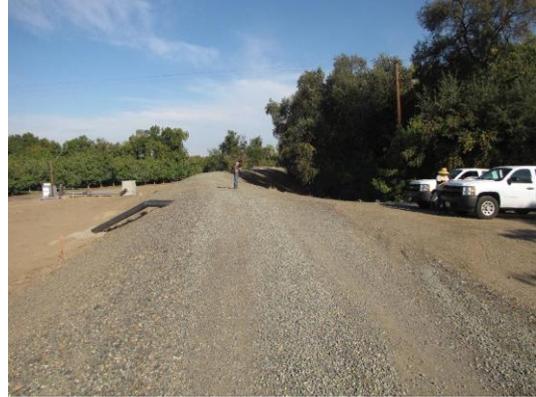
Photo 1 of 2 : UCIP\_SP\_2016\_47615\_70236.jpg

FS\_ID:47615  
 DS\_ID:16452  
 EP\_NO: 1800  
 Repair Type: Urgent  
 Crossing Status: Found  
 UCIP Comments: 4/25/2016 Erosion still present by the WS pipes.4/20/2015 Erosion happening near WS shoulder where the pipes enter the levee. May just be caused by rain runoff.6/23/2014 Same as last inspection.12/17/2013 Same as last inspection.7/18/2013 Same as last inspection.10/30/2012 This crossing has been completely modified--need recent permit issued to allow work on levee and levee toe. Was levee compacted to CVFPB standards? This crossing was listed in the USACE Periodic Inspection as ID# USACE\_CESPK\_MA1C\_2010\_p\_0371 unable to determine why this crossing was assigned "U".  
 FIELD\_STRUCT\_DESC: 1 of 2: 14-inch steel pipes through levee at approximately 3-4 feet below the crown. Siphon breakers on the waterside (WS) end. (Permit No. 1800-1959, Jimeno Rancho) New pipe visible on landside (LS).

LM Start	<b>10.21</b>	Rating **	U	Issue No.	<b>649 (cont)</b>
LM End	<b>10.21</b>	Issue Type +	En	Location *	WS

Overview of levee crown looking upstream at crossing.

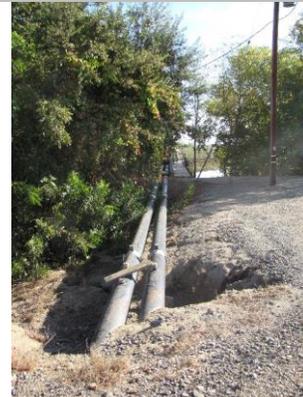
Photo 2 of 2 : UCIP\_SP\_2016\_47615\_70235.jpg

View of 2-14 inch crossings through levee on WS.

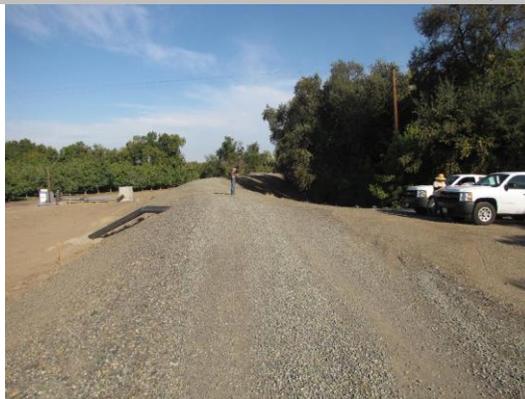
Photo 1 of 2 : UCIP\_SP\_2016\_47616\_70228.jpg

FS\_ID:47616  
 DS\_ID:17571  
 EP\_NO: 1800  
 Repair Type: Urgent  
 Crossing Status: Found  
 UCIP Comments: 4/25/2016 Erosion still present near the WS pipes.4/20/2015 Erosion happening on WS shoulder near where pipes enter the levee. May just be from rain runoff.6/23/2014 Same as last inspection.10/30/2012 This crossing has been completely modified--need recent permit issued to allow work on levee and levee toe. Was levee compacted to CVFPB standards? This crossing was listed in the USACE Periodic Inspection as ID# USACE\_CESPK\_MA1C\_2010\_p\_0371 unable to determine why this crossing was assigned "U".12/17/2013 Same as last inspection.7/18/2013 Same as last inspection.  
 FIELD\_STRUCT\_DESC: 2 of 2: 14-inch steel pipe through levee at approximately 3-4 feet below the crown. Siphon breaker located on the waterside (WS) end. (Permit No. 1800-1959, Jimeno Rancho)  
 FS Date: 5/4/2016 2:58:00 PM

LM Start	<b>10.21</b>	Rating **	U	Issue No.	<b>650 (cont)</b>
LM End	<b>10.21</b>	Issue Type +	En	Location *	WS

Overview of levee crown looking upstream at crossing.

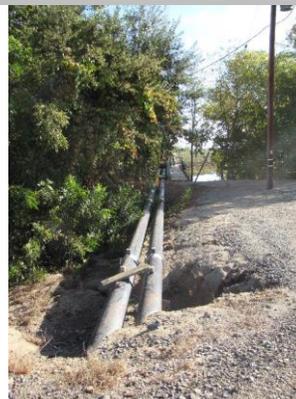
Photo 2 of 2 : UCIP\_SP\_2016\_47616\_70227.jpg

View of WS looking at crossing.

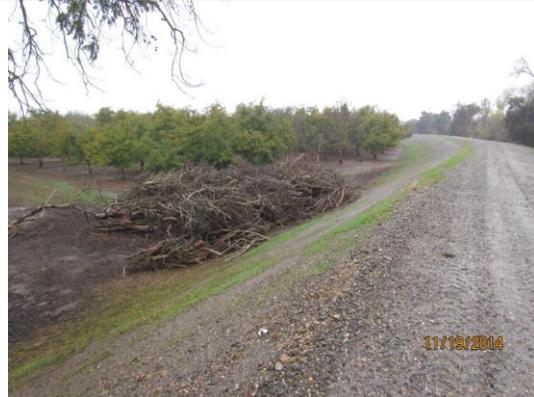
Photo 1 of 1 : SP\_2016\_MA0001\_297\_636\_20160316\_00023.jpg

LM Start	<b>10.32</b>	Rating **	M	Issue No.	<b>636</b>
LM End	<b>10.32</b>	Issue Type +	En	Location *	LS
Category	Earthen Levee		GPS Latitude/Longitude		
			Start	End	
Item	Encroachments		39.331320 °	39.331320 °	
			-122.029932 °	-122.029932 °	
DWR ID	DWR_MA0001_01_f_2014_636				
Comment Code					
PR : Prunings					
Inspector Comment

View of the pruning along the landside toe.

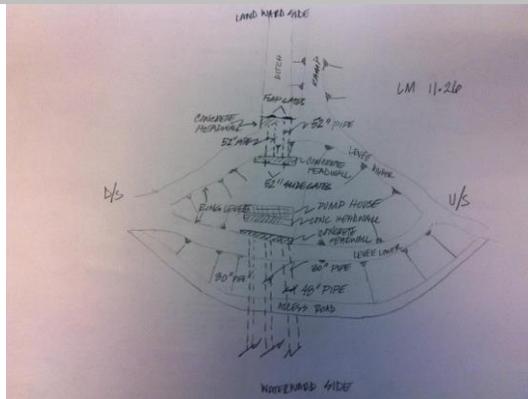
Photo 1 of 2 : UCIP\_SP\_2016\_47585\_70267.jpg

Item	DWR UCIP Field Study		39.340867 °	39.340867 °	
			-122.032932 °	-122.032932 °	
DWR ID					
Comment Code					
Inspector Comment					
<p>FS_ID:47585                  DS_ID:16449                  EP_NO: 187                  Repair Type: Non-Urgent                  Crossing Status: Found                  UCIP Comments: 4/25/2016 Crossing appears to be abandoned.4/21/2015 Same as last inspection.6/23/2014 Same as last inspection.12/17/2013 Same as last inspection.7/18/2013 Same as last inspection.10/30/2012 Need to determine if structure is still in use--contact owner. If abandoned structure--structure needs to be properly abandoned. This crossing was listed in the USACE Periodic Inspections as ID# USACE_CESPK_MA1C_2010_p_0393 missing gate. FIELD_STRUCT_DESC: 1 of 2: 52-inch irrigation corrugated metal pipe (CMP), 48-inch measured, through levee at approximately 15 feet below the levee crown. Slide gate on waterside (WS) and flap gate on landside (LS). Concrete headwalls at both sides. This structure is associated with another abandoned structure located on WS. Abandoned structure includes pump house, multiple concrete walls, and 3 additional crossings (2-30 inch pipes and 1-48 inch pipe). (Permit No. 187-1921, Compton-Delevan Irrigation District-Maxwell I.D.) New pump and platform installed and old pump house removed under Permit No. 9183. (Permit No. 9183-1973, Maxwell Irrigation District)                  FS Date: 5/5/2016 7:21:00 AM</p>

Sketch of structure located at levee mile 11.26.

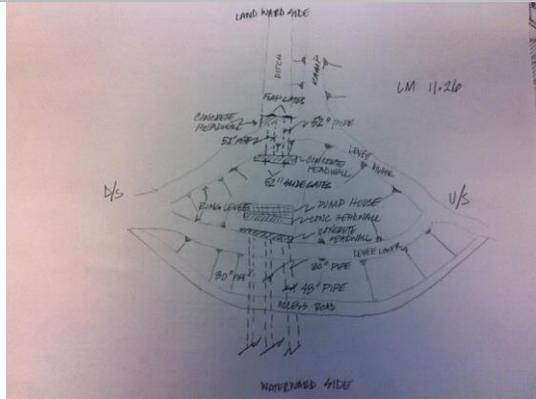
Photo 1 of 2 : UCIP\_SP\_2016\_47586\_70272.jpg

FS\_ID:47586  
 DS\_ID:17572  
 EP\_NO: 187  
 Repair Type: Urgent  
 Crossing Status: Found  
 UCIP Comments: 4/25/2016 Crossing appears to be abandoned. Slide gate needs to be replaced or pipe needs to be plugged to prevent water flow during high water season.4/21/2015 Same as last inspection.6/23/2014 Same as last inspection.12/17/2013 Same as last inspection.7/18/2013 Same as last inspection.10/30/2012 Missing positive closure device. Need to determine if structure is still in use--contact owner. If abandoned structure--structure needs to be abandoned properly. This crossing was listed in the USACE Periodic Inspections as ID# USACE\_CESPK\_MA1C\_2010\_p\_0393 missing gate. FIELD\_STRUCT\_DESC: 2 of 2: 52-inch irrigation corrugated metal pipe (CMP), 48-inch measured, through levee at approximately 15 feet below the crown. Slide gate on waterside (WS) and flap gate on landside (LS). Concrete headwalls at both sides. This structure is associated with another abandoned structure located on WS. Abandoned structure includes pump house, multiple concrete walls, and 3 additional crossings (2-30 inch pipes and 1-48 inch pipe). (Permit No. 187-1921, Compton-Delevan Irrigation District-Maxwell I.D.) New pump and platform installed and old pump house removed under Permit No. 9183. (Permit No. 9183-1973, Maxwell Irrigation District)

LM Start	<b>11.02</b>	Rating **	U	Issue No.	<b>677 (cont)</b>
LM End	<b>11.02</b>	Issue Type +	En	Location *	LS

Sketch of structure through levee ring located at levee mile 11.26.

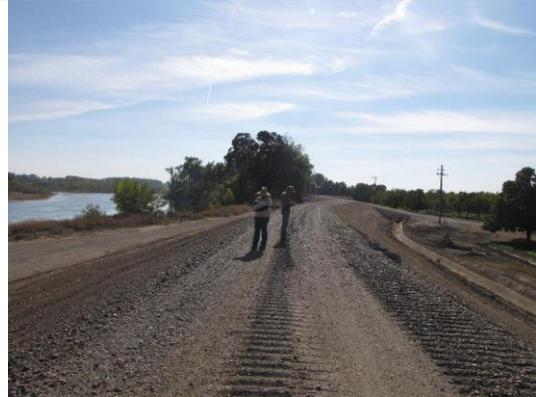
Photo 2 of 2 : UCIP\_SP\_2016\_48135\_70333.jpg

Item	DWR UCIP Field Study			39.344376 °	39.344376 °
				-122.031792 °	-122.031792 °
DWR ID					
Comment Code					
Inspector Comment					
FS_ID:48135 DS_ID:20582 EP_NO: N/A Repair Type: Non-Urgent Crossing Status: Found UCIP Comments: 4/25/2016 Crossing appears to be in good condition.4/21/2015 Same as last inspection.6/23/2014 Same as last inspection.12/17/2013 Same as last inspection.7/22/2013 Same as last inspection.10/30/2012 Need to determine encroachment permit associated with this crossing. FIELD_STRUCT_DESC: [Maxwell Irrigation District] 1 of 3: 24 inch steel drainage pipe through levee, at an unknown depth. Crossing is tied to existing Maxwell Irrigation District Pump Station located on waterside (WS). Siphon breaker inside corrugated metal pipe (CMP) riser located on landside (LS) shoulder. No permit has been identified since crossing was field discovered in 2012. FS Date: 5/5/2016 2:09:00 PM

Overview of levee crown looking downstream at crossing.

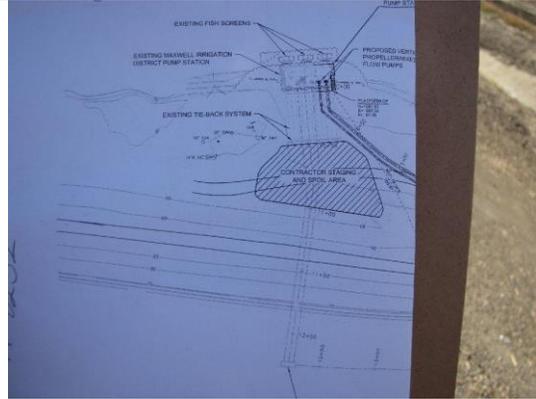
Photo 1 of 2 : UCIP\_SP\_2016\_47594\_70337.jpg

Item	DWR UCIP Field Study		39.344390 °	39.344390 °	
			-122.031787 °	-122.031787 °	
DWR ID					
Comment Code					
Inspector Comment					
FS_ID:47594 DS_ID:20583 EP_NO: N/A Repair Type: Non-Urgent Crossing Status: Found UCIP Comments: 4/25/2016 Crossing appears to be in good condition.4/21/2015 Same as last inspection.Need to determine encroachment permit for this crossing.7/22/2013 Same as last inspection.12/17/2013 Same as last inspection.6/23/2014 Same as last inspection. FIELD_STRUCT_DESC: 2 of 3: [Maxwell Irrigation District Pump] 24-inch discharge pipe through levee at an unknown depth. Crossing is tied to existing Maxwell Irrigation District Pump Station located on waterside (WS). Siphon breaker inside corrugated metal pipe (CMP) riser located on landside (LS) shoulder. FS Date: 5/5/2016 2:10:00 PM

LM Start	<b>11.27</b>	Rating **	M	Issue No.	<b>680 (cont)</b>
LM End	<b>11.27</b>	Issue Type +	En	Location *	LS

Drawing of existing Maxwell Irrigation District Conveyance Pipeline (DWG available through Permit No. 17471 for work located at LM 11.51).

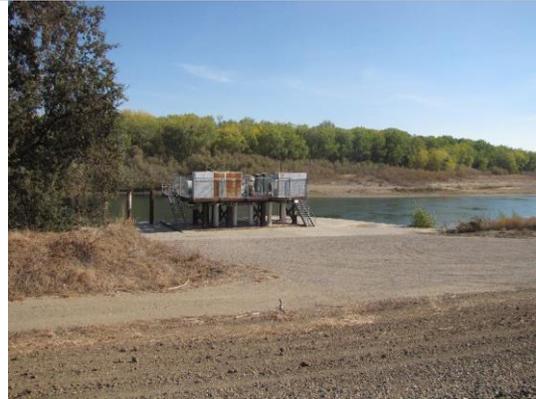
Photo 2 of 2 : UCIP\_SP\_2016\_47594\_70338.jpg

Pump Station located on WS.

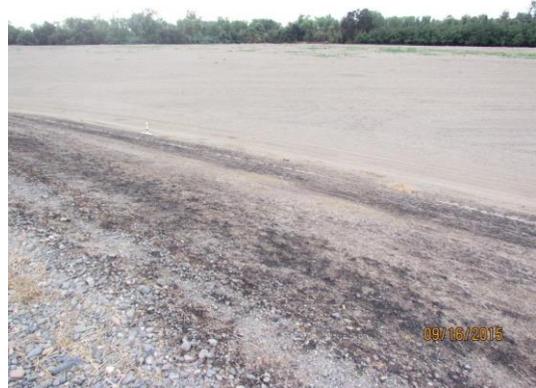
Photo 1 of 1 : SP\_2016\_MA0001\_297\_78\_20160316\_00021.jpg

LM Start	<b>12.27</b>	Rating **	A/W	Issue No.	<b>78</b>
LM End	<b>12.27</b>	Issue Type +	Ma	Location *	WS
Category	Earthen Levee			GPS Latitude/Longitude	
				Start	End
Item	Animal Control			39.357497 °	39.357497 °
				-122.026093 °	-122.026093 °
DWR ID	DWR_MA0001_01_f_2015_78				
Comment Code					
A1 : Exterminate rodents and backfill and compact or grout burrows.					
Inspector Comment

View of the rodent holes along the waterside slope.

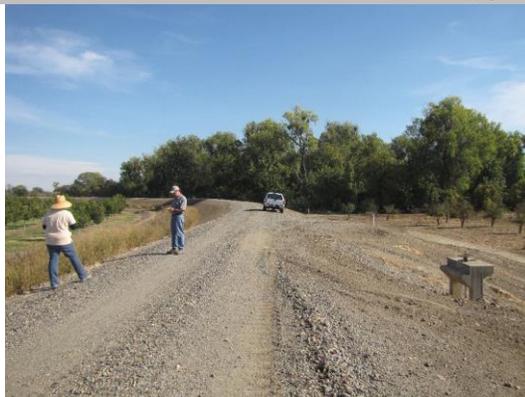
Photo 1 of 2 : UCIP\_SP\_2016\_47598\_70352.jpg

FS\_ID:47598  
 DS\_ID:16445  
 EP\_NO: 9462  
 Repair Type: Non-Urgent  
 Crossing Status: Found  
 UCIP Comments: 4/25/2016 Appears to be an abandoned crossing. WS slide gate still buried and inoperable.4/21/2015 Same as last inspection. 6/23/2014 Same as last inspection.12/17/2013 Same as last inspection.7/22/2013 Same as last inspection.10/30/2012 Slide gate unoperable-blocked by sediment. LS-flap gate missing. 5-inch pipe goes through 24-inch crossing--unable to determine is authorized. This crossing was listed in the USACE Periodic Inspections as ID# USACE\_CESPK\_MA1C\_2010\_p\_0435 for smaller pipe running inside existing crossing.  
 FIELD\_STRUCT\_DESC: \*ABANDONED\* 24-inch corrugated metal pipe (CMP) through levee at approximately 10 feet below the crown. Slide gate on both waterside (WS) and landside (LS). Gate missing on LS. Structure was retained under an automatic board order (ABO) issued as Permit No. 9462. (Permit No. 9462-1974, Thousand Acre Ranch)

LM Start	<b>12.69</b>	Rating **	M	Issue No.	<b>640 (cont)</b>
LM End	<b>12.69</b>	Issue Type +	En	Location *	WS

Overview of levee crown looking downstream at crossing.

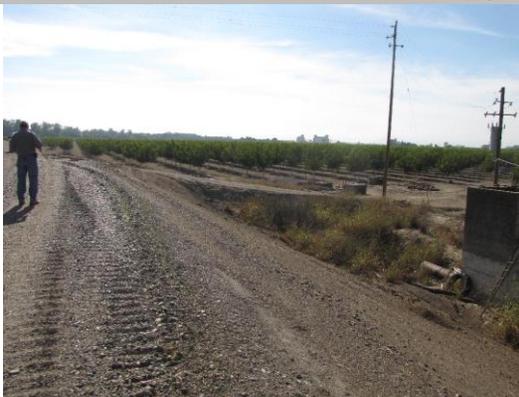
Photo 1 of 2 : UCIP\_SP\_2016\_47603\_70377.jpg

FS\_ID:47603  
 DS\_ID:16443  
 EP\_NO: 9461  
 Repair Type: Non-Urgent  
 Crossing Status: Found  
 UCIP Comments: 4/25/2016 Slide gate in WS box visually appears to be closed as its stem is all the way down. Still cannot look into box to confirm 100% though.4/21/2015 Same as last inspection.6/23/2014 Same as last inspection.12/17/2013 Same as last inspection.7/22/2013 Same as last inspection.10/30/2012 Unable to close positive closure device due to missing ladder-slucse gate inaccessible. Need to determine the condition of the gate. This crossing was listed in the USACE Periodic Inspections as ID# USACE\_CESPK\_MA1C\_2010\_p\_0453 for an inaccessible gate box with its ladder broken on the waterward side.  
 FIELD\_STRUCT\_DESC: 36-inch corrugated metal pipe through levee, 21.5 feet below crown. Slide gate in concrete box on waterward end. Pump on the bank. Tall concrete box located on landside (LS) Structure was retained under an automatic board order (ABO) issued as Permit No. 9461. (Permit No. 9461-1974, Annie D. Propfe) This entry matches the Drainage and Irrigation Structure referenced in O&M manual (Station 710+82).

LM Start	<b>13.47</b>	Rating **	M	Issue No.	<b>641 (cont)</b>
LM End	<b>13.47</b>	Issue Type +	En	Location *	WS

View of LS looking downstream at crossing.

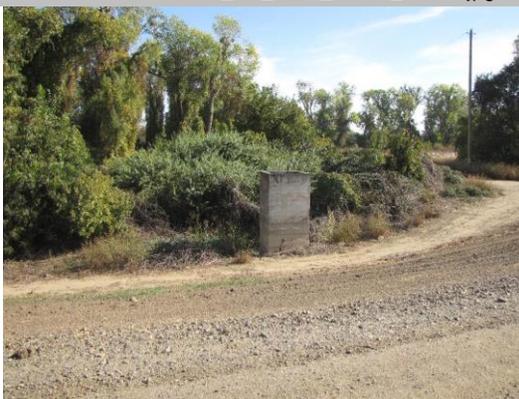
Photo 2 of 2 : UCIP\_SP\_2016\_47603\_70376.jpg

View of WS at crossing.

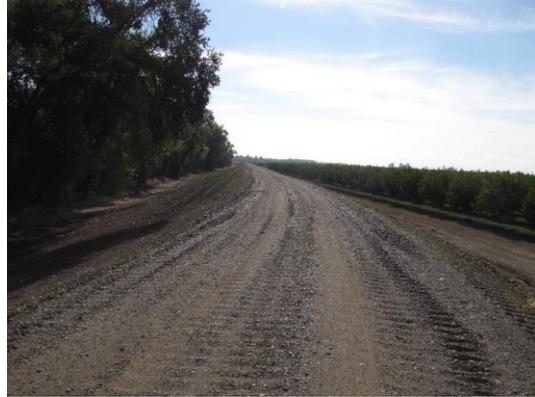
Photo 1 of 2 : UCIP\_SP\_2016\_47605\_70379.jpg

Item	DWR UCIP Field Study			39.371934 °	39.371934 °
				-122.012945 °	-122.012945 °
DWR ID					
Comment Code					
Inspector Comment					
FS_ID:47605 DS_ID:16442 EP_NO: N/A Repair Type: Non-Urgent Crossing Status: Found UCIP Comments: 4/25/2016 Abandoned crossing4/21/2015 Slide gate is still buried.6/23/2014 Same as last inspection.12/17/2013 Same as last inspection.7/22/2013 Same as last inspection.10/30/2012 Slide gate is buried-non-fuctional. This crossing was listed in the USACE Periodic Inspections as ID# USACE_CESPK_MA1C_2010_p_0457 for buried slide gate. FIELD_STRUCT_DESC: *ABANDONED* 36-inch corrugated metal pipe through levee at approximately 15-18 feet below the crown. Slide gate on waterside (WS) end. (Davis Ranches) FS Date: 5/5/2016 2:25:00 PM

Overview of levee crown looking downstream at crossing.

LM Start	<b>13.79</b>	Rating **	M	Issue No.	<b>642 (cont)</b>
LM End	<b>13.79</b>	Issue Type +	En	Location *	WS

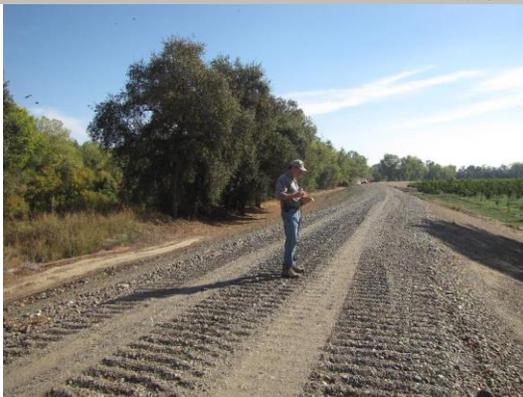
Photo 1 of 2 : UCIP\_SP\_2016\_47607\_70383.jpg

FS\_ID:47607  
 DS\_ID:16441  
 EP\_NO: 9460  
 Repair Type: Non-Urgent  
 Crossing Status: Found  
 UCIP Comments: 4/25/2016 WS concrete box appears to be abandoned. LS box appears to get filled by a well pump on LS.4/21/2015 Same as last inspection.6/23/2014 Same as last inspection.12/17/2013 Same as last inspection.7/22/2013 Same as last inspection.10/30/2012 Need to determine if crossing is still being used there are some abandoned features that remain at this crossing-- crossing has been modified. This crossing was listed in the USACE Periodic Inspections as ID# USACE\_CESPK\_MA1C\_2010\_p\_0464 for abandoned pump station.  
 FIELD\_STRUCT\_DESC: \*ABANDONED\* 18-inch steel pipe through levee. Gate valve on the waterward end. Pump house on the waterside (WS) berm. Concrete distribution box and flap gate at the landside (LS) toe. Structure was retained under an automatic board order (ABO) issued as Permit No. 9460. (Permit No. 9460-1974, Morici Corporation) 2016 Inspector noted that this structure appears to be partially abandoned concrete box appears to be in use. LS box appears to get filled by a well pump located on LS and water distributed.

LM Start	<b>14.28</b>	Rating **	M	Issue No.	<b>643 (cont)</b>
LM End	<b>14.28</b>	Issue Type +	En	Location *	WS

View of levee crown looking downstream at crossing.

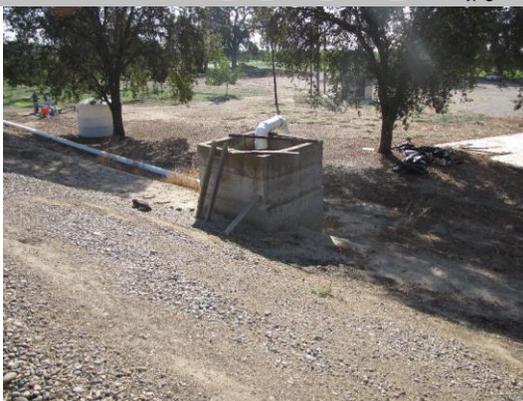
Photo 2 of 2 : UCIP\_SP\_2016\_47607\_70382.jpg

Concrete distribution box located on LS toe.

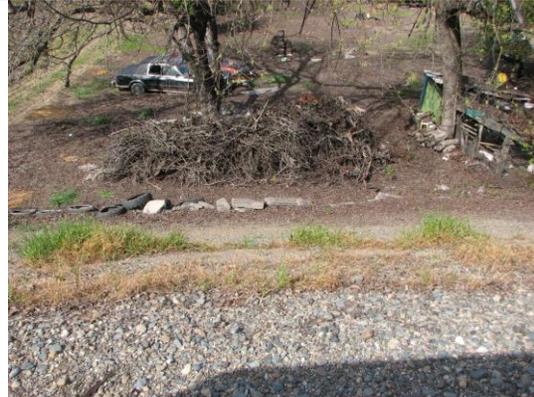
Photo 1 of 1 : SP\_2016\_MA0001\_297\_85\_20160405\_00146.jpg

LM Start	<b>15.79</b>	Rating **	U	Issue No.	<b>85</b>
LM End	<b>15.79</b>	Issue Type +	En	Location *	LS
Category	Earthen Levee		GPS Latitude/Longitude		
			Start	End	
Item	Encroachments		39.399929 °	39.399929 °	
			-122.010028 °	-122.010028 °	
DWR ID	DWR_MA0001_01_s_2016_85				
Comment Code					
DE : Debris					
Inspector Comment					
prunings, concrete and tires.

Prunings, concrete and tires at toe

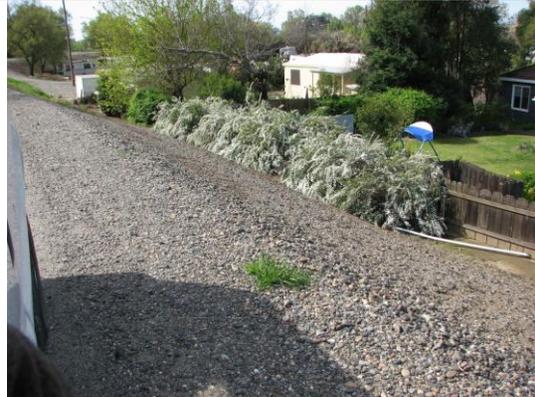
Photo 1 of 1 : SP\_2016\_MA0001\_297\_88\_20160405\_00147.jpg

LM Start	<b>15.95</b>	Rating **	U	Issue No.	<b>88</b>
LM End	<b>15.97</b>	Issue Type +	En	Location *	LS
Category	Earthen Levee		GPS Latitude/Longitude		
			Start	End	
Item	Vegetation		39.402130 °	39.402400 °	
			-122.009354 °	-122.009344 °	
DWR ID	DWR_MA0001_01_s_2016_88				
Comment Code					
V6 : Landscaping					
Inspector Comment

Landscaping obstructing visibility and access

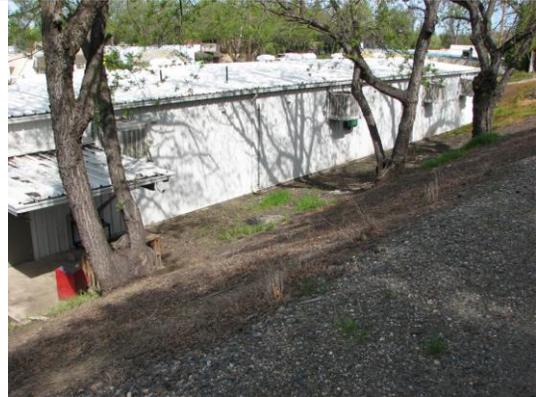
Photo 1 of 1 : SP\_2016\_MA0001\_297\_91\_20160405\_00150.jpg

LM Start	<b>16.06</b>	Rating **	U	Issue No.	<b>91</b>
LM End	<b>16.06</b>	Issue Type +	En	Location *	LS
Category	Earthen Levee		GPS Latitude/Longitude		
			Start	End	
Item	Encroachments		39.403565 °	39.403565 °	
			-122.009039 °	-122.009039 °	
DWR ID	DWR_MA0001_01_s_2016_91				
Comment Code					
BU : Building					
Inspector Comment					
long, white metal building with several AC units

Building obstructung access

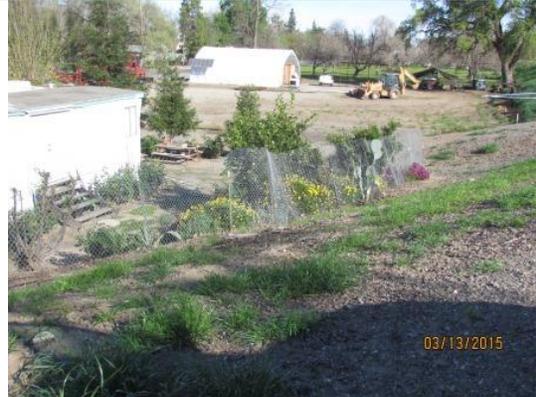
Photo 1 of 1 : SP\_2016\_MA0001\_297\_74\_20160316\_00017.jpg

LM Start	<b>16.10</b>	Rating **	M	Issue No.	<b>74</b>
LM End	<b>16.10</b>	Issue Type +	En	Location *	LS
Category	Earthen Levee			GPS Latitude/Longitude	
				Start	End
Item	Encroachments			39.404255 °	39.404255 °
				-122.008842 °	-122.008842 °
DWR ID	DWR_MA0001_01_s_2015_74				
Comment Code					
LI : Landscape Irrigation					
Inspector Comment					
Remove the landscape from the landside slope and toe.

View of the landscape along the landside slope and toe.

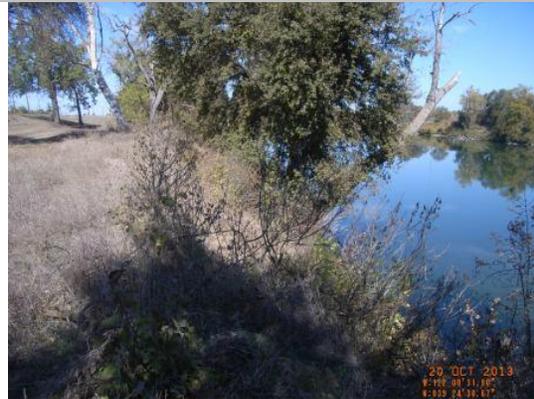
Photo 1 of 2 : SP\_2016\_MA0001\_297\_9\_20160316\_00006.jpg

LM Start	<b>16.35</b>	Rating **	M	Issue No.	<b>9</b>
LM End	<b>16.58</b>	Issue Type +	Ma	Location *	WS
Category	Supplemental		GPS Latitude/Longitude		
			Start	End	
Item	2015 USACE Erosion Survey, DRAFT		39.407837 °	39.411111 °	
			-122.008763 °	-122.009238 °	
DWR ID	DWR_MA0001_01_s_2016_9				
Comment Code					
Inspector Comment					
Erosion site added in 1997 and removed in 2005. 2009 - Site added back in, hard toe with slow moving erosion. Potential geotechnical failure. 2011 - Site extended downstream. 2015: Last observed in 2013. [2015 Site ID: SAC_164-3_R]

USACE 2013 Photo #1

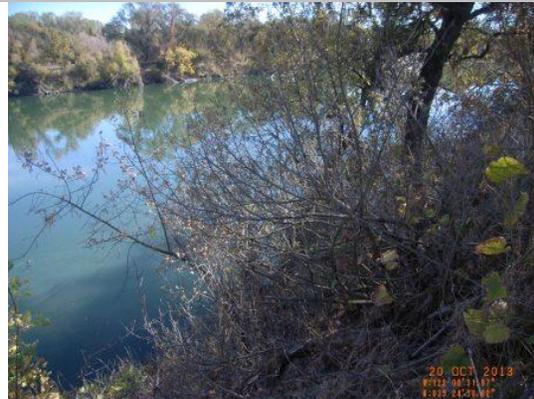
Photo 2 of 2 : SP\_2016\_MA0001\_297\_9\_20160316\_00007.jpg

LM Start	<b>16.35</b>	Rating **	M	Issue No.	<b>9 (cont)</b>
LM End	<b>16.58</b>	Issue Type +	Ma	Location *	WS

USACE 2013 Photo #2

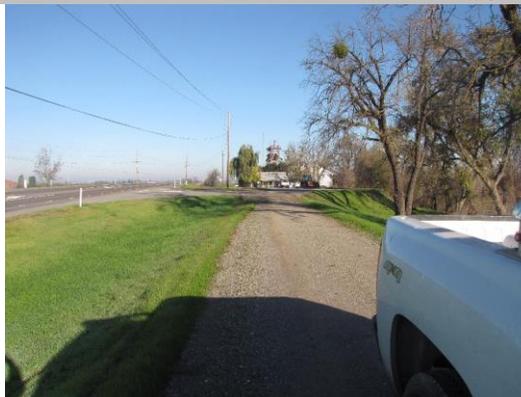
Photo 1 of 2 : UCIP\_SP\_2016\_47611\_70391.jpg

Item	DWR UCIP Field Study			39.410645 °	39.410645 °
				-122.009705 °	-122.009705 °
DWR ID					
Comment Code					
Inspector Comment					
<p>FS_ID:47611                  DS_ID:16448                  EP_NO: 14424                  Repair Type: Non-Urgent                  Crossing Status: Found                  UCIP Comments: 4/25/2016 WS marker sign is still knocked over.4/21/2015 Same as last inspection.11/3/2014 (DWR-Olivia) Need to contact owner to determine when markers will be placed.</p> <p>6/23/2014 Same as last inspection.12/17/2013 Same as last inspection7/22/2013 Same as last inspection.12/2012 Waiting for information regarding crossing from PG&amp;E. Regarding damage warning sign--PG&amp;E has initiated a project to replace pipeline crossing sign and utility markers, as required by DOT codes/regulations.11/2012 Utility warning sign damaged. Olivia (UCIP team) is coordinating with PG&amp;E to determine more info on crossing.</p> <p>FIELD_STRUCT_DESC: 12-inch gas pipeline through levee, 30-inches below crown. This 12-inch replacement pipe was installed by horizontally directionally drilling under the State HWY. Crossing is cathodically protected against external corrosion. Line was bored with a minimum cover of 48 feet under the right bank levee, 60 feet under the right bank, 25 feet under the channel and 52 feet under the left bank. (Permit No. 14424-1988, PG&amp;E) Emergency contact: Monte Penland, Gas Maintenance Supervisor, 15871 Central Street, Meridian, CA 95957; Office No. 530-634-6520 or Mobile No. 530-356-7396. Utility crossing coordinates are approximate. This pipe is under pressure and cathodic protection (CP) readings are taken on a regular schedule.                  FS Date: 5/5/2016 2:33:00 PM</p>

View just upstream of utility crossing.

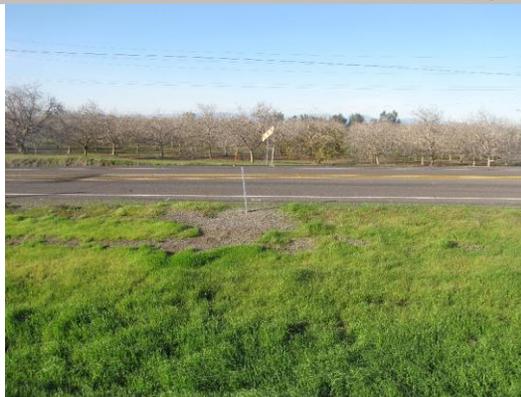
Photo 2 of 2 : UCIP\_SP\_2016\_47611\_70390.jpg

Item	DWR UCIP Field Study			39.410645 °	39.410645 °
				-122.009705 °	-122.009705 °
DWR ID					
Comment Code					
Inspector Comment					
<p>FS_ID:47611                  DS_ID:16448                  EP_NO: 14424                  Repair Type: Non-Urgent                  Crossing Status: Found                  UCIP Comments: 4/25/2016 WS marker sign is still knocked over.4/21/2015 Same as last inspection.11/3/2014 (DWR-Olivia) Need to contact owner to determine when markers will be placed.</p> <p>6/23/2014 Same as last inspection.12/17/2013 Same as last inspection7/22/2013 Same as last inspection.12/2012 Waiting for information regarding crossing from PG&amp;E. Regarding damage warning sign--PG&amp;E has initiated a project to replace pipeline crossing sign and utility markers, as required by DOT codes/regulations.11/2012 Utility warning sign damaged. Olivia (UCIP team) is coordinating with PG&amp;E to determine more info on crossing.</p> <p>FIELD_STRUCT_DESC: 12-inch gas pipeline through levee, 30-inches below crown. This 12-inch replacement pipe was installed by horizontally directionally drilling under the State HWY. Crossing is cathodically protected against external corrosion. Line was bored with a minimum cover of 48 feet under the right bank levee, 60 feet under the right bank, 25 feet under the channel and 52 feet under the left bank. (Permit No. 14424-1988, PG&amp;E) Emergency contact: Monte Penland, Gas Maintenance Supervisor, 15871 Central Street, Meridian, CA 95957; Office No. 530-634-6520 or Mobile No. 530-356-7396. Utility crossing coordinates are approximate. This pipe is under pressure and cathodic protection (CP) readings are taken on a regular schedule.                  FS Date: 5/5/2016 2:33:00 PM</p>

View of utility marker located on LS across hwy.
