**Flood Control Project Maintenance
Levee Inspections**
LMA District Cover Sheet
Spring 2019 Levee Inspection Results

Spring 2019 Levee Inspection Results

Sutter Maintenance Yard Maintenance Area 0001

Waterway			Bank	Unit Miles
Unit No. 01 Sacramento River			Right	16.76
	Spring (March - May)	Summer (June - August)	(September - November) Fall	Winter (December - February)
Unit Maintenance Rating (Fall Only)				
Date of Inspection	4/17/2019 - 4/17/2019			
DWR Inspector	Makar Sokol			
Accompanied By	Bryan Reniff Sutter Maintenance Yard

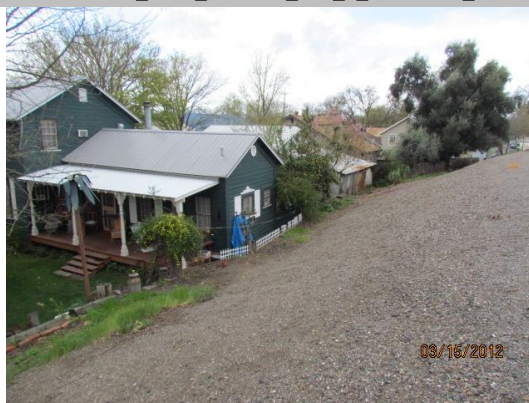
Photo 1 of 1 : SP_2019_MA0001_297_2_20190327_00001.jpg

LM Start	0.04	Rating **	U	Issue No.	2
LM End	0.23	Issue Type +	En	Location *	LS
Category	Earthen Levee			GPS Latitude/Longitude	
				Start	End
Item	Encroachments			39.213988 °	39.215198 °
				-122.001537 °	-122.004775 °
DWR ID	DWR_MA0001_01_s_2012_2				
Comment Code					
BU : Building					
Inspector Comment					
Multiple buildings and homes along the landside slope and toe through this area.

View of the building along the landside toe.

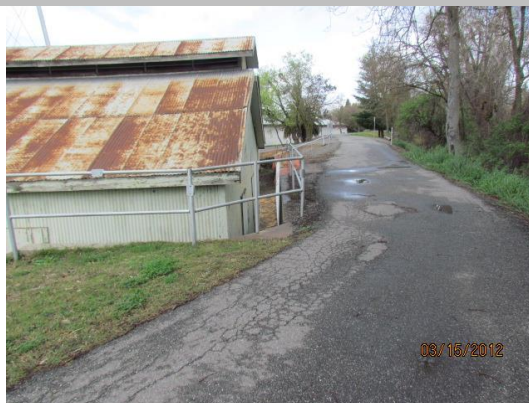
Photo 1 of 1 : SP_2019_MA0001_297_7_20190327_00004.jpg

LM Start	0.67	Rating **	U	Issue No.	7
LM End	0.70	Issue Type +	En	Location *	LS
Category	Earthen Levee			GPS Latitude/Longitude	
				Start	End
Item	Encroachments			39.216533 °	39.216680 °
				-122.012512 °	-122.012907 °
DWR ID	DWR_MA0001_01_s_2012_7				
Comment Code					
BU : Building					
Inspector Comment

View of the buildings along the landside toe.

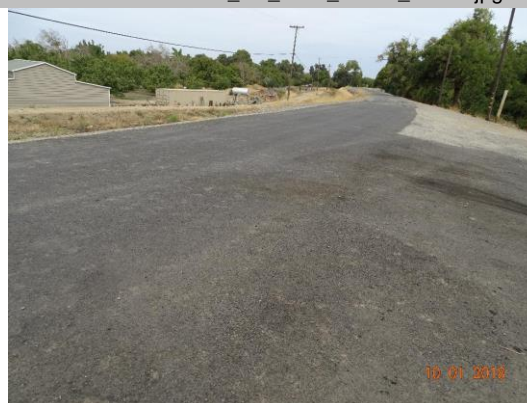
Photo 1 of 3 : UCIP_SP_2019_53078_78328.jpg

Comment Code					
Inspector Comment					
FS_ID:53078 DS_ID:25564 EP_NO: N/A Repair Type: Non-Urgent Crossing Status: Found UCIP Comments: 10/1/2018 Pipe installed according to emergency work authorization dated 07/31/2017 under existing permit No. 9481. Owner Roberts Ditch Company needs to submit as-builts. (O.Yakimov - DWR) FIELD_STRUCT_DESC: 36-inch smooth steel epoxy coated interior/exterior irrigation pipe with positive closure device on the water side of the levee. Crossing penetrates the levee at an angle. Other appurtenances located at this crossing include 2 slant pumps connected to a concrete distribution box, and shed structure located 100 feet northeast from levee crossing. Flow is carried from concrete distribution box to slide gate via concrete lined ditch. pipe is open to an irrigation ditch on LS. (Installed according to the board emergency work authorization dated 07/31/2017 under existing permit No. 9481. Owner Roberts Ditch Company). Replaces pipe with DSID 16431. FS Date: 10/1/2018 10:51:57 AM

View of levee crown at crossing.

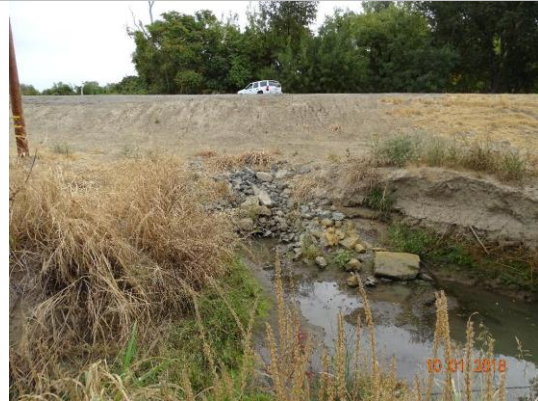
Photo 3 of 3 : UCIP_SP_2019_53078_78330.jpg

Comment Code						
Inspector Comment						
FS_ID:53078 DS_ID:25564 EP_NO: N/A Repair Type: Non-Urgent Crossing Status: Found UCIP Comments: 10/1/2018 Pipe installed according to emergency work authorization dated 07/31/2017 under existing permit No. 9481. Owner Roberts Ditch Company needs to submit as-builts. (O.Yakimov - DWR) FIELD_STRUCT_DESC: 36-inch smooth steel epoxy coated interior/exterior irrigation pipe with positive closure device on the water side of the levee. Crossing penetrates the levee at an angle. Other appurtenances located at this crossing include 2 slant pumps connected to a concrete distribution box, and shed structure located 100 feet northeast from levee crossing. Flow is carried from concrete distribution box to slide gate via concrete lined ditch. pipe is open to an irrigation ditch on LS. (Installed according to the board emergency work authorization dated 07/31/2017 under existing permit No. 9481. Owner Roberts Ditch Company). Replaces pipe with DSID 16431. FS Date: 10/1/2018 10:51:57 AM

View of LS levee slope and irrigation ditch at levee toe.

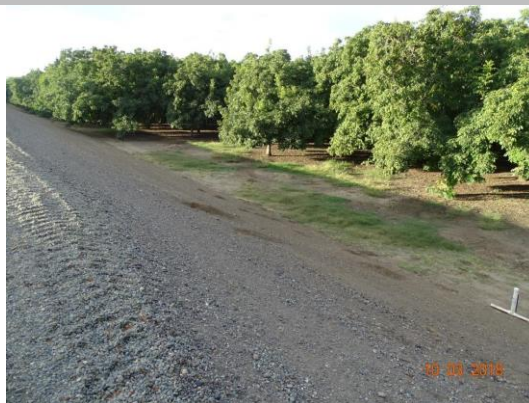
Photo 1 of 1 : SP_2019_MA0001_297_68_20190327_00015.jpg

LM Start	1.87	Rating **	M	Issue No.	68
LM End	1.87	Issue Type +	Ma	Location *	LS
Category	Earthen Levee			GPS Latitude/Longitude	
				Start	End
Item	Animal Control			39.231195 °	39.231195 °
				-122.015460 °	-122.015460 °
DWR ID	DWR_MA0001_01_f_2018_68				
Comment Code					
A3 : No rodents visible, but rodent burrows visible; need to backfill and compact or grout burrows.					
Inspector Comment

View of the rodent holes along the landside slope.

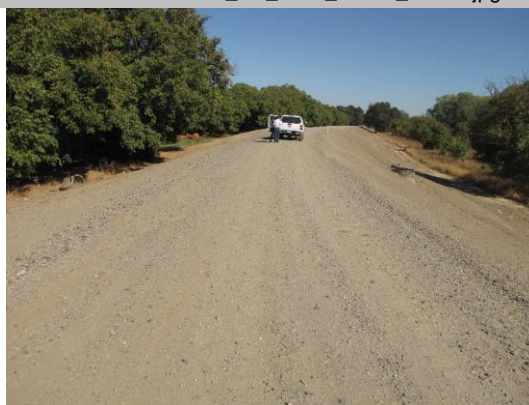
Photo 1 of 3 : UCIP_SP_2019_51852_70064.jpg

Comment Code						
Inspector Comment						
FS_ID:51852 DS_ID:16430 EP_NO: 9487 Repair Type: Non-Urgent Crossing Status: Found UCIP Comments: 5/3/2017 WS end still partially plugged. (DWR Sutter Yard- A Freitag)10/24/2016 Ws end is till partially plugged.(DWR Sutter Yard- A Freitag)4/25/2016 WS pipe end is still plugged with soil. Rest of the pipe appeared to be in good condition.4/20/2015 WS pipe end is plugged about 50% by soil.6/18/2014 Same as last inspection.12/17/2013 Same as last inspection.7/18/2013 WS pipe end has been reformed but is still clogged about 50% by sediment.10/18/2012 Remove dirt and debris in riser. Outlet deformed and blocked over 50%. Debris-round concrete section on landward side. This crossing was listed in the USACE Periodic Inspections as ID# USACE_CESPK_MA1C_2010_p_0116 for crossing outlet deformed and clogged with dirt. FIELD_STRUCT_DESC: 1 of 2: 36-inch corrugated metal drainage pipe through the levee, approximately 12-15 feet below the crown. Slide gates in corrugated metal pipe (CMP) riser located on the waterside (WS) slope. Pipe daylights on the landside (LS). (36-inch pipe [HLM 1.97] authorized under Automatic Board Order (ABO) issued as Permit No. 9487, 1974 - Jimeno Rancho) [Additional Reference(s): DWR Levee Log, 1992. USACE Sacramento O&M Manual 137, August 1955, (Station 103+18)]. FS Date: 5/19/2017 1:20:29 PM

Overview of levee crown and slopes looking upstream towards crossing.

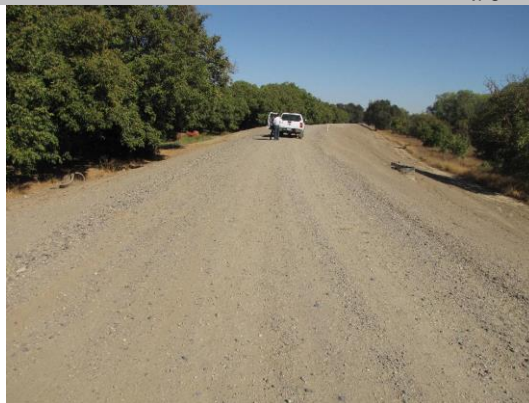
Photo 1 of 3 : UCIP_SP_2019_51853_70071.jpg

FS_ID:51853
DS_ID:17565
EP_NO: 9487
Repair Type: Non-Urgent
Crossing Status: Found
UCIP Comments: 5/3/2017 Ws end still partially plugged. (DWR Sutter Yard- A Freitag) 10/24/2016 Ws pipe end still plugged. (DWR Sutter Yard- A Freitag) 4/25/2016 WS pipe end still plugged with soil. rest of pipe appears in good condition. 4/20/2015 WS pipe end plugged about 50% by soil. 6/18/2014 Same as last inspection. 12/17/2013 Same as last inspection. 7/18/2013 WS pipe end has been reformed but is still partially blocked with dirt and debris. 10/18/2012 WS-remove dirt and debris in riser. Outlet deformed and blocked over 50%. Burrow activity near outlet on waterward slope. Debris around concrete section on landward side. This crossing was listed in the USACE Periodic Inspections as ID# USACE_CESPK_MA1C_2010_p_0116 for crossing outlet deformed and clogged with dirt.
FIELD_STRUCT_DESC: 2 of 2: 36-inch corrugated metal drainage pipe through the levee, approximately 12-15 feet below the crown. Slide gates in corrugated metal pipe (CMP) riser on the waterside (WS) slope. Pipe daylights on the landside (LS). (36-inch pipe [HLM 1.97] authorized under Automatic Board Order (ABO) issued as Permit No. 9487, 1974 - Jimeno Rancho) [Additional Reference(s): DWR Levee Log, 1992. USACE Sacramento O&M Manual 137, August 1955, (Station 103+18)].

View of levee crown and slopes looking upstream at crossing.

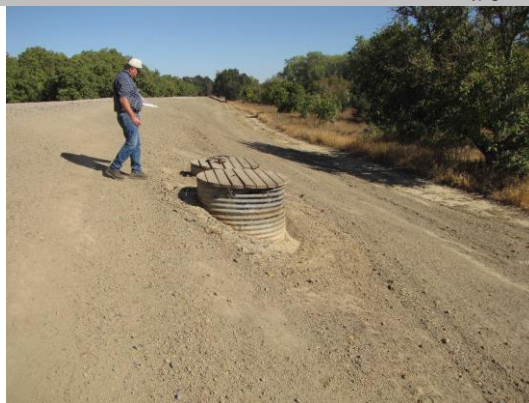
Photo 2 of 3 : UCIP_SP_2019_51853_70074.jpg

View of CMP risers located on WS slope.

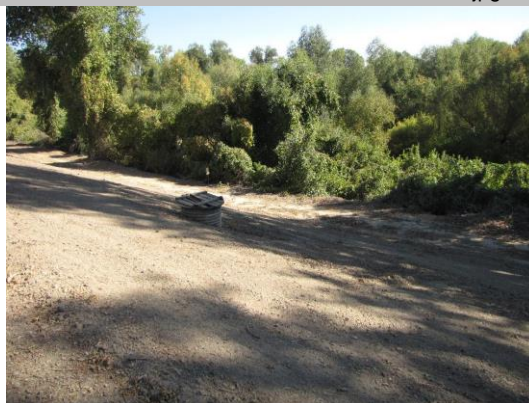
Photo 2 of 3 : UCIP_SP_2019_51855_70084.jpg

View of WS slope and toe.

Comment Code						
Inspector Comment						
FS_ID:51855 DS_ID:16428 EP_NO: 9467 Repair Type: Non-Urgent Crossing Status: Found UCIP Comments: 5/3/2017 Abandoned- needs to be done so properly. (DWR Sutter Yard- A Freitag)10/24/2016 Abandoned.(DWR Sutter Yard- A Freitag)4/25/2016 Abandoned crossing. Unable to locate any WS and LS pipe ends.4/20/2015 Same as last inspection.6/18/2014 Same as last inspection.12/17/2013 Same as last inspection.7/18/2013 Same as last inspection.10/18/2012 Only riser visible. Debris and sediment blocking gate. Gate inside riser is buried and non-functional. If crossing is abandoned, owner needs to properly abandon. This crossing was listed in the USACE Periodic Inspections as ID# USACE_CESPK_MA1C_2010_p_0132 no culvert through the levee is visible here. FIELD_STRUCT_DESC: *ABANDONED* 24-inch corrugated metal drainage pipe through the levee, approximately 12-15 feet below the crown. Slide gate in CM pipe riser on the waterside (WS) slope. No signs of inlet visible on the landside (LS). (24-inch pipe [HLM 2.31] authorized under Automatic Board Order (ABO) issued as Permit No. 9467, 1974 - Lovell E. Spurgeon) [Additional Reference(s): DWR Levee Log, 1992. USACE Sacramento O&M Manual 137, August 1955, (Station 120+60)]. FS Date: 5/19/2017 1:48:04 PM

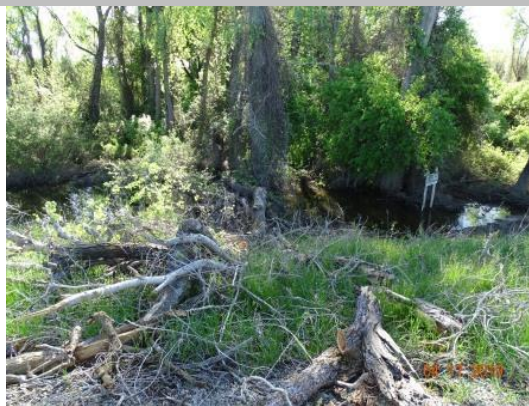
Photo 1 of 1 : SP_2019_MA0001_297_84_20190418_00152.jpg

LM Start	2.37	Rating **	U	Issue No.	84
LM End	2.37	Issue Type +	Ma	Location *	WS
Category	Earthen Levee			GPS Latitude/Longitude	
				Start	End
Item	Encroachments			39.237692 °	39.237692 °
				-122.011827 °	-122.011827 °
DWR ID	DWR_MA0001_01_s_2019_84				
Comment Code					
PR : Prunings					
Inspector Comment

The tree branches and limbs should be removed from the waterside slope and toe. Spring 2019.

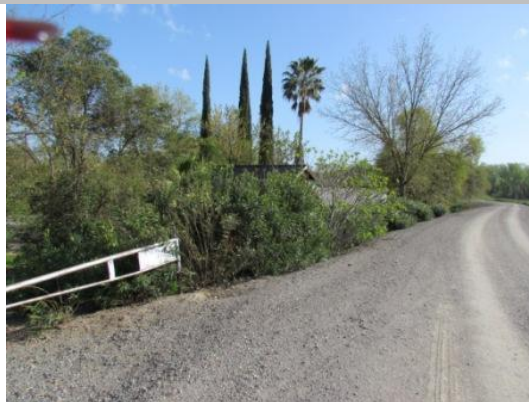
Photo 1 of 1 : SP_2019_MA0001_297_20_20190327_00009.jpg

LM Start	2.53	Rating **	U	Issue No.	20
LM End	2.55	Issue Type +	En	Location *	LS
Category	Earthen Levee			GPS Latitude/Longitude	
				Start	End
Item	Encroachments			39.239750 °	39.239955 °
				-122.010390 °	-122.010090 °
DWR ID	DWR_MA0001_01_s_2012_20				
Comment Code					
BU : Building					
Inspector Comment

View of the house next to the levee.

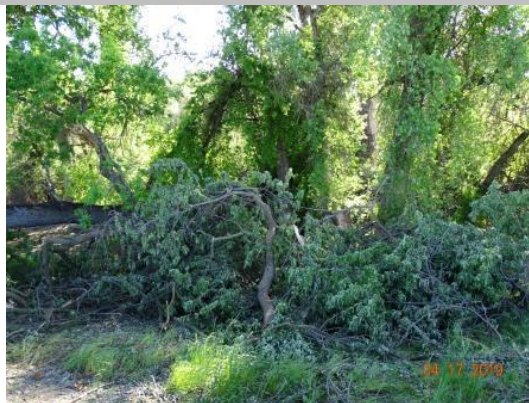
Photo 1 of 1 : SP_2019_MA0001_297_96_20190418_00153.jpg

LM Start	2.93	Rating **	U	Issue No.	96
LM End	2.93	Issue Type +	Ma	Location *	WS
Category	Earthen Levee			GPS Latitude/Longitude	
				Start	End
Item	Encroachments			39.245068 °	39.245068 °
				-122.007831 °	-122.007831 °
DWR ID	DWR_MA0001_01_s_2019_96				
Comment Code					
TR : Tree or limb					
Inspector Comment					
The tree branches and limbs should be removed from the waterside slope and toe.

View of the tree branches on the waterside slope. Spring 2019.

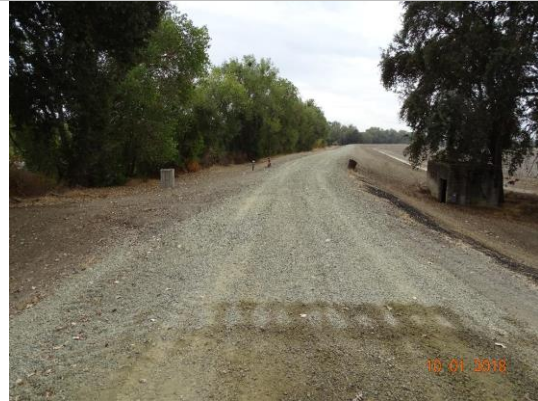
Photo 1 of 3 : UCIP_SP_2019_53048_78239.jpg

FIELD_STRUCT_DESC: 24-inch asphalt coated steel irrigation pipe through the levee, approximately 10 feet below the crown. Gate valve on the waterside (WS) shoulder. 1-1/4 inch conduit through the levee. Siphon breaker on the landside (LS) shoulder. Concrete distribution box and control box located on the LS. Pump, walkway, and gate located on the WS berm. (Permit No. 4213, 1973 - Scott Ranch) [Additional Reference(s): DWR Levee Log, 1992].
FS Date: 10/1/2018 1:24:05 PM

View of levee crown at crossing

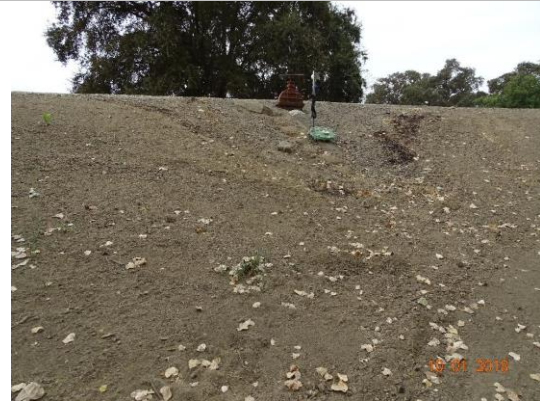
Photo 2 of 3 : UCIP_SP_2019_53048_78238.jpg

Comment Code						
Inspector Comment						
FS_ID:53048 DS_ID:16436 EP_NO: 4213 Repair Type: Urgent Crossing Status: Found UCIP Comments: 10/1/2018 Sinkhole near concrete structure on the LS was filled with soil and debris. Flow meter at the WS shoulder and a manometer on the pipe on the LS shoulder was installed. Video inspection is recommended to determine pipe integrity through levee. (O.Yakimov - DWR)5/3/2017 Sinkhole still present next to concrete structure on LS. (DWR Sutter Yard- AFreitag)10/24/2016 Pump is on WS. Sinkhole still present over pipe alignment next to the concrete building.(DWR Sutter Yard- AFreitag)4/25/2016 No repairs have been made since last inspection. Sink holes are still present above pipe next to concrete building on LS. (DWR Sutter Yard - afreitag)4/20/2015 Sink hole over pipe alignment on LS up against the concrete building. Need to dig up pipe and see if its leaking. (DWR Sutter Yard - afreitag)6/23/2014 Same as last inspection. (DWR Sutter Yard - afreitag)6/18/2014 Same as last inspection. (DWR Sutter Yard - afreitag)12/17/2013 Same as last inspection. (DWR Sutter Yard - afreitag)7/18/2013 Same as last inspection. (DWR Sutter Yard - afreitag)10/19/2012 Recommend adding door to LS concrete structure. Riser located on landward side is damaged. This crossing was listed in the USACE Periodic Inspection as ID# USACE_CESPK_MA1C_2010_p_0194 no issues logged. (DWR UCIP - omagana) FIELD_STRUCT_DESC: 24-inch asphalt coated steel irrigation pipe through the levee, approximately 10 feet below the crown. Gate valve on the waterside (WS) shoulder. 1-1/4 inch conduit through the levee. Siphon breaker on the landside (LS) shoulder. Concrete distribution box and control box located on the LS. Pump, walkway, and gate located on the WS berm. (Permit No. 4213, 1973 - Scott Ranch) [Additional Reference(s): DWR Levee Log, 1992]. FS Date: 10/1/2018 1:24:05 PM

Flow meter installed.

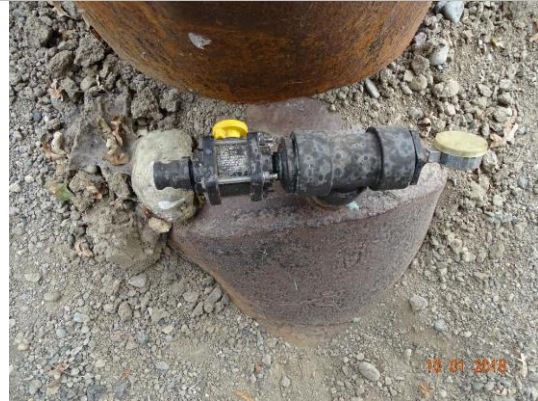
Photo 3 of 3 : UCIP_SP_2019_53048_78236.jpg

FIELD_STRUCT_DESC: 24-inch asphalt coated steel irrigation pipe through the levee, approximately 10 feet below the crown. Gate valve on the waterside (WS) shoulder. 1-1/4 inch conduit through the levee. Siphon breaker on the landside (LS) shoulder. Concrete distribution box and control box located on the LS. Pump, walkway, and gate located on the WS berm. (Permit No. 4213, 1973 - Scott Ranch) [Additional Reference(s): DWR Levee Log, 1992].
FS Date: 10/1/2018 1:24:05 PM

Manometer and air valve installed on pipe at LS shoulder.

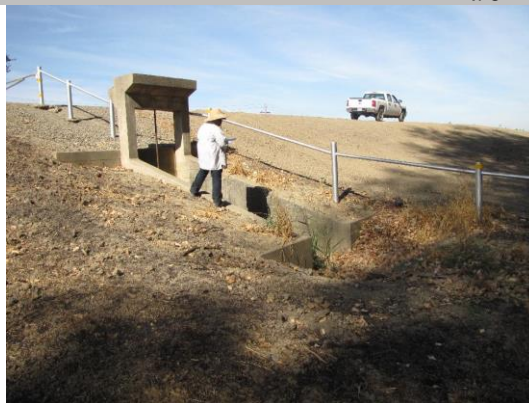
Photo 2 of 3 : UCIP_SP_2019_51864_70139.jpg

Comment Code						
Inspector Comment						
FS_ID:51864 DS_ID:16422 EP_NO: N/A Repair Type: Non-Urgent Crossing Status: Found UCIP Comments: 5/3/2017 Appears abandoned- needs to be done so properly. (DWR Sutter Yard- AFreitag)10/24/2016 Appears to be abandoned.(DWR Sutter Yard- AFreitag)4/25/2016 Appears to be an abandoned crossing. 4/20/2015 Debrs is still blocking gate. Appears to be an abandoned crossing.6/18/2014 Same as last inspection.12/17/2013 Same as last inspection.7/18/2013 Wheel to operate slide gate has been replaced but gate is still blocked by debris.10/19/2012 WS-wheel to operate slide gate missing, walkway has been removed; burrow activity near structure; debris in concrete distribution box WS blocking gate. This crossing was listed in the USACE Periodic Inspection as ID# USACE_CESPK_MA1C_2010_p_0207 the wheel to operate sluice gate missing. FIELD_STRUCT_DESC: *ABANDONED* 24-inch drainage pipe of an unknown material through the levee, unknown depth below the crown. Walkway to slide gate on the waterside (WS) end. Walkway has been removed. Flap gate in concrete distribution box at the landside (LS) toe. [Additional Reference(s): DWR Levee Log, 1992]. FS Date: 5/19/2017 2:05:36 PM

View of WS slope with concrete structure.

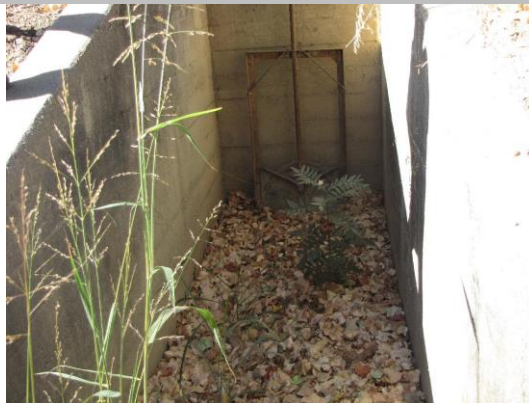
Photo 3 of 3 : UCIP_SP_2019_51864_70138.jpg

View of slide gate located on WS.

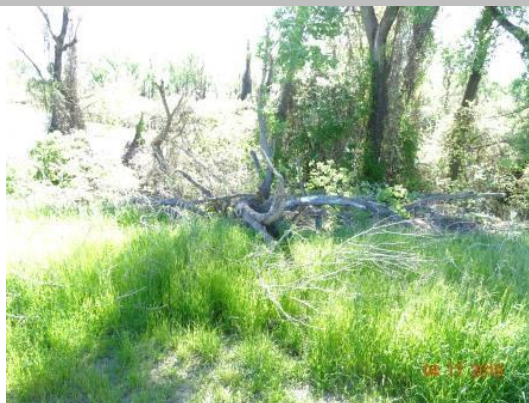
Photo 1 of 1 : SP_2019_MA0001_297_105_20190418_00154.jpg

LM Start	4.18	Rating **	U	Issue No.	105
LM End	4.18	Issue Type +	Ma	Location *	WS
Category	Earthen Levee			GPS Latitude/Longitude	
				Start	End
Item	Encroachments			39.261201 °	39.261201 °
				-122.012160 °	-122.012160 °
DWR ID	DWR_MA0001_01_s_2019_105				
Comment Code					
TR : Tree or limb					
Inspector Comment					
The large fallen tree should be removed from the waterside slope.

View of the fallen tree on the waterside slope. Spring 2019.

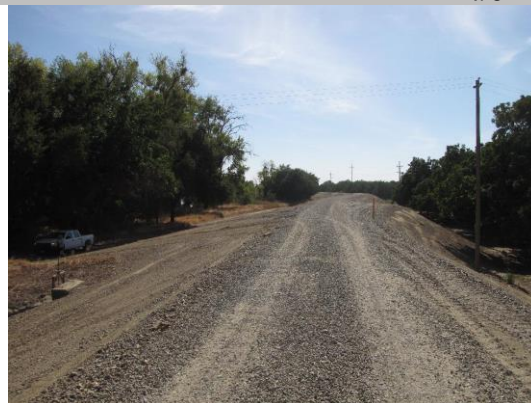
Photo 1 of 3 : UCIP_SP_2019_51869_70154.jpg

Comment Code					
Inspector Comment					
FS_ID:51869 DS_ID:16419 EP_NO: 9476 Repair Type: Non-Urgent Crossing Status: Found UCIP Comments: 5/3/2017 Culvert has sediment build up in it- needs to be cleaned out. (DWR Sutter Yard- AFreitag)10/24/2016 LS outlets becoming over grown with vegetation in the ditch.(DWR Sutter Yard- AFreitag)4/25/2016 WS entry still blocked and wingwalls still cracked.4/20/2015 WS entry still blocked and wingwalls still cracked.6/18/2014 Same as last inspection.12/17/2013 Same as last inspection.7/18/2013 Same as last inspection.10/19/2012 blocked, no entry on WS. This crossing was listed in the USACE Periodic Inspection as ID# USACE_CESPK_MA1C_2010_p_0247 for u/s and d/s wing wall shows some cracking and tilting. FIELD_STRUCT_DESC: 1 of 2: 36-inch corrugated metal irrigation pipe and concrete box culvert through the levee at an unknown depth below the crown. Concrete headwall visible on the landside (LS) toe. (Automatic Board Order (ABO) issued as Permit No. 9476, 1974 - Ohliger) [Additional Reference(s): DWR Levee Log, 1992]. FS Date: 5/23/2017 9:51:10 AM

Overview of levee crown looking downstream at crossing.

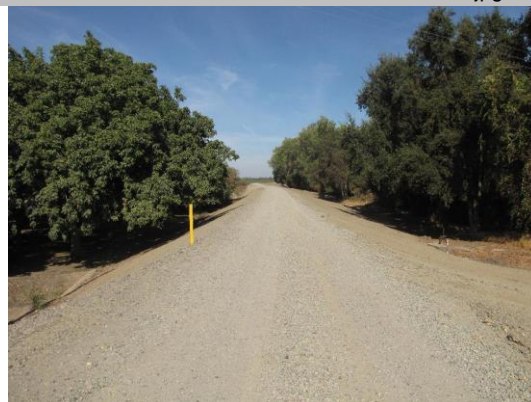
Photo 2 of 3 : UCIP_SP_2019_51869_70152.jpg

View of crossing looking upstream at crossing.

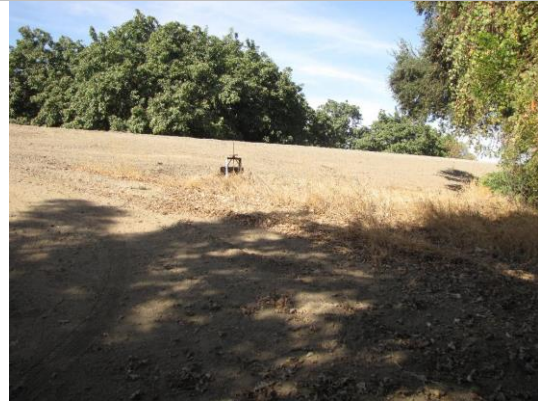
Photo 3 of 3 : UCIP_SP_2019_51869_70156.jpg

Comment Code						
Inspector Comment						
FS_ID:51869 DS_ID:16419 EP_NO: 9476 Repair Type: Non-Urgent Crossing Status: Found UCIP Comments: 5/3/2017 Culvert has sediment build up in it- needs to be cleaned out. (DWR Sutter Yard- AFreitag)10/24/2016 LS outlets becoming over grown with vegetation in the ditch.(DWR Sutter Yard- AFreitag)4/25/2016 WS entry still blocked and wingwalls still cracked.4/20/2015 WS entry still blocked and wingwalls still cracked.6/18/2014 Same as last inspection.12/17/2013 Same as last inspection.7/18/2013 Same as last inspection.10/19/2012 blocked, no entry on WS. This crossing was listed in the USACE Periodic Inspection as ID# USACE_CESPK_MA1C_2010_p_0247 for u/s and d/s wing wall shows some cracking and tilting. FIELD_STRUCT_DESC: 1 of 2: 36-inch corrugated metal irrigation pipe and concrete box culvert through the levee at an unknown depth below the crown. Concrete headwall visible on the landside (LS) toe. (Automatic Board Order (ABO) issued as Permit No. 9476, 1974 - Ohliger) [Additional Reference(s): DWR Levee Log, 1992]. FS Date: 5/23/2017 9:51:10 AM

View of WS slope and access road. Slide gate is second crossing at this location.

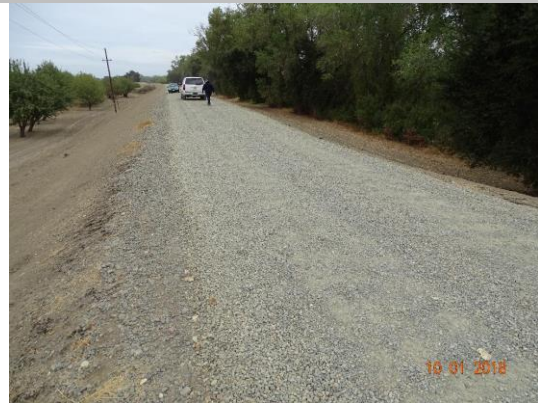
Photo 1 of 3 : UCIP_SP_2019_53049_78240.jpg

FS_ID:53049
DS_ID:16446
EP_NO: N/A
Repair Type: Urgent
Crossing Status: Found
UCIP Comments: 10/1/2018 PVC pipe underneath the slide gate that is located inside CMP riser on WS shoulder was restored and blocks gate from closing. Sediment built up at the bottom of CMP riser. PVC pipe needs to be removed in order to properly close slide gate. (O.Yakimov - DWR)5/3/2017 Pipe leaked during the Jan/Feb 2017 high water event. Sand bags were placed at both the LS and WS outlets as well as down inside the standpipe to slow the water flow. The 5inch pvc was cut away but the slide gate could still not close fully. Suspect sediment build up was in the bottom of the stand pipe was blocking the gate. Inside of pipe should be cleaned out. (DWR Sutter Yard-AFreitag)10/24/2016 Pvc was back running through the crossing and blocking the screwgate. photo attached(DWR Sutter Yard-AFreitag)9/28/2016 Crossing has been downgraded from Urgent to Non-Urgent 5-inch PVC pipe was cut to allow the slide gate to close. Need to contact owner to remove unauthorized pipe to comply with Title 23. (DWR UCIP - omagana)4/25/2016 5 inch pvc pipe running through crossing has been cut out to allow the slide gate to close. (DWR Sutter Yard - afreitag)4/20/2015 5inch pvc is still present blocking slide gate from closing. WS end of pipe has been exposed so there is no way to stop water from flowing through pipe during highwater times. (DWR Sutter Yard - afreitag)6/23/2014 Same as last inspection. There is no way to stop water from flowing through pipe during high water times. (DWR Sutter Yard - afreitag)12/17/2013 Same as last inspection. (DWR Sutter Yard - afreitag)7/18/2013 Same as last inspection. (DWR Sutter Yard - afreitag)10/19/2012 Unauthorized 5 inch PVC pipe running through 36 inch crossing. 5 inch PVC crossing prevents slide gate from closing during high water. Debris and sediment inside riser. This crossing was listed in the USACE Periodic Inspection as ID# USACE_CESPK_MA1C_2010_p_0258 for 5 inch PVC pipe running through culvert. (DWR UCIP - omagana) FIELD_STRUCT_DESC: 36-inch steel (not corrugated metal, as referenced in O&M manual) drainage pipe through the levee, approximately 14-16 feet below levee crown. Slide gate in corrugated metal pipe (CMP) riser on the waterside (WS) slope. Pipe also visible on the landside (LS). [Additional Reference(s): DWR Levee Log, 1992. USACE Sacramento O&M Manual 137, August 1955, (Station 331+31)]. FS Date: 10/1/2018 2:59:44 PM

View of levee crown at crossing.

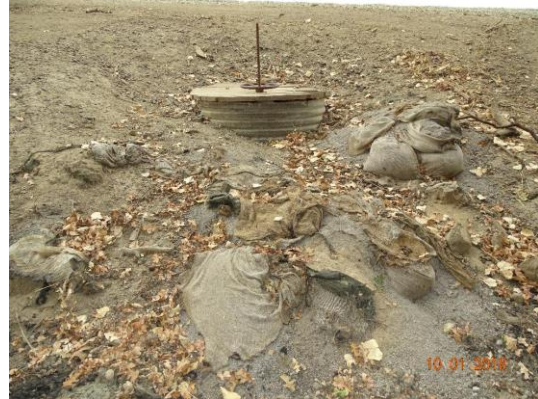
Photo 2 of 3 : UCIP_SP_2019_53049_78243.jpg

FS_ID:53049
DS_ID:16446
EP_NO: N/A
Repair Type: Urgent
Crossing Status: Found
UCIP Comments: 10/1/2018 PVC pipe underneath the slide gate that is located inside CMP riser on WS shoulder was restored and blocks gate from closing. Sediment built up at the bottom of CMP riser. PVC pipe needs to be removed in order to properly close slide gate. (O.Yakimov - DWR)5/3/2017 Pipe leaked during the Jan/Feb 2017 high water event. Sand bags were placed at both the LS and WS outlets as well as down inside the standpipe to slow the water flow. The 5inch pvc was cut away but the slide gate could still not close fully. Suspect sediment build up was in the bottom of the stand pipe was blocking the gate. Inside of pipe should be cleaned out. (DWR Sutter Yard-AFreitag)10/24/2016 Pvc was back running through the crossing and blocking the screwgate. photo attached(DWR Sutter Yard-AFreitag)9/28/2016 Crossing has been downgraded from Urgent to Non-Urgent 5-inch PVC pipe was cut to allow the slide gate to close. Need to contact owner to remove unauthorized pipe to comply with Title 23. (DWR UCIP - omagana)4/25/2016 5 inch pvc pipe running through crossing has been cut out to allow the slide gate to close. (DWR Sutter Yard - afreitag)4/20/2015 5inch pvc is still present blocking slide gate from closing. WS end of pipe has been exposed so there is no way to stop water from flowing through pipe during highwater times. (DWR Sutter Yard - afreitag)6/23/2014 Same as last inspection. There is no way to stop water from flowing through pipe during high water times. (DWR Sutter Yard - afreitag)12/17/2013 Same as last inspection. (DWR Sutter Yard - afreitag)7/18/2013 Same as last inspection. (DWR Sutter Yard - afreitag)10/19/2012 Unauthorized 5 inch PVC pipe running through 36 inch crossing. 5 inch PVC crossing prevents slide gate from closing during high water. Debris and sediment inside riser. This crossing was listed in the USACE Periodic Inspection as ID# USACE_CESPK_MA1C_2010_p_0258 for 5 inch PVC pipe running through culvert. (DWR UCIP - omagana) FIELD_STRUCT_DESC: 36-inch steel (not corrugated metal, as referenced in O&M manual) drainage pipe through the levee, approximately 14-16 feet below levee crown. Slide gate in corrugated metal pipe (CMP) riser on the waterside (WS) slope. Pipe also visible on the landside (LS). [Additional Reference(s): DWR Levee Log, 1992. USACE Sacramento O&M Manual 137, August 1955, (Station 331+31)]. FS Date: 10/1/2018 2:59:44 PM

View of CMP riser at WS shoulder.

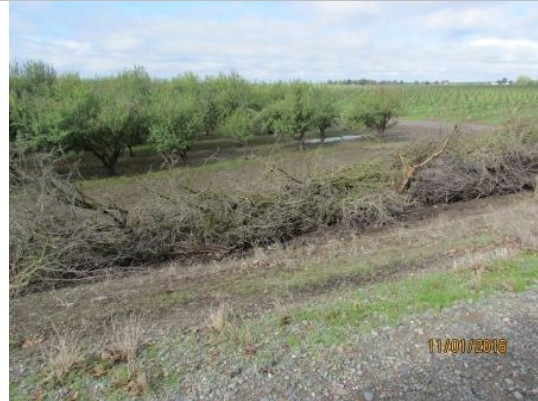
Photo 1 of 1 : SP_2019_MA0001_297_115_20190327_00034.jpg

LM Start	6.38	Rating **	M	Issue No.	115
LM End	6.38	Issue Type +	En	Location *	LS
Category	Earthen Levee			GPS Latitude/Longitude	
				Start	End
Item	Encroachments			39.281425 °	39.281425 °
				-122.022000 °	-122.022000 °
DWR ID	DWR_MA0001_01_f _ 2016_115				
Comment Code					
PR : Prunings					
Inspector Comment					
Remove prunings from the landside toe.

View of the prunings along the landside toe.

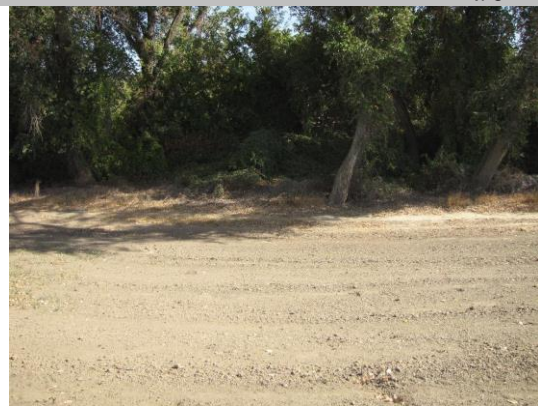
Photo 1 of 3 : UCIP_SP_2019_51874_70181.jpg

Comment Code					
Inspector Comment					
FS_ID:51874 DS_ID:16425 EP_NO: N/A Repair Type: Non-Urgent Crossing Status: Found UCIP Comments: 5/3/2017 Abandoned- needs to be done properly. (DWR Sutter Yard- A Freitag)10/24/2016 Abandoned(DWR Sutter Yard- A Freitag)4/25/2016 Abandoned crossing.4/20/2015 Same as last inspection.6/23/2014 Same as last inspection.12/17/2013 Same as last inspection.7/18/2013 Same as last inspection.10/19/2012 Need to be properly abandoned concrete structure; plate covers concrete box; Concrete headwall damaged. This crossing was listed in the USACE Periodic Inspection as ID# USACE_CESPK_MA1C_2010_p_0262 for damage to concrete structure (vertical 2 inch wide cracks and spalling visible). FIELD_STRUCT_DESC: *ABANDONED* 72-inch corrugated metal (precast concrete) drainage pipe through the levee at an unknown depth below the crown. Structure is blocked on the waterside (WS) end with 3-foot concrete plug installed in 1980. Slide gate in concrete well on the landside (LS) shoulder. Concrete headwall at both toes. WS headwall not found. [Additional Reference(s): DWR Levee Log, 1992. USACE Sacramento O&M Manual 137, August 1955, (Station 339+74)]. FS Date: 5/23/2017 10:13:24 AM

View of WS no structure features visible.

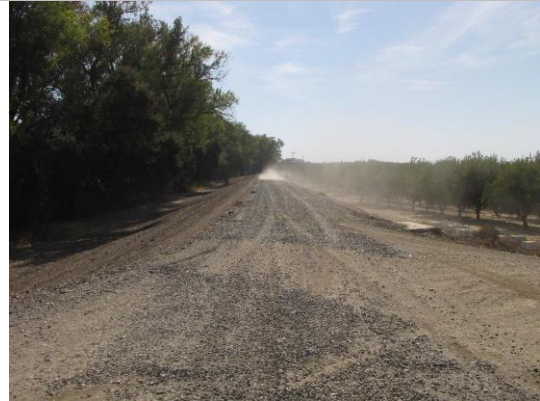
Photo 2 of 3 : UCIP_SP_2019_51874_70180.jpg

Comment Code						
Inspector Comment						
FS_ID:51874 DS_ID:16425 EP_NO: N/A Repair Type: Non-Urgent Crossing Status: Found UCIP Comments: 5/3/2017 Abandoned- needs to be done properly. (DWR Sutter Yard- A Freitag)10/24/2016 Abandoned(DWR Sutter Yard- A Freitag)4/25/2016 Abandoned crossing.4/20/2015 Same as last inspection.6/23/2014 Same as last inspection.12/17/2013 Same as last inspection.7/18/2013 Same as last inspection.10/19/2012 Need to be properly abandoned concrete structure; plate covers concrete box; Concrete headwall damaged. This crossing was listed in the USACE Periodic Inspection as ID# USACE_CESPK_MA1C_2010_p_0262 for damage to concrete structure (vertical 2 inch wide cracks and spalling visible). FIELD_STRUCT_DESC: *ABANDONED* 72-inch corrugated metal (precast concrete) drainage pipe through the levee at an unknown depth below the crown. Structure is blocked on the waterside (WS) end with 3-foot concrete plug installed in 1980. Slide gate in concrete well on the landside (LS) shoulder. Concrete headwall at both toes. WS headwall not found. [Additional Reference(s): DWR Levee Log, 1992. USACE Sacramento O&M Manual 137, August 1955, (Station 339+74)]. FS Date: 5/23/2017 10:13:24 AM

LM Start	6.40	Rating **	M	Issue No.	658 (cont)
LM End	6.40	Issue Type +	Ma	Location *

Overview of levee crown looking downstream at crossing.

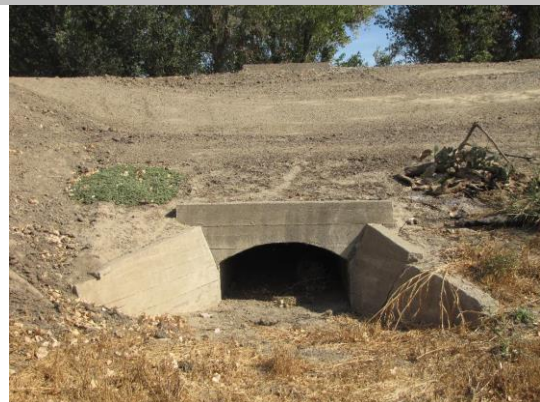
Photo 3 of 3 : UCIP_SP_2019_51874_70179.jpg

View of structure located in LS.

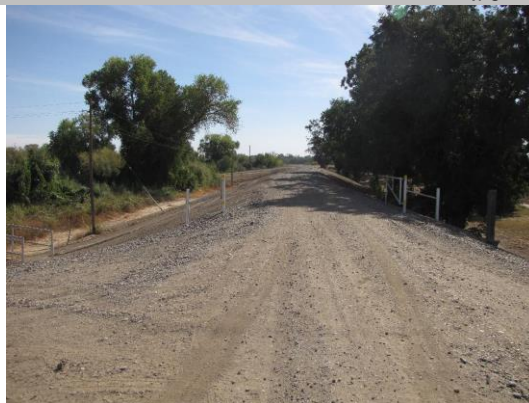
Photo 1 of 3 : UCIP_SP_2019_51876_70194.jpg

6/23/2014 Same as last inspection. Soil dug out again and water flowing through crossing. 12/17/2013 WS screw gate was closed and buried by soil again. 7/18/2013 WS screw gate has been cleared of dirt and is open to irrigate LS fields. LS outlet is still mostly blocked by sediment. 10/19/2012 Structure is buried and non-operational. This crossing was listed in the USACE Periodic Inspection as ID# USACE_CESPK_MA1C_2010_p_0288 for sluice gate closed and backfilled on WS and full of sediment with wingwall cracked on LS. FIELD_STRUCT_DESC: 2 of 2: 36-inch reinforced concrete irrigation pipe through the levee, approximately 18 feet below the crown. Wooden slide gates on the waterside (WS) end. Sliding metal gate noted in O&M manual. Concrete structure located on both WS and landside (LS). Inspector noticed that during 2015-2016 that this crossing is used in the spring and summer, and buried in the winter. O&M manual structure reference is 4'-9" x 9'-6" concrete box culvert. (Automatic Board Order (ABO) issued as Permit No. 9482-1974, Elizabeth M. Farnsworth) [Additional Reference(s): DWR Levee Log, 1992. USACE Sacramento O&M Manual 137, August 1955, (Station 370+90)]. FS Date: 5/23/2017 10:15:43 AM

Overview of levee crown looking downstream at crossing.

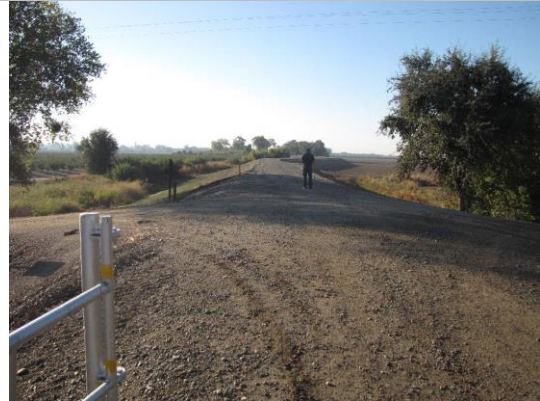
Photo 1 of 3 : UCIP_SP_2019_51877_70202.jpg

Comment Code					
Inspector Comment					
FS_ID:51877 DS_ID:16456 EP_NO: N/A Repair Type: Non-Urgent Crossing Status: Found UCIP Comments: 5/3/2017 Culvert was flowing water during site visit. Appears to be in good condition. Some sediment build up in the bottom of WS box. (DWR Sutter Yard- AFreitag)10/24/2016 Notes mentioned needing to confirm size of the culvert but was unable to access the ends at this inspection.(DWR Sutter Yard- AFreitag)4/25/2016 Second slide gate was held open to allow water to flow through to the LS ditch.4/20/2015 Same as last inspection. Rebar pin was still in place holding the gate opened.6/23/2014 Same as last inspection.12/17/2013 Same as last inspection.7/18/2013 Same as last inspection.10/30/2012 Sediment and debris on waterward and landward side. This crossing was listed in the USACE Periodic Inspection as ID# USACE_CESPK_MA1C_2010_p_0293 for wooden slide gate held open by a piece of rebar acting as a pin. FIELD_STRUCT_DESC: 60-inches by 72-inches (5-foot by 6-foot) reinforced concrete box irrigation culvert (O&M manual references 3-foot and 10-inch by 6-foot culvert) through the levee, approximately 12-15 feet below the crown. Two wooden slide gates on the waterside (WS) end. Concrete v-ditch along landside (LS) toe. [Additional Reference(s): DWR Levee Log, 1992. USACE Sacramento O&M Manual 137, August 1955, (Station 385+33.5)]. FS Date: 5/23/2017 10:27:11 AM

LM Start	7.27	Rating **	M	Issue No.	661 (cont)
LM End	7.27	Issue Type +	En	Location *

Overview of levee crown looking downstream at crossing.

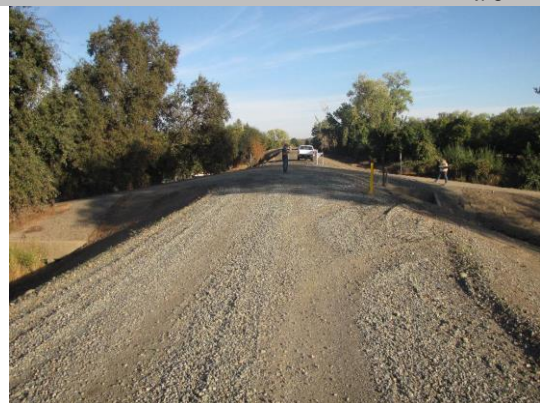
Photo 2 of 3 : UCIP_SP_2019_51877_70204.jpg

Overview of levee crown looking upstream at crossing.

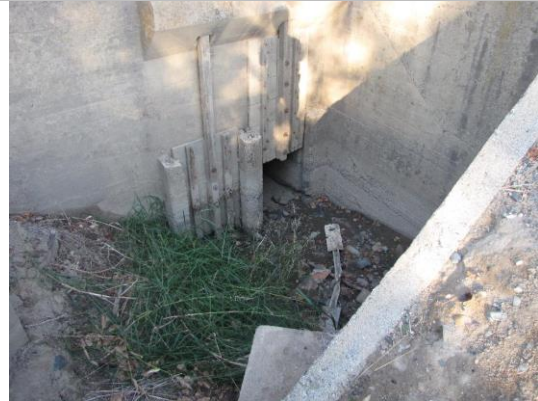
Photo 3 of 3 : UCIP_SP_2019_51877_70203.jpg

Comment Code						
Inspector Comment						
FS_ID:51877 DS_ID:16456 EP_NO: N/A Repair Type: Non-Urgent Crossing Status: Found UCIP Comments: 5/3/2017 Culvert was flowing water during site visit. Appears to be in good condition. Some sediment build up in the bottom of WS box. (DWR Sutter Yard- AFreitag)10/24/2016 Notes mentioned needing to confirm size of the culvert but was unable to access the ends at this inspection.(DWR Sutter Yard- AFreitag)4/25/2016 Second slide gate was held open to allow water to flow through to the LS ditch.4/20/2015 Same as last inspection. Rebar pin was still in place holding the gate opened.6/23/2014 Same as last inspection.12/17/2013 Same as last inspection.7/18/2013 Same as last inspection.10/30/2012 Sediment and debris on waterward and landward side. This crossing was listed in the USACE Periodic Inspection as ID# USACE_CESPK_MA1C_2010_p_0293 for wooden slide gate held open by a piece of rebar acting as a pin. FIELD_STRUCT_DESC: 60-inches by 72-inches (5-foot by 6-foot) reinforced concrete box irrigation culvert (O&M manual references 3-foot and 10-inch by 6-foot culvert) through the levee, approximately 12-15 feet below the crown. Two wooden slide gates on the waterside (WS) end. Concrete v-ditch along landside (LS) toe. [Additional Reference(s): DWR Levee Log, 1992. USACE Sacramento O&M Manual 137, August 1955, (Station 385+33.5)]. FS Date: 5/23/2017 10:27:11 AM

View of wooden sluice gates located on WS.

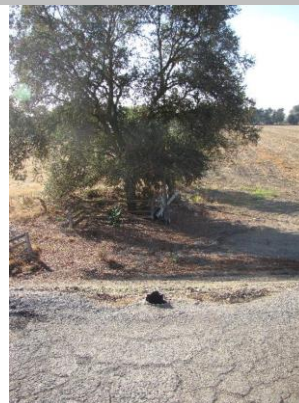
Photo 3 of 3 : UCIP_SP_2019_51878_70211.jpg

Comment Code						
Inspector Comment						
FS_ID:51878 DS_ID:16455 EP_NO: 12334 Repair Type: Non-Urgent Crossing Status: Found UCIP Comments: 5/3/2017 No LS inlet found and no pump on WS- appears to have been abandoned. If so needs to be done properly. (DWR Sutter Yard- A Freitag)10/24/2016 Pump removed from WS pipe. Pipe end left open and should be capped.(DWR Sutter Yard- A Freitag)4/25/2016 No LS inlet found4/20/2015 Same as last inspection.6/23/2014 Same as last inspection.12/17/2013 Same as last inspection.7/18/2013 Same as last inspection.10/30/2012 Siphon breaker housing unit is bent and has debris inside. LS outlet not found. FIELD_STRUCT_DESC: 10-inch asphalt coated steel irrigation pipe through the levee, 3 feet below the crown. Centrifugal pump on the waterside (WS) bank. Siphon breaker on the landside (LS) shoulder of the levee. (Permit No. 12334, 1978 - Jean James) [Additional Reference(s): DWR Levee Log, 1992]. FS Date: 5/23/2017 10:29:58 AM

View of LS with apertures present on levee shoulder.

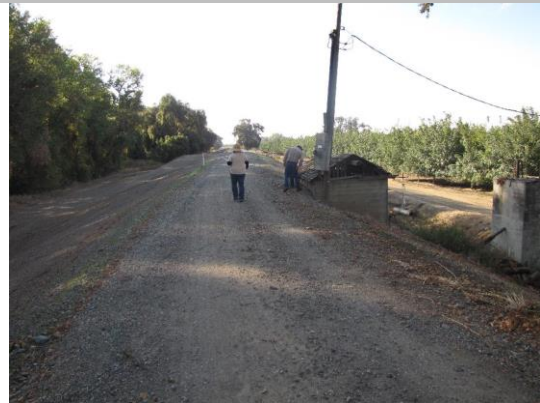
Photo 1 of 3 : UCIP_SP_2019_51879_70219.jpg

Comment Code						
Inspector Comment						
FS_ID:51879 DS_ID:16454 EP_NO: 9466 Repair Type: Non-Urgent Crossing Status: Found UCIP Comments: 5/3/2017 Abandoned- needs to be done properly. (DWR Sutter Yard- A Freitag)10/24/2016 Abandoned.(DWR Sutter Yard- A Freitag)4/25/2016 Crossing appears to be abandoned. Power lines cut from the panels inside the concrete structure on LS.4/20/2015 Same as last inspection.6/23/2014 Same as last inspection.12/17/2013 Same as last inspection.7/18/2013 Same as last inspection.10/30/2012 No access to inspect slide gate on LS. Roof of pumping house deteriorating and debris scattered on LS. WS crossing not found. This crossing was listed in the USACE Periodic Inspection as ID# USACE_CESPK_MA1C_2010_p_345 no issues recorded. FIELD_STRUCT_DESC: *ABANDONED* 24-inch steel irrigation pipe through the levee, approximately 8-10 feet below the crown. Slide gate in concrete riser on the landside (LS) slope. Pump house encroaches into the LS slope. Two service poles on the LS shoulder. No visible appurtenances found on the waterside (WS) toe. Power source cut on the LS. (Automatic Board Order (ABO) issued as Permit No. 9466, 1974 - Roman Catholic Bishop of Sacramento). [Additional Reference(s): DWR Levee Log, 1992]. FS Date: 5/23/2017 10:31:07 AM

Overview of levee crown looking downstream at crossing.

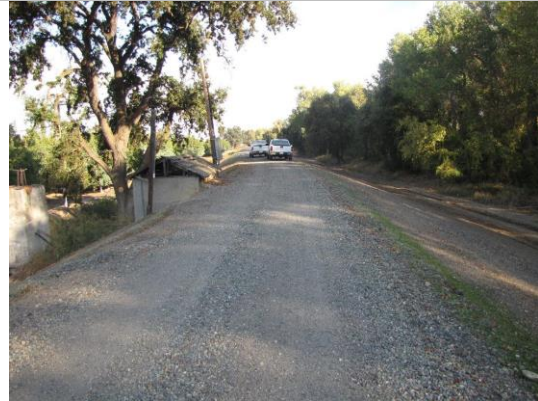
Photo 2 of 3 : UCIP_SP_2019_51879_70217.jpg

Comment Code						
Inspector Comment						
FS_ID:51879 DS_ID:16454 EP_NO: 9466 Repair Type: Non-Urgent Crossing Status: Found UCIP Comments: 5/3/2017 Abandoned- needs to be done properly. (DWR Sutter Yard- A Freitag)10/24/2016 Abandoned.(DWR Sutter Yard- A Freitag)4/25/2016 Crossing appears to be abandoned. Power lines cut from the panels inside the concrete structure on LS.4/20/2015 Same as last inspection.6/23/2014 Same as last inspection.12/17/2013 Same as last inspection.7/18/2013 Same as last inspection.10/30/2012 No access to inspect slide gate on LS. Roof of pumping house deteriorating and debris scattered on LS. WS crossing not found. This crossing was listed in the USACE Periodic Inspection as ID# USACE_CESPK_MA1C_2010_p_345 no issues recorded. FIELD_STRUCT_DESC: *ABANDONED* 24-inch steel irrigation pipe through the levee, approximately 8-10 feet below the crown. Slide gate in concrete riser on the landside (LS) slope. Pump house encroaches into the LS slope. Two service poles on the LS shoulder. No visible appurtenances found on the waterside (WS) toe. Power source cut on the LS. (Automatic Board Order (ABO) issued as Permit No. 9466, 1974 - Roman Catholic Bishop of Sacramento). [Additional Reference(s): DWR Levee Log, 1992]. FS Date: 5/23/2017 10:31:07 AM

LM Start	8.92	Rating **	M	Issue No.	663 (cont)
LM End	8.92	Issue Type +	En	Location *

Overview of levee crown looking upstream at crossing.

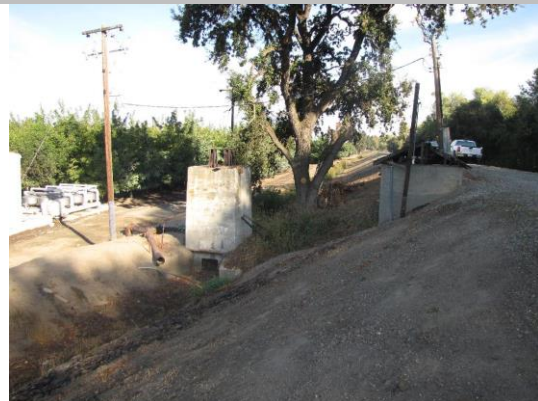
Photo 3 of 3 : UCIP_SP_2019_51879_70218.jpg

View of pump and standpipe located on LS.

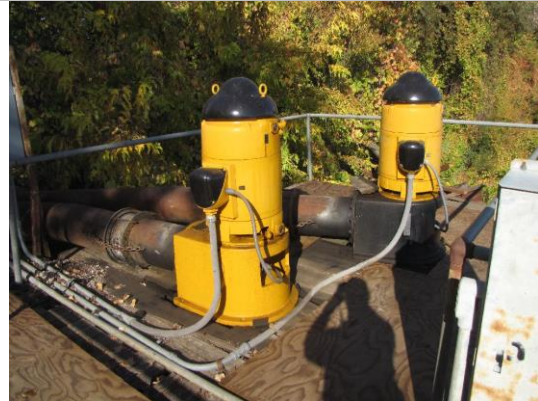
Photo 2 of 3 : UCIP_SP_2019_53050_70239.jpg

Item	DWR UCIP Field Study			39.329750 °	39.329750 °	
				-122.029602 °	-122.029602 °	
DWR ID	16452					
Comment Code						
Inspector Comment						
FS_ID:53050 DS_ID:16452 EP_NO: 1800 Repair Type: Non-Urgent Crossing Status: Found UCIP Comments: 10/1/2018 Runoff erosion near pipe on WS is present. Pipe is in good condition. Need to verify new permit for the pipe. (O.Yakimov - DWR)5/3/2017 Rain run off erosion still present near pipe on WS sshoulder. (DWR Sutter Yard- AFreitag)10/24/2016 Ws erosion still present. Looks to be just from rain run off.(DWR Sutter Yard- AFreitag)4/25/2016 Erosion still present by the WS pipes. (DWR Sutter Yard - aFreitag)4/20/2015 Erosion happening near WS shoulder where the pipes enter the levee. May just be caused by rain runoff. (DWR Sutter Yard - aFreitag)6/23/2014 Same as last inspection. (DWR Sutter Yard - aFreitag)12/17/2013 Same as last inspection. (DWR Sutter Yard - aFreitag)7/18/2013 Same as last inspection. (DWR Sutter Yard - aFreitag)10/30/2012 This crossing has been completely modified--need recent permit issued to allow work on levee and levee toe. Was levee compacted to CVFPB standards? This crossing was listed in the USACE Periodic Inspection as ID# USACE_CESPK_MA1C_2010_p_0371 unable to determine why this crossing was assigned "U". (DWR UCIP - omagana) FIELD_STRUCT_DESC: 1 of 2: 14-inch steel irrigation pipe through the levee, approximately 3-4 feet below the crown. Siphon breakers on the waterside (WS) end. (Permit No. 1800, 1959 - Jimeno Rancho) New pipe visible on the landside (LS). [Additional Reference(s): DWR Levee Log, 1992]. FS Date: 10/1/2018 3:15:38 PM

Pumps corresponding to 2-14 inch pipes.

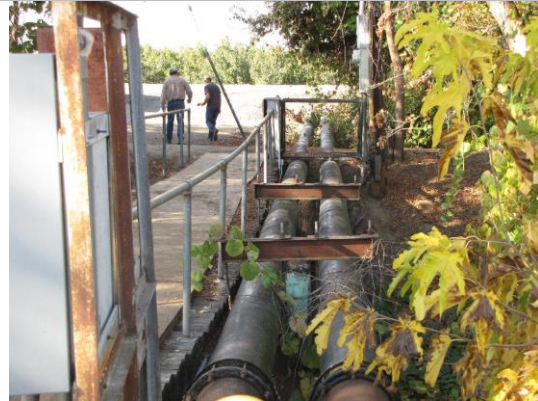
Photo 3 of 3 : UCIP_SP_2019_53050_70238.jpg

Item	DWR UCIP Field Study			39.329750 °	39.329750 °	
				-122.029602 °	-122.029602 °	
DWR ID	16452					
Comment Code						
Inspector Comment						
FS_ID:53050 DS_ID:16452 EP_NO: 1800 Repair Type: Non-Urgent Crossing Status: Found UCIP Comments: 10/1/2018 Runoff erosion near pipe on WS is present. Pipe is in good condition. Need to verify new permit for the pipe. (O.Yakimov - DWR)5/3/2017 Rain run off erosion still present near pipe on WS sshoulder. (DWR Sutter Yard- AFreitag)10/24/2016 Ws erosion still present. Looks to be just from rain run off.(DWR Sutter Yard- AFreitag)4/25/2016 Erosion still present by the WS pipes. (DWR Sutter Yard - afreitag)4/20/2015 Erosion happening near WS shoulder where the pipes enter the levee. May just be caused by rain runoff. (DWR Sutter Yard - afreitag)6/23/2014 Same as last inspection. (DWR Sutter Yard - afreitag)12/17/2013 Same as last inspection. (DWR Sutter Yard - afreitag)7/18/2013 Same as last inspection. (DWR Sutter Yard - afreitag)10/30/2012 This crossing has been completely modified--need recent permit issued to allow work on levee and levee toe. Was levee compacted to CVFPB standards? This crossing was listed in the USACE Periodic Inspection as ID# USACE_CESPK_MA1C_2010_p_0371 unable to determine why this crossing was assigned "U". (DWR UCIP - omagana) FIELD_STRUCT_DESC: 1 of 2: 14-inch steel irrigation pipe through the levee, approximately 3-4 feet below the crown. Siphon breakers on the waterside (WS) end. (Permit No. 1800, 1959 - Jimeno Rancho) New pipe visible on the landside (LS). [Additional Reference(s): DWR Levee Log, 1992]. FS Date: 10/1/2018 3:15:38 PM

WS-2-14 inch pipes parallel catwalk and go through levee.

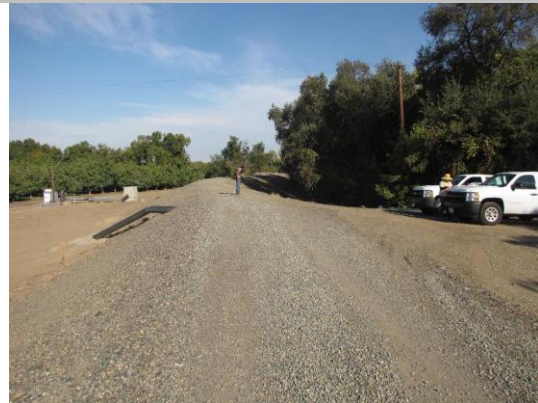
Photo 1 of 3 : UCIP_SP_2019_53051_70228.jpg

Comment Code					
Inspector Comment					
FS_ID:53051 DS_ID:17571 EP_NO: 1800 Repair Type: Non-Urgent Crossing Status: Found UCIP Comments: 10/1/2018 Runoff erosion near pipe on WS is present. Pipe is in good condition. Need to verify new permit for the pipe. (O.Yakimov - DWR)5/3/2017 Rain runoff erosion still present near pipes on WS shoulder. (DWR Sutter Yard- AFreitag)10/24/2016 Ws erosion still present. Looks to be just from rain run off.(DWR Sutter Yard- AFreitag)4/25/2016 Erosion still present near the WS pipes. (DWR Sutter Yard - afreitag)4/20/2015 Erosion happening on WS shoulder near where pipes enter the levee. May just be from rain runoff. (DWR Sutter Yard - afreitag)6/23/2014 Same as last inspection. (DWR Sutter Yard - afreitag)12/17/2013 Same as last inspection. (DWR Sutter Yard - afreitag)7/18/2013 Same as last inspection. (DWR Sutter Yard - afreitag)10/30/2012 This crossing has been completely modified--need recent permit issued to allow work on levee and levee toe. Was levee compacted to CVFPB standards? This crossing was listed in the USACE Periodic Inspection as ID# USACE_CESPK_MA1C_2010_p_0371 unable to determine why this crossing was assigned "U". (DWR UCIP - omagana) FIELD_STRUCT_DESC: 2 of 2: 14-inch steel irrigation pipe through the levee, approximately 3-4 feet below the crown. Siphon breaker located on the waterside (WS) end. (Permit No. 1800, 1959 - Jimeno Rancho) [Additional Reference(s): DWR Levee Log, 1992]. FS Date: 10/1/2018 3:18:33 PM

LM Start	10.21	Rating **	M	Issue No.	667 (cont)
LM End	10.21	Issue Type +	En	Location *

Overview of levee crown looking upstream at crossing.

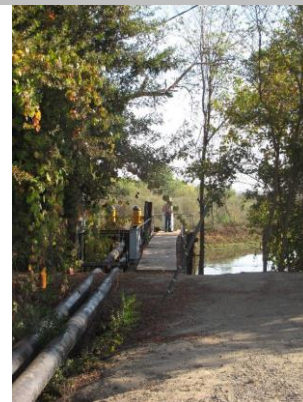
Photo 2 of 3 : UCIP_SP_2019_53051_70226.jpg

View of catwalk and pump station located on WS.

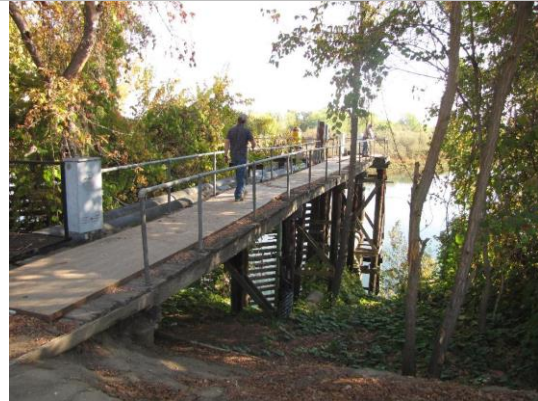
Photo 3 of 3 : UCIP_SP_2019_53051_70232.jpg

Item	DWR UCIP Field Study			39.329750 °	39.329750 °	
				-122.029602 °	-122.029602 °	
DWR ID	17571					
Comment Code						
Inspector Comment						
FS_ID:53051 DS_ID:17571 EP_NO: 1800 Repair Type: Non-Urgent Crossing Status: Found UCIP Comments: 10/1/2018 Runoff erosion near pipe on WS is present. Pipe is in good condition. Need to verify new permit for the pipe. (O.Yakimov - DWR)5/3/2017 Rain runoff erosion still present near pipes on WS shoulder. (DWR Sutter Yard- AFreitag)10/24/2016 Ws erosion still present. Looks to be just from rain run off.(DWR Sutter Yard- AFreitag)4/25/2016 Erosion still present near the WS pipes. (DWR Sutter Yard - afreitag)4/20/2015 Erosion happening on WS shoulder near where pipes enter the levee. May just be from rain runoff. (DWR Sutter Yard - afreitag)6/23/2014 Same as last inspection. (DWR Sutter Yard - afreitag)12/17/2013 Same as last inspection. (DWR Sutter Yard - afreitag)7/18/2013 Same as last inspection. (DWR Sutter Yard - afreitag)10/30/2012 This crossing has been completely modified--need recent permit issued to allow work on levee and levee toe. Was levee compacted to CVFPB standards? This crossing was listed in the USACE Periodic Inspection as ID# USACE_CESPK_MA1C_2010_p_0371 unable to determine why this crossing was assigned "U". (DWR UCIP - omagana) FIELD_STRUCT_DESC: 2 of 2: 14-inch steel irrigation pipe through the levee, approximately 3-4 feet below the crown. Siphon breaker located on the waterside (WS) end. (Permit No. 1800, 1959 - Jimeno Rancho) [Additional Reference(s): DWR Levee Log, 1992]. FS Date: 10/1/2018 3:18:33 PM

Close-up of catwalk, control panel, and pump station located on WS.

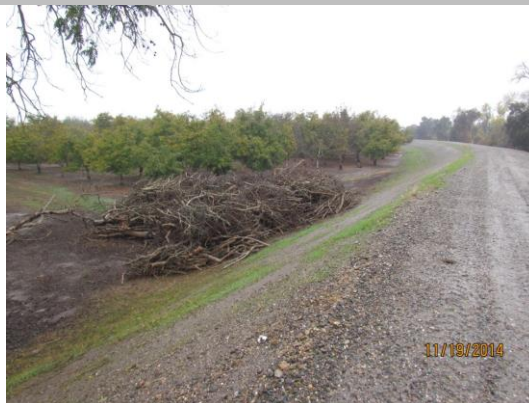
Photo 1 of 1 : SP_2019_MA0001_297_636_20190327_00040.jpg

LM Start	10.32	Rating **	M	Issue No.	636
LM End	10.32	Issue Type +	En	Location *	LS
Category	Earthen Levee			GPS Latitude/Longitude	
				Start	End
Item	Encroachments			39.331320 °	39.331320 °
				-122.029932 °	-122.029932 °
DWR ID	DWR_MA0001_01_f_2014_636				
Comment Code					
PR : Prunings					
Inspector Comment					
Remove prunings from the landside toe.

View of the pruning along the landside toe.

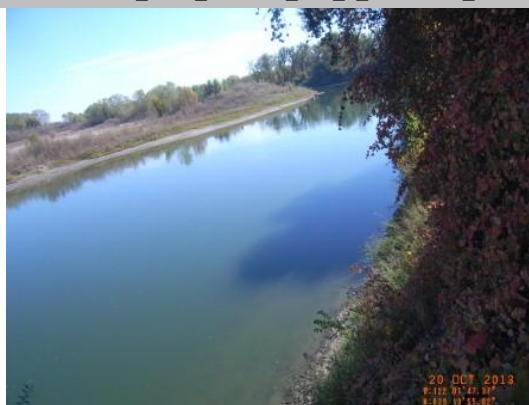
Photo 1 of 1 : SP_2019_MA0001_297_6_20190327_00003.jpg

LM Start	10.32	Rating **	A/W	Issue No.	6
LM End	10.41	Issue Type +	Ma	Location *	WS
Category	Supplemental			GPS Latitude/Longitude	
				Start	End
Item	2017 USACE Erosion Survey, DRAFT			39.331447 °	39.332716 °
				-122.029440 °	-122.029953 °
DWR ID	DWR_ST0003_01_f_2018_1				
Comment Code					
Inspector Comment					
2017 Site ID: SAC 157.7 R					
Status: Eroding					
2017 Field Notes: Vertical face of clay sand bank, new tree popout.					
Bank continues to erode.					
Site History: 2004 - Slowly eroding but near vertical with no vegetation to hold it. 2005 - Erosion is close to levee toe but not into the levee section yet. 2010 - Some new toe scour.

USACE 2013 Photo #1

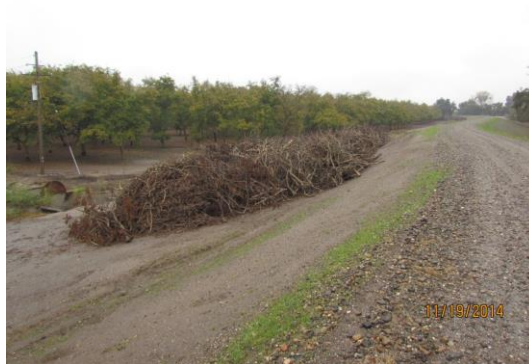
Photo 1 of 1 : SP_2019_MA0001_297_637_20190327_00041.jpg

LM Start	10.78	Rating **	M	Issue No.	637
LM End	10.78	Issue Type +	En	Location *	LS
Category	Earthen Levee			GPS Latitude/Longitude	
				Start	End
Item	Encroachments			39.337523 °	39.337523 °
				-122.032437 °	-122.032437 °
DWR ID	DWR_MA0001_01_f_2014_637				
Comment Code					
PR : Prunings					
Inspector Comment

View of the pruning along the landside toe.

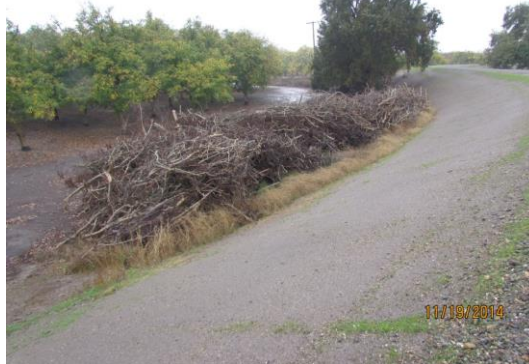
Photo 1 of 1 : SP_2019_MA0001_297_638_20190327_00042.jpg

LM Start	10.96	Rating **	M	Issue No.	638
LM End	10.96	Issue Type +	En	Location *	LS
Category	Earthen Levee			GPS Latitude/Longitude	
				Start	End
Item	Encroachments			39.340217 °	39.340217 °
				-122.032605 °	-122.032605 °
DWR ID	DWR_MA0001_01_f_2014_638				
Comment Code					
PR : Prunings					
Inspector Comment					
Remove prunings from the landside toe.

View of the pruning along the landside toe.

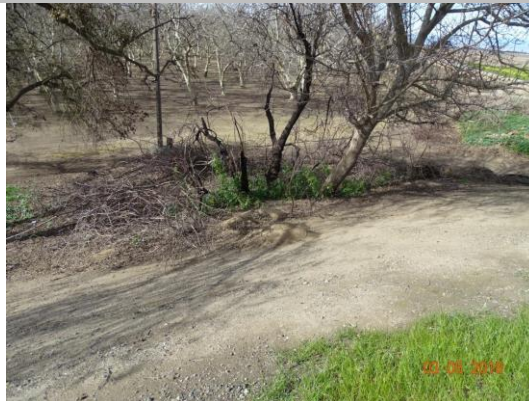
Photo 1 of 1 : SP_2019_MA0001_297_69_20190327_00016.jpg

LM Start	11.01	Rating **	M	Issue No.	69
LM End	11.01	Issue Type +	Ma	Location *	LS
Category	Earthen Levee			GPS Latitude/Longitude	
				Start	End
Item	Animal Control			39.340803 °	39.340803 °
				-122.032868 °	-122.032868 °
DWR ID	DWR_MA0001_01_s_2018_69				
Comment Code					
A3 : No rodents visible, but rodent burrows visible; need to backfill and compact or grout burrows.					
Inspector Comment

View of the rodent holes along the landside slope.
