**Flood Control Project Maintenance
Levee Inspections**
LMA District Cover Sheet
Spring 2019 Levee Inspection Results

Spring 2019 Levee Inspection Results

Sutter Maintenance Yard Maintenance Area 0001

Waterway			Bank	Unit Miles
Unit No. 01 Sacramento River			Right	16.76
	Spring (March - May)	Summer (June - August)	(September - November) Fall	Winter (December - February)
Unit Maintenance Rating (Fall Only)				
Date of Inspection	4/17/2019 - 4/17/2019			
DWR Inspector	Makar Sokol			
Accompanied By	Bryan Reniff Sutter Maintenance Yard

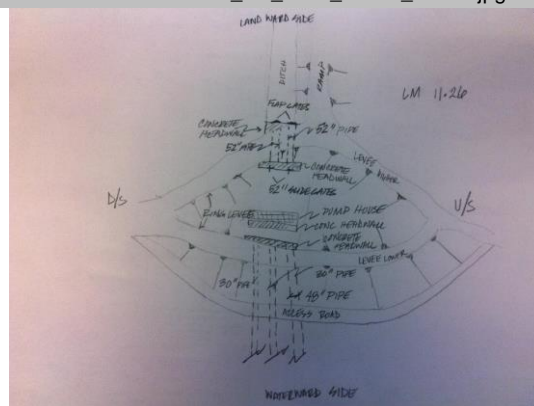
Photo 1 of 3 : UCIP_SP_2019_53053_70267.jpg

FS_ID:53053
DS_ID:16449
EP_NO: 187
Repair Type: Non-Urgent
Crossing Status: Found
UCIP Comments: 10/1/2018 Pipe closed by steel plate at LS end. Plate is bolted to concrete headwall. CVFPB is working with owner to address issue. (O.Yakimov - DWR)5/3/2017 No changes have been made to this crossing since the NOV was sent out in January 2017. (DWR Sutter Yard- AFreitag)01/31/2017 Informal Notice of Violation (NOV) was sent out January 31, 2017 by DWR Flood Maintenance Office--owner will need to coordinate with CVFPB to remove, replace, or abandon pipe in-place. Owner has until Monday February 27th, 2017 to respond to DWR contact: Bryan Reniff. (refer to Official Notice for details). (DWR UCIP - O. Magana)10/24/2016 Appears abandoned. Slide gate needs to be dug out and fully closed to prevent water flow during high water.(DWR Sutter Yard- AFreitag)4/25/2016 Crossing appears to be abandoned.4/21/2015 Same as last inspection.6/23/2014 Same as last inspection.12/17/2013 Same as last inspection.7/18/2013 Same as last inspection.10/30/2012 Need to determine if structure is still in use--contact owner. If abandoned structure--structure needs to be properly abandoned. This crossing was listed in the USACE Periodic Inspections as ID# USACE_CESPK_MA1C_2010_p_0393 missing gate.

Sketch of structure located at levee mile 11.26.

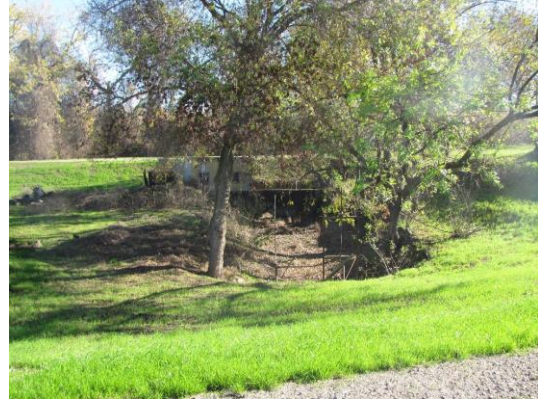
Photo 2 of 3 : UCIP_SP_2019_53053_70265.jpg

View of abandoned structure located on WS (inside ring levee).

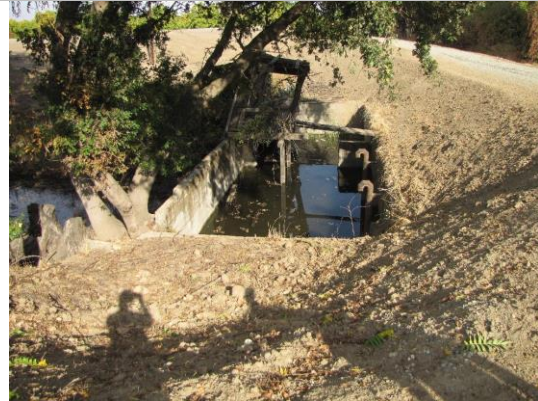
Photo 2 of 3 : UCIP_SP_2019_53052_70276.jpg

Abandoned structure (multiple headwalls and pump structure) located near the lower levee (ring levee).

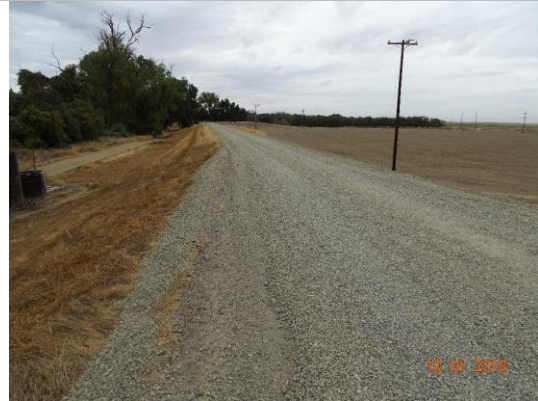
Photo 1 of 3 : UCIP_SP_2019_53054_78258.jpg

Comment Code					
Inspector Comment					
FS_ID:53054 DS_ID:17691 EP_NO: 17471 Repair Type: Urgent Crossing Status: Found UCIP Comments: 10/1/2018 Sink hole between CMP risers on WS has grown. Need to contact owner to address issue. Recommend video inspection. (O.Yakimov - DWR)5/3/2017 Sink hole still present between the WS risers. It does not appears to be getting worse. Pumps were running during site visit but the sink hole was dry this time. (DWR Sutter Yard- AFreitag)10/24/2016 Sinkhole still present.(DWR Sutter Yard- AFreitag)4/25/2016 Sink hole between the standpipes seems to be getting worse. Measurements of the hole are 3' wide x 3' long x 3' deep. The pipe was flowing water and there was water present in the bottom of the sink hole. (DWR Sutter Yard - afreitag)4/21/2015 Sink hole still present between risers. (DWR Sutter Yard - afreitag)6/23/2014 Standing water was present in the bottom of the sinkhole. (DWR Sutter Yard - afreitag)12/17/2013 Same as last inspection. (DWR Sutter Yard - afreitag)7/18/2013 Same as last inspection. (DWR Sutter Yard - afreitag)10/30/2012 Erosion between risers with slide gates located on waterward side; This crossing was listed in the USACE Periodic Inspections as ID# USACE_CESPK_MA1C_2010_p_0398 for possible sinkhole between access gate structures. (DWR UCIP - omagana) FIELD_STRUCT_DESC: 1 of 2: 24-inch high-density polyethylene (HDPE) irrigation pipe to be connected to the existing corrugated metal pipe (CMP) riser within the waterside (WS) and parallel to the right (west) bank levee of the Sacramento River. (Permit 17471, 2002 - Maxwell Irrigation District). FS Date: 10/1/2018 3:53:48 PM

View of levee crown at crossing.

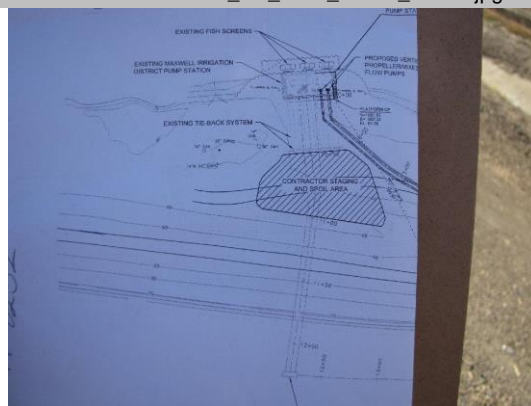
Photo 1 of 3 : UCIP_SP_2019_51900_70342.jpg

Drawing of existing Maxwell Irrigation District Conveyance Pipeline (DWG available through Permit No. 17471 for work located at LM 11.51).

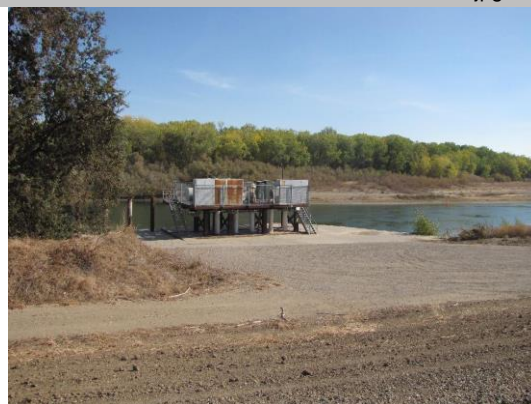
Photo 2 of 3 : UCIP_SP_2019_51900_70343.jpg

Maxwell Irrigation District Pump Station located on WS.

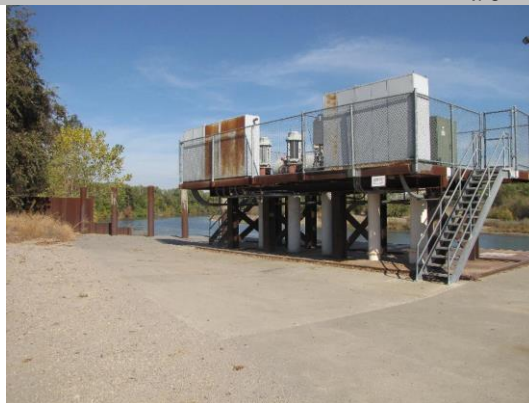
Photo 3 of 3 : UCIP_SP_2019_51900_70345.jpg

Maxwell Irrigation District Pump Station located on WS.

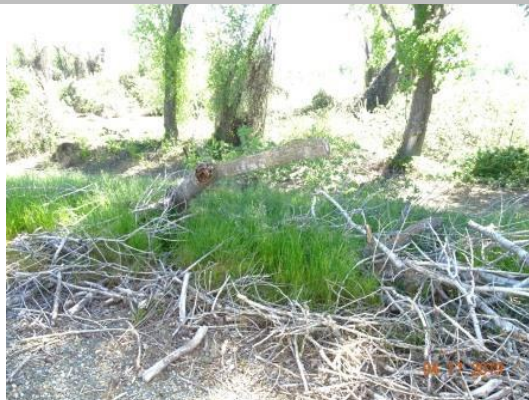
Photo 1 of 1 : SP_2019_MA0001_297_116_20190418_00155.jpg

LM Start	11.51	Rating **	U	Issue No.	116
LM End	11.51	Issue Type +	Ma	Location *	WS
Category	Earthen Levee			GPS Latitude/Longitude	
				Start	End
Item	Encroachments			39.347841 °	39.347841 °
				-122.031342 °	-122.031342 °
DWR ID	DWR_MA0001_01_s_2019_116				
Comment Code					
TR : Tree or limb					
Inspector Comment					
The fallen tree should be removed from the waterside slope.

View of the fallen tree on the waterside slope. Spring 2019.

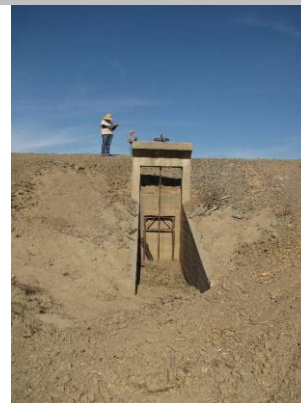
Photo 2 of 3 : UCIP_SP_2019_51903_70351.jpg

WS concrete structure with slide gate. Gate is blocked by sediment.

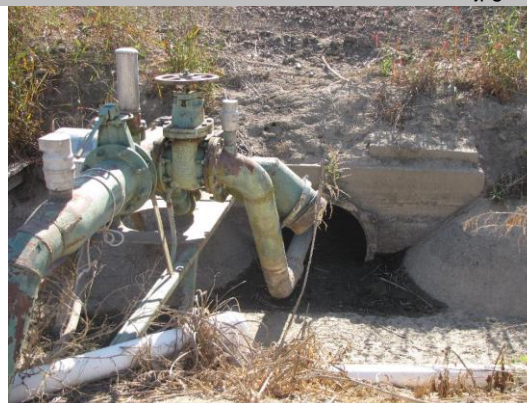
Photo 3 of 3 : UCIP_SP_2019_51903_70350.jpg

6-inch irrigation pipe through crossing at LS. Flap gate missing.

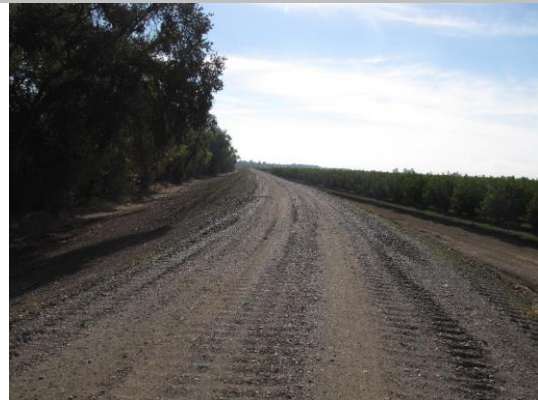
Photo 1 of 2 : UCIP_SP_2019_51910_70379.jpg

Comment Code					
Inspector Comment					
FS_ID:51910 DS_ID:16442 EP_NO: N/A Repair Type: Non-Urgent Crossing Status: Found UCIP Comments: 5/3/2017 Abandoned- needs to be done so properly. (DWR Sutter Yard- A Freitag)10/24/2016 Abandoned.(DWR Sutter Yard- A Freitag)4/25/2016 Abandoned crossing4/21/2015 Slide gate is still buried.6/23/2014 Same as last inspection.12/17/2013 Same as last inspection.7/22/2013 Same as last inspection.10/30/2012 Slide gate is buried-non-fuctional. This crossing was listed in the USACE Periodic Inspections as ID# USACE_CESPK_MA1C_2010_p_0457 for buried slide gate. FIELD_STRUCT_DESC: *ABANDONED* 36-inch corrugated metal drainage pipe through the levee at approximately 15-18 feet below the crown. Slide gate on the waterside (WS) end. (Davis Ranches) [Additional Reference(s): DWR Levee Log, 1992]. FS Date: 5/23/2017 12:02:52 PM

Overview of levee crown looking downstream at crossing.

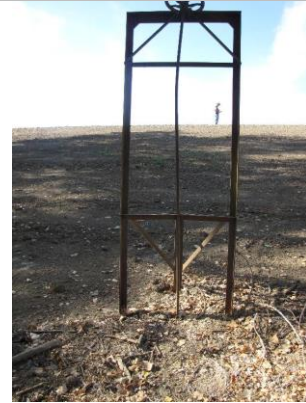
Photo 2 of 2 : UCIP_SP_2019_51910_70380.jpg

Item	DWR UCIP Field Study			39.371934 °	39.371934 °	
				-122.012945 °	-122.012945 °	
DWR ID	16442					
Comment Code						
Inspector Comment						
FS_ID:51910 DS_ID:16442 EP_NO: N/A Repair Type: Non-Urgent Crossing Status: Found UCIP Comments: 5/3/2017 Abandoned- needs to be done so properly. (DWR Sutter Yard- A Freitag)10/24/2016 Abandoned.(DWR Sutter Yard- A Freitag)4/25/2016 Abandoned crossing4/21/2015 Slide gate is still buried.6/23/2014 Same as last inspection.12/17/2013 Same as last inspection.7/22/2013 Same as last inspection.10/30/2012 Slide gate is buried-non-fuctional. This crossing was listed in the USACE Periodic Inspections as ID# USACE_CESPK_MA1C_2010_p_0457 for buried slide gate. FIELD_STRUCT_DESC: *ABANDONED* 36-inch corrugated metal drainage pipe through the levee at approximately 15-18 feet below the crown. Slide gate on the waterside (WS) end. (Davis Ranches) [Additional Reference(s): DWR Levee Log, 1992]. FS Date: 5/23/2017 12:02:52 PM

WS-Slide gate buried-non-functional.

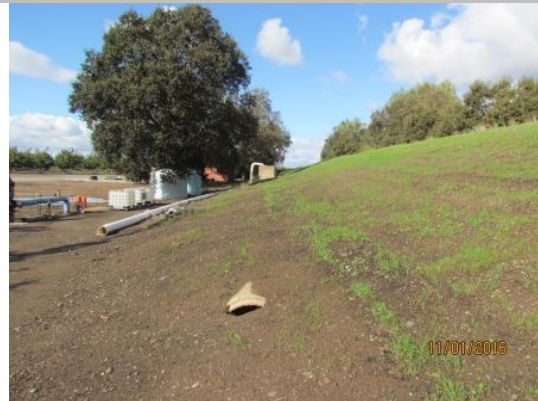
Photo 1 of 1 : SP_2019_MA0001_297_128_20190327_00036.jpg

LM Start	14.25	Rating **	U	Issue No.	128
LM End	14.30	Issue Type +	En	Location *	LS
Category	Earthen Levee			GPS Latitude/Longitude	
				Start	End
Item	Encroachments			39.378129 °	39.378800 °
				-122.013040 °	-122.013360 °
DWR ID	DWR_MA0001_01_s_2019_128				
Comment Code					
PI : Pipe					
Inspector Comment					
Concrete pipe runs along the landside toe and concrete box at the end.

View of a concrete pipe that runs along the levee toe.

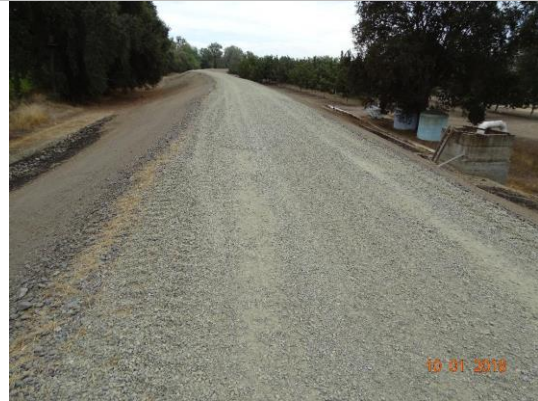
Photo 1 of 3 : UCIP_SP_2019_53059_78266.jpg

FS_ID:53059
DS_ID:16441
EP_NO: 9460
Repair Type: Urgent
Crossing Status: Found
UCIP Comments: 10/1/2018 A gap visible between pipe end in concrete box on LS and flap gate. Pipe might be partially silted that blocks flap gate from closing properly. Needs proper abandonment if not in use. Open conduit allows for flooding during high water events. (O.Yakimov - DWR)5/3/2017 Water leaked through this crossing during the Jan/Feb 2017 high water event. A concrete pipe of unknown diameter exits the LS distribution box and follows the levee alignment downstream about 120ft and uncontrolled water flowed from that pipe end. If crossing is abandoned then it needs to be done so properly. (DWR Sutter Yard- A Freitag)10/24/2016 This entire crossing now appears to be abandoned. The pvc pipe that was previously connected to the LS well pump is no longer connected and used to fill the box.(DWR Sutter Yard- A Freitag)4/25/2016 WS concrete box appears to be abandoned. LS box appears to get filled by a well pump on LS.4/21/2015 Same as last inspection.6/23/2014 Same as last inspection.12/17/2013 Same as last inspection.7/22/2013 Same as last inspection.10/30/2012 Need to determine if crossing is still being used there are some abandoned features that remain at this crossing-- crossing has been modified. This crossing was listed in the USACE Periodic Inspections as ID# USACE_CESPK_MA1C_2010_p_0464 for abandoned pump station.

View of levee crown at crossing.

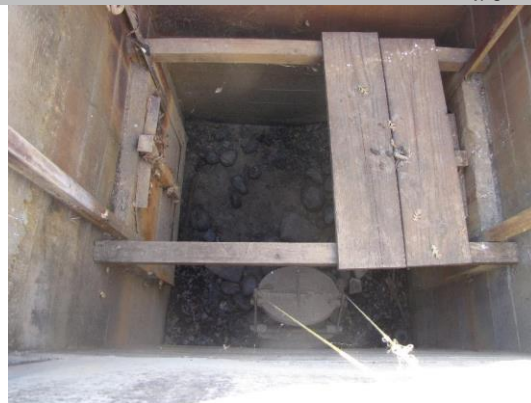
Photo 3 of 3 : UCIP_SP_2019_53059_70381.jpg

FS_ID:53059
DS_ID:16441
EP_NO: 9460
Repair Type: Urgent
Crossing Status: Found
UCIP Comments: 10/1/2018 A gap visible between pipe end in concrete box on LS and flap gate. Pipe might be partially silted that blocks flap gate from closing properly. Needs proper abandonment if not in use. Open conduit allows for flooding during high water events. (O.Yakimov - DWR)5/3/2017 Water leaked through this crossing during the Jan/Feb 2017 high water event. A concrete pipe of unknown diameter exits the LS distribution box and follows the levee alignment downstream about 120ft and uncontrolled water flowed from that pipe end. If crossing is abandoned then it needs to be done so properly. (DWR Sutter Yard- AFreitag)10/24/2016 This entire crossing now appears to be abandoned. The pvc pipe that was previously connected to the LS well pump is no longer connected and used to fill the box.(DWR Sutter Yard- AFreitag)4/25/2016 WS concrete box appears to be abandoned. LS box appears to get filled by a well pump on LS.4/21/2015 Same as last inspection.6/23/2014 Same as last inspection.12/17/2013 Same as last inspection.7/22/2013 Same as last inspection.10/30/2012 Need to determine if crossing is still being used there are some abandoned features that remain at this crossing-- crossing has been modified. This crossing was listed in the USACE Periodic Inspections as ID# USACE_CESPK_MA1C_2010_p_0464 for abandoned pump station.

Inside view of concrete distribution box located on LS toe.

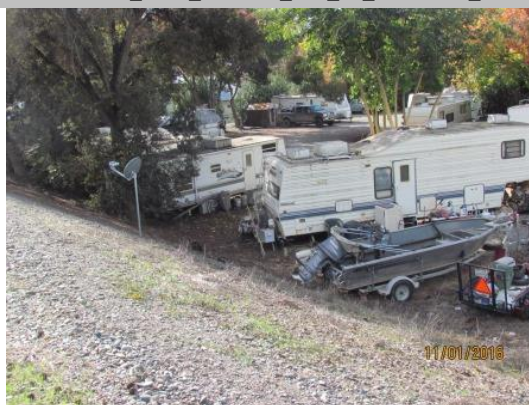
Photo 1 of 1 : SP_2019_MA0001_297_86_20190327_00022.jpg

LM Start	15.84	Rating **	U	Issue No.	86
LM End	15.90	Issue Type +	En	Location *	LS
Category	Earthen Levee			GPS Latitude/Longitude	
				Start	End
Item	Encroachments			39.400601 °	39.401365 °
				-122.009889 °	-122.009374 °
DWR ID	DWR_MA0001_01_s_2016_86				
Comment Code					
BU : Building					
Inspector Comment					
Mobile homes and trailers.

View of the mobile homes and trailers along the landside toe.

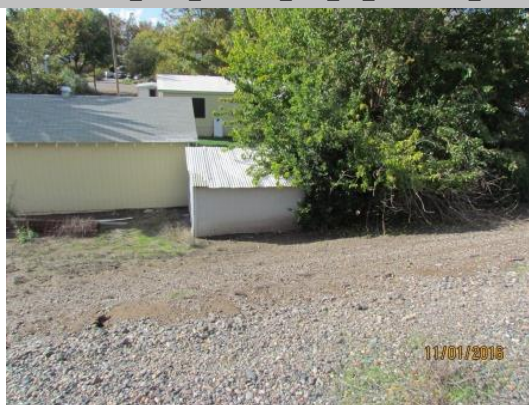
Photo 1 of 1 : SP_2019_MA0001_297_87_20190327_00023.jpg

LM Start	15.95	Rating **	U	Issue No.	87
LM End	15.95	Issue Type +	En	Location *	LS
Category	Earthen Levee			GPS Latitude/Longitude	
				Start	End
Item	Encroachments			39.401994 °	39.401994 °
				-122.009352 °	-122.009352 °
DWR ID	DWR_MA0001_01_s_2016_87				
Comment Code					
BU : Building					
Inspector Comment

View of a shed along the landside toe.

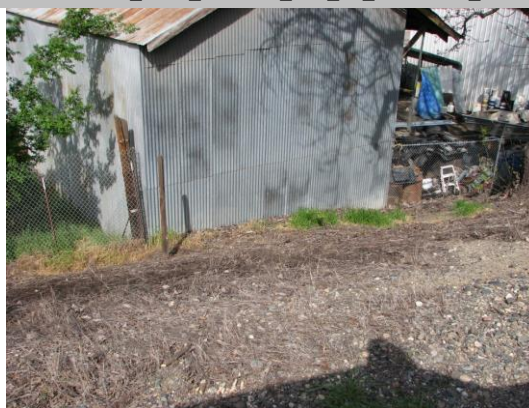
Photo 1 of 1 : SP_2019_MA0001_297_90_20190327_00025.jpg

LM Start	16.03	Rating **	U	Issue No.	90
LM End	16.03	Issue Type +	En	Location *	LS
Category	Earthen Levee			GPS Latitude/Longitude	
				Start	End
Item	Encroachments			39.403206 °	39.403206 °
				-122.009116 °	-122.009116 °
DWR ID	DWR_MA0001_01_s_2016_90				
Comment Code					
BU : Building					
Inspector Comment					
Metal sided building

View of a corrugated metal building obstructing visibility and access.

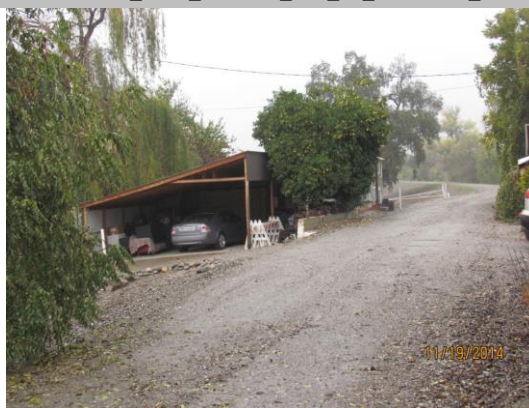
Photo 1 of 1 : SP_2019_MA0001_297_26_20190327_00011.jpg

LM Start	16.10	Rating **	U	Issue No.	26
LM End	16.10	Issue Type +	En	Location *	LS
Category	Earthen Levee			GPS Latitude/Longitude	
				Start	End
Item	Encroachments			39.404135 °	39.404135 °
				-122.008797 °	-122.008797 °
DWR ID	DWR_MA0001_01_s_2012_26				
Comment Code					
BU : Building					
Inspector Comment

View of the building on the landside slope.

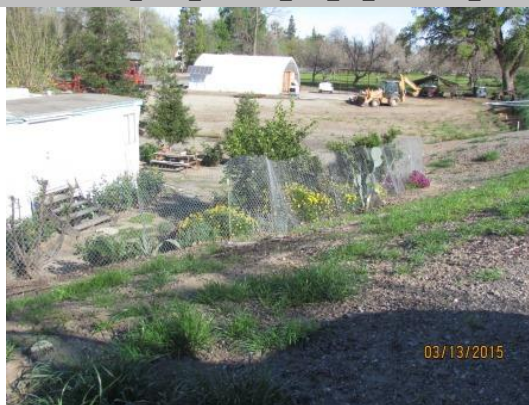
Photo 1 of 1 : SP_2019_MA0001_297_74_20190327_00018.jpg

LM Start	16.10	Rating **	M	Issue No.	74
LM End	16.10	Issue Type +	En	Location *	LS
Category	Earthen Levee			GPS Latitude/Longitude	
				Start	End
Item	Vegetation			39.404255 °	39.404255 °
				-122.008842 °	-122.008842 °
DWR ID	DWR_MA0001_01_s_2015_74				
Comment Code					
V6 : Landscaping					
Inspector Comment					
Remove the landscape from the landside slope and toe.

View of the landscape along the landside slope and toe.

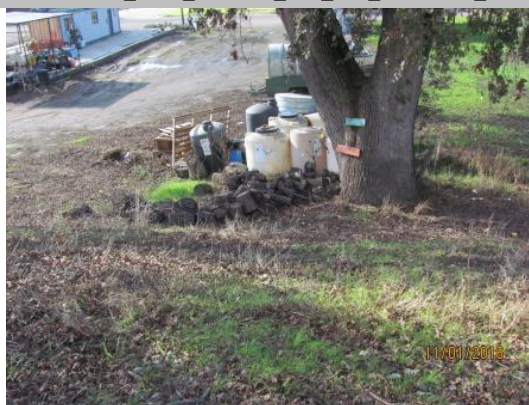
Photo 1 of 1 : SP_2019_MA0001_297_133_20190327_00037.jpg

LM Start	16.17	Rating **	M	Issue No.	133
LM End	16.17	Issue Type +	En	Location *	LS
Category	Earthen Levee			GPS Latitude/Longitude	
				Start	End
Item	Encroachments			39.405147 °	39.405147 °
				-122.008630 °	-122.008630 °
DWR ID	DWR_MA0001_01_f_2016_133				
Comment Code					
PR : Prunings					
Inspector Comment

View of firewood and containers along the landside toe.

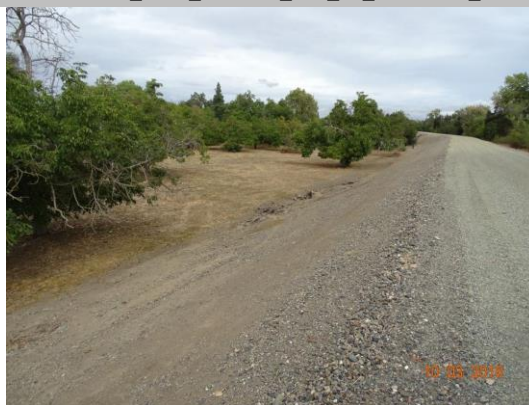
Photo 1 of 1 : SP_2019_MA0001_297_71_20190327_00017.jpg

LM Start	16.19	Rating **	M	Issue No.	71
LM End	16.19	Issue Type +	Ma	Location *	LS
Category	Earthen Levee			GPS Latitude/Longitude	
				Start	End
Item	Animal Control			39.405435 °	39.405435 °
				-122.008598 °	-122.008598 °
DWR ID	DWR_MA0001_01_f_2018_71				
Comment Code					
A3 : No rodents visible, but rodent burrows visible; need to backfill and compact or grout burrows.					
Inspector Comment

View of the rodent holes along the landside slope.

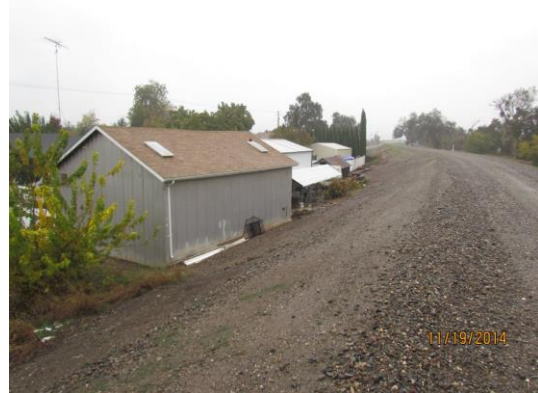
Photo 1 of 1 : SP_2019_MA0001_297_46_20190327_00013.jpg

LM Start	16.31	Rating **	U	Issue No.	46
LM End	16.33	Issue Type +	En	Location *	LS
Category	Earthen Levee			GPS Latitude/Longitude	
				Start	End
Item	Encroachments			39.407225 °	39.407545 °
				-122.008570 °	-122.008640 °
DWR ID	DWR_MA0001_01_s_2012_46				
Comment Code					
BU : Building					
Inspector Comment

View of the building along the landside toe.

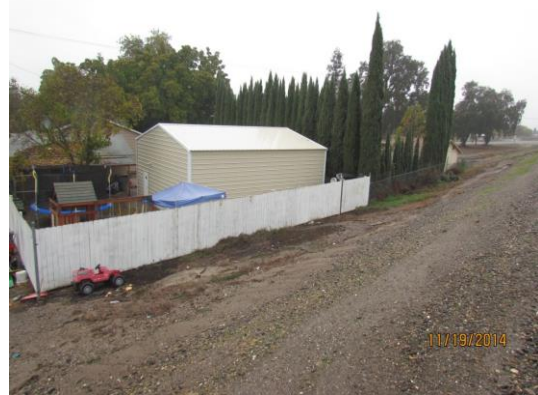
Photo 1 of 1 : SP_2019_MA0001_297_47_20190327_00014.jpg

LM Start	16.34	Rating **	U	Issue No.	47
LM End	16.35	Issue Type +	En	Location *	LS
Category	Earthen Levee			GPS Latitude/Longitude	
				Start	End
Item	Encroachments			39.407670 °	39.407823 °
				-122.008685 °	-122.008740 °
DWR ID	DWR_MA0001_01_s_2012_47				
Comment Code					
FE : Fence					
Inspector Comment

View of the fence along the landside toe.

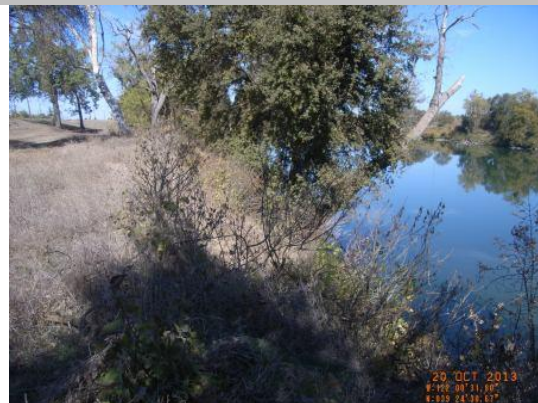
Photo 1 of 2 : SP_2019_MA0001_297_9_20190327_00005.jpg

LM Start	16.35	Rating **	A/W	Issue No.	9
LM End	16.58	Issue Type +	Ma	Location *	WS
Category	Supplemental			GPS Latitude/Longitude	
				Start	End
Item	2017 USACE Erosion Survey, DRAFT			39.407837 °	39.411111 °
				-122.008763 °	-122.009238 °
DWR ID	DWR_ST0010_02_f_2022_7				
Comment Code					
Inspector Comment					
2017 Site ID: SAC 164.3 R					
Status: Eroding					
2017 Field Notes: New erosion along entire site.					
Site History: Erosion site added in 1997 and removed in 2005. 2009 -					
Site added back in, hard toe with slow moving erosion. Potential					
geotechnical failure. 2011 - Site extended downstream

USACE 2013 Photo #1

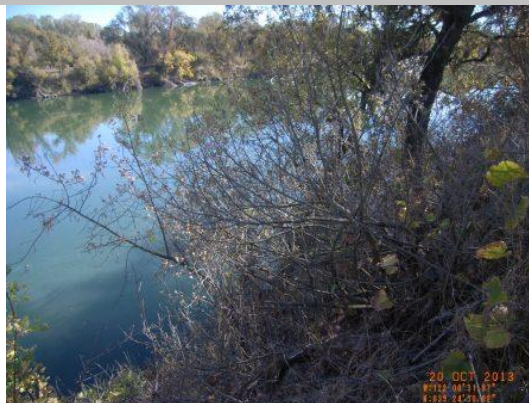
Photo 2 of 2 : SP_2019_MA0001_297_9_20190327_00006.jpg

LM Start	16.35	Rating **	A/W	Issue No.	9 (cont)	
LM End	16.58	Issue Type +	Ma	Location *	WS	
Category	Supplemental			GPS Latitude/Longitude		
				Start		End
Item	2017 USACE Erosion Survey, DRAFT			39.407837 °		39.411111 °
				-122.008763 °		-122.009238 °
DWR ID	DWR_ST0010_02_f_2022_7					
Comment Code						
Inspector Comment						
2017 Site ID: SAC 164.3 R						
Status: Eroding						
2017 Field Notes: New erosion along entire site.						
Site History: Erosion site added in 1997 and removed in 2005. 2009 - Site added back in, hard toe with slow moving erosion. Potential geotechnical failure. 2011 - Site extended downstream.

USACE 2013 Photo #2

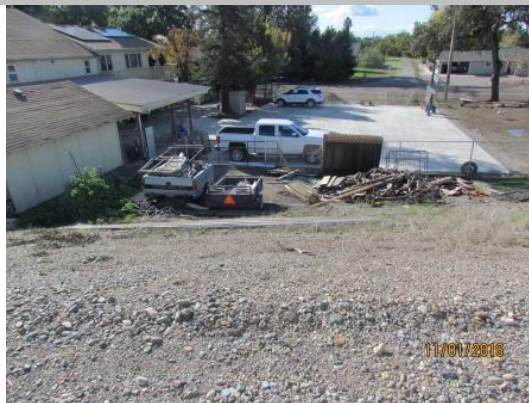
Photo 1 of 1 : SP_2019_MA0001_297_135_20190327_00039.jpg

LM Start	16.37	Rating **	M	Issue No.	135
LM End	16.37	Issue Type +	En	Location *	LS
Category	Earthen Levee			GPS Latitude/Longitude	
				Start	End
Item	Encroachments			39.408073 °	39.408073 °
				-122.009058 °	-122.009058 °
DWR ID	DWR_MA0001_01_f_2016_135				
Comment Code					
DE : Debris					
Inspector Comment					
Debris, metal, and firewood should be removed from the landside toe.

View of metal sheets along the levee slope and debris and firewood along the landside toe.
