**Flood Control Project Maintenance
Levee Inspections**
LMA District Cover Sheet
Spring 2020 Levee Inspection Results

Sutter Maintenance Yard Maintenance Area 0001

Spring 2020 Levee Inspection Results

Waterway			Bank	Unit Miles
Unit No. 01 Sacramento River			Right	16.76
	Spring (March - May)	Summer (June - August)	(September - November) Fall	Winter (December - February)
Unit Maintenance Rating (Fall Only)				
Date of Inspection	3/10/2020 - 3/10/2020			
DWR Inspector	Makar Sokol			
Accompanied By	Bob Duffey Sutter Maintenance Yard

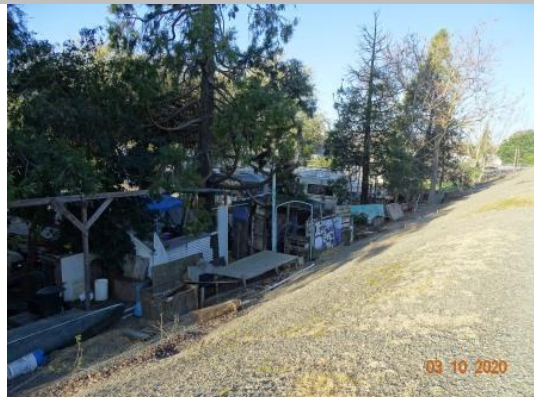
Photo 1 of 1 : SP_2020_MA0001_297_60_20200312_00144.jpg

LM Start	0.83	Rating **	M	Issue No.	60
LM End	0.83	Issue Type +	En	Location *	LS
Category	Earthen Levee			GPS Latitude/Longitude	
				Start	End
Item	Encroachments			39.217560 °	39.217560 °
				-122.015016 °	-122.015016 °
DWR ID	DWR_MA0001_01_s_2020_60				
Comment Code					
DE : Debris					
Inspector Comment

View of debris and wooden structures at the landside toe. Spring 2020.

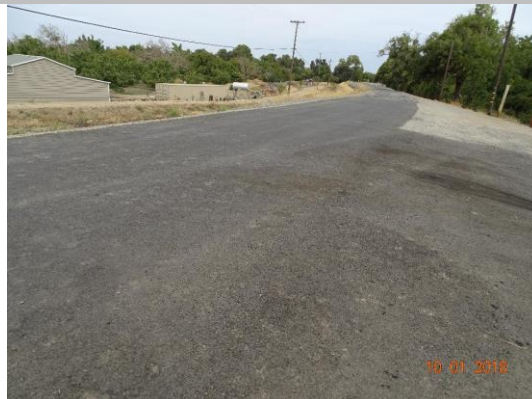
Photo 1 of 3 : UCIP_SP_2020_53078_78328.jpg

Comment Code					
Inspector Comment					
DS_ID:25564 FS_ID:53078 EP_NO: N/A Repair Type: Non-Urgent Crossing Status: Found UCIP Comments: 10/1/2018 Pipe installed according to emergency work authorization dated 07-31-2017 under existing permit No. 9481. Owner Roberts Ditch Company needs to submit as-builts. (O.Yakimov - DWR UCIP) FIELD_STRUCT_DESC: 36-inch smooth steel epoxy coated interior/exterior irrigation pipe with positive closure device on the water side of the levee. Crossing penetrates the levee at an angle. Other appurtenances located at this crossing include 2 slant pumps connected to a concrete distribution box, and shed structure located 100 feet northeast from levee crossing. Flow is carried from concrete distribution box to slide gate via concrete lined ditch. pipe is open to an irrigation ditch on LS. (36-inch installed according to the board emergency work authorization dated 07-31-2017 under Permit No. 9481-1, 2018 - Roberts Ditch Company; existing 36-inch was removed [logged under UCIP DSID 16431]). FS Date: 10/1/2018 10:51:57 AM

View of levee crown at crossing.

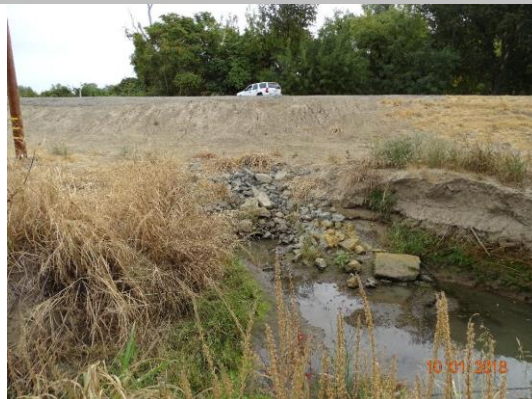
Photo 3 of 3 : UCIP_SP_2020_53078_78330.jpg

LM Start	1.17	Rating **	M	Issue No.	639 (cont)
LM End	1.17	Issue Type +	En	Location *	
Category	Supplemental		GPS Latitude/Longitude		
			Start	End	
Item	DWR UCIP Field Study		39.221685 °	39.221685 °	
			-122.015720 °	-122.015720 °	
DWR ID	25564

View of LS levee slope and irrigation ditch at levee toe.

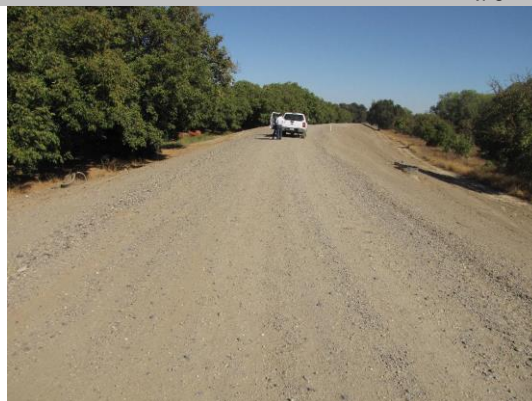
Photo 1 of 3 : UCIP_SP_2020_51852_70064.jpg

DS_ID:16430
FS_ID:51852
EP_NO: 9487
Repair Type: Non-Urgent
Crossing Status: Found
UCIP Comments: 5/3/2017 WS end still partially plugged. (DWR Sutter Yard- A Freitag)10/24/2016 WS end is still partially plugged. (DWR Sutter Yard- A Freitag)4/25/2016 WS pipe end is still plugged with soil. Rest of the pipe appeared to be in good condition.4/20/2015 WS pipe end is plugged about 50% by soil.6/18/2014 Same as last inspection.12/17/2013 Same as last inspection.7/18/2013 WS pipe end has been reformed but is still clogged about 50% by sediment.10/18/2012 Remove dirt and debris in riser. Outlet deformed and blocked over 50%. Debris-round concrete section on landward side. This crossing was listed in the USACE Periodic Inspections as ID# USACE_CESPK_MA1C_2010_p_0116 for crossing outlet deformed and clogged with dirt.
FIELD_STRUCT_DESC: 1 of 2: 36-inch corrugated metal drainage pipe through the levee, approximately 12-15 feet below the crown. Slide gates in corrugated metal pipe (CMP) riser located on the waterside (WS) slope. Pipe daylights on the landside (LS). (36-inch pipe [HLM 1.97] authorized under Automatic Board Order (ABO) issued as Permit No. 9487, 1974 - Jimeno Rancho) [Additional Reference(s): DWR Levee Log, 1992. USACE Sacramento O&M Manual 137, August 1955, (Station 103+18)].

Overview of levee crown and slopes looking upstream towards crossing.

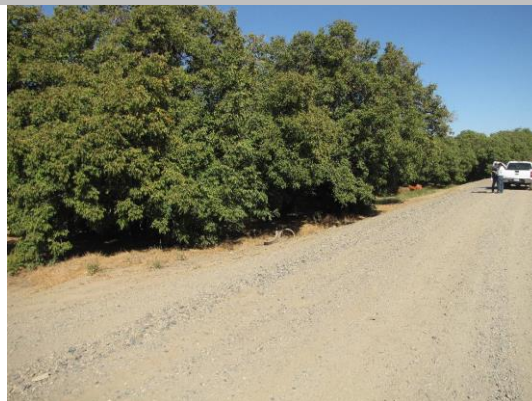
Photo 3 of 3 : UCIP_SP_2020_51852_70062.jpg

View of LS looking upstream at crossing.

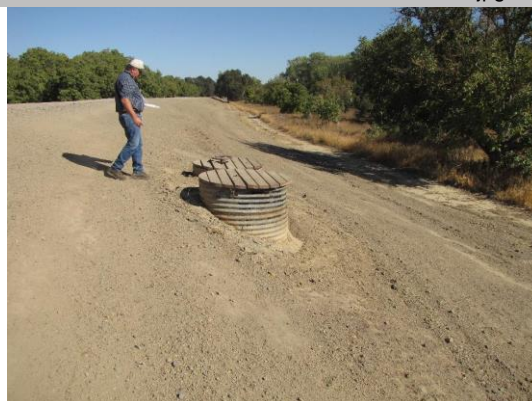
Photo 2 of 3 : UCIP_SP_2020_51853_70074.jpg

DS_ID:17565
FS_ID:51853
EP_NO: 9487
Repair Type: Non-Urgent
Crossing Status: Found
UCIP Comments: 5/3/2017 Ws end still partially plugged. (DWR Sutter Yard- A Freitag)10/24/2016 Ws pipe end still plugged.(DWR Sutter Yard- A Freitag)4/25/2016 WS pipe end still plugged with soil. rest of pipe appears in good condition.4/20/2015 WS pipe end plugged about 50% by soil.6/18/2014 Same as last inspection.12/17/2013 Same as last inspection.7/18/2013 WS pipe end has been reformed but is still partially blocked with dirt and debris.10/18/2012 WS- remove dirt and debris in riser. Outlet deformed and blocked over 50%. Burrow activity near outlet on waterward slope. Debris around concrete section on landward side. This crossing was listed in the USACE Periodic Inspections as ID# USACE_CESPK_MA1C_2010_p_0116 for crossing outlet deformed and clogged with dirt.
FIELD_STRUCT_DESC: 2 of 2: 36-inch corrugated metal drainage pipe through the levee, approximately 12-15 feet below the crown. Slide gates in corrugated metal pipe (CMP) riser on the waterside (WS) slope. Pipe daylights on the landside (LS). (36-inch pipe [HLM 1.97] authorized under Automatic Board Order (ABO) issued as Permit No. 9487, 1974 - Jimeno Rancho) [Additional Reference(s): DWR Levee Log, 1992. USACE Sacramento O&M Manual 137, August 1955, (Station 103+18)].

View of CMP risers located on WS slope.

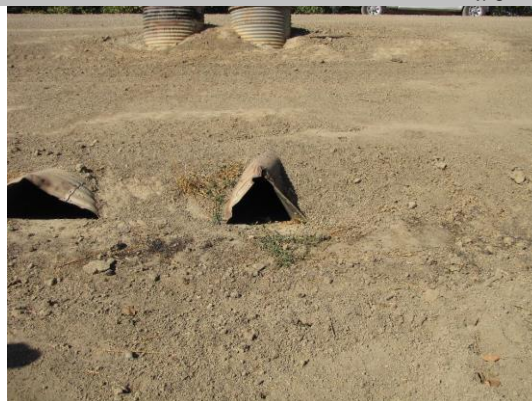
Photo 3 of 3 : UCIP_SP_2020_51853_70073.jpg

CMP pipe outlet deformed with over 50 percent blockage.

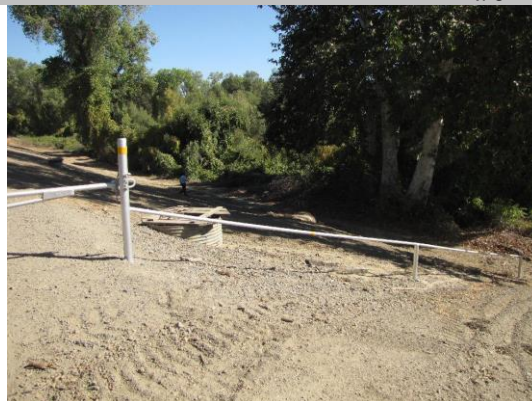
Photo 2 of 3 : UCIP_SP_2020_51854_70079.jpg

View of WS looking at slope and channel.

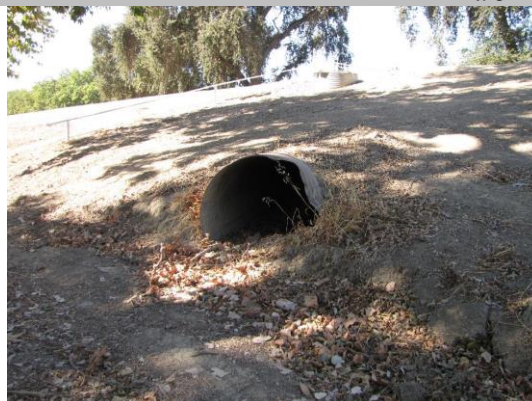
Photo 3 of 3 : UCIP_SP_2020_51854_70077.jpg

View of outlet located at WS toe.

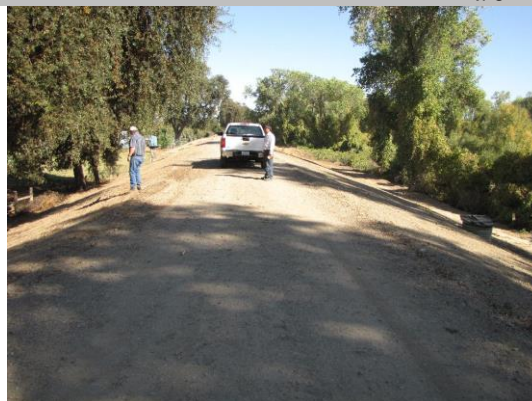
Photo 1 of 3 : UCIP_SP_2020_51855_70085.jpg

DS_ID:16428
 FS_ID:51855
 EP_NO: 9467
 Repair Type: Non-Urgent
 Crossing Status: Found
 UCIP Comments: 5/3/2017 Abandoned- needs to be done so properly.
 (DWR Sutter Yard- A Freitag)10/24/2016 Abandoned.(DWR Sutter Yard- A Freitag)4/25/2016 Abandoned crossing. Unable to locate any WS and LS pipe ends.4/20/2015 Same as last inspection.6/18/2014 Same as last inspection.12/17/2013 Same as last inspection.7/18/2013 Same as last inspection.10/18/2012 Only riser visible. Debris and sediment blocking gate. Gate inside riser is buried and non-functional. If crossing is abandoned, owner needs to properly abandon. This crossing was listed in the USACE Periodic Inspections as ID# USACE_CESPK_MA1C_2010_p_0132 no culvert through the levee is visible here.
 FIELD_STRUCT_DESC: *ABANDONED* 24-inch corrugated metal drainage pipe through the levee, approximately 12-15 feet below the crown. Slide gate in CM pipe riser on the waterside (WS) slope. No signs of inlet visible on the landside (LS). (24-inch pipe [HLM 2.31] authorized under Automatic Board Order (ABO) issued as Permit No. 9467, 1974 - Lovell E. Spurgeon) [Additional Reference(s): DWR Levee Log, 1992. USACE Sacramento O&M Manual 137, August 1955, (Station 120+60)].

Overview of levee crown looking upstream at crossing.

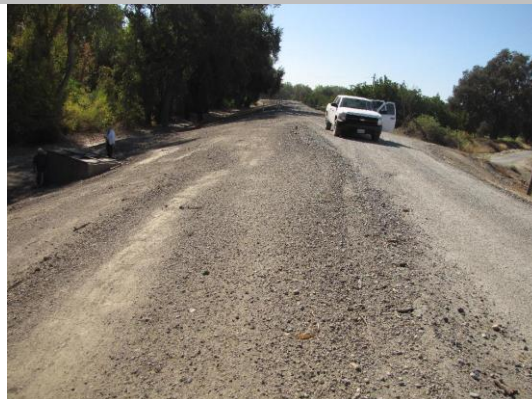
Photo 1 of 3 : UCIP_SP_2020_51856_70092.jpg

DS_ID:16416
FS_ID:51856
EP_NO: 9474
Repair Type: Non-Urgent
Crossing Status: Found
UCIP Comments: 5/3/2017 Appears abandoned- WS vault full of soil. Needs to be abandoned properly. (DWR Sutter Yard- A Freitag) 10/24/2016 Appears to be abandoned. WS vault full of soil to help prevent water from flowing through during high water season. (DWR Sutter Yard- A Freitag) 4/25/2016 Concrete box was filled with dirt to help prevent water from through during high water times. 4/20/2015 Positive closure device is missing and water cannot be prevented from flowing through pipe during high water. 6/18/2014 Same as last inspection. 12/17/2013 Same as last inspection. 7/18/2013 Same as last inspection. 10/18/12 During high water flow goes through levee. Missing positive closure device on waterward side. This structure appears abandoned-slide gates have been removed. Crossing needs to be properly abandoned. This crossing was listed in the USACE Periodic Inspection as ID# USACE_CESPK_MA1C_2010_p_0169 for concrete box partially filled with dirt.

Overview of levee crown looking downstream at crossing.

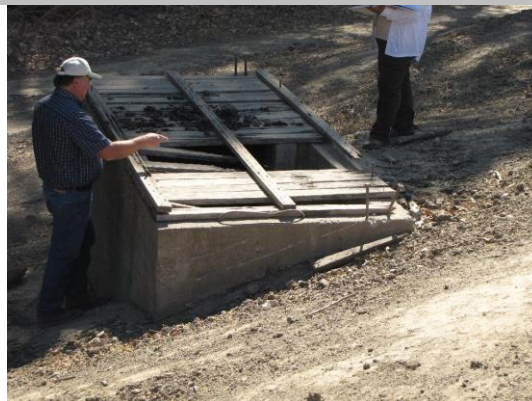
Photo 3 of 3 : UCIP_SP_2020_51857_70103.jpg

Close up view of concrete distribution box located on WS shoulder.

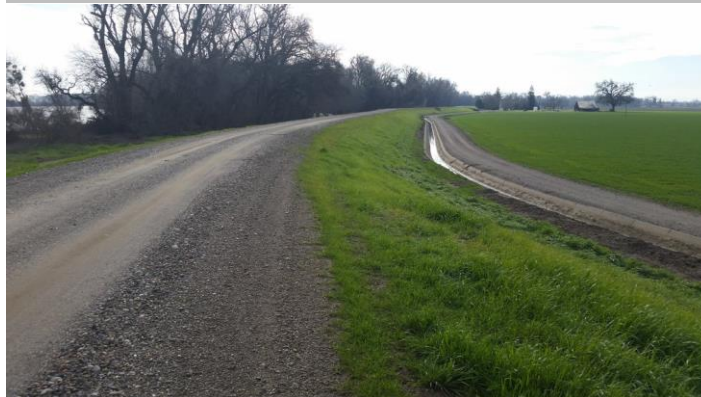
Photo 1 of 1 : SP_2020_MA0001_297_5_20200226_00002.jpg

LM Start	3.05	Rating **	U	Issue No.	5
LM End	3.70	Issue Type +	En	Location *	LS
Category	Earthen Levee			GPS Latitude/Longitude	
				Start	End
Item	Encroachments			39.246813 °	39.255976 °
				-122.008155 °	-122.009794 °
DWR ID	DWR_MA0001_01_s_2012_5				
Comment Code					
DT : Ditch					
Inspector Comment

View of the concrete lined ditch along the landside toe.

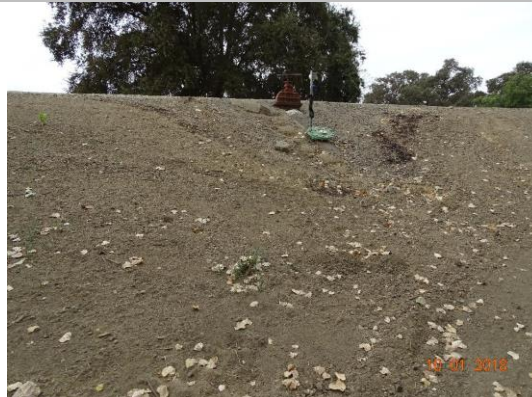
Photo 2 of 3 : UCIP_SP_2020_53048_78238.jpg

Flow meter installed.

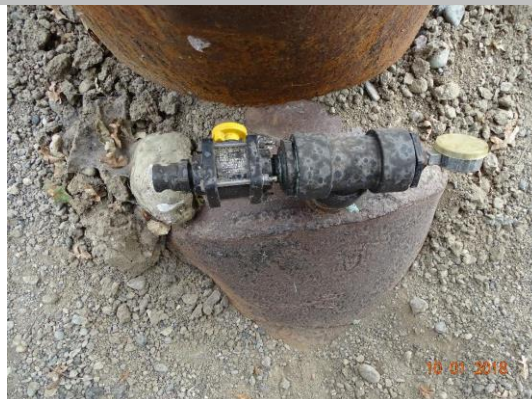
Photo 3 of 3 : UCIP_SP_2020_53048_78236.jpg

Manometer and air valve installed on pipe at LS shoulder.

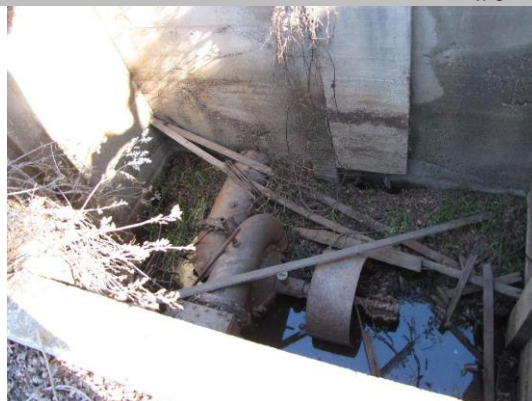
Photo 3 of 3 : UCIP_SP_2020_51861_70122.jpg

DS_ID:16424
FS_ID:51861
EP_NO: 9490
Repair Type: Non-Urgent
Crossing Status: Found
UCIP Comments: 5/3/2017 Abandoned- Needs to be done properly.
(DWR Sutter Yard- A Freitag)10/24/2016 Abandoned. Needs a cover made for the LS distribution box.(DWR Sutter Yard- A Freitag)4/25/2016 ABANDONED crossing and should be abandoned properly. Concrete distribution box on LS is opened on top and could pose a safety hazard with falling.4/20/2015 Same as last inspection. 6/18/2014 Same as last inspection.12/17/2013 Same as last inspection.7/18/2013 Same as last inspection.10/19/2012 Crossing needs to be properly abandoned. This crossing was listed in the USACE Periodic Inspection as ID#
USACE_CESPK_MA1C_2010_p_0194-6 & 7 no issues logged.
FIELD_STRUCT_DESC: *ABANDONED* 36-inch corrugated metal irrigation pipe through the levee, approximately 12-15 feet below the crown. Concrete distribution box with pump system located on the landside (LS). Slide gate on the waterside (WS) slope--removed. 18-inch pipe visible on the LS inside 10-foot by 16 foot concrete box. (Automatic Board Order (ABO) issued as Permit No. 9490, 1974 - Charles T & Virginia W. Yerxa) [Additional Reference(s): DWR Levee Log, 1992. USACE Sacramento O&M Manual 137, August 1955 (Station 197+19)]

Debris inside concrete structure located on LS.

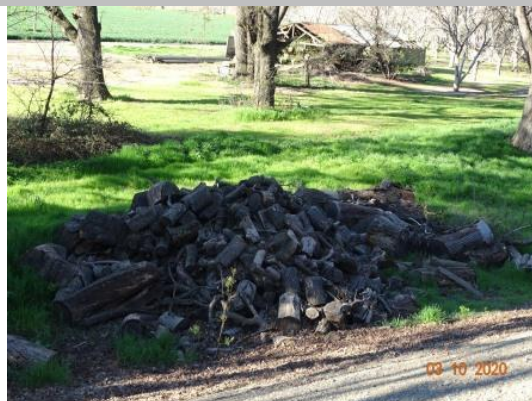
Photo 1 of 1 : SP_2020_MA0001_297_102_20200312_00146.jpg

LM Start	3.73	Rating **	M	Issue No.	102
LM End	3.73	Issue Type +	En	Location *	LS
Category	Earthen Levee			GPS Latitude/Longitude	
				Start	End
Item	Encroachments			39.256321 °	39.256321 °
				-122.010220 °	-122.010220 °
DWR ID	DWR_MA0001_01_s_2019_102				
Comment Code					
FW : Firewood					
Inspector Comment					
The firewood should be removed from the landside toe.

View of the pile of firewood at the landside toe. Spring 2020.

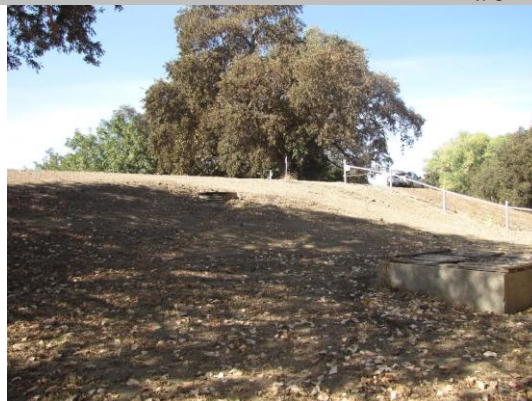
Photo 2 of 3 : UCIP_SP_2020_51862_70131.jpg

View of concrete distribution box and CMP riser located on WS.

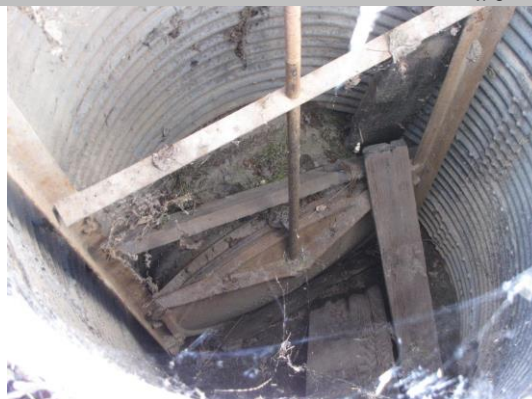
Photo 3 of 3 : UCIP_SP_2020_51862_70126.jpg

WS-Inside view of CMP riser located on waterward slope.

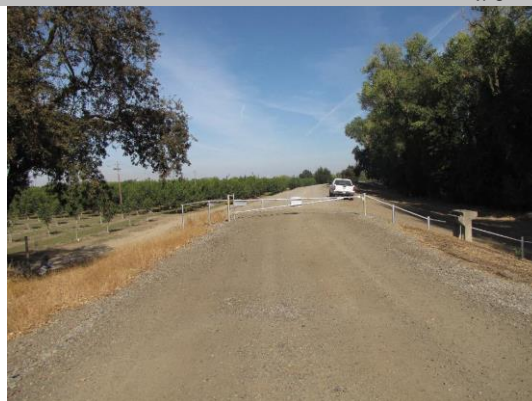
Photo 1 of 3 : UCIP_SP_2020_51864_70137.jpg

DS_ID:16422
FS_ID:51864
EP_NO: N/A
Repair Type: Non-Urgent
Crossing Status: Found
UCIP Comments: 5/3/2017 Appears abandoned- needs to be done so properly. (DWR Sutter Yard- AFreitag)10/24/2016 Appears to be abandoned.(DWR Sutter Yard- AFreitag)4/25/2016 Appears to be an abandoned crossing. 4/20/2015 Debris is still blocking gate. Appears to be an abandoned crossing.6/18/2014 Same as last inspection.12/17/2013 Same as last inspection.7/18/2013 Wheel to operate slide gate has been replaced but gate is still blocked by debris.10/19/2012 WS-wheel to operate slide gate missing, walkway has been removed; burrow activity near structure; debris in concrete distribution box WS blocking gate. This crossing was listed in the USACE Periodic Inspection as ID# USACE_CESPK_MA1C_2010_p_0207 the wheel to operate sluice gate missing.
FIELD_STRUCT_DESC: *ABANDONED* 24-inch drainage pipe of an unknown material through the levee, unknown depth below the crown. Walkway to slide gate on the waterside (WS) end. Walkway has been removed. Flap gate in concrete distribution box at the landside (LS) toe. [Additional Reference(s): DWR Levee Log, 1992].

View of levee crown looking upstream at crossing.

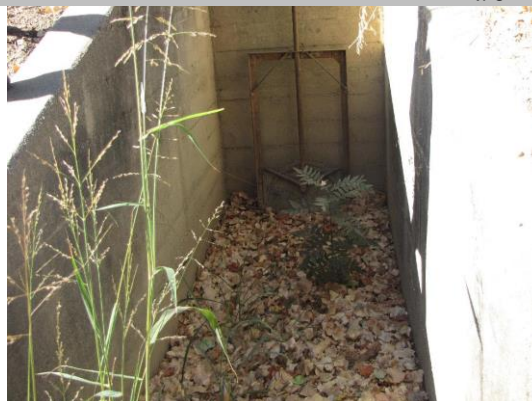
Photo 3 of 3 : UCIP_SP_2020_51864_70138.jpg

View of slide gate located on WS.

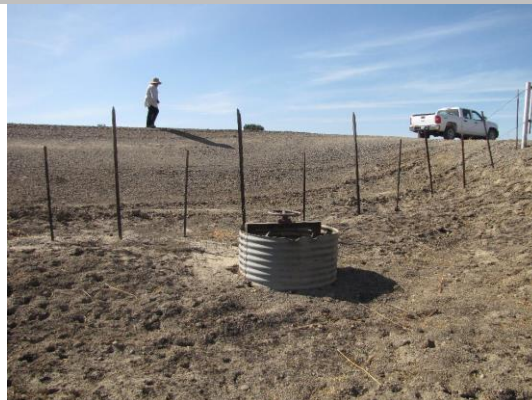
Photo 2 of 3 : UCIP_SP_2020_51865_70147.jpg

Riser with slide gate located on WS toe.

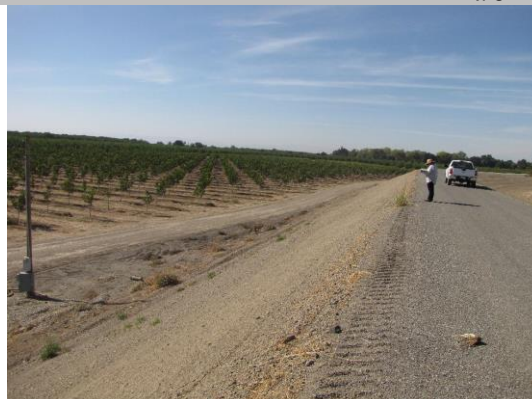
Photo 2 of 3 : UCIP_SP_2020_51868_70149.jpg

View of levee crown looking upstream at crossing.

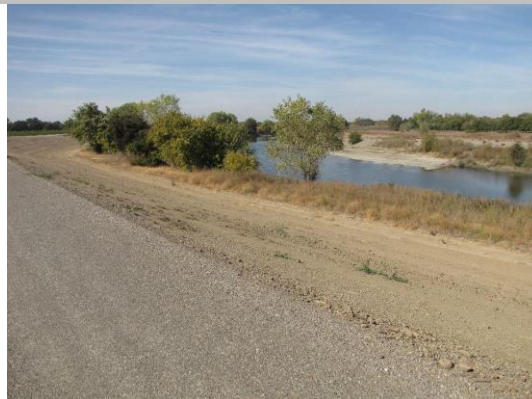
Photo 3 of 3 : UCIP_SP_2020_51868_70148.jpg

View of WS-no visible appurtenances associated with structure.

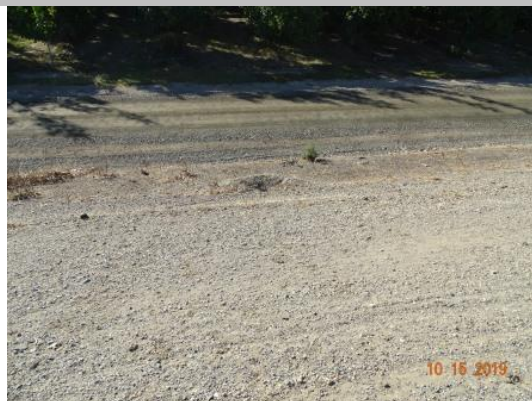
Photo 1 of 1 : SP_2020_MA0001_297_80_20200226_00017.jpg

LM Start	5.00	Rating **	M	Issue No.	80
LM End	5.00	Issue Type +	Ma	Location *	LS
Category	Earthen Levee			GPS Latitude/Longitude	
				Start	End
Item	Animal Control			39.264840 °	39.264840 °
				-122.016437 °	-122.016437 °
DWR ID	DWR_MA0001_01_f _ 2019_80				
Comment Code					
A3 : No rodents visible, but rodent burrows visible; need to backfill and compact or grout burrows.					
Inspector Comment

View of the rodent activity at the landside toe. Fall 2019.

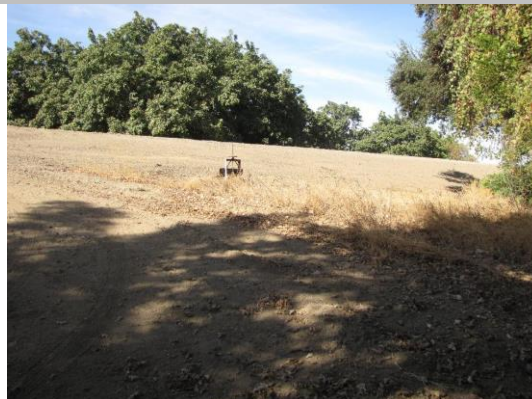
Photo 3 of 3 : UCIP_SP_2020_51869_70156.jpg

View of WS slope and access road. Slide gate is second crossing at this location.

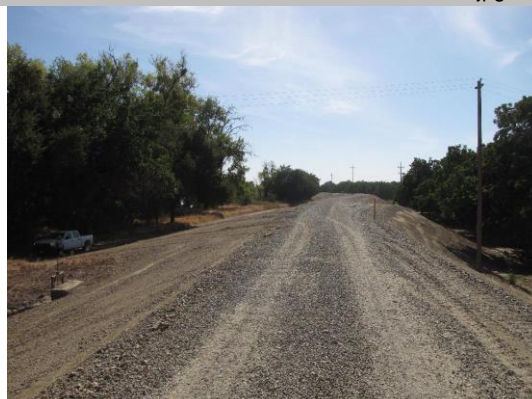
Photo 1 of 3 : UCIP_SP_2020_51870_70162.jpg

DS_ID:17569
FS_ID:51870
EP_NO: 9476
Repair Type: Non-Urgent
Crossing Status: Found
UCIP Comments: 5/3/2107 Culvert has sediment build up in it- needs to be cleaned out. (DWR Sutter Yard- A Freitag)10/24/2016 LS outlets becoming overgrown with vegetation in the dtch.(DWR Sutter Yard- A Freitag)4/25/2016 WS entry still blocked and wingwalls still cracked.4/20/2015 WS entry still blocked and wingwalls still cracked.6/18/2014 Same as last inspection.12/17/2013 Same as last inspection.7/18/2013 Same as last inspection.10/19/2012 blocked, no entry on WS. This crossing was listed in the USACE Periodic Inspection as ID# USACE_CESPK_MA1C_2010_p_0247 for u/s and d/s wing wall shows some cracking and tilting.
FIELD_STRUCT_DESC: 2 of 2: 36-inch corrugated metal irrigation pipe (15 feet long) and concrete box culvert through the levee at an unknown depth below the crown. Slide gate located on the waterside (WS). Concrete headwall visible on the landside (LS) toe. (Automatic Board Order (ABO) issued as Permit No. 9476-1974, Howard C. & Nadine M. Ohliger) [Additional Reference(s): DWR Levee Log, 1992].

View of levee crown looking downstream at crossing.

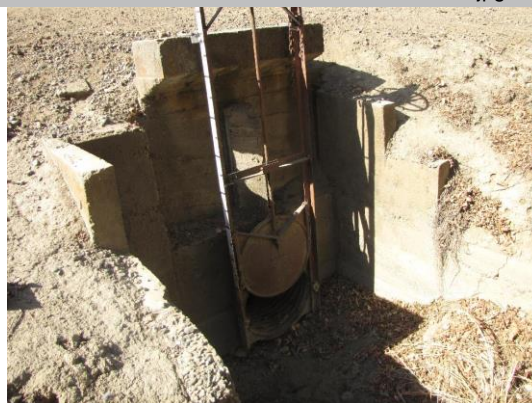
Photo 3 of 3 : UCIP_SP_2020_51870_70160.jpg

Headwall and slide gate located on WS.

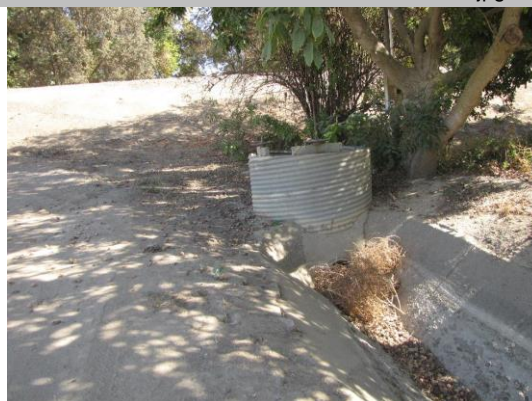
Photo 2 of 3 : UCIP_SP_2020_51872_70166.jpg

CMP riser and concrete lined v-ditch located on LS toe.

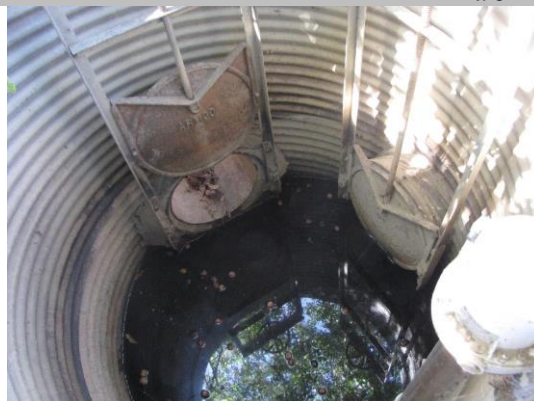
Photo 3 of 3 : UCIP_SP_2020_51872_70171.jpg

Photo 1 of 2 inside view of CMP riser located on LS toe.

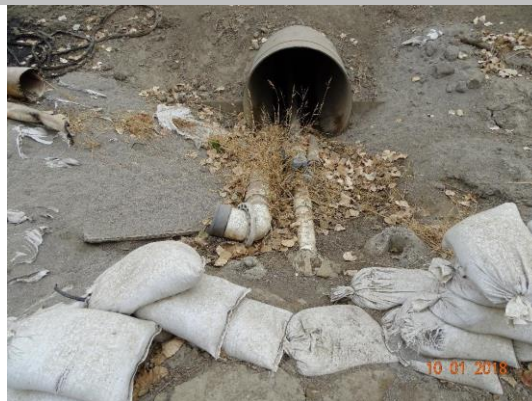
Photo 3 of 3 : UCIP_SP_2020_53049_78244.jpg

Pipe at LS toe.

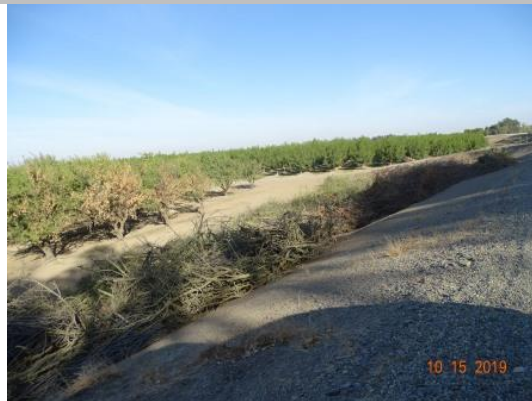
Photo 1 of 1 : SP_2020_MA0001_297_115_20200226_00026.jpg

LM Start	6.38	Rating **	U	Issue No.	115
LM End	6.38	Issue Type +	En	Location *	LS
Category	Earthen Levee			GPS Latitude/Longitude	
				Start	End
Item	Encroachments			39.281425 °	39.281425 °
				-122.022000 °	-122.022000 °
DWR ID	DWR_MA0001_01_f _ 2016_115				
Comment Code					
PR : Prunings					
Inspector Comment					
Remove prunings from the landside slope and toe.

View of the prunings along the landside slope and toe. Fall 2019.

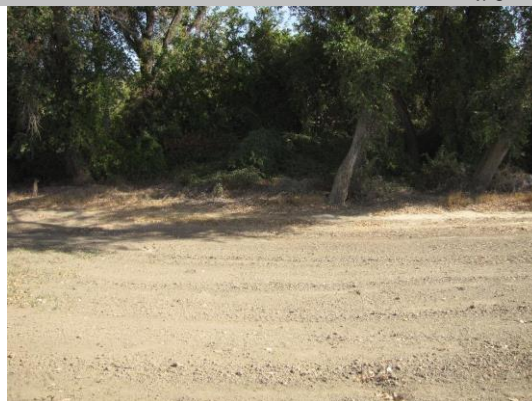
Photo 1 of 3 : UCIP_SP_2020_51874_70181.jpg

DS_ID:16425
FS_ID:51874
EP_NO: N/A
Repair Type: Non-Urgent
Crossing Status: Found
UCIP Comments: 5/3/2017 Abandoned- needs to be done properly.
(DWR Sutter Yard- A Freitag)10/24/2016 Abandoned(DWR Sutter Yard- A Freitag)4/25/2016 Abandoned crossing.4/20/2015 Same as last inspection.6/23/2014 Same as last inspection.12/17/2013 Same as last inspection.7/18/2013 Same as last inspection.10/19/2012 Need to be properly abandoned concrete structure; plate covers concrete box; Concrete headwall damaged. This crossing was listed in the USACE Periodic Inspection as ID# USACE_CESPK_MA1C_2010_p_0262 for damage to concrete structure (vertical 2 inch wide cracks and spalling visible).
FIELD_STRUCT_DESC: *ABANDONED* 72-inch corrugated metal (precast concrete) drainage pipe through the levee at an unknown depth below the crown. Structure is blocked on the waterside (WS) end with 3-foot concrete plug installed in 1980. Slide gate in concrete well on the landside (LS) shoulder. Concrete headwall at both toes. WS headwall not found. [Additional Reference(s): DWR Levee Log, 1992. USACE Sacramento O&M Manual 137, August 1955, (Station 339+74)].

View of WS no structure features visible.

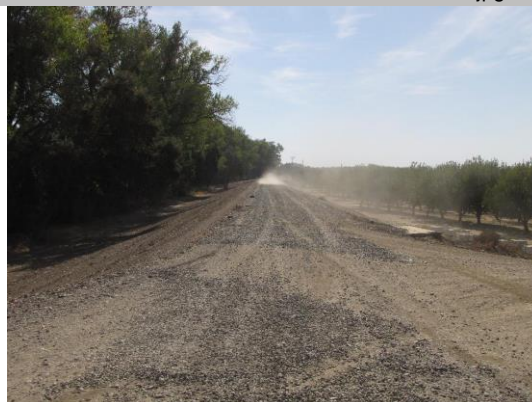
Photo 2 of 3 : UCIP_SP_2020_51874_70180.jpg

Overview of levee crown looking downstream at crossing.

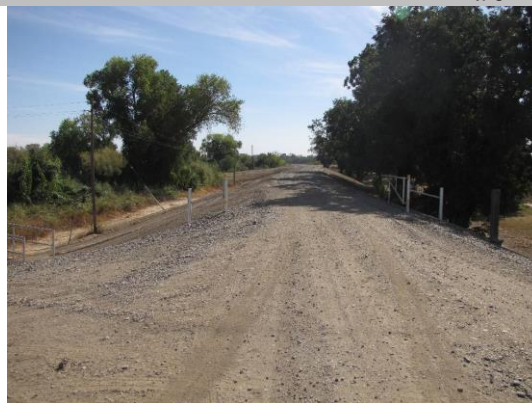
Photo 1 of 3 : UCIP_SP_2020_51875_70188.jpg

DS_ID:16427
FS_ID:51875
EP_NO: 9482
Repair Type: Non-Urgent
Crossing Status: Found
UCIP Comments: 5/3/2017 Abandoned- Needs to be done properly.
(DWR Sutter Yard- A Freitag)10/24/2016 Abandoned.(DWR Sutter Yard- A Freitag)4/25/2016 Abandoned pipe. Needs to be properly plugged if it never gets used.4/20/2015 Same as last inspection.
Structure is still buried.6/23/2014 Same as last inspection.12/17/2013 Same as last inspection.7/18/2013 Same as last inspection.10/19/2012 Structure is buried and non-operational.
This crossing was listed in the USACE Periodic Inspection as ID# USACE_CESPK_MA1C_2010_p_0288 for sluice gate closed and backfilled on WS and full of sediment with wingwall cracked on LS.
FIELD_STRUCT_DESC: *ABANDONED* 1 of 2: 36-inch reinforced concrete irrigation pipe through the levee at approximately 18 feet below the crown. Wooden slide gates on the waterside (WS) end. Sliding metal gate noted in O&M manual. Concrete headwalls located on both WS and landside (LS). O&M manual structure reference is 4'-9" x 9'-6" concrete box culvert. (Automatic Board Order (ABO) issued as Permit No. 9482, 1974 - Elizabeth M. Farnsworth) [Additional Reference(s): DWR Levee Log, 1992. USACE Sacramento O&M Manual 137, August 1955, (Station 370+90)].

Overview of levee crown looking downstream at crossing.

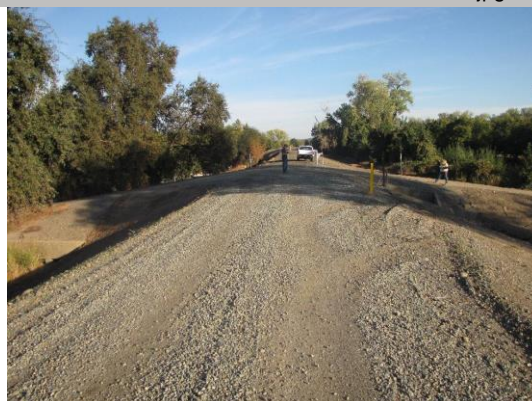
Photo 2 of 3 : UCIP_SP_2020_51877_70204.jpg

Overview of levee crown looking upstream at crossing.

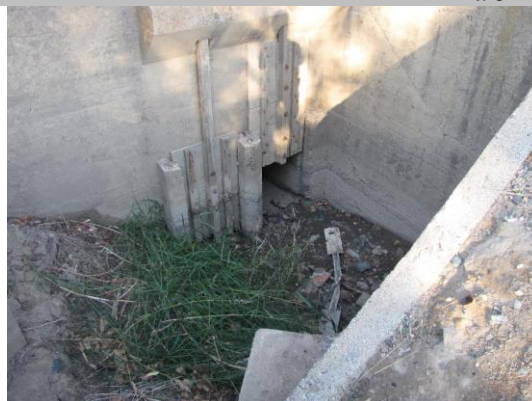
Photo 3 of 3 : UCIP_SP_2020_51877_70203.jpg

View of wooden sluice gates located on WS.

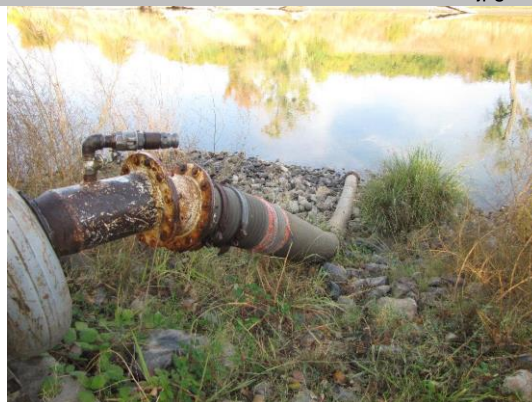
Photo 2 of 3 : UCIP_SP_2020_51878_70210.jpg

Pump located on WS bank.

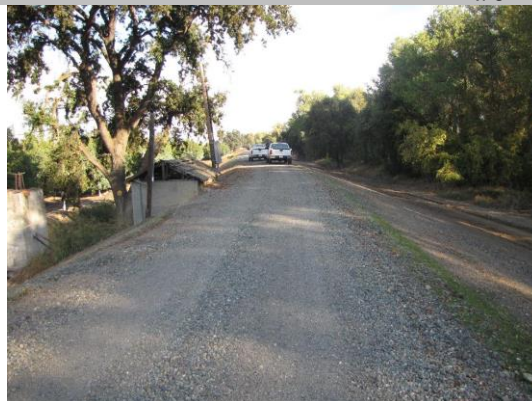
Photo 2 of 3 : UCIP_SP_2020_51879_70217.jpg

Overview of levee crown looking upstream at crossing.

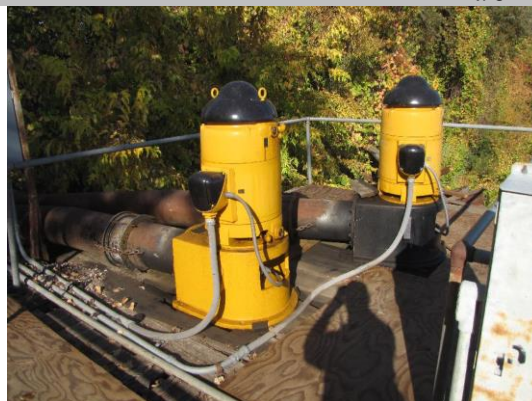
Photo 2 of 3 : UCIP_SP_2020_53050_70239.jpg

Pumps corresponding to 2-14 inch pipes.

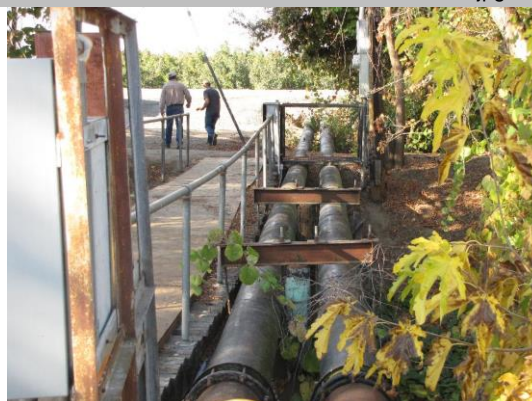
Photo 3 of 3 : UCIP_SP_2020_53050_70238.jpg

WS-2-14 inch pipes parallel catwalk and go through levee.

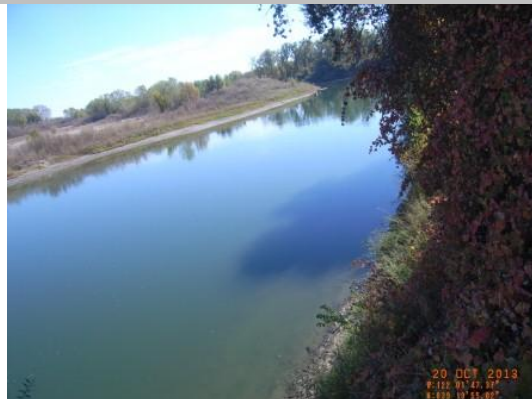
Photo 1 of 1 : SP_2020_MA0001_297_6_20200226_00003.jpg

LM Start	10.32	Rating **	A/W	Issue No.	6
LM End	10.41	Issue Type +	Ma	Location *	WS
Category	Supplemental			GPS Latitude/Longitude	
				Start	End
Item	2017 USACE Erosion Survey			39.331447 °	39.332716 °
				-122.029440 °	-122.029953 °
DWR ID	DWR_ST0003_01_f_2018_1				
Comment Code					
Inspector Comment					
2017 Site ID: SAC 157.7 R					
Status: Eroding					
2017 Field Notes: Vertical face of clay sand bank, new tree popout.					
Bank continues to erode.					
Site History: 2004 - Slowly eroding but near vertical with no vegetation					
to hold it. 2005 - Erosion is close to levee toe but not into the levee					
section yet. 2010 - Some new toe scour.

USACE 2013 Photo #1

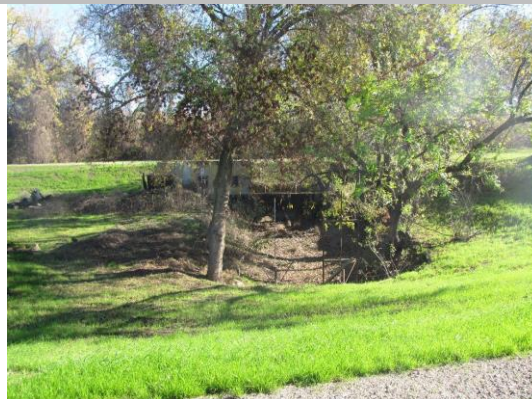
Photo 2 of 3 : UCIP_SP_2020_53053_70265.jpg

View of abandoned structure located on WS (inside ring levee).

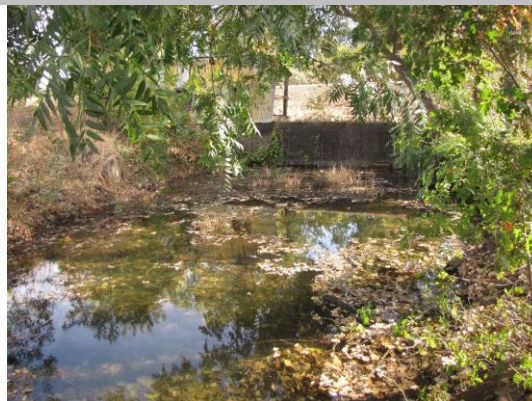
Photo 3 of 3 : UCIP_SP_2020_53053_70260.jpg

Drain channel inside ring levee.

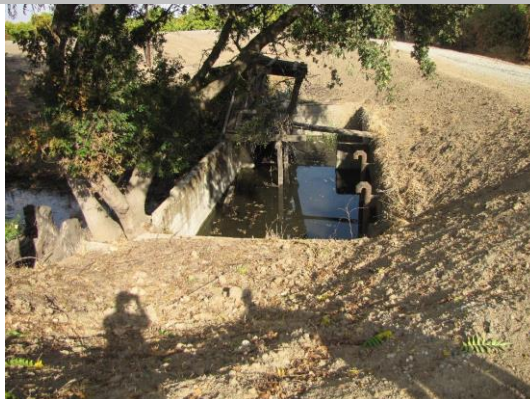
Photo 2 of 3 : UCIP_SP_2020_53052_70276.jpg

Abandoned structure (multiple headwalls and pump structure) located near the lower levee (ring levee).

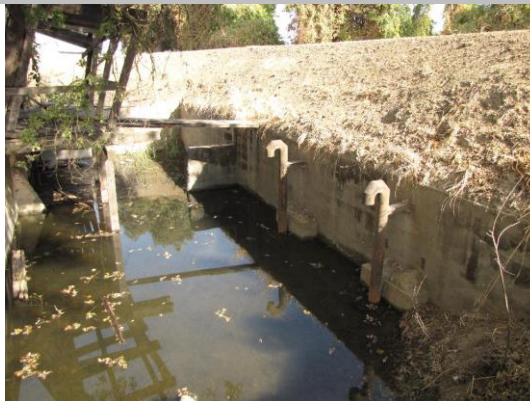
Photo 3 of 3 : UCIP_SP_2020_53052_70275.jpg

DS_ID:15752
 FS_ID:53052
 EP_NO: 187
 Repair Type: Urgent
 Crossing Status: Found
 UCIP Comments: 10/1/2018 Pipe closed by steel plate at LS end. Plate is bolted to concrete headwall. CVFPB is working with owner to address issue. Crossing remains "Urgent" because of missing slide gate on WS. (O.Yakimov - DWR UCIP)5/3/2017 No changes have been made at this crossing since the NOV was sent out in January 2017. (DWR Sutter Yard- AFreitag)01/31/2017 Informal Notice of Violation (NOV) was sent out January 31, 2017 by DWR Flood Maintenance Office--owner will need to coordinate with CVFPB to remove, replace, or abandon pipe in-place. Owner has until Monday February 27th, 2017 to respond to DWR contact: Bryan Reniff. (refer to Official Notice for details). (DWR UCIP - O. Magana)10/24/2016 Appears abandoned. Slide gate needs to be replaced or pipe end capped to prevent water flow during high water. (DWR Sutter Yard- AFreitag)4/25/2016 Crossing appears to be abandoned. Slide gate needs to be replaced or pipe needs to be plugged to prevent water flow during high water season. (DWR Sutter Yard - aFreitag)4/21/2015 Same as last inspection. (DWR Sutter Yard - aFreitag)6/23/2014 Same as last inspection. (DWR Sutter Yard - aFreitag)12/17/2013 Same as last inspection. (DWR Sutter Yard - aFreitag)7/18/2013 Same as last inspection. (DWR Sutter Yard - aFreitag)10/30/2012 Missing positive closure device. Need to determine if structure is still in use--contact owner. If abandoned structure--structure needs to be abandoned properly. This crossing was listed in the USACE Periodic Inspections as ID# USACE_CESPK_MA1C_2010_p_0393 missing gate. (DWR UCIP - omagana)

WS-Concrete headwall with multiple crossings (2-30 inch pipes and 1-48 inch pipe).

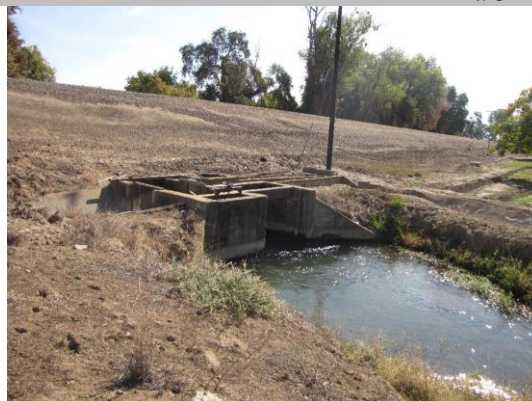
Photo 2 of 3 : UCIP_SP_2020_53054_70326.jpg

View of concrete distribution box located on LS toe.

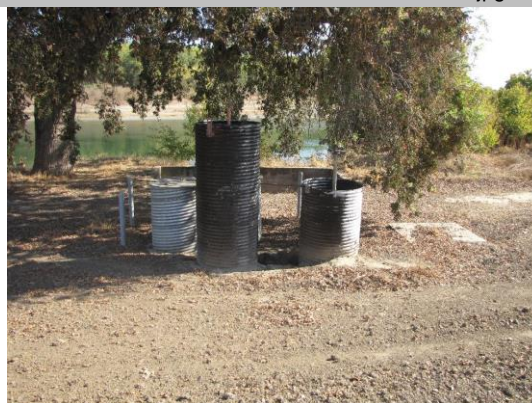
Photo 3 of 3 : UCIP_SP_2020_53054_70330.jpg

CMP risers located on WS berm. 18-inch pipe corresponds to downstream riser with slide gate. 24-inch pipe corresponds to upstream riser with slide gate.

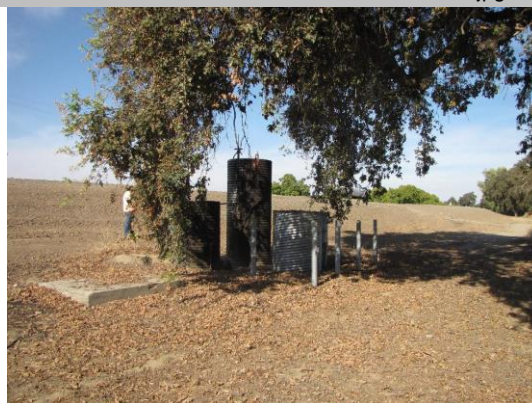
Photo 3 of 3 : UCIP_SP_2020_53056_70323.jpg

Comment Code					
Inspector Comment					
DS_ID:17624 FS_ID:53056 EP_NO: 17471 Repair Type: Urgent Crossing Status: Found UCIP Comments: 10/1/2018 Sink hole between CMP risers on WS has grown. Need to contact owner to address issue. Recommend video inspection. (O.Yakimov - DWR UCIP)5/3/2017 Sink hole still present between the WS risers. It does not appears to be getting worse. Pumps were running during site visit but the sink hole was dry this time. (DWR Sutter Yard- AFreitag)10/24/2016 Sinkhole still present.(DWR Sutter Yard- AFreitag)4/25/2016 Sink hole between risers was getting worse (3' wide x 3' long x 3' deep). New smaller sink hole is appearing on the upstream side of this stand pipe (4.5" wide x 20" deep). (DWR Sutter Yard - afreitag)4/21/2015 Sink hole still present between risers. (DWR Sutter Yard - afreitag)6/23/2014 Standing water was present in the bottom of the sinkhole. (DWR Sutter Yard - afreitag)12/17/2013 Same as last inspection. (DWR Sutter Yard - afreitag)7/18/2013 Same as last inspection. (DWR Sutter Yard - afreitag)10/30/2012 Erosion between risers with slide gates located on waterward side; This crossing was listed in the USACE Periodic Inspections as ID# USACE_CESPK_MA1C_2010_p_0398 for possible sinkhole between access gate structures. (DWR UCIP - omagana) FIELD_STRUCT_DESC: 2 of 2: 18-inch high-density polyethylene (HDPE) irrigation pipe connected to the existing corrugated metal pipe (CMP) riser within the waterside (WS) and parallel to the right (west) bank levee of the Sacramento River. Pipe depth through the levee unknown. Pump station is located approximately 450 feet upstream of crossing. (Permit 17471, 2002 - Maxwell Irrigation District) FS Date: 10/1/2018 3:58:00 PM

View of CMP risers located on WS berm.

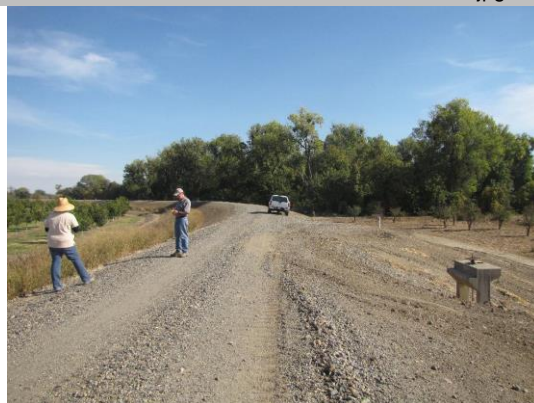
Photo 1 of 3 : UCIP_SP_2020_51903_70352.jpg

Comment Code						
Inspector Comment						
DS_ID:16445 FS_ID:51903 EP_NO: 9462 Repair Type: Non-Urgent Crossing Status: Found UCIP Comments: 5/3/2017 Appears abandoned- needs to be done properly.(DWR Sutter Yard- AFreitag)10/24/2016 Appears abandoned. LS concrete canal is filled by pipe DSID 16444.4/25/2016 Appears to be an abandoned crossing. WS slide gate still buried and inoperable.4/21/2015 Same as last inspection. 6/23/2014 Same as last inspection.12/17/2013 Same as last inspection.7/22/2013 Same as last inspection.10/30/2012 Slide gate unoperable-blocked by sediment. LS-flap gate missing. 5-inch pipe goes through 24-inch crossing--unable to determine is authorized. This crossing was listed in the USACE Periodic Inspections as ID# USACE_CESPK_MA1C_2010_p_0435 for smaller pipe running inside existing crossing. FIELD_STRUCT_DESC: *ABANDONED* 24-inch corrugated metal drainage pipe through the levee, approximately 10 feet below the crown. Slide gate on both waterside (WS) and landside (LS). Gate missing on the LS. (Automatic Board Order (ABO) issued as Permit No. 9462-1974, Thousand Acre Ranch) [Additional Reference(s): DWR Levee Log, 1992]. FS Date: 5/23/2017 11:50:30 AM

Overview of levee crown looking downstream at crossing.

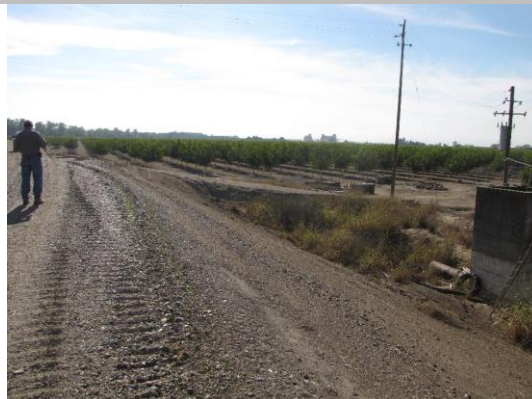
Photo 1 of 3 : UCIP_SP_2020_53058_70377.jpg

DS_ID:16443
FS_ID:53058
EP_NO: 9461
Repair Type: Urgent
Crossing Status: Found
UCIP Comments: 10/1/2018 Backwash erosion from ditch appears to be growing along LS toe. FSRP evaluation is recommended. (O. Yakimov - DWR UCIP)5/3/2017 Water was leaking from the LS distribution box during the Jan/Feb 2017 high water event. If this crossing is abandoned then it needs to be so properly. (DWR Sutter Yard- A Freitag)11/01/2016 Erosion/cavity collapse visible on LS toe. Slide gate inside concrete riser located on the WS is in the open position. Need to contact owner to confirm status of crossing and to determine cause of erosion on LS (pipe or concrete box might be leaking). (O. Magana - DWR UCIP)10/24/2016 Appears abandoned.(DWR Sutter Yard- A Freitag)4/25/2016 Slide gate in WS box visually appears to be closed as its stem is all the way down. Still cannot look into box to confirm 100% though. (A. Freitag - DWR Sutter Yard)4/21/2015 Same as last inspection. (A. Freitag - DWR Sutter Yard)6/23/2014 Same as last inspection. (A. Freitag - DWR Sutter Yard)12/17/2013 Same as last inspection. (A. Freitag - DWR Sutter Yard)7/22/2013 Same as last inspection. (A. Freitag - DWR Sutter Yard)10/30/2012 Unable to close positive closure device due to missing ladder-slucce gate inaccessible. Need to determine the condition of the gate. This crossing was listed in the USACE Periodic Inspections as ID# USACE_CESPK_MA1C_2010_p_0453 for an inaccessible gate box with its ladder broken on the waterward side. (O. Magana - DWR UCIP)

View of LS looking downstream at crossing.

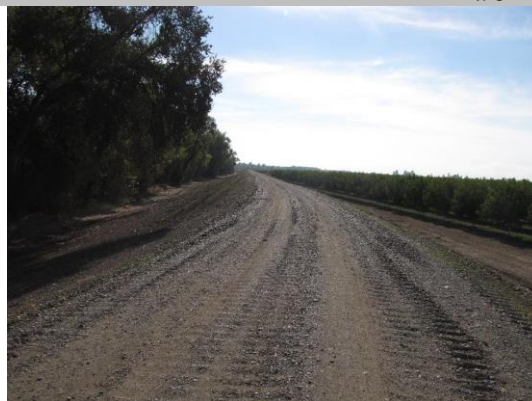
Photo 1 of 2 : UCIP_SP_2020_51910_70379.jpg

Comment Code						
Inspector Comment						
DS_ID:16442 FS_ID:51910 EP_NO: N/A Repair Type: Non-Urgent Crossing Status: Found UCIP Comments: 5/3/2017 Abandoned- needs to be done so properly. (DWR Sutter Yard- A Freitag)10/24/2016 Abandoned.(DWR Sutter Yard- A Freitag)4/25/2016 Abandoned crossing4/21/2015 Slide gate is still buried.6/23/2014 Same as last inspection.12/17/2013 Same as last inspection.7/22/2013 Same as last inspection.10/30/2012 Slide gate is buried-non-fuctional. This crossing was listed in the USACE Periodic Inspections as ID# USACE_CESPK_MA1C_2010_p_0457 for buried slide gate. FIELD_STRUCT_DESC: *ABANDONED* 36-inch corrugated metal drainage pipe through the levee at approximately 15-18 feet below the crown. Slide gate on the waterside (WS) end. (Davis Ranches) [Additional Reference(s): DWR Levee Log, 1992]. FS Date: 5/23/2017 12:02:52 PM

Overview of levee crown looking downstream at crossing.

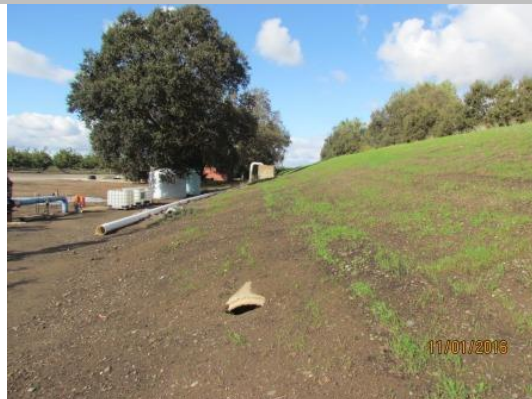
Photo 1 of 1 : SP_2020_MA0001_297_128_20200226_00028.jpg

LM Start	14.25	Rating **	U	Issue No.	128
LM End	14.30	Issue Type +	En	Location *	LS
Category	Earthen Levee			GPS Latitude/Longitude	
				Start	End
Item	Encroachments			39.378129 °	39.378800 °
				-122.013040 °	-122.013360 °
DWR ID	DWR_MA0001_01_s_2019_128				
Comment Code					
PI : Pipe					
Inspector Comment					
Concrete pipe runs along the landside toe and concrete box at the end.

View of a concrete pipe that runs along the levee toe.

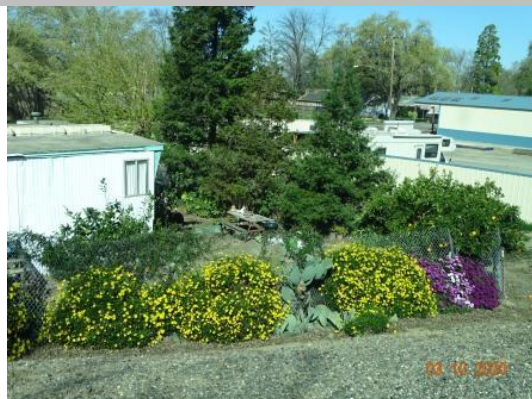
Photo 1 of 1 : SP_2020_MA0001_297_74_20200312_00149.jpg

LM Start	16.10	Rating **	M	Issue No.	74
LM End	16.10	Issue Type +	En	Location *	LS
Category	Earthen Levee			GPS Latitude/Longitude	
				Start	End
Item	Vegetation			39.404255 °	39.404255 °
				-122.008842 °	-122.008842 °
DWR ID	DWR_MA0001_01_s_2015_74				
Comment Code					
V6 : Landscaping					
Inspector Comment					
Remove the landscape from the landside slope and toe.

View of the landscaping along the landside slope and toe. Spring 2020.

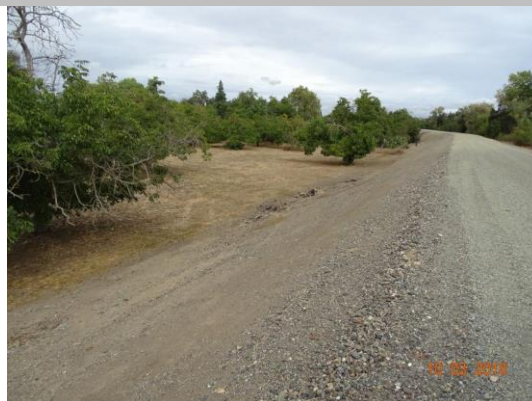
Photo 1 of 1 : SP_2020_MA0001_297_71_20200226_00014.jpg

LM Start	16.19	Rating **	M	Issue No.	71
LM End	16.19	Issue Type +	Ma	Location *	LS
Category	Earthen Levee			GPS Latitude/Longitude	
				Start	End
Item	Animal Control			39.405435 °	39.405435 °
				-122.008598 °	-122.008598 °
DWR ID	DWR_MA0001_01_f_2018_71				
Comment Code					
A3 : No rodents visible, but rodent burrows visible; need to backfill and compact or grout burrows.					
Inspector Comment

View of the rodent holes along the landside slope.

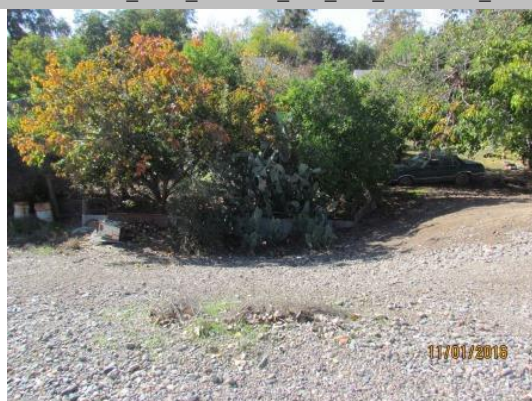
Photo 1 of 1 : SP_2020_MA0001_297_134_20200226_00029.jpg

LM Start	16.26	Rating **	M	Issue No.	134
LM End	16.26	Issue Type +	En	Location *	LS
Category	Earthen Levee			GPS Latitude/Longitude	
				Start	End
Item	Vegetation			39.406520 °	39.406520 °
				-122.008635 °	-122.008635 °
DWR ID	DWR_MA0001_01_f_2016_134				
Comment Code					
V6 : Landscaping					
Inspector Comment

View of cactus and fruit trees along the landside toe blocking visibility.

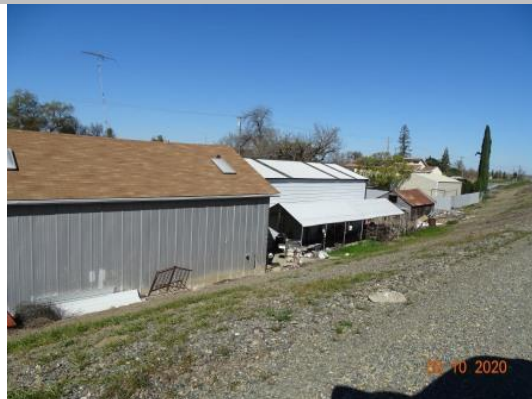
Photo 1 of 1 : SP_2020_MA0001_297_46_20200312_00150.jpg

LM Start	16.31	Rating **	U	Issue No.	46
LM End	16.33	Issue Type +	En	Location *	LS
Category	Earthen Levee			GPS Latitude/Longitude	
				Start	End
Item	Encroachments			39.407225 °	39.407545 °
				-122.008570 °	-122.008640 °
DWR ID	DWR_MA0001_01_s_2012_46				
Comment Code					
BU : Building					
Inspector Comment

View of the buildings along the landside toe. Spring 2020.

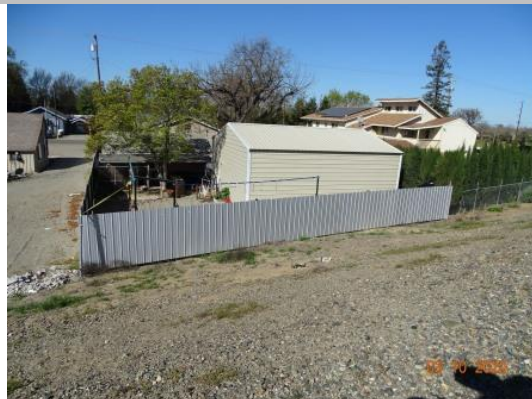
Photo 1 of 1 : SP_2020_MA0001_297_47_20200312_00151.jpg

LM Start	16.34	Rating **	U	Issue No.	47
LM End	16.35	Issue Type +	En	Location *	LS
Category	Earthen Levee			GPS Latitude/Longitude	
				Start	End
Item	Encroachments			39.407670 °	39.407823 °
				-122.008685 °	-122.008740 °
DWR ID	DWR_MA0001_01_s_2012_47				
Comment Code					
FE : Fence					
Inspector Comment

View of the fence along the landside toe. Spring 2020.

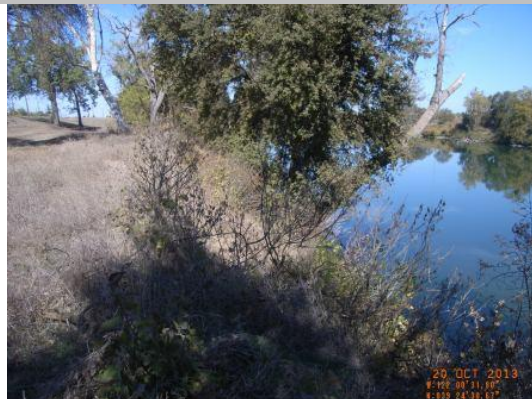
Photo 1 of 2 : SP_2020_MA0001_297_9_20200226_00005.jpg

LM Start	16.35	Rating **	A/W	Issue No.	9
LM End	16.58	Issue Type +	Ma	Location *	WS
Category	Supplemental			GPS Latitude/Longitude	
				Start	End
Item	2017 USACE Erosion Survey			39.407837 °	39.411111 °
				-122.008763 °	-122.009238 °
DWR ID	DWR_ST0010_02_f_2022_7				
Comment Code					
Inspector Comment					
2017 Site ID: SAC 164.3 R					
Status: Eroding					
2017 Field Notes: New erosion along entire site.					
Site History: Erosion site added in 1997 and removed in 2005. 2009 -					
Site added back in, hard toe with slow moving erosion. Potential					
geotechnical failure. 2011 - Site extended downstream.

USACE 2013 Photo #1

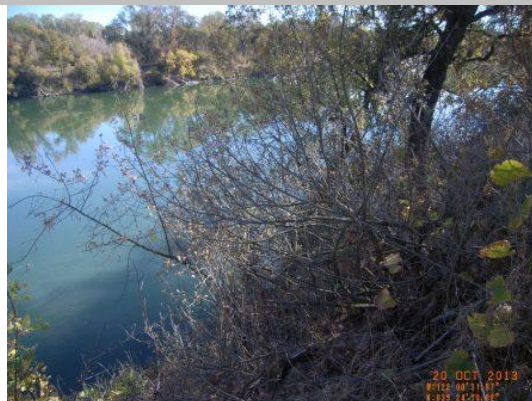
Photo 2 of 2 : SP_2020_MA0001_297_9_20200226_00006.jpg

USACE 2013 Photo #2
