**Flood Control Project Maintenance  
Levee Inspections  
LMA District Cover Sheet**

**Sutter Maintenance Yard Maintenance Area 0001**

Waterway			Bank	Unit Miles
Unit No. 01 Sacramento River			Right	16.76
	Spring (March - May)	Summer (June - August)	(September - November) Fall	Winter (December - February)
Unit Maintenance Rating (Fall Only)				
Date of Inspection	3/19/2021 - 3/19/2021			
DWR Inspector	Makar Sokol			
Accompanied By	Bob Duffey Sutter Maintenance Yard

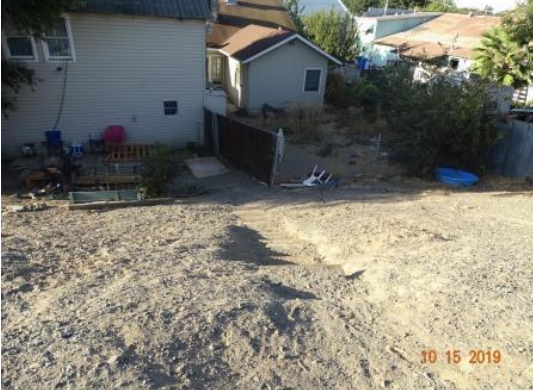
Photo 2 of 2 : SP\_2021\_MA0001\_297\_63\_20210224\_00015.jpg

View of the wooden stairs cut into the landside slope. Fall 2019.

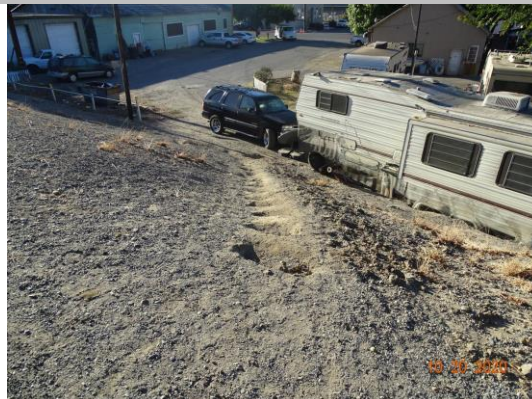
Photo 1 of 1 : SP\_2021\_MA0001\_297\_61\_20210224\_00013.jpg

LM Start	0.16	Rating **	M	Issue No.	61
LM End	0.16	Issue Type +	En	Location *	LS
Category	Earthen Levee			GPS Latitude/Longitude	
				Start	End
Item	Encroachments			39.214662 °	39.214662 °
				-122.003581 °	-122.003581 °
DWR ID	DWR_MA0001_01_f _ 2020_61				
Comment Code					
ST : Stairway					
Inspector Comment

View of the stairs cut into the landside slope. Fall 2020.

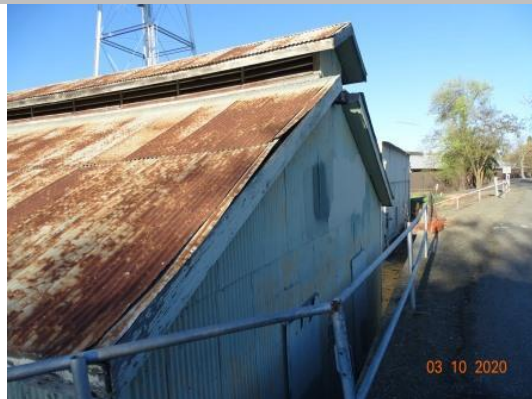
Photo 1 of 1 : SP\_2021\_MA0001\_297\_7\_20210224\_00004.jpg

LM Start	0.67	Rating **	U	Issue No.	7
LM End	0.70	Issue Type +	En	Location *	LS
Category	Earthen Levee			GPS Latitude/Longitude	
				Start	End
Item	Encroachments			39.216533 °	39.216680 °
				-122.012512 °	-122.012907 °
DWR ID	DWR_MA0001_01_s_2012_7				
Comment Code					
BU : Building					
Inspector Comment

View of the buildings along the landside toe. Spring 2020.

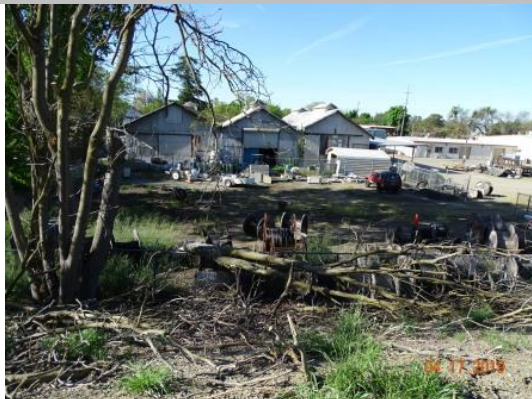
Photo 1 of 1 : SP\_2021\_MA0001\_297\_79\_20210224\_00019.jpg

LM Start	0.87	Rating **	M	Issue No.	79
LM End	0.87	Issue Type +	Ma	Location *	LS
Category	Earthen Levee			GPS Latitude/Longitude	
				Start	End
Item	Encroachments			39.217717 °	39.217717 °
				-122.015717 °	-122.015717 °
DWR ID	DWR_MA0001_01_s_2019_79				
Comment Code					
TR : Tree or limb					
Inspector Comment

View of the tree branches and limbs at the landside toe. Spring 2019.

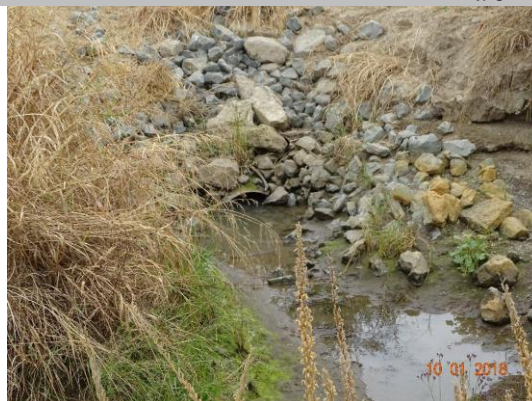
Photo 2 of 3 : UCIP\_SP\_2021\_58087\_78329.jpg

Comment Code					
Inspector Comment					
FS_ID:58087 DS_ID:25564 EP_NO: 9481-1 Repair Type: Non-Urgent Crossing Status: Found UCIP Comments: 10/01/2018 Pipe installed according to emergency work authorization dated 07-31-2017 under existing permit No. 9481. Owner Roberts Ditch Company needs to submit as-builts. (O.Yakimov - DWR UCIP) FIELD_STRUCT_DESC: 36-inch smooth steel epoxy coated interior/exterior irrigation pipe with positive closure device on the water side of the levee. Crossing penetrates the levee at an angle. Other appurtenances located at this crossing include 2 slant pumps connected to a concrete distribution box, and shed structure located 100 feet northeast from levee crossing. Flow is carried from concrete distribution box to slide gate via concrete lined ditch. pipe is open to an irrigation ditch on LS. (36-inch installed according to the board emergency work authorization dated 07-31-2017 under Permit No. 9481-1, 2018 - Roberts Ditch Company; existing 36-inch was removed [logged under UCIP DSID 16431]). FS Date: 10/1/2018 10:51:00 AM

View of pipe end in irrigation ditch on LS.

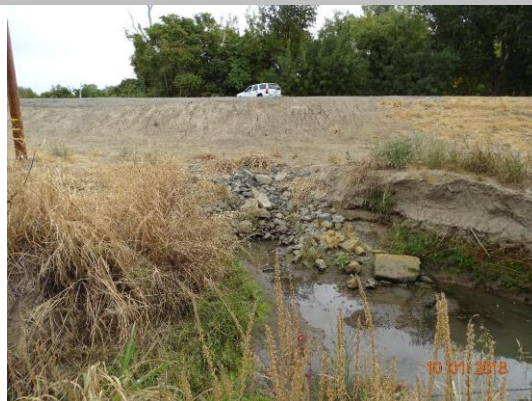
Photo 3 of 3 : UCIP\_SP\_2021\_58087\_78330.jpg

View of LS levee slope and irrigation ditch at levee toe.

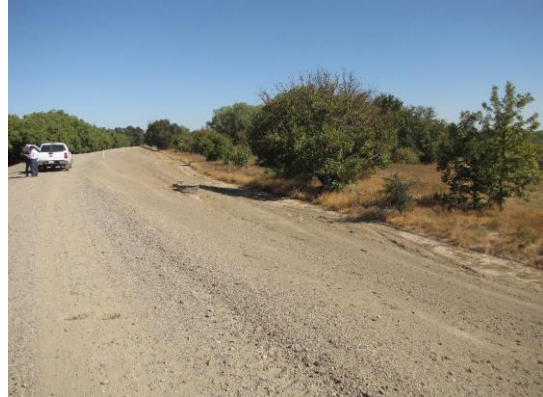
Photo 2 of 3 : UCIP\_SP\_2021\_58090\_70063.jpg

Comment Code						
Inspector Comment						
FS_ID:58090 DS_ID:16430 EP_NO: 9487 Repair Type: Non-Urgent Crossing Status: Found UCIP Comments: 05/03/2017 WS end still partially plugged. (A. Freitag - DWR Sutter Yard)10/24/2016 Ws end is till partially plugged. (A. Freitag - DWR Sutter Yard)04/25/2016 WS pipe end is still plugged with soil. Rest of the pipe appeared to be in good condition. (A. Freitag - DWR Sutter Yard)04/20/2015 WS pipe end is plugged about 50% by soil. (A. Freitag - DWR Sutter Yard)06/18/2014 Same as last inspection. (A. Freitag - DWR Sutter Yard)12/17/2013 Same as last inspection. (A. Freitag - DWR Sutter Yard)07/18/2013 WS pipe end has been reformed but is still clogged about 50% by sediment.10/18/2012 Remove dirt and debris in riser. Outlet deformed and blocked over 50%. Debris-round concrete section on landward side. This crossing was listed in the USACE Periodic Inspections as ID# USACE_CESPK_MA1C_2010_p_0116 for crossing outlet deformed and clogged with dirt. (O. Magana - DWR UCIP) FIELD_STRUCT_DESC: 1 of 2: 36-inch corrugated metal drainage pipe through the levee, approximately 12-15 feet below the crown. Slide gates in corrugated metal pipe (CMP) riser located on the waterside (WS) slope. Pipe daylights on the landside (LS). (36-inch pipe [HLM 1.97] authorized under Automatic Board Order (ABO) issued as Permit No. 9487, 1974 - Jimeno Rancho) [Additional Reference(s): DWR Levee Log, 1992. USACE Sacramento O&M Manual 137, August 1955, (Station 103+18)]. FS Date: 5/19/2017 1:20:00 PM

View of WS looking upstream at CMP riser on slope.

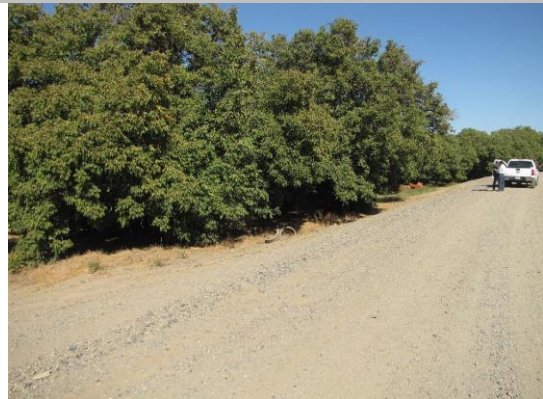
Photo 3 of 3 : UCIP\_SP\_2021\_58090\_70062.jpg

View of LS looking upstream at crossing.

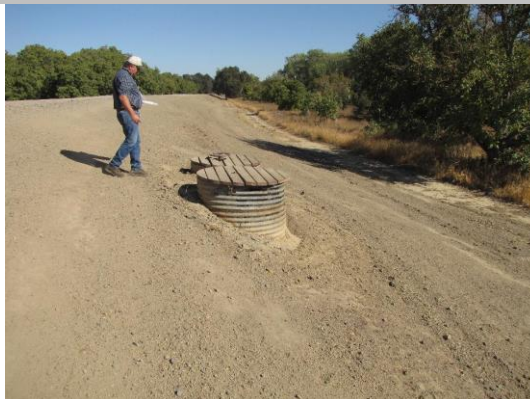
Photo 2 of 3 : UCIP\_SP\_2021\_58092\_70074.jpg

FS\_ID:58092  
DS\_ID:17565  
EP\_NO: 9487  
Repair Type: Non-Urgent  
Crossing Status: Found  
UCIP Comments: 05/03/2017 Ws end still partially plugged. (A. Freitag - DWR Sutter Yard)10/24/2016 Ws pipe end still plugged. (A. Freitag - DWR Sutter Yard)04/25/2016 WS pipe end still plugged with soil. rest of pipe appears in good condition. (A. Freitag - DWR Sutter Yard)04/20/2015 WS pipe end plugged about 50% by soil. (A. Freitag - DWR Sutter Yard)06/18/2014 Same as last inspection. (A. Freitag - DWR Sutter Yard)12/17/2013 Same as last inspection. (A. Freitag - DWR Sutter Yard)07/18/2013 WS pipe end has been reformed but is still partially blocked with dirt and debris.10/18/2012 WS-remove dirt and debris in riser. Outlet deformed and blocked over 50%. Burrow activity near outlet on waterward slope. Debris around concrete section on landward side. This crossing was listed in the USACE Periodic Inspections as ID# USACE\_CESPK\_MA1C\_2010\_p\_0116 for crossing outlet deformed and clogged with dirt. (O. Magana - DWR UCIP)

View of CMP risers located on WS slope.

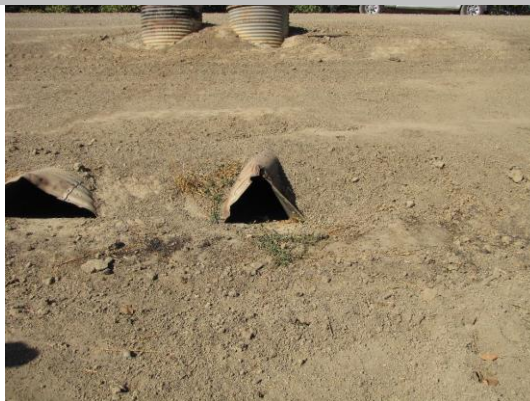
Photo 3 of 3 : UCIP\_SP\_2021\_58092\_70073.jpg

CMP pipe outlet deformed with over 50 percent blockage.

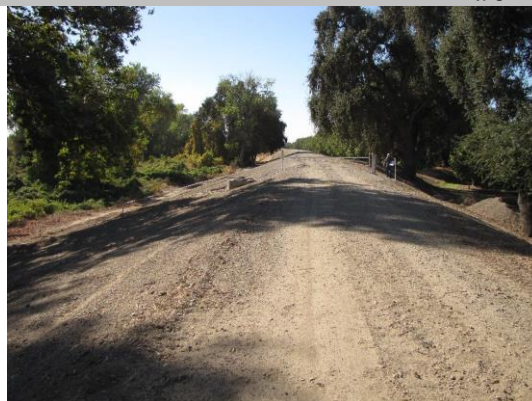
Photo 1 of 3 : UCIP\_SP\_2021\_58093\_70078.jpg

FS\_ID:58093  
DS\_ID:16429  
EP\_NO: 9472  
Repair Type: Non-Urgent  
Crossing Status: Found  
UCIP Comments: 05/03/2017 LS inlet partially plugged with soil. Some debris still present inside riser. (A. Freitag - DWR Sutter Yard)10/24/2016 Debris still inside of riser. (A. Freitag - DWR Sutter Yard)04/25/2016 Pipe still inside of riser and LS end plugged about 50% by soil. (A. Freitag - DWR Sutter Yard)04/20/2015 Same as last inspection. (A. Freitag - DWR Sutter Yard)06/18/2014 Same as last inspection. (A. Freitag - DWR Sutter Yard)12/17/2013 Same as last inspection. (A. Freitag - DWR Sutter Yard)07/18/2013 Same as last inspection. (A. Freitag - DWR Sutter Yard)10/18/2012 Remove debris from riser. Landward inlet is blocked by over 50%. This crossing was listed in the USACE Periodic Inspections as ID# USACE\_CESPK\_MA1C\_2010\_p\_0128 for sediment build up at inlet (landward side) and debris inside riser. (O. Magana - DWR UCIP) FIELD\_STRUCT\_DESC: 54-inch corrugated metal drainage pipe through the levee, approximately 12-15 feet below the crown. Slide gate in corrugated metal pipe (CMP) riser on the waterside (WS) slope. 48-inch CMP at landside (LS) slope. This crossing crosses the levee at an angle. (54-inch pipe [HLM 2.29] authorized under Automatic Board Order (ABO) issued as Permit No. 9472, 1974 - Ballard ) [Additional Reference(s): DWR Levee Log, 1992. USACE Sacramento O&M Manual 137, August 1955, (Station 120+00)].

View of levee crown looking downstream at crossing. CMP riser located on WS shoulder.

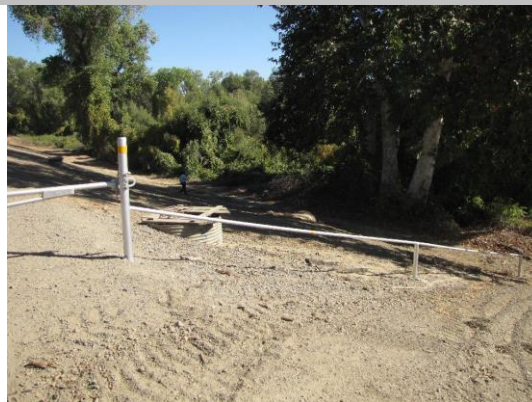
Photo 2 of 3 : UCIP\_SP\_2021\_58093\_70079.jpg

View of WS looking at slope and channel.

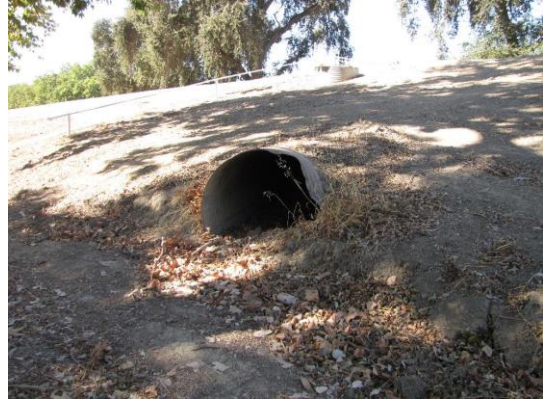
Photo 3 of 3 : UCIP\_SP\_2021\_58093\_70077.jpg

View of outlet located at WS toe.

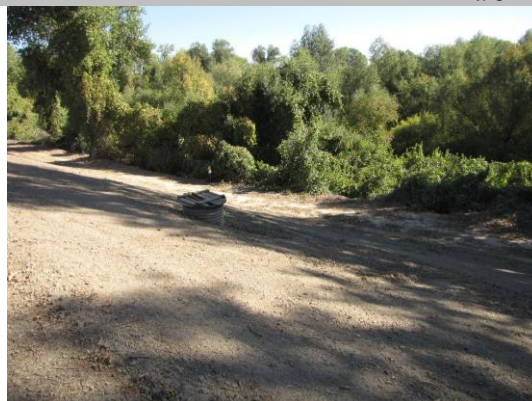
Photo 2 of 3 : UCIP\_SP\_2021\_58095\_70084.jpg

Comment Code						
Inspector Comment						
FS_ID:58095 DS_ID:16428 EP_NO: 9467 Repair Type: Non-Urgent Crossing Status: Found UCIP Comments: 05/03/2017 Abanoned- needs to be done so properly. (A. Freitag - DWR Sutter Yard)10/24/2016 Abandoned. (A. Freitag - DWR Sutter Yard)04/25/2016 Abandoned crossing. Unable to locate any WS and LS pipe ends. (A. Freitag - DWR Sutter Yard)04/20/2015 Same as last inspection. (A. Freitag - DWR Sutter Yard)06/18/2014 Same as last inspection. (A. Freitag - DWR Sutter Yard)12/17/2013 Same as last inspection. (A. Freitag - DWR Sutter Yard)07/18/2013 Same as last inspection. (A. Freitag - DWR Sutter Yard)10/18/2012 Only riser visible. Debris and sediment blocking gate. Gate inside riser is buried and non-functional. If crossing is abandoned, owner needs to properly abandon. This crossing was listed in the USACE Periodic Inspections as ID# USACE_CESPK_MA1C_2010_p_0132 no culvert through the levee is visible here. (O. Magana - DWR UCIP) FIELD_STRUCT_DESC: *ABANDONED* 24-inch corrugated metal drainage pipe through the levee, approximately 12-15 feet below the crown. Slide gate in CM pipe riser on the waterside (WS) slope. No signs of inlet visible on the landside (LS). (24-inch pipe [HLM 2.31] authorized under Automatic Board Order (ABO) issued as Permit No. 9467, 1974 - Lovell E. Spurgeon) [Additional Reference(s): DWR Levee Log, 1992. USACE Sacramento O&M Manual 137, August 1955, (Station 120+60)]. FS Date: 5/19/2017 1:48:00 PM

View of WS slope and toe.

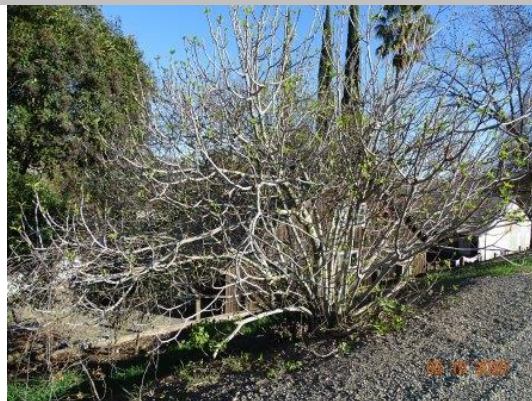
Photo 1 of 1 : SP\_2021\_MA0001\_297\_88\_20210224\_00022.jpg

LM Start	2.53	Rating **	M	Issue No.	88
LM End	2.53	Issue Type +	En	Location *	LS
Category	Earthen Levee			GPS Latitude/Longitude	
				Start	End
Item	Vegetation			39.239764 °	39.239764 °
				-122.010397 °	-122.010397 °
DWR ID	DWR_MA0001_01_s_2019_88				
Comment Code					
V6 : Landscaping					
Inspector Comment					
The fig tree should be removed from the landside shoulder.

View of the fig tree on the landside shoulder. Spring 2020.

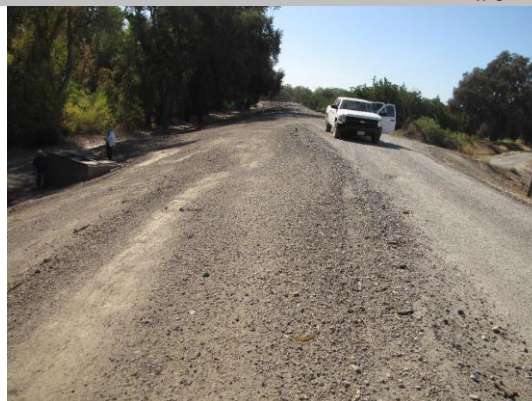
Photo 1 of 3 : UCIP\_SP\_2021\_58096\_70092.jpg

FS\_ID:58096  
DS\_ID:16416  
EP\_NO: 9474  
Repair Type: Non-Urgent  
Crossing Status: Found  
UCIP Comments: 05/03/2017 Appears abandoned- WS vault full of soil. Needs to be abandoned properly. (A. Freitag - DWR Sutter Yard)10/24/2016 Appears to be abandoned. WS vault full of soil to help prevent water from flowing through during high water season. (A. Freitag - DWR Sutter Yard)04/25/2016 Concrete box was filled with dirt to help prevent water from through during high water times. (A. Freitag - DWR Sutter Yard)04/20/2015 Positive closure device is missing and water cannot be prevented from flowing through pipe during high water. (A. Freitag - DWR Sutter Yard)06/18/2014 Same as last inspection. (A. Freitag - DWR Sutter Yard)12/17/2013 Same as last inspection. (A. Freitag - DWR Sutter Yard)07/18/2013 Same as last inspection. (A. Freitag - DWR Sutter Yard)10/18/2012 During high water flow goes through levee. Missing positive closure device on waterward side. This structure appears abandoned-slide gates have been removed. Crossing needs to be properly abandoned. This crossing was listed in the USACE Periodic Inspection as ID# USACE\_CESPK\_MA1C\_2010\_p\_0169 for concrete box partially filled with dirt. (O. Magana - DWR UCIP)

FIELD\_STRUCT\_DESC: 1 of 2: 60-inch reinforced concrete irrigation pipe through the levee, approximately 12-15 feet below the crown. This crossing penetrates the levee at an angle. Slide gates in concrete well at the waterside (WS) toe. Slide gates missing. (Automatic Board Order (ABO) issued as Permit No. 9774, 1974 - George R. Zumwalt) O&M manual description is for two 5-foot by 5-foot concrete culverts with two hand-operated slide gates. Culvert constructed with wing walls and gates. [Additional Reference(s): DWR Levee Log, 1992. USACE Sacramento O&M Manual 137, August 1955, (Station 150+06)].  
FS Date: 5/19/2017 1:48:00 PM

Overview of levee crown looking downstream at crossing.

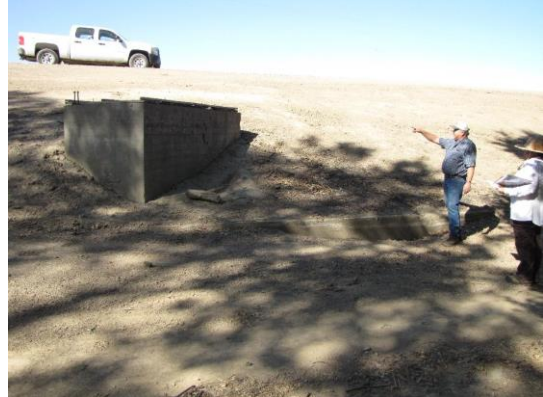
Photo 2 of 3 : UCIP\_SP\_2021\_58096\_70094.jpg

View of concrete distribution box and headwall located on WS.

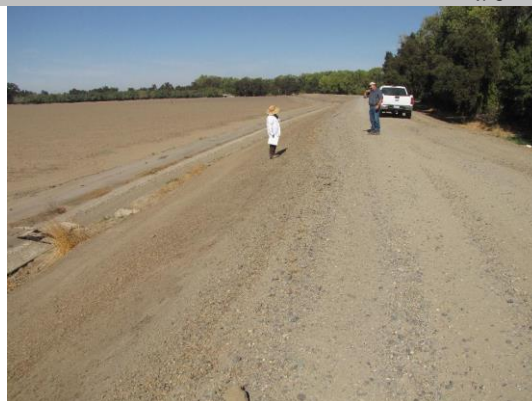
Photo 1 of 3 : UCIP\_SP\_2021\_58101\_70110.jpg

Comment Code						
Inspector Comment						
FS_ID:58101 DS_ID:16426 EP_NO: 9490 Repair Type: Non-Urgent Crossing Status: Found UCIP Comments: 05/03/2017 Sediment build up in WS pipe end. WS slide gate stem bent but it does not affect its operation. (A. Freitag - DWR Sutter Yard)10/24/2016 WS slide gate stem is still bent. (A. Freitag - DWR Sutter Yard)04/25/2016 WS slide gate is slightly bent. Rest of crossing appears to be in good condition. (A. Freitag - DWR Sutter Yard) 04/20/2015 LS inlet still has some minor sediment build up. Needs to be cleaned. (A. Freitag - DWR Sutter Yard)06/18/2014 Same as last inspection. (A. Freitag - DWR Sutter Yard)12/17/2013 Same as last inspection. (A. Freitag - DWR Sutter Yard)07/18/2013 WS slide gate looks to be in good condition but stem is slightly bent. Not sure if bend will hinder gates operation or not. LS inlet is still blocked by minor sediment build up.10/18/2012 LS pipe slightly deformed and sediment build up blocking about 30% of opening; need to check the condition of the slide gate-need photo. Metal marker down. This crossing was listed in the USACE Periodic Inspection as ID# USACE_CESPK_MA1C_2010_p_0187 for sediment build up at landward toe. (O. Magana - DWR UCIP) FIELD_STRUCT_DESC: 36-inch corrugated metal drainage pipe through the levee, approximately 12-15 feet below the crown. Slide gate in corrugated metal pipe (CMP) riser on the waterside (WS) slope. (36-inch pipe [HLM 3.78] authorized under Automatic Board Order (ABO) issued as Permit No. 9490, 1955 - Charles & Virginia Yerxa) [Additional Reference(s): DWR Levee Log, 1992. USACE Sacramento O&M Manual 137, August 1955, (Station 177+67)]. FS Date: 5/19/2017 1:53:00 PM

View of LS looking upstream.

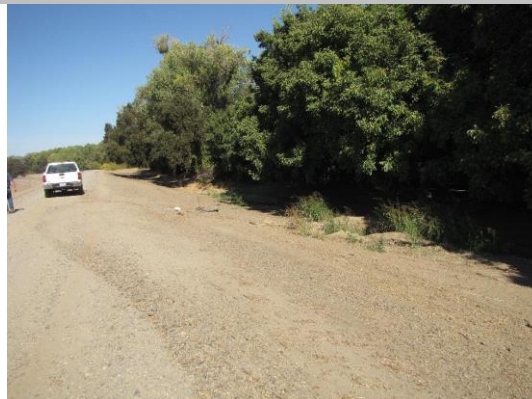
Photo 2 of 3 : UCIP\_SP\_2021\_58101\_70109.jpg

View of WS looking upstream.

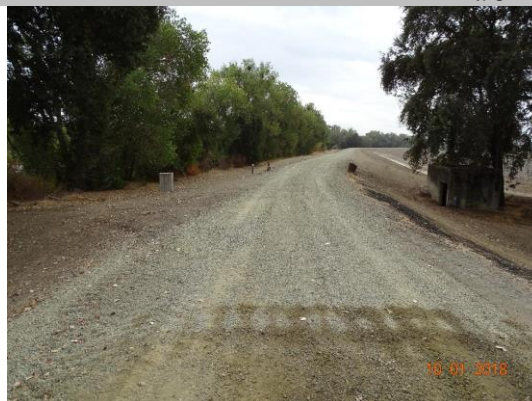
Photo 1 of 3 : UCIP\_SP\_2021\_58103\_78239.jpg

FS\_ID:58103  
DS\_ID:16436  
EP\_NO: 4213  
Repair Type: Urgent  
Crossing Status: Found  
UCIP Comments: 10/01/2018 Sinkhole near concrete structure on the LS was filled with soil and debris. Flow meter at the WS shoulder and a manometer on the pipe on the LS shoulder was installed. Video inspection is recommended to determine pipe integrity through levee. (O.Yakimov - DWR UCIP)05/03/2017 Sinkhole still present next to concrete structure on LS. (A. Freitag - DWR Sutter Yard)10/24/2016 Pump is on WS. Sinkhole still present over pipe alignment next to the concrete building. (A. Freitag - DWR Sutter Yard)04/25/2016 No repairs have been made since last inspection. Sink holes are still present above pipe next to concrete building on LS. (A. Freitag - DWR Sutter Yard)04/20/2015 Sink hole over pipe alignment on LS up against the concrete building. Need to dig up pipe and see if its leaking. (A. Freitag - DWR Sutter Yard)06/23/2014 Same as last inspection. (A. Freitag - DWR Sutter Yard)06/18/2014 Same as last inspection. (A. Freitag - DWR Sutter Yard)12/17/2013 Same as last inspection. (A. Freitag - DWR Sutter Yard)07/18/2013 Same as last inspection. (A. Freitag - DWR Sutter Yard)10/19/2012 Recommend adding door to LS concrete structure. Riser located on landward side is damaged. This crossing was listed in the USACE Periodic Inspection as ID# USACE\_CESPK\_MA1C\_2010\_p\_0194 no issues logged. (O. Magana - DWR UCIP)

View of levee crown at crossing

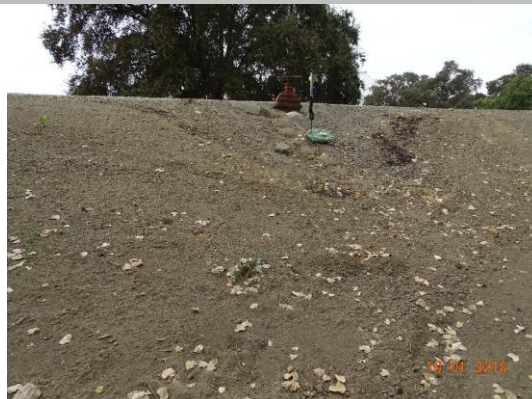
Photo 2 of 3 : UCIP\_SP\_2021\_58103\_78238.jpg

Flow meter installed.

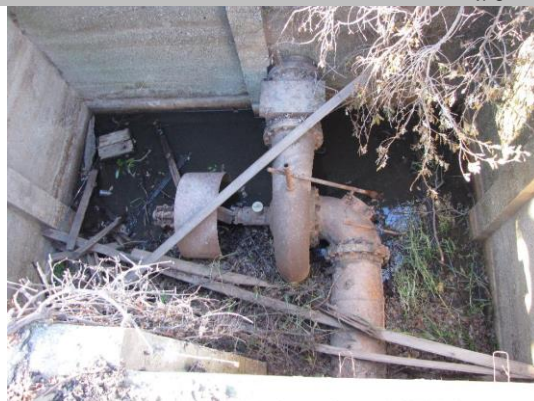
Photo 2 of 3 : UCIP\_SP\_2021\_58104\_70123.jpg

FS\_ID:58104  
DS\_ID:16424  
EP\_NO: 9490  
Repair Type: Non-Urgent  
Crossing Status: Found  
UCIP Comments: 05/03/2017 Abandoned- Needs to be done properly. (A. Freitag - DWR Sutter Yard)10/24/2016 Abandoned. Needs a cover made for the LS distribution box. (A. Freitag - DWR Sutter Yard)04/25/2016 ABANDONED crossing and should be abandoned properly. Concrete distribution box on LS is opened on top and could pose a safety hazard with falling. (A. Freitag - DWR Sutter Yard)04/20/2015 Same as last inspection. (A. Freitag - DWR Sutter Yard) 06/18/2014 Same as last inspection. (A. Freitag - DWR Sutter Yard)12/17/2013 Same as last inspection. (A. Freitag - DWR Sutter Yard)07/18/2013 Same as last inspection. (A. Freitag - DWR Sutter Yard)10/19/2012 Crossing needs to be properly abandoned. This crossing was listed in the USACE Periodic Inspection as ID# USACE\_CESPK\_MA1C\_2010\_p\_0194-6 & 7 no issues logged. (O. Magana - DWR UCIP)

Abandoned pump system inside concrete structure located on LS.

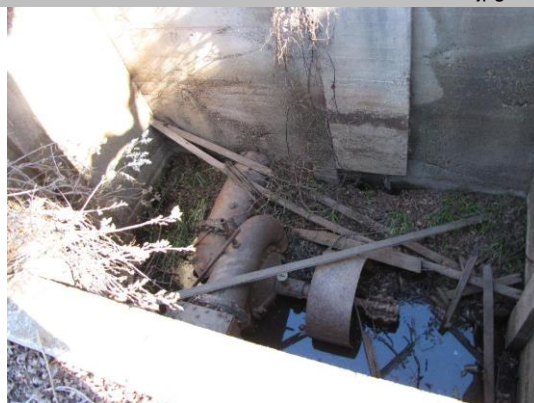
Photo 3 of 3 : UCIP\_SP\_2021\_58104\_70122.jpg

Debris inside concrete structure located on LS.

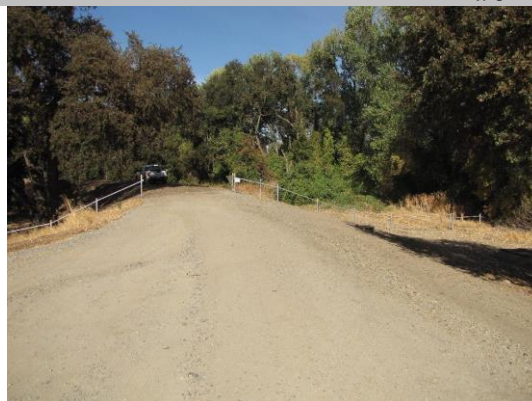
Photo 1 of 3 : UCIP\_SP\_2021\_58105\_70128.jpg

Comment Code						
Inspector Comment						
FS_ID:58105 DS_ID:16423 EP_NO: 9489 Repair Type: Non-Urgent Crossing Status: Found UCIP Comments: 05/03/2017 Appears abandoned- if so needs to be done properly. (A. Freitag - DWR Sutter Yard)10/24/2016 Crossing appears abandoned. (A. Freitag - DWR Sutter Yard)04/25/2016 Crossing appears abandoned and should be abandoned properly. (A. Freitag - DWR Sutter Yard)04/20/2015 Same as last inspection. (A. Freitag - DWR Sutter Yard)06/18/2014 Same as last inspection. (A. Freitag - DWR Sutter Yard)12/17/2013 Same as last inspection. (A. Freitag - DWR Sutter Yard)07/18/2013 Same as last inspection. (A. Freitag - DWR Sutter Yard)10/19/2012 Slide gate wheel handle missing. Clear debris from CMP riser. This crossing was listed in the USACE Periodic Inspection as ID# USACE_CESPK_MA1C_2010_p_0196 for access box contains backfilled (permanently shut) and outlet located on landside has sediment build up. (O. Magana - DWR UCIP) FIELD_STRUCT_DESC: 36-inch corrugated metal irrigation pipe through the levee at an unknown depth below the crown. Slide gate in corrugated metal pipe (CMP) riser on the waterside (WS) slope. 6-foot by 6-foot concrete box on the WS berm. Additional 12-inch pipe inside concrete distribution box. (Automatic Board Order (ABO) issued as Permit No. 9489, 1974 - Mayfair Farms Inc.) [Additional Reference(s): DWR Levee Log, 1992. USACE Sacramento O&M Manual 137, August 1955, (Station 198+00)]. FS Date: 5/19/2017 2:02:00 PM

View of crossing looking upstream. Concrete box located on the WS.

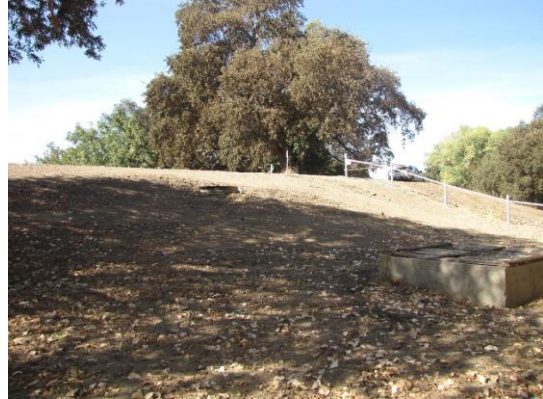
Photo 2 of 3 : UCIP\_SP\_2021\_58105\_70131.jpg

View of concrete distribution box and CMP riser located on WS.

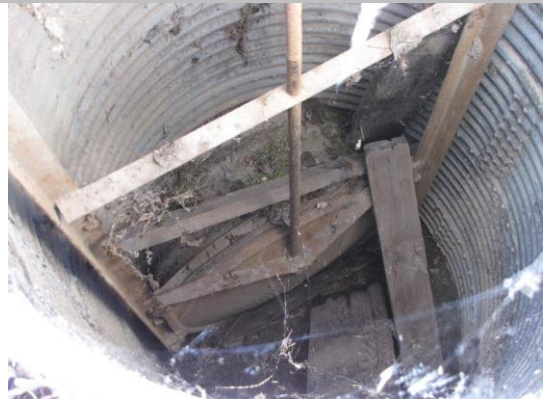
Photo 3 of 3 : UCIP\_SP\_2021\_58105\_70126.jpg

LM Start	<b>3.77</b>	Rating **	M	Issue No.	<b>20 (cont)</b>
LM End	<b>3.77</b>	Issue Type +	En	Location *

WS-Inside view of CMP riser located on waterward slope.

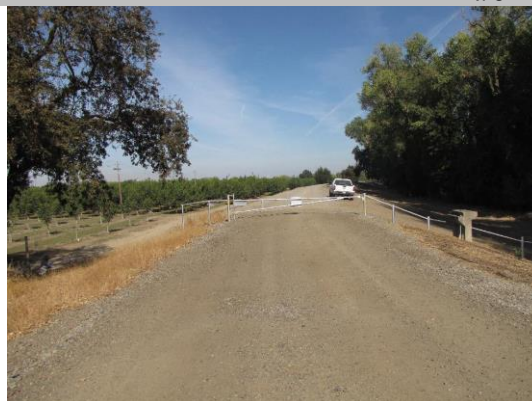
Photo 1 of 3 : UCIP\_SP\_2021\_58108\_70137.jpg

Comment Code					
Inspector Comment					
FS_ID:58108 DS_ID:16422 EP_NO: N/A Repair Type: Non-Urgent Crossing Status: Found UCIP Comments: 05/03/2017 Appears abandoned- needs to be done so properly. (A. Freitag - DWR Sutter Yard)10/24/2016 Appears to be abandoned. (A. Freitag - DWR Sutter Yard)04/25/2016 Appears to be an abandoned crossing. (A. Freitag - DWR Sutter Yard) 04/20/2015 Debrs is still blocking gate. Appears to be an abandoned crossing. (A. Freitag - DWR Sutter Yard)06/18/2014 Same as last inspection. (A. Freitag - DWR Sutter Yard)12/17/2013 Same as last inspection. (A. Freitag - DWR Sutter Yard)07/18/2013 Wheel to operate slide gate has been replaced but gate is still blocked by debris.10/19/2012 WS-wheel to operate slide gate missing, walkway has been removed; burrow activity near structure; debris in concrete distribution box WS blocking gate. This crossing was listed in the USACE Periodic Inspection as ID# USACE_CESPK_MA1C_2010_p_0207 the wheel to operate sluice gate missing. (O. Magana - DWR UCIP) FIELD_STRUCT_DESC: *ABANDONED* 24-inch drainage pipe of an unknown material through the levee, unknown depth below the crown. Walkway to slide gate on the waterside (WS) end. Walkway has been removed. Flap gate in concrete distribution box at the landside (LS) toe. [Additional Reference(s): DWR Levee Log, 1992]. FS Date: 5/19/2017 2:05:00 PM

View of levee crown looking upstream at crossing.

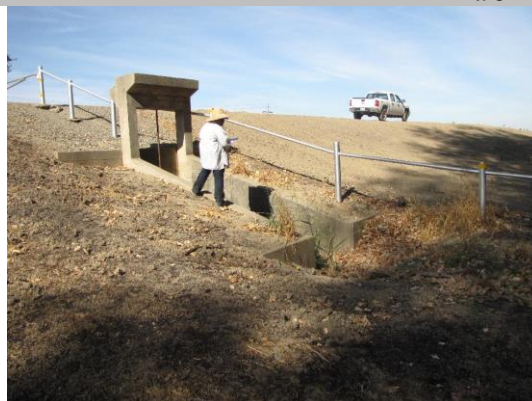
Photo 2 of 3 : UCIP\_SP\_2021\_58108\_70139.jpg

LM Start	3.95	Rating **	M	Issue No.	22 (cont)
LM End	3.95	Issue Type +	En	Location *	
Category	Supplemental			GPS Latitude/Longitude	
				Start	End
Item	DWR UCIP Field Study			39.258073 °	39.258073 °
				-122.013165 °	-122.013165 °
DWR ID	16422

View of WS slope with concrete structure.

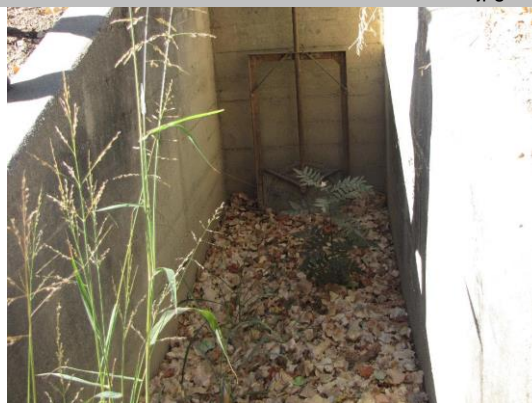
Photo 3 of 3 : UCIP\_SP\_2021\_58108\_70138.jpg

LM Start	<b>3.95</b>	Rating **	M	Issue No.	<b>22 (cont)</b>
LM End	<b>3.95</b>	Issue Type +	En	Location *

View of slide gate located on WS.

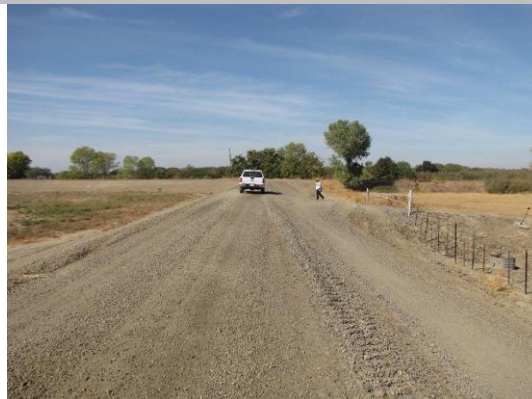
Photo 1 of 3 : UCIP\_SP\_2021\_58109\_70144.jpg

FS\_ID:58109  
DS\_ID:16421  
EP\_NO: 9475  
Repair Type: Non-Urgent  
Crossing Status: Found  
UCIP Comments: 05/03/2017 Abandoned- only WS standpipe visible.

LM Start	<b>4.65</b>	Rating **	M	Issue No.	<b>24 (cont)</b>
LM End	<b>4.65</b>	Issue Type +	En	Location *

Overview of levee crown looking upstream at crossing.

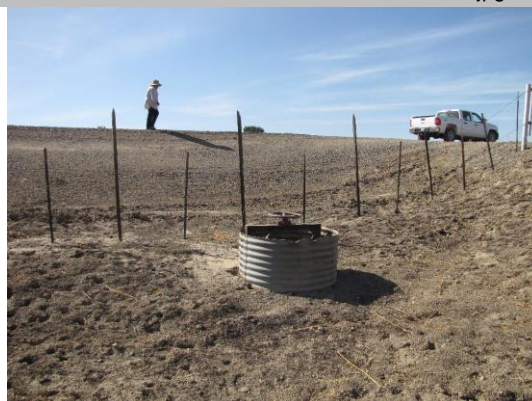
Photo 2 of 3 : UCIP\_SP\_2021\_58109\_70147.jpg

Riser with slide gate located on WS toe.

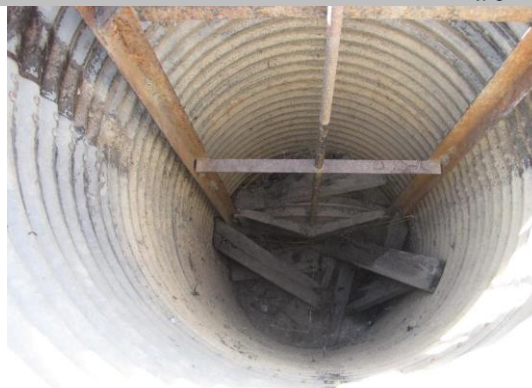
Photo 3 of 3 : UCIP\_SP\_2021\_58109\_70146.jpg

LM Start	<b>4.65</b>	Rating **	M	Issue No.	<b>24 (cont)</b>
LM End	<b>4.65</b>	Issue Type +	En	Location *	
Category	Supplemental			GPS Latitude/Longitude	
				Start	End
Item	DWR UCIP Field Study			39.266435 °	39.266435 °
				-122.010943 °	-122.010943 °
DWR ID	16421

WS--Woody debris inside riser blocking gate.

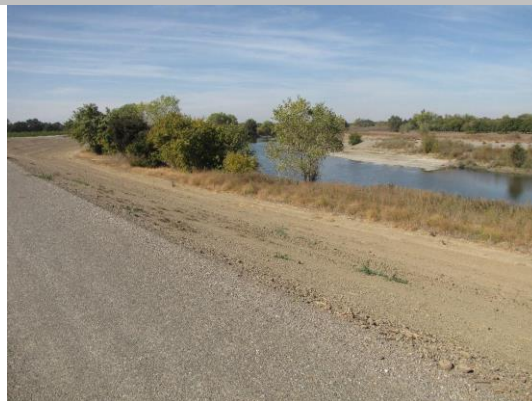
Photo 3 of 3 : UCIP\_SP\_2021\_58110\_70148.jpg

LM Start	<b>4.97</b>	Rating **	M	Issue No.	<b>25 (cont)</b>
LM End	<b>4.97</b>	Issue Type +	En	Location *

View of WS-no visible appurtenances associated with structure.

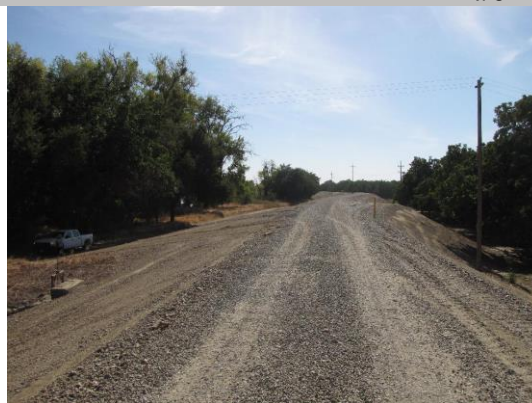
Photo 1 of 3 : UCIP\_SP\_2021\_58112\_70154.jpg

Comment Code						
Inspector Comment						
FS_ID:58112 DS_ID:16419 EP_NO: 9476 Repair Type: Non-Urgent Crossing Status: Found UCIP Comments: 05/03/2017 Culvert has sediment build up in it- needs to be cleaned out. (A. Freitag - DWR Sutter Yard)10/24/2016 LS outlets becoming over grown with vegetation in the ditch. (A. Freitag - DWR Sutter Yard)04/25/2016 WS entry still blocked and wingwalls still cracked. (A. Freitag - DWR Sutter Yard)04/20/2015 WS entry still blocked and wingwalls still cracked. (A. Freitag - DWR Sutter Yard)06/18/2014 Same as last inspection. (A. Freitag - DWR Sutter Yard)12/17/2013 Same as last inspection. (A. Freitag - DWR Sutter Yard)07/18/2013 Same as last inspection. (A. Freitag - DWR Sutter Yard)10/19/2012 blocked, no entry on WS. This crossing was listed in the USACE Periodic Inspection as ID# USACE_CESPK_MA1C_2010_p_0247 for u/s and d/s wing wall shows some cracking and tilting. (O. Magana - DWR UCIP) FIELD_STRUCT_DESC: 1 of 2: 36-inch corrugated metal irrigation pipe and concrete box culvert through the levee at an unknown depth below the crown. Concrete headwall visible on the landside (LS) toe. (Automatic Board Order (ABO) issued as Permit No. 9476, 1974 - Ohliger) [Additional Reference(s): DWR Levee Log, 1992]. FS Date: 5/23/2017 9:51:00 AM

Overview of levee crown looking downstream at crossing.

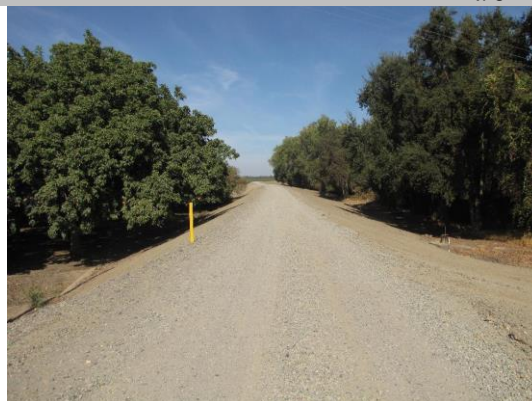
Photo 2 of 3 : UCIP\_SP\_2021\_58112\_70152.jpg

LM Start	5.72	Rating **	M	Issue No.	27 (cont)
LM End	5.72	Issue Type +	En	Location *	
Category	Supplemental			GPS Latitude/Longitude	
				Start	End
Item	DWR UCIP Field Study			39.272069 °	39.272069 °
				-122.023240 °	-122.023240 °
DWR ID	16419

View of crossing looking upstream at crossing.

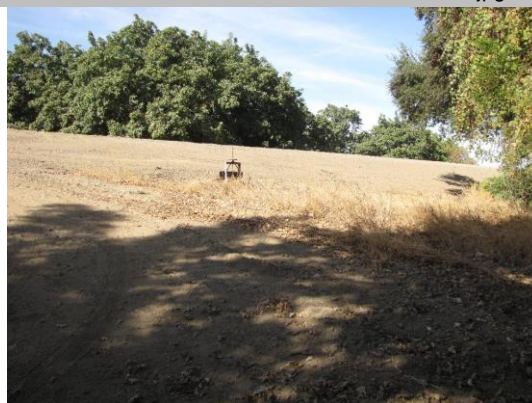
Photo 3 of 3 : UCIP\_SP\_2021\_58112\_70156.jpg

LM Start	<b>5.72</b>	Rating **	M	Issue No.	<b>27 (cont)</b>
LM End	<b>5.72</b>	Issue Type +	En	Location *

View of WS slope and access road. Slide gate is second crossing at this location.

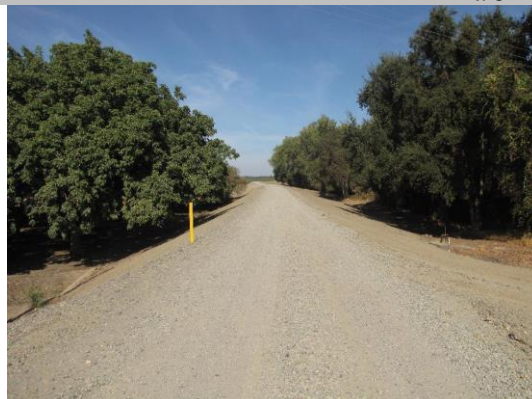
Photo 2 of 3 : UCIP\_SP\_2021\_58113\_70161.jpg

View of levee crown looking upstream at crossing.

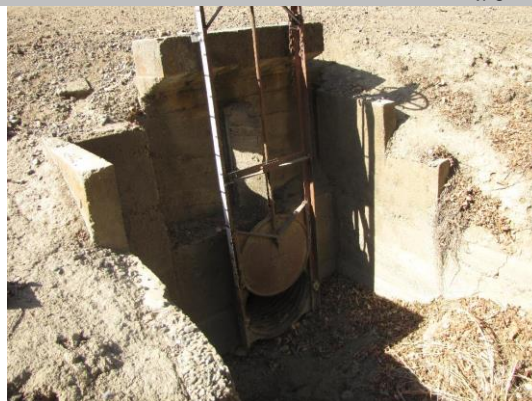
Photo 3 of 3 : UCIP\_SP\_2021\_58113\_70160.jpg

LM Start	5.72	Rating **	M	Issue No.	30 (cont)
LM End	5.72	Issue Type +	En	Location *	
Category	Supplemental			GPS Latitude/Longitude	
				Start	End
Item	DWR UCIP Field Study			39.272069 °	39.272069 °
				-122.023240 °	-122.023240 °
DWR ID	17569

Headwall and slide gate located on WS.

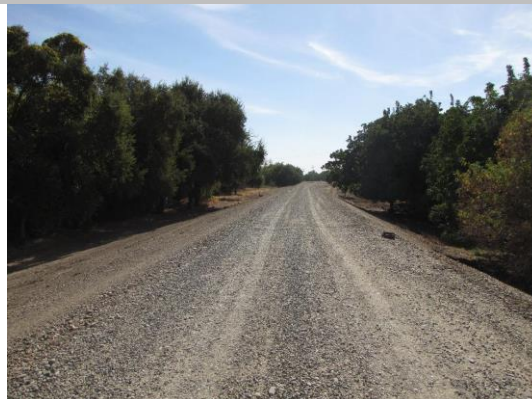
Photo 1 of 3 : UCIP\_SP\_2021\_58115\_70167.jpg

Comment Code						
Inspector Comment						
FS_ID:58115 DS_ID:16418 EP_NO: 6263 Repair Type: Non-Urgent Crossing Status: Found UCIP Comments: 05/03/2017 Crossing appears to be in good condition. (A. Freitag - DWR Sutter Yard)10/24/2016 Appears to be in good condition. (A. Freitag - DWR Sutter Yard)04/25/2016 Pressure gauge and valve were added to pipe near the siphon breaker on LS shoulder. (A. Freitag - DWR Sutter Yard)04/20/2015 Modifications are being made to pipe near the LS shoulder. Not sure what all exactly is being done. (A. Freitag - DWR Sutter Yard)06/23/2014 Same as last inspection. (A. Freitag - DWR Sutter Yard) 12/17/2013 Same as last inspection. (A. Freitag - DWR Sutter Yard)07/18/2013 Debris cleared from in front of LS standpipe. (A. Freitag - DWR Sutter Yard)10/19/2012 Remove debris from landward side see photo 2. This crossing was listed in the USACE Periodic Inspection as ID# USACE_CESPK_MA1C_2010_p_0249 however, unable to determine why crossing was marked "U". (O. Magana - DWR UCIP) FIELD_STRUCT_DESC: 18-inch asphalt coated steel irrigation pipe through the levee, 2 feet below the crown. Siphon breaker on the landside (LS) shoulder. Corrugated metal pipe (CMP) riser located on the LS connects with concrete V-ditch. Dual slant pumps and gate valves on the bank approximately 215 feet from waterside (WS) toe. Pump feeds into single 18-inch steel pipe. 2-inch electrical conduit buried in the same trench as the irrigation pipe. (Permit No. 6263, 1968 - C. Tuttle) [Additional Reference(s): DWR Levee Log, 1992]. FS Date: 5/23/2017 10:05:00 AM

Overview of levee crown looking downstream at crossing.

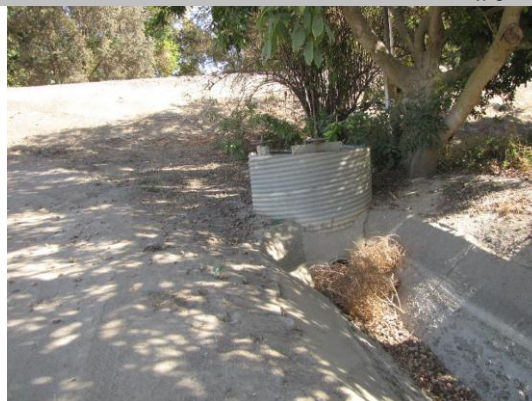
Photo 2 of 3 : UCIP\_SP\_2021\_58115\_70166.jpg

LM Start	<b>5.77</b>	Rating **	M	Issue No.	<b>31 (cont)</b>
LM End	<b>5.77</b>	Issue Type +	En	Location *	
Category	Supplemental		GPS Latitude/Longitude		
			Start	End	
Item	DWR UCIP Field Study		39.272829 °	39.272829 °	
			-122.023282 °	-122.023282 °	
DWR ID	16418

CMP riser and concrete lined v-ditch located on LS toe.

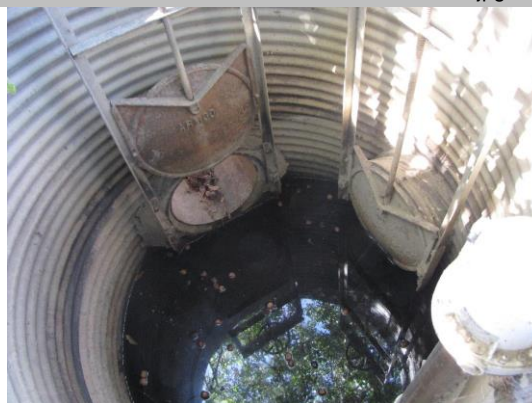
Photo 3 of 3 : UCIP\_SP\_2021\_58115\_70171.jpg

LM Start	<b>5.77</b>	Rating **	M	Issue No.	<b>31 (cont)</b>
LM End	<b>5.77</b>	Issue Type +	En	Location *

Photo 1 of 2 inside view of CMP riser located on LS toe.

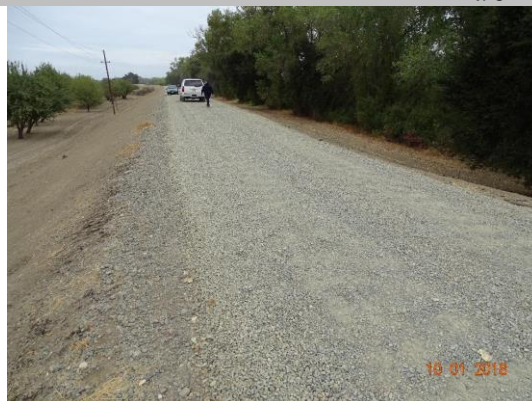
Photo 1 of 3 : UCIP\_SP\_2021\_58116\_78240.jpg

FS\_ID:58116  
DS\_ID:16446  
EP\_NO: N/A  
Repair Type: Urgent  
Crossing Status: Found  
UCIP Comments: 10/01/2018 PVC pipe underneath the slide gate that is located inside CMP riser on WS shoulder was restored and blocks gate from closing. Sediment built up at the bottom of CMP riser. PVC pipe needs to be removed in order to properly close slide gate. (O.Yakimov - DWR UCIP)05/03/2017 Pipe leaked during the Jan/Feb 2017 high water event. Sand bags were placed at both the LS and WS outlets as well as down inside the standpipe to slow the water flow. The 5inch pvc was cut away but the slide gate could still not close fully. Suspect sediment build up was in the bottom of the stand pipe was blocking the gate. Inside of pipe should be cleaned out. (A. Freitag - DWR Sutter Yard)10/24/2016 Pvc was back running through the crossing and blocking the screwgate. photo attached. (A. Freitag - DWR Sutter Yard)09/28/2016 Crossing has been downgraded from Urgent to Non-Urgent 5-inch PVC pipe was cut to allow the slide gate to close. Need to contact owner to remove unauthorized pipe to comply with Title 23. (O. Magana - DWR UCIP)04/25/2016 5 inch pvc pipe running through crossing has been cut out to allow the slide gate to close. (A. Freitag - DWR Sutter Yard)04/20/2015 5inch pvc is still present blocking slide gate from closing. WS end of pipe has been exposed so there is no way to stop water from flowing through pipe during highwater times. (A. Freitag - DWR Sutter Yard)06/23/2014 Same as last inspection. There is no way to stop water from flowing through pipe during high water times. (A. Freitag - DWR Sutter Yard)12/17/2013 Same as last inspection. (A. Freitag - DWR Sutter Yard)07/18/2013 Same as last inspection. (A. Freitag - DWR Sutter Yard)10/19/2012 Unauthorized 5 inch PVC pipe running through 36 inch crossing. 5 inch PVC crossing prevents slide gate from closing during high water. Debris and sediment inside riser. This crossing was listed in the USACE Periodic Inspection as ID# USACE\_CESPK\_MA1C\_2010\_p\_0258 for 5 inch PVC pipe running through culvert. (O. Magana - DWR UCIP)

FIELD\_STRUCT\_DESC: 36-inch steel (not corrugated metal, as referenced in O&M manual) drainage pipe through the levee, approximately 14-16 feet below levee crown. Slide gate in corrugated metal pipe (CMP) riser on the waterside (WS) slope. Pipe also visible on the landside (LS). [Additional Reference(s): DWR Levee Log, 1992. USACE Sacramento O&M Manual 137, August 1955, (Station 331+31)].  
FS Date: 10/1/2018 2:59:00 PM

View of levee crown at crossing.

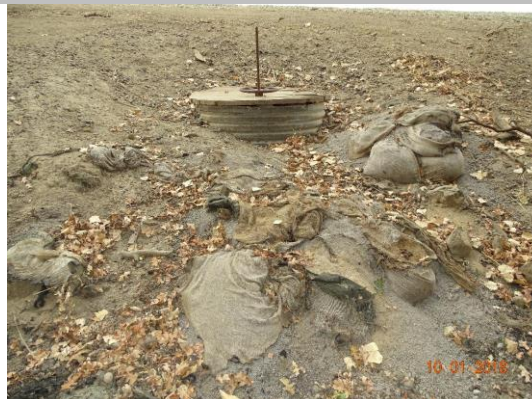
Photo 2 of 3 : UCIP\_SP\_2021\_58116\_78243.jpg

LM Start	<b>6.24</b>	Rating **	U	Issue No.	<b>32 (cont)</b>
LM End	<b>6.24</b>	Issue Type +	Ma	Location *	
Category	Supplemental		GPS Latitude/Longitude		
			Start	End	
Item	DWR UCIP LMA Responsibility		39.279462 °	39.279462 °	
			-122.022461 °	-122.022461 °	
DWR ID	16446

View of CMP riser at WS shoulder.

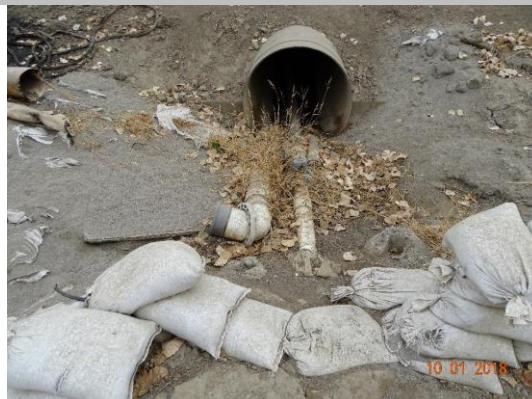
Photo 3 of 3 : UCIP\_SP\_2021\_58116\_78244.jpg

LM Start	<b>6.24</b>	Rating **	U	Issue No.	<b>32 (cont)</b>
LM End	<b>6.24</b>	Issue Type +	Ma	Location *

Pipe at LS toe.

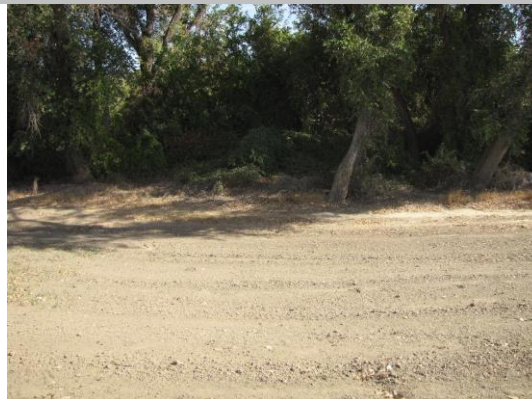
Photo 1 of 3 : UCIP\_SP\_2021\_58119\_70181.jpg

FS\_ID:58119  
DS\_ID:16425  
EP\_NO: N/A  
Repair Type: Non-Urgent  
Crossing Status: Found  
UCIP Comments: 05/03/2017 Abandoned- needs to be done properly. (A. Freitag - DWR Sutter Yard)10/24/2016 Abandoned. (A. Freitag - DWR Sutter Yard)04/25/2016 Abandoned crossing. (A. Freitag - DWR Sutter Yard)04/20/2015 Same as last inspection. (A. Freitag - DWR Sutter Yard)06/23/2014 Same as last inspection. (A. Freitag - DWR Sutter Yard)12/17/2013 Same as last inspection. (A. Freitag - DWR Sutter Yard)07/18/2013 Same as last inspection. (A. Freitag - DWR Sutter Yard)10/19/2012 Need to be properly abandoned concrete structure; plate covers concrete box; Concrete headwall damaged. This crossing was listed in the USACE Periodic Inspection as ID# USACE\_CESPK\_MA1C\_2010\_p\_0262 for damage to concrete structure (vertical 2 inch wide cracks and spalling visible). (O. Magana - DWR UCIP)  
FIELD\_STRUCT\_DESC: \*ABANDONED\* 72-inch corrugated metal (precast concrete) drainage pipe through the levee at an unknown depth below the crown. Structure is blocked on the waterside (WS) end with 3-foot concrete plug installed in 1980. Slide gate in concrete well on the landside (LS) shoulder. Concrete headwall at both toes. WS headwall not found. [Additional Reference(s): DWR Levee Log, 1992. USACE Sacramento O&M Manual 137, August 1955, (Station 339+74)].

LM Start	6.40	Rating **	M	Issue No.	33 (cont)
LM End	6.40	Issue Type +	Ma	Location *

View of WS no structure features visible.

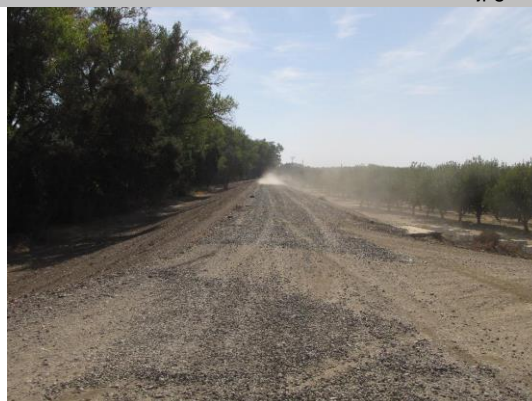
Photo 2 of 3 : UCIP\_SP\_2021\_58119\_70180.jpg

Overview of levee crown looking downstream at crossing.

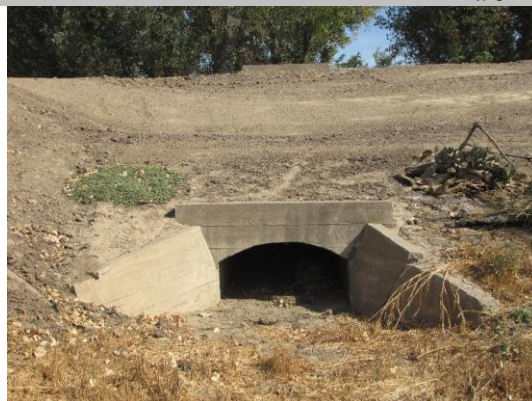
Photo 3 of 3 : UCIP\_SP\_2021\_58119\_70179.jpg

LM Start	6.40	Rating **	M	Issue No.	33 (cont)
LM End	6.40	Issue Type +	Ma	Location *	
Category	Supplemental			GPS Latitude/Longitude	
				Start	End
Item	DWR UCIP LMA Responsibility			39.281721 °	39.281721 °
				-122.021894 °	-122.021894 °
DWR ID	16425

View of structure located in LS.

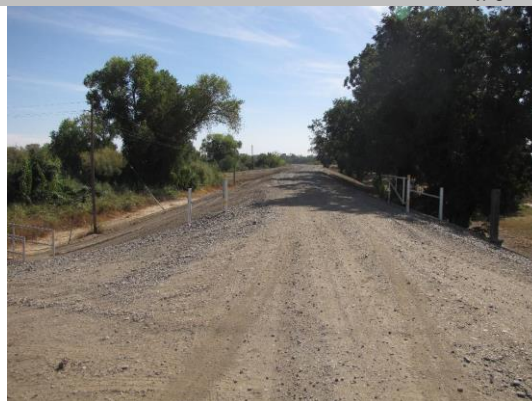
Photo 1 of 3 : UCIP\_SP\_2021\_58120\_70188.jpg

Comment Code						
Inspector Comment						
FS_ID:58120 DS_ID:16427 EP_NO: 9482 Repair Type: Non-Urgent Crossing Status: Found UCIP Comments: 05/03/2017 Abandoned- Needs to be done properly. (A. Freitag - DWR Sutter Yard)10/24/2016 Abandoned. (A. Freitag - DWR Sutter Yard)04/25/2016 Abandoned pipe. Needs to be properly plugged if it never gets used. (A. Freitag - DWR Sutter Yard)04/20/2015 Same as last inspection. Structure is still buried. (A. Freitag - DWR Sutter Yard)06/23/2014 Same as last inspection. (A. Freitag - DWR Sutter Yard)12/17/2013 Same as last inspection. (A. Freitag - DWR Sutter Yard)07/18/2013 Same as last inspection. (A. Freitag - DWR Sutter Yard)10/19/2012 Structure is buried and non-operational. This crossing was listed in the USACE Periodic Inspection as ID# USACE_CESPK_MA1C_2010_p_0288 for sluice gate closed and backfilled on WS and full of sediment with wingwall cracked on LS. (O. Magana - DWR UCIP) FIELD_STRUCT_DESC: *ABANDONED* 1 of 2: 36-inch reinforced concrete irrigation pipe through the levee at approximately 18 feet below the crown. Wooden slide gates on the waterside (WS) end. Sliding metal gate noted in O&M manual. Concrete headwalls located on both WS and landside (LS). O&M manual structure reference is 4'-9" x 9'-6" concrete box culvert. (Automatic Board Order (ABO) issued as Permit No. 9482, 1974 - Elizabeth M. Farnsworth) [Additional Reference(s): DWR Levee Log, 1992. USACE Sacramento O&M Manual 137, August 1955, (Station 370+90)]. FS Date: 5/23/2017 10:14:00 AM

Overview of levee crown looking downstream at crossing.

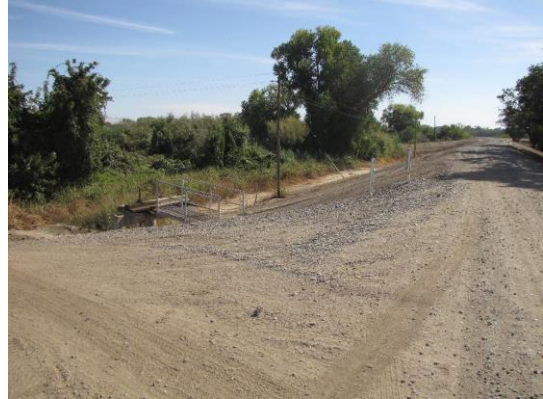
Photo 2 of 3 : UCIP\_SP\_2021\_58121\_70193.jpg

Comment Code					
Inspector Comment					
FS_ID:58121 DS_ID:17570 EP_NO: 9482 Repair Type: Non-Urgent Crossing Status: Found UCIP Comments: 05/03/2017 WS slide gate was unburied and crossing was being used for irrigaton during site visit. (A. Freitag - DWR Sutter Yard)10/24/2016 WS slide gate was unbruied and opened. (A. Freitag - DWR Sutter Yard)04/25/2016 WS slide gate was unburied and opened allowing water to flow through to LS fields. (A. Freitag - DWR Sutter Yard)04/20/2015 Structure is operational. WS slide gate was unburied allowing water to irrigate the fields. It gets reburried during highwater season. (A. Freitag - DWR Sutter Yard) 06/23/2014 Same as last inspection. Soli dug out again and water flowing through crossing.12/17/2013 WS screw gate was closed and buried by soil again. (A. Freitag - DWR Sutter Yard)07/18/2013 WS screw gate has been cleared of dirt and is open to irrigate LS fields. LS outlet is still mostly blocked by sediment. (A. Freitag - DWR Sutter Yard)10/19/2012 Structure is buried and non-operational. This crossing was listed in the USACE Periodic Inspection as ID# USACE_CESPK_MA1C_2010_p_0288 for sluice gate closed and backfilled on WS and full of sediment with wingwall cracked on LS. (O. Magana - DWR UCIP) FIELD_STRUCT_DESC: 2 of 2: 36-inch reinforced concrete irrigation pipe through the levee, approximately 18 feet below the crown. Wooden slide gates on the waterside (WS) end. Sliding metal gate noted in O&M manual. Concrete structure located on both WS and landside (LS). Inspector noticed that during 2015-2016 that this crossing is used in the spring and summer, and buried in the winter. O&M manual structure reference is 4'-9" x 9'-6" concrete box culvert. (Automatic Board Order (ABO) issued as Permit No. 9482-1974, Elizabeth M. Farnsworth) [Additional Reference(s): DWR Levee Log, 1992. USACE Sacramento O&M Manual 137, August 1955, (Station 370+90)]. FS Date: 5/23/2017 10:15:00 AM

LM Start	<b>6.99</b>	Rating **	M	Issue No.	<b>36 (cont)</b>
LM End	<b>6.99</b>	Issue Type +	En	Location *	
Category	Supplemental		GPS Latitude/Longitude		
			Start	End	
Item	DWR UCIP Field Study		39.290169 °	39.290169 °	
			-122.021532 °	-122.021532 °	
DWR ID	17570

WS-walkway and concrete headwall.

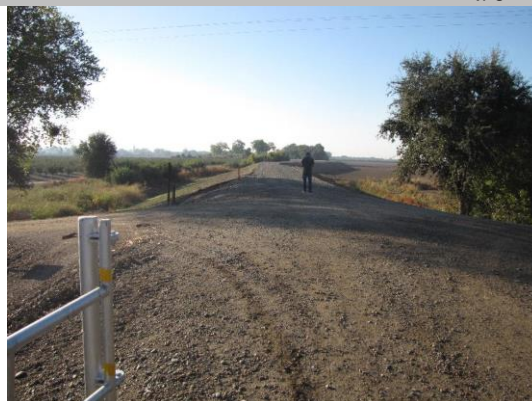
Photo 1 of 3 : UCIP\_SP\_2021\_58122\_70202.jpg

FS\_ID:58122  
DS\_ID:16456  
EP\_NO: N/A  
Repair Type: Non-Urgent  
Crossing Status: Found  
UCIP Comments: 05/03/2017 Culvert was flowing water during site visit. Appears to be in good condition. Some sediment build up in the bottom of WS box. (A. Freitag - DWR Sutter Yard)10/24/2016 Notes mentioned needing to confirm size of the culvert but was unable to access the ends at this inspection. (A. Freitag - DWR Sutter Yard)04/25/2016 Second slide gate was held open to allow water to flow through to the LS ditch. (A. Freitag - DWR Sutter Yard)04/20/2015 Same as last inspection. Rebar pin was still in place holding the gate opened. (A. Freitag - DWR Sutter Yard)06/23/2014 Same as last inspection. (A. Freitag - DWR Sutter Yard)12/17/2013 Same as last inspection. (A. Freitag - DWR Sutter Yard)07/18/2013 Same as last inspection. (A. Freitag - DWR Sutter Yard)10/30/2012 Sediment and debris on waterward and landward side. This crossing was listed in the USACE Periodic Inspection as ID# USACE\_CESPK\_MA1C\_2010\_p\_0293 for wooden slide gate held open by a piece of rebar acting as a pin. (O. Magana - DWR UCIP) FIELD\_STRUCT\_DESC: 60-inches by 72-inches (5-foot by 6-foot) reinforced concrete box irrigation culvert (O&M manual references 3-foot and 10-inch by 6-foot culvert) through the levee, approximately 12-15 feet below the crown. Two wooden slide gates on the waterside (WS) end. Concrete v-ditch along landside (LS) toe. [Additional Reference(s): DWR Levee Log, 1992. USACE Sacramento O&M Manual 137, August 1955, (Station 385+33.5)].

Overview of levee crown looking downstream at crossing.

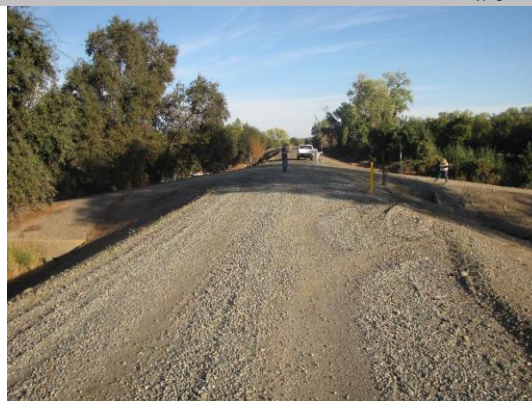
Photo 2 of 3 : UCIP\_SP\_2021\_58122\_70204.jpg

LM Start	<b>7.27</b>	Rating **	M	Issue No.	<b>37 (cont)</b>
LM End	<b>7.27</b>	Issue Type +	En	Location *	
Category	Supplemental		GPS Latitude/Longitude		
			Start	End	
Item	DWR UCIP Field Study		39.294074 °	39.294074 °	
			-122.021435 °	-122.021435 °	
DWR ID	16456

Overview of levee crown looking upstream at crossing.

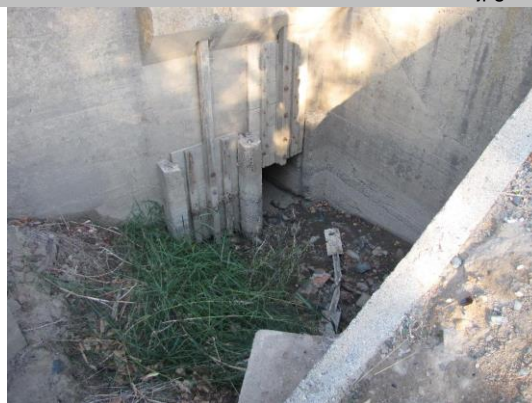
Photo 3 of 3 : UCIP\_SP\_2021\_58122\_70203.jpg

View of wooden sluice gates located on WS.

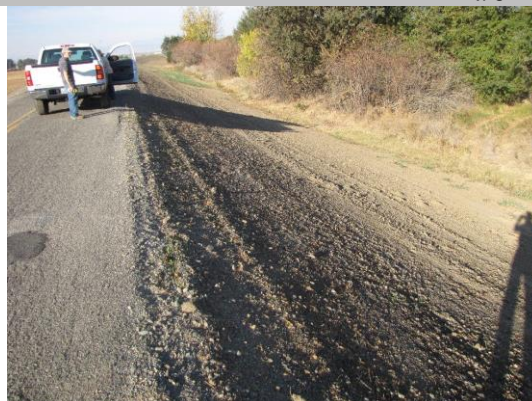
Photo 1 of 3 : UCIP\_SP\_2021\_58125\_70209.jpg

Comment Code					
Inspector Comment					
FS_ID:58125 DS_ID:16455 EP_NO: 12334 Repair Type: Non-Urgent Crossing Status: Found UCIP Comments: 05/03/2017 No LS inlet found and no pump on WS-appears to have been abandoned. If so needs to be done properly. (A. Freitag - DWR Sutter Yard)10/24/2016 Pump removed from WS pipe. Pipe end left open and should be capped. (A. Freitag - DWR Sutter Yard)04/25/2016 No LS inlet found. (A. Freitag - DWR Sutter Yard)04/20/2015 Same as last inspection. (A. Freitag - DWR Sutter Yard)06/23/2014 Same as last inspection. (A. Freitag - DWR Sutter Yard)12/17/2013 Same as last inspection. (A. Freitag - DWR Sutter Yard)07/18/2013 Same as last inspection. (A. Freitag - DWR Sutter Yard)10/30/2012 Siphon breaker housing unit is bent and has debris inside. LS outlet not found. (O. Magana - DWR UCIP) FIELD_STRUCT_DESC: 10-inch asphalt coated steel irrigation pipe through the levee, 3 feet below the crown. Centrifugal pump on the waterside (WS) bank. Siphon breaker on the landside (LS) shoulder of the levee. (Permit No. 12334, 1978 - Jean James) [Additional Reference(s): DWR Levee Log, 1992]. FS Date: 5/23/2017 10:29:00 AM

View of WS-no features on levee shoulder or slope.
