**Flood Control Project Maintenance  
Levee Inspections  
LMA District Cover Sheet**

**Sutter Maintenance Yard Maintenance Area 0001**

Waterway			Bank	Unit Miles
Unit No. 01 Sacramento River			Right	16.76
	Spring (March - May)	Summer (June - August)	(September - November) Fall	Winter (December - February)
Unit Maintenance Rating (Fall Only)				
Date of Inspection	3/19/2021 - 3/19/2021			
DWR Inspector	Makar Sokol			
Accompanied By	Bob Duffey Sutter Maintenance Yard

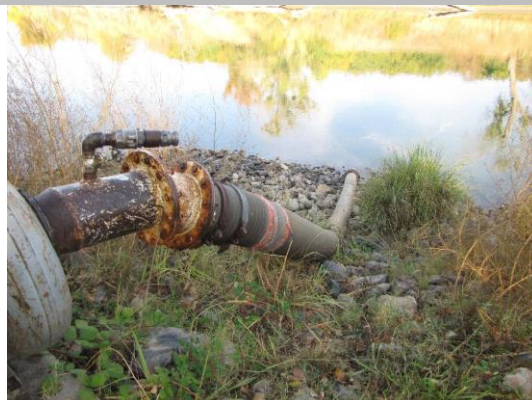
Photo 2 of 3 : UCIP\_SP\_2021\_58125\_70210.jpg

Pump located on WS bank.

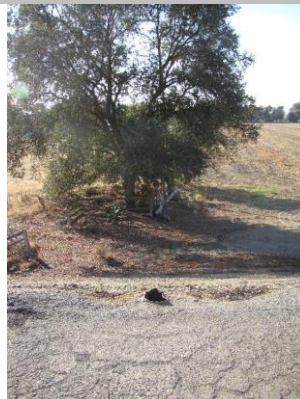
Photo 3 of 3 : UCIP\_SP\_2021\_58125\_70211.jpg

LM Start	7.58	Rating **	M	Issue No.	38 (cont)
LM End	7.58	Issue Type +	En	Location *	
Category	Supplemental			GPS Latitude/Longitude	
				Start	End
Item	DWR UCIP Field Study			39.297384 °	39.297384 °
				-122.022989 °	-122.022989 °
DWR ID	16455

View of LS with appurtenances present on levee shoulder.

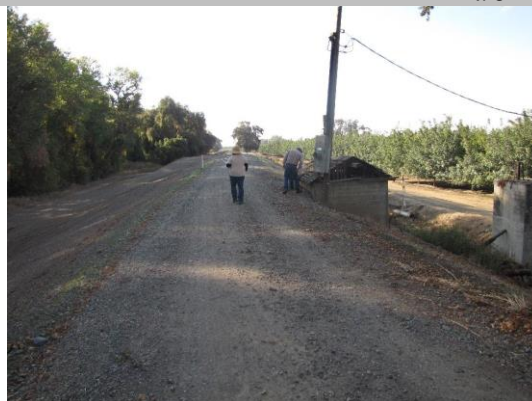
Photo 1 of 3 : UCIP\_SP\_2021\_58126\_70219.jpg

FS\_ID:58126  
DS\_ID:16454  
EP\_NO: 9466  
Repair Type: Non-Urgent  
Crossing Status: Found  
UCIP Comments: 05/03/2017 Abandoned- needs to be done properly. (A. Freitag - DWR Sutter Yard)10/24/2016 Abandoned. (A. Freitag - DWR Sutter Yard)04/25/2016 Crossing appears to be abandoned. Power lines cut from the panels inside the concrete structure on LS. (A. Freitag - DWR Sutter Yard)04/20/2015 Same as last inspection. (A. Freitag - DWR Sutter Yard)06/23/2014 Same as last inspection. (A. Freitag - DWR Sutter Yard)12/17/2013 Same as last inspection. (A. Freitag - DWR Sutter Yard)07/18/2013 Same as last inspection. (A. Freitag - DWR Sutter Yard)10/30/2012 No access to inspect slide gate on LS. Roof of pumping house deteriorating and debris scattered on LS. WS crossing not found. This crossing was listed in the USACE Periodic Inspection as ID# USACE\_CESPK\_MA1C\_2010\_p\_345 no issues recorded. (O. Magana - DWR UCIP)

FIELD\_STRUCT\_DESC: \*ABANDONED\* 24-inch steel irrigation pipe through the levee, approximately 8-10 feet below the crown. Slide gate in concrete riser on the landside (LS) slope. Pump house encroaches into the LS slope. Two service poles on the LS shoulder. No visible appurtenances found on the waterside (WS) toe. Power source cut on the LS. (Automatic Board Order (ABO) issued as Permit No. 9466, 1974 - Roman Catholic Bishop of Sacramento). [Additional Reference(s): DWR Levee Log, 1992].  
FS Date: 5/23/2017 10:31:00 AM

Overview of levee crown looking downstream at crossing.

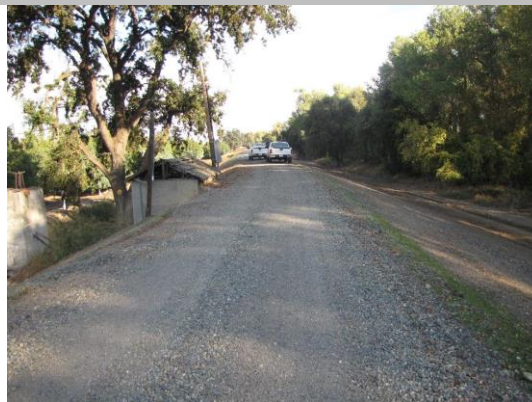
Photo 2 of 3 : UCIP\_SP\_2021\_58126\_70217.jpg

Overview of levee crown looking upstream at crossing.

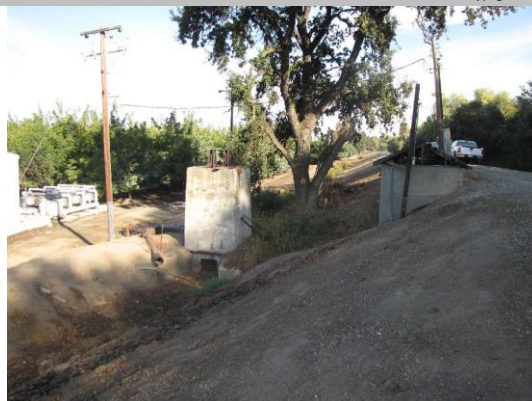
Photo 3 of 3 : UCIP\_SP\_2021\_58126\_70218.jpg

LM Start	8.92	Rating **	M	Issue No.	39 (cont)	
LM End	8.92	Issue Type +	En	Location *		
Category	Supplemental			GPS Latitude/Longitude		
				Start		End
Item	DWR UCIP Field Study			39.311103 °		39.311103 °
				-122.030541 °		-122.030541 °
DWR ID	16454

View of pump and standpipe located on LS.

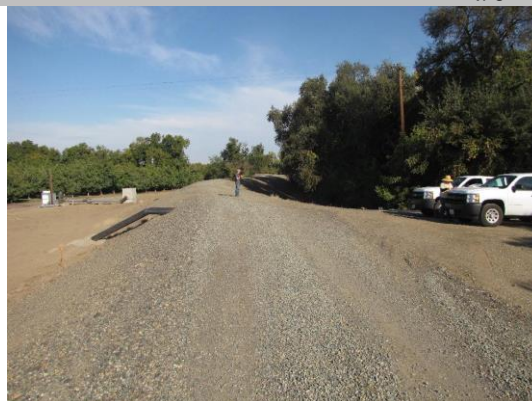
Photo 1 of 3 : UCIP\_SP\_2021\_58132\_70236.jpg

FS\_ID:58132  
DS\_ID:16452  
EP\_NO: 1800  
Repair Type: Non-Urgent  
Crossing Status: Found  
UCIP Comments: 10/01/2018 Runoff erosion near pipe on WS is present. Pipe is in good condition. Need to verify new permit for the pipe. (O.Yakimov - DWR UCIP)05/03/2017 Rain run off erosion still present near pipe on WS shoulder. (A. Freitag - DWR Sutter Yard)10/24/2016 Ws erosion still present. Looks to be just from rain run off. (A. Freitag - DWR Sutter Yard)04/25/2016 Erosion still present by the WS pipes. (A. Freitag - DWR Sutter Yard)04/20/2015 Erosion happening near WS shoulder where the pipes enter the levee. May just be caused by rain runoff. (A. Freitag - DWR Sutter Yard)06/23/2014 Same as last inspection. (A. Freitag - DWR Sutter Yard)12/17/2013 Same as last inspection. (A. Freitag - DWR Sutter Yard)07/18/2013 Same as last inspection. (A. Freitag - DWR Sutter Yard)10/30/2012 This crossing has been completely modified--need recent permit issued to allow work on levee and levee toe. Was levee compacted to CVFPB standards? This crossing was listed in the USACE Periodic Inspection as ID# USACE\_CESPK\_MA1C\_2010\_p\_0371 unable to determine why this crossing was assigned "U". (O. Magana - DWR UCIP)

FIELD\_STRUCT\_DESC: 1 of 2: 14-inch steel irrigation pipe through the levee, approximately 3-4 feet below the crown. Siphon breakers on the waterside (WS) end. (Permit No. 1800, 1959 - Jimeno Rancho) New pipe visible on the landside (LS). [Additional Reference(s): DWR Levee Log, 1992].  
FS Date: 10/1/2018 3:15:00 PM

Overview of levee crown looking upstream at crossing.

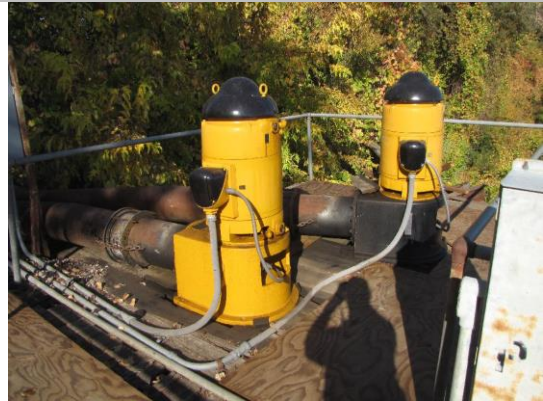
Photo 2 of 3 : UCIP\_SP\_2021\_58132\_70239.jpg

LM Start	<b>10.21</b>	Rating **	M	Issue No.	<b>42 (cont)</b>
LM End	<b>10.21</b>	Issue Type +	En	Location *	
Category	Supplemental		GPS Latitude/Longitude		
			Start	End	
Item	DWR UCIP Field Study		39.329750 °	39.329750 °	
			-122.029602 °	-122.029602 °	
DWR ID	16452

Pumps corresponding to 2-14 inch pipes.

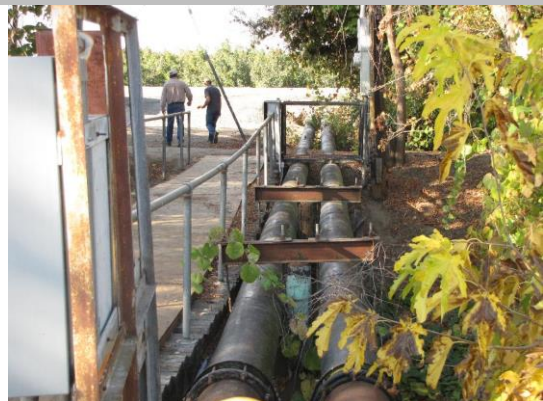
Photo 3 of 3 : UCIP\_SP\_2021\_58132\_70238.jpg

WS-2-14 inch pipes parallel catwalk and go through levee.

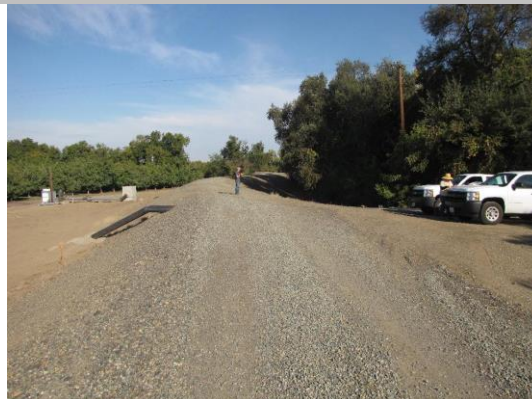
Photo 1 of 3 : UCIP\_SP\_2021\_53051\_70228.jpg

FS\_ID:53051  
DS\_ID:17571  
EP\_NO: 1800  
Repair Type: Non-Urgent  
Crossing Status: Found  
UCIP Comments: 10/1/2018 Runoff erosion near pipe on WS is present. Pipe is in good condition. Need to verify new permit for the pipe. (O.Yakimov - DWR UCIP)5/3/2017 Rain runoff erosion still present near pipes on WS shoulder. (DWR Sutter Yard-AFreitag)10/24/2016 Ws erosion still present. Looks to be just from rain run off.(DWR Sutter Yard- AFreitag)4/25/2016 Erosion still present near the WS pipes. (DWR Sutter Yard - afreitag)4/20/2015 Erosion happening on WS shoulder near where pipes enter the levee. May just be from rain runoff. (DWR Sutter Yard - afreitag)6/23/2014 Same as last inspection. (DWR Sutter Yard - afreitag)12/17/2013 Same as last inspection. (DWR Sutter Yard - afreitag)7/18/2013 Same as last inspection. (DWR Sutter Yard - afreitag)10/30/2012 This crossing has been completely modified--need recent permit issued to allow work on levee and levee toe. Was levee compacted to CVFPB standards? This crossing was listed in the USACE Periodic Inspection as ID# USACE\_CESPK\_MA1C\_2010\_p\_0371 unable to determine why this crossing was assigned "U". (DWR UCIP - omagana)

LM Start	10.21	Rating **	M	Issue No.	43 (cont)
LM End	10.21	Issue Type +	En	Location *

Overview of levee crown looking upstream at crossing.

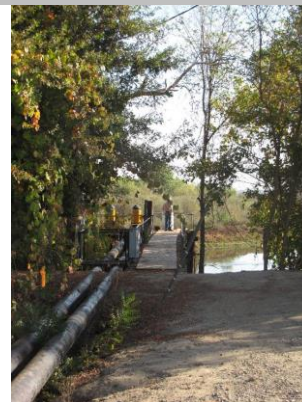
Photo 2 of 3 : UCIP\_SP\_2021\_53051\_70226.jpg

View of catwalk and pump station located on WS.

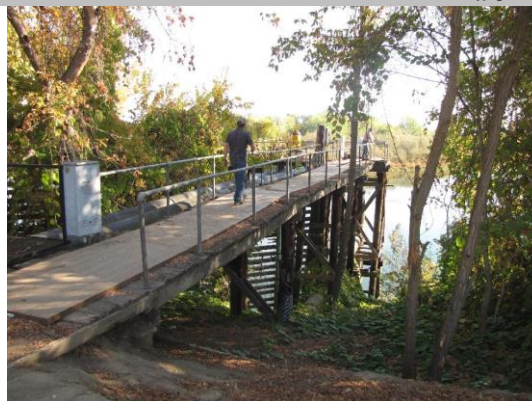
Photo 3 of 3 : UCIP\_SP\_2021\_53051\_70232.jpg

LM Start	10.21	Rating **	M	Issue No.	43 (cont)	
LM End	10.21	Issue Type +	En	Location *		
Category	Supplemental			GPS Latitude/Longitude		
				Start		End
Item	DWR UCIP Field Study			39.329750 °		39.329750 °
				-122.029602 °		-122.029602 °
DWR ID	17571

Close-up of catwalk, control panel, and pump station located on WS.

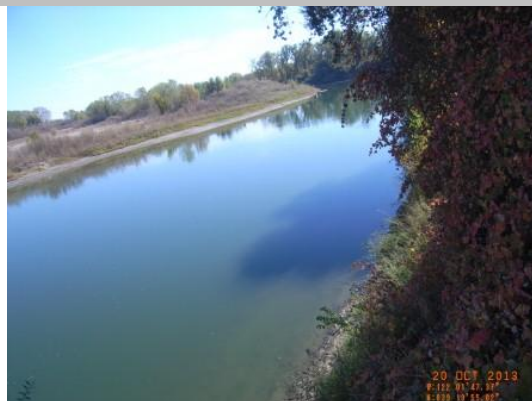
Photo 1 of 1 : SP\_2021\_MA0001\_297\_6\_20210224\_00003.jpg

LM Start	10.32	Rating **	A/W	Issue No.	6
LM End	10.41	Issue Type +	Ma	Location *	WS
Category	Supplemental			GPS Latitude/Longitude	
				Start	End
Item	2017 USACE Erosion Survey			39.331447 °	39.332716 °
				-122.029440 °	-122.029953 °
DWR ID	DWR ST0003 01 f 2018 1

2017 Site ID: SAC 157.7 R  
 Status: Eroding  
 2017 Field Notes: Vertical face of clay sand bank, new tree popout.  
 Bank continues to erode.  
 Site History: 2004 - Slowly eroding but near vertical with no vegetation to hold it. 2005 - Erosion is close to levee toe but not into the levee section yet. 2010 - Some new toe scour.

USACE 2013 Photo #1

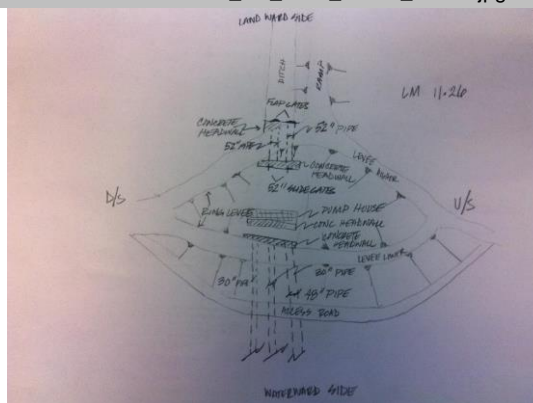
Photo 1 of 3 : UCIP\_SP\_2021\_53053\_70267.jpg

FS\_ID:53053  
DS\_ID:16449  
EP\_NO: 187  
Repair Type: Non-Urgent  
Crossing Status: Found  
UCIP Comments: 10/1/2018 Pipe closed by steel plate at LS end. Plate is bolted to concrete headwall. CVFPB is working with owner to address issue. (O.Yakimov - DWR UCIP)5/3/2017 No changes have been made to this crossing since the NOV was sent out in January 2017. (DWR Sutter Yard- AFreitag)01/31/2017 Informal Notice of Violation (NOV) was sent out January 31, 2017 by DWR Flood Maintenance Office--owner will need to coordinate with CVFPB to remove, replace, or abandon pipe in-place. Owner has until Monday February 27th, 2017 to repond to DWR contact: Bryan Reniff. (refer to Official Notice for details). (DWR UCIP - O. Magana)10/24/2016 Appears abandoned. Slide gate needs to be dug out and fully closed to prevent water flow during high water.(DWR Sutter Yard- AFreitag)4/25/2016 Crossing appears to be abandoned.4/21/2015 Same as last inspection.6/23/2014 Same as last inspection.12/17/2013 Same as last inspection.7/18/2013 Same as last inspection.10/30/2012 Need to determine if structure is still in use--contact owner. If abandoned structure--structure needs to be properly abandoned. This crossing was listed in the USACE Periodic Inspections as ID# USACE\_CESPK\_MA1C\_2010\_p\_0393 missing gate.

FIELD\_STRUCT\_DESC: 1 of 2: 52-inch corrugated metal irrigation pipe, 48-inch measured, through the levee, approximately 15 feet below the crown. Slide gate on the waterside (WS) and flap gate on the landside (LS). Concrete headwalls at both WS and LS. This structure is associated with another abandoned structure located on the WS. Abandoned structure includes pump house, multiple concrete walls, and 3 additional crossings (two 30-inch pipes and one 48-inch pipe). (Original structure installed under Permit No. 187, 1921 - Compton-Delevan Irrigation District-Maxwell I.D., new pump and platform installed and old pump house removed under Permit No. 9183-1973, Maxwell Irrigation District) [Additional Reference(s): DWR Levee Log, 1992].  
FS Date: 10/1/2018 3:42:41 PM

Sketch of structure located at levee mile 11.26.

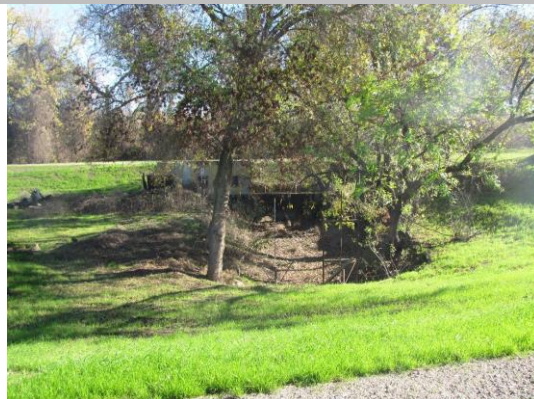
Photo 2 of 3 : UCIP\_SP\_2021\_53053\_70265.jpg

LM Start	<b>11.01</b>	Rating **	M	Issue No.	<b>44 (cont)</b>
LM End	<b>11.01</b>	Issue Type +	En	Location *	
Category	Supplemental		GPS Latitude/Longitude		
			Start	End	
Item	DWR UCIP Field Study		39.340867 °	39.340867 °	
			-122.032932 °	-122.032932 °	
DWR ID	16449

View of abandoned structure located on WS (inside ring levee).

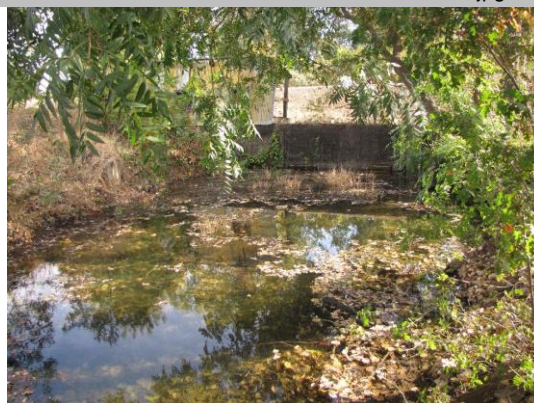
Photo 3 of 3 : UCIP\_SP\_2021\_53053\_70260.jpg

Drain channel inside ring levee.

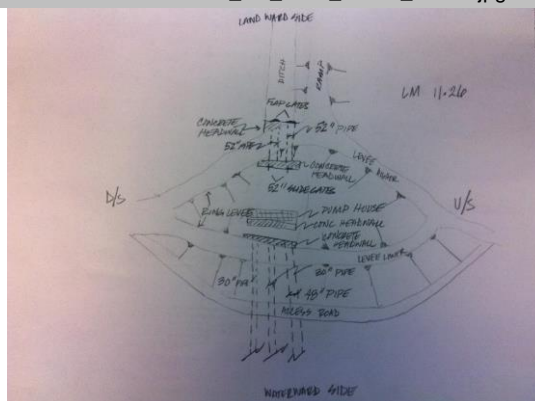
Photo 1 of 3 : UCIP\_SP\_2021\_53052\_70272.jpg

Repair Type: Urgent

UCIP Comments: 10/1/2018 Pipe closed by steel plate at LS end. Plate is bolted to concrete headwall. CVFPB is working with owner to address issue. Crossing remains "Urgent" because of missing slide gate on WS. (O.Yakimov - DWR UCIP)5/3/2017 No changes have been made at this crossing since the NOV was sent out in January 2017. (DWR Sutter Yard- AFreitag)01/31/2017 Informal Notice of Violation (NOV) was sent out January 31, 2017 by DWR Flood Maintenance Office--owner will need to coordinate with CVFPB to remove, replace, or abandon pipe in-place. Owner has until Monday February 27th, 2017 to respond to DWR contact: Bryan Reniff. (refer to Official Notice for details). (DWR UCIP - O. Magana)10/24/2016 Appears abandoned. Slide gate needs to be replaced or pipe end capped to prevent water flow during high water. (DWR Sutter Yard- AFreitag)4/25/2016 Crossing appears to be abandoned. Slide gate needs to be replaced or pipe needs to be plugged to prevent water flow during high water season. (DWR Sutter Yard - afreitag)4/21/2015 Same as last inspection. (DWR Sutter Yard - afreitag)6/23/2014 Same as last inspection. (DWR Sutter Yard - afreitag)12/17/2013 Same as last inspection. (DWR Sutter Yard - afreitag)7/18/2013 Same as last inspection. (DWR Sutter Yard - afreitag)10/30/2012 Missing positive closure device. Need to determine if structure is still in use--contact owner. If abandoned structure--structure needs to be abandoned properly. This crossing was listed in the USACE Periodic Inspections as ID# USACE\_CESPK\_MA1C\_2010\_p\_0393 missing gate. (DWR UCIP - omagana)

Sketch of structure through levee ring located at levee mile 11.26.

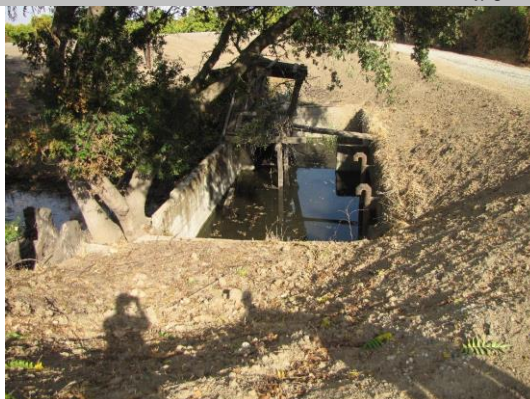
Photo 2 of 3 : UCIP\_SP\_2021\_53052\_70276.jpg

LM Start	<b>11.02</b>	Rating **	U	Issue No.	<b>45 (cont)</b>
LM End	<b>11.02</b>	Issue Type +	En	Location *	
Category	Supplemental		GPS Latitude/Longitude		
			Start	End	
Item	DWR UCIP Field Study		39.340971 °	39.340971 °	
			-122.032957 °	-122.032957 °	
DWR ID	17572

Abandoned structure (multiple headwalls and pump structure) located near the lower levee (ring levee).

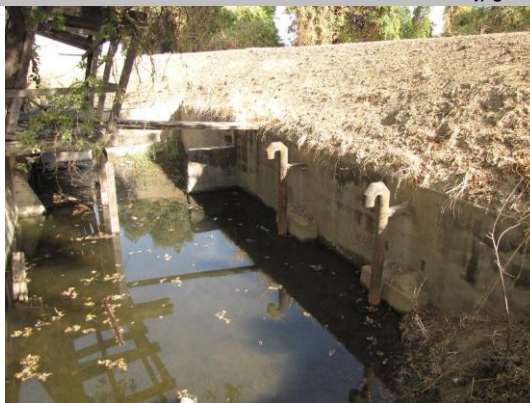
Photo 3 of 3 : UCIP\_SP\_2021\_53052\_70275.jpg

WS-Concrete headwall with multiple crossings (2-30 inch pipes and 1-48 inch pipe).

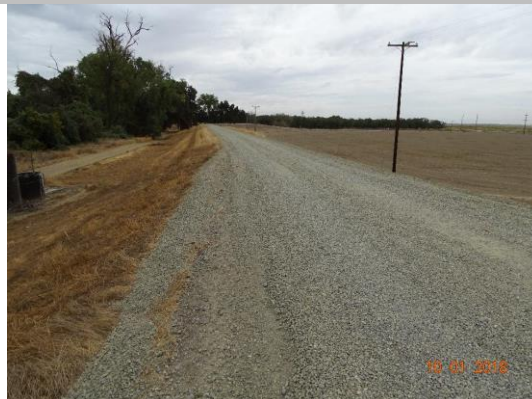
Photo 1 of 3 : UCIP\_SP\_2021\_53054\_78258.jpg

Comment Code						
Inspector Comment						
FS_ID:53054 DS_ID:17691 EP_NO: 17471 Repair Type: Urgent Crossing Status: Found UCIP Comments: 10/1/2018 Sink hole between CMP risers on WS has grown. Need to contact owner to address issue. Recommend video inspection. (O.Yakimov - DWR UCIP)5/3/2017 Sink hole still present between the WS risers. It does not appears to be getting worse. Pumps were running during site visit but the sink hole was dry this time. (DWR Sutter Yard- AFreitag)10/24/2016 Sinkhole still present.(DWR Sutter Yard- AFreitag)4/25/2016 Sink hole between the standpipes seems to be getting worse. Measurements of the hole are 3' wide x 3' long x 3' deep. The pipe was flowing water and there was water present in the bottom of the sink hole. (DWR Sutter Yard - afreitag)4/21/2015 Sink hole still present between risers. (DWR Sutter Yard - afreitag)6/23/2014 Standing water was present in the bottom of the sinkhole. (DWR Sutter Yard - afreitag)12/17/2013 Same as last inspection. (DWR Sutter Yard - afreitag)7/18/2013 Same as last inspection. (DWR Sutter Yard - afreitag)10/30/2012 Erosion between risers with slide gates located on waterward side; This crossing was listed in the USACE Periodic Inspections as ID# USACE_CESPK_MA1C_2010_p_0398 for possible sinkhole between access gate structures. (DWR UCIP - omagana) FIELD_STRUCT_DESC: 1 of 2: 24-inch high-density polyethylene (HDPE) irrigation pipe to be connected to the existing corrugated metal pipe (CMP) riser within the waterside (WS) and parallel to the right (west) bank levee of the Sacramento River. (Permit 17471, 2002 - Maxwell Irrigation District). FS Date: 10/1/2018 3:53:48 PM

View of levee crown at crossing.

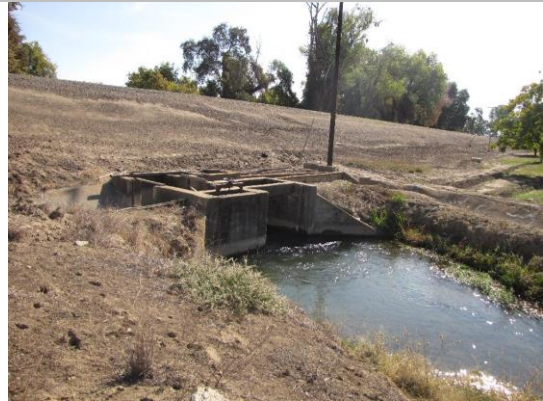
Photo 2 of 3 : UCIP\_SP\_2021\_53054\_70326.jpg

LM Start	11.19	Rating **	U	Issue No.	48 (cont)
LM End	11.19	Issue Type +	En	Location *	
Category	Supplemental		GPS Latitude/Longitude		
			Start	End	
Item	DWR UCIP Field Study		39.343263 °	39.343263 °	
			-122.032152 °	-122.032152 °	
DWR ID	17691

View of concrete distribution box located on LS toe.

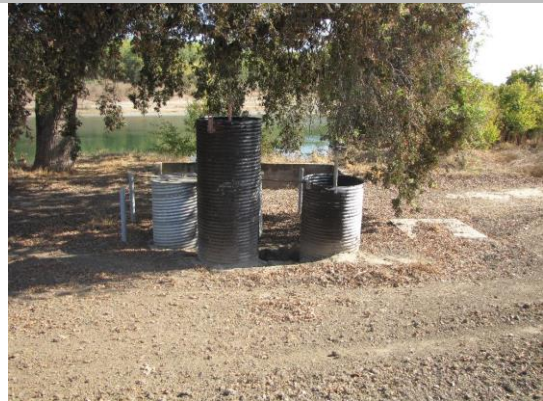
Photo 3 of 3 : UCIP\_SP\_2021\_53054\_70330.jpg

CMP risers located on WS berm. 18-inch pipe corresponds to downstream riser with slide gate. 24-inch pipe corresponds to upstream riser with slide gate.

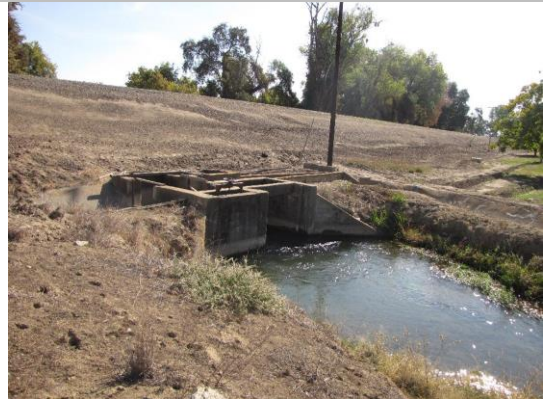
Photo 2 of 3 : UCIP\_SP\_2021\_53056\_70324.jpg

Comment Code					
Inspector Comment					
FS_ID:53056 DS_ID:17624 EP_NO: 17471 Repair Type: Urgent Crossing Status: Found UCIP Comments: 10/1/2018 Sink hole between CMP risers on WS has grown. Need to contact owner to address issue. Recommend video inspection. (O.Yakimov - DWR UCIP)5/3/2017 Sink hole still present between the WS risers. It does not appears to be getting worse. Pumps were running during site visit but the sink hole was dry this time. (DWR Sutter Yard- AFreitag)10/24/2016 Sinkhole still present.(DWR Sutter Yard- AFreitag)4/25/2016 Sink hole between risers was getting worse (3' wide x 3' long x 3' deep). New smaller sink hole is appearing on the upstream side of this stand pipe (4.5" wide x 20" deep). (DWR Sutter Yard - afreitag)4/21/2015 Sink hole still present between risers. (DWR Sutter Yard - afreitag)6/23/2014 Standing water was present in the bottom of the sinkhole. (DWR Sutter Yard - afreitag)12/17/2013 Same as last inspection. (DWR Sutter Yard - afreitag)7/18/2013 Same as last inspection. (DWR Sutter Yard - afreitag)10/30/2012 Erosion between risers with slide gates located on waterward side; This crossing was listed in the USACE Periodic Inspections as ID# USACE_CESPK_MA1C_2010_p_0398 for possible sinkhole between access gate structures. (DWR UCIP - omagana) FIELD_STRUCT_DESC: 2 of 2: 18-inch high-density polyethylene (HDPE) irrigation pipe connected to the existing corrugated metal pipe (CMP) riser within the waterside (WS) and parallel to the right (west) bank levee of the Sacramento River. Pipe depth through the levee unknown. Pump station is located approximately 450 feet upstream of crossing. (Permit 17471, 2002 - Maxwell Irrigation District) FS Date: 10/1/2018 3:58:00 PM

LM Start	11.19	Rating **	U	Issue No.	49 (cont)
LM End	11.19	Issue Type +	En	Location *	
Category	Supplemental		GPS Latitude/Longitude		
			Start	End	
Item	DWR UCIP Field Study		39.343283 °	39.343283 °	
			-122.032145 °	-122.032145 °	
DWR ID	17624

View of concrete distribution box located on LS toe.

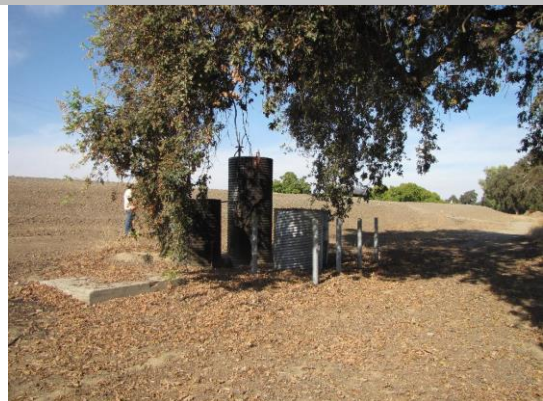
Photo 3 of 3 : UCIP\_SP\_2021\_53056\_70323.jpg

View of CMP risers located on WS berm.

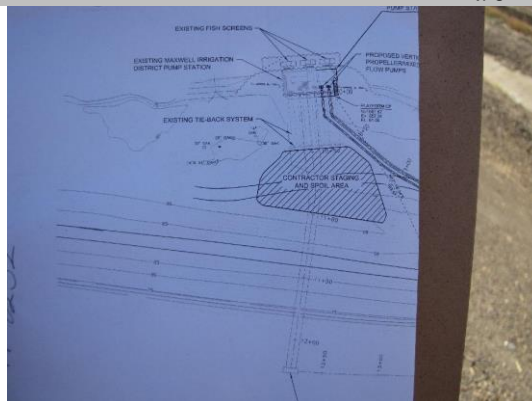
Photo 1 of 3 : UCIP\_SP\_2021\_51900\_70342.jpg

Comment Code						
Inspector Comment						
FS_ID:51900 DS_ID:20584 EP_NO: N/A Repair Type: Non-Urgent Crossing Status: Found UCIP Comments: 5/3/2017 Crossing appears to be in good condition. (DWR Sutter Yard- AFreitag)10/24/2016 appears to be in good condition.(DWR Sutter Yard- AFreitag)4/25/2016 Crossing appears to be in good condition.4/21/2015 Same as last inspection.6/23/2014 Same as last inspection.12/17/2013 Same as last inspection.7/22/2013 Same as last inspection.10/30/2012 Need to determine encroachment permit for this crossing. FIELD_STRUCT_DESC: [Maxwell Irrigation District] 3 of 3: 24-inch steel irrigation pipe through the levee at an unknown depth below the crown. Crossing is tied to existing Maxwell Irrigation District Pump Station located on the waterside (WS). Siphon breaker inside corrugated metal pipe (CMP) riser located on the landside (LS) shoulder. No permit has been identified since crossing was field discovered in 2012. FS Date: 5/23/2017 11:47:50 AM

Drawing of existing Maxwell Irrigation District Conveyance Pipeline  
(DWG available through Permit No. 17471 for work located at LM 11.51).

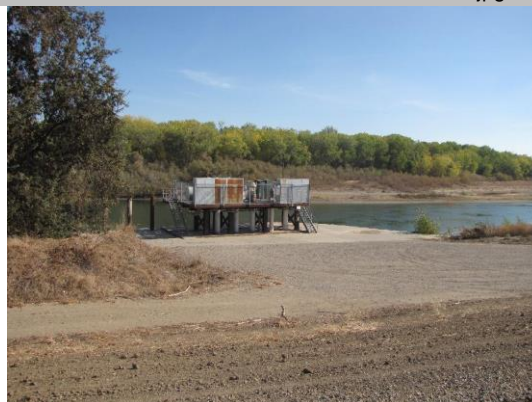
Photo 2 of 3 : UCIP\_SP\_2021\_51900\_70343.jpg

Maxwell Irrigation District Pump Station located on WS.

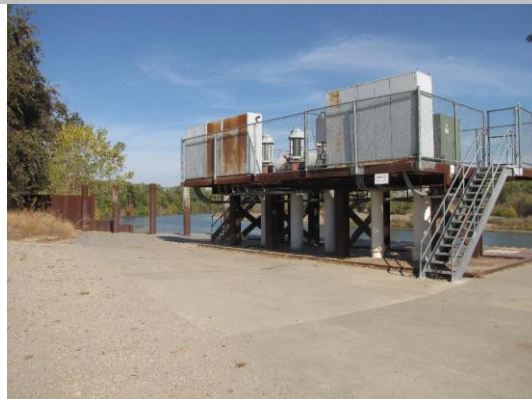
Photo 3 of 3 : UCIP\_SP\_2021\_51900\_70345.jpg

Maxwell Irrigation District Pump Station located on WS.

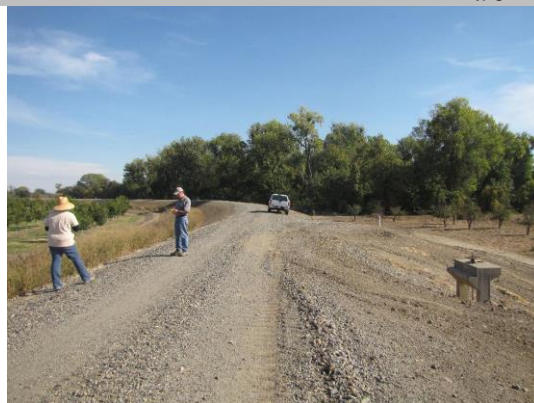
Photo 1 of 3 : UCIP\_SP\_2021\_51903\_70352.jpg

Comment Code					
Inspector Comment					
FS_ID:51903 DS_ID:16445 EP_NO: 9462 Repair Type: Non-Urgent Crossing Status: Found UCIP Comments: 5/3/2017 Appears abandoned- needs to be done properly.(DWR Sutter Yard- AFreitag)10/24/2016 Appears abandoned. LS concrete canal is filled by pipe DSID 16444.4/25/2016 Appears to be an abandoned crossing. WS slide gate still buried and inoperable.4/21/2015 Same as last inspection.  6/23/2014 Same as last inspection.12/17/2013 Same as last inspection.7/22/2013 Same as last inspection.10/30/2012 Slide gate unoperable-blocked by sediment. LS-flap gate missing. 5-inch pipe goes through 24-inch crossing--unable to determine is authorized. This crossing was listed in the USACE Periodic Inspections as ID# USACE_CESPK_MA1C_2010_p_0435 for smaller pipe running inside existing crossing. FIELD_STRUCT_DESC: *ABANDONED* 24-inch corrugated metal drainage pipe through the levee, approximately 10 feet below the crown. Slide gate on both waterside (WS) and landside (LS). Gate missing on the LS. (Automatic Board Order (ABO) issued as Permit No. 9462-1974, Thousand Acre Ranch) [Additional Reference(s): DWR Levee Log, 1992]. FS Date: 5/23/2017 11:50:30 AM

Overview of levee crown looking downstream at crossing.

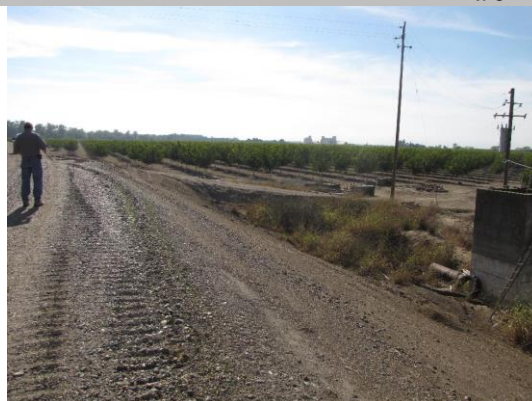
Photo 1 of 3 : UCIP\_SP\_2021\_58138\_70377.jpg

FS\_ID:58138  
DS\_ID:16443  
EP\_NO: 9461  
Repair Type: Urgent  
Crossing Status: Found  
UCIP Comments: 10/01/2018 Backwash erosion from ditch appears to be growing along LS toe. FSRP evaluation is recommended. (O.Yakimov - DWR UCIP)05/03/2017 Water was leaking from the LS distribution box during the Jan/Feb 2017 high water event. If this crossing is abandoned then it needs to be so properly. (A. Freitag - DWR Sutter Yard)11/01/2016 Erosion/cavity collapse visible on LS toe. Slide gate inside concrete riser located on the WS is in the open position. Need to contact owner to confirm status of crossing and to determine cause of erosion on LS (pipe or concrete box might be leaking). (O. Magana - DWR UCIP)10/24/2016 Appears abandoned. (A. Freitag - DWR Sutter Yard)04/25/2016 Slide gate in WS box visually appears to be closed as its stem is all the way down. Still cannot look into box to confirm 100% though. (A. Freitag - DWR Sutter Yard)04/21/2015 Same as last inspection. (A. Freitag - DWR Sutter Yard)06/23/2014 Same as last inspection. (A. Freitag - DWR Sutter Yard)12/17/2013 Same as last inspection. (A. Freitag - DWR Sutter Yard)07/22/2013 Same as last inspection. (A. Freitag - DWR Sutter Yard)10/30/2012 Unable to close positive closure device due to missing ladder-sluice gate inaccessible. Need to determine the condition of the gate. This crossing was listed in the USACE Periodic Inspections as ID# USACE\_CESPK\_MA1C\_2010\_p\_0453 for an inaccessible gate box with its ladder broken on the waterward side. (O. Magana - DWR UCIP)

FIELD\_STRUCT\_DESC: 36-inch corrugated metal irrigation pipe through the levee, 21.5 feet below the crown. Slide gate in concrete box on the waterside (WS) end. Pump on the bank. Tall concrete box located on the landside (LS). (Automatic Board Order (ABO) issued as Permit No. 9461, 1974 - Annie D. Propfe) [Additional Reference(s): DWR Levee Log, 1992. USACE Sacramento O&M Manual 137, August 1955, (Station 710+82)].  
FS Date: 10/1/2018 4:06:00 PM

View of LS looking downstream at crossing.

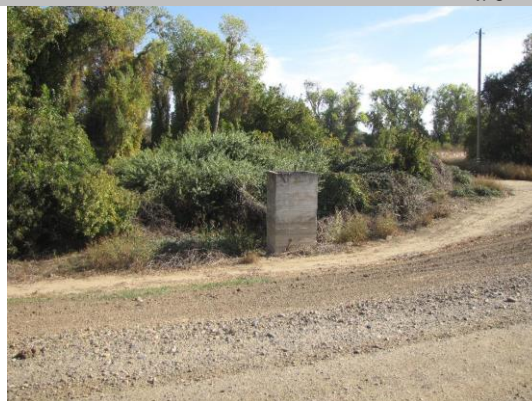
Photo 2 of 3 : UCIP\_SP\_2021\_58138\_70376.jpg

View of WS at crossing.

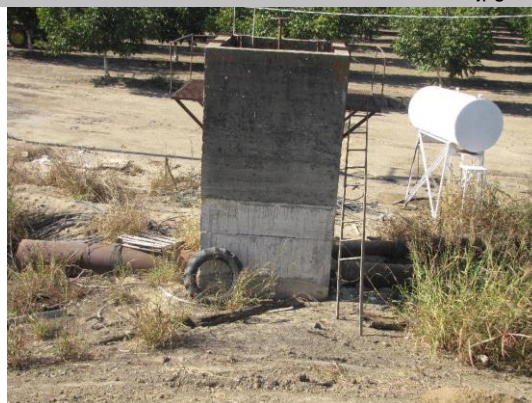
Photo 3 of 3 : UCIP\_SP\_2021\_58138\_70375.jpg

Concrete distribution box located on LS toe.

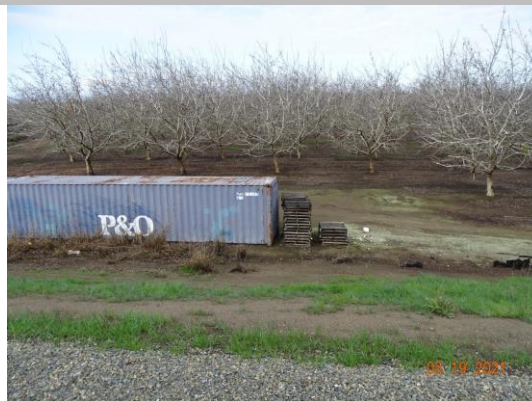
Photo 1 of 1 : SP\_2021\_MA0001\_297\_126\_20210322\_00145.jpg

LM Start	13.48	Rating **	M	Issue No.	126
LM End	13.48	Issue Type +	En	Location *	LS
Category	Earthen Levee			GPS Latitude/Longitude	
				Start	End
Item	Encroachments			39.367832 °	39.367832 °
				-122.015130 °	-122.015130 °
DWR ID	DWR_MA0001_01_f _ 2016_126				
Comment Code					
EQ : Equipment					
Inspector Comment					
Shipping container should be moved 10 feet away from the landside toe.

View of the shipping container along the landside toe. Spring 2021.

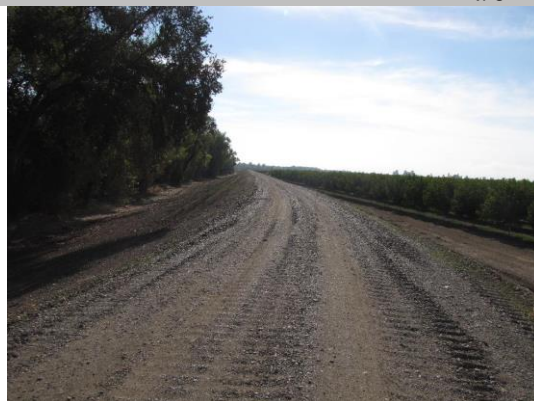
Photo 1 of 2 : UCIP\_SP\_2021\_58141\_70379.jpg

Comment Code					
Inspector Comment					
FS_ID:58141 DS_ID:16442 EP_NO: N/A Repair Type: Non-Urgent Crossing Status: Found UCIP Comments: 05/03/2017 Abandoned- needs to be done so properly. (A. Freitag - DWR Sutter Yard)10/24/2016 Abandoned. (A. Freitag - DWR Sutter Yard)04/25/2016 Abandoned crossing. (A. Freitag - DWR Sutter Yard)04/21/2015 Slide gate is still buried. (A. Freitag - DWR Sutter Yard)06/23/2014 Same as last inspection. (A. Freitag - DWR Sutter Yard)12/17/2013 Same as last inspection. (A. Freitag - DWR Sutter Yard)07/22/2013 Same as last inspection. (A. Freitag - DWR Sutter Yard)10/30/2012 Slide gate is buried-non-fuctional. This crossing was listed in the USACE Periodic Inspections as ID# USACE_CESPK_MA1C_2010_p_0457 for buried slide gate. (O. Magana - DWR UCIP) FIELD_STRUCT_DESC: *ABANDONED* 36-inch corrugated metal drainage pipe through the levee at approximately 15-18 feet below the crown. Slide gate on the waterside (WS) end. (Davis Ranches) [Additional Reference(s): DWR Levee Log, 1992]. FS Date: 5/23/2017 12:02:00 PM

Overview of levee crown looking downstream at crossing.

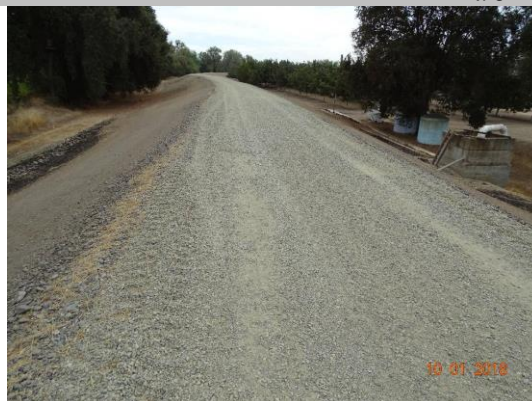
Photo 1 of 3 : UCIP\_SP\_2021\_58143\_78266.jpg

FS\_ID:58143  
DS\_ID:16441  
EP\_NO: 9460  
Repair Type: Urgent  
Crossing Status: Found  
UCIP Comments: 12/17/2020 NOV issued (Enforcement case 2020-10284). Abandoned concrete distribution boxes on both slopes, abandoned concrete pipe heading north and south from LS concrete box, plastic pipe along landside levee toe within 10-foot distance from the toe. (O.Yakimov - DWR UCIP)  
10/01/2018 A gap visible between pipe end in concrete box on LS and flap gate. Pipe might be partially silted that blocks flap gate from closing properly. Needs proper abandonment if not in use. Open conduit allows for flooding during high water events. (O. Yakimov - DWR UCIP)05/03/2017 Water leaked through this crossing during the Jan/Feb 2017 high water event. A concrete pipe of unknown diameter exits the LS distribution box and follows the levee alignment downstream about 120ft and uncontrolled water flowed from that pipe end. If crossing is abandoned then it needs to be done so properly. (A. Freitag - DWR Sutter Yard)10/24/2016 This entire crossing now appears to be abandoned. The pvc pipe that was previously connected to the LS well pump is no longer connected and used to fill the box. (A. Freitag - DWR Sutter Yard)04/25/2016 WS concrete box appears to be abandoned. LS box appears to get filled by a well pump on LS. (A. Freitag - DWR Sutter Yard)04/21/2015 Same as last inspection. (A. Freitag - DWR Sutter Yard)06/23/2014 Same as last inspection. (A. Freitag - DWR Sutter Yard)12/17/2013 Same as last inspection. (A. Freitag - DWR Sutter Yard)07/22/2013 Same as last inspection. (A. Freitag - DWR Sutter Yard)10/30/2012 Need to determine if crossing is still being used there are some abandoned features that remain at this crossing--crossing has been modified. This crossing was listed in the USACE Periodic Inspections as ID# USACE\_CESPK\_MA1C\_2010\_p\_0464 for abandoned pump station. (O. Magana - DWR UCIP)

FIELD\_STRUCT\_DESC: \*ABANDONED\* 18-inch steel irrigation pipe through the levee, at an unknown depth below the crown. Gate valve on the waterside (WS) end. Pump house on the WS berm. Concrete distribution box and flap gate at the landside (LS) toe. Inspector noted in 2016 that this structure appears to be partially abandoned concrete box appears to be in use. LS box appears to get filled by a well pump located on the LS and water distributed. (Automatic Board Order (ABO) issued as Permit No. 9460, 1974 - Morici Corporation) [Additional Reference(s): DWR Levee Log, 1992].  
FS Date: 10/1/2018 4:13:00 PM

View of levee crown at crossing.

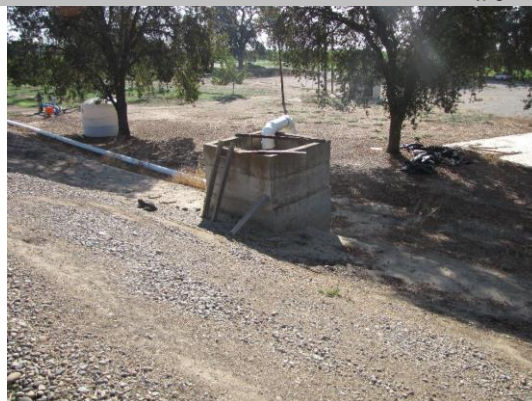
Photo 2 of 3 : UCIP\_SP\_2021\_58143\_70382.jpg

Concrete distribution box located on LS toe.

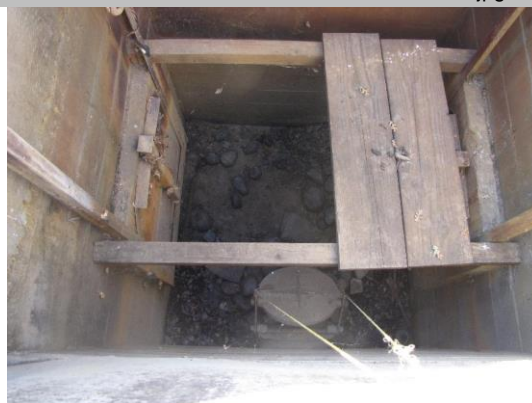
Photo 3 of 3 : UCIP\_SP\_2021\_58143\_70381.jpg

Inside view of concrete distribution box located on LS toe.

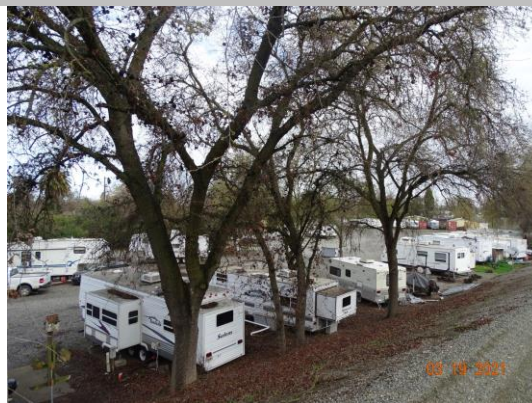
Photo 1 of 1 : SP\_2021\_MA0001\_297\_86\_20210322\_00146.jpg

LM Start	15.84	Rating **	U	Issue No.	86
LM End	15.90	Issue Type +	En	Location *	LS
Category	Earthen Levee			GPS Latitude/Longitude	
				Start	End
Item	Encroachments			39.400601 °	39.401365 °
				-122.009889 °	-122.009374 °
DWR ID	DWR_MA0001_01_s_2016_86				
Comment Code					
BU : Building					
Inspector Comment					
Mobile homes and trailers are within the landside toe easement.

View of the mobile homes along the landside toe. Spring 2021.

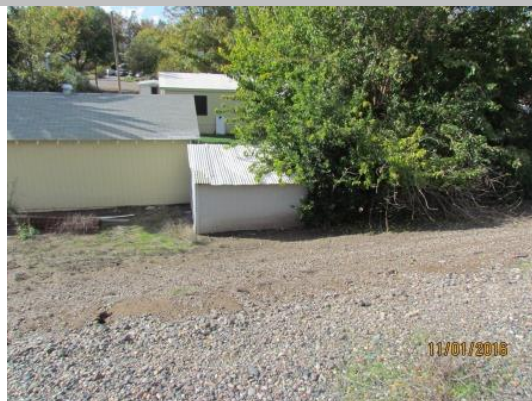
Photo 1 of 1 : SP\_2021\_MA0001\_297\_87\_20210224\_00021.jpg

LM Start	15.95	Rating **	U	Issue No.	87
LM End	15.95	Issue Type +	En	Location *	LS
Category	Earthen Levee			GPS Latitude/Longitude	
				Start	End
Item	Encroachments			39.401994 °	39.401994 °
				-122.009352 °	-122.009352 °
DWR ID	DWR_MA0001_01_s _ 2016_87				
Comment Code					
BU : Building					
Inspector Comment

View of a shed along the landside toe.

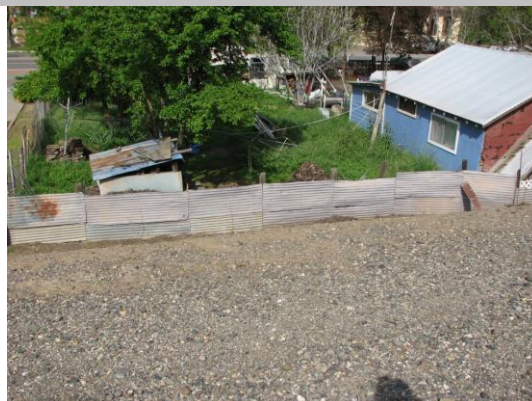
Photo 1 of 1 : SP\_2021\_MA0001\_297\_89\_20210224\_00023.jpg

LM Start	16.00	Rating **	U	Issue No.	89
LM End	16.02	Issue Type +	En	Location *	LS
Category	Earthen Levee			GPS Latitude/Longitude	
				Start	End
Item	Encroachments			39.402756 °	39.403040 °
				-122.009261 °	-122.009186 °
DWR ID	DWR_MA0001_01_s _ 2016_89				
Comment Code					
BU : Building					
Inspector Comment					
Red house and metal fence runs along the landside toe.

Corrugated metal fence obstructing visibility and access

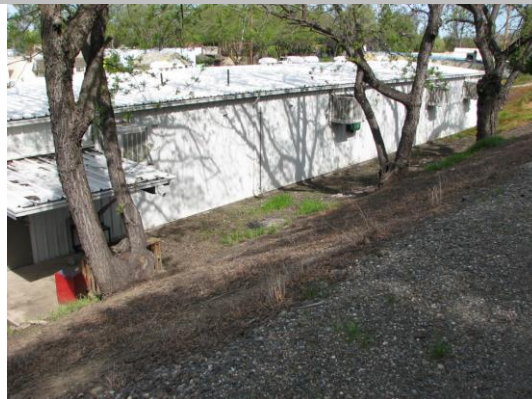
Photo 1 of 1 : SP\_2021\_MA0001\_297\_91\_20210224\_00025.jpg

LM Start	16.06	Rating **	U	Issue No.	91
LM End	16.06	Issue Type +	En	Location *	LS
Category	Earthen Levee			GPS Latitude/Longitude	
				Start	End
Item	Encroachments			39.403565 °	39.403565 °
				-122.009039 °	-122.009039 °
DWR ID	DWR_MA0001_01_s_2016_91				
Comment Code					
BU : Building					
Inspector Comment					
Long, white metal building with several AC units is at the landside toe.

View of a building obstructing access.

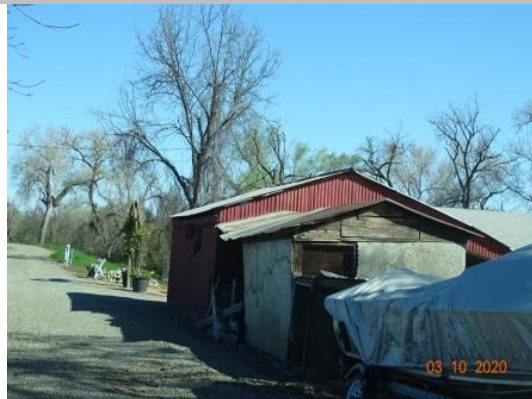
Photo 1 of 1 : SP\_2021\_MA0001\_297\_14\_20210224\_00007.jpg

LM Start	16.08	Rating **	U	Issue No.	14
LM End	16.08	Issue Type +	En	Location *	WS
Category	Earthen Levee			GPS Latitude/Longitude	
				Start	End
Item	Encroachments			39.403930 °	39.403930 °
				-122.008925 °	-122.008925 °
DWR ID	DWR_MA0001_01_s_2012_14				
Comment Code					
BU : Building					
Inspector Comment

View of the building on the waterside slope. Spring 2020.

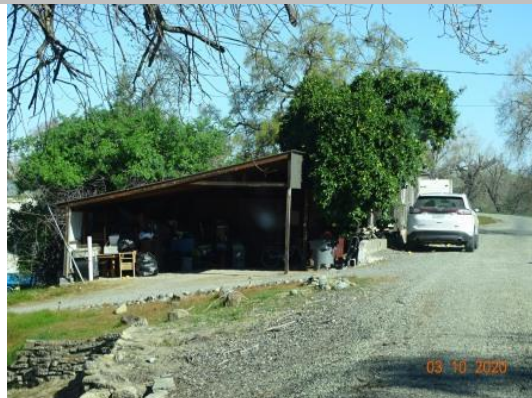
Photo 1 of 1 : SP\_2021\_MA0001\_297\_26\_20210224\_00009.jpg

LM Start	16.10	Rating **	U	Issue No.	26
LM End	16.10	Issue Type +	En	Location *	LS
Category	Earthen Levee			GPS Latitude/Longitude	
				Start	End
Item	Encroachments			39.404135 °	39.404135 °
				-122.008797 °	-122.008797 °
DWR ID	DWR_MA0001_01_s_2012_26				
Comment Code					
BU : Building					
Inspector Comment

View of the building on the landside slope. Spring 2020.

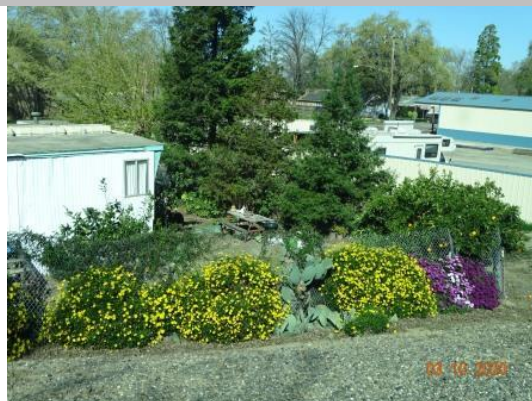
Photo 1 of 1 : SP\_2021\_MA0001\_297\_74\_20210224\_00017.jpg

LM Start	16.10	Rating **	M	Issue No.	74
LM End	16.10	Issue Type +	En	Location *	LS
Category	Earthen Levee			GPS Latitude/Longitude	
				Start	End
Item	Vegetation			39.404255 °	39.404255 °
				-122.008842 °	-122.008842 °
DWR ID	DWR_MA0001_01_s_2015_74				
Comment Code					
V6 : Landscaping					
Inspector Comment					
Remove the landscape from the landside slope and toe.

View of the landscaping along the landside slope and toe. Spring 2020.

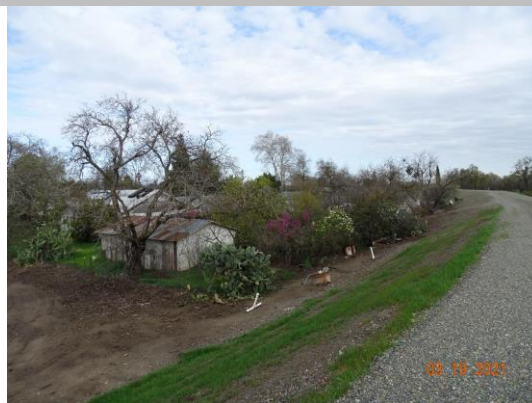
Photo 1 of 1 : SP\_2021\_MA0001\_297\_134\_20210322\_00147.jpg

LM Start	16.26	Rating **	M	Issue No.	134
LM End	16.26	Issue Type +	En	Location *	LS
Category	Earthen Levee			GPS Latitude/Longitude	
				Start	End
Item	Vegetation			39.406520 °	39.406520 °
				-122.008635 °	-122.008635 °
DWR ID	DWR_MA0001_01_f _ 2016_134				
Comment Code					
V6 : Landscaping					
Inspector Comment

View of the landscaping and fruit trees along the landside toe. Spring 2021.

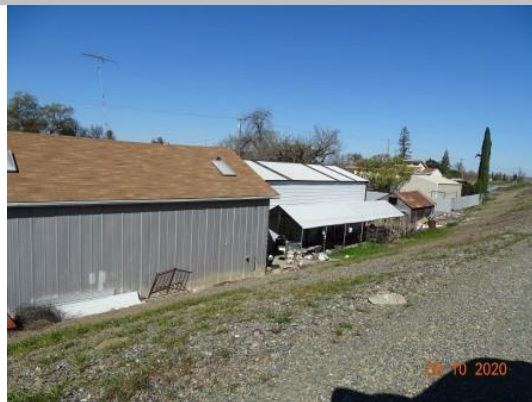
Photo 1 of 1 : SP\_2021\_MA0001\_297\_46\_20210224\_00010.jpg

LM Start	16.31	Rating **	U	Issue No.	46
LM End	16.33	Issue Type +	En	Location *	LS
Category	Earthen Levee			GPS Latitude/Longitude	
				Start	End
Item	Encroachments			39.407225 °	39.407545 °
				-122.008570 °	-122.008640 °
DWR ID	DWR_MA0001_01_s_2012_46				
Comment Code					
BU : Building					
Inspector Comment

View of the buildings along the landside toe. Spring 2020.

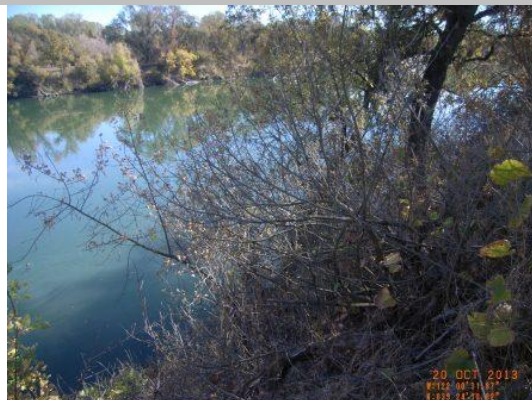
Photo 2 of 2 : SP\_2021\_MA0001\_297\_9\_20210224\_00006.jpg

LM Start	16.35	Rating **	A/W	Issue No.	9
LM End	16.58	Issue Type +	Ma	Location *	WS
Category	Supplemental			GPS Latitude/Longitude	
				Start	End
Item	2017 USACE Erosion Survey			39.407837 °	39.411111 °
				-122.008763 °	-122.009238 °
DWR ID	DWR_ST0010_02_f_2022_7				
Comment Code					
Inspector Comment					
2017 Site ID: SAC 164.3 R					
Status: Eroding					
2017 Field Notes: New erosion along entire site.					
Site History: Erosion site added in 1997 and removed in 2005. 2009 - Site added back in, hard toe with slow moving erosion. Potential geotechnical failure. 2011 - Site extended downstream.

USACE 2013 Photo #2

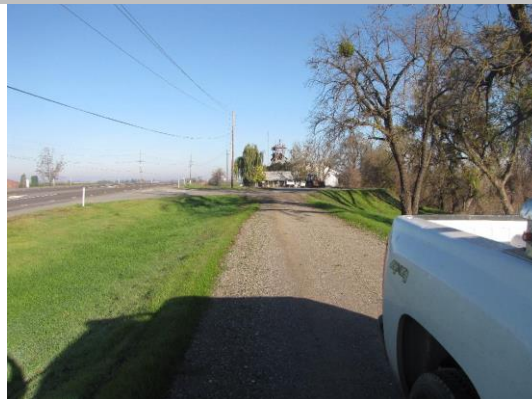
Photo 1 of 3 : UCIP\_SP\_2021\_60390\_70391.jpg

FS\_ID:60390  
DS\_ID:16448  
EP\_NO: 14424  
Repair Type: Non-Urgent  
Crossing Status: Found  
UCIP Comments: 05/03/2017 WS sign still knocked over- needs to be replaced. (A. Freitag - DWR Sutter Yard)10/24/2016 WS marker sign still knocked over. (A. Freitag - DWR Sutter Yard)04/25/2016 WS marker sign is still knocked over. (A. Freitag - DWR Sutter Yard)04/21/2015 Same as last inspection. (A. Freitag - DWR Sutter Yard)11/03/2014 Need to contact owner to determine when markers will be placed. (O. Magana - DWR UCIP)06/23/2014 Same as last inspection. (A. Freitag - DWR Sutter Yard)12/17/2013 Same as last inspection. (A. Freitag - DWR Sutter Yard) 07/22/2013 Same as last inspection. (A. Freitag - DWR Sutter Yard)12/01/2012 Waiting for information regarding crossing from PG&E. Regarding damage warning sign--PG&E has initiated a project to replace pipeline crossing sign and utility markers, as required by DOT codes/regulations. (O. Magana - DWR UCIP)11/14/2012 Utility warning sign damaged. Olivia (UCIP team) is coordinating with PG&E to determine more info on crossing. (O. Magana - DWR UCIP)

FIELD\_STRUCT\_DESC: 12-inch gas line of unknown material through the levee, 30-feet below the crown. This 12-inch replacement pipe was installed by horizontally directionally drilling under the State HWY. Crossing is cathodically protected against external corrosion. Line was bored with a minimum cover of 48 feet under the right bank levee, 60 feet under the right bank, 25 feet under the channel and 52 feet under the left bank. Emergency contact: Monte Penland, Gas Maintenance Supervisor, 15871 Central Street, Meridian, CA 95957; Office No. 530-634-6520 or Mobile No. 530-356-7396. Utility crossing coordinates are approximate. This pipe is under pressure and cathodic protection (CP) readings are taken on a regular schedule. (12-inch gas line authorized under Permit No. 14424, 1988 - Pacific Gas & Electric [PG&E])  
[Additional Reference(s): DWR Levee Log, 1992 (HLM 16.91, listed as 12-inch gas line)].

View just upstream of utility crossing.

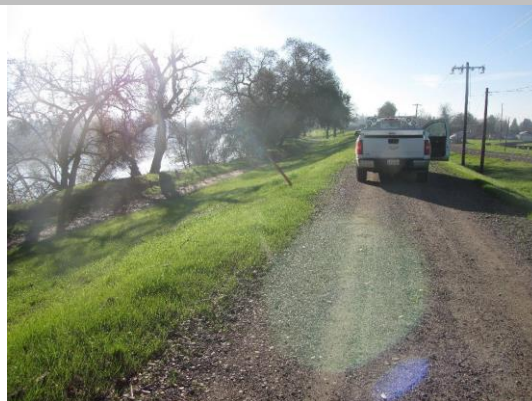
Photo 3 of 3 : UCIP\_SP\_2021\_60390\_70395.jpg

LM Start	<b>16.55</b>	Rating **	M	Issue No.	<b>58 (cont)</b>
LM End	<b>16.55</b>	Issue Type +	En	Location *

View of levee looking downstream at crossing.
