**Flood Control Project Maintenance
Levee Inspections
LMA District Cover Sheet**

Sutter Maintenance Yard Maintenance Area 0001

Waterway			Bank	Unit Miles
Unit No. 01 Sacramento River			Right	16.76
	Spring (March - May)	Summer (June - August)	(September - November) Fall	Winter (December - February)
Unit Maintenance Rating (Fall Only)				
Date of Inspection	4/5/2022 - 4/5/2022			
DWR Inspector	Makar Sokol			
Accompanied By	Gregg Ahlers DWR Sutter Yard

Levee Inspection Report By Mile - Spring 2022

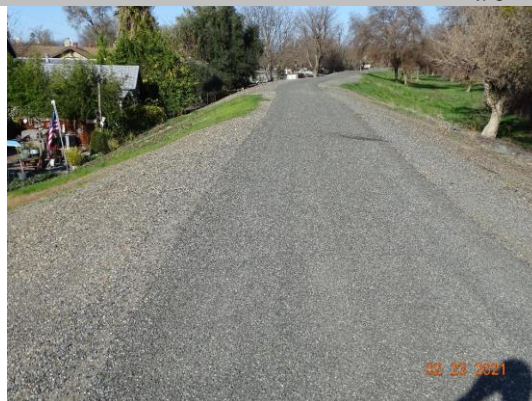
Photo 1 of 3 : UCIP_SP_2022_62857_91098.jpg

FS_ID:62857
DS_ID:16417
EP_NO: 861
Repair Type: Non-Urgent
Crossing Status: Not Found
UCIP Comments: 02/23/2021 Record is Non-Urgent. Crossing not found. Overhead power line crossing levee at this location. (O.Yakimov - DWR UCIP)
04/18/2017 Unable to locate. (A. Freitag - DWR Sutter Yard)
10/24/2016 Unable to locate. (A. Freitag - DWR Sutter Yard)
04/25/2016 Unable to locate. (A. Freitag - DWR Sutter Yard)
04/20/2015 Unable to locate. (A. Freitag - DWR Sutter Yard)
06/18/2014 Unable to locate. (A. Freitag - DWR Sutter Yard)
12/17/2013 Unable to locate. (A. Freitag - DWR Sutter Yard)
07/18/2013 Same as last inspection. Unable to locate. (A. Freitag - DWR Sutter Yard)
FIELD_STRUCT_DESC: Submarine electric transmission cable of an unknown material through the levee and extending across the overflow channel of Sacramento River. (Installation of submarine transmission cable authorized under Permit No. 861, 1941 - Pacific Gas and Electric).

Top of Levee: View of levee crown looking upstream

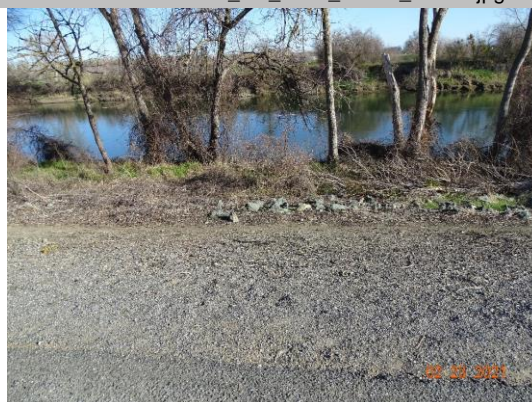
Photo 2 of 3 : UCIP_SP_2022_62857_91099.jpg

Water-Side: View of levee slope looking from crown

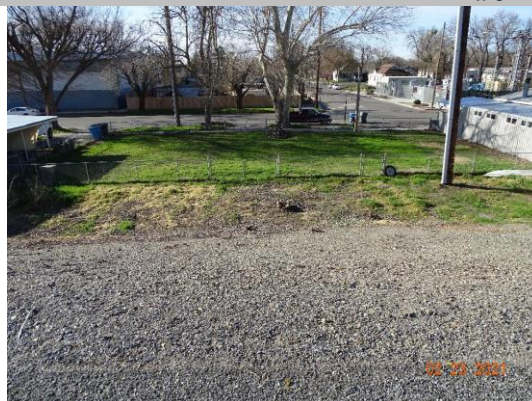
Photo 3 of 3 : UCIP_SP_2022_62857_91100.jpg

Land-Side: View of levee slope looking from crown

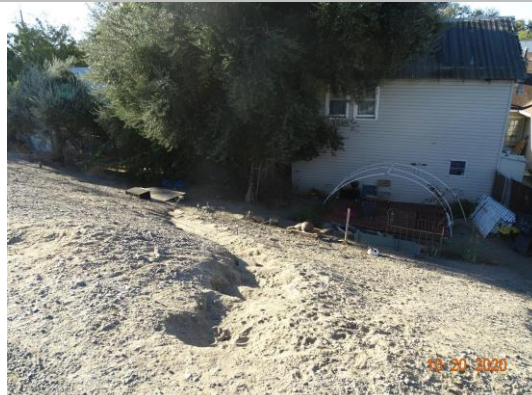
Photo 1 of 2 : SP_2022_MA0001_297_63_20220307_00015.jpg

LM Start	0.11	Rating **	U	Issue No.	63
LM End	0.11	Issue Type +	En	Location *	LS
Category	Earthen Levee			GPS Latitude/Longitude	
				Start	End
Item	Encroachments			39.214379 °	39.214379 °
				-122.002791 °	-122.002791 °
DWR ID	DWR_MA0001_01_f_2019_63				
Comment Code					
ST : Stairway					
Inspector Comment					
Two sets of stairs are cut into the landside slope. The stairs need to be removed and the slope needs to be restored.

View of one of the stairs cut into the landside slope. Fall 2020.

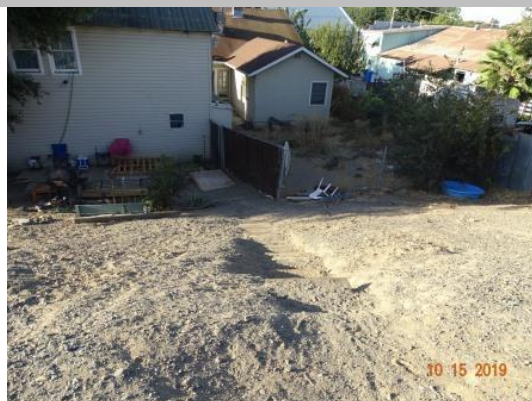
Photo 2 of 2 : SP_2022_MA0001_297_63_20220307_00016.jpg

View of the wooden stairs cut into the landside slope. Fall 2019.

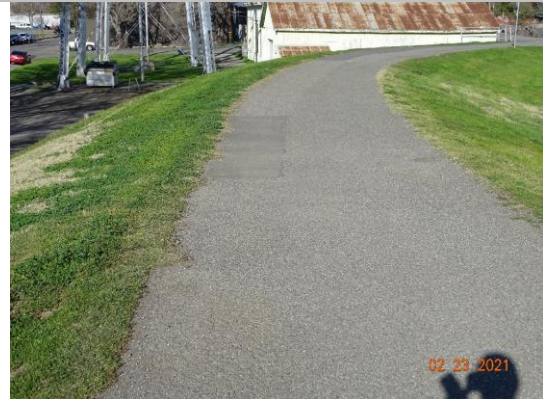
Photo 1 of 3 : UCIP_SP_2022_62858_91102.jpg

FS_ID:62858
DS_ID:16435
EP_NO: 10524-C
Repair Type: Non-Urgent
Crossing Status: Not Found
UCIP Comments: 02/23/2021 Record is Non-Urgent. Crossing not found. Unable to locate siphon breaker on landside shoulder. Permit file 10524-C not available, unable to confirm pipe alignment through levee. (O.Yakimov - DWR UCIP)
04/18/2017 Unable to locate. (A. Freitag - DWR Sutter Yard)10/24/2016 Unable to locate. (A. Freitag - DWR Sutter Yard)04/25/2016 Unable to locate. (A. Freitag - DWR Sutter Yard)04/20/2015 Unable to locate. (A. Freitag - DWR Sutter Yard)06/18/2014 Unable to locate. (A. Freitag - DWR Sutter Yard)12/17/2013 Unable to locate. (A. Freitag - DWR Sutter Yard)07/18/2013 Same as last inspection. Unable to locate. (A. Freitag - DWR Sutter Yard)
FIELD_STRUCT_DESC: Two 2-inch polyvinyl chloride water mains through the levee, 2 feet below the crown. Siphon breaker on the landside (LS) shoulder. (Water mains authorized under revised Permit No. 10524-C, 1979 - City of Colusa Department of Parks and Recreation; related superseded permits Permit No. 10524, 10524-A, and 10524-B, 1979 - City of Colusa, Department of Parks and Recreation). [Additional Reference(s): DWR Levee Log, 1992 (HLM 0.65), listed as 2-1/2-inch pipe].

Top of Levee: View of levee crown looking upstream

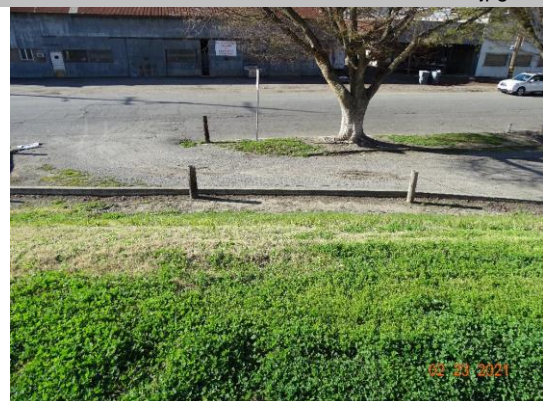
Photo 2 of 3 : UCIP_SP_2022_62858_91103.jpg

Land-Side: View of levee slope looking from crown

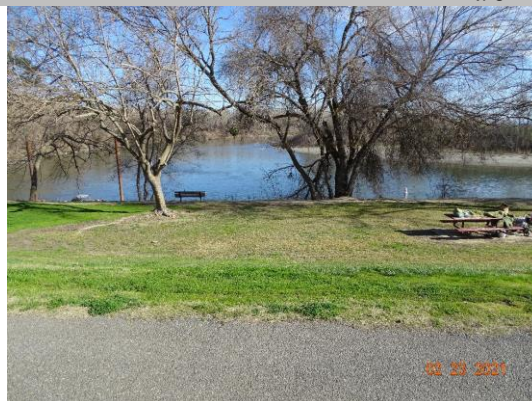
Photo 3 of 3 : UCIP_SP_2022_62858_91104.jpg

Water-Side: View of levee slope looking from crown

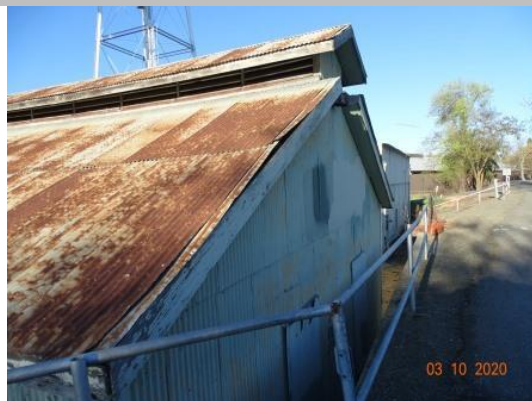
Photo 1 of 1 : SP_2022_MA0001_297_7_20220307_00005.jpg

LM Start	0.67	Rating **	U	Issue No.	7
LM End	0.70	Issue Type +	En	Location *	LS
Category	Earthen Levee			GPS Latitude/Longitude	
				Start	End
Item	Encroachments			39.216533 °	39.216680 °
				-122.012512 °	-122.012907 °
DWR ID	DWR_MA0001_01_s_2012_7				
Comment Code					
BU : Building					
Inspector Comment

View of the buildings along the landside toe. Spring 2020.

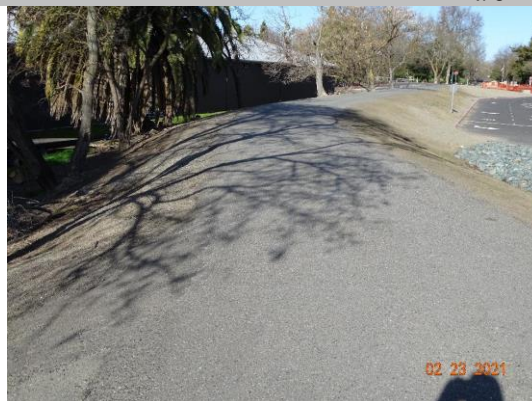
Photo 1 of 3 : UCIP_SP_2022_62859_91106.jpg

FS_ID:62859
DS_ID:16434
EP_NO: N/A
Repair Type: Non-Urgent
Crossing Status: Not Found
UCIP Comments: 02/23/2021 Record is Non-Urgent. Crossing not found. Unauthorized encroachment recorded in Levee Log prior to 2011. Unable to locate a permit and confirm proper pipe abandonment. (O.Yakimov - DWR UCIP)
04/18/2017 Unable to locate. (A. Freitag - DWR Sutter Yard)10/24/2016 Unable to locate. (A. Freitag - DWR Sutter Yard)04/25/2016 Unable to locate. (A. Freitag - DWR Sutter Yard)04/20/2015 Unable to locate. (A. Freitag - DWR Sutter Yard)06/18/2014 Unable to locate. (A. Freitag - DWR Sutter Yard)12/17/2013 Unable to locate. (A. Freitag - DWR Sutter Yard)07/18/2013 Same as last inspection. Unable to locate. (A. Freitag - DWR Sutter Yard)
FIELD_STRUCT_DESC: 1 of 3: 3-inch pipe of unknown material through the levee, 22 feet below the crown. Steel plate bolted on the landside (LS) end. Levee logs indicate pipe was plugged by USACE in 1971. [Additional Reference(s): DWR Levee Log, 1992 (HLM 0.71)].

Top of Levee: View of levee crown looking upstream

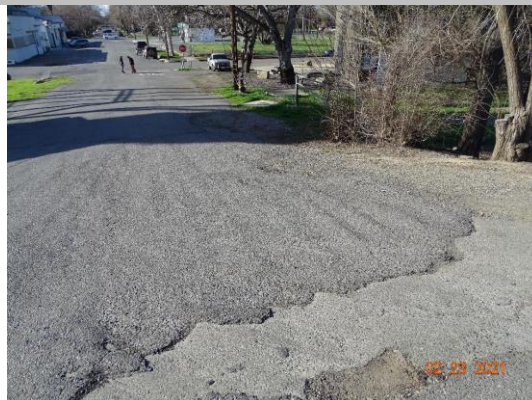
Photo 2 of 3 : UCIP_SP_2022_62859_91107.jpg

Land-Side: View of levee slope looking from crown

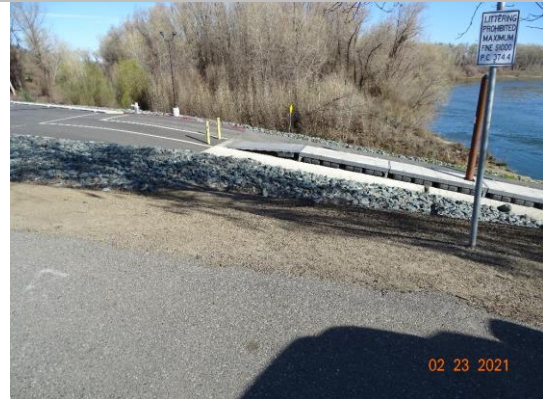
Photo 3 of 3 : UCIP_SP_2022_62859_91108.jpg

Water-Side: View of levee slope looking from crown

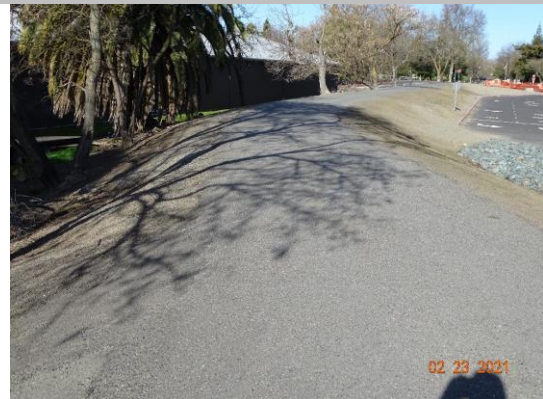
Photo 1 of 3 : UCIP_SP_2022_62860_91110.jpg

FS_ID:62860
DS_ID:17534
EP_NO: N/A
Repair Type: Non-Urgent
Crossing Status: Not Found
UCIP Comments: 02/23/2021 Record is Non-Urgent. Crossing not found. Unauthorized encroachment recorded in Levee Log prior to 2011. Unable to locate a permit and confirm proper pipe abandonment. (O.Yakimov - DWR UCIP)
04/18/2017 Unable to locate. (A. Freitag - DWR Sutter Yard)
10/24/2016 Unable to locate. (A. Freitag - DWR Sutter Yard)
04/25/2016 Unable to locate. (A. Freitag - DWR Sutter Yard)
04/20/2015 Unable to locate. (A. Freitag - DWR Sutter Yard)
06/18/2014 Unable to locate. (A. Freitag - DWR Sutter Yard)
12/17/2013 Unable to locate. (A. Freitag - DWR Sutter Yard)
07/18/2013 Same as last inspection. Unable to locate. (A. Freitag - DWR Sutter Yard)
FIELD_STRUCT_DESC: 2 of 3: 8-inch pipe through the levee 22 feet below the crown. Steel plate bolted on the landside (LS) end. Levee logs indicate pipe was plugged by USACE in 1971. [Additional Reference(s): DWR Levee Log, 1992 (HLM 0.71)].

Top of Levee: View of levee crown looking upstream

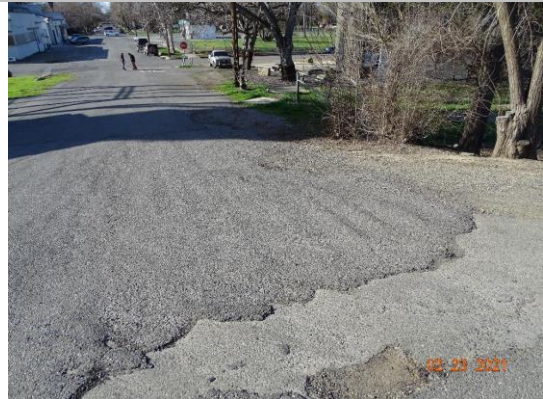
Photo 2 of 3 : UCIP_SP_2022_62860_91111.jpg

Land-Side: View of levee slope looking from crown

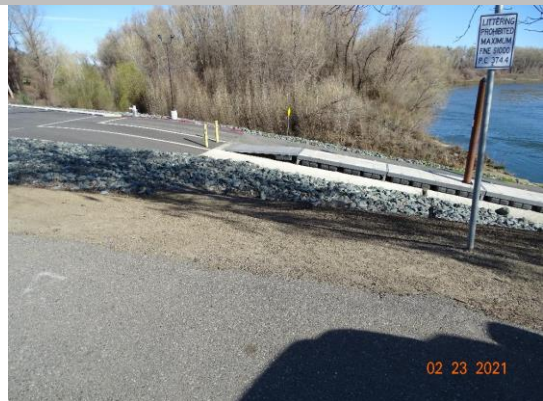
Photo 3 of 3 : UCIP_SP_2022_62860_91112.jpg

Water-Side: View of levee slope looking from crown

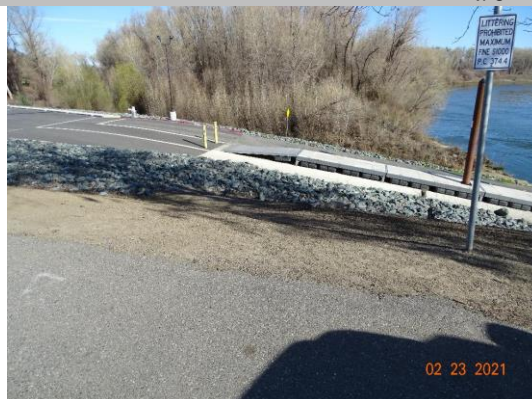
Photo 3 of 3 : UCIP_SP_2022_62861_91116.jpg

FS_ID:62861
DS_ID:17535
EP_NO: N/A
Repair Type: Non-Urgent
Crossing Status: Not Found
UCIP Comments: 02/23/2021 Record is Non-Urgent. Crossing not found. Unauthorized encroachment recorded in Levee Log prior to 2011. Unable to locate a permit and confirm proper pipe abandonment. (O.Yakimov - DWR UCIP)
04/18/2017 Unable to locate. (A. Freitag - DWR Sutter Yard)10/24/2016 Unable to locate. (A. Freitag - DWR Sutter Yard)04/25/2016 Unable to locate. (A. Freitag - DWR Sutter Yard)04/20/2015 Unable to locate. (A. Freitag - DWR Sutter Yard)06/18/2014 Unable to locate. (A. Freitag - DWR Sutter Yard)12/17/2013 Unable to locate. (A. Freitag - DWR Sutter Yard)07/18/2013 Same as last inspection. Unable to locate. (A. Freitag - DWR Sutter Yard)
FIELD_STRUCT_DESC: 3 of 3: 10-inch pipe through the levee , 22 feet below the crown. Steel plate bolted on the landside (LS) ends. According to levee logs pipe was plugged by USACE in 1971. [Additional Reference(s): DWR Levee Log, 1992 (HLM 0.71)].

Water-Side: View of levee slope looking from crown

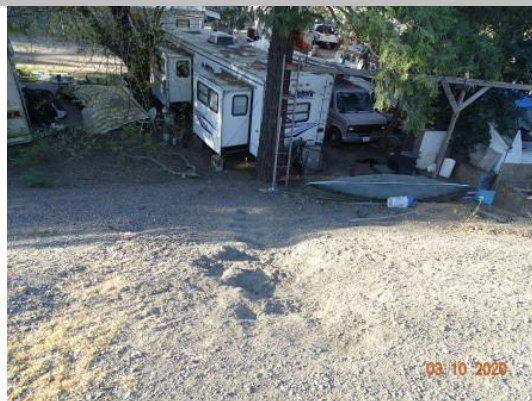
Photo 1 of 1 : SP_2022_MA0001_297_59_20220307_00013.jpg

LM Start	0.82	Rating **	M	Issue No.	59
LM End	0.82	Issue Type +	En	Location *	LS
Category	Earthen Levee			GPS Latitude/Longitude	
				Start	End
Item	Encroachments			39.217523 °	39.217523 °
				-122.014862 °	-122.014862 °
DWR ID	DWR_MA0001_01_s_2020_59				
Comment Code					
ST : Stairway					
Inspector Comment					
Stairs cut into the landside slope.

View of the stairs cut into the landside slope. Spring 2020.

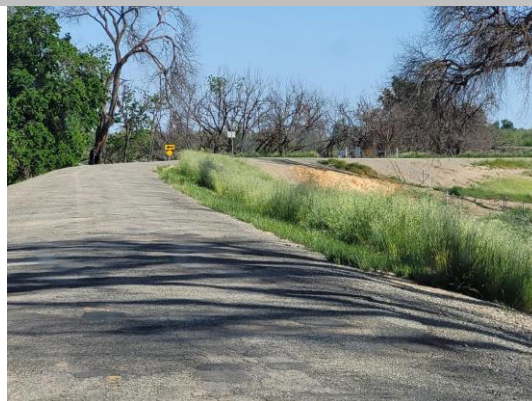
Photo 1 of 1 : SP_2022_MA0001_297_83_20220417_00192.jpg

LM Start	1.21	Rating **	M	Issue No.	83
LM End	16.55	Issue Type +	Ma	Location *	WS
Category	Earthen Levee			GPS Latitude/Longitude	
				Start	End
Item	Vegetation			39.222175 °	39.410651 °
				-122.015752 °	-122.009720 °
DWR ID	DWR_MA0001_01_s _ 2022_83				
Comment Code					
V1 : Control annual grass and weeds on the levee slopes and easements.					
Inspector Comment

View of the vegetation along the waterside slope. Spring 2022.

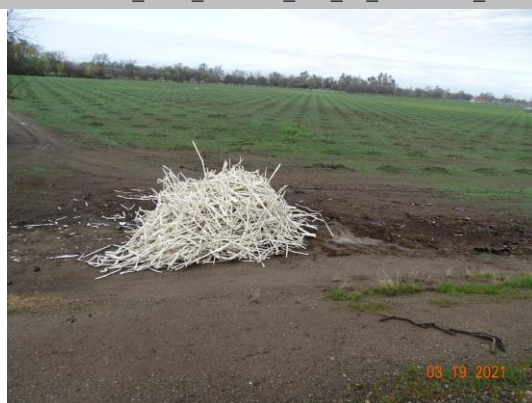
Photo 1 of 1 : SP_2022_MA0001_297_62_20220307_00014.jpg

LM Start	1.54	Rating **	M	Issue No.	62
LM End	1.54	Issue Type +	En	Location *	LS
Category	Earthen Levee			GPS Latitude/Longitude	
				Start	End
Item	Encroachments			39.226445 °	39.226445 °
				-122.014452 °	-122.014452 °
DWR ID	DWR_MA0001_01_s _ 2021_62				
Comment Code					
DE : Debris					
Inspector Comment					
Pile of PVC pipes should be removed.

View of the pile of PVC pipes at the landside toe. Spring 2021.

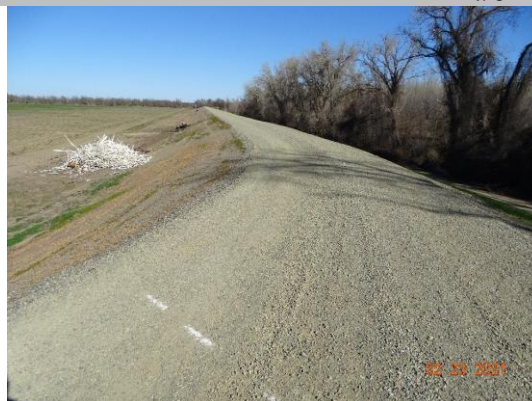
Photo 1 of 3 : UCIP_SP_2022_62866_91136.jpg

FS_ID:62866
DS_ID:16486
EP_NO: 15617
Repair Type: Non-Urgent
Crossing Status: Not Found
UCIP Comments: 02/23/2021 Record is Non-Urgent. Crossing not found. Irrigation PVC pipe debris pile on landside. (O.Yakimov - DWR UCIP)
06/01/2016 DELETE record not through levees. (A. Freitag - DWR Sutter Yard)04/25/2016 Unable to locate. (A. Freitag - DWR Sutter Yard)04/20/2015 Unable to locate. (A. Freitag - DWR Sutter Yard)06/18/2014 Unable to locate. (A. Freitag - DWR Sutter Yard)12/17/2013 Unable to locate. (A. Freitag - DWR Sutter Yard)07/18/2013 Same as last inspection. Unable to locate.
FIELD_STRUCT_DESC: *NOT THROUGH LEVEE* A portable irrigation pump on the right bank of the Sacramento River during the irrigation season. (Installation of portable irrigation pump authorized under Permit No. 15617, 1991 - Nancy Ward).
FS Date: 2/23/2021 8:56:22 AM

Top of Levee: View of levee crown looking upstream

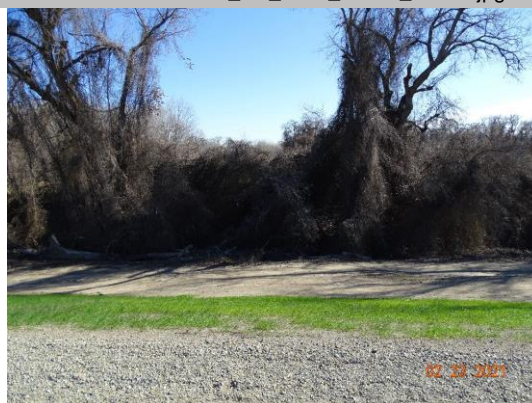
Photo 2 of 3 : UCIP_SP_2022_62866_91137.jpg

Water-Side: View of levee slope looking from crown

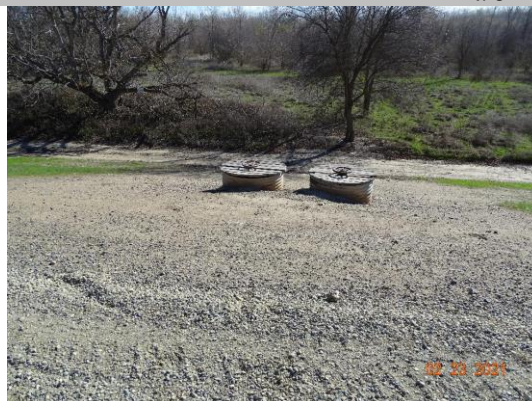
Photo 2 of 3 : UCIP_SP_2022_62869_91151.jpg

FS_ID:62869
DS_ID:16430
EP_NO: 9487
Repair Type: Urgent
Crossing Status: Found
UCIP Comments: 02/23/2021 Record updated from Non-Urgent to Urgent. DMP internal video inspection has found pipe integrity issues. LOF of crossing is between 5 and 6. Crossing will be monitored until funding becomes available to address the issues. No permit has been identified authorizing pipe. Need to have CVFPB review ABO and determine current owner. (O.Yakimov - DWR UCIP)
05/03/2017 WS end still partially plugged. (A. Freitag - DWR Sutter Yard)
10/24/2016 WS end is till partially plugged. (A. Freitag - DWR Sutter Yard)04/25/2016 WS pipe end is still plugged with soil. Rest of the pipe appeared to be in good condition. (A. Freitag - DWR Sutter Yard)04/20/2015 WS pipe end is plugged about 50% by soil. (A. Freitag - DWR Sutter Yard)06/18/2014 Same as last inspection. (A. Freitag - DWR Sutter Yard)12/17/2013 Same as last inspection. (A. Freitag - DWR Sutter Yard)07/18/2013 WS pipe end has been reformed but is still clogged about 50% by sediment.10/18/2012 Remove dirt and debris in riser. Outlet deformed and blocked over 50%. Debris-round concrete section on landward side. This crossing was listed in the USACE Periodic Inspections as ID#

Water-Side: View of levee slope looking from crown

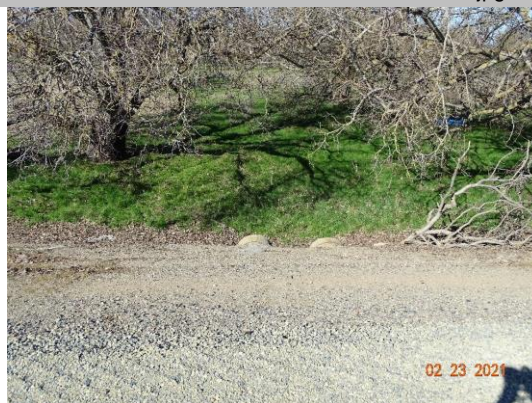
Photo 3 of 3 : UCIP_SP_2022_62869_91152.jpg

Land-Side: View of levee slope looking from crown

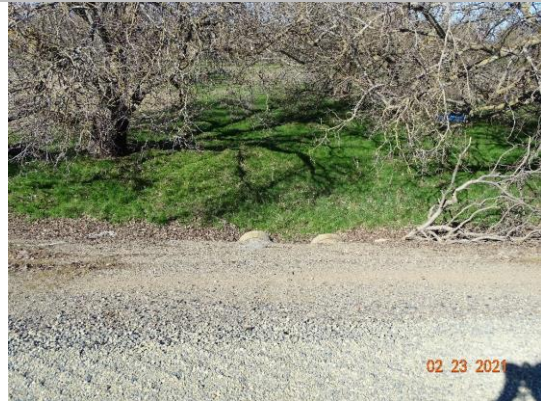
Photo 3 of 3 : UCIP_SP_2022_62871_91164.jpg

FS_ID:62871
DS_ID:17565
EP_NO: 9487
Repair Type: Urgent
Crossing Status: Found
UCIP Comments: 02/23/2021 Record updated from Non-Urgent to Urgent. DMP internal video inspection has found pipe integrity issues. LOF of crossing is between 5 and 6. Crossing will be monitored until funding becomes available to address the issues. No permit has been identified authorizing pipe. Need to have CVFPB review ABO and determine current owner. (O.Yakimov - DWR UCIP)
05/03/2017 WS end still partially plugged. (A. Freitag - DWR Sutter Yard)10/24/2016 WS pipe end still plugged. (A. Freitag - DWR Sutter Yard)04/25/2016 WS pipe end still plugged with soil. rest of pipe appears in good condition. (A. Freitag - DWR Sutter Yard)04/20/2015 WS pipe end plugged about 50% by soil. (A. Freitag - DWR Sutter Yard)06/18/2014 Same as last inspection. (A. Freitag - DWR Sutter Yard)12/17/2013 Same as last inspection. (A. Freitag - DWR Sutter Yard)07/18/2013 WS pipe end has been reformed but is still partially blocked with dirt and debris.10/18/2012 WS-remove dirt and debris in riser. Outlet deformed and blocked over 50%. Burrow activity near outlet on waterward slope. Debris around concrete section on landward side. This crossing was listed in the USACE Periodic Inspections as ID# USACE_CESPK_MA1C_2010_p_0116 for crossing outlet deformed and clogged with dirt. (O. Magana - DWR UCIP)

Land-Side: View of levee slope looking from crown

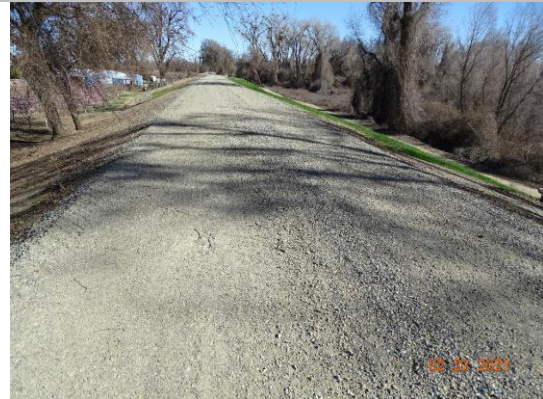
Photo 1 of 3 : UCIP_SP_2022_62873_91178.jpg

FS_ID:62873
DS_ID:16428
EP_NO: 9467
Repair Type: Non-Urgent
Crossing Status: Found
UCIP Comments: 02/23/2021 Record remains Non-Urgent.
Geophysical study indicates possible presence of pipe through levee. Owner needs to coordinate with the CVFPB to remove or abandon crossing according to Title 23 requirements. Crossing appears abandoned. Pipe ends on both slopes are buried in soil. No permit has been identified authorizing pipe. Need to have CVFPB review ABO and determine current owner. (O.Yakimov - DWR UCIP)
05/03/2017 Abandoned- needs to be done so properly. (A. Freitag - DWR Sutter Yard)10/24/2016 Abandoned. (A. Freitag - DWR Sutter Yard)04/25/2016 Abandoned crossing. Unable to locate any WS and LS pipe ends. (A. Freitag - DWR Sutter Yard)04/20/2015 Same as last inspection. (A. Freitag - DWR Sutter Yard)06/18/2014 Same as last inspection. (A. Freitag - DWR Sutter Yard)12/17/2013 Same as last inspection. (A. Freitag - DWR Sutter Yard)07/18/2013 Same as last inspection. (A. Freitag - DWR Sutter Yard)10/18/2012 Only riser visible. Debris and sediment blocking gate. Gate inside riser is buried and non-functional. If crossing is abandoned, owner needs to properly abandon. This crossing was listed in the USACE Periodic Inspections as ID# USACE_CESPK_MA1C_2010_p_0132 no culvert through the levee is visible here. (O. Magana - DWR UCIP)

FIELD_STRUCT_DESC: 24-inch corrugated metal drainage pipe through the levee, approximately 12-15 feet below the crown. Slide gate in CM pipe riser on the waterside (WS) slope. No signs of inlet visible on the landside (LS). (24-inch pipe [HLM 2.31] authorized under Automatic Board Order (ABO) issued as Permit No. 9467, 1974 - Lovell E. Spurgeon). [Additional Reference(s): DWR Levee Log, 1992 (HLM 2.31). USACE Sacramento O&M Manual, Unit 137, August 1955, Revised 29 December 2016, (STA 120+60), listed as 24-inch pipe].
FS Date: 2/23/2021 9:30:51 AM

Top of Levee: View of levee crown looking upstream

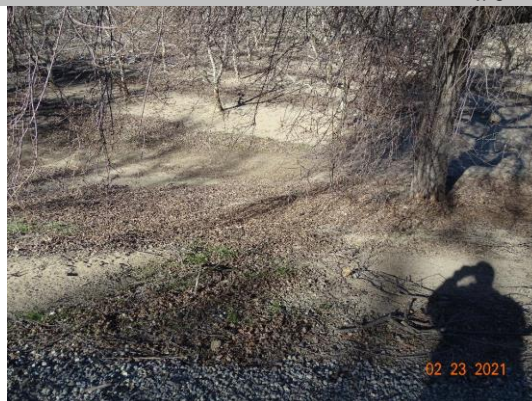
Photo 2 of 3 : UCIP_SP_2022_62873_91177.jpg

Land-Side: View of levee slope looking from crown

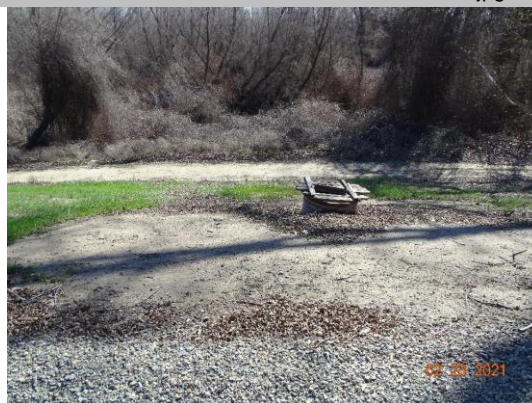
Photo 3 of 3 : UCIP_SP_2022_62873_91176.jpg

Water-Side: View of levee slope looking from crown. CMP riser on levee slope

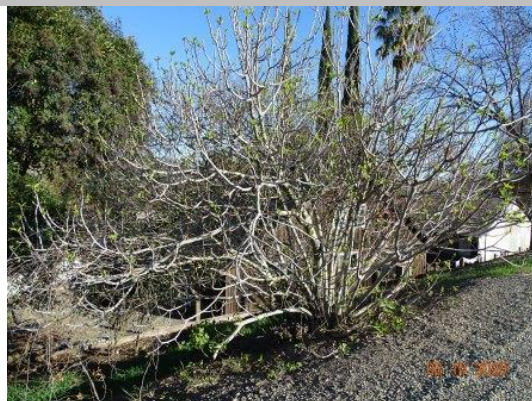
Photo 1 of 1 : SP_2022_MA0001_297_88_20220307_00022.jpg

LM Start	2.53	Rating **	M	Issue No.	88
LM End	2.53	Issue Type +	En	Location *	LS
Category	Earthen Levee			GPS Latitude/Longitude	
				Start	End
Item	Vegetation			39.239764 °	39.239764 °
				-122.010397 °	-122.010397 °
DWR ID	DWR_MA0001_01_s _ 2019_88				
Comment Code					
V6 : Landscaping					
Inspector Comment					
The fig tree should be removed from the landside shoulder.

View of the fig tree on the landside shoulder. Spring 2020.

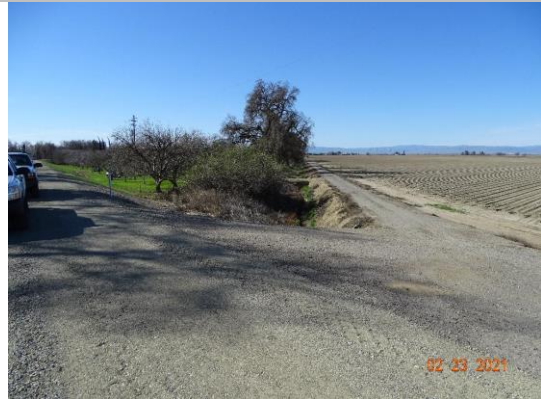
Photo 2 of 3 : UCIP_SP_2022_62892_91311.jpg

FS_ID:62892
DS_ID:16416
EP_NO: 9474
Repair Type: Urgent
Crossing Status: Found
UCIP Comments: 02/23/2021 Record updated from Non-Urgent to Urgent. Missing slide gate on pipe in concrete box on waterside slope creates flood threat to landside. Crossing appears abandoned. Concrete box on waterside filled with soil, soil deposits inside and around pipe end on landside. No permit has been identified authorizing pipe. Need to have CVFPB review ABO and determine current owner. (O.Yakimov - DWR UCIP)
05/03/2017 Appears abandoned- WS vault full of soil. Needs to be abandoned properly. (A. Freitag - DWR Sutter Yard)10/24/2016 Appears to be abandoned. WS vault full of soil to help prevent water from flowing through during high water season. (A. Freitag - DWR Sutter Yard)04/25/2016 Concrete box was filled with dirt to help prevent water from through during high water times. (A. Freitag - DWR Sutter Yard)04/20/2015 Positive closure device is missing and water cannot be prevented from flowing through pipe during high water. (A. Freitag - DWR Sutter Yard)06/18/2014 Same as last inspection. (A. Freitag - DWR Sutter Yard)12/17/2013 Same as last inspection. (A. Freitag - DWR Sutter Yard)07/18/2013 Same as last inspection. (A. Freitag - DWR Sutter Yard)10/18/2012 During high water flow goes through levee. Missing positive closure device on waterward side. This structure appears abandoned-slide gates have been removed. Crossing needs to be properly abandoned. This crossing was listed in the USACE Periodic Inspection as ID# USACE_CESPK_MA1C_2010_p_0169 for concrete box partially filled with dirt. (O. Magana - DWR UCIP)

LM Start	2.81	Rating **	U	Issue No.	20 (cont)
LM End	2.81	Issue Type +	En	Location *	
Category	Supplemental		GPS Latitude/Longitude		
			Start	End	
Item	DWR UCIP Field Study		39.243410 °	39.243410 °	
			-122.008393 °	-122.008393 °	
DWR ID	16416

Land-Side: View of levee slope looking from crown

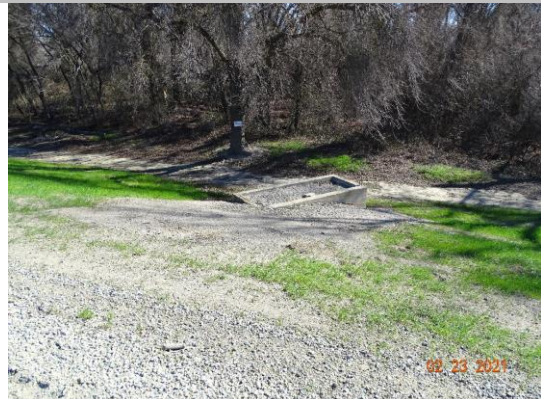
Photo 3 of 3 : UCIP_SP_2022_62892_91310.jpg

LM Start	2.81	Rating **	U	Issue No.	20 (cont)
LM End	2.81	Issue Type +	En	Location *

Water-Side: View of levee slope looking from crown

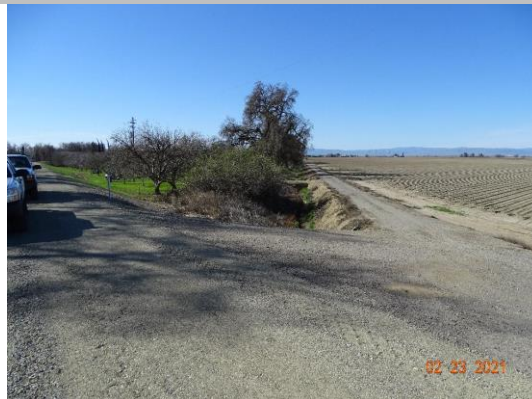
Photo 2 of 3 : UCIP_SP_2022_62894_91326.jpg

FS_ID:62894
DS_ID:17567
EP_NO: 9474
Repair Type: Urgent
Crossing Status: Found
UCIP Comments: 02/23/2021 Record updated from Non-Urgent to Urgent. Missing slide gate on pipe in concrete box on waterside slope creates flood threat to landside. Crossing appears abandoned. Concrete box on waterside filled with soil, soil deposits inside and around pipe end on landside. No permit has been identified authorizing pipe. Need to have CVFPB review ABO and determine current owner. (O.Yakimov - DWR UCIP)
05/03/2017 Appears abandoned- WS vault full of soil. Needs to be abandoned properly. (A. Freitag - DWR Sutter Yard)10/24/2016 Appears to be abandoned. WS vault full of soil to help prevent water from flowing through during high water season. (A. Freitag - DWR Sutter Yard)04/25/2016 Concrete box on WS was filled with soil to help prevent water form flowing through during times of high water. (A. Freitag - DWR Sutter Yard)04/20/2015 Positive closure device is missing and water cannot be prevented from flowing through pipe during high water. (A. Freitag - DWR Sutter Yard)06/18/2014 Same as last inspection. (A. Freitag - DWR Sutter Yard)12/17/2013 Same as last inspection. (A. Freitag - DWR Sutter Yard)07/18/2013 Same as last inspection. (A. Freitag - DWR Sutter Yard)10/18/2015 During high water flow goes through levee. Missing positive closure device on waterward side. This structure appears abandoned-slide gates have been removed. Crossing needs to be properly abandoned. This crossing was listed in the USACE Periodic Inspection as ID# USACE_CESPK_MA1C_2010_p_0169 for concrete box partially filled with dirt. (O. Magana - DWR UCIP)

LM Start	2.81	Rating **	U	Issue No.	21 (cont)
LM End	2.81	Issue Type +	En	Location *	
Category	Supplemental		GPS Latitude/Longitude		
			Start	End	
Item	DWR UCIP Field Study		39.243433 °	39.243433 °	
			-122.008386 °	-122.008386 °	
DWR ID	17567

Land-Side: View of levee slope looking from crown

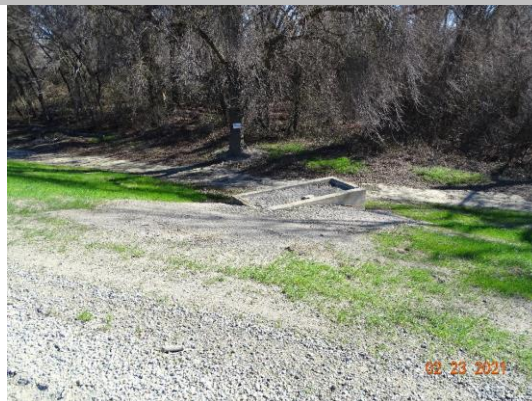
Photo 3 of 3 : UCIP_SP_2022_62894_91325.jpg

LM Start	2.81	Rating **	U	Issue No.	21 (cont)
LM End	2.81	Issue Type +	En	Location *

Water-Side: View of levee slope looking from crown

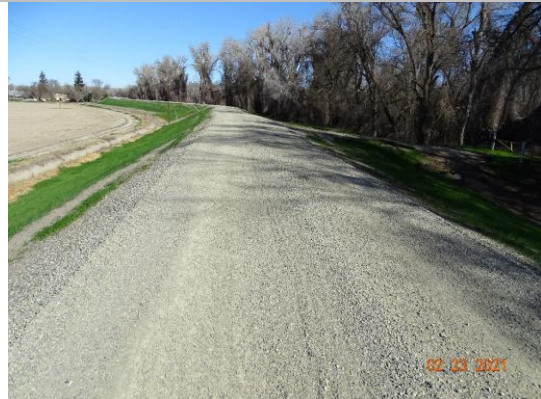
Photo 1 of 3 : UCIP_SP_2022_62895_91327.jpg

FS_ID:62895
DS_ID:17660
EP_NO: 1675
Repair Type: Non-Urgent
Crossing Status: Not Found
UCIP Comments: 02/23/2021 Record is Non-Urgent. Crossing not found. Geophysical results did not confirm presence of pipe through levee. Record will remain in UCIP's inspection records until future Levee Improvement Project can confirm no crossing was found through the levee. No permit has been identified authorizing pipe. (O.Yakimov - DWR UCIP)
05/03/2017 Unable to locate. (A. Freitag - DWR Sutter Yard)
10/24/2016 Unable to locate. (A. Freitag - DWR Sutter Yard)
04/25/2016 Unable to locate. (A. Freitag - DWR Sutter Yard)
04/20/2015 Unable to locate. (A. Freitag - DWR Sutter Yard)
06/18/2014 Unable to locate. (A. Freitag - DWR Sutter Yard)
12/17/2013 Unable to locate. (A. Freitag - DWR Sutter Yard)
07/18/2013 Same as last inspection. Unable to locate. (A. Freitag - DWR Sutter Yard)
FIELD_STRUCT_DESC: 30-inch corrugated metal irrigation pipe through the levee, approximately 12-15 feet below the crown. Slide gate on the outlet end of the pipe. Concrete spillbox on the waterside (WS).

LM Start	2.90	Rating **	M	Issue No.	22 (cont)
LM End	2.90	Issue Type +	En	Location *

Top of Levee: View of levee crown looking upstream

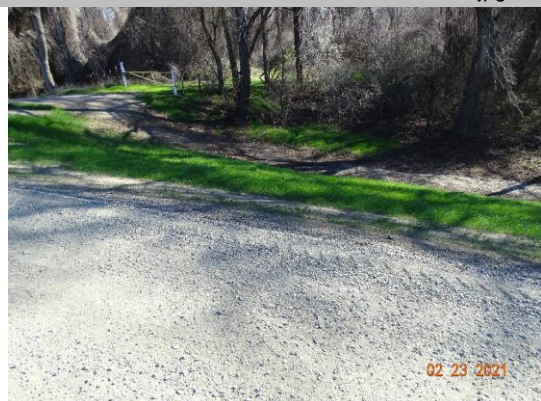
Photo 2 of 3 : UCIP_SP_2022_62895_91328.jpg

Water-Side: View of levee slope looking from crown

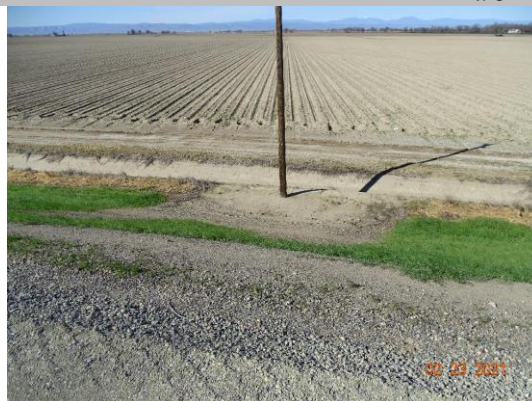
Photo 3 of 3 : UCIP_SP_2022_62895_91329.jpg

LM Start	2.90	Rating **	M	Issue No.	22 (cont)
LM End	2.90	Issue Type +	En	Location *	
Category	Supplemental		GPS Latitude/Longitude		
			Start	End	
Item	DWR UCIP Field Study		39.244650 °	39.244650 °	
			-122.007918 °	-122.007918 °	
DWR ID	17660

Land-Side: View of levee slope looking from crown

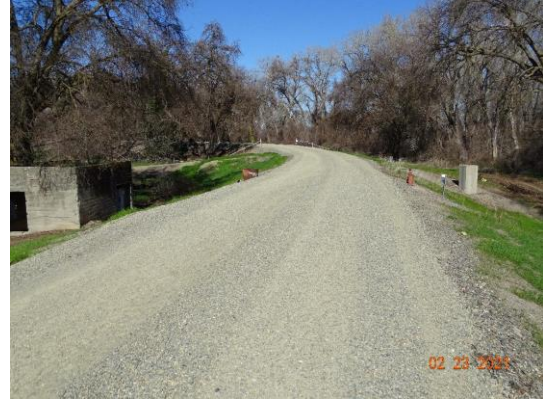
Photo 1 of 3 : UCIP_SP_2022_62897_91349.jpg

FS_ID:62897
DS_ID:16436
EP_NO: 4213
Repair Type: Urgent
Crossing Status: Found
UCIP Comments: 02/23/2021 Record remains Urgent. Existing sinkhole in pipe alignment at pumphouse wall measures 5 feet in diameter and about 1 foot deep. Recommend owner perform pipe integrity test. (O.Yakimov - DWR UCIP)
10/01/2018 Sinkhole near concrete structure on the LS was filled with soil and debris. Flow meter at the WS shoulder and a manometer on the pipe on the LS shoulder was installed. Video inspection is recommended to determine pipe integrity through levee. (O.Yakimov - DWR UCIP)05/03/2017 Sinkhole still present next to concrete structure on LS. (A. Freitag - DWR Sutter Yard)10/24/2016 Pump is on WS. Sinkhole still present over pipe alignment next to the concrete building. (A. Freitag - DWR Sutter Yard)04/25/2016 No repairs have been made since last inspection. Sink holes are still present above pipe next to concrete building on LS. (A. Freitag - DWR Sutter Yard)04/20/2015 Sink hole over pipe alignment on LS up against the concrete building. Need to dig up pipe and see if its leaking. (A. Freitag - DWR Sutter Yard)06/23/2014 Same as last inspection. (A. Freitag - DWR Sutter Yard)06/18/2014 Same as last inspection. (A. Freitag - DWR Sutter Yard)12/17/2013 Same as last inspection. (A. Freitag - DWR Sutter Yard)07/18/2013 Same as last inspection. (A. Freitag - DWR Sutter Yard)10/19/2012 Recommend adding door to LS concrete structure. Riser located on landward side is damaged. This crossing was listed in the USACE Periodic Inspection as ID# USACE_CESPK_MA1C_2010_p_0194 no issues logged. (O. Magana - DWR UCIP)

FIELD_STRUCT_DESC: 24-inch asphalt coated steel irrigation pipe through the levee, approximately 10 feet below the crown. Gate valve and flow meter on the waterside (WS) shoulder. 1-1/4 inch conduit through the levee. Siphon breaker on the landside (LS) shoulder. Concrete distribution box and control box located on the LS. Pump and walkway located on the WS berm. This crossing replaces 24-inch pipe (see DSID 25707). (24-inch pipe authorized under Permit No. 4213, 1963 - N.J. Scott Ranch). [Additional Reference(s): DWR Levee Log, 1992 (HLM 3.77)].
FS Date: 2/23/2021 2:07:42 PM

Top of Levee: View of levee crown looking upstream

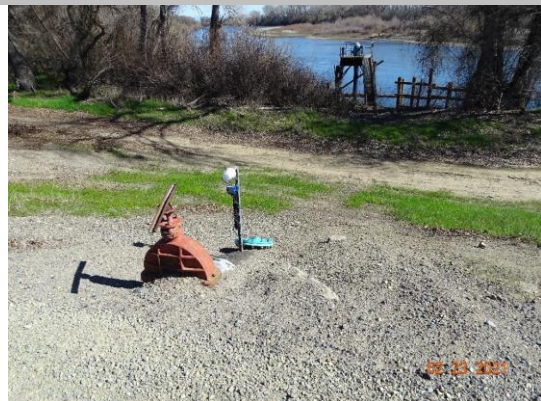
Photo 3 of 3 : UCIP_SP_2022_62897_91345.jpg

LM Start	3.68	Rating **	U	Issue No.	25 (cont)
LM End	3.68	Issue Type +	En	Location *

Water-Side: View of levee slope looking from crown

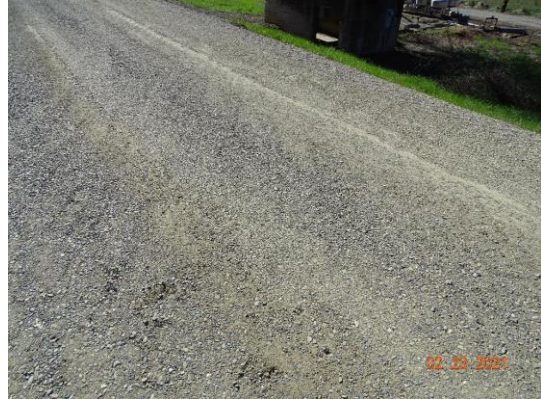
Photo 1 of 3 : UCIP_SP_2022_62898_91352.jpg

Comment Code					
Inspector Comment					
FS_ID:62898 DS_ID:16424 EP_NO: 9490 Repair Type: Non-Urgent Crossing Status: Found UCIP Comments: 02/23/2021 Record remains Non-Urgent. Crossing appears abandoned. Abandoned pump located inside of concrete distribution box at landside levee toe. Concrete box open at ground level creates fall hazard. Pipe not found on waterside. No permit has been identified authorizing pipe. Need to have CVFPB review ABO and determine current owner. (O.Yakimov - DWR UCIP) 05/03/2017 Abandoned- Needs to be done properly. (A. Freitag - DWR Sutter Yard)10/24/2016 Abandoned. Needs a cover made for the LS distribution box. (A. Freitag - DWR Sutter Yard)04/25/2016 ABANDONED crossing and should be abandoned properly. Concrete distribution box on LS is opened on top and could pose a safety hazard with falling. (A. Freitag - DWR Sutter Yard)04/20/2015 Same as last inspection. (A. Freitag - DWR Sutter Yard) 06/18/2014 Same as last inspection. (A. Freitag - DWR Sutter Yard)12/17/2013 Same as last inspection. (A. Freitag - DWR Sutter Yard)07/18/2013 Same as last inspection. (A. Freitag - DWR Sutter Yard)10/19/2012 Crossing needs to be properly abandoned. This crossing was listed in the USACE Periodic Inspection as ID# USACE_CESPK_MA1C_2010_p_0194-6 & 7 no issues logged. (O. Magana - DWR UCIP) FIELD_STRUCT_DESC: 36-inch corrugated metal irrigation pipe through the levee, approximately 12-15 feet below the crown. Concrete distribution box with pump system located on the landside (LS). Slide gate on the waterside (WS) slope--removed. 18-inch pipe visible on the LS inside 10-foot by 16-foot concrete box. Pipe crossing levee at angle. (36-inch pipe [HLM 3.78] authorized under Automatic Board Order (ABO) issued as Permit No. 9490, 1974 - Charles and Virginia Yerxa). [Additional Reference(s): DWR Levee Log, 1992 (HLM 3.78), referenced as abandoned 36-inch CMP-inch pipe.USACE Sacramento O&M Manual, Unit 137, August 1955, Revised 29 December 2016, (STA 197+19), listed as 36-inch pipe]. FS Date: 2/23/2021 2:11:35 PM

Top of Levee: View of levee crown looking towards landside

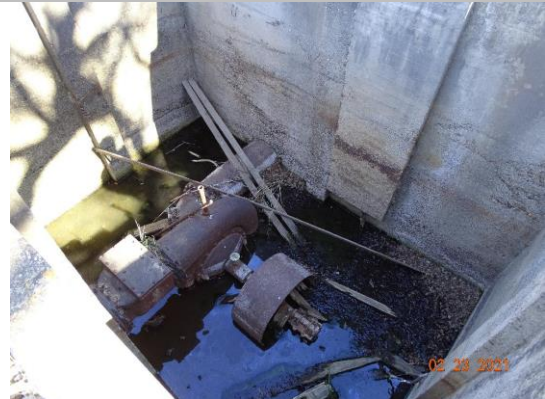
Photo 2 of 3 : UCIP_SP_2022_62898_91353.jpg

LM Start	3.69	Rating **	M	Issue No.	27 (cont)
LM End	3.69	Issue Type +	En	Location *	
Category	Supplemental			GPS Latitude/Longitude	
				Start	End
Item	DWR UCIP Field Study			39.255936 °	39.255936 °
				-122.009787 °	-122.009787 °
DWR ID	16424

Land-Side: Abandoned pipe and pump inside of concrete box

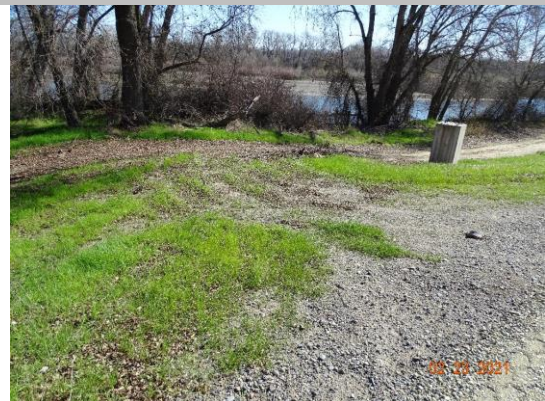
Photo 3 of 3 : UCIP_SP_2022_62898_91351.jpg

LM Start	3.69	Rating **	M	Issue No.	27 (cont)
LM End	3.69	Issue Type +	En	Location *

Water-Side: View of levee slope looking from crown

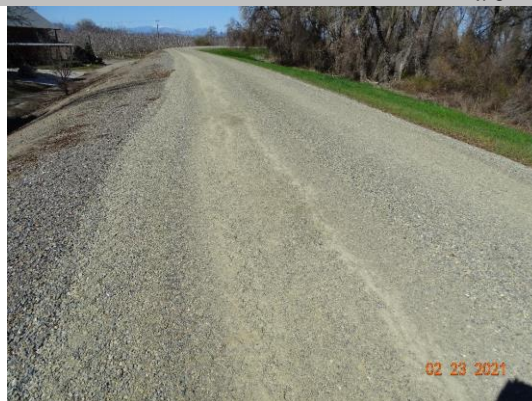
Photo 1 of 3 : UCIP_SP_2022_62900_91370.jpg

Comment Code						
Inspector Comment						
FS_ID:62900 DS_ID:17659 EP_NO: N/A Repair Type: Non-Urgent Crossing Status: Not Found UCIP Comments: 02/23/2021 Record remains Non-Urgent. Crossing not found. Geophysical results did not confirm presence of pipe through levee. Record will remain in UCIP's inspection records until future Levee Improvement Project can confirm no crossing was found through the levee. No permit has been identified authorizing pipe. Updated coordinates of crossing to match location to O&M (STA 198+00). (O.Yakimov - DWR UCIP) 05/03/2017 Unable to locate. (A. Freitag - DWR Sutter Yard) 10/24/2016 Unable to locate. (A. Freitag - DWR Sutter Yard) 04/25/2016 Unable to locate. (A. Freitag - DWR Sutter Yard) 04/20/2015 Same as last inspection. (A. Freitag - DWR Sutter Yard) 06/18/2014 Same as last inspection. (A. Freitag - DWR Sutter Yard) 12/17/2013 Same as last inspection. (A. Freitag - DWR Sutter Yard) 07/18/2013 Same as last inspection. (A. Freitag - DWR Sutter Yard) 10/19/2012 USA flag markers show some type of alignment on LS. Unable to determine if crossing still exists at this location. (O. Magana - DWR UCIP) FIELD_STRUCT_DESC: 18-inch steel drainage pipe through the levee at an unknown depth below the crown. Automatic drainage gate on the outlet end of the pipe. [Additional Reference(s): USACE Sacramento O&M Manual, Unit 137, August 1955, Revised 29 December 2016, (STA 198+00), listed as 18-inch pipe]. FS Date: 2/23/2021 2:19:54 PM

Top of Levee: View of levee crown looking upstream

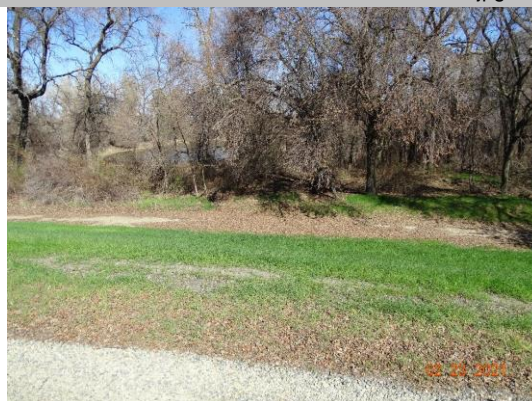
Photo 3 of 3 : UCIP_SP_2022_62900_91372.jpg

LM Start	3.72	Rating **	M	Issue No.	30 (cont)
LM End	3.72	Issue Type +	En	Location *

Water-Side: View of levee slope looking from crown

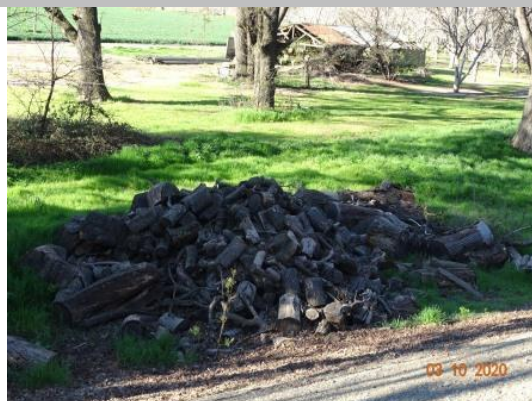
Photo 1 of 1 : SP_2022_MA0001_297_102_20220307_00027.jpg

LM Start	3.73	Rating **	M	Issue No.	102
LM End	3.73	Issue Type +	En	Location *	LS
Category	Earthen Levee			GPS Latitude/Longitude	
				Start	End
Item	Encroachments			39.256321 °	39.256321 °
				-122.010220 °	-122.010220 °
DWR ID	DWR_MA0001_01_s_2019_102				
Comment Code					
FW : Firewood					
Inspector Comment					
The firewood should be removed from the landside toe.

View of the pile of firewood at the landside toe. Spring 2020.

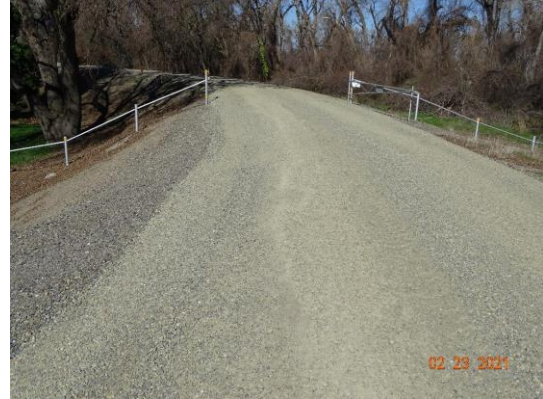
Photo 1 of 3 : UCIP_SP_2022_62899_91366.jpg

Comment Code					
Inspector Comment					
FS_ID:62899 DS_ID:16423 EP_NO: 9489 Repair Type: Non-Urgent Crossing Status: Found UCIP Comments: 02/23/2021 Record remains Non-Urgent. No permit has been identified authorizing pipe. Need to have CVFPB review ABO and determine current owner. Recommend clearing pipe outlet from debris. (O.Yakimov - DWR UCIP) 05/03/2017 Appears abandoned- if so needs to be done properly. (A. Freitag - DWR Sutter Yard)10/24/2016 Crossing appears abandoned. (A. Freitag - DWR Sutter Yard)04/25/2016 Crossing appears abandoned and should be abandoned properly. (A. Freitag - DWR Sutter Yard)04/20/2015 Same as last inspection. (A. Freitag - DWR Sutter Yard)06/18/2014 Same as last inspection. (A. Freitag - DWR Sutter Yard)12/17/2013 Same as last inspection. (A. Freitag - DWR Sutter Yard)07/18/2013 Same as last inspection. (A. Freitag - DWR Sutter Yard)10/19/2012 Slide gate wheel handle missing. Clear debris from CMP riser. This crossing was listed in the USACE Periodic Inspection as ID# USACE_CESPK_MA1C_2010_p_0196 for access box contains backfilled (permanently shut) and outlet located on landside has sediment build up. (O. Magana - DWR UCIP) FIELD_STRUCT_DESC: 36-inch corrugated metal irrigation pipe through the levee at an unknown depth below the crown. Slide gate in corrugated metal pipe (CMP) riser on the waterside (WS) slope. 6-foot by 6-foot concrete box on the WS berm. Additional 12-inch pipe inside concrete distribution box. (36-inch pipe [HLM 3.80] authorized under Automatic Board Order (ABO) issued as Permit No. 9489, 1974 - Mayfar Farms Inc). [Additional Reference(s): DWR Levee Log, 1992 (HLM 3.80). USACE Sacramento O&M Manual, Unit 137, August 1955, Revised 29 December 2016, (STA 198+00), listed as 36-inch pipe]. FS Date: 2/23/2021 2:13:42 PM

Top of Levee: View of levee crown looking upstream

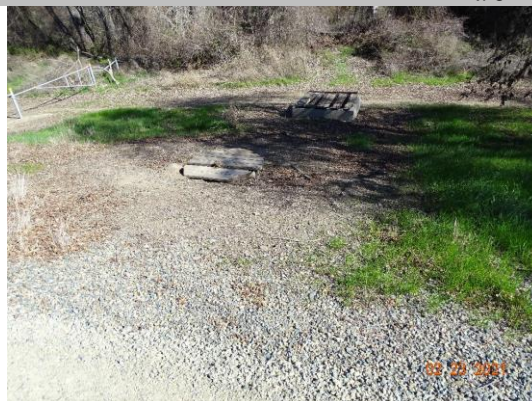
Photo 2 of 3 : UCIP_SP_2022_62899_91367.jpg

LM Start	3.77	Rating **	M	Issue No.	31 (cont)
LM End	3.77	Issue Type +	En	Location *	
Category	Supplemental		GPS Latitude/Longitude		
			Start	End	
Item	DWR UCIP Field Study		39.256203 °	39.256203 °	
			-122.009940 °	-122.009940 °	
DWR ID	16423

Water-Side: View of levee slope looking from crown

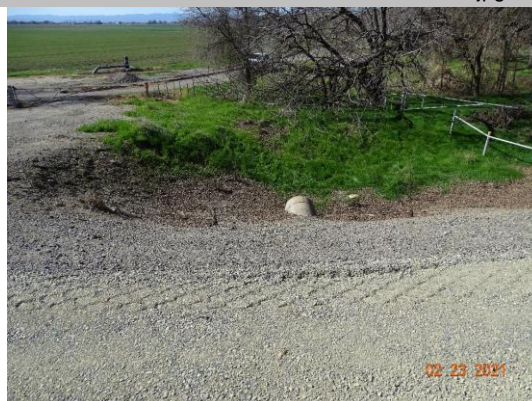
Photo 3 of 3 : UCIP_SP_2022_62899_91368.jpg

LM Start	3.77	Rating **	M	Issue No.	31 (cont)
LM End	3.77	Issue Type +	En	Location *

Land-Side: View of levee slope looking from crown

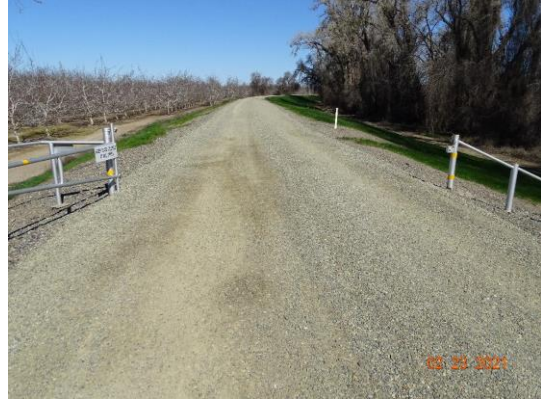
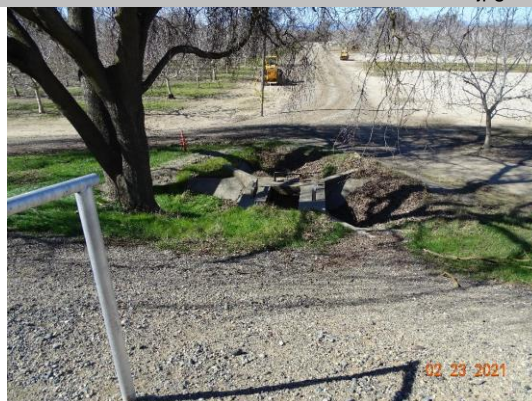
Photo 1 of 3 : UCIP_SP_2022_62902_91393.jpg

Comment Code					
Inspector Comment					
FS_ID:62902 DS_ID:16422 EP_NO: N/A Repair Type: Urgent Crossing Status: Found UCIP Comments: 02/23/2021 Record updated from Non-Urgent to Urgent. DMP internal video inspection has found pipe integrity issues. LOF of crossing is between 5 and 6. Crossing will be monitored until funding becomes available to address the issues. Debris and sediment need to be cleared around screw gate on waterside slope for proper operation. Unauthorized encroachment recorded in Levee Log prior to 2011. (O.Yakimov - DWR UCIP) 05/03/2017 Appears abandoned- needs to be done so properly. (A. Freitag - DWR Sutter Yard)10/24/2016 Appears to be abandoned. (A. Freitag - DWR Sutter Yard)04/25/2016 Appears to be an abandoned crossing. (A. Freitag - DWR Sutter Yard) 04/20/2015 Debrs is still blocking gate. Appears to be an abandoned crossing. (A. Freitag - DWR Sutter Yard)06/18/2014 Same as last inspection. (A. Freitag - DWR Sutter Yard)12/17/2013 Same as last inspection. (A. Freitag - DWR Sutter Yard)07/18/2013 Wheel to operate slide gate has been replaced but gate is still blocked by debris.10/19/2012 WS-wheel to operate slide gate missing, walkway has been removed; burrow activity near structure; debris in concrete distribution box WS blocking gate. This crossing was listed in the USACE Periodic Inspection as ID# USACE_CESPK_MA1C_2010_p_0207 the wheel to operate sluice gate missing. (O. Magana - DWR UCIP) FIELD_STRUCT_DESC: 24-inch drainage pipe of an unknown material through the levee, unknown depth below the crown. Walkway to slide gate on the waterside (WS) end. Walkway has been removed. Flap gate in concrete distribution box at the landside (LS) toe. [Additional Reference(s): DWR Levee Log, 1992 (HLM 4.05)]. FS Date: 2/23/2021 2:23:36 PM

LM Start	3.95	Rating **	U	Issue No.	32 (cont)
LM End	3.95	Issue Type +	En	Location *	
Category	Supplemental		GPS Latitude/Longitude		
			Start	End	
Item	DWR UCIP Field Study		39.258073 °	39.258073 °	
			-122.013165 °	-122.013165 °	
DWR ID	16422

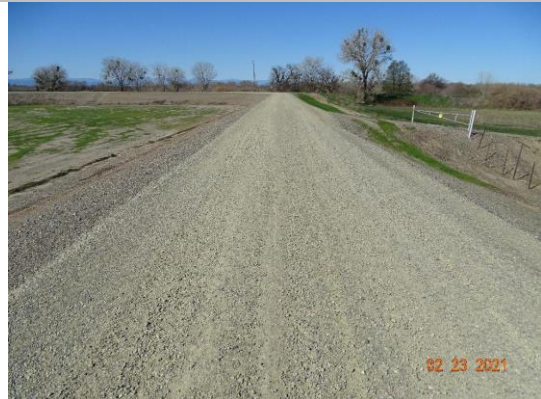
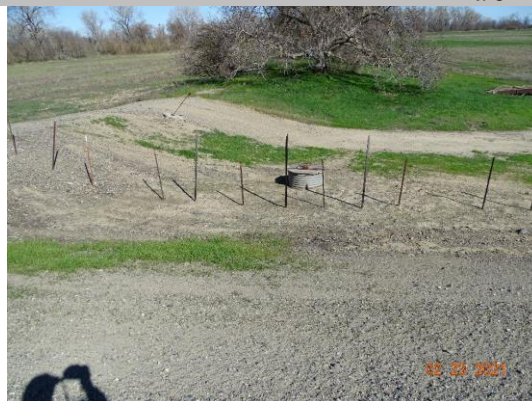
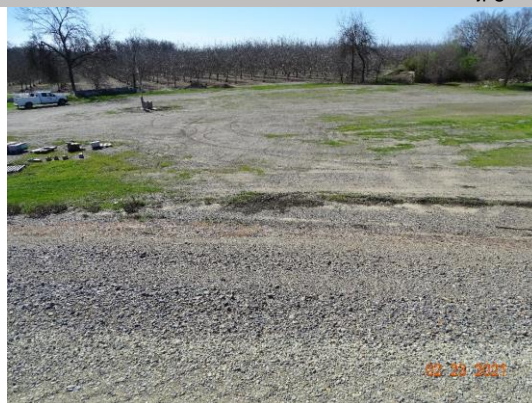
Photo 1 of 3 : UCIP_SP_2022_62905_91405.jpg

Comment Code					
Inspector Comment					
FS_ID:62905 DS_ID:16421 EP_NO: 9475 Repair Type: Non-Urgent Crossing Status: Found UCIP Comments: 02/23/2021 Record remains Non-Urgent. Crossing appears abandoned. Pipe not found on landside. Screw gate in CMP riser on waterside is in closed position. Abandoned structure on landside appears to be remainings of old pumphouse. Recommend owner to contact CVFPB to abandon or remove pipe from levee. No permit has been identified authorizing pipe. Need to have CVFPB review ABO and determine current owner. (O.Yakimov - DWR UCIP) 05/03/2017 Abandoned- only WS standpipe visible. (A. Freitag - DWR Sutter Yard)10/24/2016 Appears to be abandoned. (A. Freitag - DWR Sutter Yard)04/25/2016 Abandoned crossing. Only WS standpipe is visible. (A. Freitag - DWR Sutter Yard)04/20/2015 Same as last inspection. (A. Freitag - DWR Sutter Yard)06/18/2014 Same as last inspection. (A. Freitag - DWR Sutter Yard)12/17/2013 Same as last inspection. (A. Freitag - DWR Sutter Yard)07/18/2013 Same as last inspection. (A. Freitag - DWR Sutter Yard)10/19/2012 Burrow activity; limited visibility of this crossing only on WS riser. This crossing was listed in the USACE Periodic Inspection as ID# USACE_CESPK_MA1C_2010_p_0207 the wheel to operate sluice gate missing. Issue addressed wheel to slide gate has been installed. (O. Magana - DWR UCIP) FIELD_STRUCT_DESC: 30-inch corrugated metal irrigation pipe through the levee, 16.1 feet below the crown. Slide gate inside corrugated metal pipe (CMP) riser located on the waterside (WS) end. Line buried on the WS and landside (LS). (30-inch pipe [HLM 4.76] authorized under Automatic Board Order (ABO) issued as Permit No. 9475, 1974 - Mattie B. Zumwalt Co). [Additional Reference(s): DWR Levee Log, 1992 (HLM 4.76). USACE Sacramento O&M Manual, Unit 137, August 1955, Revised 29 December 2016, (STA 247+86), listed as 30-inch pipe]. FS Date: 2/23/2021 2:54:56 PM

LM Start	4.65	Rating **	M	Issue No.	33 (cont)
LM End	4.65	Issue Type +	En	Location *	
Category	Supplemental			GPS Latitude/Longitude	
				Start	End
Item	DWR UCIP Field Study			39.266435 °	39.266435 °
				-122.010943 °	-122.010943 °
DWR ID	16421
