**Flood Control Project Maintenance
Levee Inspections
LMA District Cover Sheet**

Sutter Maintenance Yard Maintenance Area 0001

Waterway			Bank	Unit Miles
Unit No. 01 Sacramento River			Right	16.76
	Spring (March - May)	Summer (June - August)	(September - November) Fall	Winter (December - February)
Unit Maintenance Rating (Fall Only)				
Date of Inspection	4/5/2022 - 4/5/2022			
DWR Inspector	Makar Sokol			
Accompanied By	Gregg Ahlers DWR Sutter Yard

Levee Inspection Report By Mile - Spring 2022

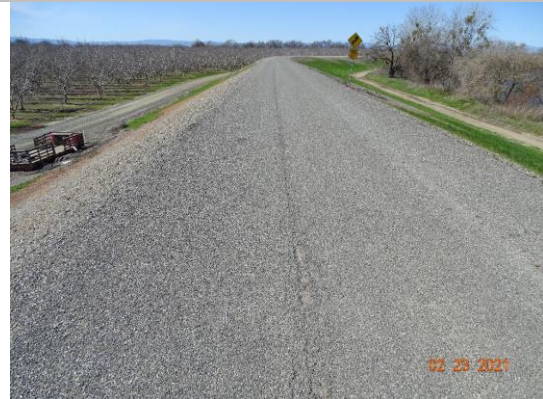
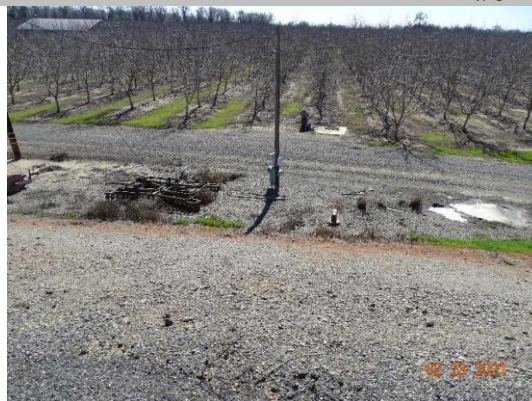
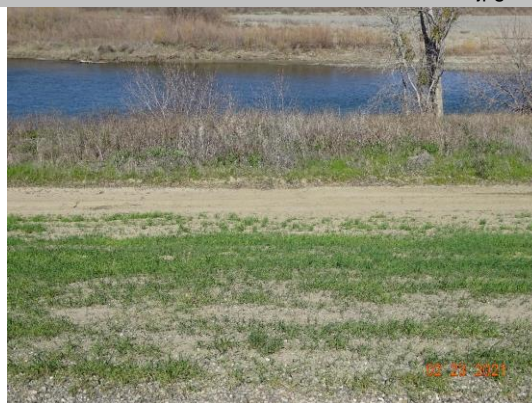
Photo 1 of 3 : UCIP_SP_2022_62908_91425.jpg

Comment Code					
Inspector Comment					
FS_ID:62908 DS_ID:16420 EP_NO: 4903 Repair Type: Urgent Crossing Status: Found UCIP Comments: 02/23/2021 Record updated from Non-Urgent to Urgent. Pipe is 18-20 feet below levee crown open on waterside poses potential flood threat to landside. Pipe is capped at landside toe. Crossing appears abandoned. (O.Yakimov - DWR UCIP) 05/03/2017 Appears abandoned- if so needs to be done properly. (A. Freitag - DWR Sutter Yard)10/24/2016 appears to be abandoned. (A. Freitag - DWR Sutter Yard)04/25/2016 Appears to be an abandoned crossing. (A. Freitag - DWR Sutter Yard)04/20/2015 Suspect that pump on LS is a well pump and has nothing to do with this crossing. (A. Freitag - DWR Sutter Yard)06/18/2014 Same as last inspection. (A. Freitag - DWR Sutter Yard)12/17/2013 Same as last inspection. (A. Freitag - DWR Sutter Yard)07/18/2013 Same as last inspection. (A. Freitag - DWR Sutter Yard)10/19/2012 Unable to locate siphon breaker, pump on LS; unable to tell if pump system is part of appurtenances. This crossing was listed in the USACE Periodic Inspection as ID# USACE_CESPK_MA1C_2010_p_0233 for utility pole and 8 inch steel riser located on landward toe. (O. Magana - DWR UCIP) FIELD_STRUCT_DESC: 12-inch asphalt coated steel irrigation pipe through the levee, approximately 18-20 feet below the crown. Siphon breaker in 24-inch corrugated metal pipe (CMP) riser on the landside (LS) shoulder--not found. 3-inch electrical conduit through the levee--not found. Utility pole visible on the LS. Well station visible on the LS. No appurtenances visible on the waterside (WS). (12-inch irrigation pipe and electrical conduit authorized under Permit No. 4903, 1965 - Mattie B. Zumwalt Company). (Irrigation pipe and portable pump authorized under Permit No. 4903-A, 1965 - Mattie B. Zumwalt Company). [Additional Reference(s): DWR Levee Log, 1992 (HLM 5.08)]. FS Date: 2/23/2021 2:58:13 PM

LM Start	4.97	Rating **	U	Issue No.	34 (cont)
LM End	4.97	Issue Type +	En	Location *	
Category	Supplemental		GPS Latitude/Longitude		
			Start	End	
Item	DWR UCIP Field Study		39.264924 °	39.264924 °	
			-122.015887 °	-122.015887 °	
DWR ID	16420

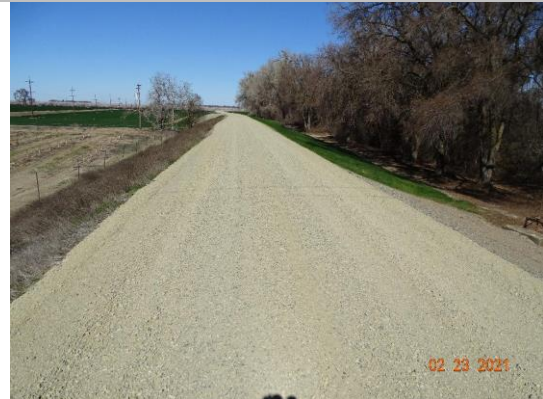
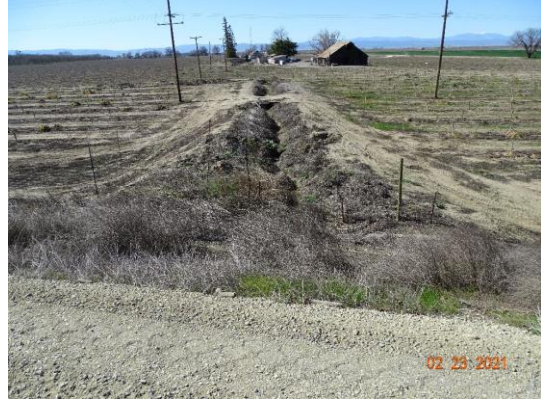
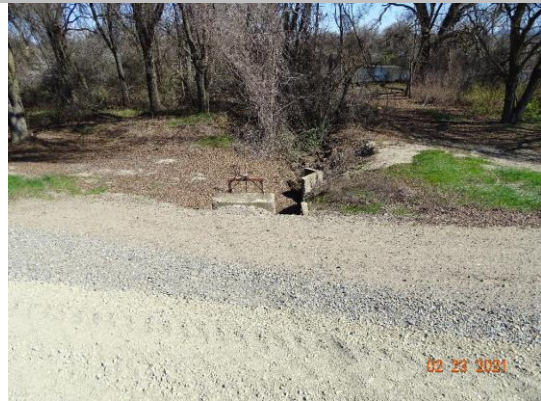
Photo 1 of 3 : UCIP_SP_2022_62909_91436.jpg

Comment Code						
Inspector Comment						
FS_ID:62909 DS_ID:16419 EP_NO: 9476 Repair Type: Non-Urgent Crossing Status: Found UCIP Comments: 02/23/2021 Record remains Non-Urgent. Sediment inside the pipe and at headwall on landside needs clearing. No permit has been identified authorizing pipe. Need to have CVFPB review ABO and determine current owner. (O.Yakimov - DWR UCIP) 05/03/2017 Culvert has sediment build up in it- needs to be cleaned out. (A. Freitag - DWR Sutter Yard)10/24/2016 LS outlets becoming over grown with vegetation in the ditch. (A. Freitag - DWR Sutter Yard)04/25/2016 WS entry still blocked and wingwalls still cracked. (A. Freitag - DWR Sutter Yard)04/20/2015 WS entry still blocked and wingwalls still cracked. (A. Freitag - DWR Sutter Yard)06/18/2014 Same as last inspection. (A. Freitag - DWR Sutter Yard)12/17/2013 Same as last inspection. (A. Freitag - DWR Sutter Yard)07/18/2013 Same as last inspection. (A. Freitag - DWR Sutter Yard)10/19/2012 blocked, no entry on WS. This crossing was listed in the USACE Periodic Inspection as ID# USACE_CESPK_MA1C_2010_p_0247 for u/s and d/s wing wall shows some cracking and tilting. (O. Magana - DWR UCIP) FIELD_STRUCT_DESC: 1 of 2: 36-inch corrugated metal irrigation pipe and concrete box culvert through the levee at an unknown depth below the crown. Concrete headwall visible on the landside (LS) toe. (36-inch pipe [HLM 5.85] authorized under Automatic Board Order (ABO) issued as Permit No. 9476, 1974 - Howard and Nadine Ohliger). [Additional Reference(s): DWR Levee Log, 1992 (HLM 5.85), listed as 15 feet long 36-inch pipe and concrete box culvert through the levee]. FS Date: 2/23/2021 3:24:08 PM

LM Start	5.72	Rating **	M	Issue No.	35 (cont)
LM End	5.72	Issue Type +	En	Location *	
Category	Supplemental			GPS Latitude/Longitude	
				Start	End
Item	DWR UCIP Field Study			39.272069 °	39.272069 °
				-122.023240 °	-122.023240 °
DWR ID	16419

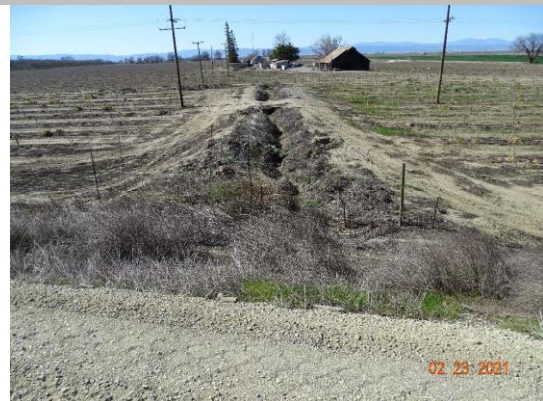
Photo 1 of 3 : UCIP_SP_2022_62910_91439.jpg

Comment Code						
Inspector Comment						
FS_ID:62910 DS_ID:17569 EP_NO: 9476 Repair Type: Non-Urgent Crossing Status: Found UCIP Comments: 02/23/2021 Record remains Non-Urgent. Sediment blocking more than 50% of pipe cross section area as seen at headwall on landside, needs clearing. Unauthorized encroachment recorded in Levee Log prior to 2011. Need to have CVFPB review ABO and determine current owner. (O.Yakimov - DWR UCIP) 05/03/2107 Culvert has sediment build up in it- needs to be cleaned out. (A. Freitag - DWR Sutter Yard)10/24/2016 LS outlets becoming overgrown with vegetation in the dtch. (A. Freitag - DWR Sutter Yard)04/25/2016 WS entry still blocked and wingwalls still cracked. (A. Freitag - DWR Sutter Yard)04/20/2015 WS entry still blocked and wingwalls still cracked. (A. Freitag - DWR Sutter Yard)06/18/2014 Same as last inspection. (A. Freitag - DWR Sutter Yard)12/17/2013 Same as last inspection. (A. Freitag - DWR Sutter Yard)07/18/2013 Same as last inspection. (A. Freitag - DWR Sutter Yard)10/19/2012 blocked, no entry on WS. This crossing was listed in the USACE Periodic Inspection as ID# USACE_CESPK_MA1C_2010_p_0247 for u/s and d/s wing wall shows some cracking and tilting. (O. Magana - DWR UCIP) FIELD_STRUCT_DESC: 2 of 2: 36-inch corrugated metal irrigation pipe (15 feet long) and concrete box culvert through the levee at an unknown depth below the crown. Slide gate located on the waterside (WS). Concrete headwall visible on the landside (LS) toe. (36-inch pipe [HLM 5.85] authorized under Automatic Board Order (ABO) issued as Permit No. 9476, 1974 - Howard and Nadine Ohliger). [Additional Reference(s): DWR Levee Log, 1992 (HLM 5.85), listed as 15 feet long 36-inch pipe and concrete box culvert through the levee]. FS Date: 2/23/2021 3:26:52 PM

LM Start	5.72	Rating **	M	Issue No.	36 (cont)
LM End	5.72	Issue Type +	En	Location *	
Category	Supplemental		GPS Latitude/Longitude		
			Start	End	
Item	DWR UCIP Field Study		39.272069 °	39.272069 °	
			-122.023240 °	-122.023240 °	
DWR ID	17569

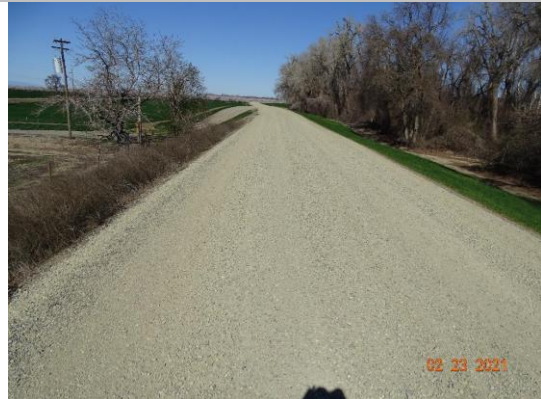
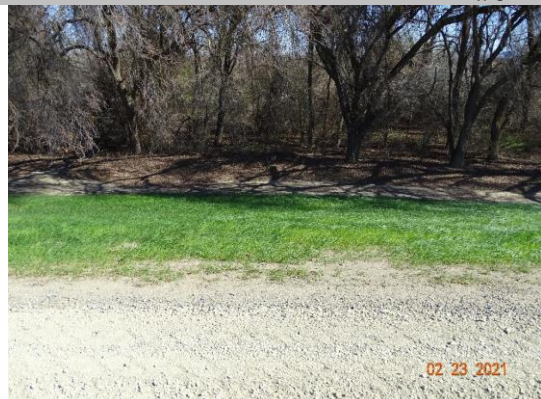
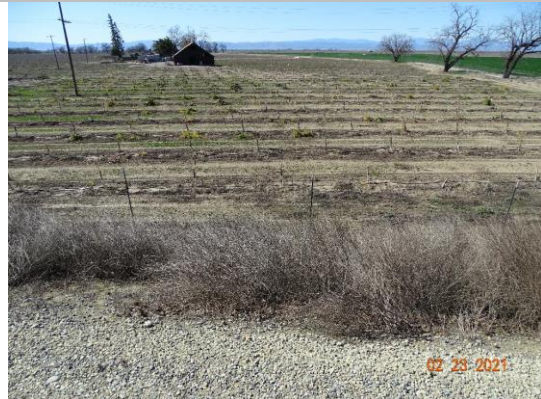
Photo 1 of 3 : UCIP_SP_2022_62911_91445.jpg

Comment Code						
Inspector Comment						
FS_ID:62911						
DS_ID:17658						
EP_NO: N/A						
Repair Type: Non-Urgent						
Crossing Status: Not Found						
UCIP Comments: 02/23/2021 Record is Non-Urgent. Crossing not found. Geophysical results did not confirm presence of pipe through levee. Record will remain in UCIP's inspection records until future Levee Improvement Project can confirm no crossing was found through the levee. No permit has been identified authorizing pipe. (O.Yakimov - DWR UCIP)						
05/03/2017 Unable to locate. (A. Freitag - DWR Sutter Yard)						
10/24/2016 Unable to locate. (A. Freitag - DWR Sutter Yard)						
04/25/2016 Unable to locate. (A. Freitag - DWR Sutter Yard)						
04/20/2015 Unable to locate. (A. Freitag - DWR Sutter Yard)						
06/23/2014 Unable to locate. (A. Freitag - DWR Sutter Yard)						
12/17/2013 Unable to locate. (A. Freitag - DWR Sutter Yard)						
07/18/2013 Same as last inspection. Unable to locate. (A. Freitag - DWR Sutter Yard)

LM Start	5.75	Rating **	M	Issue No.	37 (cont)
LM End	5.75	Issue Type +	En	Location *	
Category	Supplemental			GPS Latitude/Longitude	
				Start	End
Item	DWR UCIP Field Study			39.272400 °	39.272400 °
				-122.023248 °	-122.023248 °
DWR ID	17658

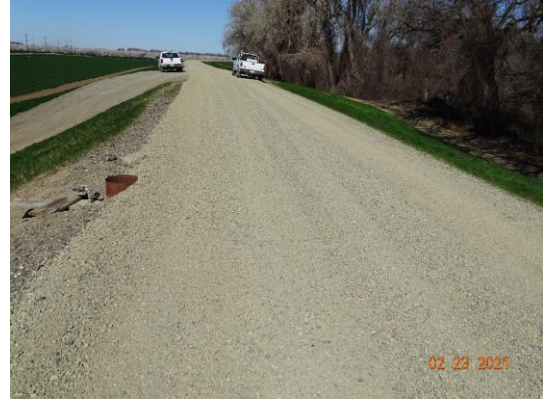
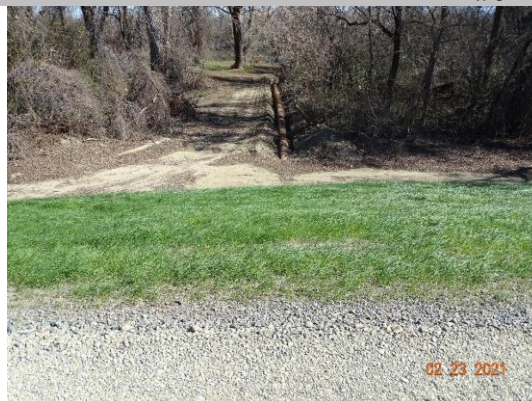
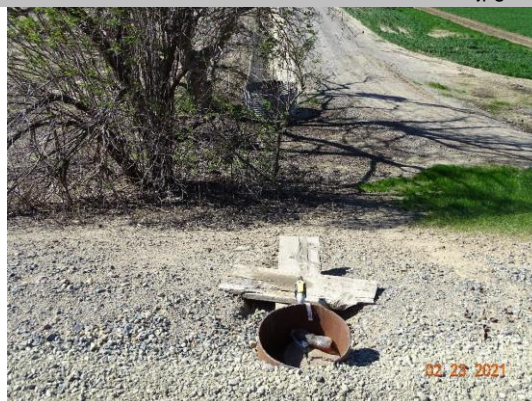
Photo 1 of 3 : UCIP_SP_2022_62912_91448.jpg

Comment Code					
Inspector Comment					
FS_ID:62912 DS_ID:16418 EP_NO: 6263 Repair Type: Urgent Crossing Status: Found UCIP Comments: 02/23/2021 Record updated from Non-Urgent to Urgent. Pipe exposed in a trench on waterside starting 20 feet from waterside levee toe going toward pumps. Pumps are dismantled, discharge pipe cut open under pumping platform. Unable to find a permit for modification. (O.Yakimov - DWR UCIP) 05/03/2017 Crossing appears to be in good condition. (A. Freitag - DWR Sutter Yard)10/24/2016 Appears to be in good condition. (A. Freitag - DWR Sutter Yard)04/25/2016 Pressure gauge and valve were added to pipe near the siphon breaker on LS shoulder. (A. Freitag - DWR Sutter Yard)04/20/2015 Modifications are being made to pipe near the LS shoulder. Not sure what all exactly is being done. (A. Freitag - DWR Sutter Yard)06/23/2014 Same as last inspection. (A. Freitag - DWR Sutter Yard) 12/17/2013 Same as last inspection. (A. Freitag - DWR Sutter Yard)07/18/2013 Debris cleared from in front of LS standpipe. (A. Freitag - DWR Sutter Yard)10/19/2012 Remove debris from landward side see photo 2. This crossing was listed in the USACE Periodic Inspection as ID# USACE_CESPK_MA1C_2010_p_0249 however, unable to determine why crossing was marked "U". (O. Magana - DWR UCIP) FIELD_STRUCT_DESC: 18-inch asphalt coated steel irrigation pipe through the levee, 2 feet below the crown. Siphon breaker on the landside (LS) shoulder. Corrugated metal pipe (CMP) riser located on the LS connects with concrete V-ditch. Dual slant pumps and gate valves on the bank approximately 215 feet from waterside (WS) toe. Pumps feed into single 18-inch steel pipe. 2-inch electrical conduit buried in the same trench as the irrigation pipe. (18-inch pipe authorized under Permit No. 6263, 1968 - Charles W. Tuttle). [Additional Reference(s): DWR Levee Log, 1992 (HLM 5.90)]. FS Date: 2/23/2021 3:41:43 PM

LM Start	5.77	Rating **	U	Issue No.	38 (cont)
LM End	5.77	Issue Type +	En	Location *	
Category	Supplemental		GPS Latitude/Longitude		
			Start	End	
Item	DWR UCIP Field Study		39.272829 °	39.272829 °	
			-122.023282 °	-122.023282 °	
DWR ID	16418

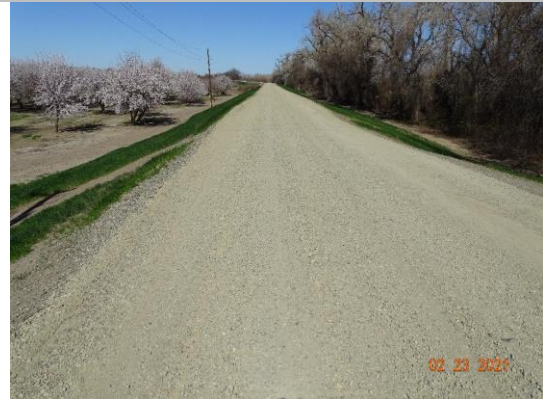
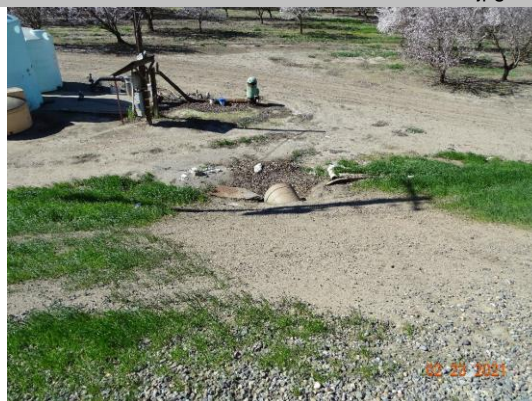
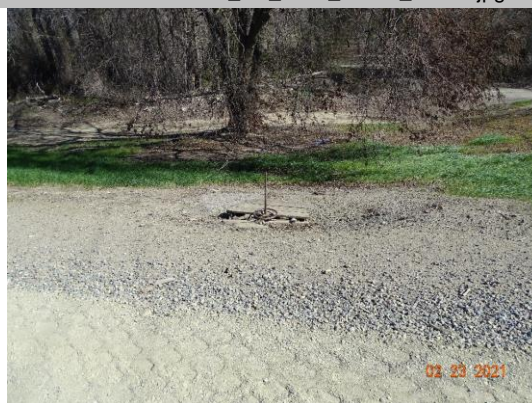
Photo 1 of 3 : UCIP_SP_2022_62913_91460.jpg

FS_ID:62913
DS_ID:16446
EP_NO: N/A
Repair Type: Urgent
Crossing Status: Found
UCIP Comments: 02/23/2021 Record remains Urgent. 4-inch PVC sleeved through 36-inch steel pipe through levee. Screw gate can't be closed due to the PVC pipe. No permit has been identified authorizing pipe. (O.Yakimov - DWR UCIP)
10/01/2018 PVC pipe underneath the slide gate that is located inside CMP riser on WS shoulder was restored and blocks gate from closing. Sediment built up at the bottom of CMP riser. PVC pipe needs to be removed in order to properly close slide gate. (O.Yakimov - DWR UCIP)05/03/2017 Pipe leaked during the Jan/Feb 2017 high water event. Sand bags were placed at both the LS and WS outlets as well as down inside the standpipe to slow the water flow. The 5inch pvc was cut away but the slide gate could still not close fully. Suspect sediment build up was in the bottom of the stand pipe was blocking the gate. Inside of pipe should be cleaned out. (A. Freitag - DWR Sutter Yard)10/24/2016 Pvc was back running through the crossing and blocking the screwgate. photo attached. (A. Freitag - DWR Sutter Yard)09/28/2016 Crossing has been downgraded from Urgent to Non-Urgent 5-inch PVC pipe was cut to allow the slide gate to close. Need to contact owner to remove unauthorized pipe to comply with Title 23. (O. Magana - DWR UCIP)04/25/2016 5 inch pvc pipe running through crossing has been cut out to allow the slide gate to close. (A. Freitag - DWR Sutter Yard)04/20/2015 5inch pvc is still present blocking slide gate from closing. WS end of pipe has been exposed so there is no way to stop water from flowing through pipe during highwater times. (A. Freitag - DWR Sutter Yard)06/23/2014 Same as last inspection. There is no way to stop water from flowing though pipe during high water times. (A. Freitag - DWR Sutter Yard)12/17/2013 Same as last inspection. (A. Freitag - DWR Sutter Yard)07/18/2013 Same as last inspection. (A. Freitag - DWR Sutter Yard)10/19/2012 Unauthorized 5 inch PVC pipe running through 36 inch crossing. 5 inch PVC crossing prevents slide gate from closing during high water. Debris and sediment inside riser. This crossing was listed in the USACE Periodic Inspection as ID# USACE_CESPK_MA1C_2010_p_0258 for 5 inch PVC pipe running through culvert. (O. Magana - DWR UCIP)

FIELD_STRUCT_DESC: 36-inch steel (not corrugated metal, as referenced in O&M manual) drainage pipe through the levee, approximately 14-16 feet below levee crown. Slide gate in corrugated metal pipe (CMP) riser on the waterside (WS) slope. Pipe also visible on the landside (LS). [Additional Reference(s): DWR Levee Log, 1992 (HLM 6.38). USACE Sacramento O&M Manual, Unit 137, August 1955, Revised 29 December 2016, (STA 331+31), listed as 36-inch pipe].
FS Date: 2/23/2021 3:47:40 PM

LM Start	6.24	Rating **	U	Issue No.	39 (cont)
LM End	6.24	Issue Type +	Ma	Location *

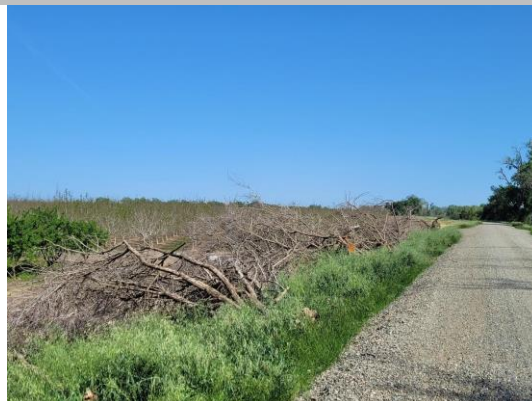
Photo 1 of 1 : SP_2022_MA0001_297_115_20220417_00193.jpg

LM Start	6.35	Rating **	U	Issue No.	115
LM End	6.38	Issue Type +	En	Location *	LS
Category	Earthen Levee			GPS Latitude/Longitude	
				Start	End
Item	Encroachments			39.281062 °	39.281425 °
				-122.022110 °	-122.022000 °
DWR ID	DWR_MA0001_01_f_2016_115				
Comment Code					
PR : Prunings					
Inspector Comment					
Remove prunings from the landside slope and toe.

View of the prunings along the landside slope and toe. Spring 2022.

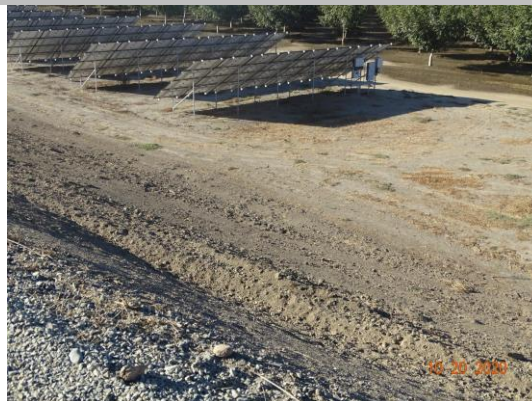
Photo 1 of 1 : SP_2022_MA0001_297_77_20220307_00019.jpg

LM Start	6.98	Rating **	M	Issue No.	77
LM End	6.98	Issue Type +	Ma	Location *	LS
Category	Earthen Levee			GPS Latitude/Longitude	
				Start	End
Item	Erosion / Vehicle Traffic			39.289935 °	39.289935 °
				-122.021462 °	-122.021462 °
DWR ID	DWR_MA0001_01_f_2020_77				
Comment Code					
E6 : Repair the levee slope damaged by vehicle traffic and prevent access where possible.					
Inspector Comment					
Repair erosion caused by vehicle on the slope.

View of the vehicle erosion along the landside slope. Fall 2020.

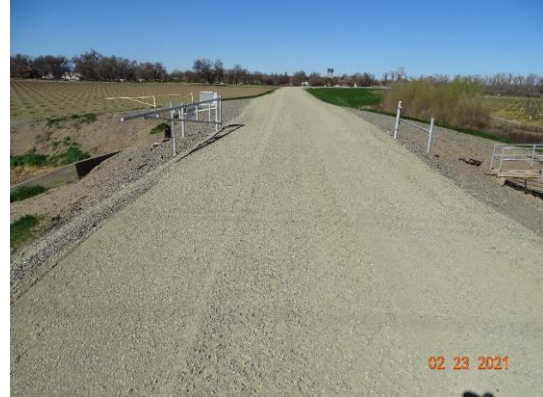
Photo 1 of 3 : UCIP_SP_2022_62915_91471.jpg

FS_ID:62915
DS_ID:16427
EP_NO: 9482
Repair Type: Urgent
Crossing Status: Found
UCIP Comments: 02/23/2021 Record updated from Non-Urgent to Urgent. Missing slide gate at U-shaped headwall on waterside slope. Pipe outlet blocked with a pile of soil. Inlet to concrete culvert at landside toe is filled with soil blocking more than 50% of cross sectional area. Crossing appears abandoned. No permit has been identified authorizing pipe. Need to have CVFPB review ABO and determine current owner. (O.Yakimov - DWR UCIP)
05/03/2017 Abandoned- Needs to be done properly. (A. Freitag - DWR Sutter Yard)10/24/2016 Abandoned. (A. Freitag - DWR Sutter Yard)04/25/2016 Abandoned pipe. Needs to be properly plugged if it never gets used. (A. Freitag - DWR Sutter Yard)04/20/2015 Same as last inspection. Structure is still buried. (A. Freitag - DWR Sutter Yard)06/23/2014 Same as last inspection. (A. Freitag - DWR Sutter Yard)12/17/2013 Same as last inspection. (A. Freitag - DWR Sutter Yard)07/18/2013 Same as last inspection. (A. Freitag - DWR Sutter Yard)10/19/2012 Structure is buried and non-operational. This crossing was listed in the USACE Periodic Inspection as ID# USACE_CESPK_MA1C_2010_p_0288 for sluice gate closed and backfilled on WS and full of sediment with wingwall cracked on LS. (O. Magana - DWR UCIP)

Top of Levee: View of levee crown looking upstream

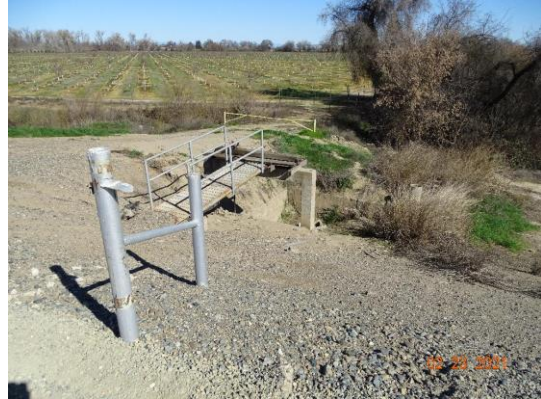
Photo 2 of 3 : UCIP_SP_2022_62915_91472.jpg

Water-Side: View of levee slope looking from crown. Headwall on levee slope

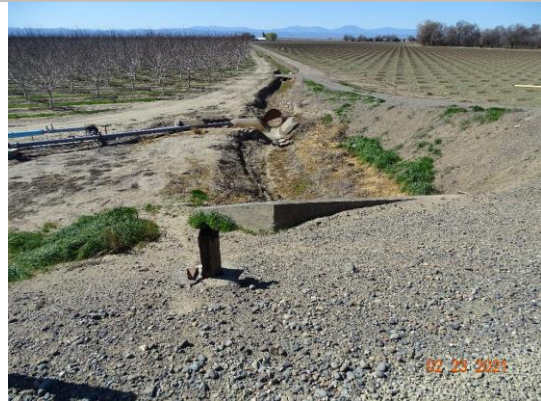
Photo 3 of 3 : UCIP_SP_2022_62915_91473.jpg

Land-Side: View of levee slope looking from crown. Irrigation ditch on landside

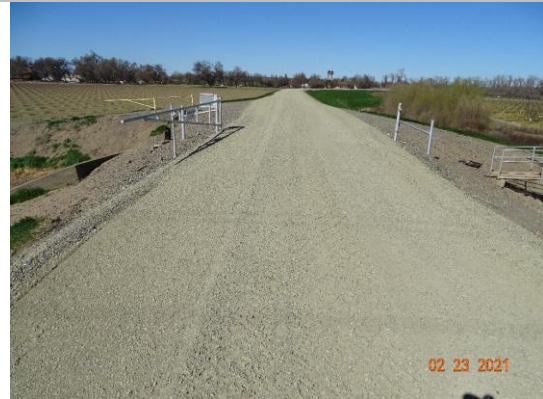
Photo 1 of 3 : UCIP_SP_2022_62916_91475.jpg

FS_ID:62916
DS_ID:17570
EP_NO: 9482
Repair Type: Non-Urgent
Crossing Status: Found
UCIP Comments: 02/23/2021 Record remains Non-Urgent. Pipe outlet blocked with a pile of soil. Inlet to concrete culvert at landside toe is filled with soil blocking more than 50% of cross sectional area. Crossing appears abandoned. Unauthorized encroachment recorded in Levee Log prior to 2011. Need to have CVFPB review ABO and determine current owner. (O.Yakimov - DWR UCIP)
05/03/2017 WS slide gate was unburied and crossing was being used for irrigaton during site visit. (A. Freitag - DWR Sutter Yard)10/24/2016 WS slide gate was unbruied and opened. (A. Freitag - DWR Sutter Yard)04/25/2016 WS slide gate was unburied and opened allowing water to flow through to LS fields. (A. Freitag - DWR Sutter Yard)04/20/2015 Structure is operational. WS slide gate was unburied allowing water to irrigate the fields. It gets reburied during highwater season. (A. Freitag - DWR Sutter Yard) 06/23/2014 Same as last inspection. Soli dug out again and water flowing through crossing.12/17/2013 WS screw gate was closed and buried by soil again. (A. Freitag - DWR Sutter Yard)07/18/2013 WS screw gate has been cleared of dirt and is open to irrigate LS fields. LS outlet is still mostly blocked by sediment. (A. Freitag - DWR Sutter Yard)10/19/2012 Structure is buried and non-operational. This crossing was listed in the USACE Periodic Inspection as ID# USACE_CESPK_MA1C_2010_p_0288 for sluice gate closed and backfilled on WS and full of sediment with wingwall cracked on LS. (O. Magana - DWR UCIP)

Top of Levee: View of levee crown looking upstream

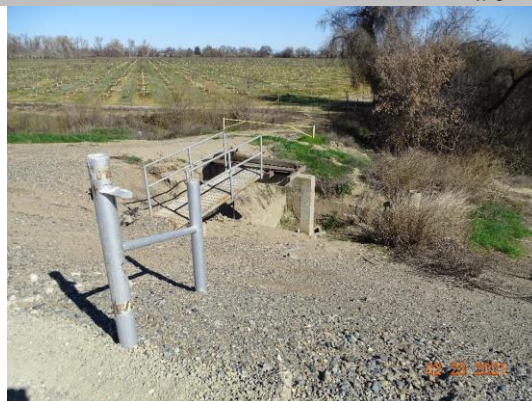
Photo 2 of 3 : UCIP_SP_2022_62916_91476.jpg

Water-Side: View of levee slope looking from crown

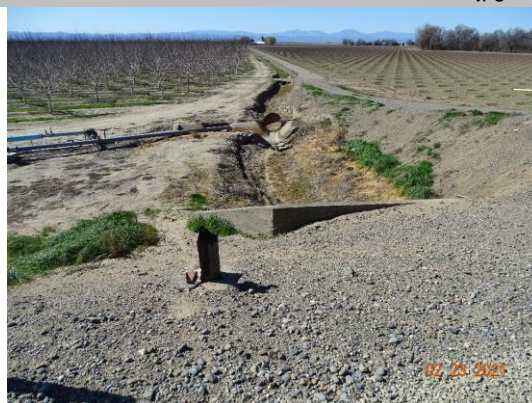
Photo 3 of 3 : UCIP_SP_2022_62916_91477.jpg

Land-Side: View of levee slope looking from crown

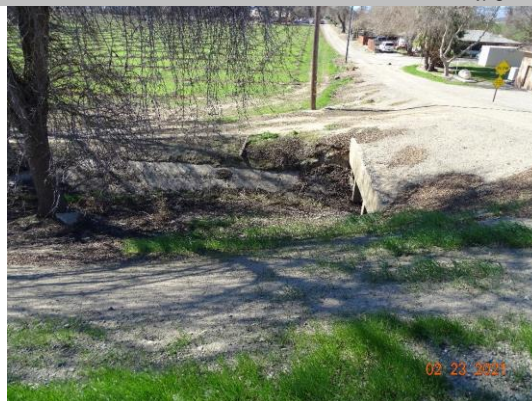
Photo 2 of 3 : UCIP_SP_2022_62917_91482.jpg

Land-Side: View of levee slope looking from crown

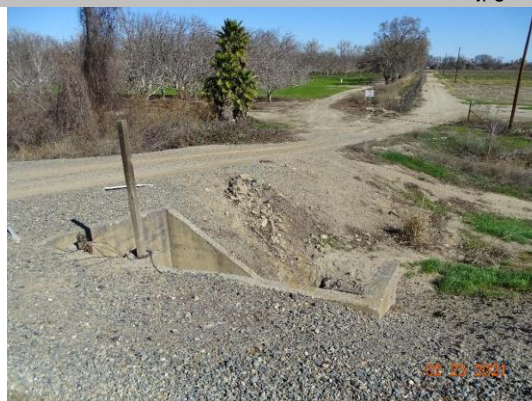
Photo 3 of 3 : UCIP_SP_2022_62917_91486.jpg

Water-Side: Concrete vault is open at ground level needs a cover or guard rails. View of levee slope

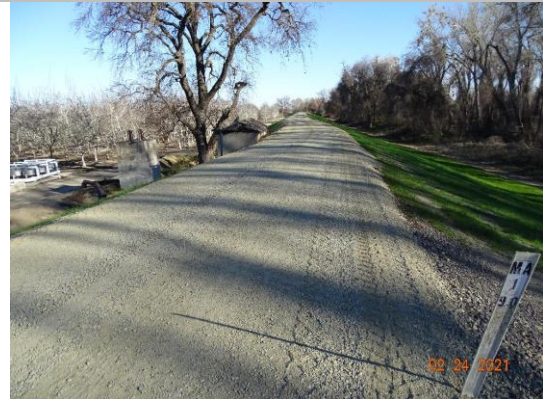
Photo 1 of 3 : UCIP_SP_2022_62919_91495.jpg

Comment Code					
Inspector Comment					
FS_ID:62919 DS_ID:16454 EP_NO: 9466 Repair Type: Non-Urgent Crossing Status: Found UCIP Comments: 02/24/2021 Record remains Non-Urgent. Crossing appears abandoned. Abandoned pump at the bottom of vault in pumphouse on landside shoulder. Pipe not found on waterside. Unauthorized encroachment recorded in Levee Log prior to 2011. Need to have CVFPB review ABO and determine current owner. (O.Yakimov - DWR UCIP) 05/03/2017 Abandoned- needs to be done properly. (A. Freitag - DWR Sutter Yard)10/24/2016 Abandoned. (A. Freitag - DWR Sutter Yard)04/25/2016 Crossing appears to be abandoned. Power lines cut from the panels inside the concrete structure on LS. (A. Freitag - DWR Sutter Yard)04/20/2015 Same as last inspection. (A. Freitag - DWR Sutter Yard)06/23/2014 Same as last inspection. (A. Freitag - DWR Sutter Yard)12/17/2013 Same as last inspection. (A. Freitag - DWR Sutter Yard)07/18/2013 Same as last inspection. (A. Freitag - DWR Sutter Yard)10/30/2012 No access to inspect slide gate on LS. Roof of pumping house deteriorating and debris scattered on LS. WS crossing not found. This crossing was listed in the USACE Periodic Inspection as ID# USACE_CESPK_MA1C_2010_p_345 no issues recorded. (O. Magana - DWR UCIP) FIELD_STRUCT_DESC: 24-inch steel irrigation pipe through the levee, approximately 8-10 feet below the crown. Slide gate in concrete riser on the landside (LS) slope. Pump house encroaches into the LS slope. Two service poles on the LS shoulder. No visible appurtenances found on the waterside (WS) toe. Power source cut on the LS. (24-inch pipe [HLM 9.12] authorized under Automatic Board Order (ABO) issued as Permit No. 9466, 1974 - Roman Catholic Bishop of Sacramento). [Additional Reference(s): DWR Levee Log, 1992 (HLM 9.12)]. FS Date: 2/24/2021 10:39:15 AM

Top of Levee: View of levee crown looking upstream

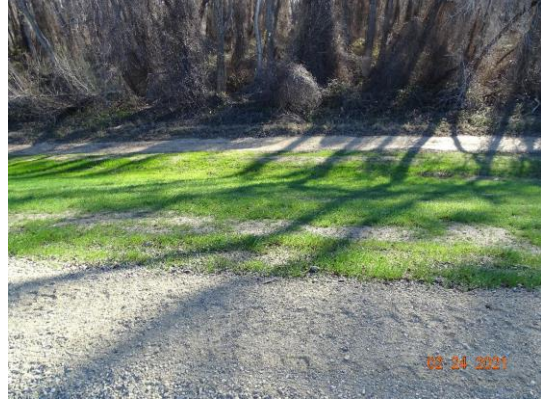
Photo 2 of 3 : UCIP_SP_2022_62919_91496.jpg

Water-Side: View of levee slope looking from crown

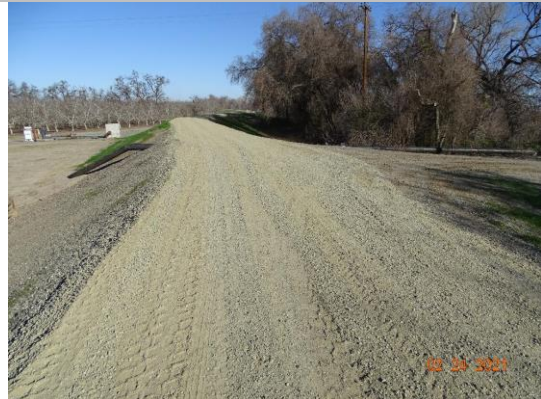
Photo 1 of 3 : UCIP_SP_2022_62922_91509.jpg

Comment Code					
Inspector Comment					
FS_ID:62922 DS_ID:16453 EP_NO: N/A Repair Type: Non-Urgent Crossing Status: Found UCIP Comments: 02/24/2021 Record updated from No Action Needed to Non-Urgent. New pump and new pipe have been installed on waterside berm. Unable to find a permit for modification. No permit has been identified authorizing pipe. (O.Yakimov - DWR UCIP) 05/03/2017 Appears to be in good condition. (A. Freitag - DWR Sutter Yard)10/24/2016 Ws erosion still present. Looks to be just from rain run off. (A. Freitag - DWR Sutter Yard)04/25/2016 Erosion still present by the WS pipes. (A. Freitag - DWR Sutter Yard)04/20/2015 Erosion happening near WS shoulder where the pipes enter the levee. May just be caused by rain runoff. (A. Freitag - DWR Sutter Yard)06/23/2014 Same as last inspection. (A. Freitag - DWR Sutter Yard)12/17/2013 Same as last inspection. (A. Freitag - DWR Sutter Yard)07/18/2013 Same as last inspection. (A. Freitag - DWR Sutter Yard)10/30/2012 Landward side has been completely altered. Need to find permit for new work. (O. Magana - DWR UCIP) FIELD_STRUCT_DESC: 1 of 3: 24-inch steel pipe through the levee, approximately 15-20 feet below the crown. Gate valve on the waterside (WS) end. Slant pump on pile structure - one of two located upstream. Pipe covered with soil on both levee berms. Concrete distribution box on landside off levee toe. (Junction boxes, HDPE pipe and appurtenances on landside authorized under Permit No. 19093, 2018 - Colusa Indian Community Council). (Replacement of pumps, pumping platform, adding fish screen authorized under Permit No. 19328, 2019 - Colusa Indian Community Council. New pipes on waterside berm connected to existing pipes through levee). [Additional Reference(s): DWR Levee Log, 1992 (HLM 10.43). USACE Sacramento O&M Manual, Unit 137, August 1955, Revised 29 December 2016, (STA 538+42), listed as 24-inch pipe]. FS Date: 2/24/2021 11:06:52 AM

Top of Levee: View of levee crown looking upstream

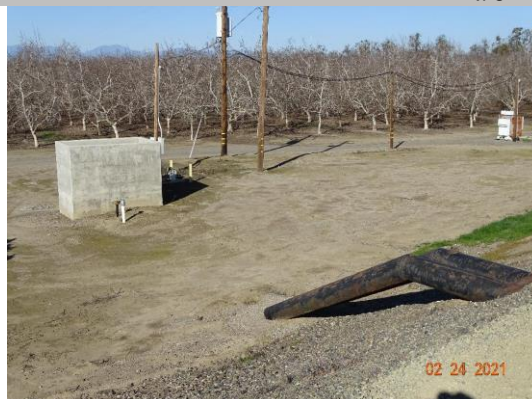
Photo 2 of 3 : UCIP_SP_2022_62922_91508.jpg

Land-Side: View of levee slope and distribution box in the field

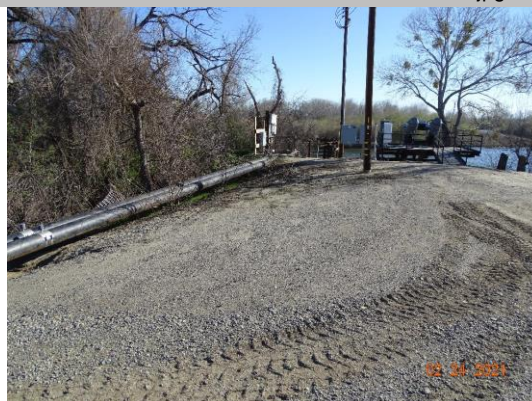
Photo 3 of 3 : UCIP_SP_2022_62922_91505.jpg

Water-Side: Wide berm on waterside. Slant pump at riverbank

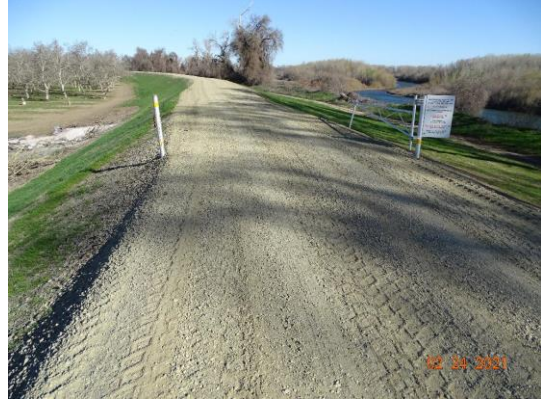
Photo 1 of 3 : UCIP_SP_2022_62925_91522.jpg

Comment Code						
Inspector Comment						
FS_ID:62925 DS_ID:19411 EP_NO: 2639 Repair Type: Non-Urgent Crossing Status: Found UCIP Comments: 02/24/2021 Record is Non-Urgent. Crossing not found. Unable to locate a permit and confirm proper pipe abandonment. No inspection records were available to determine status of line through the levee. (O.Yakimov - DWR UCIP) 05/03/2017 abandoned (A. Freitag - DWR Sutter Yard)04/25/2016 ABANDONED GASLINE (A. Freitag - DWR Sutter Yard)04/20/2015 retired gasline. capped and grouted. (A. Freitag - DWR Sutter Yard)06/23/2014 Same as last inspection. (A. Freitag - DWR Sutter Yard)12/17/2013 Same as last inspection. (A. Freitag - DWR Sutter Yard)07/18/2013 Same as last inspection. (A. Freitag - DWR Sutter Yard)12/01/2012 According to PG&E, their records indicate this pipeline was retired in 1968 and the pipe segments in the levee were cut, capped and filled with grout. Markers were removed from retired crossing. (O. Magana - DWR UCIP) 10/30/2012 No markers visible. Olivia (UCIP team) is coordinating with PG&E to determine more info on crossing. (O. Magana - DWR UCIP) FIELD_STRUCT_DESC: 6.625-inch coated steel gas pipeline from Compton Landing Gas field to Main No. 172 through the levee, 3 feet below the crown. Levee and berm slopes were cobbles rip-rapped ten feet on each side of cut. PG&E reference number L-167-4-4 at Packer Road was installed in 1957. Emergency contact Mr. Monte Penland, Gas Maintenance Supervisor, 15871 Central Street, Meridian, CA 95957; Office No. 530-634-6520 or Mobile No. 530-356-7396. PG&E records indicate this pipeline was retired in 1968 and the pipe segments in the levee were cut, capped and filled with grout. Markers were removed from retired crossing. Utility crossing coordinates are approximate. (6.625-inch steel gas line authorized under Permit No. 2639, 1957 - Pacific Gas and Electric Company [PG&E]) FS Date: 2/24/2021 11:19:27 AM

Top of Levee: View of levee crown looking upstream

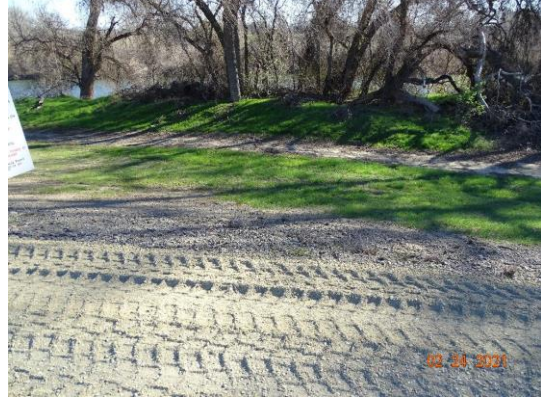
Photo 2 of 3 : UCIP_SP_2022_62925_91523.jpg

LM Start	10.32	Rating **	M	Issue No.	51 (cont)
LM End	10.32	Issue Type +	En	Location *	
Category	Supplemental		GPS Latitude/Longitude		
			Start	End	
Item	DWR UCIP Field Study		39.331275 °	39.331275 °	
			-122.029952 °	-122.029952 °	
DWR ID	19411

Water-Side: View of levee slope looking from crown

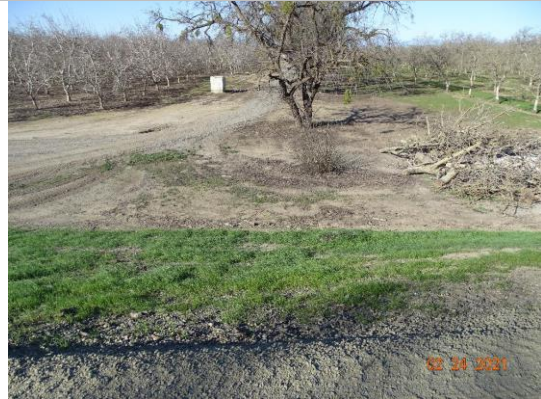
Photo 3 of 3 : UCIP_SP_2022_62925_91524.jpg

LM Start	10.32	Rating **	M	Issue No.	51 (cont)
LM End	10.32	Issue Type +	En	Location *

Land-Side: View of levee slope looking from crown

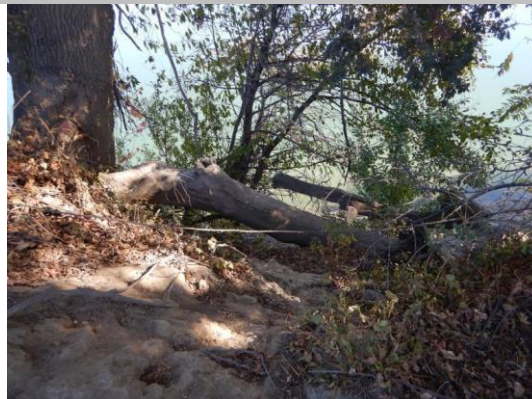
Photo 1 of 2 : SP_2022_MA0001_297_6_20220307_00003.jpg

LM Start	10.32	Rating **	A/W	Issue No.	6 (cont)
LM End	10.41	Issue Type +	Ma	Location *	WS

USACE 2018 Erosion Photo #1

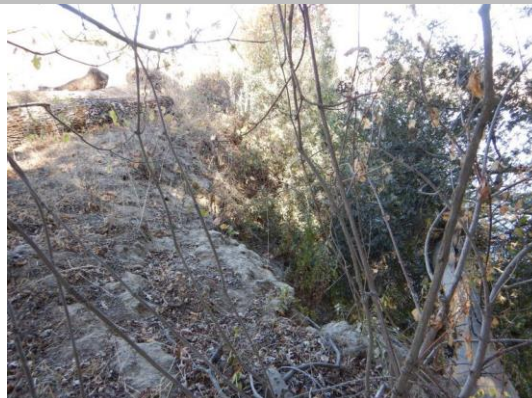
Photo 2 of 2 : SP_2022_MA0001_297_6_20220307_00004.jpg

USACE 2018 Erosion Photo #2

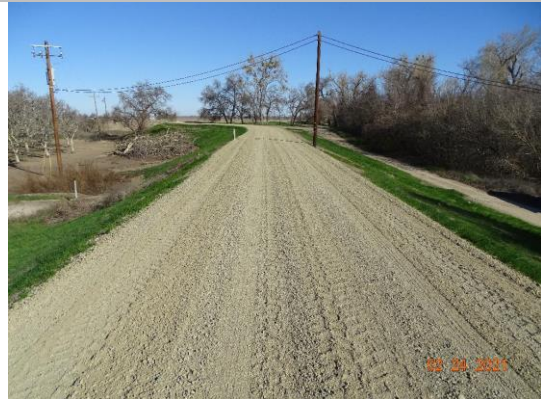
Photo 1 of 3 : UCIP_SP_2022_62927_91536.jpg

Comment Code						
Inspector Comment						
FS_ID:62927 DS_ID:16450 EP_NO: 9465 Repair Type: Non-Urgent Crossing Status: Found UCIP Comments: 02/24/2021 Record updated from No Action Needed to Non-Urgent. No permit has been identified authorizing pipe. Need to have CVFPB review ABO and determine current owner. (O.Yakimov - DWR UCIP) 5/3/2017 Crossing appears to be in good condition. (DWR Sutter Yard-AFreitag)10/24/2016 Appears to be in good condition.(DWR Sutter Yard- AFreitag)4/25/2016 Crossing appears to be in good condition.4/20/2015 Same as last inspection. no issues.6/23/2014 Same as last inspection.12/17/2013 Same as last inspection.7/18/2013 Same as last inspection.10/30/2012 This crossing was listed in the USACE Periodic Inspections as ID# USACE_CESPK_MA1C_2010_p_0389 no issues recorded. FIELD_STRUCT_DESC: 24-inch steel irrigation pipe through the levee, approximately 2-3 feet below the crown. Flap gate on the landside (LS) end. (Automatic Board Order (ABO) issued as Permit No. 9465, 1974 - Merle S. Thompson). [Additional Reference(s): DWR Levee Log, 1992 (HLM 11.19). USACE Sacramento O&M Manual, Unit 137, August 1955, Revised 29 December 2016, (STA 578+60), listed as 24-inch pipe]. FS Date: 2/24/2021 11:47:02 AM

LM Start	10.95	Rating **	M	Issue No.	52 (cont)
LM End	10.95	Issue Type +	En	Location *

Top of Levee: View of levee crown looking upstream

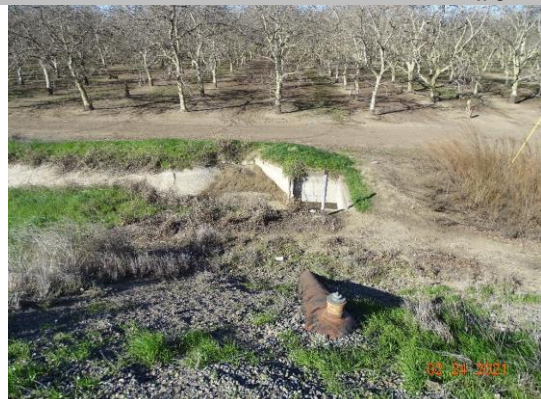
Photo 2 of 3 : UCIP_SP_2022_62927_91537.jpg

Land-Side: View of levee slope looking from crown

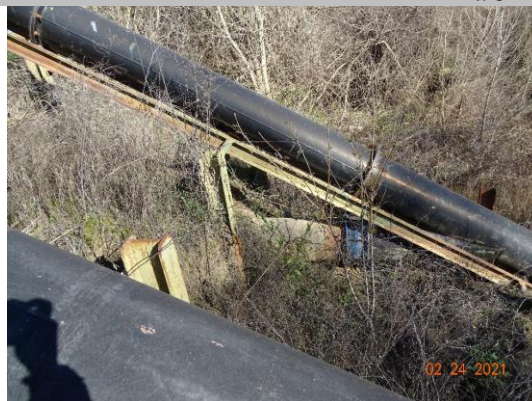
Photo 3 of 3 : UCIP_SP_2022_62927_91531.jpg

LM Start	10.95	Rating **	M	Issue No.	52 (cont)
LM End	10.95	Issue Type +	En	Location *	
Category	Supplemental			GPS Latitude/Longitude	
				Start	End
Item	DWR UCIP Field Study			39.340015 °	39.340015 °
				-122.032554 °	-122.032554 °
DWR ID	16450

Water-Side: Discharge pipe entering ground under slant pump

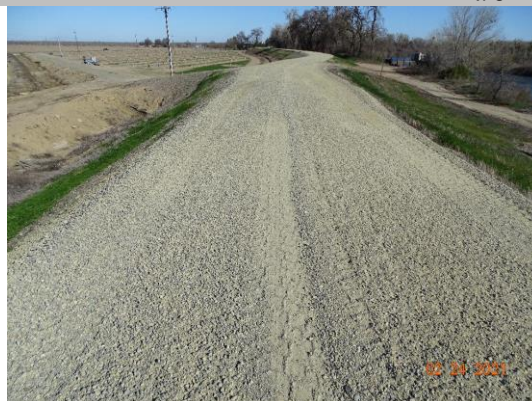
Photo 1 of 3 : UCIP_SP_2022_62935_91596.jpg

Comment Code						
Inspector Comment						
FS_ID:62935 DS_ID:16480 EP_NO: 11982 Repair Type: Non-Urgent Crossing Status: Not Found UCIP Comments: 02/24/2021 Record is Non-Urgent. No permit has been found authorizing original 24-inch pipe through the levee. Crossing not found. Concrete pad located 5 feet from waterside levee toe may indicate former pump location. Geophysical results did not confirm presence of pipe through levee. Record will remain in UCIP's inspection records until future Levee Improvement Project can confirm no crossing was found through the levee. (O.Yakimov - DWR UCIP) 5/3/2017 Unable to locate. (DWR Sutter Yard- A/Freitag)10/24/2016 Unable to locate.(DWR Sutter Yard- A/Freitag)4/25/2016 Unable to locate.4/21/2015 Unable to locate.6/23/2014 Unable to locate.12/17/2013 Unable to locate.7/18/2013 Unable to locate. FIELD_STRUCT_DESC: 16-inch coated steel irrigation pipe, sleeved through existing 24-inch pipe, through the levee at an unknown depth below the crown. Void between pipes pressure grouted. There is a closure valve in a 4-foot corrugated metal pipe (CMP) housing. (Placing 16-inch pipe inside existing 24-inch pipe authorized under Permit No. 11982, 1977 - Charles W. Tuttle, Jr). FS Date: 2/24/2021 2:31:12 PM

LM Start	11.19	Rating **	M	Issue No.	53 (cont)
LM End	11.19	Issue Type +	En	Location *

Top of Levee: View of levee crown looking upstream

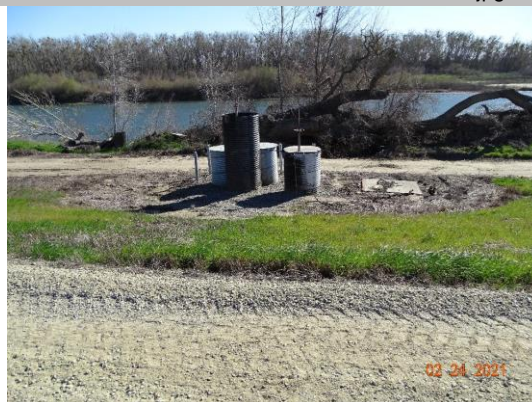
Photo 2 of 3 : UCIP_SP_2022_62935_91597.jpg

Water-Side: View of levee slope looking from crown

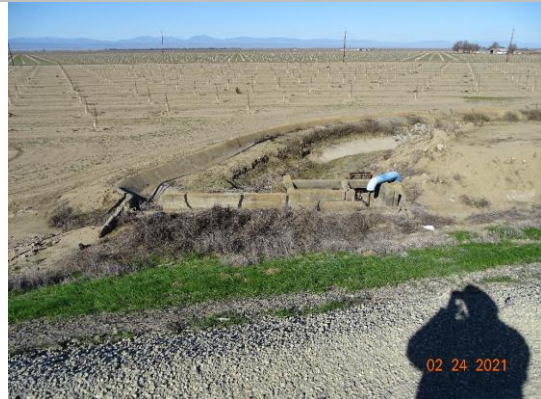
Photo 3 of 3 : UCIP_SP_2022_62935_91598.jpg

LM Start	11.19	Rating **	M	Issue No.	53 (cont)
LM End	11.19	Issue Type +	En	Location *	
Category	Supplemental		GPS Latitude/Longitude		
			Start	End	
Item	DWR UCIP Field Study		39.343246 °	39.343246 °	
			-122.032119 °	-122.032119 °	
DWR ID	16480

Land-Side: View of levee slope looking from crown

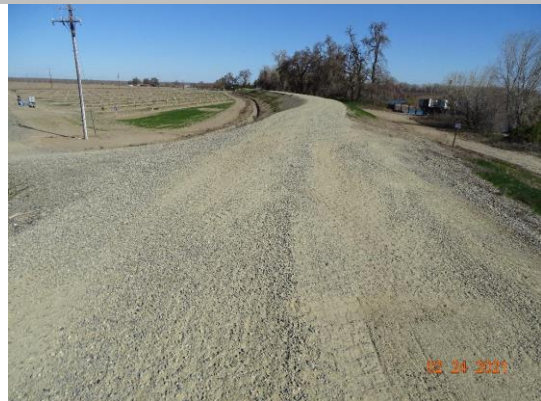
Photo 1 of 3 : UCIP_SP_2022_62939_91623.jpg

FS_ID:62939
DS_ID:16437
EP_NO: N/A
Repair Type: Non-Urgent
Crossing Status: Not Found
UCIP Comments: 02/24/2021 Record is Non-Urgent. Crossing not found. Unauthorized encroachment recorded in Levee Log prior to 2011. (O.Yakimov - DWR UCIP)
5/3/2017 Unable to locate. (DWR Sutter Yard- AFreitag)10/24/2016 Abandoned.(DWR Sutter Yard- AFreitag)4/25/2016 Unable to locate.4/21/2015 Unable to locate.6/23/2014 Unable to locate.12/17/2013 Unable to locate.7/22/2013 Same as last inspection. Unable to locate.
FIELD_STRUCT_DESC: 18-inch steel pipe (crossing type unknown) through the levee, 23.5 feet below the crown. Levee logs indicate pipe was plugged on the waterside (WS) end. [Additional Reference(s): DWR Levee Log, 1992 (HLM 11.44), listed as abandoned 18-inch steel pipe].
FS Date: 2/24/2021 3:01:29 PM

Top of Levee: View of levee crown looking upstream

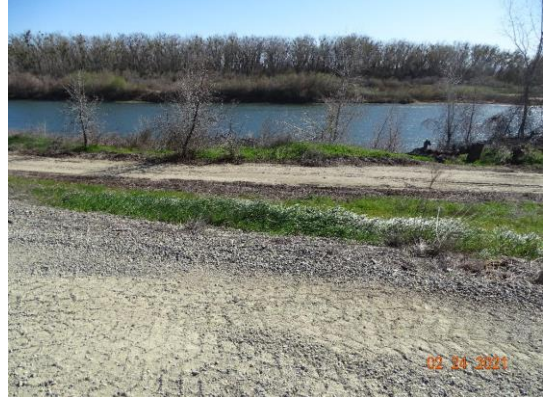
Photo 2 of 3 : UCIP_SP_2022_62939_91624.jpg

LM Start	11.20	Rating **	M	Issue No.	54 (cont)
LM End	11.20	Issue Type +	En	Location *	
Category	Supplemental			GPS Latitude/Longitude	
				Start	End
Item	DWR UCIP Field Study			39.343385 °	39.343385 °
				-122.032085 °	-122.032085 °
DWR ID	16437

Water-Side: View of levee slope looking from crown

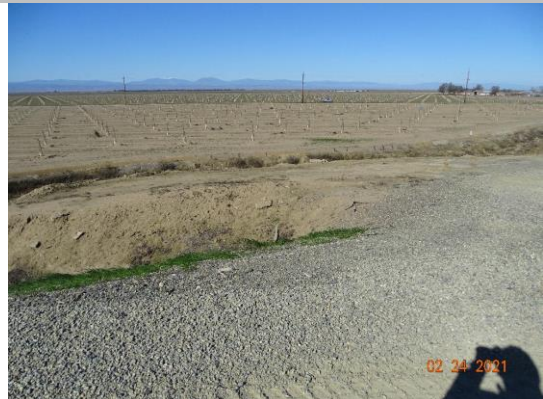
Photo 3 of 3 : UCIP_SP_2022_62939_91625.jpg

LM Start	11.20	Rating **	M	Issue No.	54 (cont)
LM End	11.20	Issue Type +	En	Location *

Land-Side: View of levee slope looking from crown

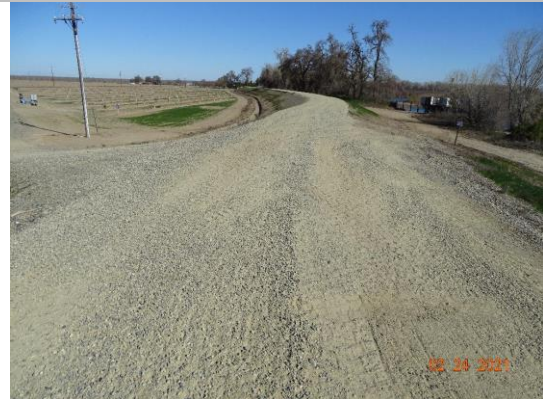
Photo 1 of 3 : UCIP_SP_2022_62940_91626.jpg

FS_ID:62940
DS_ID:16447
EP_NO: 11982
Repair Type: Non-Urgent
Crossing Status: Not Found
UCIP Comments: 02/24/2021 Record is Non-Urgent. No permit found authorizing original 30-inch pipe through the levee. Encroachment recorded in Levee Log prior to 2011. Crossing not found. Geophysical results did not confirm presence of pipe through levee. Record will remain in UCIP's inspection records until future Levee Improvement Project can confirm no crossing was found through the levee. (O.Yakimov - DWR UCIP)
5/3/2017 Unable to locate. (DWR Sutter Yard- A Freitag) 10/24/2016 Unable to locate. (DWR Sutter Yard- A Freitag) 4/25/2016 Unable to locate. 4/21/2015 Unable to locate. 7/22/2013 Same as last inspection. Unable to locate. 12/17/2013 Unable to locate 6/23/2014 Unable to locate.
FIELD_STRUCT_DESC: 16-inch steel drainage pipe sleeved through a 24-inch pipe, 24-inch pipe sleeved through 30-inch pipe, through the levee 23.5 feet below the crown. Control valve in corrugated metal pipe (CMP) riser on the waterside (WS) berm. (Placing 24-inch pipe through existing 30-inch pipe authorized under Permit No. 8657, 1973 - Charles W. Tuttle, Jr.) (Placing 16-inch pipe inside existing 24-inch pipe authorized under Permit No. 11982, 1977 - Charles W. Tuttle, Jr.) [Additional Reference(s): DWR Levee Log, 1992 (HLM 11.44), listed as 16-inch pipe sleeved through a 20-inch pipe].

LM Start	11.20	Rating **	M	Issue No.	55 (cont)
LM End	11.20	Issue Type +	En	Location *

Top of Levee: View of levee crown looking upstream

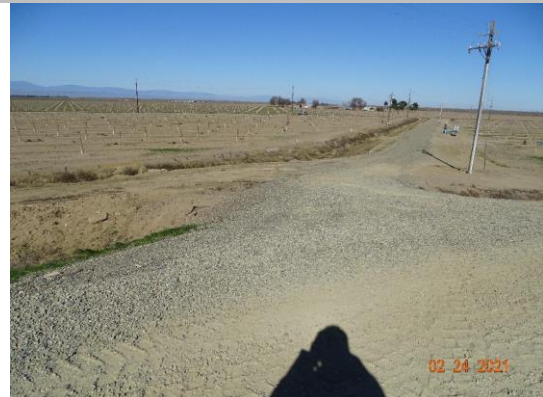
Photo 2 of 3 : UCIP_SP_2022_62940_91627.jpg

Land-Side: View of levee slope looking from crown

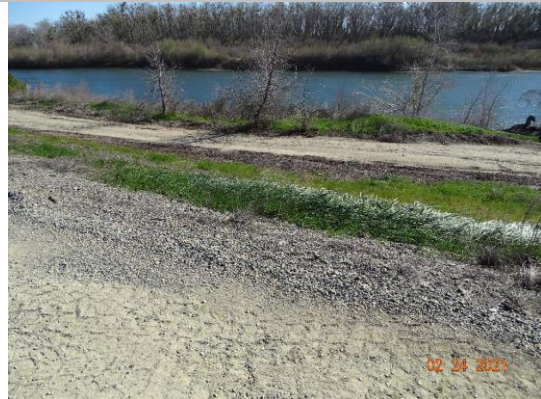
Photo 3 of 3 : UCIP_SP_2022_62940_91628.jpg

LM Start	11.20	Rating **	M	Issue No.	55 (cont)
LM End	11.20	Issue Type +	En	Location *	
Category	Supplemental		GPS Latitude/Longitude		
			Start	End	
Item	DWR UCIP Field Study		39.343386 °	39.343386 °	
			-122.032084 °	-122.032084 °	
DWR ID	16447

Water-Side: View of levee slope looking from crown

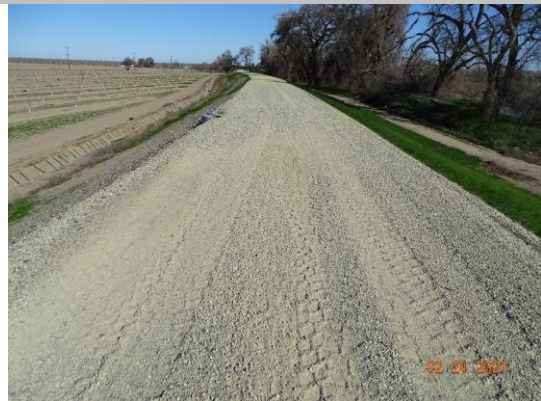
Photo 1 of 3 : UCIP_SP_2022_62942_91634.jpg

FS_ID:62942
 DS_ID:20582
 EP_NO: N/A
 Repair Type: Non-Urgent
 Crossing Status: Found
 UCIP Comments: 02/24/2021 Record updated from No Action Needed to Non-Urgent. No primary permit has been found authorizing this pipe through the levee. Permit 16085 file not available, unable to confirm that pipe through levee was authorized. (O.Yakimov - DWR UCIP) 5/3/2017 Crossing appears to be in good condition. (DWR Sutter Yard- A Freitag) 10/24/2016 Appears to be in good condition. (DWR Sutter Yard- A Freitag) 4/25/2016 Crossing appears to be in good condition. 4/21/2015 Same as last inspection. 6/23/2014 Same as last inspection. 12/17/2013 Same as last inspection. 7/22/2013 Same as last inspection. 10/30/2012 Need to determine encroachment permit associated with this crossing.
 FIELD_STRUCT_DESC: [Maxwell Irrigation District] 24-inch steel irrigation pipe through the levee at an unknown depth below the crown. Crossing is tied to existing Maxwell Irrigation District Pump Station located on the waterside (WS). Siphon breaker inside corrugated metal pipe (CMP) riser located on the landside (LS) shoulder. (Pumping plant authorized under Permit No. 16085, 1993 - Maxwell Irrigation District).

Top of Levee: View of levee crown looking upstream

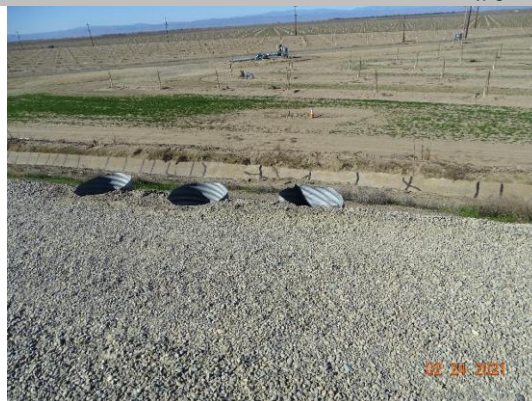
Photo 2 of 3 : UCIP_SP_2022_62942_91636.jpg

LM Start	11.27	Rating **	M	Issue No.	56 (cont)
LM End	11.27	Issue Type +	En	Location *	
Category	Supplemental		GPS Latitude/Longitude		
			Start	End	
Item	DWR UCIP Field Study		39.344376 °	39.344376 °	
			-122.031792 °	-122.031792 °	
DWR ID	20582

Land-Side: View of levee slope looking from crown. CMP riser with siphon breaker on levee shoulder

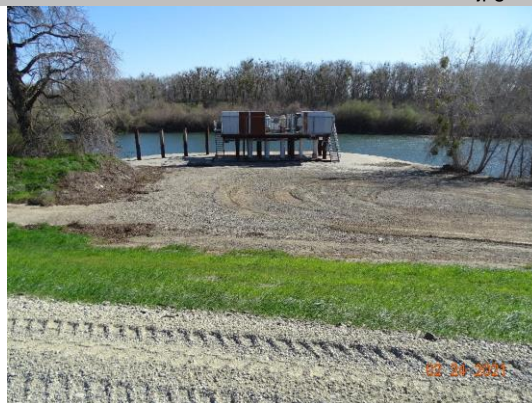
Photo 3 of 3 : UCIP_SP_2022_62942_91635.jpg

LM Start	11.27	Rating **	M	Issue No.	56 (cont)
LM End	11.27	Issue Type +	En	Location *

Water-Side: View of levee slope looking from crown. Pump station on the berm

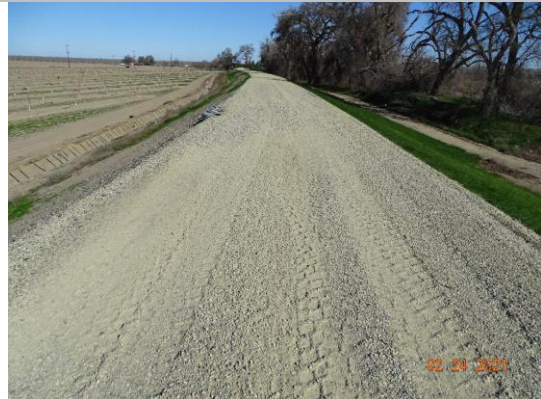
Photo 1 of 3 : UCIP_SP_2022_62943_91637.jpg

Comment Code						
Inspector Comment						
FS_ID:62943 DS_ID:20583 EP_NO: N/A Repair Type: Non-Urgent Crossing Status: Found UCIP Comments: 02/24/2021 Record updated from No Action Needed to Non-Urgent. No primary permit has been found authorizing this pipe through the levee. Permit 16085 file not available, unable to confirm that pipe through levee was authorized. (O.Yakimov - DWR UCIP) 5/3/2017 Crossing appears to be in good condition. (DWR Sutter Yard- A Freitag) 10/24/2016 Appears to be in good condition.(DWR Sutter Yard- A Freitag) 4/25/2016 Crossing appears to be in good condition. 4/21/2015 Same as last inspection. Need to determine encroachment permit for this crossing. 7/22/2013 Same as last inspection. 12/17/2013 Same as last inspection. 6/23/2014 Same as last inspection. FIELD_STRUCT_DESC: [Maxwell Irrigation District] 24-inch steel irrigation pipe through the levee at an unknown depth below the crown. Crossing is tied to existing Maxwell Irrigation District Pump Station located on the waterside (WS). Siphon breaker inside corrugated metal pipe (CMP) riser located on the landside (LS) shoulder. (Pumping plant authorized under Permit No. 16085, 1993 - Maxwell Irrigation District). FS Date: 2/24/2021 3:11:10 PM

LM Start	11.27	Rating **	M	Issue No.	57 (cont)
LM End	11.27	Issue Type +	En	Location *

Top of Levee: View of levee crown looking upstream

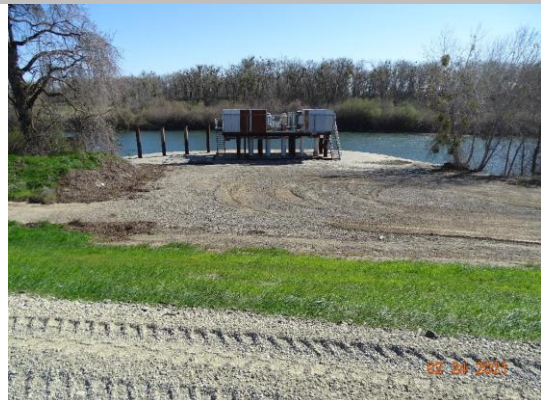
Photo 2 of 3 : UCIP_SP_2022_62943_91638.jpg

Water-Side: View of levee slope looking from crown. Pump station on the berm

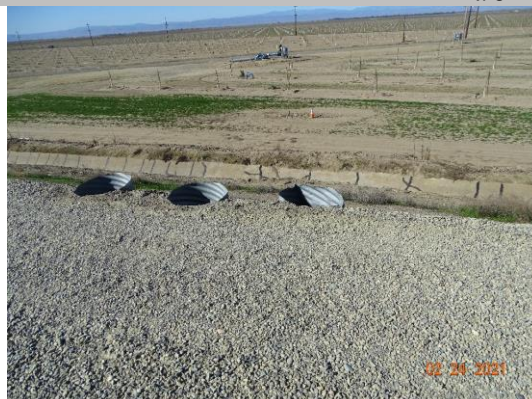
Photo 3 of 3 : UCIP_SP_2022_62943_91639.jpg

LM Start	11.27	Rating **	M	Issue No.	57 (cont)
LM End	11.27	Issue Type +	En	Location *	
Category	Supplemental		GPS Latitude/Longitude		
			Start	End	
Item	DWR UCIP Field Study		39.344390 °	39.344390 °	
			-122.031787 °	-122.031787 °	
DWR ID	20583

View of levee slope looking from crown. CMP riser with siphon breaker on levee shoulder
