**Flood Control Project Maintenance
Levee Inspections
LMA District Cover Sheet**

Sutter Maintenance Yard Maintenance Area 0001

Waterway			Bank	Unit Miles
Unit No. 01 Sacramento River			Right	16.76
	Spring (March - May)	Summer (June - August)	(September - November) Fall	Winter (December - February)
Unit Maintenance Rating (Fall Only)				
Date of Inspection	4/5/2022 - 4/5/2022			
DWR Inspector	Makar Sokol			
Accompanied By	Gregg Ahlers DWR Sutter Yard

Levee Inspection Report By Mile - Spring 2022

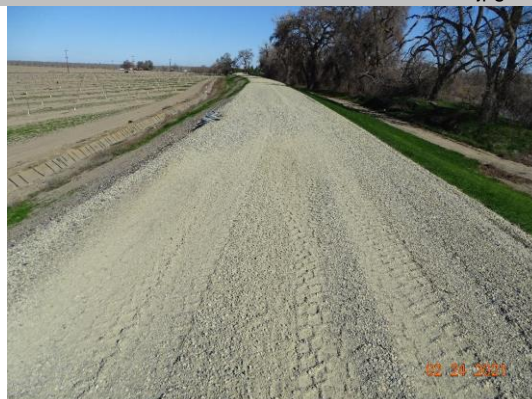
Photo 1 of 3 : UCIP_SP_2022_62944_91643.jpg

FS_ID:62944
DS_ID:20584
EP_NO: N/A
Repair Type: Non-Urgent
Crossing Status: Found
UCIP Comments: 02/24/2021 Record remains Non-Urgent. No primary permit has been found authorizing this pipe through the levee. Permit 16085 file not available, unable to confirm that pipe through levee was authorized. (O.Yakimov - DWR UCIP)
5/3/2017 Crossing appears to be in good condition. (DWR Sutter Yard-AFreitag)10/24/2016 appears to be in good condition.(DWR Sutter Yard- AFreitag)4/25/2016 Crossing appears to be in good condition.4/21/2015 Same as last inspection.6/23/2014 Same as last inspection.12/17/2013 Same as last inspection.7/22/2013 Same as last inspection.10/30/2012 Need to determine encroachment permit for this crossing.
FIELD_STRUCT_DESC: [Maxwell Irrigation District] 24-inch steel irrigation pipe through the levee at an unknown depth below the crown. Crossing is tied to existing Maxwell Irrigation District Pump Station located on the waterside (WS). Siphon breaker inside corrugated metal pipe (CMP) riser located on the landside (LS) shoulder. (Pumping plant authorized under Permit No. 16085, 1993 - Maxwell Irrigation District).

Top of Levee: View of levee crown looking upstream

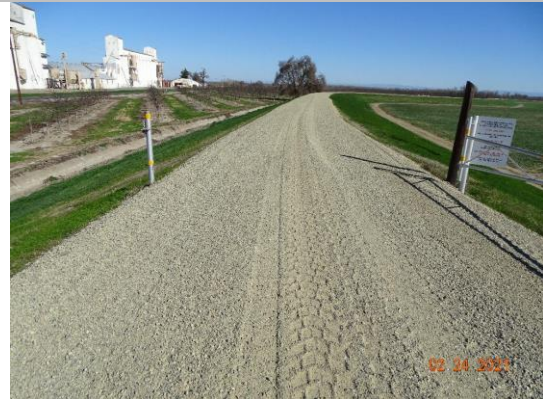
Photo 1 of 3 : UCIP_SP_2022_62945_91647.jpg

FS_ID:62945
DS_ID:16457
EP_NO: 13449
Repair Type: Non-Urgent
Crossing Status: Not Found
UCIP Comments: 02/24/2021 Record remains Non-Urgent. Crossing not found. Markers indicating alignment not found. No inspection records were available to determine status of line through the levee. According to previous inspection records crossing is abandoned without permit. (O.Yakimov - DWR UCIP)
05/03/2017 Unable to locate. (A. Freitag - DWR Sutter Yard)10/24/2016 Unable to locate. (A. Freitag - DWR Sutter Yard)04/25/2016 Unable to locate any markers fro this crossing. (A. Freitag - DWR Sutter Yard)04/21/2015 Same as last inspection. (A. Freitag - DWR Sutter Yard)06/23/2014 Same as last inspection. (A. Freitag - DWR Sutter Yard)12/17/2013 Same as last inspection. (A. Freitag - DWR Sutter Yard)07/22/2013 Same as last inspection. (A. Freitag - DWR Sutter Yard)12/01/2012 According to PG&E, their records indicate that pipe segment has been retired per dwgs. PG&E is finding additional information to confirm if crossing has been retired and method of retirement. Waiting for clarification from PG&E Emergency contact Mr. Monte Penland, Gas Maintenance Supervisor, 15871 Central Street, Meridian, CA 95957; Office No. 530-634-6520 or Mobile No. 530-356-7396. (O. Magana - DWR UCIP)10/30/2012 Buried line. No markers found; Need to contact PG&E to determine if crossing is still present. (O. Magana - DWR UCIP)

FIELD_STRUCT_DESC: 4-inch asphalt coated steel gas pipeline through the levee, 30-inches below the crown. PG&E crossing is known as Reference No. 167-6-13. (4-inch gas line authorized under Permit No. 13449, 1983 - Pacific Gas and Electric Company [PG&E]). Coordinates are approximate--crossing is abandoned according to PG&E records but without permit. [Additional Reference(s): DWR Levee Log, 1992 (HLM 12.32)].
FS Date: 2/24/2021 3:15:53 PM

Top of Levee: View of levee crown looking upstream

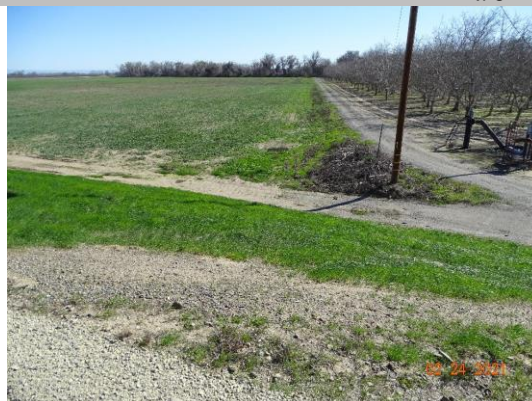
Photo 2 of 3 : UCIP_SP_2022_62945_91648.jpg

LM Start	12.06	Rating **	M	Issue No.	60 (cont)
LM End	12.06	Issue Type +	En	Location *	
Category	Supplemental		GPS Latitude/Longitude		
			Start	End	
Item	DWR UCIP Field Study		39.355516 °	39.355516 °	
			-122.028700 °	-122.028700 °	
DWR ID	16457

Water-Side: View of levee slope looking from crown

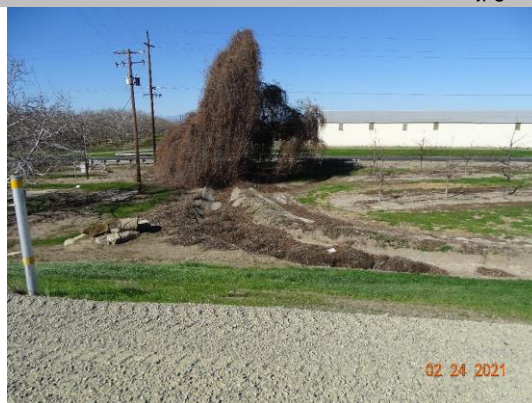
Photo 3 of 3 : UCIP_SP_2022_62945_91649.jpg

LM Start	12.06	Rating **	M	Issue No.	60 (cont)
LM End	12.06	Issue Type +	En	Location *

Land-Side: View of levee slope looking from crown

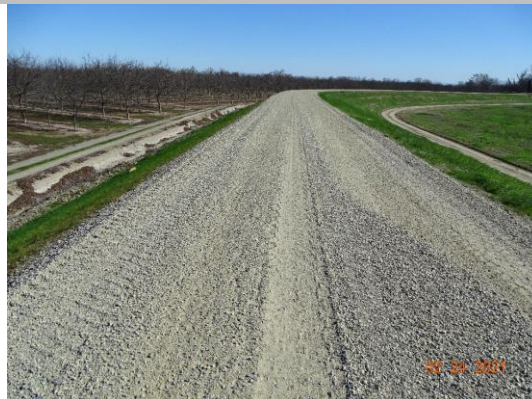
Photo 1 of 3 : UCIP_SP_2022_62946_91650.jpg

FS_ID:62946
DS_ID:17654
EP_NO: N/A
Repair Type: Non-Urgent
Crossing Status: Not Found
UCIP Comments: 02/24/2021 Record is Non-Urgent. Crossing not found. Geophysical results did not confirm presence of pipe through levee. Record will remain in UCIP's inspection records until future Levee Improvement Project can confirm no crossing was found through the levee. No permit has been identified authorizing pipe. (O.Yakimov - DWR UCIP)
5/3/2017 Unable to locate. (DWR Sutter Yard- A Freitag) 10/24/2016 Unable to locate. (DWR Sutter Yard- A Freitag) 4/25/2016 Unable to locate. 4/21/2015 Unable to locate. 6/23/2014 Unable to locate. 12/17/2013 Unable to locate. 7/22/2013 Same as last inspection. Unable to locate.
FIELD_STRUCT_DESC: 30-inch corrugated metal drainage pipe through the levee at an unknown depth below the crown. Slide gate on the outlet end of the pipe. [Additional Reference(s): USACE Sacramento O&M Manual, Unit 137, August 1955, Revised 29 December 2016, (STA 670+00), listed as 30-inch pipe].

LM Start	12.53	Rating **	M	Issue No.	61 (cont)
LM End	12.53	Issue Type +	En	Location *

Top of Levee: View of levee crown looking upstream

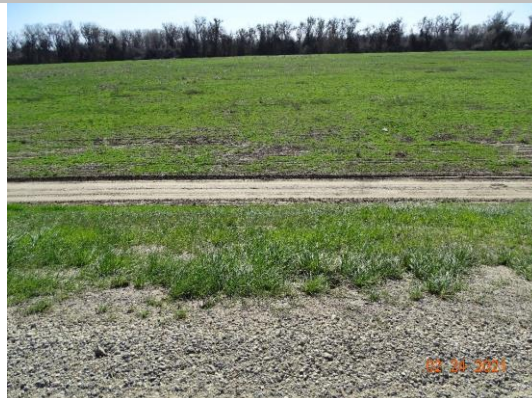
Photo 2 of 3 : UCIP_SP_2022_62946_91651.jpg

Water-Side: View of levee slope looking from crown

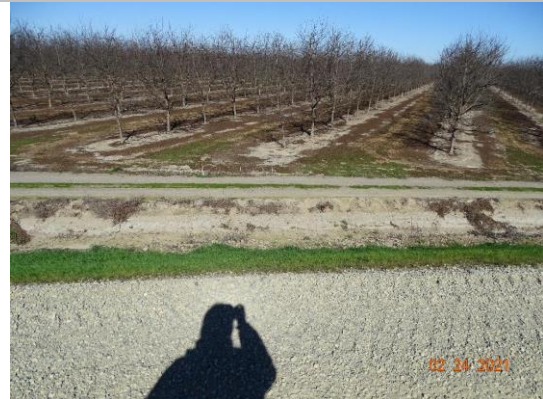
Photo 3 of 3 : UCIP_SP_2022_62946_91652.jpg

LM Start	12.53	Rating **	M	Issue No.	61 (cont)
LM End	12.53	Issue Type +	En	Location *	
Category	Supplemental			GPS Latitude/Longitude	
				Start	End
Item	DWR UCIP Field Study			39.359810 °	39.359810 °
				-122.022247 °	-122.022247 °
DWR ID	17654

Land-Side: View of levee slope looking from crown

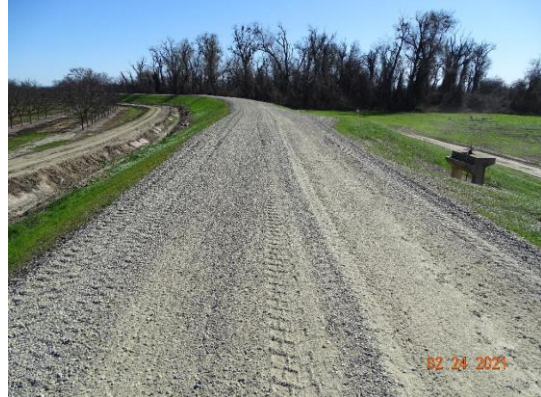
Photo 1 of 3 : UCIP_SP_2022_62947_91654.jpg

Comment Code						
Inspector Comment						
FS_ID:62947 DS_ID:16445 EP_NO: 9462 Repair Type: Urgent Crossing Status: Found UCIP Comments: 02/24/2021 Record updated from Non-Urgent to Urgent. 6-inch steel pipe sleeved through CMP pipe. Screw gate on waterside slightly open and buried in soil. Soil and debris deposits inside CMP pipe. Crossing appears abandoned. Unauthorized encroachment recorded in Levee Log prior to 2011. Need to have CVFPB review ABO and determine current owner. (O.Yakimov - DWR UCIP) 5/3/2017 Appears abandoned- needs to be done properly.(DWR Sutter Yard- A.Freitag)10/24/2016 Appears abandoned. LS concrete canal is filled by pipe DSID 16444.4/25/2016 Appears to be an abandoned crossing. WS slide gate still buried and inoperable.4/21/2015 Same as last inspection. 6/23/2014 Same as last inspection.12/17/2013 Same as last inspection.7/22/2013 Same as last inspection.10/30/2012 Slide gate unoperable-blocked by sediment. LS-flap gate missing. 5-inch pipe goes through 24-inch crossing--unable to determine is authorized. This crossing was listed in the USACE Periodic Inspections as ID# USACE_CESPK_MA1C_2010_p_0435 for smaller pipe running inside existing crossing. FIELD_STRUCT_DESC: 24-inch corrugated metal drainage pipe through the levee, approximately 10 feet below the crown. Slide gate on both waterside (WS) and landside (LS). Gate missing on the LS. (24-inch pipe [HLM 12.97] authorized under Automatic Board Order (ABO) issued as Permit No. 9462, 1974 - Thousand Acre Ranch). [Additional Reference(s): DWR Levee Log, 1992 (HLM 12.97)]. FS Date: 2/24/2021 3:19:42 PM

Top of Levee: View of levee crown looking upstream

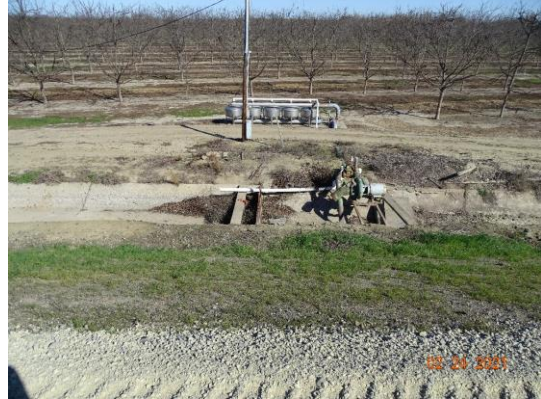
Photo 2 of 3 : UCIP_SP_2022_62947_91655.jpg

Land-Side: View of levee slope looking from crown

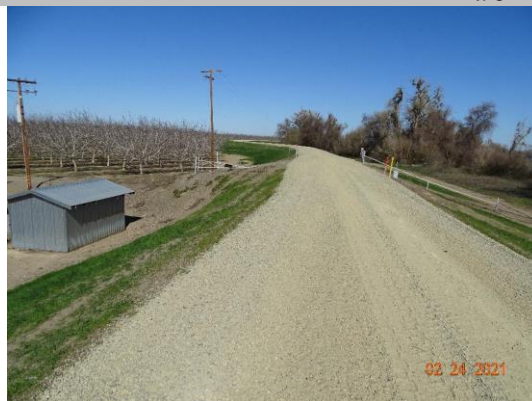
Photo 1 of 3 : UCIP_SP_2022_62948_91664.jpg

FS_ID:62948
DS_ID:16444
EP_NO: 9462
Repair Type: Non-Urgent
Crossing Status: Found
UCIP Comments: 02/24/2021 Record updated from No Action Needed to Non-Urgent. No permit has been identified authorizing pipe. Need to have CVFPB review ABO and determine current owner. (O.Yakimov - DWR UCIP)
5/3/2017 Crossing appears to be in good condition. (DWR Sutter Yard-AFreitag)10/24/2016 Appears to be in good condition. This pipe is used to fill the LS concrete canal.(DWR Sutter Yard-AFreitag)4/25/2016 Crossing appears to be in good condition.4/21/2015 Same as last inspection.6/23/2014 Same as last inspection.12/17/2013 Same as last inspection.7/22/2013 Same as last inspection.10/30/2012 This crossing was listed in the USACE Periodic Inspections as ID#
USACE_CESPK_MA1C_2010_p_0444 no issues recorded.
FIELD_STRUCT_DESC: 14-inch (permit calls for an 18-inch pipe) steel irrigation pipe through the levee at an unknown depth below the crown. Pump and gate valve in pump house on the landside (LS). (18-inch pipe [HLM 13.39] authorized under Automatic Board Order (ABO) issued as Permit No. 9462, 1974 - Thousand Acre Ranch). [Additional Reference(s): DWR Levee Log, 1992 (HLM 13.39), listed as 18-inch steel pipe].

Top of Levee: View of levee crown looking upstream

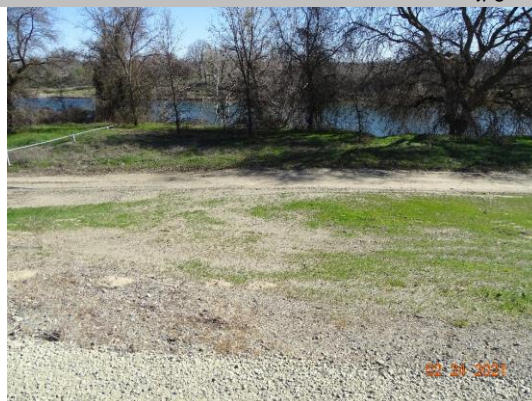
Photo 2 of 3 : UCIP_SP_2022_62948_91665.jpg

Water-Side: View of levee slope looking from crown

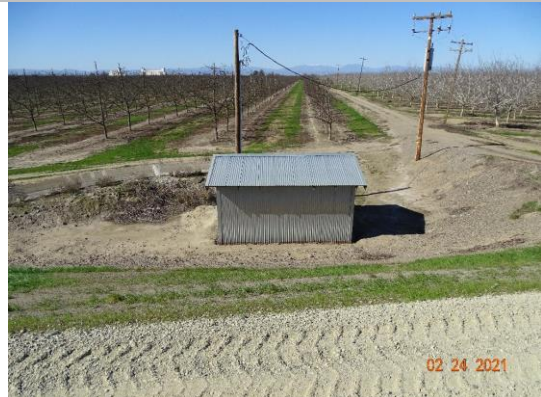
Photo 3 of 3 : UCIP_SP_2022_62948_91666.jpg

Land-Side: View of levee slope looking from crown. Pumphouse at levee toe

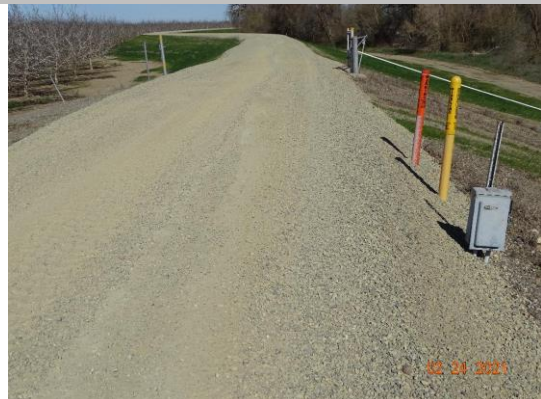
Photo 1 of 3 : UCIP_SP_2022_62951_91680.jpg

FS_ID:62951
DS_ID:20585
EP_NO: N/A
Repair Type: Non-Urgent
Crossing Status: Found
UCIP Comments: 02/24/2021 Record updated from No Action Needed to Non-Urgent. No permit has been found authorizing this pipe through the levee. (O.Yakimov - DWR UCIP)
05/03/2017 Crossing appears to be in good condition. (A. Freitag - DWR Sutter Yard)10/24/2016 Appears to be in good condition. (A. Freitag - DWR Sutter Yard)04/25/2016 Crossing appears to be in good condition. (A. Freitag - DWR Sutter Yard)04/21/2015 Same as last inspection. (A. Freitag - DWR Sutter Yard)06/23/2014 Same as last inspection. (A. Freitag - DWR Sutter Yard)12/17/2013 Same as last inspection. (A. Freitag - DWR Sutter Yard)07/22/2013 Same as last inspection. (A. Freitag - DWR Sutter Yard)
FIELD_STRUCT_DESC: Buried fiber optics cable through the levee at unknown depth below the crown. Marker (orange) is located on the waterside (WS) shoulder. Second marker is located on the WS berm edge. Emergency contact number 1-866-940-7351. Unknown owner. No permit has been identified since crossing was field discovered in 2012.

Top of Levee: View of levee crown looking upstream

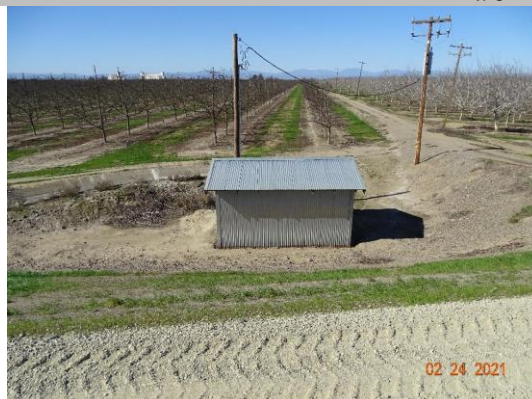
Photo 2 of 3 : UCIP_SP_2022_62951_91679.jpg

Land-Side: View of levee crown looking from crown

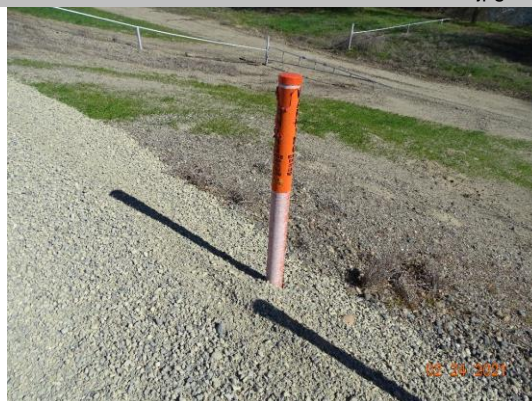
Photo 3 of 3 : UCIP_SP_2022_62951_91681.jpg

Top of Levee: Marker on waterside shoulder

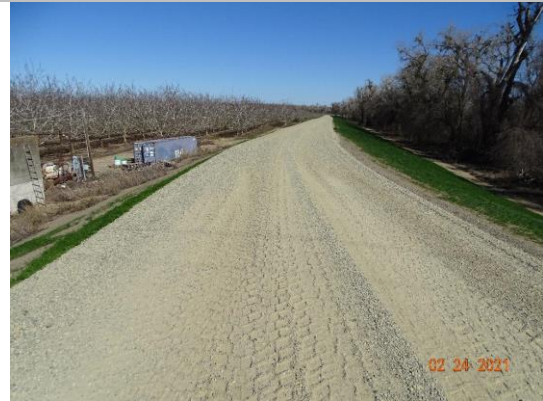
Photo 1 of 3 : UCIP_SP_2022_62952_91685.jpg

FS_ID:62952
DS_ID:16443
EP_NO: 9461
Repair Type: Urgent
Crossing Status: Found
UCIP Comments: 02/24/2021 Record remains Urgent. Backwash erosion extends up to 11 feet from concrete distribution box to landside levee toe. No permit has been identified authorizing pipe. Need to have CVFPB review ABO and determine current owner. (O.Yakimov - DWR UCIP)
10/01/2018 Backwash erosion from ditch appears to be growing along LS toe. FSRP evaluation is recommended. (O.Yakimov - DWR UCIP)05/03/2017 Water was leaking from the LS distribution box during the Jan/Feb 2017 high water event. If this crossing is abandoned then it needs to be so properly. (A. Freitag - DWR Sutter Yard)11/01/2016 Erosion/cavity collapse visible on LS toe. Slide gate inside concrete riser located on the WS is in the open position. Need to contact owner to confirm status of crossing and to determine cause of erosion on LS (pipe or concrete box might be leaking). (O. Magana - DWR UCIP)10/24/2016 Appears abandoned. (A. Freitag - DWR Sutter Yard)04/25/2016 Slide gate in WS box visually appears to be closed as its stem is all the way down. Still cannot look into box to confirm 100% though. (A. Freitag - DWR Sutter Yard)04/21/2015 Same as last inspection. (A. Freitag - DWR Sutter Yard)06/23/2014 Same as last inspection. (A. Freitag - DWR Sutter Yard)12/17/2013 Same as last inspection. (A. Freitag - DWR Sutter Yard)07/22/2013 Same as last inspection. (A. Freitag - DWR Sutter Yard)10/30/2012 Unable to close positive closure device due to missing ladder-sluce gate inaccessible. Need to determine the condition of the gate. This crossing was listed in the USACE Periodic Inspections as ID# USACE_CESPK_MA1C_2010_p_0453 for an inaccessible gate box with its ladder broken on the waterward side. (O. Magana - DWR UCIP) FIELD_STRUCT_DESC: 36-inch corrugated metal irrigation pipe through the levee, 21.5 feet below the crown. Slide gate in concrete box on the waterside (WS) end. Pump on the bank. Tall concrete box located on the landside (LS). (36-inch pipe [HLM 13.76] authorized under Automatic Board Order (ABO) issued as Permit No. 9461, 1974 - Annie D. Propfe). [Additional Reference(s): DWR Levee Log, 1992 (HLM 13.76). USACE Sacramento O&M Manual, Unit 137, August 1955, Revised 29 December 2016, (STA 710+82), listed as 36-inch pipe].

Top of Levee: View of levee crown looking upstream

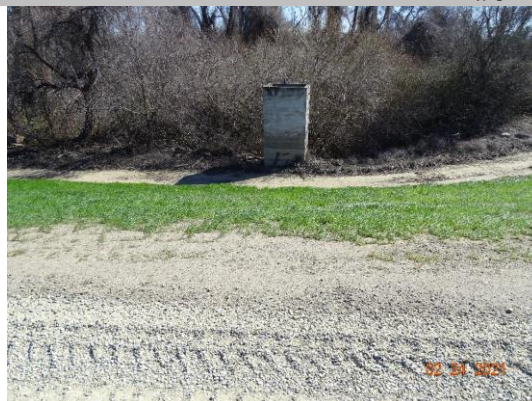
Photo 2 of 3 : UCIP_SP_2022_62952_91686.jpg

Water-Side: View of levee crown looking from crown. Concrete box off levee toe

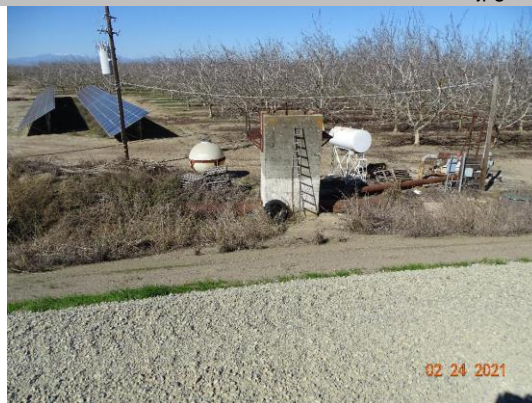
Photo 3 of 3 : UCIP_SP_2022_62952_91687.jpg

Land-Side: View of levee slope looking from crown. Concrete distribution box near levee toe

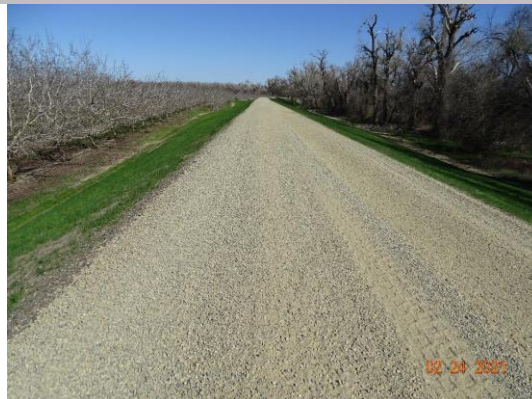
Photo 1 of 3 : UCIP_SP_2022_62953_91691.jpg

FS_ID:62953
DS_ID:17653
EP_NO: N/A
Repair Type: Non-Urgent
Crossing Status: Not Found
UCIP Comments: 05/23/2017 Record is Non-Urgent. Crossing not found. Geophysical results did not confirm presence of pipe through levee. Record will remain in UCIP's inspection records until future Levee Improvement Project can confirm no crossing was found through the levee. No permit has been identified authorizing pipe. (A.Freitag - DWR UCIP)
05/03/2017 Unable to locate. (A. Freitag - DWR Sutter Yard)10/24/2016 Unable to locate. (A. Freitag - DWR Sutter Yard)04/25/2016 Unable to locate. (A. Freitag - DWR Sutter Yard)04/21/2015 Unable to locate. (A. Freitag - DWR Sutter Yard)06/23/2014 Unable to locate. (A. Freitag - DWR Sutter Yard)12/17/2013 Unable to locate. (A. Freitag - DWR Sutter Yard)07/22/2013 Same as last inspection. Unable to locate. (A. Freitag - DWR Sutter Yard)
FIELD_STRUCT_DESC: 36-inch corrugated metal drainage pipe through the levee at an unknown depth below the crown. [Additional Reference(s): USACE Sacramento O&M Manual, Unit 137, August 1955, Revised 29 December 2016, (STA 727+65), listed as 36-inch pipe].

Top of Levee: View of levee crown looking upstream

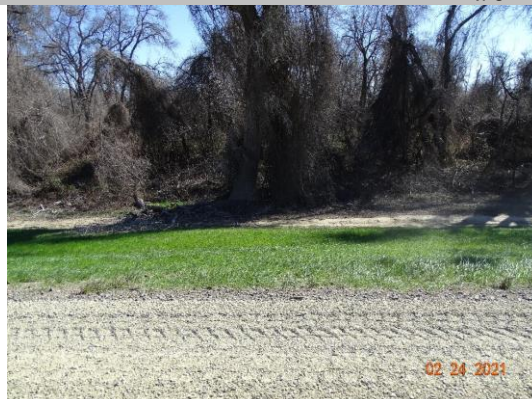
Photo 2 of 3 : UCIP_SP_2022_62953_91692.jpg

Water-Side: View of levee slope looking from crown

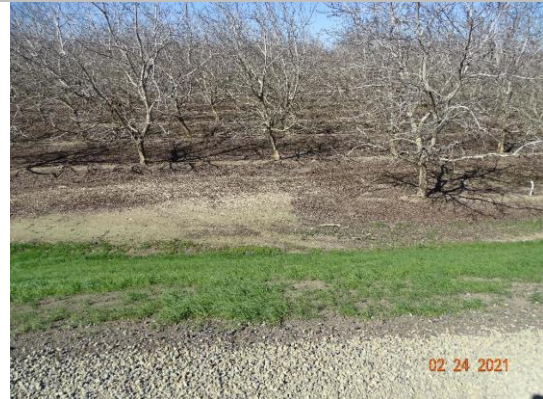
Photo 3 of 3 : UCIP_SP_2022_62953_91693.jpg

Land-Side: View of levee slope looking from crown

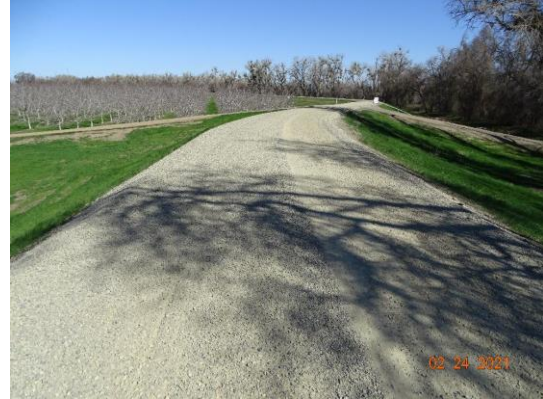
Photo 1 of 3 : UCIP_SP_2022_62954_91694.jpg

Comment Code						
Inspector Comment						
FS_ID:62954 DS_ID:16442 EP_NO: N/A Repair Type: Non-Urgent Crossing Status: Found UCIP Comments: 02/24/2021 Record remains Non-Urgent. Geophysical study indicates possible presence of pipe through levee. Owner needs to coordinate with the CVFPB to remove or abandon crossing according to Title 23 requirements. Crossing appears abandoned: screw gate stem has been bent, screw gate buried in soil completely. No pipe inlet found on landside. No permit has been identified authorizing pipe. (O.Yakimov - DWR UCIP) 05/03/2017 Abandoned- needs to be done so properly. (A. Freitag - DWR Sutter Yard)10/24/2016 Abandoned. (A. Freitag - DWR Sutter Yard)04/25/2016 Abandoned crossing. (A. Freitag - DWR Sutter Yard)04/21/2015 Slide gate is still buried. (A. Freitag - DWR Sutter Yard)06/23/2014 Same as last inspection. (A. Freitag - DWR Sutter Yard)12/17/2013 Same as last inspection. (A. Freitag - DWR Sutter Yard)07/22/2013 Same as last inspection. (A. Freitag - DWR Sutter Yard)10/30/2012 Slide gate is buried-non-fuctional. This crossing was listed in the USACE Periodic Inspections as ID# USACE_CESPK_MA1C_2010_p_0457 for buried slide gate. (O. Magana - DWR UCIP) FIELD_STRUCT_DESC: 36-inch corrugated metal drainage pipe through the levee at approximately 15-18 feet below the crown. Slide gate on the waterside (WS) end. (Davis Ranches). [Additional Reference(s): DWR Levee Log, 1992 (HLM 14.09), listed as abandoned 36-inch CMP]. FS Date: 2/24/2021 4:08:26 PM

Top of Levee: View of levee crown looking upstream

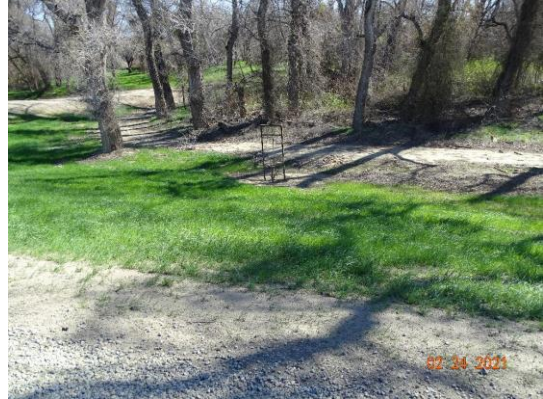
Photo 2 of 3 : UCIP_SP_2022_62954_91695.jpg

Water-Side: View of levee slope looking from crown

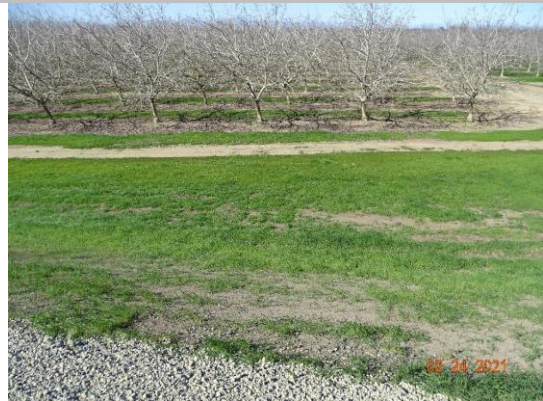
Photo 3 of 3 : UCIP_SP_2022_62954_91696.jpg

Land-Side: View of levee slope looking from crown

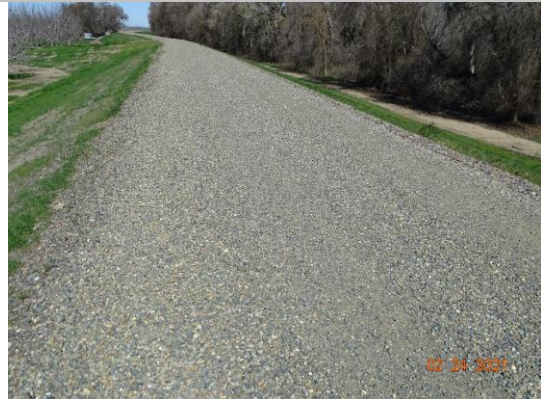
Photo 1 of 3 : UCIP_SP_2022_62955_91699.jpg

FS_ID:62955
DS_ID:17652
EP_NO: N/A
Repair Type: Non-Urgent
Crossing Status: Not Found
UCIP Comments: 02/24/2021 Record is Non-Urgent. Crossing not found. Geophysical results did not confirm presence of pipe through levee. Record will remain in UCIP's inspection records until future Levee Improvement Project can confirm no crossing was found through the levee. No permit has been identified authorizing pipe. (O.Yakimov - DWR UCIP)
05/03/2017 Unable to locate. (A. Freitag - DWR Sutter Yard)10/24/2016 Unable to locate. (A. Freitag - DWR Sutter Yard)04/25/2016 Unable to locate. (A. Freitag - DWR Sutter Yard)04/21/2015 Unable to locate. (A. Freitag - DWR Sutter Yard)06/23/2014 Unable to locate. (A. Freitag - DWR Sutter Yard)12/17/2013 Unable to locate. (A. Freitag - DWR Sutter Yard)07/22/2013 Same as last inspection. Unable to locate. (A. Freitag - DWR Sutter Yard)
FIELD_STRUCT_DESC: 16-inch steel drainage pipe through the levee at an unknown depth below the crown. Automatic drainage gate on the outlet end of the pipe. [Additional Reference(s): USACE Sacramento O&M Manual, Unit 137, August 1955, Revised 29 December 2016, (STA 754+20), listed as 16-inch steel pipe].

Top of Levee: View of levee crown looking upstream

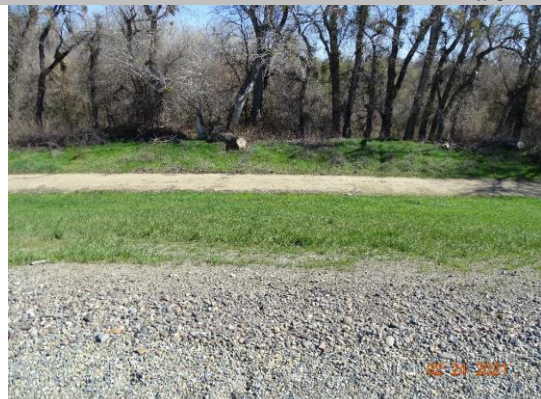
Photo 2 of 3 : UCIP_SP_2022_62955_91700.jpg

Water-Side: View of levee slope looking from crown

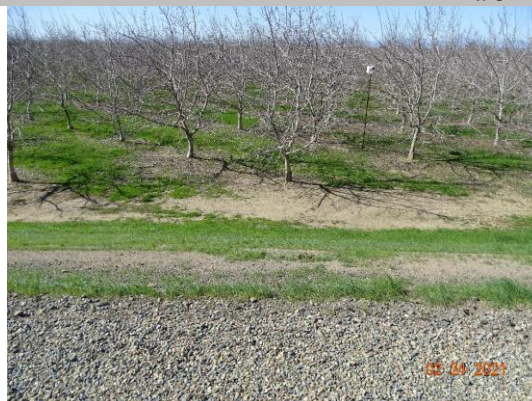
Photo 3 of 3 : UCIP_SP_2022_62955_91701.jpg

Land-Side: View of levee slope looking from crown

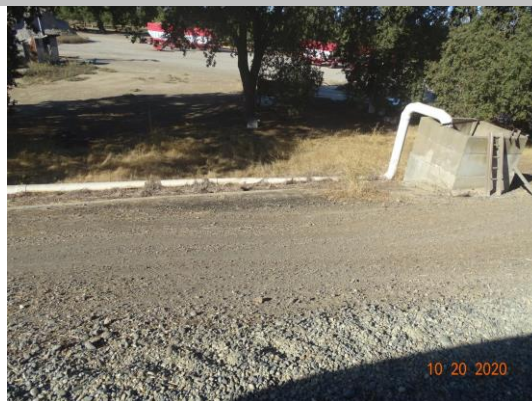
Photo 1 of 1 : SP_2022_MA0001_297_128_20220307_00031.jpg

LM Start	14.25	Rating **	U	Issue No.	128
LM End	14.30	Issue Type +	En	Location *	LS
Category	Earthen Levee			GPS Latitude/Longitude	
				Start	End
Item	Encroachments			39.378129 °	39.378800 °
				-122.013040 °	-122.013360 °
DWR ID	DWR_MA0001_01_s_2019_128				
Comment Code					
PI : Pipe					
Inspector Comment					
Concrete pipe runs along the landside toe and concrete box at the end.

View of the concrete pipe that runs along the landside toe. Fall 2020.

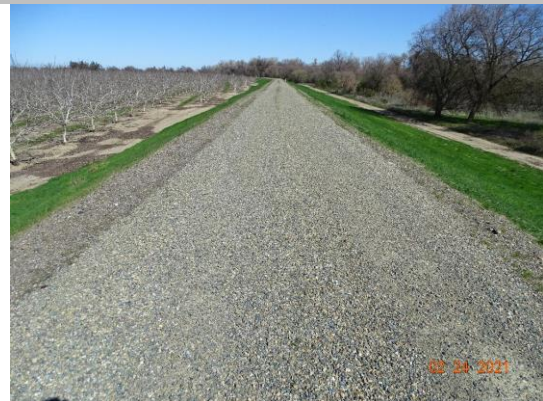
Photo 1 of 3 : UCIP_SP_2022_62957_91706.jpg

Comment Code						
Inspector Comment						
FS_ID:62957 DS_ID:16440 EP_NO: 13361 Repair Type: Non-Urgent Crossing Status: Not Found UCIP Comments: 02/24/2021 Record is Non-Urgent. Crossing not found. Geophysical study indicates possible presence of pipe through levee. Owner needs to coordinate with the CVFPB to remove or abandon crossing according to Title 23 requirements. (O.Yakimov - DWR UCIP) 05/03/2017 Unable to locate. (A. Freitag - DWR Sutter Yard)10/24/2016 Unable to locate. (A. Freitag - DWR Sutter Yard)04/25/2016 Unable to locate. (A. Freitag - DWR Sutter Yard)04/21/2015 Unable to locate. (A. Freitag - DWR Sutter Yard)06/23/2014 Unable to locate. (A. Freitag - DWR Sutter Yard)12/17/2013 Unable to locate. (A. Freitag - DWR Sutter Yard)07/22/2013 Same as last inspection. Unable to locate. (A. Freitag - DWR Sutter Yard) FIELD_STRUCT_DESC: 8-inch asphalt coated steel irrigation pipe through the levee, 3 feet below the crown. Siphon breaker on the landside (LS) shoulder. (8-inch pipe authorized under Permit No. 13361, 1982 - Princeton Ranch). [Additional Reference(s): DWR Levee Log, 1992 (HLM 15.58)]. FS Date: 2/24/2021 4:22:54 PM

Top of Levee: View of levee crown looking upstream

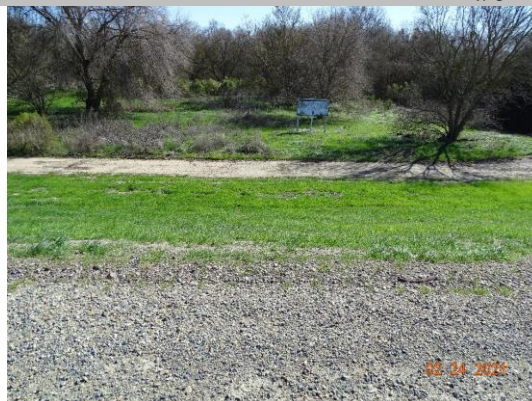
Photo 2 of 3 : UCIP_SP_2022_62957_91707.jpg

Water-Side: View of levee slope looking from crown

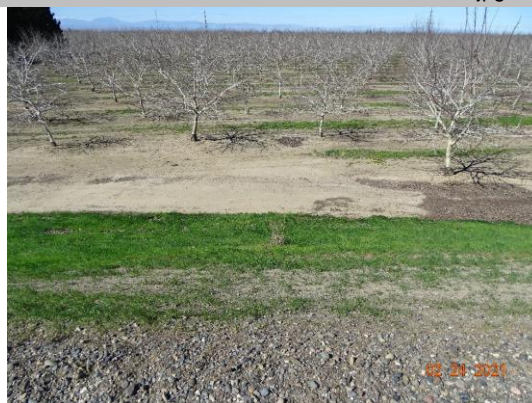
Photo 3 of 3 : UCIP_SP_2022_62957_91708.jpg

Land-Side: View of levee slope looking from crown

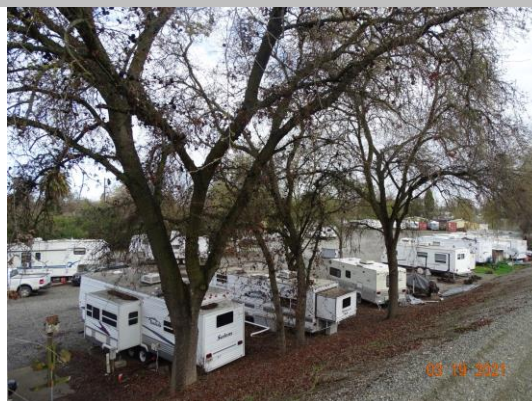
Photo 1 of 1 : SP_2022_MA0001_297_86_20220307_00021.jpg

LM Start	15.84	Rating **	U	Issue No.	86
LM End	15.90	Issue Type +	En	Location *	LS
Category	Earthen Levee			GPS Latitude/Longitude	
				Start	End
Item	Encroachments			39.400601 °	39.401365 °
				-122.009889 °	-122.009374 °
DWR ID	DWR_MA0001_01_s_2016_86				
Comment Code					
BU : Building					
Inspector Comment					
Mobile homes and trailers are within the landside toe easement.

View of the mobile homes along the landside toe. Spring 2021.

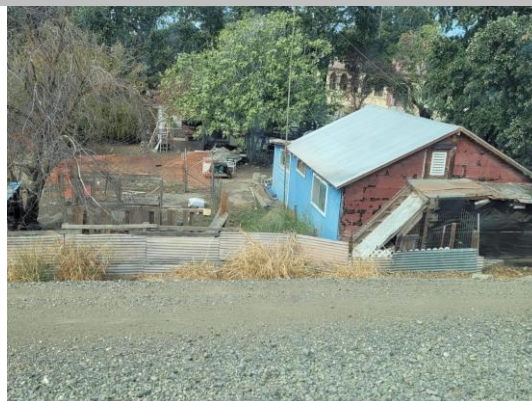
Photo 1 of 1 : SP_2022_MA0001_297_89_20220307_00023.jpg

LM Start	16.00	Rating **	U	Issue No.	89
LM End	16.02	Issue Type +	En	Location *	LS
Category	Earthen Levee			GPS Latitude/Longitude	
				Start	End
Item	Encroachments			39.402756 °	39.403040 °
				-122.009261 °	-122.009186 °
DWR ID	DWR_MA0001_01_s_2016_89				
Comment Code					
BU : Building					
Inspector Comment					
Red house and metal fence runs along the landside toe.

View of the building and corrugated metal fence along the landside slope. Fall 2021.

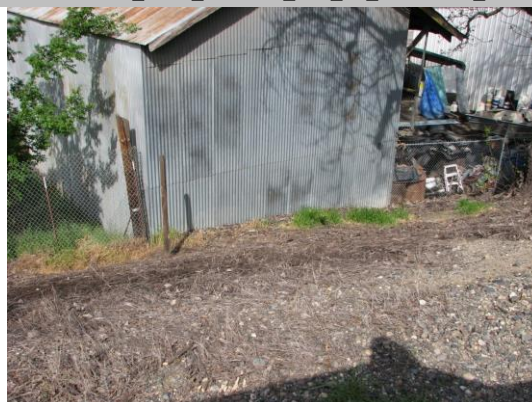
Photo 1 of 1 : SP_2022_MA0001_297_90_20220307_00024.jpg

LM Start	16.03	Rating **	U	Issue No.	90
LM End	16.03	Issue Type +	En	Location *	LS
Category	Earthen Levee			GPS Latitude/Longitude	
				Start	End
Item	Encroachments			39.403206 °	39.403206 °
				-122.009116 °	-122.009116 °
DWR ID	DWR_MA0001_01_s_2016_90				
Comment Code					
BU : Building					
Inspector Comment					
Metal sided building is at the landside toe.

View of a corrugated metal building obstructing visibility and access.

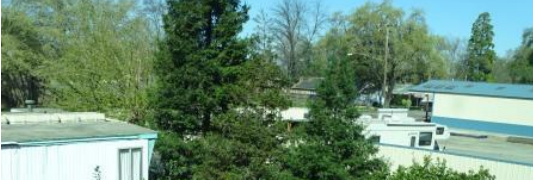
Photo 1 of 1 : SP_2022_MA0001_297_74_20220307_00018.jpg

View of the landscaping along the landside slope and toe. Spring 2020.

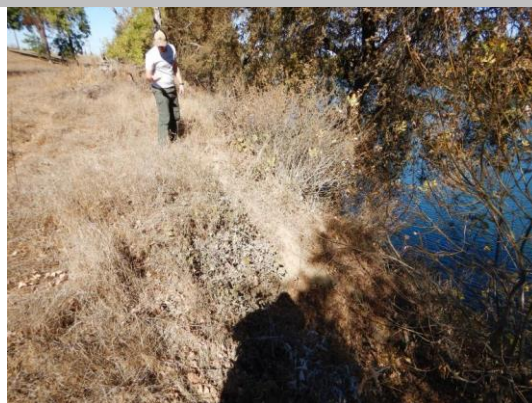
Photo 1 of 2 : SP_2022_MA0001_297_9_20220307_00006.jpg

LM Start	16.35	Rating **	A/W	Issue No.	9
LM End	16.58	Issue Type +	Ma	Location *	WS
Category	Supplemental			GPS Latitude/Longitude	
				Start	End
Item	2018 USACE Erosion Survey			39.407837 °	39.411111 °
				-122.008763 °	-122.009238 °
DWR ID	DWR_MA0001_01_s_2022_9				
Comment Code					
Inspector Comment					
2018 Site ID: SAC 164.3 R					
Status: Eroding					
2018 Field Notes: Minor new erosion throughout site.					
Site History: Erosion site added in 1997 and removed in 2005. 2009 -					
Site added back in, hard toe with slow moving erosion. Potential					
geotechnical failure. 2011 - Site extended downstream. 2017 - New					
erosion along entire site.

USACE 2018 Erosion Photo #1

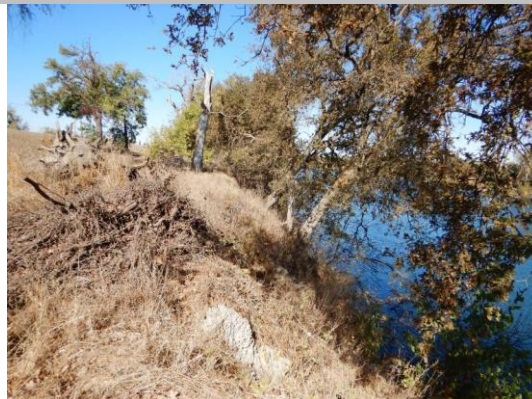
Photo 2 of 2 : SP_2022_MA0001_297_9_20220307_00007.jpg

LM Start	16.35	Rating **	A/W	Issue No.	9 (cont)
LM End	16.58	Issue Type +	Ma	Location *	WS
Category	Supplemental			GPS Latitude/Longitude	
				Start	End
Item	2018 USACE Erosion Survey			39.407837 °	39.411111 °
				-122.008763 °	-122.009238 °
DWR ID	DWR_MA0001_01_s_2022_9

USACE 2018 Erosion Photo #2

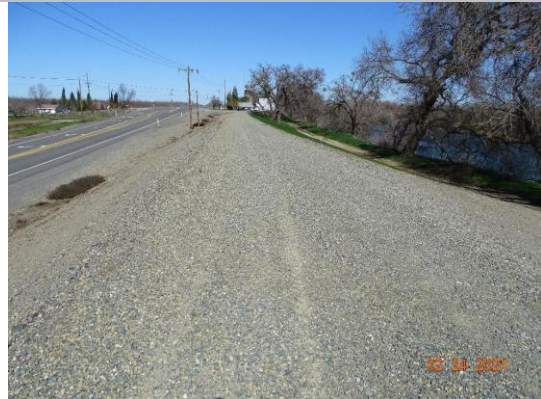
Photo 1 of 3 : UCIP_SP_2022_62959_91715.jpg

FS_ID:62959
DS_ID:16438
EP_NO: 2189
Repair Type: Non-Urgent
Crossing Status: Indicator Found
UCIP Comments: 02/24/2021 Record remains Non-Urgent. No inspection records were available to determine status of line through the levee. Yellow posts guard on landside may indicate location of gas line on landside. No gas line markers installed on both slopes. (O.Yakimov - DWR UCIP)
05/03/2017 Needs new markers if line is still active. (A. Freitag - DWR Sutter Yard)10/24/2016 Abandoned. (A. Freitag - DWR Sutter Yard)04/25/2016 Abandoned pipes. (A. Freitag - DWR Sutter Yard)04/21/2015 Same as last inspection. (A. Freitag - DWR Sutter Yard)11/03/2014 Need to contact owner to determine when markers will be placed. Also need to determine additional details--depth and alignment. Emergency contact Mr. Monte Penland, Gas Maintenance Supervisor, 15871 Central Street, Meridian, CA 95957; Office No. 530-634-6520 or Mobile No. 530-356-7396. (O. Magana - DWR UCIP)06/23/2014 Same as last inspection. (A. Freitag - DWR Sutter Yard)12/17/2013 Same as last inspection. (A. Freitag - DWR Sutter Yard)07/22/2013 Same as last inspection. (A. Freitag - DWR Sutter Yard)12/01/2012 Crossing is an active line. Waiting for additional information from PG&E. (O. Magana - DWR UCIP)11/14/2012 Buried line--no markers visible. Olivia (UCIP team) is coordinating with PG&E to determine more info on crossing. (O. Magana - DWR UCIP)

FIELD_STRUCT_DESC: 2-inch gas line along landside (LS) toe from 12-inch gas line at levee mile 16.85 to the Princeton Rice Dryer. 2-inch pipeline installed longitudinally on the levee parallel to highway (HWY) 45 in a northerly direction from the point where the 2-10-inch pipes were installed in the levee. Utility crossing coordinates are approximate. (2-inch gas line extension authorized under Permit No. 2189, 1958 - Pacific Gas & Electric [PG&E]). [Additional Reference(s): DWR Levee Log, 1992 (HLM 16.85 - 17.00), listed as 2-inch gas line along landward toe].
FS Date: 2/24/2021 4:30:02 PM

Top of Levee: View of levee crown looking upstream

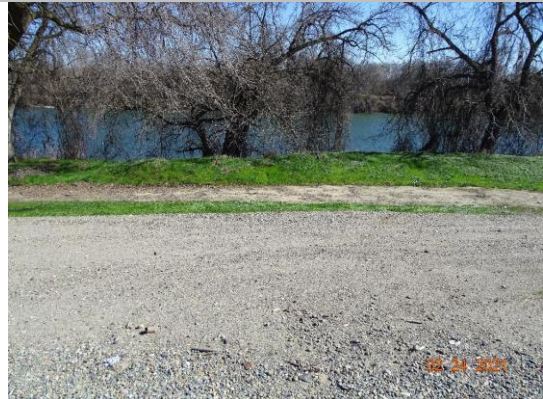
Photo 2 of 3 : UCIP_SP_2022_62959_91716.jpg

LM Start	16.49	Rating **	M	Issue No.	81 (cont)
LM End	16.49	Issue Type +	En	Location *	
Category	Supplemental		GPS Latitude/Longitude		
			Start	End	
Item	DWR UCIP Field Study		39.409758 °	39.409758 °	
			-122.009562 °	-122.009562 °	
DWR ID	16438

Water-Side: View of levee slope looking from crown

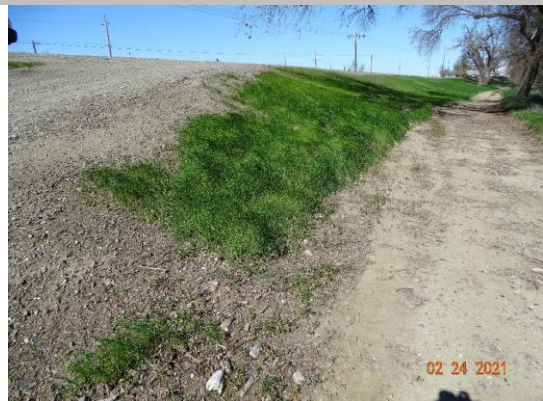
Photo 3 of 3 : UCIP_SP_2022_62959_91717.jpg

LM Start	16.49	Rating **	M	Issue No.	81 (cont)
LM End	16.49	Issue Type +	En	Location *

Water-Side: View of levee slope looking waterside berm
