**Flood Control Project Maintenance
Levee Inspections
LMA District Cover Sheet**

**Flood Control Project Maintenance
Levee Inspections
Unit Cover Sheet**

Waterway			Bank	Unit Miles
Unit No. 01 Sacramento River			Right	16.76
	Spring (March - May)	Summer (June - August)	(September - November) Fall	Winter (December - February)
Unit Maintenance Rating (Fall Only)				
Date of Inspection	4/11/2023 - 4/11/2023			
DWR Inspector	Makar Sokol			
Accompanied By	Gregg Ahlers DWR Sutter Yard

Levee Inspection Report By Mile - Spring 2023

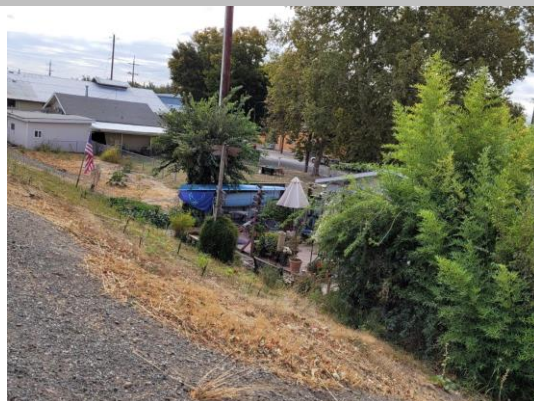
Photo 1 of 1 : SP_2023_MA0001_297_106_20230410_00029.jpg

LM Start	0.07	Rating **	M	Issue No.	106
LM End	0.07	Issue Type +	En	Location *	LS
Category	Earthen Levee			GPS Latitude/Longitude	
				Start	End
Item	Encroachments			39.214162°	39.214162°
				-122.002174°	-122.002174°
DWR ID	DWR_MA0001_01_f_2021_106				
Comment Code					
LI : Landscape Irrigation					
Inspector Comment

View of the irrigation system on the landside slope. Fall 2021.

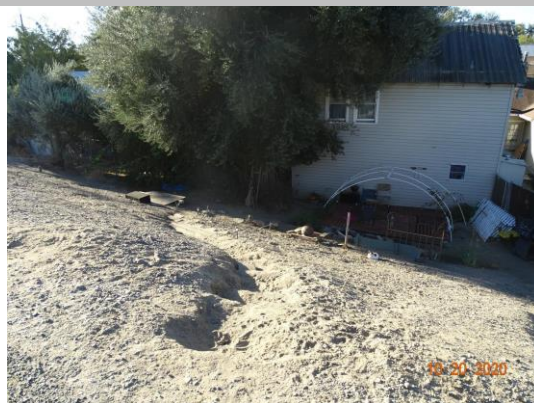
Photo 1 of 2 : SP_2023_MA0001_297_63_20230410_00015.jpg

LM Start	0.11	Rating **	U	Issue No.	63
LM End	0.11	Issue Type +	En	Location *	LS
Category	Earthen Levee			GPS Latitude/Longitude	
				Start	End
Item	Encroachments			39.214379°	39.214379°
				-122.002791°	-122.002791°
DWR ID	DWR_MA0001_01_f_2019_63				
Comment Code					
ST : Stairway					
Inspector Comment					
Two sets of stairs are cut into the landside slope. The stairs need to be removed and the slope needs to be restored.

View of one of the stairs cut into the landside slope. Fall 2020.

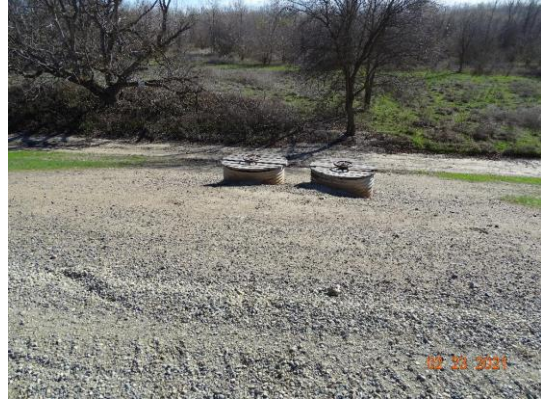
Photo 1 of 3 : UCIP_SP_2023_62869_91151.jpg

Comment Code					
Inspector Comment					
DS_ID:16430 FS_ID:62869 EP_NO: 9487 Repair Type: Urgent EVAL Issue: 1, Pipe Integrity Crossing Status: Found UCIP Comments: 02/23/2021 Record updated from Non-Urgent to Urgent. DMP internal video inspection has found pipe integrity issues. LOF of crossing is between 5 and 6. Crossing will be monitored until funding becomes available to address the issues. No permit has been identified authorizing pipe. Need to have CVFPB review ABO and determine current owner. (O.Yakimov - DWR UCIP) 05/03/2017 WS end still partially plugged. (A. Freitag - DWR Sutter Yard) 10/24/2016 WS end is till partially plugged. (A. Freitag - DWR Sutter Yard)04/25/2016 WS pipe end is still plugged with soil. Rest of the pipe appeared to be in good condition. (A. Freitag - DWR Sutter Yard)04/20/2015 WS pipe end is plugged about 50% by soil. (A. Freitag - DWR Sutter Yard)06/18/2014 Same as last inspection. (A. Freitag - DWR Sutter Yard)12/17/2013 Same as last inspection. (A. Freitag - DWR Sutter Yard)07/18/2013 WS pipe end has been reformed but is still clogged about 50% by sediment.10/18/2012 Remove dirt and debris in riser. Outlet deformed and blocked over 50%. Debris-round concrete section on landward side. This crossing was listed in the USACE Periodic Inspections as ID# USACE_CESPK_MA1C_2010_p_0116 for crossing outlet deformed and clogged with dirt. (O. Magana - DWR UCIP) FIELD_STRUCT_DESC: 1 of 2: 36-inch corrugated metal drainage pipe through the levee, approximately 12-15 feet below the crown. Slide gates in corrugated metal pipe (CMP) riser located on the waterside (WS) slope. Pipe daylights on the landside (LS). (36-inch pipe [HLM 1.97] authorized under Automatic Board Order (ABO) issued as Permit No. 9487, 1974 - Jimeno Rancho). [Additional Reference(s): DWR Levee Log, 1992 (HLM 1.97).USACE Sacramento O&M Manual, Unit 137, August 1955, Revised 29 December 2016, (STA 103+18), listed as 36-inch pipe]. FS Date: 2/23/2021 9:20:38 AM

Water-Side: View of levee slope looking from crown

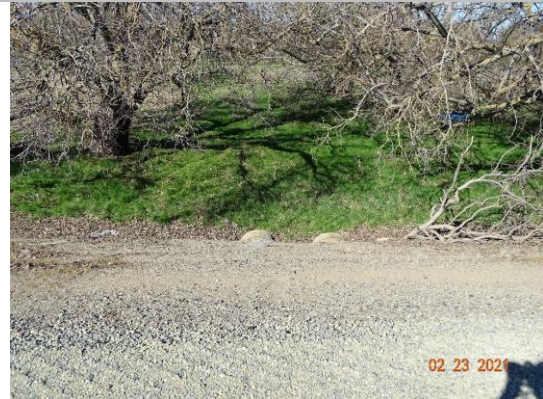
Photo 2 of 3 : UCIP_SP_2023_62869_91152.jpg

LM Start	1.92	Rating **	U	Issue No.	1 (cont)
LM End	1.92	Issue Type +	Ma	Location *	
Category	Supplemental		GPS Latitude/Longitude		
			Start	End	
Item	DWR UCIP LMA Responsibility		39.231866°	39.231866°	
			-122.015442°	-122.015442°	
DWR ID	16430

Land-Side: View of levee slope looking from crown

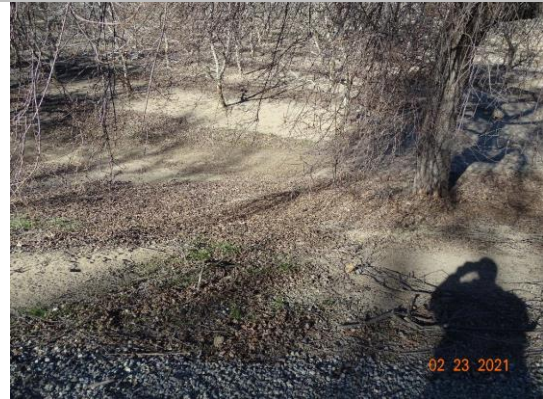
Photo 1 of 3 : UCIP_SP_2023_62873_91177.jpg

Comment Code					
Inspector Comment					
DS_ID:16428 FS_ID:62873 EP_NO: 9467 Repair Type: Non-Urgent EVAL Issue: Crossing Status: Found UCIP Comments: 02/23/2021 Record remains Non-Urgent. Geophysical study indicates possible presence of pipe through levee. Owner needs to coordinate with the CVFPB to remove or abandon crossing according to Title 23 requirements. Crossing appears abandoned. Pipe ends on both slopes are buried in soil. No permit has been identified authorizing pipe. Need to have CVFPB review ABO and determine current owner. (O.Yakimov - DWR UCIP) 05/03/2017 Abanoned- needs to be done so properly. (A. Freitag - DWR Sutter Yard)10/24/2016 Abandoned. (A. Freitag - DWR Sutter Yard)04/25/2016 Abandoned crossing. Unable to locate any WS and LS pipe ends. (A. Freitag - DWR Sutter Yard)04/20/2015 Same as last inspection. (A. Freitag - DWR Sutter Yard)06/18/2014 Same as last inspection. (A. Freitag - DWR Sutter Yard)12/17/2013 Same as last inspection. (A. Freitag - DWR Sutter Yard)07/18/2013 Same as last inspection. (A. Freitag - DWR Sutter Yard)10/18/2012 Only riser visible. Debris and sediment blocking gate. Gate inside riser is buried and non-functional. If crossing is abandoned, owner needs to properly abandon. This crossing was listed in the USACE Periodic Inspections as ID# USACE_CESPK_MA1C_2010_p_0132 no culvert through the levee is visible here. (O. Magana - DWR UCIP) FIELD_STRUCT_DESC: 24-inch corrugated metal drainage pipe through the levee, approximately 12-15 feet below the crown. Slide gate in CM pipe riser on the waterside (WS) slope. No signs of inlet visible on the landside (LS). (24-inch pipe [HLM 2.31] authorized under Automatic Board Order (ABO) issued as Permit No. 9467, 1974 - Lovell E. Spurgeon). [Additional Reference(s): DWR Levee Log, 1992 (HLM 2.31). USACE Sacramento O&M Manual, Unit 137, August 1955, Revised 29 December 2016, (STA 120+60), listed as 24-inch pipe]. FS Date: 2/23/2021 9:30:51 AM

Land-Side: View of levee slope looking from crown

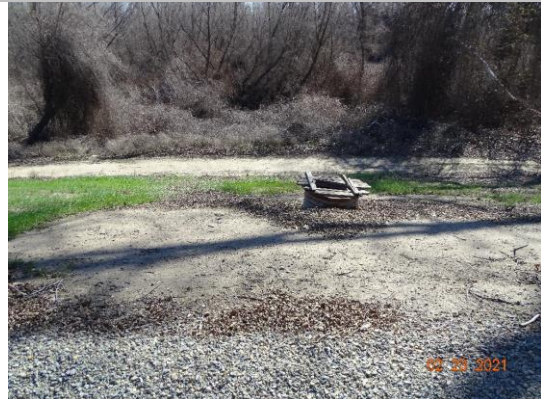
Photo 2 of 3 : UCIP_SP_2023_62873_91176.jpg

LM Start	2.25	Rating **	M	Issue No.	10 (cont)
LM End	2.25	Issue Type +	Ma	Location *	
Category	Supplemental			GPS Latitude/Longitude	
				Start	End
Item	DWR UCIP LMA Responsibility			39.236178 °	39.236178 °
				-122.012812 °	-122.012812 °
DWR ID	16428

Water-Side: View of levee slope looking from crown. CMP riser on levee slope

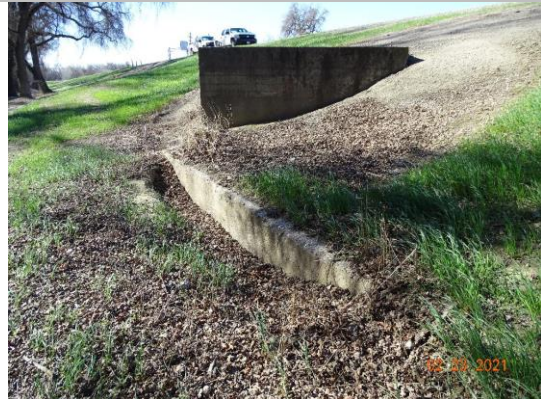
Photo 2 of 3 : UCIP_SP_2023_62892_91309.jpg

DS_ID:16416
FS_ID:62892
EP_NO: 9474
Repair Type: Urgent
EVAL Issue: 3a, Flood Risk
Crossing Status: Found
UCIP Comments: 02/23/2021 Record updated from Non-Urgent to Urgent. Missing slide gate on pipe in concrete box on waterside slope creates flood threat to landside. Crossing appears abandoned. Concrete box on waterside filled with soil, soil deposits inside and around pipe end on landside. No permit has been identified authorizing pipe. Need to have CVFPB review ABO and determine current owner. (O.Yakimov - DWR UCIP)
05/03/2017 Appears abandoned- WS vault full of soil. Needs to be abandoned properly. (A. Freitag - DWR Sutter Yard)10/24/2016 Appears to be abandoned. WS vault full of soil to help prevent water from flowing through during high water season. (A. Freitag - DWR Sutter Yard)04/25/2016 Concrete box was filled with dirt to help prevent water from through during high water times. (A. Freitag - DWR Sutter Yard)04/20/2015 Positive closure device is missing and water cannot be prevented from flowing through pipe during high water. (A. Freitag - DWR Sutter Yard)06/18/2014 Same as last inspection. (A. Freitag - DWR Sutter Yard)12/17/2013 Same as last inspection. (A. Freitag - DWR Sutter Yard)07/18/2013 Same as last inspection. (A. Freitag - DWR Sutter Yard)10/18/2012 During high water flow goes through levee. Missing positive closure device on waterward side. This structure appears abandoned-slide gates have been removed. Crossing needs to be properly abandoned. This crossing was listed in the USACE Periodic Inspection as ID# USACE_CESPK_MA1C_2010_p_0169 for concrete box partially filled with dirt. (O. Magana - DWR UCIP)

LM Start	2.81	Rating **	U	Issue No.	11 (cont)	
LM End	2.81	Issue Type +	En	Location *		
Category	Supplemental			GPS Latitude/Longitude		
				Start		End
Item	DWR UCIP Field Study			39.243410°	39.243410°	
				-122.008393°	-122.008393°	
DWR ID	16416

Water-Side: View of abandoned concrete box on levee slope

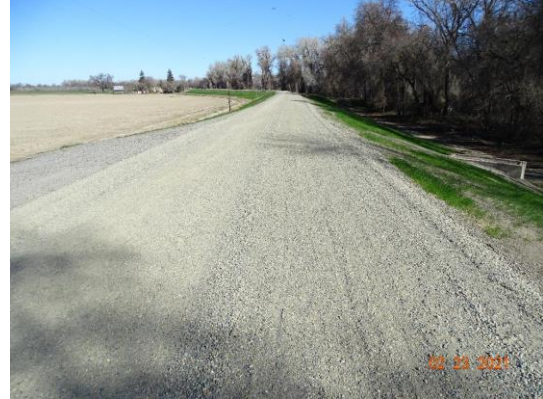
Photo 1 of 3 : UCIP_SP_2023_62894_91323.jpg

DS_ID:17567
FS_ID:62894
EP_NO: 9474
Repair Type: Urgent
EVAL Issue: 3a, Flood Risk
Crossing Status: Found
UCIP Comments: 02/23/2021 Record updated from Non-Urgent to Urgent. Missing slide gate on pipe in concrete box on waterside slope creates flood threat to landside. Crossing appears abandoned. Concrete box on waterside filled with soil, soil deposits inside and around pipe end on landside. No permit has been identified authorizing pipe. Need to have CVFPB review ABO and determine current owner. (O.Yakimov - DWR UCIP)
05/03/2017 Appears abandoned- WS vault full of soil. Needs to be abandoned properly. (A. Freitag - DWR Sutter Yard)10/24/2016 Appears to be abandoned. WS vault full of soil to help prevent water from flowing through during high water season. (A. Freitag - DWR Sutter Yard)04/25/2016 Concrete box on WS was filled with soil to help prevent water form flowing through during times of high water. (A. Freitag - DWR Sutter Yard)04/20/2015 Positive closure device is missing and water cannot be prevented from flowing through pipe during high water. (A. Freitag - DWR Sutter Yard)06/18/2014 Same as last inspection. (A. Freitag - DWR Sutter Yard)12/17/2013 Same as last inspection. (A. Freitag - DWR Sutter Yard)07/18/2013 Same as last inspection. (A. Freitag - DWR Sutter Yard)10/18/2015 During high water flow goes through levee. Missing positive closure device on waterward side. This structure appears abandoned-slide gates have been removed. Crossing needs to be properly abandoned. This crossing was listed in the USACE Periodic Inspection as ID# USACE_CESPK_MA1C_2010_p_0169 for concrete box partially filled with dirt. (O. Magana - DWR UCIP)

FIELD_STRUCT_DESC: 60-inch reinforced concrete irrigation pipe through the levee, approximately 12-15 feet below the crown. Culvert constructed with wing walls and gates. Crossing goes through the levee at an angle. Slide gates in concrete well at the waterside (WS) toe. (60-inch pipe [HLM 2.89] authorized under Automatic Board Order (ABO) issued as Permit No. 9474, 1974 - George R. Zumwalt, et al).
[Additional Reference(s): DWR Levee Log, 1992 (HLM 2.89). USACE Sacramento O&M Manual, Unit 137, August 1955, Revised 29 December 2016, (STA 150+06), listed as 5-foot by 5-foot concrete culvert with hand-operated slide gate].
FS Date: 2/23/2021 2:01:03 PM

Top of Levee: View of levee crown looking upstream

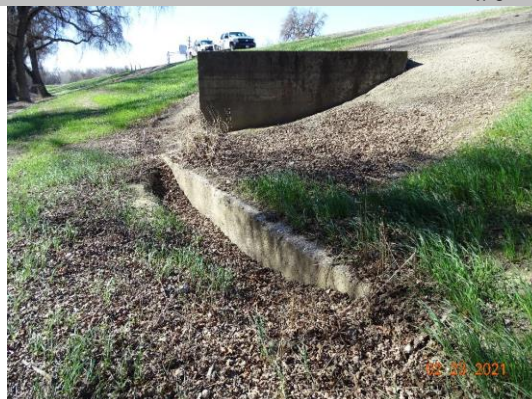
Photo 2 of 3 : UCIP_SP_2023_62894_91324.jpg

LM Start	2.81	Rating **	U	Issue No.	12 (cont)
LM End	2.81	Issue Type +	En	Location *	
Category	Supplemental		GPS Latitude/Longitude		
			Start	End	
Item	DWR UCIP Field Study		39.243433°	39.243433°	
			-122.008386°	-122.008386°	
DWR ID	17567

Water-Side: Abandoned, filled with soil concrete box on levee slope, buried headwall at toe

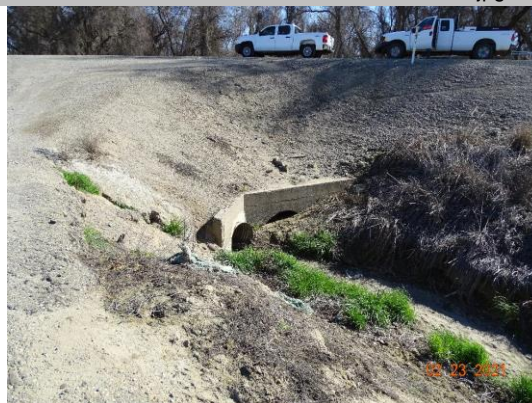
Photo 3 of 3 : UCIP_SP_2023_62894_91321.jpg

Land-Side: Headwall at the toe. Irrigation ditch starts at pipe outfall

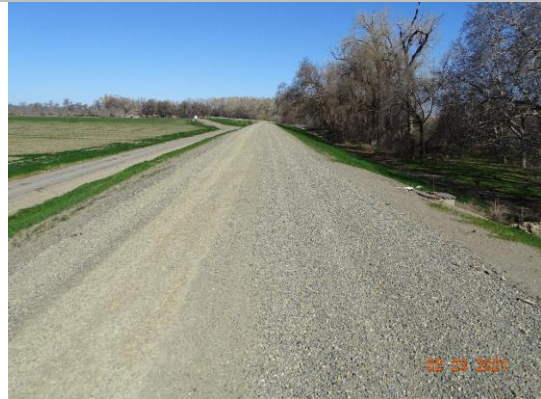
Photo 1 of 3 : UCIP_SP_2023_62896_91330.jpg

DS_ID:16426
FS_ID:62896
EP_NO: 9490
Repair Type: Non-Urgent
EVAL Issue:
Crossing Status: Found
UCIP Comments: 02/23/2021 Record remains Non-Urgent. No permit has been identified authorizing pipe. Need to have CVFPB review ABO and determine current owner. Bent stem has been repaired, pipe inlet and outfall cleared from sediment. (O.Yakimov - DWR UCIP)
05/03/2017 Sediment build up in WS pipe end. WS slide gate stem bent but it does not affect its operation. (A. Freitag - DWR Sutter Yard)10/24/2016 WS slide gate stem is still bent. (A. Freitag - DWR Sutter Yard)04/25/2016 WS slide gate is slightly bent. Rest of crossing appears to be in good condition. (A. Freitag - DWR Sutter Yard) 04/20/2015 LS inlet still has some minor sediment build up. Needs to be cleaned. (A. Freitag - DWR Sutter Yard)06/18/2014 Same as last inspection. (A. Freitag - DWR Sutter Yard)12/17/2013 Same as last inspection. (A. Freitag - DWR Sutter Yard)07/18/2013 WS slide gate looks to be in good condition but stem is slightly bent. Not sure if bend will hinder gates operation or not. LS inlet is still blocked by minor sediment build up.10/18/2012 LS pipe slightly deformed and sediment build up blocking about 30% of opening; need to check the condition of the slide gate-need photo. Metal marker down. This crossing was listed in the USACE Periodic Inspection as ID# USACE_CESPK_MA1C_2010_p_0187 for sediment build up at landward toe. (O. Magana - DWR UCIP)

FIELD_STRUCT_DESC: 36-inch corrugated metal drainage pipe through the levee, approximately 12-15 feet below the crown. Slide gate in corrugated metal pipe (CMP) riser on the waterside (WS) slope. (36-inch pipe [HLM 3.78] authorized under Automatic Board Order (ABO) issued as Permit No. 9490, 1955 - Charles & Virginia Yerxa). [Additional Reference(s): DWR Levee Log, 1992 (HLM 3.39). USACE Sacramento O&M Manual, Unit 137, August 1955, Revised 29 December 2016, (STA 177+67), listed as 36-inch pipe].
FS Date: 2/23/2021 2:05:19 PM

Top of Levee: View of levee crown looking upstream

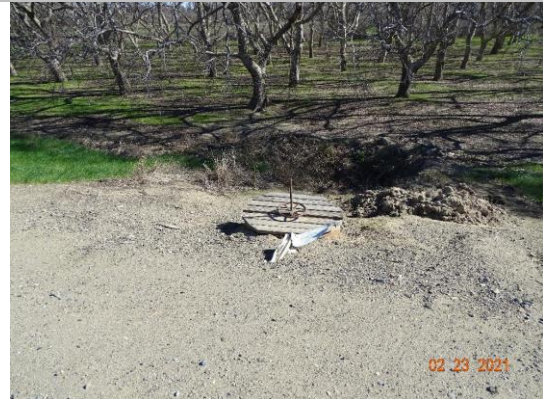
Photo 2 of 3 : UCIP_SP_2023_62896_91331.jpg

LM Start	3.33	Rating **	M	Issue No.	13 (cont)
LM End	3.33	Issue Type +	Ma	Location *	
Category	Supplemental		GPS Latitude/Longitude		
			Start	End	
Item	DWR UCIP LMA Responsibility		39.250843 °	39.250843 °	
			-122.007992 °	-122.007992 °	
DWR ID	16426

Water-Side: CMP riser on levee slope

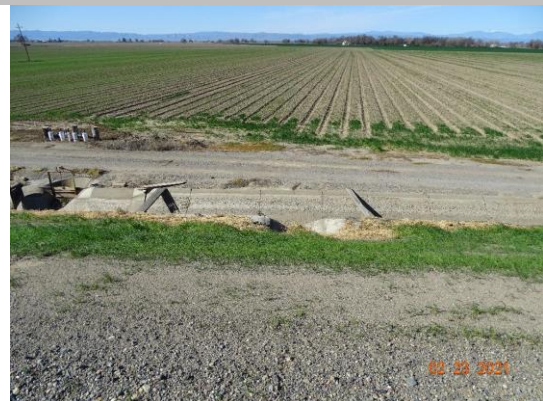
Photo 3 of 3 : UCIP_SP_2023_62896_91332.jpg

Land-Side: View of levee slope looking from crown

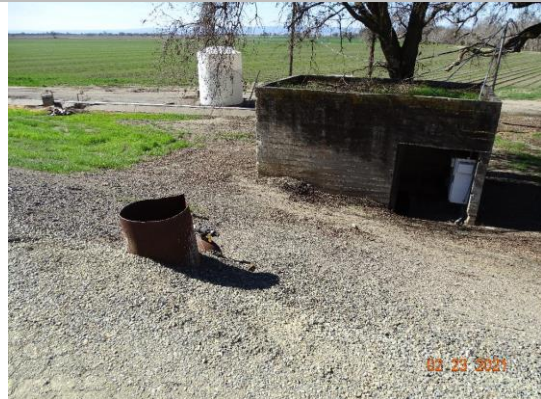
Photo 1 of 3 : UCIP_SP_2023_62897_91346.jpg

DS_ID:16436
FS_ID:62897
EP_NO: 4213
Repair Type: Urgent
EVAL Issue: 2b, Levee Integrity
Crossing Status: Found
UCIP Comments: 02/23/2021 Record remains Urgent. Existing sinkhole in pipe alignment at pumphouse wall measures 5 feet in diameter and about 1 foot deep. Recommend owner perform pipe integrity test. (O.Yakimov - DWR UCIP)
10/01/2018 Sinkhole near concrete structure on the LS was filled with soil and debris. Flow meter at the WS shoulder and a manometer on the pipe on the LS shoulder was installed. Video inspection is recommended to determine pipe integrity through levee. (O.Yakimov - DWR UCIP)05/03/2017 Sinkhole still present next to concrete structure on LS. (A. Freitag - DWR Sutter Yard)10/24/2016 Pump is on WS. Sinkhole still present over pipe alignment next to the concrete building. (A. Freitag - DWR Sutter Yard)04/25/2016 No repairs have been made since last inspection. Sink holes are still present above pipe next to concrete building on LS. (A. Freitag - DWR Sutter Yard)04/20/2015 Sink hole over pipe alignment on LS up against the concrete building. Need to dig up pipe and see if its leaking. (A. Freitag - DWR Sutter Yard)06/23/2014 Same as last inspection. (A. Freitag - DWR Sutter Yard)06/18/2014 Same as last inspection. (A. Freitag - DWR Sutter Yard)12/17/2013 Same as last inspection. (A. Freitag - DWR Sutter Yard)07/18/2013 Same as last inspection. (A. Freitag - DWR Sutter Yard)10/19/2012 Recommend adding door to LS concrete structure. Riser located on landward side is damaged. This crossing was listed in the USACE Periodic Inspection as ID# USACE_CESPK_MA1C_2010_p_0194 no issues logged. (O. Magana - DWR UCIP)

FIELD_STRUCT_DESC: 24-inch asphalt coated steel irrigation pipe through the levee, approximately 10 feet below the crown. Gate valve and flow meter on the waterside (WS) shoulder. 1-1/4 inch conduit through the levee. Siphon breaker on the landside (LS) shoulder. Concrete distribution box and control box located on the LS. Pump and walkway located on the WS berm. This crossing replaces 24-inch pipe (see DSID 25707). (24-inch pipe authorized under Permit No. 4213, 1963 - N.J. Scott Ranch). [Additional Reference(s): DWR Levee Log, 1992 (HLM 3.77)].
FS Date: 2/23/2021 2:07:42 PM

Land-Side: View of levee slope looking from crown

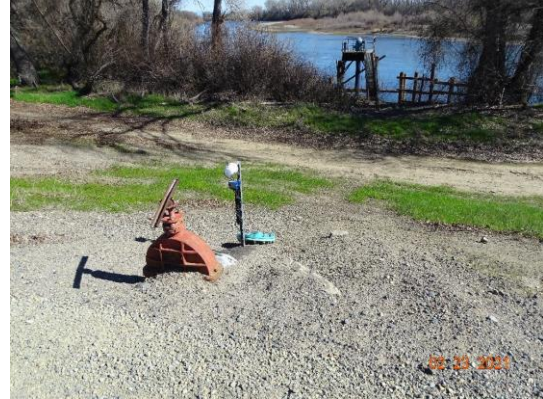
Photo 2 of 3 : UCIP_SP_2023_62897_91345.jpg

LM Start	3.68	Rating **	U	Issue No.	15 (cont)
LM End	3.68	Issue Type +	En	Location *	
Category	Supplemental		GPS Latitude/Longitude		
			Start	End	
Item	DWR UCIP Field Study		39.255803 °	39.255803 °	
			-122.009683 °	-122.009683 °	
DWR ID	16436

Water-Side: View of levee slope looking from crown

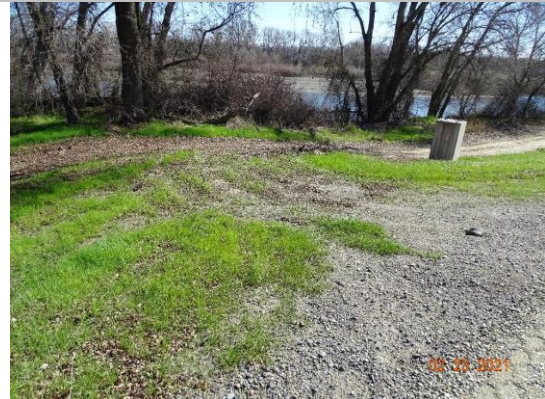
Photo 2 of 3 : UCIP_SP_2023_62898_91351.jpg

LM Start	3.69	Rating **	M	Issue No.	16 (cont)	
LM End	3.69	Issue Type +	En	Location *		
Category	Supplemental			GPS Latitude/Longitude		
				Start		End
Item	DWR UCIP Field Study			39.255936°		39.255936°
				-122.009787°		-122.009787°
DWR ID	16424

Water-Side: View of levee slope looking from crown

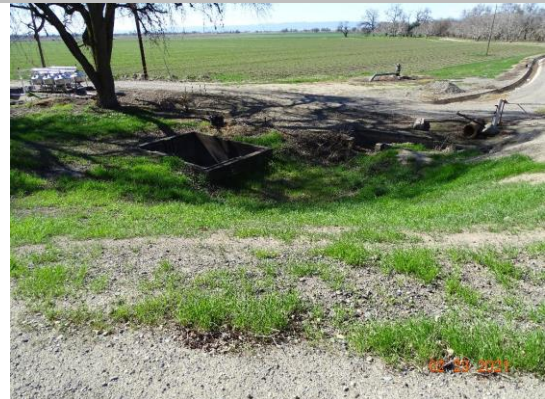
Photo 3 of 3 : UCIP_SP_2023_62898_91350.jpg

Land-Side: View of levee slope looking from crown

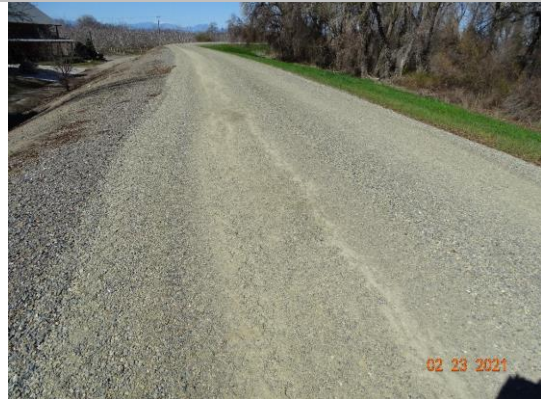
Photo 1 of 3 : UCIP_SP_2023_62900_91370.jpg

Comment Code						
Inspector Comment						
DS_ID:17659 FS_ID:62900 EP_NO: N/A Repair Type: Non-Urgent EVAL Issue: Crossing Status: Not Found UCIP Comments: 02/23/2021 Record remains Non-Urgent. Crossing not found. Geophysical results did not confirm presence of pipe through levee. Record will remain in UCIP's inspection records until future Levee Improvement Project can confirm no crossing was found through the levee. No permit has been identified authorizing pipe. Updated coordinates of crossing to match location to O&M (STA 198+00). (O.Yakimov - DWR UCIP) 05/03/2017 Unable to locate. (A. Freitag - DWR Sutter Yard) 10/24/2016 Unable to locate. (A. Freitag - DWR Sutter Yard) 04/25/2016 Unable to locate. (A. Freitag - DWR Sutter Yard) 04/20/2015 Same as last inspection. (A. Freitag - DWR Sutter Yard) 06/18/2014 Same as last inspection. (A. Freitag - DWR Sutter Yard) 12/17/2013 Same as last inspection. (A. Freitag - DWR Sutter Yard) 07/18/2013 Same as last inspection. (A. Freitag - DWR Sutter Yard) 10/19/2012 USA flag markers show some type of alignment on LS. Unable to determine if crossing still exists at this location. (O. Magana - DWR UCIP) FIELD_STRUCT_DESC: 18-inch steel drainage pipe through the levee at an unknown depth below the crown. Automatic drainage gate on the outlet end of the pipe. [Additional Reference(s): USACE Sacramento O&M Manual, Unit 137, August 1955, Revised 29 December 2016, (STA 198+00), listed as 18-inch pipe]. FS Date: 2/23/2021 2:19:54 PM

Top of Levee: View of levee crown looking upstream

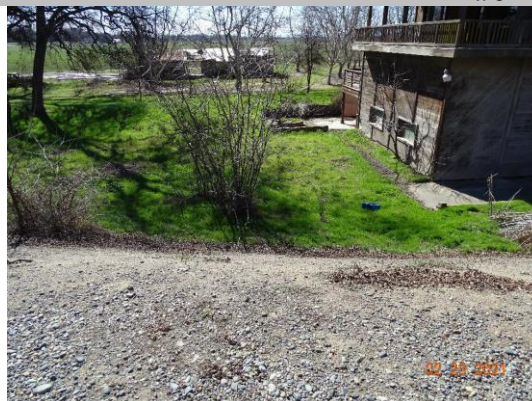
Photo 2 of 3 : UCIP_SP_2023_62900_91371.jpg

LM Start	3.72	Rating **	M	Issue No.	17 (cont)
LM End	3.72	Issue Type +	Ma	Location *	
Category	Supplemental		GPS Latitude/Longitude		
			Start	End	
Item	DWR UCIP LMA Responsibility		39.256246°	39.256246°	
			-122.009974°	-122.009974°	
DWR ID	17659

Land-Side: View of levee slope looking from crown

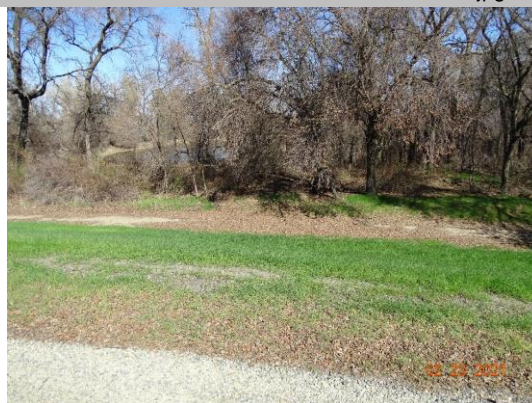
Photo 3 of 3 : UCIP_SP_2023_62900_91372.jpg

Water-Side: View of levee slope looking from crown

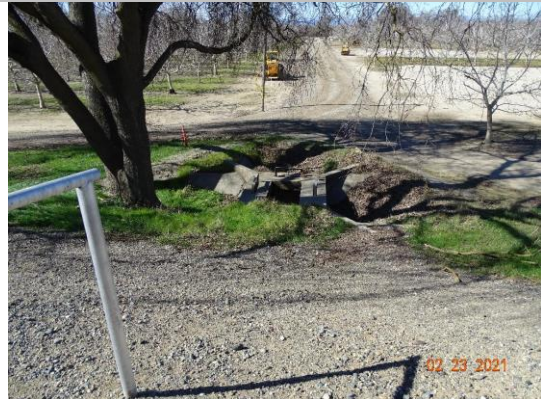
Photo 1 of 3 : UCIP_SP_2023_62902_91391.jpg

FIELD_STRUCT_DESC: 24-inch drainage pipe of an unknown material through the levee, unknown depth below the crown. Walkway to slide gate on the waterside (WS) end. Walkway has been removed. Flap gate in concrete distribution box at the landside (LS) toe. [Additional Reference(s): DWR Levee Log, 1992 (HLM 4.05)].
FS Date: 2/23/2021 2:23:36 PM

Land-Side: View of levee slope looking from crown

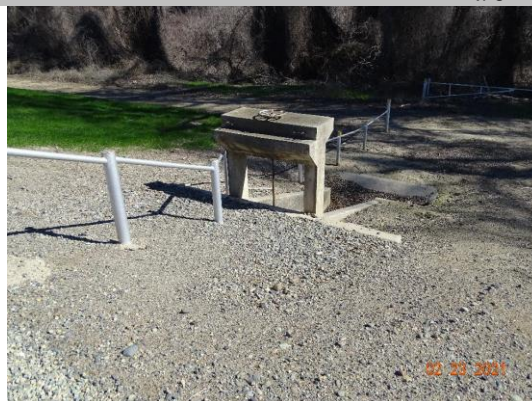
Photo 2 of 3 : UCIP_SP_2023_62902_91394.jpg

LM Start	3.95	Rating **	U	Issue No.	20 (cont)
LM End	3.95	Issue Type +	En	Location *	
Category	Supplemental		GPS Latitude/Longitude		
			Start	End	
Item	DWR UCIP Field Study		39.258073 °	39.258073 °	
			-122.013165 °	-122.013165 °	
DWR ID	16422

Water-Side: View of levee slope looking from crown

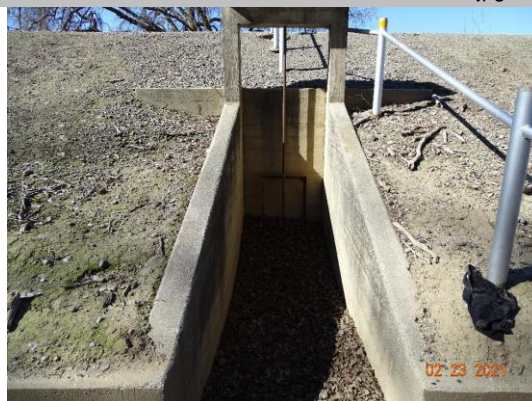
Photo 3 of 3 : UCIP_SP_2023_62902_91395.jpg

Water-Side: U-shaped headwall and screw gate in debris on levee slope

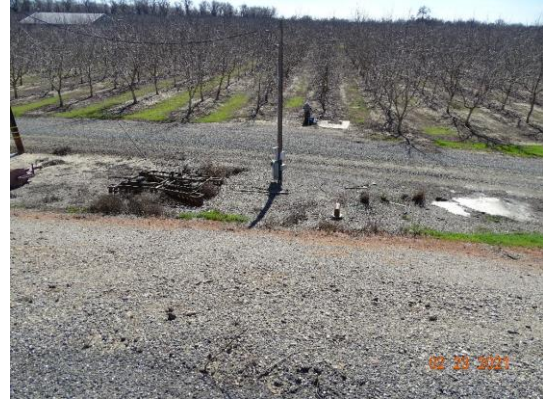
Photo 1 of 3 : UCIP_SP_2023_62908_91426.jpg

Comment Code					
Inspector Comment					
DS_ID:16420 FS_ID:62908 EP_NO: 4903 Repair Type: Urgent EVAL Issue: 3a, Flood Risk Crossing Status: Found UCIP Comments: 02/23/2021 Record updated from Non-Urgent to Urgent. Pipe is 18-20 feet below levee crown open on waterside poses potential flood threat to landside. Pipe is capped at landside toe. Crossing appears abandoned. (O.Yakimov - DWR UCIP) 05/03/2017 Appears abandoned- if so needs to be done properly. (A. Freitag - DWR Sutter Yard)10/24/2016 appears to be abandoned. (A. Freitag - DWR Sutter Yard)04/25/2016 Appears to be an abandoned crossing. (A. Freitag - DWR Sutter Yard)04/20/2015 Suspect that pump on LS is a well pump and has nothing to do with this crossing. (A. Freitag - DWR Sutter Yard)06/18/2014 Same as last inspection. (A. Freitag - DWR Sutter Yard)12/17/2013 Same as last inspection. (A. Freitag - DWR Sutter Yard)07/18/2013 Same as last inspection. (A. Freitag - DWR Sutter Yard)10/19/2012 Unable to locate siphon breaker, pump on LS; unable to tell if pump system is part of appurtenances. This crossing was listed in the USACE Periodic Inspection as ID# USACE_CESPK_MA1C_2010_p_0233 for utility pole and 8 inch steel riser located on landward toe. (O. Magana - DWR UCIP) FIELD_STRUCT_DESC: 12-inch asphalt coated steel irrigation pipe through the levee, approximately 18-20 feet below the crown. Siphon breaker in 24-inch corrugated metal pipe (CMP) riser on the landside (LS) shoulder--not found. 3-inch electrical conduit through the levee--not found. Utility pole visible on the LS. Well station visible on the LS. No appurtenances visible on the waterside (WS). (12-inch irrigation pipe and electrical conduit authorized under Permit No. 4903, 1965 - Mattie B. Zumwalt Company). (Irrigation pipe and portable pump authorized under Permit No. 4903-A, 1965 - Mattie B. Zumwalt Company). [Additional Reference(s): DWR Levee Log, 1992 (HLM 5.08)]. FS Date: 2/23/2021 2:58:13 PM

Land-Side: View of levee slope looking from crown

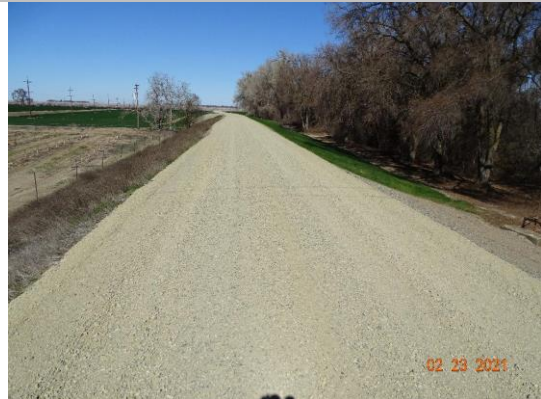
Photo 1 of 3 : UCIP_SP_2023_62909_91436.jpg

Comment Code					
Inspector Comment					
DS_ID:16419 FS_ID:62909 EP_NO: 9476 Repair Type: Non-Urgent EVAL Issue: 11, Maintenance Compliance Issue Crossing Status: Found UCIP Comments: 02/23/2021 Record remains Non-Urgent. Sediment inside the pipe and at headwall on landside needs clearing. No permit has been identified authorizing pipe. Need to have CVFPB review ABO and determine current owner. (O.Yakimov - DWR UCIP) 05/03/2017 Culvert has sediment build up in it- needs to be cleaned out. (A. Freitag - DWR Sutter Yard)10/24/2016 LS outlets becoming over grown with vegetation in the ditch. (A. Freitag - DWR Sutter Yard)04/25/2016 WS entry still blocked and wingwalls still cracked. (A. Freitag - DWR Sutter Yard)04/20/2015 WS entry still blocked and wingwalls still cracked. (A. Freitag - DWR Sutter Yard)06/18/2014 Same as last inspection. (A. Freitag - DWR Sutter Yard)12/17/2013 Same as last inspection. (A. Freitag - DWR Sutter Yard)07/18/2013 Same as last inspection. (A. Freitag - DWR Sutter Yard)10/19/2012 blocked, no entry on WS. This crossing was listed in the USACE Periodic Inspection as ID# USACE_CESPK_MA1C_2010_p_0247 for u/s and d/s wing wall shows some cracking and tilting. (O. Magana - DWR UCIP) FIELD_STRUCT_DESC: 1 of 2: 36-inch corrugated metal irrigation pipe and concrete box culvert through the levee at an unknown depth below the crown. Concrete headwall visible on the landside (LS) toe. (36-inch pipe [HLM 5.85] authorized under Automatic Board Order (ABO) issued as Permit No. 9476, 1974 - Howard and Nadine Ohliger). [Additional Reference(s): DWR Levee Log, 1992 (HLM 5.85), listed as 15 feet long 36-inch pipe and concrete box culvert through the levee]. FS Date: 2/23/2021 3:24:08 PM

Top of Levee: View of levee crown looking upstream

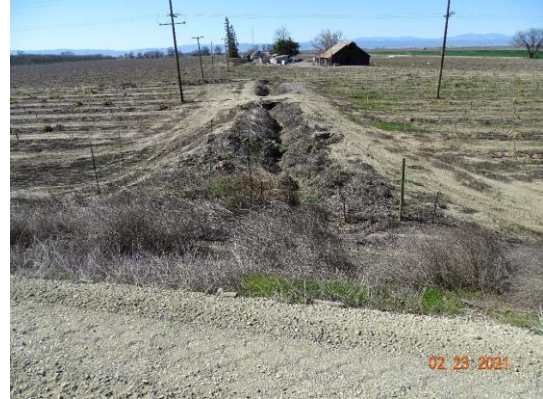
Photo 2 of 3 : UCIP_SP_2023_62909_91431.jpg

Land-Side: View of levee slope looking from crown

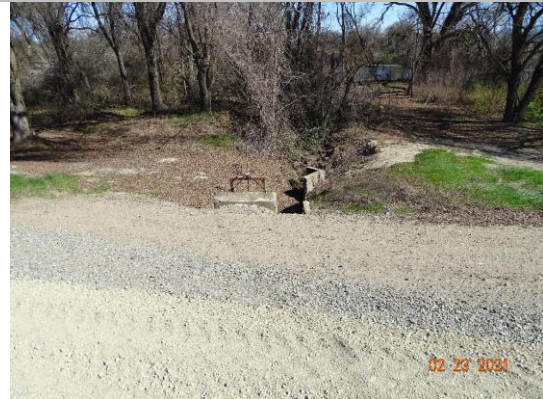
Photo 1 of 3 : UCIP_SP_2023_62910_91440.jpg

Comment Code					
Inspector Comment					
DS_ID:17569 FS_ID:62910 EP_NO: 9476 Repair Type: Non-Urgent EVAL Issue: 11, Maintenance Compliance Issue Crossing Status: Found UCIP Comments: 02/23/2021 Record remains Non-Urgent. Sediment blocking more than 50% of pipe cross section area as seen at headwall on landside, needs clearing. Unauthorized encroachment recorded in Levee Log prior to 2011. Need to have CVFPB review ABO and determine current owner. (O.Yakimov - DWR UCIP) 05/03/2107 Culvert has sediment build up in it- needs to be cleaned out. (A. Freitag - DWR Sutter Yard)10/24/2016 LS outlets becoming overgrown with vegetation in the dtch. (A. Freitag - DWR Sutter Yard)04/25/2016 WS entry still blocked and wingwalls still cracked. (A. Freitag - DWR Sutter Yard)04/20/2015 WS entry still blocked and wingwalls still cracked. (A. Freitag - DWR Sutter Yard)06/18/2014 Same as last inspection. (A. Freitag - DWR Sutter Yard)12/17/2013 Same as last inspection. (A. Freitag - DWR Sutter Yard)07/18/2013 Same as last inspection. (A. Freitag - DWR Sutter Yard)10/19/2012 blocked, no entry on WS. This crossing was listed in the USACE Periodic Inspection as ID# USACE_CESPK_MA1C_2010_p_0247 for u/s and d/s wing wall shows some cracking and tilting. (O. Magana - DWR UCIP) FIELD_STRUCT_DESC: 2 of 2: 36-inch corrugated metal irrigation pipe (15 feet long) and concrete box culvert through the levee at an unknown depth below the crown. Slide gate located on the waterside (WS). Concrete headwall visible on the landside (LS) toe. (36-inch pipe [HLM 5.85] authorized under Automatic Board Order (ABO) issued as Permit No. 9476, 1974 - Howard and Nadine Ohliger). [Additional Reference(s): DWR Levee Log, 1992 (HLM 5.85), listed as 15 feet long 36-inch pipe and concrete box culvert through the levee]. FS Date: 2/23/2021 3:26:52 PM

Water-Side: View of levee slope looking from crown

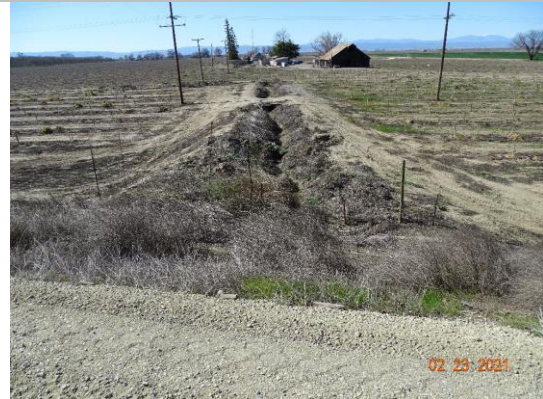
Photo 2 of 3 : UCIP_SP_2023_62910_91441.jpg

Land-Side: View of levee slope looking from crown

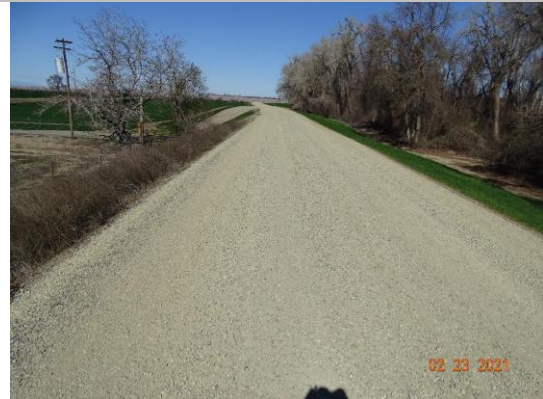
Photo 1 of 3 : UCIP_SP_2023_62911_91445.jpg

Comment Code						
Inspector Comment						
DS_ID:17658 FS_ID:62911 EP_NO: N/A Repair Type: Non-Urgent EVAL Issue: Crossing Status: Not Found UCIP Comments: 02/23/2021 Record is Non-Urgent. Crossing not found. Geophysical results did not confirm presence of pipe through levee. Record will remain in UCIP's inspection records until future Levee Improvement Project can confirm no crossing was found through the levee. No permit has been identified authorizing pipe. (O.Yakimov - DWR UCIP) 05/03/2017 Unable to locate. (A. Freitag - DWR Sutter Yard)10/24/2016 Unable to locate. (A. Freitag - DWR Sutter Yard)04/25/2016 Unable to locate. (A. Freitag - DWR Sutter Yard)04/20/2015 Unable to locate. (A. Freitag - DWR Sutter Yard)06/23/2014 Unable to locate. (A. Freitag - DWR Sutter Yard)12/17/2013 Unable to locate. (A. Freitag - DWR Sutter Yard)07/18/2013 Same as last inspection. Unable to locate. (A. Freitag - DWR Sutter Yard) FIELD_STRUCT_DESC: 36-inch corrugated metal drainage pipe through the levee at an unknown depth below the crown. [Additional Reference(s): USACE Sacramento O&M Manual, Unit 137, August 1955, Revised 29 December 2016, (STA 303+70), listed as 36-inch pipe]. FS Date: 2/23/2021 3:28:33 PM

Top of Levee: View of levee crown looking upstream

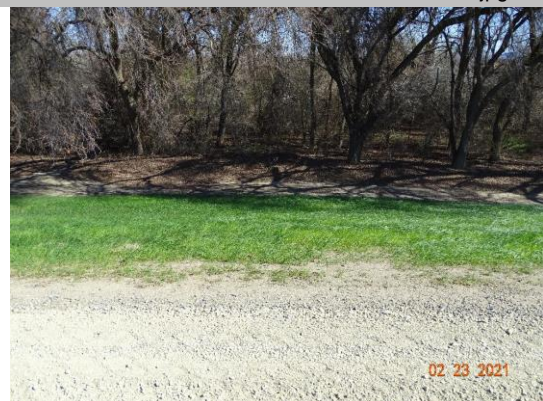
Photo 2 of 3 : UCIP_SP_2023_62911_91446.jpg

Water-Side: View of levee slope looking from crown

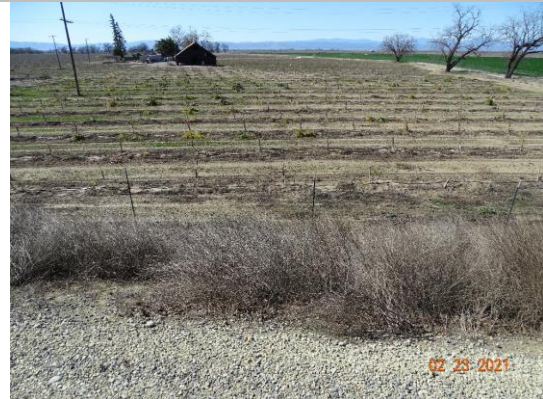
Photo 3 of 3 : UCIP_SP_2023_62911_91447.jpg

Land-Side: View of levee slope looking from crown

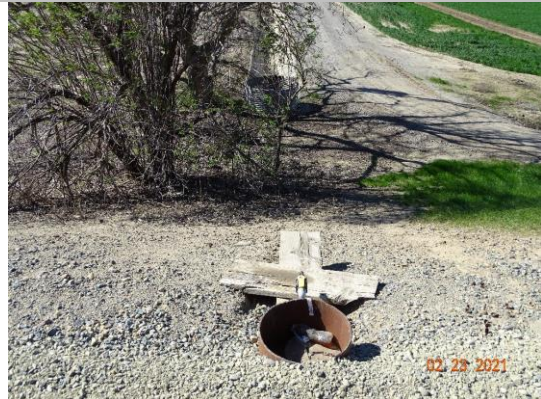
Photo 1 of 3 : UCIP_SP_2023_62912_91449.jpg

DS_ID:16418
FS_ID:62912
EP_NO: 6263
Repair Type: Urgent
EVAL Issue: 2a, Levee Integrity
Crossing Status: Found
UCIP Comments: 02/23/2021 Record updated from Non-Urgent to Urgent. Pipe exposed in a trench on waterside starting 20 feet from waterside levee toe going toward pumps. Pumps are dismantled, discharge pipe cut open under pumping platform. Unable to find a permit for modification. (O.Yakimov - DWR UCIP)
05/03/2017 Crossing appears to be in good condition. (A. Freitag - DWR Sutter Yard)10/24/2016 Appears to be in good condition. (A. Freitag - DWR Sutter Yard)04/25/2016 Pressure gauge and valve were added to pipe near the siphon breaker on LS shoulder. (A. Freitag - DWR Sutter Yard)04/20/2015 Modifications are being made to pipe near the LS shoulder. Not sure what all exactly is being done. (A. Freitag - DWR Sutter Yard)06/23/2014 Same as last inspection. (A. Freitag - DWR Sutter Yard) 12/17/2013 Same as last inspection. (A. Freitag - DWR Sutter Yard)07/18/2013 Debris cleared from in front of LS standpipe. (A. Freitag - DWR Sutter Yard)10/19/2012 Remove debris from landward side see photo 2. This crossing was listed in the USACE Periodic Inspection as ID# USACE_CESPK_MA1C_2010_p_0249 however, unable to determine why crossing was marked "U". (O. Magana - DWR UCIP)

Land-Side: View of levee slope looking from crown

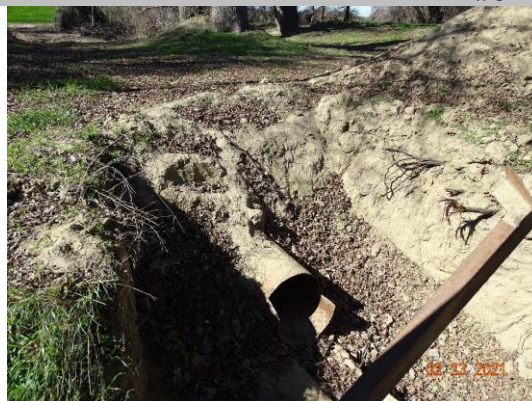
Photo 2 of 3 : UCIP_SP_2023_62912_91455.jpg

Water-Side: View of open pipe under pile structure at riverbank

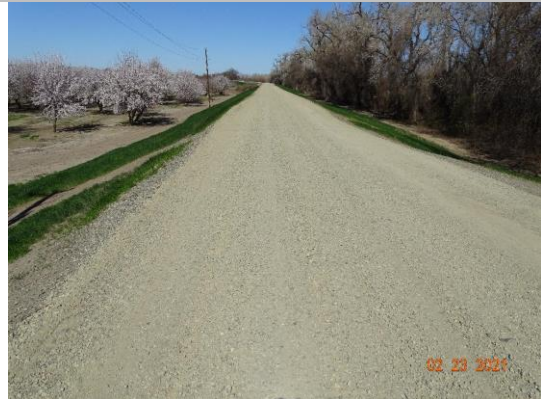
Photo 1 of 3 : UCIP_SP_2023_62913_91460.jpg

DS_ID:16446
FS_ID:62913
EP_NO: N/A
Repair Type: Urgent
EVAL Issue: 3a, Flood Risk
Crossing Status: Found
UCIP Comments: 02/23/2021 Record remains Urgent. 4-inch PVC sleeved through 36-inch steel pipe through levee. Screw gate can't be closed due to the PVC pipe. No permit has been identified authorizing pipe. (O.Yakimov - DWR UCIP)
10/01/2018 PVC pipe underneath the slide gate that is located inside CMP riser on WS shoulder was restored and blocks gate from closing. Sediment built up at the bottom of CMP riser. PVC pipe needs to be removed in order to properly close slide gate. (O.Yakimov - DWR UCIP)05/03/2017 Pipe leaked during the Jan/Feb 2017 high water event. Sand bags were placed at both the LS and WS outlets as well as down inside the standpipe to slow the water flow. The 5inch pvc was cut away but the slide gate could still not close fully. Suspect sediment build up was in the bottom of the stand pipe was blocking the gate. Inside of pipe should be cleaned out. (A. Freitag - DWR Sutter Yard)10/24/2016 Pvc was back running through the crossing and blocking the screwgate. photo attached. (A. Freitag - DWR Sutter Yard)09/28/2016 Crossing has been downgraded from Urgent to Non-Urgent 5-inch PVC pipe was cut to allow the slide gate to close. Need to contact owner to remove unauthorized pipe to comply with Title 23. (O. Magana - DWR UCIP)04/25/2016 5 inch pvc pipe running through crossing has been cut out to allow the slide gate to close. (A. Freitag - DWR Sutter Yard)04/20/2015 5inch pvc is still present blocking slide gate from closing. WS end of pipe has been exposed so there is no way to stop water from flowing through pipe during highwater times. (A. Freitag - DWR Sutter Yard)06/23/2014 Same as last inspection. There is no way to stop water from flowing through pipe during high water times. (A. Freitag - DWR Sutter Yard)12/17/2013 Same as last inspection. (A. Freitag - DWR Sutter Yard)07/18/2013 Same as last inspection. (A. Freitag - DWR Sutter Yard)10/19/2012 Unauthorized 5 inch PVC pipe running through 36 inch crossing. 5 inch PVC crossing prevents slide gate from closing during high water. Debris and sediment inside riser. This crossing was listed in the USACE Periodic Inspection as ID# USACE_CESPK_MA1C_2010_p_0258 for 5 inch PVC pipe running through culvert. (O. Magana - DWR UCIP)

Top of Levee: View of levee crown looking upstream

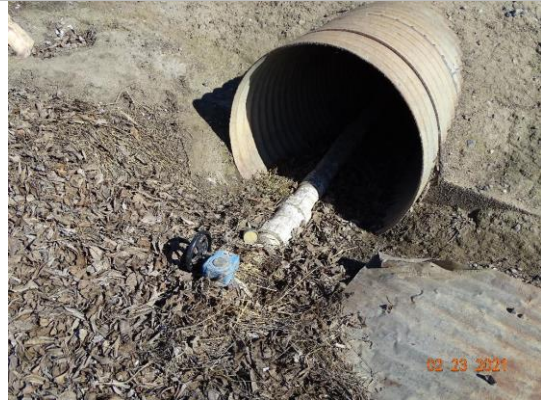
Photo 3 of 3 : UCIP_SP_2023_62913_91459.jpg

Land-Side: 4-inch PVC with shut off valve sleeved through steel pipe

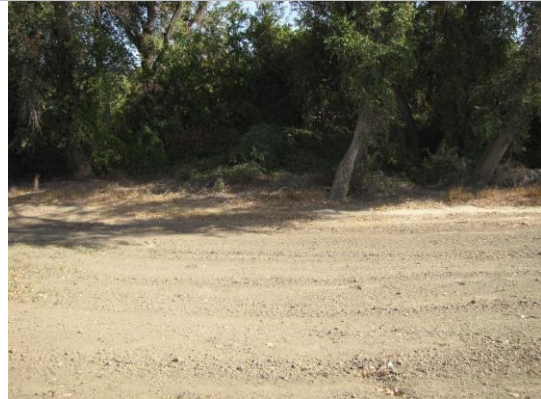
Photo 1 of 3 : UCIP_SP_2023_62914_70181.jpg

DS_ID:16425
FS_ID:62914
EP_NO: N/A
Repair Type: Non-Urgent
EVAL Issue:
Crossing Status: Found
UCIP Comments: 02/23/2021 Record remains Non-Urgent. Crossing appears abandoned. Headwall and pipe on waterside not found. Slide gate removed from concrete riser on landside shoulder. Riser is covered with steel plate bolted to concrete. Soil inside pipe crossing blocking more than 50% of cross section. No permit has been identified authorizing pipe. (O.Yakimov - DWR UCIP)
05/03/2017 Abandoned- needs to be done properly. (A. Freitag - DWR Sutter Yard)10/24/2016 Abandoned. (A. Freitag - DWR Sutter Yard)04/25/2016 Abandoned crossing. (A. Freitag - DWR Sutter Yard)04/20/2015 Same as last inspection. (A. Freitag - DWR Sutter Yard)06/23/2014 Same as last inspection. (A. Freitag - DWR Sutter Yard)12/17/2013 Same as last inspection. (A. Freitag - DWR Sutter Yard)07/18/2013 Same as last inspection. (A. Freitag - DWR Sutter Yard)10/19/2012 Need to be properly abandoned concrete structure; plate covers concrete box; Concrete headwall damaged. This crossing was listed in the USACE Periodic Inspection as ID#

View of WS no structure features visible.

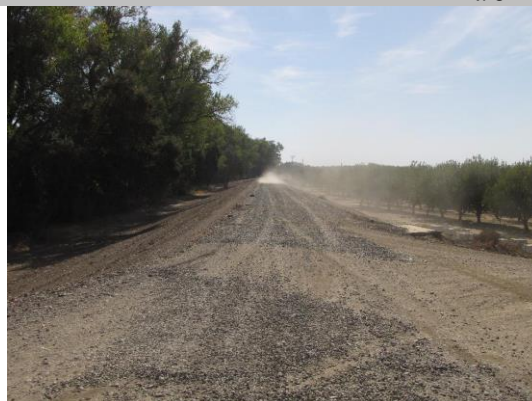
Photo 2 of 3 : UCIP_SP_2023_62914_70180.jpg

Overview of levee crown looking downstream at crossing.

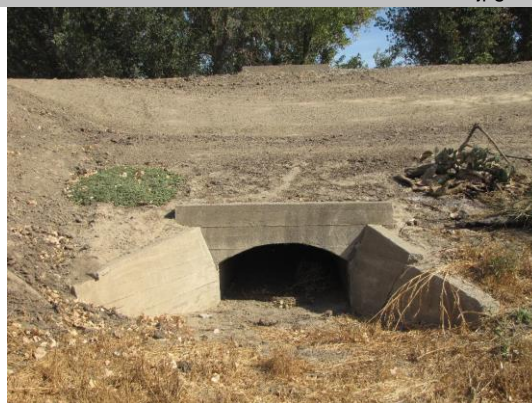
Photo 3 of 3 : UCIP_SP_2023_62914_70179.jpg

View of structure located in LS.

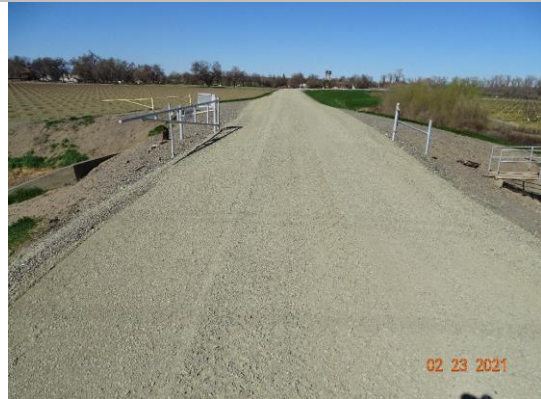
Photo 1 of 3 : UCIP_SP_2023_62915_91471.jpg

DS_ID:16427
FS_ID:62915
EP_NO: 9482
Repair Type: Urgent
EVAL Issue: 3a, Flood Risk
Crossing Status: Found
UCIP Comments: 02/23/2021 Record updated from Non-Urgent to Urgent. Missing slide gate at U-shaped headwall on waterside slope. Pipe outlet blocked with a pile of soil. Inlet to concrete culvert at landside toe is filled with soil blocking more than 50% of cross sectional area. Crossing appears abandoned. No permit has been identified authorizing pipe. Need to have CVFPB review ABO and determine current owner. (O.Yakimov - DWR UCIP)
05/03/2017 Abandoned- Needs to be done properly. (A. Freitag - DWR Sutter Yard)10/24/2016 Abandoned. (A. Freitag - DWR Sutter Yard)04/25/2016 Abandoned pipe. Needs to be properly plugged if it never gets used. (A. Freitag - DWR Sutter Yard)04/20/2015 Same as last inspection. Structure is still buried. (A. Freitag - DWR Sutter Yard)06/23/2014 Same as last inspection. (A. Freitag - DWR Sutter Yard)12/17/2013 Same as last inspection. (A. Freitag - DWR Sutter Yard)07/18/2013 Same as last inspection. (A. Freitag - DWR Sutter Yard)10/19/2012 Structure is buried and non-operational. This crossing was listed in the USACE Periodic Inspection as ID# USACE_CESPK_MA1C_2010_p_0288 for sluice gate closed and backfilled on WS and full of sediment with wingwall cracked on LS. (O. Magana - DWR UCIP)

Top of Levee: View of levee crown looking upstream

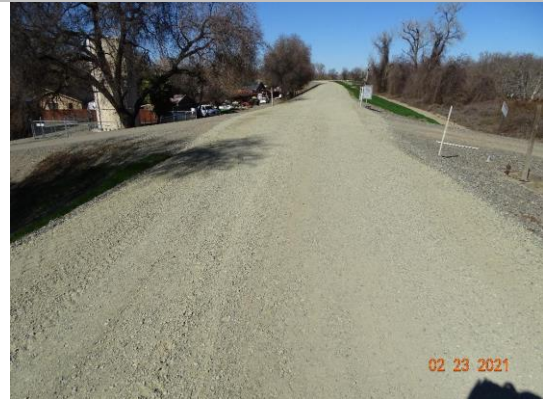
Photo 1 of 3 : UCIP_SP_2023_62917_91485.jpg

Comment Code					
Inspector Comment					
DS_ID:16456 FS_ID:62917 EP_NO: N/A Repair Type: Urgent EVAL Issue: 3a, Flood Risk Crossing Status: Found UCIP Comments: 02/23/2021 Record updated from Non-Urgent to Urgent. Wooden stem at one of wooden slide gate is broken at level of concrete vault making slide gate non-operable, slide gate in open position. Crack in body of remaining stem. Concrete vault is open at ground level creates fall hazard. No permit has been identified authorizing pipe. (O.Yakimov - DWR UCIP) 05/03/2017 Culvert was flowing water during site visit. Appears to be in good condition. Some sediment build up in the bottom of WS box. (A. Freitag - DWR Sutter Yard)10/24/2016 Notes mentioned needing to confirm size of the culvert but was unable to access the ends at this inspection. (A. Freitag - DWR Sutter Yard)04/25/2016 Second slide gate was held open to allow water to flow through to the LS ditch. (A. Freitag - DWR Sutter Yard)04/20/2015 Same as last inspection. Rebar pin was still in place holding the gate opened. (A. Freitag - DWR Sutter Yard)06/23/2014 Same as last inspection. (A. Freitag - DWR Sutter Yard)12/17/2013 Same as last inspection. (A. Freitag - DWR Sutter Yard)07/18/2013 Same as last inspection. (A. Freitag - DWR Sutter Yard)10/30/2012 Sediment and debris on waterward and landward side. This crossing was listed in the USACE Periodic Inspection as ID# USACE_CESPK_MA1C_2010_p_0293 for wooden slide gate held open by a piece of rebar acting as a pin. (O. Magana - DWR UCIP) FIELD_STRUCT_DESC: 60-inches by 72-inches (5-foot by 6-foot) reinforced concrete box irrigation culvert (O&M manual references 3-foot and 10-inch by 6-foot culvert) through the levee, approximately 12-15 feet below the crown. Two wooden slide gates on the waterside (WS) end. Concrete v-ditch along landside (LS) toe. [Additional Reference(s): DWR Levee Log, 1992 (HLM 7.43). USACE Sacramento O&M Manual, Unit 137, August 1955, Revised 29 December 2016, (STA 385+33.5), listed as 3'-10" x 6' concrete culvert] FS Date: 2/23/2021 8:52:55 AM

Top of Levee: View of levee crown looking upstream

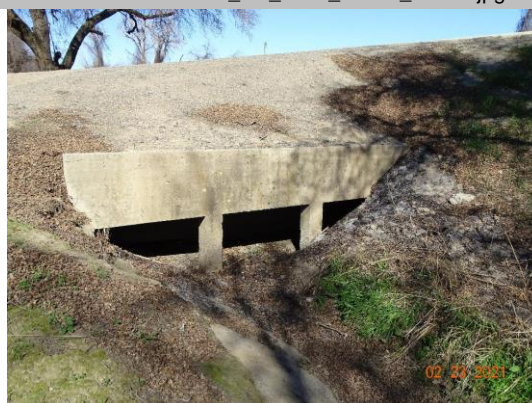
Photo 3 of 3 : UCIP_SP_2023_62917_91484.jpg

Land-Side: Reinforced concrete box irrigation culvert visible at irrigation ditch at levee toe

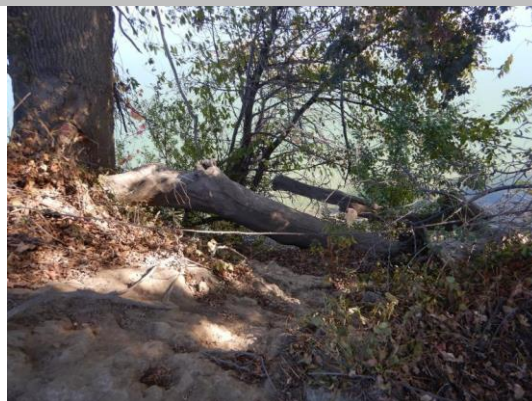
Photo 1 of 2 : SP_2023_MA0001_297_6_20230410_00003.jpg

USACE 2018 Erosion Photo #1

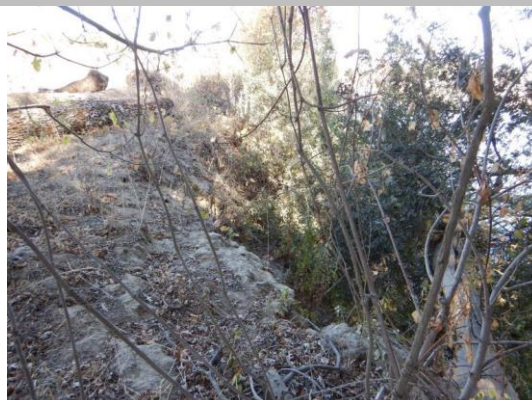
Photo 2 of 2 : SP_2023_MA0001_297_6_20230410_00004.jpg

USACE 2018 Erosion Photo #2

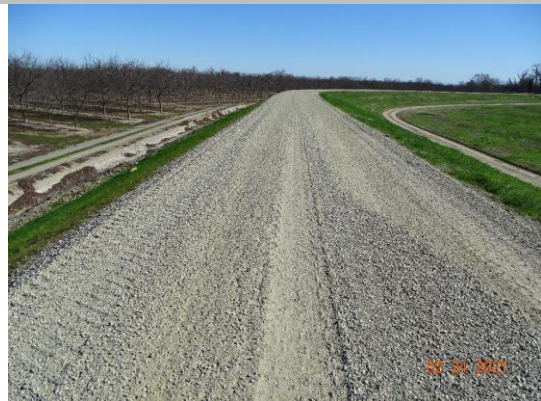
Photo 1 of 3 : UCIP_SP_2023_62946_91650.jpg

Comment Code						
Inspector Comment						
DS_ID:17654 FS_ID:62946 EP_NO: N/A Repair Type: Non-Urgent EVAL Issue: Crossing Status: Not Found UCIP Comments: 02/24/2021 Record is Non-Urgent. Crossing not found. Geophysical results did not confirm presence of pipe through levee. Record will remain in UCIP's inspection records until future Levee Improvement Project can confirm no crossing was found through the levee. No permit has been identified authorizing pipe. (O.Yakimov - DWR UCIP) 5/3/2017 Unable to locate. (DWR Sutter Yard- AFreitag)10/24/2016 Unable to locate.(DWR Sutter Yard- AFreitag)4/25/2016 Unable to locate.4/21/2015 Unable to locate.6/23/2014 Unable to locate.12/17/2013 Unable to locate.7/22/2013 Same as last inspection. Unable to locate. FIELD_STRUCT_DESC: 30-inch corrugated metal drainage pipe through the levee at an unknown depth below the crown. Slide gate on the outlet end of the pipe. [Additional Reference(s): USACE Sacramento O&M Manual, Unit 137, August 1955, Revised 29 December 2016, (STA 670+00), listed as 30-inch pipe]. FS Date: 2/24/2021 3:17:11 PM

Top of Levee: View of levee crown looking upstream

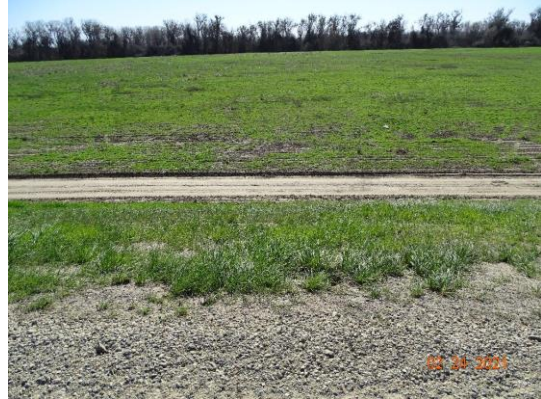
Photo 2 of 3 : UCIP_SP_2023_62946_91651.jpg

LM Start	12.53	Rating **	M	Issue No.	35 (cont)
LM End	12.53	Issue Type +	Ma	Location *	
Category	Supplemental			GPS Latitude/Longitude	
				Start	End
Item	DWR UCIP LMA Responsibility			39.359810°	39.359810°
				-122.022247°	-122.022247°
DWR ID	17654

Water-Side: View of levee slope looking from crown

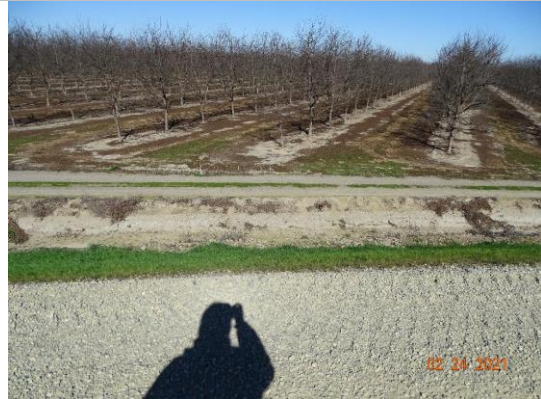
Photo 3 of 3 : UCIP_SP_2023_62946_91652.jpg

Land-Side: View of levee slope looking from crown

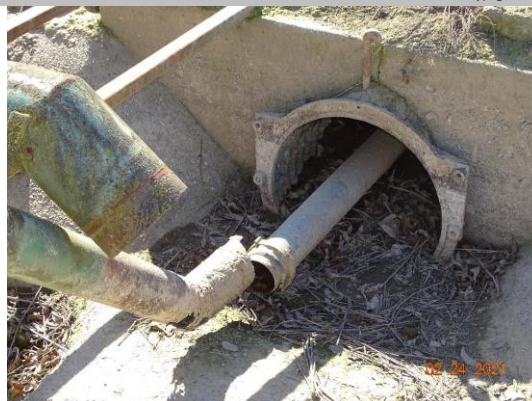
Photo 2 of 3 : UCIP_SP_2023_62947_91659.jpg

DS_ID:16445
FS_ID:62947
EP_NO: 9462
Repair Type: Urgent
EVAL Issue: 3a, Flood Risk
Crossing Status: Found
UCIP Comments: 02/24/2021 Record updated from Non-Urgent to Urgent. 6-inch steel pipe sleeved through CMP pipe. Screw gate on waterside slightly open and burried in soil. Soil and debris deposits inside CMP pipe. Crossing appears abandoned. Unauthorized encroachment recorded in Levee Log prior to 2011. Need to have CVFPB review ABO and determine current owner. (O.Yakimov - DWR UCIP)
5/3/2017 Appears abandoned- needs to be done properly.(DWR Sutter Yard- A.Freitag)10/24/2016 Appears abandoned. LS concrete canal is filled by pipe DSID 16444.4/25/2016 Appears to be an abandoned crossing. WS slide gate still buried and inoperable.4/21/2015 Same as last inspection. 6/23/2014 Same as last inspection.12/17/2013 Same as last inspection.7/22/2013 Same as last inspection.10/30/2012 Slide gate unoperable-blocked by sediment. LS-flap gate missing. 5-inch pipe goes through 24-inch crossing--unable to determine is authorized. This crossing was listed in the USACE Periodic Inspections as ID# USACE_CESPK_MA1C_2010_p_0435 for smaller pipe running inside existing crossing.

FIELD_STRUCT_DESC: 24-inch corrugated metal drainage pipe through the levee, approximately 10 feet below the crown. Slide gate on both waterside (WS) and landside (LS). Gate missing on the LS. (24-inch pipe [HLM 12.97] authorized under Automatic Board Order (ABO) issued as Permit No. 9462, 1974 - Thousand Acre Ranch). [Additional Reference(s): DWR Levee Log, 1992 (HLM 12.97)].
FS Date: 2/24/2021 3:19:42 PM

LM Start	12.69	Rating **	U	Issue No.	36 (cont)
LM End	12.69	Issue Type +	En	Location *	
Category	Supplemental		GPS Latitude/Longitude		
			Start	End	
Item	DWR UCIP Field Study		39.359843 °	39.359843 °	
			-122.019529 °	-122.019529 °	
DWR ID	16445

Land-Side: 6-inch steel pipe sleeved through drainage pipe, view in irrigation ditch

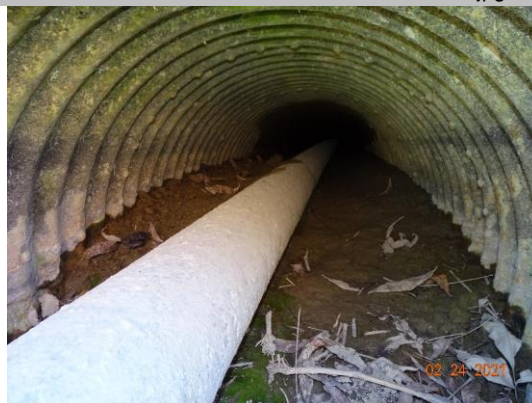
Photo 3 of 3 : UCIP_SP_2023_62947_91653.jpg

Land-Side: View inside of pipe looking from irrigation ditch
