**Flood Control Project Maintenance
Levee Inspections
LMA District Cover Sheet**

**Flood Control Project Maintenance
Levee Inspections
Unit Cover Sheet**

Waterway			Bank	Unit Miles
Unit No. 01 Sacramento River			Right	16.76
	Spring (March - May)	Summer (June - August)	(September - November) Fall	Winter (December - February)
Unit Maintenance Rating (Fall Only)				
Date of Inspection	4/11/2023 - 4/11/2023			
DWR Inspector	Makar Sokol			
Accompanied By	Gregg Ahlers DWR Sutter Yard

Levee Inspection Report By Mile - Spring 2023

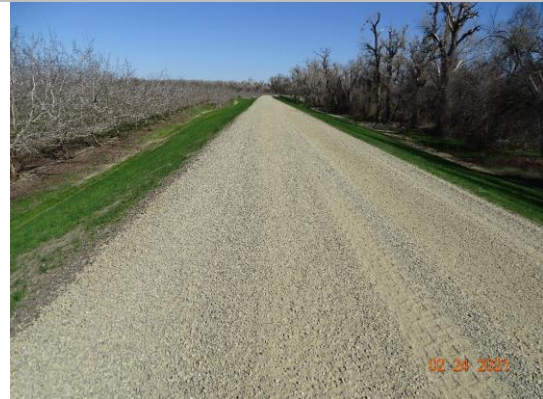
Photo 1 of 3 : UCIP_SP_2023_62953_91691.jpg

Comment Code						
Inspector Comment						
DS_ID:17653 FS_ID:62953 EP_NO: N/A Repair Type: Non-Urgent EVAL Issue: Crossing Status: Not Found UCIP Comments: 05/23/2017 Record is Non-Urgent. Crossing not found. Geophysical results did not confirm presence of pipe through levee. Record will remain in UCIP's inspection records until future Levee Improvement Project can confirm no crossing was found through the levee. No permit has been identified authorizing pipe. (A.Freitag - DWR UCIP) 05/03/2017 Unable to locate. (A. Freitag - DWR Sutter Yard)10/24/2016 Unable to locate. (A. Freitag - DWR Sutter Yard)04/25/2016 Unable to locate. (A. Freitag - DWR Sutter Yard)04/21/2015 Unable to locate. (A. Freitag - DWR Sutter Yard)06/23/2014 Unable to locate. (A. Freitag - DWR Sutter Yard)12/17/2013 Unable to locate. (A. Freitag - DWR Sutter Yard)07/22/2013 Same as last inspection. Unable to locate. (A. Freitag - DWR Sutter Yard) FIELD_STRUCT_DESC: 36-inch corrugated metal drainage pipe through the levee at an unknown depth below the crown. [Additional Reference(s): USACE Sacramento O&M Manual, Unit 137, August 1955, Revised 29 December 2016, (STA 727+65), listed as 36-inch pipe]. FS Date: 5/23/2017 12:01:00 PM

LM Start	13.61	Rating **	M	Issue No.	37 (cont)
LM End	13.61	Issue Type +	Ma	Location *

Top of Levee: View of levee crown looking upstream

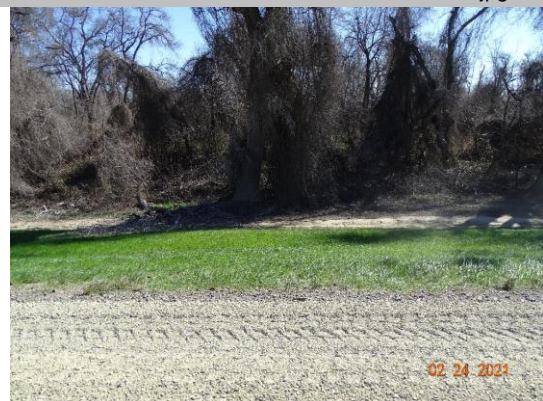
Photo 2 of 3 : UCIP_SP_2023_62953_91692.jpg

Water-Side: View of levee slope looking from crown

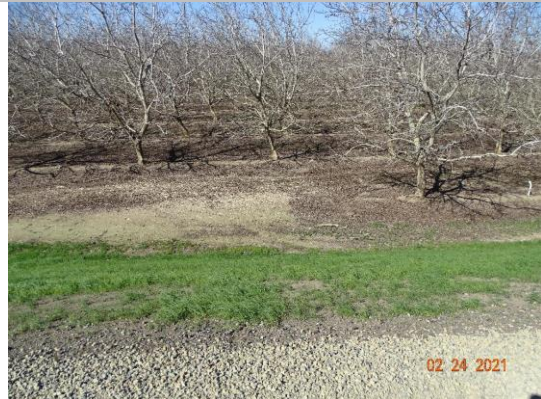
Photo 3 of 3 : UCIP_SP_2023_62953_91693.jpg

LM Start	13.61	Rating **	M	Issue No.	37 (cont)
LM End	13.61	Issue Type +	Ma	Location *	
Category	Supplemental		GPS Latitude/Longitude		
			Start	End	
Item	DWR UCIP LMA Responsibility		39.369523°	39.369523°	
			-122.014199°	-122.014199°	
DWR ID	17653

Land-Side: View of levee slope looking from crown

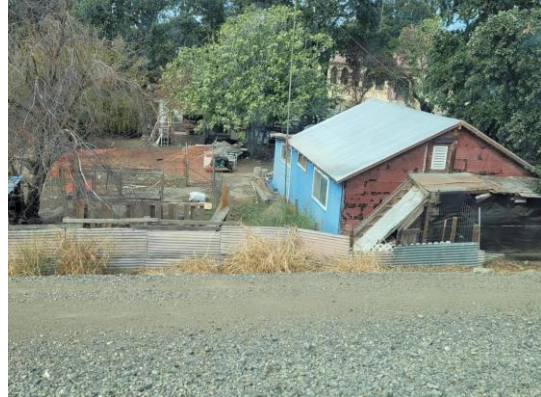
Photo 1 of 1 : SP_2023_MA0001_297_89_20230410_00024.jpg

LM Start	16.00	Rating **	U	Issue No.	89
LM End	16.02	Issue Type +	En	Location *	LS
Category	Earthen Levee			GPS Latitude/Longitude	
				Start	End
Item	Encroachments			39.402756°	39.403040°
				-122.009261°	-122.009186°
DWR ID	DWR_MA0001_01_s_2016_89				
Comment Code					
BU : Building					
Inspector Comment					
Red house and metal fence runs along the landside toe.

View of the building and corrugated metal fence along the landside slope. Fall 2021.

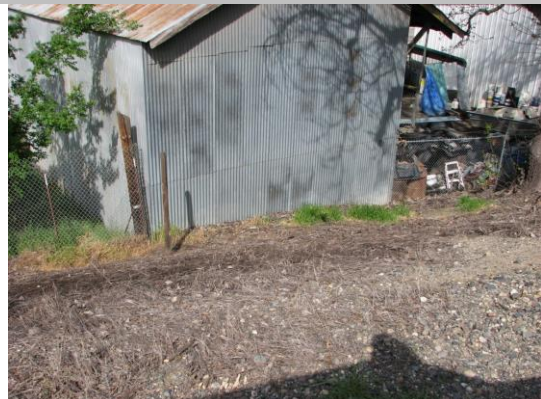
Photo 1 of 1 : SP_2023_MA0001_297_90_20230410_00025.jpg

LM Start	16.03	Rating **	U	Issue No.	90
LM End	16.03	Issue Type +	En	Location *	LS
Category	Earthen Levee			GPS Latitude/Longitude	
				Start	End
Item	Encroachments			39.403206°	39.403206°
				-122.009116°	-122.009116°
DWR ID	DWR_MA0001_01_s_2023_90				
Comment Code					
BU : Building					
Inspector Comment					
Metal sided building is at the landside toe.

View of a corrugated metal building obstructing visibility and access.

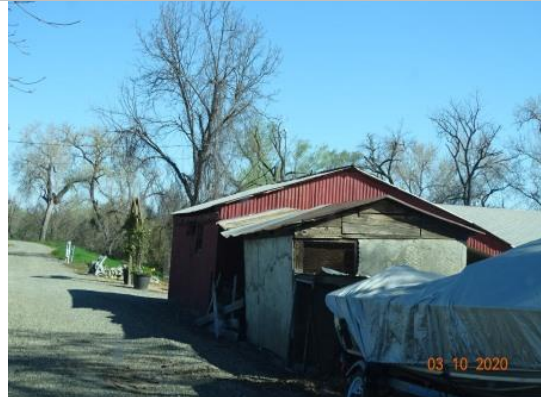
Photo 1 of 1 : SP_2023_MA0001_297_14_20230410_00008.jpg

LM Start	16.08	Rating **	U	Issue No.	14
LM End	16.08	Issue Type +	En	Location *	WS
Category	Earthen Levee			GPS Latitude/Longitude	
				Start	End
Item	Encroachments			39.403930°	39.403930°
				-122.008925°	-122.008925°
DWR ID	DWR_MA0001_01_s_2012_14				
Comment Code					
BU : Building					
Inspector Comment

View of the building on the waterside slope. Spring 2020.

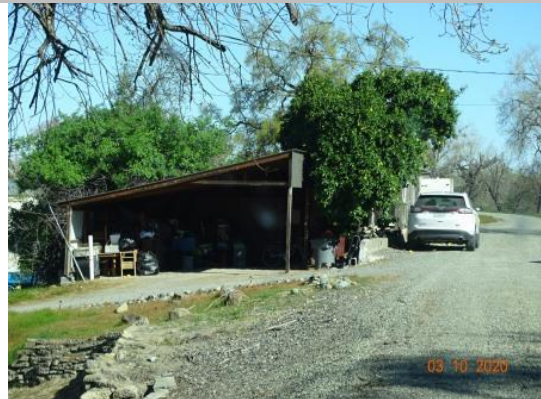
Photo 1 of 1 : SP_2023_MA0001_297_26_20230410_00010.jpg

LM Start	16.10	Rating **	U	Issue No.	26
LM End	16.10	Issue Type +	En	Location *	LS
Category	Earthen Levee			GPS Latitude/Longitude	
				Start	End
Item	Encroachments			39.404135°	39.404135°
				-122.008797°	-122.008797°
DWR ID	DWR_MA0001_01_s_2012_26				
Comment Code					
BU : Building					
Inspector Comment

View of the building on the landside slope. Spring 2020.

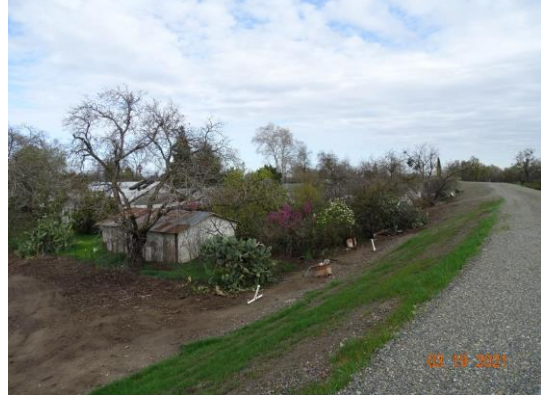
Photo 1 of 1 : SP_2023_MA0001_297_134_20230410_00031.jpg

LM Start	16.26	Rating **	M	Issue No.	134
LM End	16.26	Issue Type +	En	Location *	LS
Category	Earthen Levee			GPS Latitude/Longitude	
				Start	End
Item	Vegetation			39.406520°	39.406520°
				-122.008635°	-122.008635°
DWR ID	DWR_MA0001_01_f_2016_134				
Comment Code					
V6 : Landscaping					
Inspector Comment

View of the landscaping and fruit trees along the landside toe. Spring 2021.

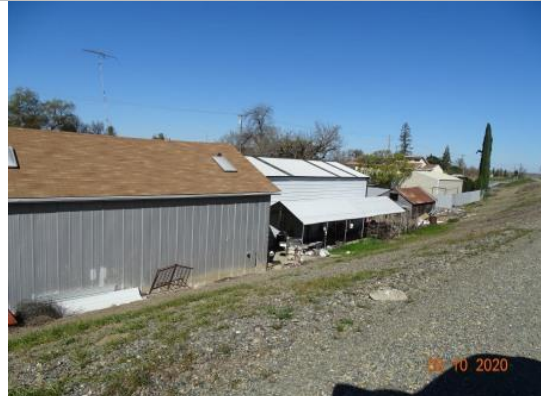
Photo 1 of 1 : SP_2023_MA0001_297_46_20230410_00011.jpg

LM Start	16.31	Rating **	U	Issue No.	46
LM End	16.33	Issue Type +	En	Location *	LS
Category	Earthen Levee			GPS Latitude/Longitude	
				Start	End
Item	Encroachments			39.407225°	39.407545°
				-122.008570°	-122.008640°
DWR ID	DWR_MA0001_01_s_2012_46				
Comment Code					
BU : Building					
Inspector Comment

View of the buildings along the landside toe. Spring 2020.

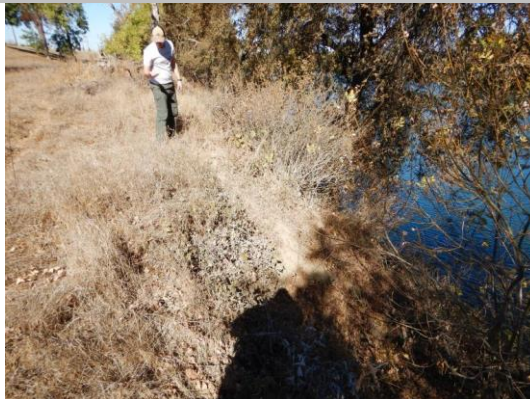
Photo 1 of 2 : SP_2023_MA0001_297_9_20230410_00006.jpg

LM Start	16.35	Rating **	A/W	Issue No.	9
LM End	16.58	Issue Type +	Ma	Location *	WS
Category	Supplemental			GPS Latitude/Longitude	
				Start	End
Item	2018 USACE Erosion Survey			39.407837°	39.411111°
				-122.008763°	-122.009238°
DWR ID	DWR_MA0001_01_s_2022_9				
Comment Code					
Inspector Comment					
2018 Site ID: SAC 164.3 R					
Status: Eroding					
2018 Field Notes: Minor new erosion throughout site.					
Site History: Erosion site added in 1997 and removed in 2005. 2009 - Site added back in, hard toe with slow moving erosion. Potential geotechnical failure. 2011 - Site extended downstream. 2017 - New erosion along entire site.

USACE 2018 Erosion Photo #1

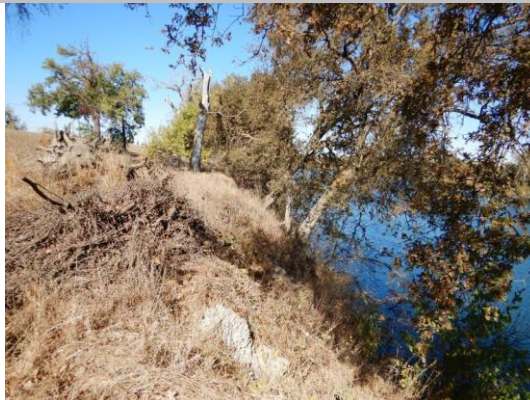
Photo 2 of 2 : SP_2023_MA0001_297_9_20230410_00007.jpg

USACE 2018 Erosion Photo #2
