Flood Control Project Maintenance  
Levee Inspections  
LMA District Cover Sheet

Sutter Maintenance Yard Maintenance Area 0001

**Flood Control Project Maintenance  
Levee Inspections**

**Levee Inspection Report By Mile - Spring 2024**

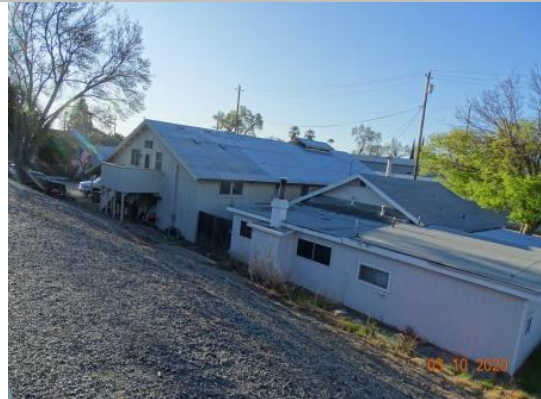
Photo 1 of 1 : SP\_2024\_MA0001\_297\_2\_20240212\_00001.jpg

LM Start	0.04	Rating **	U	Issue No.	2
LM End	0.23	Issue Type +	En	Location *	LS
Category	Earthen Levee			GPS Latitude/Longitude	
				Start	End
Item	Encroachments			39.213988°	39.215198°
				-122.001537°	-122.004775°
DWR ID	DWR_MA0001_01_s_2012_2				
Comment Code					
BU : Building					
Inspector Comment					
Multiple buildings and homes along the landside slope and toe through this area.

View of the buildings along the landside toe. Spring 2020.

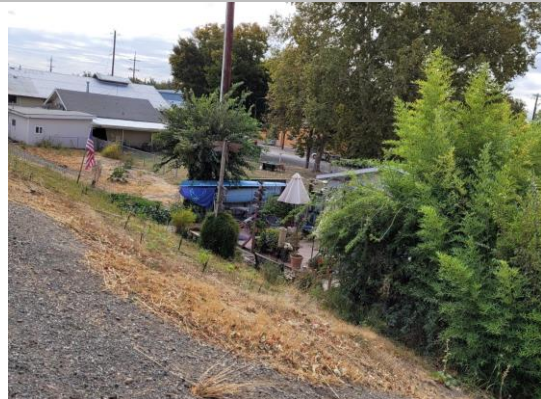
Photo 1 of 1 : SP\_2024\_MA0001\_297\_106\_20240212\_00024.jpg

LM Start	0.07	Rating **	M	Issue No.	106
LM End	0.07	Issue Type +	En	Location *	LS
Category	Earthen Levee			GPS Latitude/Longitude	
				Start	End
Item	Encroachments			39.214162°	39.214162°
				-122.002174°	-122.002174°
DWR ID	DWR_MA0001_01_f_2021_106				
Comment Code					
LI : Landscape Irrigation					
Inspector Comment

View of the irrigation system on the landside slope. Fall 2021.

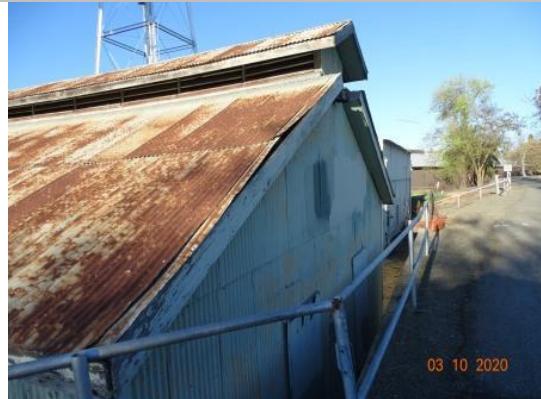
Photo 1 of 1 : SP\_2024\_MA0001\_297\_7\_20240212\_00005.jpg

LM Start	0.67	Rating **	U	Issue No.	7
LM End	0.70	Issue Type +	En	Location *	LS
Category	Earthen Levee			GPS Latitude/Longitude	
				Start	End
Item	Encroachments			39.216533°	39.216680°
				-122.012512°	-122.012907°
DWR ID	DWR_MA0001_01_s_2012_7				
Comment Code					
BU : Building					
Inspector Comment

View of the buildings along the landside toe. Spring 2020.

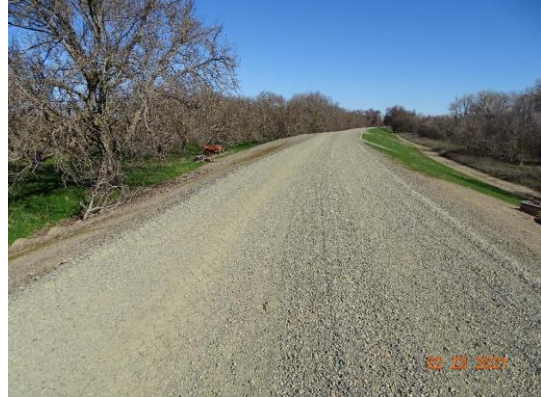
Photo 1 of 3 : UCIP\_SP\_2024\_62871\_91162.jpg

Comment Code					
Inspector Comment					
DS_ID:17565 FS_ID:62871 EP_NO: 9487 Repair Type: Urgent EVAL Issue: 1, Pipe Integrity Crossing Status: Found UCIP Comments: 02/23/2021 Record updated from Non-Urgent to Urgent. DMP internal video inspection has found pipe integrity issues. LOF of crossing is between 5 and 6. Crossing will be monitored until funding becomes available to address the issues. No permit has been identified authorizing pipe. Need to have CVFPB review ABO and determine current owner. (O.Yakimov - DWR UCIP) 05/03/2017 Ws end still partially plugged. (A. Freitag - DWR Sutter Yard)10/24/2016 Ws pipe end still plugged. (A. Freitag - DWR Sutter Yard)04/25/2016 WS pipe end still plugged with soil. rest of pipe appears in good condition. (A. Freitag - DWR Sutter Yard)04/20/2015 WS pipe end plugged about 50% by soil. (A. Freitag - DWR Sutter Yard)06/18/2014 Same as last inspection. (A. Freitag - DWR Sutter Yard)12/17/2013 Same as last inspection. (A. Freitag - DWR Sutter Yard)07/18/2013 WS pipe end has been reformed but is still partially blocked with dirt and debris.10/18/2012 WS-remove dirt and debris in riser. Outlet deformed and blocked over 50%. Burrow activity near outlet on waterward slope. Debris around concrete section on landward side. This crossing was listed in the USACE Periodic Inspections as ID# USACE_CESPK_MA1C_2010_p_0116 for crossing outlet deformed and clogged with dirt. (O. Magana - DWR UCIP) FIELD_STRUCT_DESC: 2 of 2: 36-inch corrugated metal drainage pipe through the levee, approximately 12-15 feet below the crown. Slide gates in corrugated metal pipe (CMP) riser on the waterside (WS) slope. Pipe daylights on the landside (LS). (36-inch pipe [HLM 1.97] authorized under Automatic Board Order (ABO) issued as Permit No. 9487, 1974 - Jimeno Rancho) [Additional Reference(s): DWR Levee Log, 1992 (HLM 1.97).USACE Sacramento O&M Manual, Unit 137, August 1955, Revised 29 December 2016, (STA 103+18), listed as 36-inch pipe]. FS Date: 2/23/2021 9:23:26 AM

Top of Levee: View of levee crown looking upstream

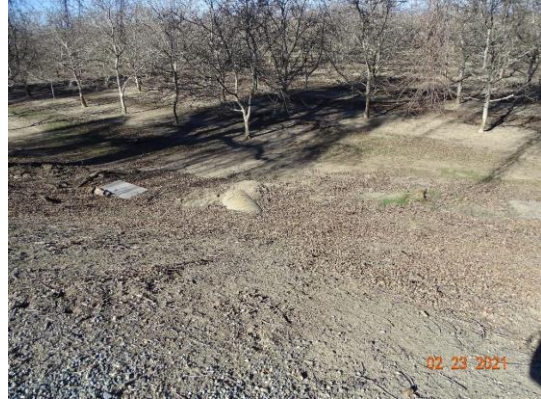
Photo 1 of 3 : UCIP\_SP\_2024\_62872\_91172.jpg

Comment Code					
Inspector Comment					
DS_ID:16429 FS_ID:62872 EP_NO: 9472 Repair Type: Urgent EVAL Issue: 1, Pipe Integrity Crossing Status: Found UCIP Comments: 02/23/2021 Record updated from Non-Urgent to Urgent. DMP internal video inspection has found pipe integrity issues. LOF of crossing is between 5 and 6. Crossing will be monitored until funding becomes available to address the issues. No permit has been identified authorizing pipe. Need to have CVFPB review ABO and determine current owner. Crossing appears abandoned. Soil blocks more than 80% of pipe end at landside toe. (O.Yakimov - DWR UCIP) 05/03/2017 LS inlet partially plugged with soil. Some debris still present inside riser. (A. Freitag - DWR Sutter Yard)10/24/2016 Debris still inside of riser. (A. Freitag - DWR Sutter Yard)04/25/2016 Pipe still inside of riser and LS end plugged about 50% by soil. (A. Freitag - DWR Sutter Yard)04/20/2015 Same as last inspection. (A. Freitag - DWR Sutter Yard)06/18/2014 Same as last inspection. (A. Freitag - DWR Sutter Yard)12/17/2013 Same as last inspection. (A. Freitag - DWR Sutter Yard)07/18/2013 Same as last inspection. (A. Freitag - DWR Sutter Yard)10/18/2012 Remove debris from riser. Landward inlet is blocked by over 50%. This crossing was listed in the USACE Periodic Inspections as ID# USACE_CESPK_MA1C_2010_p_0128 for sediment build up at inlet (landward side) and debris inside riser. (O. Magana - DWR UCIP) FIELD_STRUCT_DESC: 54-inch corrugated metal drainage pipe through the levee, approximately 12-15 feet below the crown. Slide gate in corrugated metal pipe (CMP) riser on the waterside (WS) slope. Pipe daylights at landside toe. This pipe crosses the levee at angle. (54-inch pipe [HLM 2.29] authorized under Automatic Board Order (ABO) issued as Permit No. 9472, 1974 - Ballard). [Additional Reference(s): DWR Levee Log, 1992 (HLM 2.29). USACE Sacramento O&M Manual, Unit 137, August 1955, Revised 29 December 2016, (STA 120+00), listed as 54-inch pipe]. FS Date: 2/23/2021 9:25:10 AM

Land-Side: View of levee crown looking from crown

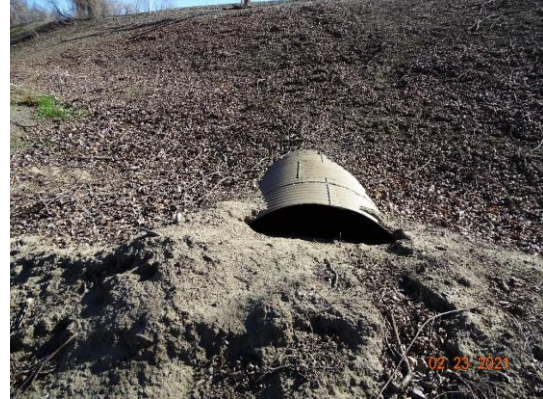
Photo 2 of 3 : UCIP\_SP\_2024\_62872\_91173.jpg

Land-Side: Pipe inlet blocked with soil

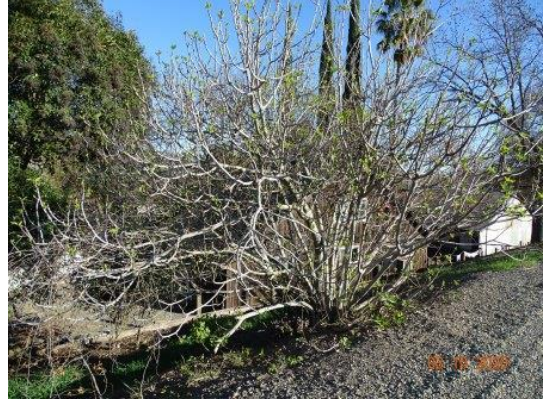
Photo 1 of 1 : SP\_2024\_MA0001\_297\_88\_20240212\_00019.jpg

LM Start	2.53	Rating **	M	Issue No.	88
LM End	2.53	Issue Type +	En	Location *	LS
Category	Earthen Levee			GPS Latitude/Longitude	
				Start	End
Item	Vegetation			39.239764°	39.239764°
				-122.010397°	-122.010397°
DWR ID	DWR_MA0001_01_s_2019_88				
Comment Code					
V6 : Landscaping					
Inspector Comment					
The fig tree should be removed from the landside shoulder.

View of the fig tree on the landside shoulder. Spring 2020.

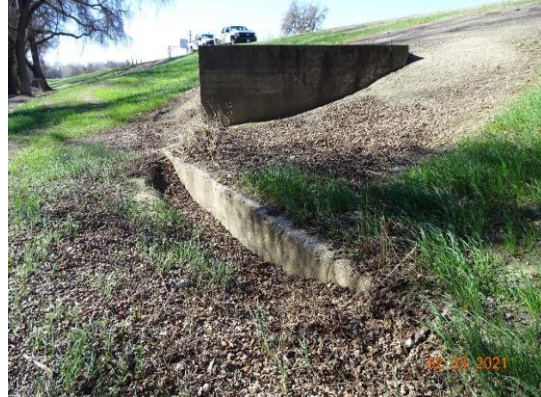
Photo 2 of 3 : UCIP\_SP\_2024\_62892\_91309.jpg

Water-Side: View of abandoned concrete box on levee slope

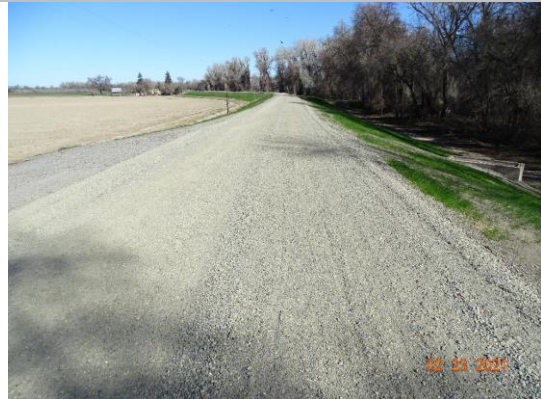
Photo 1 of 3 : UCIP\_SP\_2024\_62894\_91323.jpg

Comment Code					
Inspector Comment					
DS_ID:17567 FS_ID:62894 EP_NO: 9474 Repair Type: Urgent EVAL Issue: 3a, Flood Risk Crossing Status: Found UCIP Comments: 02/23/2021 Record updated from Non-Urgent to Urgent. Missing slide gate on pipe in concrete box on waterside slope creates flood threat to landside. Crossing appears abandoned. Concrete box on waterside filled with soil, soil deposits inside and around pipe end on landside. No permit has been identified authorizing pipe. Need to have CVFPB review ABO and determine current owner. (O.Yakimov - DWR UCIP) 05/03/2017 Appears abandoned- WS vault full of soil. Needs to be abandoned properly. (A. Freitag - DWR Sutter Yard)10/24/2016 Appears to be abandoned. WS vault full of soil to help prevent water from flowing through during high water season. (A. Freitag - DWR Sutter Yard)04/25/2016 Concrete box on WS was filled with soil to help prevent water form flowing through during times of high water. (A. Freitag - DWR Sutter Yard)04/20/2015 Positive closure device is missing and water cannot be prevented from flowing through pipe during high water. (A. Freitag - DWR Sutter Yard)06/18/2014 Same as last inspection. (A. Freitag - DWR Sutter Yard)12/17/2013 Same as last inspection. (A. Freitag - DWR Sutter Yard)07/18/2013 Same as last inspection. (A. Freitag - DWR Sutter Yard)10/18/2015 During high water flow goes through levee. Missing positive closure device on waterward side. This structure appears abandoned-slide gates have been removed. Crossing needs to be properly abandoned. This crossing was listed in the USACE Periodic Inspection as ID# USACE_CESPK_MA1C_2010_p_0169 for concrete box partially filled with dirt. (O. Magana - DWR UCIP) FIELD_STRUCT_DESC: 60-inch reinforced concrete irrigation pipe through the levee, approximately 12-15 feet below the crown. Culvert constructed with wing walls and gates. Crossing goes through the levee at an angle. Slide gates in concrete well at the waterside (WS) toe. (60-inch pipe [HLM 2.89] authorized under Automatic Board Order (ABO) issued as Permit No. 9474, 1974 - George R. Zumwalt, et al). [Additional Reference(s): DWR Levee Log, 1992 (HLM 2.89). USACE Sacramento O&M Manual, Unit 137, August 1955, Revised 29 December 2016, (STA 150+06), listed as 5-foot by 5-foot concrete culvert with hand-operated slide gate]. FS Date: 2/23/2021 2:01:03 PM

Top of Levee: View of levee crown looking upstream

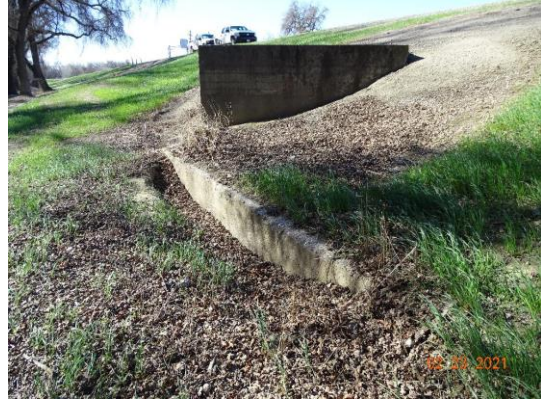
Photo 2 of 3 : UCIP\_SP\_2024\_62894\_91324.jpg

Water-Side: Abandoned, filled with soil concrete box on levee slope, buried headwall at toe

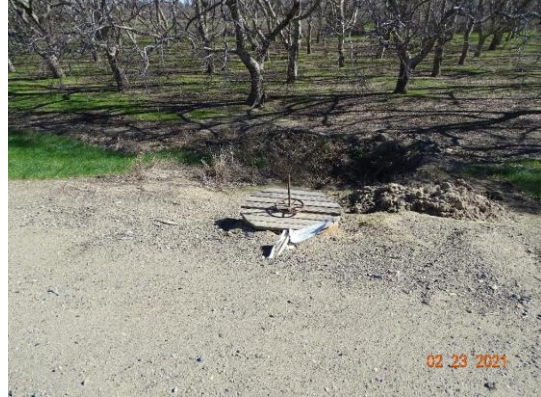
Photo 2 of 3 : UCIP\_SP\_2024\_80997\_91331.jpg

Water-Side: CMP riser on levee slope

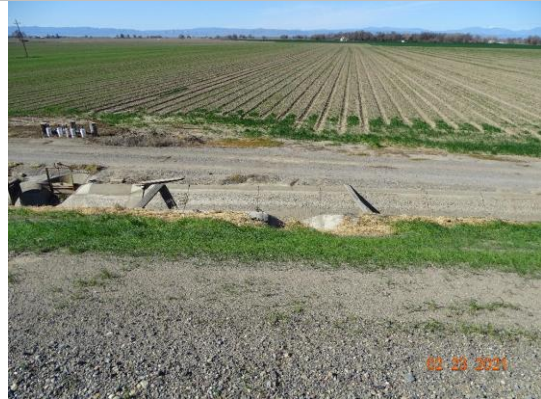
Photo 3 of 3 : UCIP\_SP\_2024\_80997\_91332.jpg

Land-Side: View of levee slope looking from crown

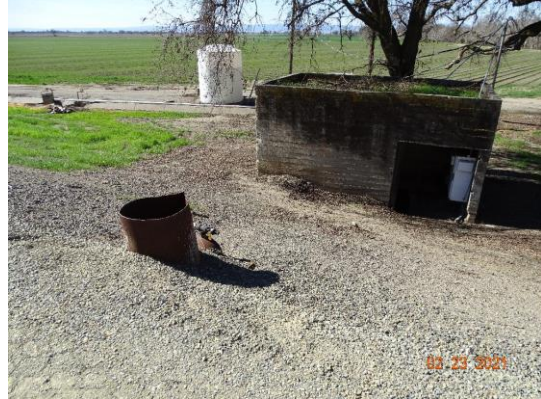
Photo 1 of 3 : UCIP\_SP\_2024\_62897\_91346.jpg

DS\_ID:16436  
FS\_ID:62897  
EP\_NO: 4213  
Repair Type: Urgent  
EVAL Issue: 2b, Levee Integrity  
Crossing Status: Found  
UCIP Comments: 02/23/2021 Record remains Urgent. Existing sinkhole in pipe alignment at pumphouse wall measures 5 feet in diameter and about 1 foot deep. Recommend owner perform pipe integrity test. (O.Yakimov - DWR UCIP)  
10/01/2018 Sinkhole near concrete structure on the LS was filled with soil and debris. Flow meter at the WS shoulder and a manometer on the pipe on the LS shoulder was installed. Video inspection is recommended to determine pipe integrity through levee. (O.Yakimov - DWR UCIP)05/03/2017 Sinkhole still present next to concrete structure on LS. (A. Freitag - DWR Sutter Yard)10/24/2016 Pump is on WS. Sinkhole still present over pipe alignment next to the concrete building. (A. Freitag - DWR Sutter Yard)04/25/2016 No repairs have been made since last inspection. Sink holes are still present above pipe next to concrete building on LS. (A. Freitag - DWR Sutter Yard)04/20/2015 Sink hole over pipe alignment on LS up against the concrete building. Need to dig up pipe and see if its leaking. (A. Freitag - DWR Sutter Yard)06/23/2014 Same as last inspection. (A. Freitag - DWR Sutter Yard)06/18/2014 Same as last inspection. (A. Freitag - DWR Sutter Yard)12/17/2013 Same as last inspection. (A. Freitag - DWR Sutter Yard)07/18/2013 Same as last inspection. (A. Freitag - DWR Sutter Yard)10/19/2012 Recommend adding door to LS concrete structure. Riser located on landward side is damaged. This crossing was listed in the USACE Periodic Inspection as ID# USACE\_CESPK\_MA1C\_2010\_p\_0194 no issues logged. (O. Magana - DWR UCIP)

Land-Side: View of levee slope looking from crown

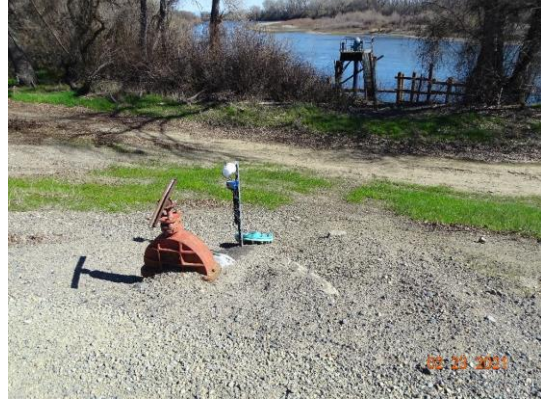
Photo 2 of 3 : UCIP\_SP\_2024\_62897\_91345.jpg

Water-Side: View of levee slope looking from crown

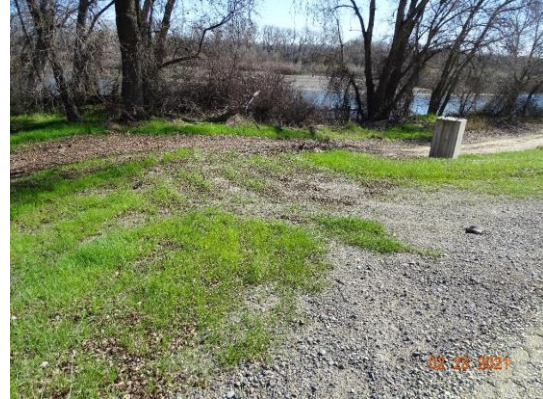
Photo 2 of 3 : UCIP\_SP\_2024\_62898\_91351.jpg

DS\_ID:16424  
FS\_ID:62898  
EP\_NO: 9490  
Repair Type: Non-Urgent  
EVAL Issue: 4b, Safety Issue  
Crossing Status: Found  
UCIP Comments: 02/23/2021 Record remains Non-Urgent. Crossing appears abandoned. Abandoned pump located inside of concrete distribution box at landside levee toe. Concrete box open at ground level creates fall hazard. Pipe not found on waterside. No permit has been identified authorizing pipe. Need to have CVFPB review ABO and determine current owner. (O.Yakimov - DWR UCIP)  
05/03/2017 Abandoned- Needs to be done properly. (A. Freitag - DWR Sutter Yard)10/24/2016 Abandoned. Needs a cover made for the LS distribution box. (A. Freitag - DWR Sutter Yard)04/25/2016 ABANDONED crossing and should be abandoned properly. Concrete distribution box on LS is opened on top and could pose a safety hazard with falling. (A. Freitag - DWR Sutter Yard)04/20/2015 Same as last inspection. (A. Freitag - DWR Sutter Yard) 06/18/2014 Same as last inspection. (A. Freitag - DWR Sutter Yard)12/17/2013 Same as last inspection. (A. Freitag - DWR Sutter Yard)07/18/2013 Same as last inspection. (A. Freitag - DWR Sutter Yard)10/19/2012 Crossing needs to be properly abandoned. This crossing was listed in the USACE Periodic Inspection as ID#

Water-Side: View of levee slope looking from crown

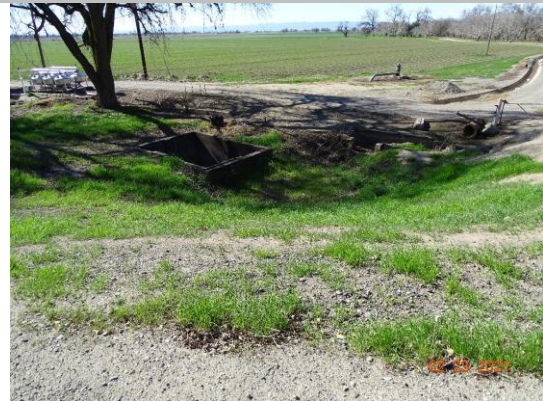
Photo 3 of 3 : UCIP\_SP\_2024\_62898\_91350.jpg

Land-Side: View of levee slope looking from crown

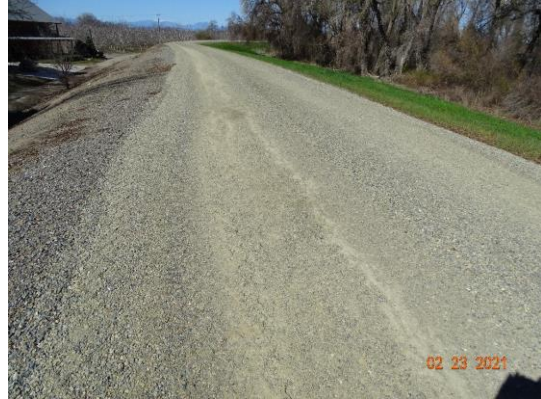
Photo 1 of 3 : UCIP\_SP\_2024\_62900\_91370.jpg

Comment Code					
Inspector Comment					
DS_ID:17659 FS_ID:62900 EP_NO: N/A Repair Type: Non-Urgent EVAL Issue: Crossing Status: Not Found UCIP Comments: 02/23/2021 Record remains Non-Urgent. Crossing not found. Geophysical results did not confirm presence of pipe through levee. Record will remain in UCIP's inspection records until future Levee Improvement Project can confirm no crossing was found through the levee. No permit has been identified authorizing pipe. Updated coordinates of crossing to match location to O&M (STA 198+00). (O.Yakimov - DWR UCIP) 05/03/2017 Unable to locate. (A. Freitag - DWR Sutter Yard) 10/24/2016 Unable to locate. (A. Freitag - DWR Sutter Yard) 04/25/2016 Unable to locate. (A. Freitag - DWR Sutter Yard) 04/20/2015 Same as last inspection. (A. Freitag - DWR Sutter Yard) 06/18/2014 Same as last inspection. (A. Freitag - DWR Sutter Yard) 12/17/2013 Same as last inspection. (A. Freitag - DWR Sutter Yard) 07/18/2013 Same as last inspection. (A. Freitag - DWR Sutter Yard) 10/19/2012 USA flag markers show some type of alignment on LS. Unable to determine if crossing still exists at this location. (O. Magana - DWR UCIP) FIELD_STRUCT_DESC: 18-inch steel drainage pipe through the levee at an unknown depth below the crown. Automatic drainage gate on the outlet end of the pipe. [Additional Reference(s): USACE Sacramento O&M Manual, Unit 137, August 1955, Revised 29 December 2016, (STA 198+00), listed as 18-inch pipe]. FS Date: 2/23/2021 2:19:54 PM

Top of Levee: View of levee crown looking upstream

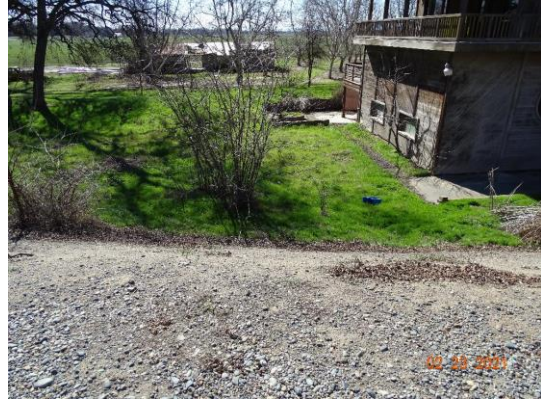
Photo 2 of 3 : UCIP\_SP\_2024\_62900\_91371.jpg

Land-Side: View of levee slope looking from crown

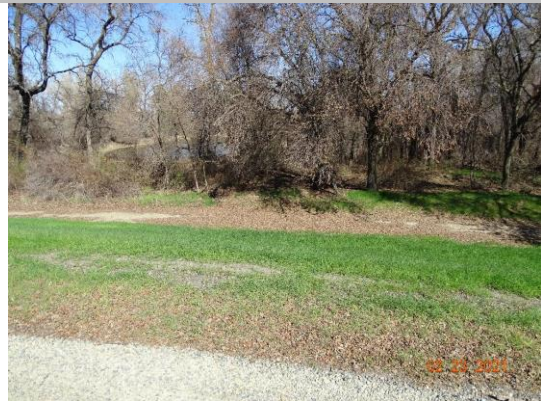
Photo 3 of 3 : UCIP\_SP\_2024\_62900\_91372.jpg

LM Start	<b>3.72</b>	Rating **	M	Issue No.	<b>145 (cont)</b>
LM End	<b>3.72</b>	Issue Type +	Ma	Location *

Water-Side: View of levee slope looking from crown

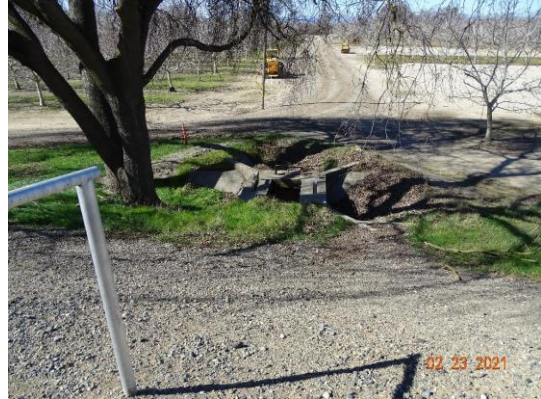
Photo 1 of 3 : UCIP\_SP\_2024\_62902\_91391.jpg

DS\_ID:16422  
FS\_ID:62902  
EP\_NO: N/A  
Repair Type: Urgent  
EVAL Issue: 1, Pipe Integrity  
Crossing Status: Found  
UCIP Comments: 02/23/2021 Record updated from Non-Urgent to Urgent. DMP internal video inspection has found pipe integrity issues. LOF of crossing is between 5 and 6. Crossing will be monitored until funding becomes available to address the issues. Debris and sediment need to be cleared around screw gate on waterside slope for proper operation. Unauthorized encroachment recorded in Levee Log prior to 2011. (O.Yakimov - DWR UCIP)  
05/03/2017 Appears abandoned- needs to be done so properly. (A. Freitag - DWR Sutter Yard)10/24/2016 Appears to be abandoned. (A. Freitag - DWR Sutter Yard)04/25/2016 Appears to be an abandoned crossing. (A. Freitag - DWR Sutter Yard) 04/20/2015 Debris is still blocking gate. Appears to be an abandoned crossing. (A. Freitag - DWR Sutter Yard)06/18/2014 Same as last inspection. (A. Freitag - DWR Sutter Yard)12/17/2013 Same as last inspection. (A. Freitag - DWR Sutter Yard)07/18/2013 Wheel to operate slide gate has been replaced but gate is still blocked by debris.10/19/2012 WS-wheel to operate slide gate missing, walkway has been removed; burrow activity near structure; debris in concrete distribution box WS blocking gate. This crossing was listed in the USACE Periodic Inspection as ID# USACE\_CESPK\_MA1C\_2010\_p\_0207 the wheel to operate sluice gate missing. (O. Magana - DWR UCIP)

FIELD\_STRUCT\_DESC: 24-inch drainage pipe of an unknown material through the levee, unknown depth below the crown. Walkway to slide gate on the waterside (WS) end. Walkway has been removed. Flap gate in concrete distribution box at the landside (LS) toe. [Additional Reference(s): DWR Levee Log, 1992 (HLM 4.05)].  
FS Date: 2/23/2021 2:23:36 PM

Land-Side: View of levee slope looking from crown

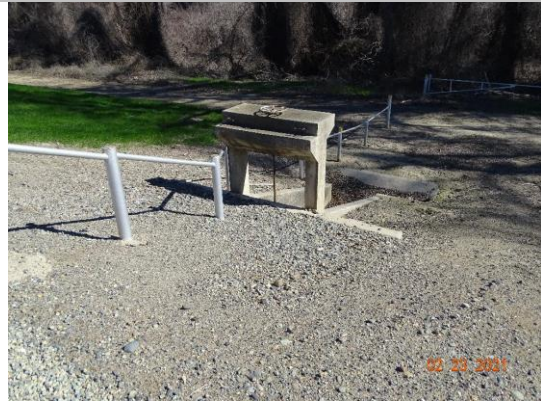
Photo 2 of 3 : UCIP\_SP\_2024\_62902\_91394.jpg

LM Start	3.95	Rating **	U	Issue No.	146 (cont)
LM End	3.95	Issue Type +	En	Location *	
Category	Supplemental			GPS Latitude/Longitude	
				Start	End
Item	DWR UCIP Field Study			39.258073 °	39.258073 °
				-122.013165 °	-122.013165 °
DWR ID	16422

Water-Side: View of levee slope looking from crown

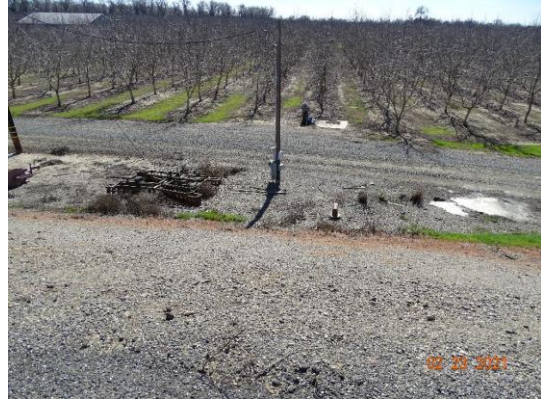
Photo 1 of 3 : UCIP\_SP\_2024\_62908\_91426.jpg

Comment Code					
Inspector Comment					
DS_ID:16420 FS_ID:62908 EP_NO: 4903 Repair Type: Urgent EVAL Issue: 3a, Flood Risk Crossing Status: Found UCIP Comments: 02/23/2021 Record updated from Non-Urgent to Urgent. Pipe is 18-20 feet below levee crown open on waterside poses potential flood threat to landside. Pipe is capped at landside toe. Crossing appears abandoned. (O.Yakimov - DWR UCIP) 05/03/2017 Appears abandoned- if so needs to be done properly. (A. Freitag - DWR Sutter Yard)10/24/2016 appears to be abandoned. (A. Freitag - DWR Sutter Yard)04/25/2016 Appears to be an abandoned crossing. (A. Freitag - DWR Sutter Yard)04/20/2015 Suspect that pump on LS is a well pump and has nothing to do with this crossing. (A. Freitag - DWR Sutter Yard)06/18/2014 Same as last inspection. (A. Freitag - DWR Sutter Yard)12/17/2013 Same as last inspection. (A. Freitag - DWR Sutter Yard)07/18/2013 Same as last inspection. (A. Freitag - DWR Sutter Yard)10/19/2012 Unable to locate siphon breaker, pump on LS; unable to tell if pump system is part of appurtenances. This crossing was listed in the USACE Periodic Inspection as ID# USACE_CESPK_MA1C_2010_p_0233 for utility pole and 8 inch steel riser located on landward toe. (O. Magana - DWR UCIP) FIELD_STRUCT_DESC: 12-inch asphalt coated steel irrigation pipe through the levee, approximately 18-20 feet below the crown. Siphon breaker in 24-inch corrugated metal pipe (CMP) riser on the landside (LS) shoulder--not found. 3-inch electrical conduit through the levee--not found. Utility pole visible on the LS. Well station visible on the LS. No appurtenances visible on the waterside (WS). (12-inch irrigation pipe and electrical conduit authorized under Permit No. 4903, 1965 - Mattie B. Zumwalt Company). (Irrigation pipe and portable pump authorized under Permit No. 4903-A, 1965 - Mattie B. Zumwalt Company). [Additional Reference(s): DWR Levee Log, 1992 (HLM 5.08)]. FS Date: 2/23/2021 2:58:13 PM

Land-Side: View of levee slope looking from crown

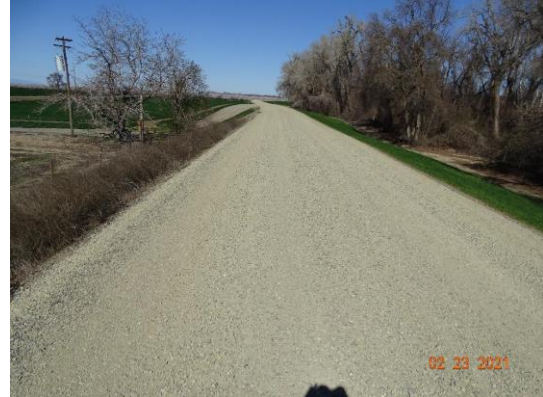
Photo 1 of 3 : UCIP\_SP\_2024\_62911\_91445.jpg

Comment Code					
Inspector Comment					
DS_ID:17658 FS_ID:62911 EP_NO: N/A Repair Type: Non-Urgent EVAL Issue: Crossing Status: Not Found UCIP Comments: 02/23/2021 Record is Non-Urgent. Crossing not found. Geophysical results did not confirm presence of pipe through levee. Record will remain in UCIP's inspection records until future Levee Improvement Project can confirm no crossing was found through the levee. No permit has been identified authorizing pipe. (O.Yakimov - DWR UCIP) 05/03/2017 Unable to locate. (A. Freitag - DWR Sutter Yard) 10/24/2016 Unable to locate. (A. Freitag - DWR Sutter Yard) 04/25/2016 Unable to locate. (A. Freitag - DWR Sutter Yard) 04/20/2015 Unable to locate. (A. Freitag - DWR Sutter Yard) 06/23/2014 Unable to locate. (A. Freitag - DWR Sutter Yard) 12/17/2013 Unable to locate. (A. Freitag - DWR Sutter Yard) 07/18/2013 Same as last inspection. Unable to locate. (A. Freitag - DWR Sutter Yard) FIELD_STRUCT_DESC: 36-inch corrugated metal drainage pipe through the levee at an unknown depth below the crown. [Additional Reference(s): USACE Sacramento O&M Manual, Unit 137, August 1955, Revised 29 December 2016, (STA 303+70), listed as 36-inch pipe]. FS Date: 2/23/2021 3:28:33 PM

Top of Levee: View of levee crown looking upstream

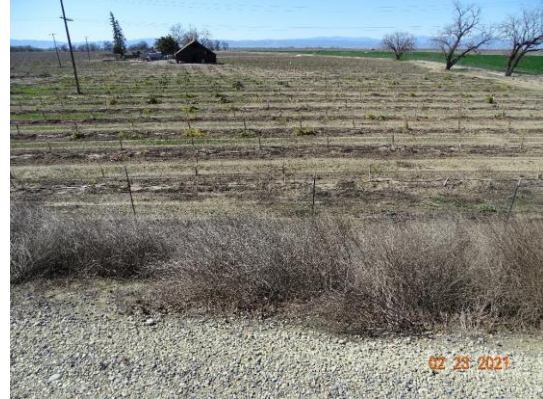
Photo 3 of 3 : UCIP\_SP\_2024\_62911\_91447.jpg

LM Start	<b>5.75</b>	Rating **	M	Issue No.	<b>150 (cont)</b>
LM End	<b>5.75</b>	Issue Type +	Ma	Location *	
Category	Supplemental			GPS Latitude/Longitude	
				Start	End
Item	DWR UCIP LMA Responsibility			39.272400 °	39.272400 °
				-122.023248 °	-122.023248 °
DWR ID	17658

Land-Side: View of levee slope looking from crown

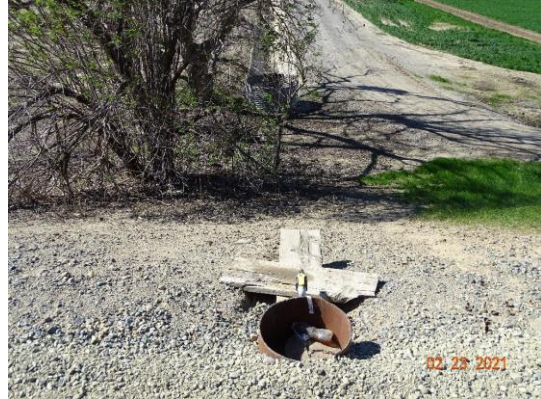
Photo 1 of 3 : UCIP\_SP\_2024\_62912\_91449.jpg

Comment Code					
Inspector Comment					
DS_ID:16418 FS_ID:62912 EP_NO: 6263 Repair Type: Urgent EVAL Issue: 2a, Levee Integrity Crossing Status: Found UCIP Comments: 02/23/2021 Record updated from Non-Urgent to Urgent. Pipe exposed in a trench on waterside starting 20 feet from waterside levee toe going toward pumps. Pumps are dismantled, discharge pipe cut open under pumping platform. Unable to find a permit for modification. (O.Yakimov - DWR UCIP) 05/03/2017 Crossing appears to be in good condition. (A. Freitag - DWR Sutter Yard)10/24/2016 Appears to be in good condition. (A. Freitag - DWR Sutter Yard)04/25/2016 Pressure gauge and valve were added to pipe near the siphon breaker on LS shoulder. (A. Freitag - DWR Sutter Yard)04/20/2015 Modifications are being made to pipe near the LS shoulder. Not sure what all exactly is being done. (A. Freitag - DWR Sutter Yard)06/23/2014 Same as last inspection. (A. Freitag - DWR Sutter Yard) 12/17/2013 Same as last inspection. (A. Freitag - DWR Sutter Yard)07/18/2013 Debris cleared from in front of LS standpipe. (A. Freitag - DWR Sutter Yard)10/19/2012 Remove debris from landward side see photo 2. This crossing was listed in the USACE Periodic Inspection as ID# USACE_CESPK_MA1C_2010_p_0249 however, unable to determine why crossing was marked "U". (O. Magana - DWR UCIP) FIELD_STRUCT_DESC: 18-inch asphalt coated steel irrigation pipe through the levee, 2 feet below the crown. Siphon breaker on the landside (LS) shoulder. Corrugated metal pipe (CMP) riser located on the LS connects with concrete V-ditch. Dual slant pumps and gate valves on the bank approximately 215 feet from waterside (WS) toe. Pumps feed into single 18-inch steel pipe. 2-inch electrical conduit buried in the same trench as the irrigation pipe. (18-inch pipe authorized under Permit No. 6263, 1968 - Charles W. Tuttle). [Additional Reference(s): DWR Levee Log, 1992 (HLM 5.90)]. FS Date: 2/23/2021 3:41:43 PM

Land-Side: View of levee slope looking from crown

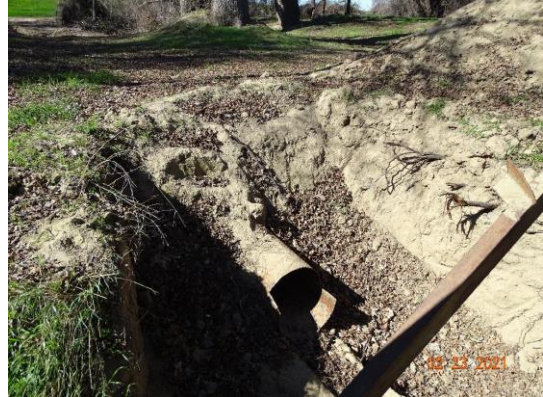
Photo 2 of 3 : UCIP\_SP\_2024\_62912\_91455.jpg

LM Start	<b>5.77</b>	Rating **	U	Issue No.	<b>151 (cont)</b>
LM End	<b>5.77</b>	Issue Type +	En	Location *	
Category	Supplemental			GPS Latitude/Longitude	
				Start	End
Item	DWR UCIP Field Study			39.272829°	39.272829°
				-122.023282°	-122.023282°
DWR ID	16418

Water-Side: View of open pipe under pile structure at riverbank

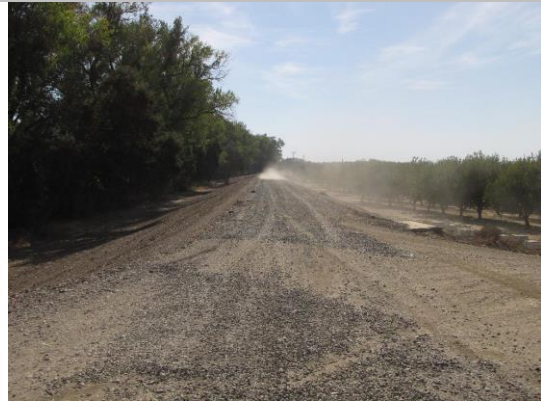
Photo 2 of 3 : UCIP\_SP\_2024\_62914\_70180.jpg

LM Start	6.40	Rating **	M	Issue No.	153 (cont)
LM End	6.40	Issue Type +	Ma	Location *	
Category	Supplemental			GPS Latitude/Longitude	
				Start	End
Item	DWR UCIP LMA Responsibility			39.281721°	39.281721°
				-122.021894°	-122.021894°
DWR ID	16425

Overview of levee crown looking downstream at crossing.

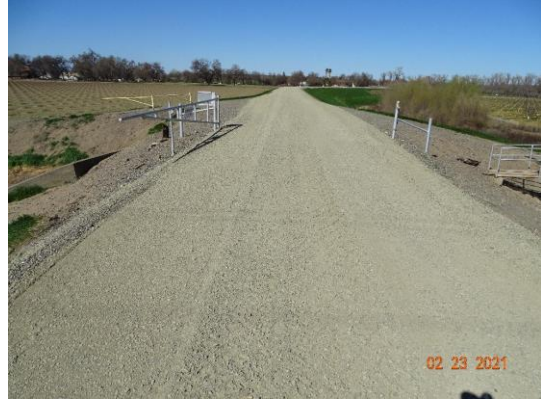
Photo 1 of 3 : UCIP\_SP\_2024\_62915\_91471.jpg

Comment Code					
Inspector Comment					
DS_ID:16427 FS_ID:62915 EP_NO: 9482 Repair Type: Urgent EVAL Issue: 3a, Flood Risk Crossing Status: Found UCIP Comments: 02/23/2021 Record updated from Non-Urgent to Urgent. Missing slide gate at U-shaped headwall on waterside slope. Pipe outlet blocked with a pile of soil. Inlet to concrete culvert at landside toe is filled with soil blocking more than 50% of cross sectional area. Crossing appears abandoned. No permit has been identified authorizing pipe. Need to have CVFPB review ABO and determine current owner. (O.Yakimov - DWR UCIP) 05/03/2017 Abandoned- Needs to be done properly. (A. Freitag - DWR Sutter Yard)10/24/2016 Abandoned. (A. Freitag - DWR Sutter Yard)04/25/2016 Abandoned pipe. Needs to be properly plugged if it never gets used. (A. Freitag - DWR Sutter Yard)04/20/2015 Same as last inspection. Structure is still buried. (A. Freitag - DWR Sutter Yard)06/23/2014 Same as last inspection. (A. Freitag - DWR Sutter Yard)12/17/2013 Same as last inspection. (A. Freitag - DWR Sutter Yard)07/18/2013 Same as last inspection. (A. Freitag - DWR Sutter Yard)10/19/2012 Structure is buried and non-operational. This crossing was listed in the USACE Periodic Inspection as ID# USACE_CESPK_MA1C_2010_p_0288 for sluice gate closed and backfilled on WS and full of sediment with wingwall cracked on LS. (O. Magana - DWR UCIP) FIELD_STRUCT_DESC: 1 of 2: 36-inch reinforced concrete irrigation pipe through the levee at approximately 18 feet below the crown. Wooden slide gates on the waterside (WS) end. Concrete headwalls located on both WS and landside (LS). (36-inch pipe [HLM 7.15] authorized under Automatic Board Order (ABO) issued as Permit No. 9482, 1974 - Elizabeth M. Farnsworth). [Additional Reference(s): DWR Levee Log, 1992 (HLM 7.15). USACE Sacramento O&M Manual, Unit 137, August 1955, Revised 29 December 2016, (STA 370+90), listed as 4'-9" x 9'-6" concrete culvert and two hand operated slide gates]. FS Date: 2/23/2021 8:44:59 AM

Top of Levee: View of levee crown looking upstream

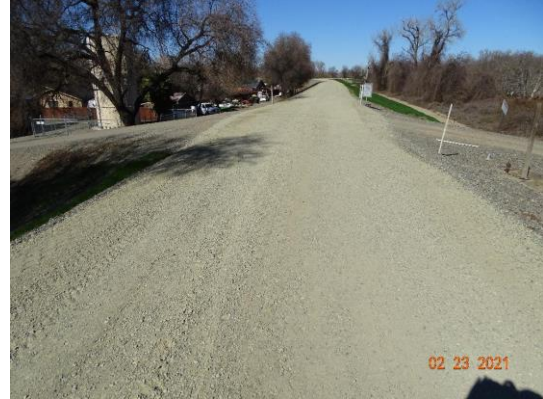
Photo 1 of 3 : UCIP\_SP\_2024\_62917\_91485.jpg

Comment Code					
Inspector Comment					
DS_ID:16456 FS_ID:62917 EP_NO: N/A Repair Type: Urgent EVAL Issue: 1, Pipe Integrity Crossing Status: Found UCIP Comments: 02/23/2021 Record updated from Non-Urgent to Urgent. Wooden stem at one of wooden slide gate is broken at level of concrete vault making slide gate non-operable, slide gate in open position. Crack in body of remaining stem. Concrete vault is open at ground level creates fall hazard. No permit has been identified authorizing pipe. (O.Yakimov - DWR UCIP) 05/03/2017 Culvert was flowing water during site visit. Appears to be in good condition. Some sediment build up in the bottom of WS box. (A. Freitag - DWR Sutter Yard)10/24/2016 Notes mentioned needing to confirm size of the culvert but was unable to access the ends at this inspection. (A. Freitag - DWR Sutter Yard)04/25/2016 Second slide gate was held open to allow water to flow through to the LS ditch. (A. Freitag - DWR Sutter Yard)04/20/2015 Same as last inspection. Rebar pin was still inplace holding the gate opened. (A. Freitag - DWR Sutter Yard)06/23/2014 Same as last inspection. (A. Freitag - DWR Sutter Yard)12/17/2013 Same as last inspection. (A. Freitag - DWR Sutter Yard)07/18/2013 Same as last inspection. (A. Freitag - DWR Sutter Yard)10/30/2012 Sediment and debris on waterward and landward side. This crossing was listed in the USACE Periodic Inspection as ID# USACE_CESPK_MA1C_2010_p_0293 for wooden slide gate held open by a piece of rebar acting as a pin. (O. Magana - DWR UCIP) FIELD_STRUCT_DESC: 60-inches by 72-inches (5-foot by 6-foot) reinforced concrete box irrigation culvert (O&M manual references 3-foot and 10-inch by 6-foot culvert) through the levee, approximately 12-15 feet below the crown. Two wooden slide gates on the waterside (WS) end. Concrete v-ditch along landside (LS) toe. [Additional Reference(s): DWR Levee Log, 1992 (HLM 7.43). USACE Sacramento O&M Manual, Unit 137, August 1955, Revised 29 December 2016, (STA 385+33.5), listed as 3'-10" x 6' concrete culvert] FS Date: 2/23/2021 8:52:55 AM

Top of Levee: View of levee crown looking upstream

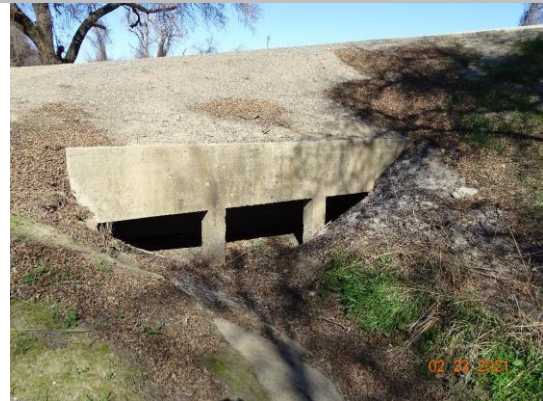
Photo 3 of 3 : UCIP\_SP\_2024\_62917\_91484.jpg

Land-Side: Reinforced concrete box irrigation culvert visible at irrigation ditch at levee toe

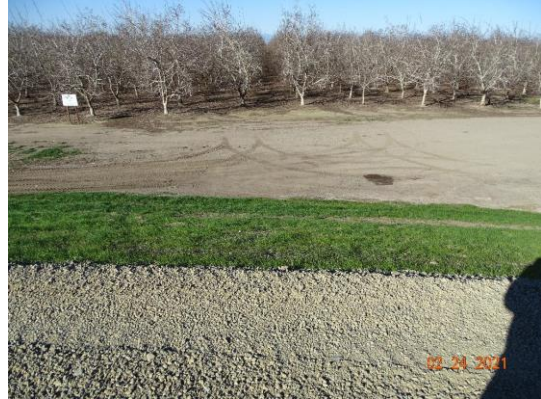
Photo 1 of 3 : UCIP\_SP\_2024\_62921\_91502.jpg

Comment Code						
Inspector Comment						
DS_ID:17655 FS_ID:62921 EP_NO: N/A Repair Type: Non-Urgent EVAL Issue: Crossing Status: Not Found UCIP Comments: 10/06/2021 After review of O&M Manual updated coordinated of potential crossing to match O&M (STA 538+42). Recommend conducting geophysical survey at updated location. (O.Yakimov - DWR UCIP) 02/24/2021 Record remains Non-Urgent. Crossing not found. Geophysical results did not confirm presence of pipe through levee at (39.328124122.09260). Record will remain in UCIP's inspection records until future Levee Improvement Project can confirm no crossing was found through the levee. No permit has been identified authorizing pipe. (O.Yakimov - DWR UCIP) 05/03/2017 Unable to locate. (A. Freitag - DWR Sutter Yard)10/24/2016 Unable to locate. (A. Freitag - DWR Sutter Yard)04/25/2016 Unable to locate. (A. Freitag - DWR Sutter Yard)04/20/2015 Unable to locate. (A. Freitag - DWR Sutter Yard)06/23/2014 Unable to locate. (A. Freitag - DWR Sutter Yard)12/17/2013 Unable to locate. (A. Freitag - DWR Sutter Yard)07/18/2013 Same as last inspection. Unable to locate. (A. Freitag - DWR Sutter Yard) FIELD_STRUCT_DESC: 36-inch corrugated metal drainage pipe through the levee at an unknown depth below the crown. Slide gate on the outlet end of the pipe. [Additional Reference(s): USACE Sacramento O&M Manual, Unit 137, August 1955, Revised 29 December 2016, (STA 538+42), listed as 36-inch pipe]. FS Date: 2/24/2021 10:43:23 AM

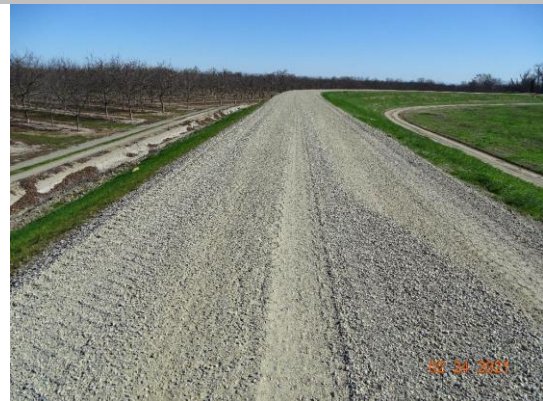
Photo 1 of 3 : UCIP\_SP\_2024\_62946\_91650.jpg

Comment Code						
Inspector Comment						
DS_ID:17654 FS_ID:62946 EP_NO: N/A Repair Type: Non-Urgent EVAL Issue: Crossing Status: Not Found UCIP Comments: 02/24/2021 Record is Non-Urgent. Crossing not found. Geophysical results did not confirm presence of pipe through levee. Record will remain in UCIP's inspection records until future Levee Improvement Project can confirm no crossing was found through the levee. No permit has been identified authorizing pipe. (O.Yakimov - DWR UCIP) 5/3/2017 Unable to locate. (DWR Sutter Yard- AFreitag)10/24/2016 Unable to locate.(DWR Sutter Yard- AFreitag)4/25/2016 Unable to locate.4/21/2015 Unable to locate.6/23/2014 Unable to locate.12/17/2013 Unable to locate.7/22/2013 Same as last inspection. Unable to locate. FIELD_STRUCT_DESC: 30-inch corrugated metal drainage pipe through the levee at an unknown depth below the crown. Slide gate on the outlet end of the pipe. [Additional Reference(s): USACE Sacramento O&M Manual, Unit 137, August 1955, Revised 29 December 2016, (STA 670+00), listed as 30-inch pipe]. FS Date: 2/24/2021 3:17:11 PM

Top of Levee: View of levee crown looking upstream

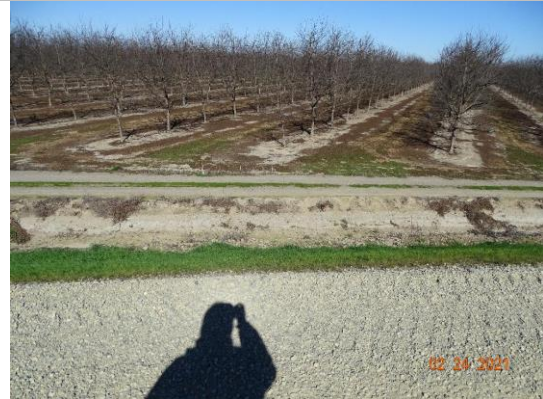
Photo 3 of 3 : UCIP\_SP\_2024\_62946\_91652.jpg

Land-Side: View of levee slope looking from crown

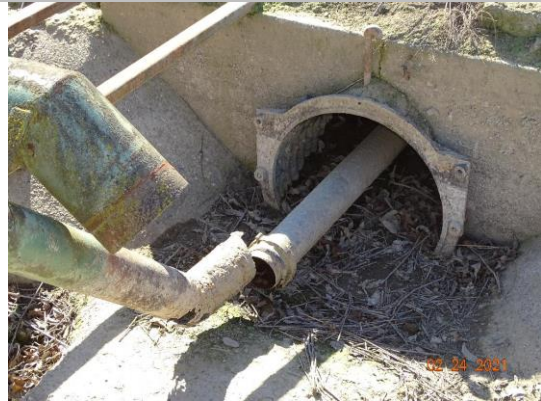
Photo 2 of 3 : UCIP\_SP\_2024\_62947\_91659.jpg

DS\_ID:16445  
FS\_ID:62947  
EP\_NO: 9462  
Repair Type: Urgent  
EVAL Issue: 3a, Flood Risk  
Crossing Status: Found  
UCIP Comments: 02/24/2021 Record updated from Non-Urgent to Urgent. 6-inch steel pipe sleeved through CMP pipe. Screw gate on waterside slightly open and burried in soil. Soil and debris deposits inside CMP pipe. Crossing appears abandoned. Unauthorized encroachment recorded in Levee Log prior to 2011. Need to have CVFPB review ABO and determine current owner. (O.Yakimov - DWR UCIP)  
5/3/2017 Appears abandoned- needs to be done properly.(DWR Sutter Yard- A Freitag)10/24/2016 Appears abandoned. LS concrete canal is filled by pipe DSID 16444.4/25/2016 Appears to be an abandoned crossing. WS slide gate still buried and inoperable.4/21/2015 Same as last inspection. 6/23/2014 Same as last inspection.12/17/2013 Same as last inspection.7/22/2013 Same as last inspection.10/30/2012 Slide gate unoperable-blocked by sediment. LS-flap gate missing. 5-inch pipe goes through 24-inch crossing--unable to determine is authorized. This crossing was listed in the USACE Periodic Inspections as ID# USACE\_CESPK\_MA1C\_2010\_p\_0435 for smaller pipe running inside existing crossing.

FIELD\_STRUCT\_DESC: 24-inch corrugated metal drainage pipe through the levee, approximately 10 feet below the crown. Slide gate on both waterside (WS) and landside (LS). Gate missing on the LS. (24-inch pipe [HLM 12.97] authorized under Automatic Board Order (ABO) issued as Permit No. 9462, 1974 - Thousand Acre Ranch). [Additional Reference(s): DWR Levee Log, 1992 (HLM 12.97)].  
FS Date: 2/24/2021 3:19:42 PM

Land-Side: 6-inch steel pipe sleeved through drainage pipe, view in irrigation ditch

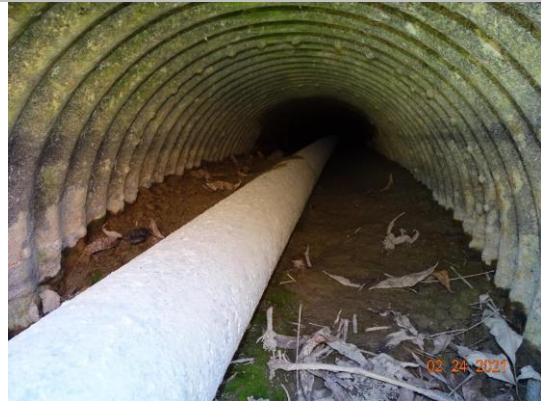
Photo 3 of 3 : UCIP\_SP\_2024\_62947\_91653.jpg

Land-Side: View inside of pipe looking from irrigation ditch

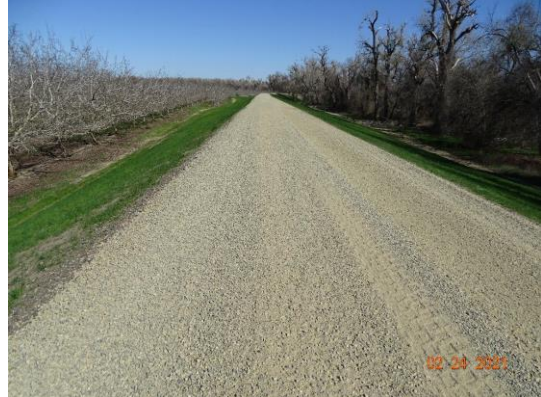
Photo 1 of 3 : UCIP\_SP\_2024\_62953\_91691.jpg

Comment Code					
Inspector Comment					
DS_ID:17653 FS_ID:62953 EP_NO: N/A Repair Type: Non-Urgent EVAL Issue: Crossing Status: Not Found UCIP Comments: 05/23/2017 Record is Non-Urgent. Crossing not found. Geophysical results did not confirm presence of pipe through levee. Record will remain in UCIP's inspection records until future Levee Improvement Project can confirm no crossing was found through the levee. No permit has been identified authorizing pipe. (A.Freitag - DWR UCIP) 05/03/2017 Unable to locate. (A. Freitag - DWR Sutter Yard)10/24/2016 Unable to locate. (A. Freitag - DWR Sutter Yard)04/25/2016 Unable to locate. (A. Freitag - DWR Sutter Yard)04/21/2015 Unable to locate. (A. Freitag - DWR Sutter Yard)06/23/2014 Unable to locate. (A. Freitag - DWR Sutter Yard)12/17/2013 Unable to locate. (A. Freitag - DWR Sutter Yard)07/22/2013 Same as last inspection. Unable to locate. (A. Freitag - DWR Sutter Yard) FIELD_STRUCT_DESC: 36-inch corrugated metal drainage pipe through the levee at an unknown depth below the crown. [Additional Reference(s): USACE Sacramento O&M Manual, Unit 137, August 1955, Revised 29 December 2016, (STA 727+65), listed as 36-inch pipe]. FS Date: 5/23/2017 12:01:00 PM

Top of Levee: View of levee crown looking upstream

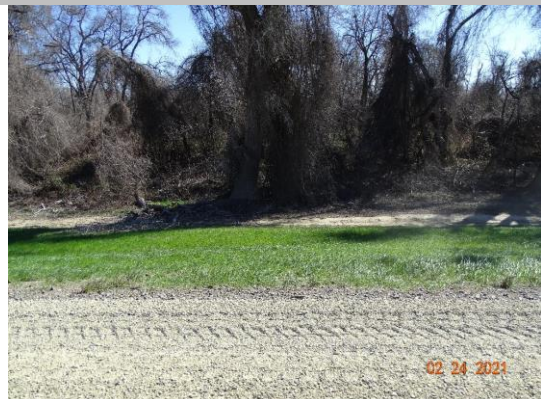
Photo 2 of 3 : UCIP\_SP\_2024\_62953\_91692.jpg

Water-Side: View of levee slope looking from crown

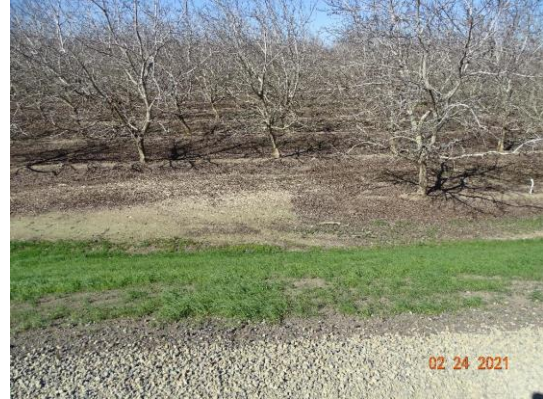
Photo 3 of 3 : UCIP\_SP\_2024\_62953\_91693.jpg

Land-Side: View of levee slope looking from crown

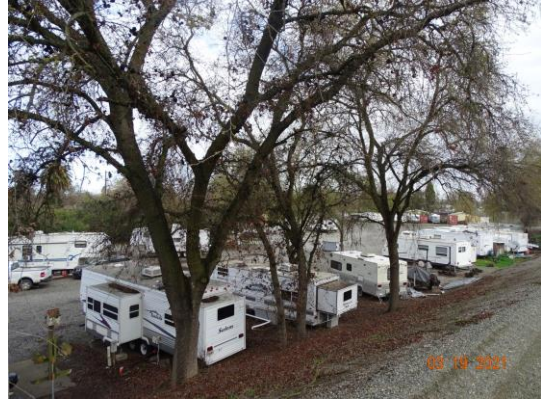
Photo 1 of 1 : SP\_2024\_MA0001\_297\_86\_20240212\_00018.jpg

LM Start	15.84	Rating **	U	Issue No.	86
LM End	15.90	Issue Type +	En	Location *	LS
Category	Earthen Levee			GPS Latitude/Longitude	
				Start	End
Item	Encroachments			39.400601°	39.401365°
				-122.009889°	-122.009374°
DWR ID	DWR_MA0001_01_s_2016_86				
Comment Code					
BU : Building					
Inspector Comment					
Mobile homes and trailers are within the landside toe easement.

View of the mobile homes along the landside toe. Spring 2021.

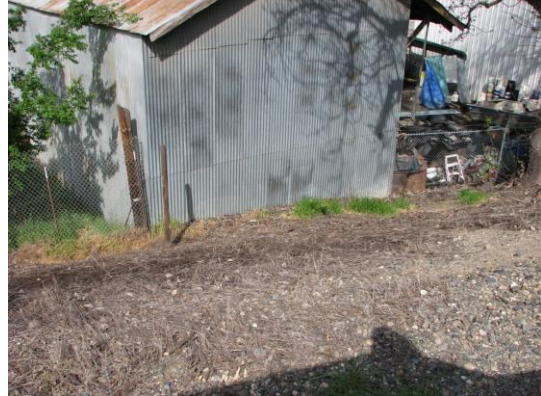
Photo 1 of 1 : SP\_2024\_MA0001\_297\_90\_20240212\_00021.jpg

LM Start	16.03	Rating **	U	Issue No.	90
LM End	16.03	Issue Type +	En	Location *	LS
Category	Earthen Levee			GPS Latitude/Longitude	
				Start	End
Item	Encroachments			39.403206°	39.403206°
				-122.009116°	-122.009116°
DWR ID	DWR_MA0001_01_s_2023_90				
Comment Code					
BU : Building					
Inspector Comment					
Metal sided building is at the landside toe.

View of a corrugated metal building obstructing visibility and access.

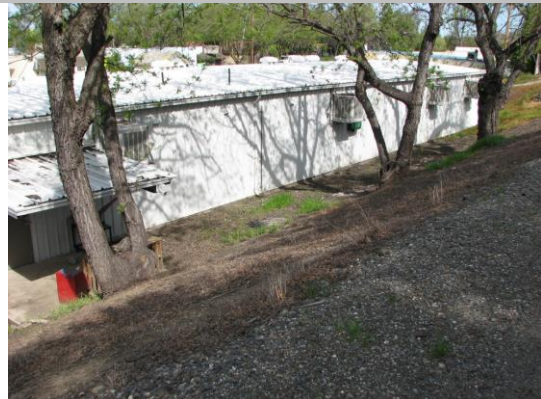
Photo 1 of 1 : SP\_2024\_MA0001\_297\_91\_20240212\_00022.jpg

LM Start	16.06	Rating **	U	Issue No.	91
LM End	16.06	Issue Type +	En	Location *	LS
Category	Earthen Levee			GPS Latitude/Longitude	
				Start	End
Item	Encroachments			39.403565°	39.403565°
				-122.009039°	-122.009039°
DWR ID	DWR_MA0001_01_s_2016_91				
Comment Code					
BU : Building					
Inspector Comment					
Long, white metal building with several AC units is at the landside toe.

View of a building obstructing access.

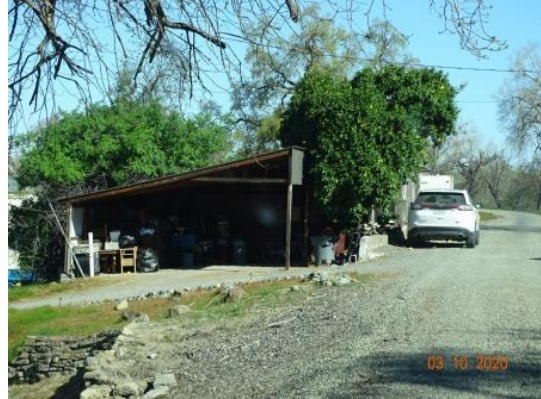
Photo 1 of 1 : SP\_2024\_MA0001\_297\_26\_20240212\_00010.jpg

LM Start	16.10	Rating **	U	Issue No.	26
LM End	16.10	Issue Type +	En	Location *	LS
Category	Earthen Levee			GPS Latitude/Longitude	
				Start	End
Item	Encroachments			39.404135°	39.404135°
				-122.008797°	-122.008797°
DWR ID	DWR_MA0001_01_s_2012_26				
Comment Code					
BU : Building					
Inspector Comment

View of the building on the landside slope. Spring 2020.

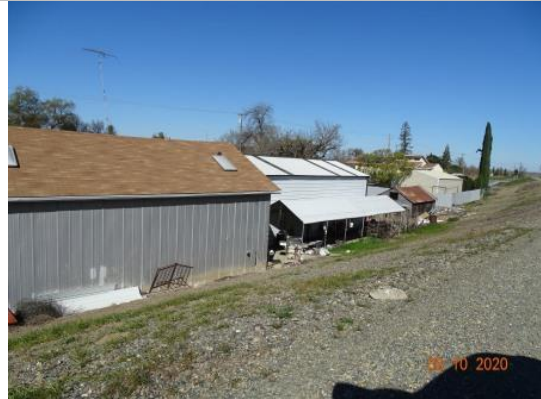
Photo 1 of 1 : SP\_2024\_MA0001\_297\_46\_20240212\_00011.jpg

LM Start	16.31	Rating **	U	Issue No.	46
LM End	16.33	Issue Type +	En	Location *	LS
Category	Earthen Levee			GPS Latitude/Longitude	
				Start	End
Item	Encroachments			39.407225°	39.407545°
				-122.008570°	-122.008640°
DWR ID	DWR_MA0001_01_s_2012_46				
Comment Code					
BU : Building					
Inspector Comment

View of the buildings along the landside toe. Spring 2020.

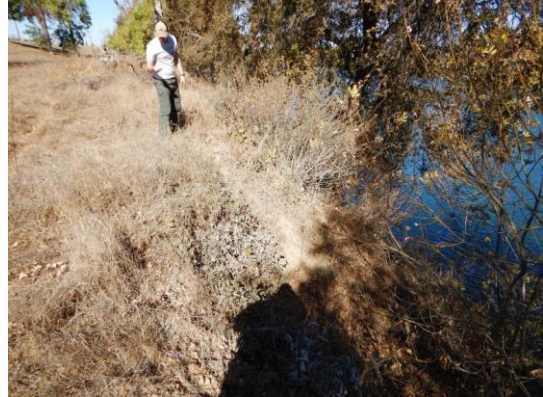
Photo 1 of 2 : SP\_2024\_MA0001\_297\_9\_20240212\_00006.jpg

Site History: Erosion site added in 1997 and removed in 2005. 2009 - Site added back in, hard toe with slow moving erosion. Potential geotechnical failure. 2011 - Site extended downstream. 2017 - New erosion along entire site.

LM Start	<b>16.35</b>	Rating **	A/W	Issue No.	<b>9 (cont)</b>
LM End	<b>16.58</b>	Issue Type +	Ma	Location *	WS

USACE 2018 Erosion Photo #1
