**Flood Control Project Maintenance  
Levee Inspections**

**Maintenance Issue Types Only, Levee Inspection Report By Mile - Spring 2020**

**Sutter Maintenance Yard Maintenance Area 0001**

Waterway	Bank	Unit Miles	Inspection Start/End	Inspector
Unit No. 01 Sacramento River	Right	16.76	03/10/2020 03/10/2020	Makar Sokol

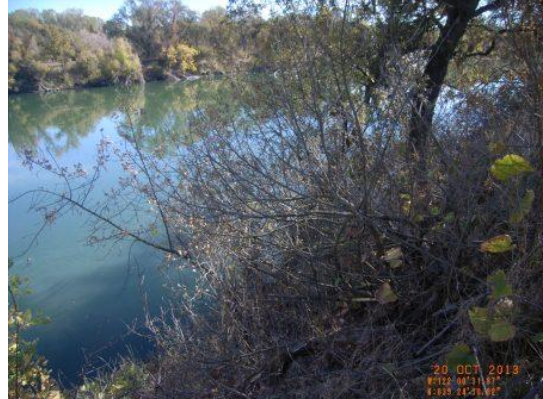
Photo 2 of 2 : SP\_2020\_MA0001\_297\_9\_20200226\_00006.jpg

LM Start	16.35	Rating **	A/W	Issue No.	9
LM End	16.58	Issue Type +	Ma	Location *	WS
Category	Supplemental			GPS Latitude/Longitude	
				Start	End
Item	2017 USACE Erosion Survey			39.407837 °	39.411111 °
				-122.008763 °	-122.009238 °
DWR ID	DWR_ST0010_02_f_2022_7				
Comment Code					
Inspector Comment					
2017 Site ID: SAC 164.3 R					
Status: Eroding					
2017 Field Notes: New erosion along entire site.					
Site History: Erosion site added in 1997 and removed in 2005. 2009 -					
Site added back in, hard toe with slow moving erosion. Potential					
geotechnical failure. 2011 - Site extended downstream.

LM Start	16.35	Rating **	A/W	Issue No.	9 (cont)	
LM End	16.58	Issue Type +	Ma	Location *	WS	
Category	Supplemental			GPS Latitude/Longitude		
				Start		End
Item	2017 USACE Erosion Survey			39.407837 °		39.411111 °
				-122.008763 °		-122.009238 °
DWR ID	DWR_ST0010_02_f_2022_7
