**Flood Control Project Maintenance
Levee Inspections**

Maintenance Issue Types Only, Levee Inspection Report By Mile - Spring 2022

Sutter Maintenance Yard Maintenance Area 0001

Waterway	Bank	Unit Miles	Inspection Start/End	Inspector
Unit No. 01 Sacramento River	Right	16.76	04/05/2022 04/05/2022	Makar Sokol

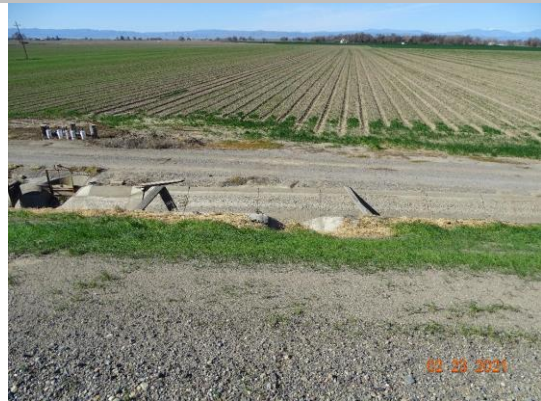
Photo 3 of 3 : UCIP_SP_2022_62896_91332.jpg

LM Start	3.33	Rating **	M	Issue No.	24 (cont)
LM End	3.33	Issue Type +	Ma	Location *

Land-Side: View of levee slope looking from crown
