**Flood Control Project Maintenance
Levee Inspections**
LMA District Cover Sheet
Spring 2020 Levee Inspection Results

Sacramento Maintenance Yard Maintenance Area 0004

Spring 2020 Levee Inspection Results

Waterway			Bank	Unit Miles
Unit No. 01 Sacramento River			Right	3.47
	Spring (March - May)	Summer (June - August)	(September - November) Fall	Winter (December - February)
Unit Maintenance Rating (Fall Only)				
Date of Inspection	4/9/2020 - 4/9/2020			
DWR Inspector	Luz Dial			
Accompanied By

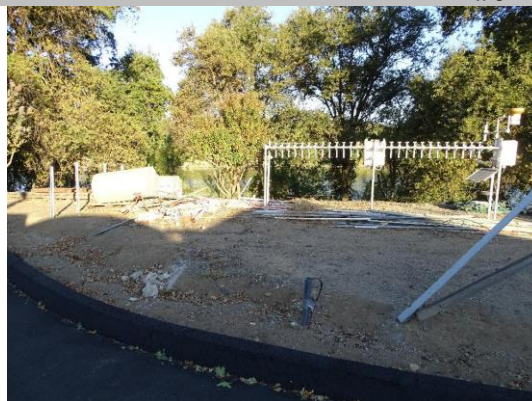
Photo 2 of 3 : UCIP_SP_2020_55304_83345.jpg

LM Start	0.46	Rating **	M	Issue No.	77 (cont)
LM End	0.46	Issue Type +	En	Location *	
Category	Supplemental		GPS Latitude/Longitude		
			Start	End	
Item	DWR UCIP Field Study		38.599205 °	38.599205 °	
			-121.540303 °	-121.540303 °	
DWR ID	25552

View of levee crown at the crossing

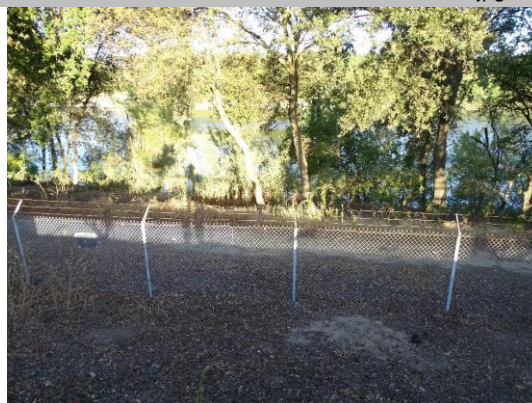
Photo 3 of 3 : UCIP_SP_2020_55304_83346.jpg

LM Start	0.46	Rating **	M	Issue No.	77 (cont)
LM End	0.46	Issue Type +	En	Location *

View of WS levee slope

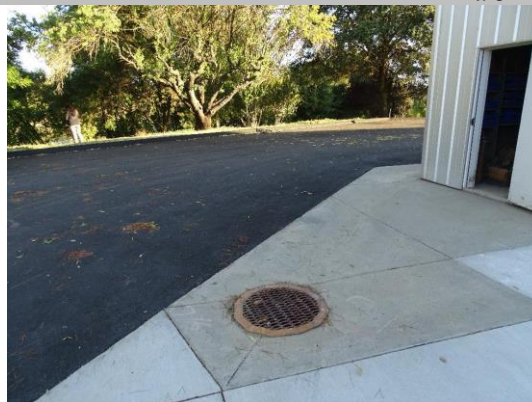
Photo 2 of 3 : UCIP_SP_2020_55305_83347.jpg

Comment Code						
Inspector Comment						
DS_ID:25550 FS_ID:55305 EP_NO: N/A Repair Type: Non-Urgent Crossing Status: Not Found UCIP Comments: 10/10/2019 Record remains Non-Urgent. Crossing not found. According to FMO staff this pipe was disconnected from Sac Yard storm drainage system and grouted in place. Unable to locate a permit and confirm proper pipe abandonment. No permit has been identified authorizing pipe. (O.Yakimov - DWR UCIP) 09/07/2018 Crossing not found (O.Yakimov - DWR UCIP) FIELD_STRUCT_DESC: 6-inch vitrified clay drainage pipe through the levee, 16.1 feet below levee crown. [Additional Reference(s): USACE Sacramento O&M Manual 116, August 1955), Dwg No. 50-4-4179, page 9 of 19]. FS Date: 10/10/2019 9:04:32 AM

LM Start	0.48	Rating **	M	Issue No.	78 (cont)
LM End	0.48	Issue Type +	En	Location *

View of crown at crossing

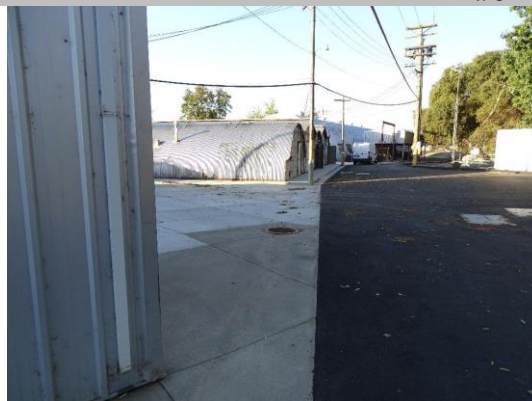
Photo 3 of 3 : UCIP_SP_2020_55305_83348.jpg

LM Start	0.48	Rating **	M	Issue No.	78 (cont)
LM End	0.48	Issue Type +	En	Location *	
Category	Supplemental		GPS Latitude/Longitude		
			Start	End	
Item	DWR UCIP Field Study		38.599396 °	38.599396 °	
			-121.540026 °	-121.540026 °	
DWR ID	25550

View of crown at crossing

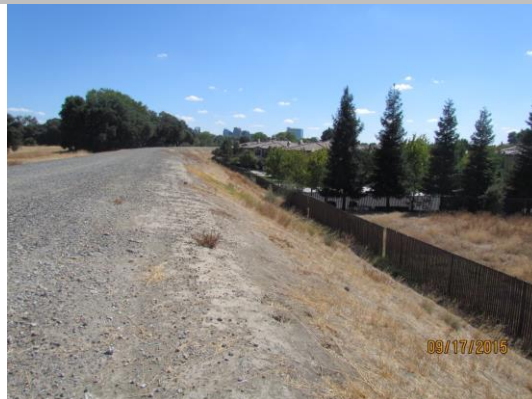
Photo 1 of 1 : SP_2020_MA0004_298_14_20200302_00007.jpg

LM Start	2.02	Rating **	M	Issue No.	14
LM End	2.21	Issue Type +	En	Location *	LS
Category	Earthen Levee			GPS Latitude/Longitude	
				Start	End
Item	Encroachments			38.599813 °	38.597533 °
				-121.513978 °	-121.513134 °
DWR ID	DWR_MA0004_01_s_2017_14				
Comment Code					
FE : Fence					
Inspector Comment					
A fence runs along the toe of the landside levee.

View of the fence running along the toe of the landward side of the levee looking downstream. Fall 2015.

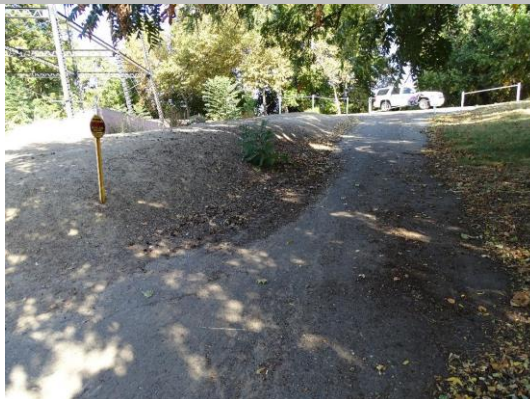
Photo 3 of 3 : UCIP_SP_2020_55310_81565.jpg

LM Start	2.78	Rating **	M	Issue No.	86 (cont)
LM End	2.78	Issue Type +	En	Location *	
Category	Supplemental		GPS Latitude/Longitude		
			Start	End	
Item	DWR UCIP Field Study		38.590100 °	38.590100 °	
			-121.509693 °	-121.509693 °	
DWR ID	265

Petroleum line marker and ramp on LS

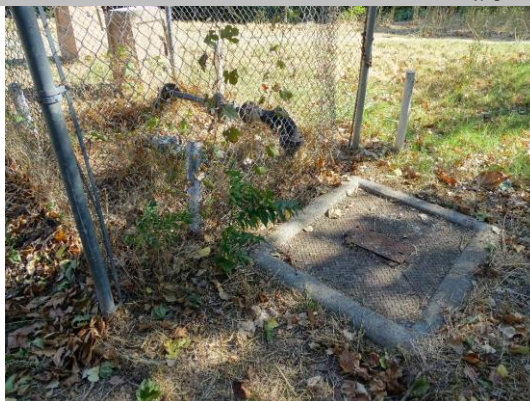
Photo 1 of 3 : UCIP_SP_2020_55311_81566.jpg

LM Start	2.78	Rating **	M	Issue No.	87
LM End	2.78	Issue Type +	En	Location *	
Category	Supplemental		GPS Latitude/Longitude		
			Start	End	
Item	DWR UCIP Field Study		38.590111 °	38.590111 °	
			-121.509695 °	-121.509695 °	
DWR ID	19406

DS_ID:19406
 FS_ID:55311
 EP_NO: N/A
 Repair Type: Non-Urgent
 Crossing Status: Found
 UCIP Comments: 10/10/2019 Record remains Non-Urgent. No permit for this crossing was found. (O.Yakimov - DWR UCIP) 09/12/2012 Found during field survey. Not listed in the desk study. (P. Amatya - DWR UCIP)
 FIELD_STRUCT_DESC: 1 of 2: 3-inch wrapped galvanized iron (GI) water pipe through the levee, at an unknown depth. Pipe daylights in a metal cage box. Valve box for the pipe is also found.
 FS Date: 10/10/2019 11:45:35 AM

Waterside view: a control valve box with a metal lid

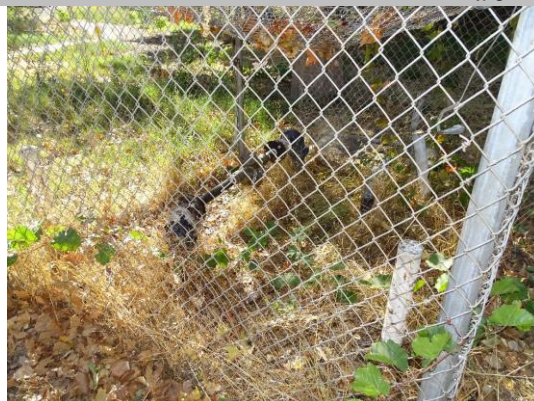
Photo 2 of 3 : UCIP_SP_2020_55311_81567.jpg

LM Start	2.78	Rating **	M	Issue No.	87 (cont)
LM End	2.78	Issue Type +	En	Location *	
Category	Supplemental		GPS Latitude/Longitude		
			Start	End	
Item	DWR UCIP Field Study		38.590111 °	38.590111 °	
			-121.509695 °	-121.509695 °	
DWR ID	19406

Waterside view: pipe daylights in a metal cage

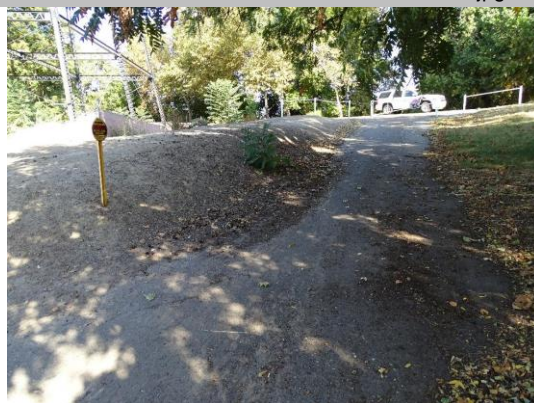
Photo 3 of 3 : UCIP_SP_2020_55311_81568.jpg

LM Start	2.78	Rating **	M	Issue No.	87 (cont)
LM End	2.78	Issue Type +	En	Location *

View of landside at the crossing

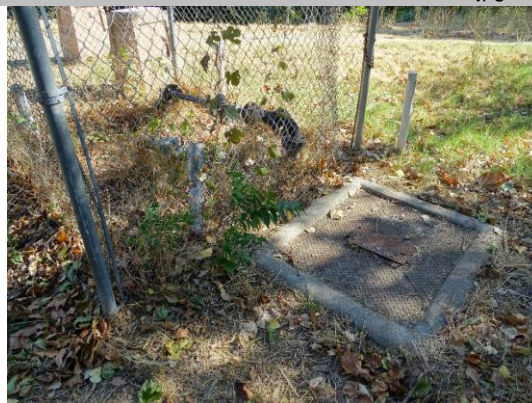
Photo 2 of 3 : UCIP_SP_2020_55312_81570.jpg

LM Start	2.78	Rating **	M	Issue No.	88
LM End	2.78	Issue Type +	En	Location *	
Category	Supplemental			GPS Latitude/Longitude	
				Start	End
Item	DWR UCIP Field Study			38.590105 °	38.590105 °
				-121.509687 °	-121.509687 °
DWR ID	19407				
Comment Code					
Inspector Comment					
DS_ID:19407 FS_ID:55312 EP_NO: N/A Repair Type: Non-Urgent Crossing Status: Found UCIP Comments: 10/10/2019 Record remains Non-Urgent. No permit has been found authorizing this pipe through the levee. (O.Yakimov - DWR UCIP) 09/12/2012 Found during field survey. Not listed in the desk study. (P. Amatya - DWR UCIP) FIELD_STRUCT_DESC: 2 of 2: 5-inch wrapped galvanized iron (GI) water pipe through the levee, at an unknown depth. Pipe daylights in a metal cage box. Valve box for the pipe is also found. FS Date: 10/10/2019 11:57:04 AM

LM Start	2.78	Rating **	M	Issue No.	88 (cont)
LM End	2.78	Issue Type +	En	Location *

Waterside view: a control valve box with a metal lid

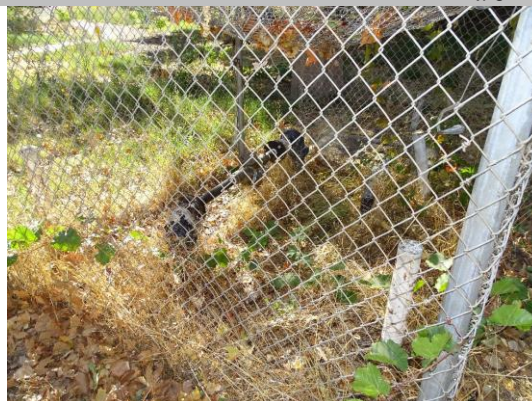
Photo 3 of 3 : UCIP_SP_2020_55312_81571.jpg

LM Start	2.78	Rating **	M	Issue No.	88 (cont)
LM End	2.78	Issue Type +	En	Location *	
Category	Supplemental			GPS Latitude/Longitude	
				Start	End
Item	DWR UCIP Field Study			38.590105 °	38.590105 °
				-121.509687 °	-121.509687 °
DWR ID	19407

Waterside view: pipe daylights in a metal cage

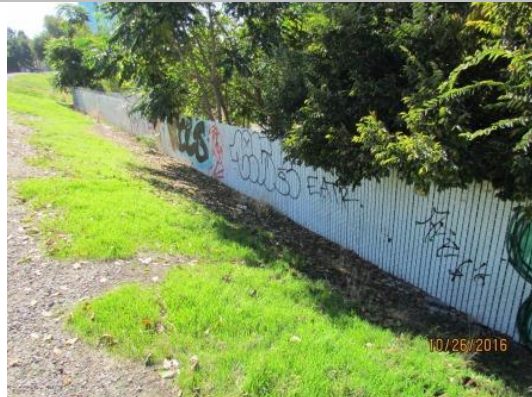
Photo 1 of 1 : SP_2020_MA0004_298_23_20200302_00015.jpg

LM Start	2.92	Rating **	U	Issue No.	23
LM End	2.95	Issue Type +	En	Location *	LS
Category	Earthen Levee			GPS Latitude/Longitude	
				Start	End
Item	Encroachments			38.588762 °	38.588384 °
				-121.507951 °	-121.507894 °
DWR ID	DWR_MA0004_01_f _ 2016_23				
Comment Code					
FE : Fence					
Inspector Comment

View of fence on LS slope. Fall 2016.

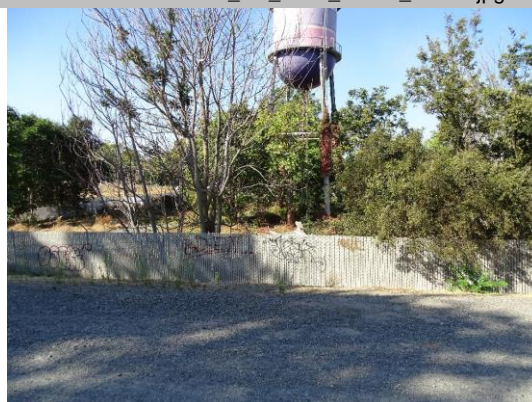
Photo 2 of 3 : UCIP_SP_2020_55314_81574.jpg

Land side view- inside water tower area

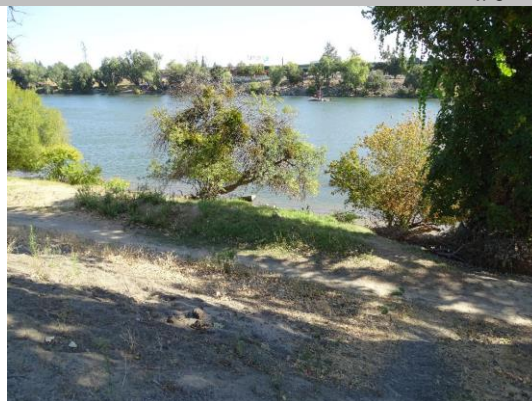
Photo 2 of 3 : UCIP_SP_2020_55315_81577.jpg

LM Start	2.93	Rating **	M	Issue No.	91 (cont)	
LM End	2.93	Issue Type +	En	Location *		
Category	Supplemental			GPS Latitude/Longitude		
				Start	End	
Item	DWR UCIP Field Study			38.588688 °	38.588688 °	
				-121.507910 °	-121.507910 °	
DWR ID	18883

Overview of waterside at pipe crossing

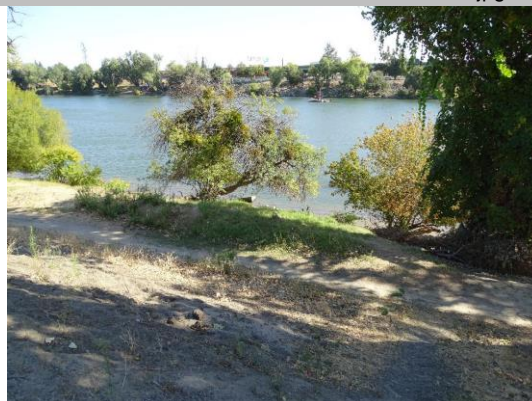
Photo 2 of 3 : UCIP_SP_2020_55316_81579.jpg

Overview of waterside at pipe crossing

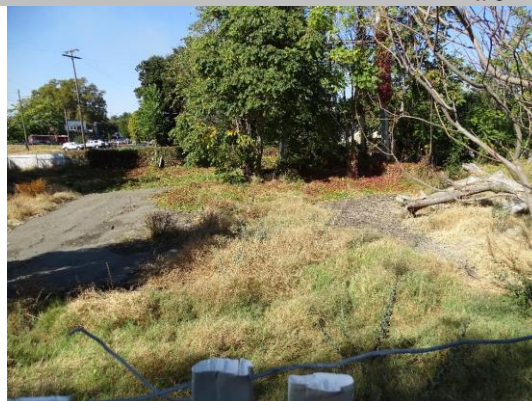
Photo 3 of 3 : UCIP_SP_2020_55316_81580.jpg

LM Start	2.93	Rating **	M	Issue No.	92 (cont)
LM End	2.93	Issue Type +	En	Location *	
Category	Supplemental			GPS Latitude/Longitude	
				Start	End
Item	DWR UCIP Field Study			38.588688 °	38.588688 °
				-121.507910 °	-121.507910 °
DWR ID	18885

View inside of water tower area

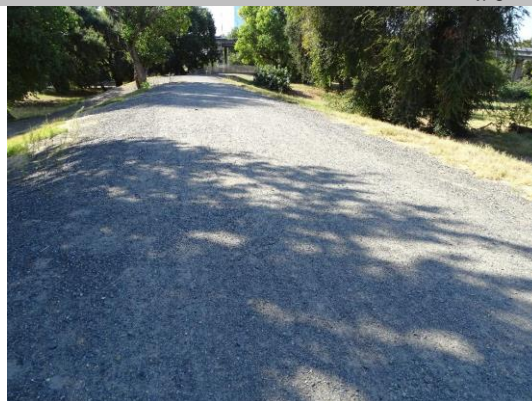
Photo 1 of 3 : UCIP_SP_2020_55317_81581.jpg

LM Start	2.99	Rating **	M	Issue No.	93 (cont)
LM End	2.99	Issue Type +	En	Location *

View of levee crown at possible crossing

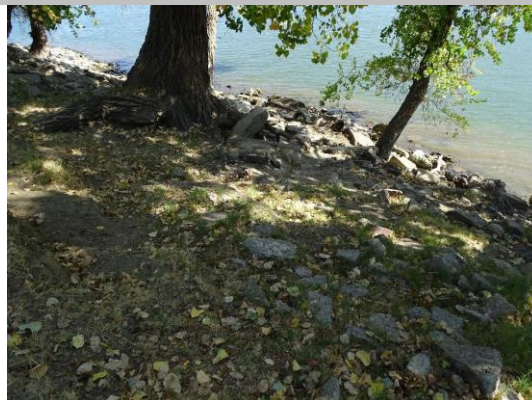
Photo 2 of 3 : UCIP_SP_2020_55317_81582.jpg

Riverbank near possible crossing

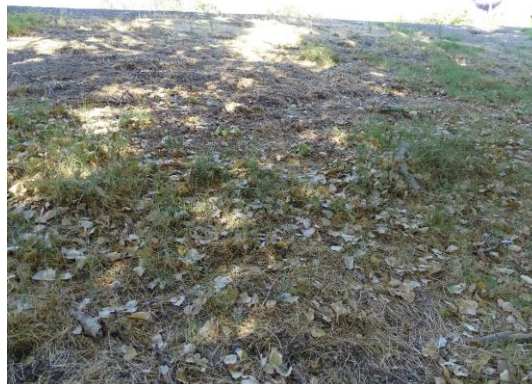
Photo 3 of 3 : UCIP_SP_2020_55317_81583.jpg

LM Start	2.99	Rating **	M	Issue No.	93 (cont)
LM End	2.99	Issue Type +	En	Location *	
Category	Supplemental			GPS Latitude/Longitude	
				Start	End
Item	DWR UCIP Field Study			38.587760 °	38.587760 °
				-121.507930 °	-121.507930 °
DWR ID	266

View of WS slope at possible crossing

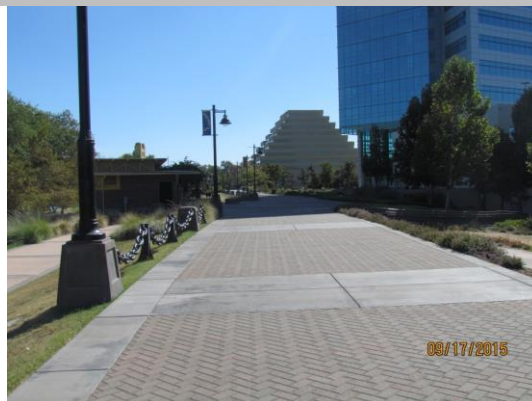
Photo 1 of 1 : SP_2020_MA0004_298_12_20200302_00003.jpg

LM Start	3.08	Rating **	A/W	Issue No.	12
LM End	3.45	Issue Type +	En	Location *	WS
Category	Earthen Levee			GPS Latitude/Longitude	
				Start	End
Item	Vegetation			38.586434 °	38.581349 °
				-121.508090 °	-121.509547 °
DWR ID	DWR_MA0004_01_s _ 2012_12				
Comment Code					
V6 : Landscaping					
Inspector Comment					
West Sacramento's River Walk runs from Tower Bridge to the I Street bridge.

The Riverwalk is part of the landscape on the levee. Fall 2015.

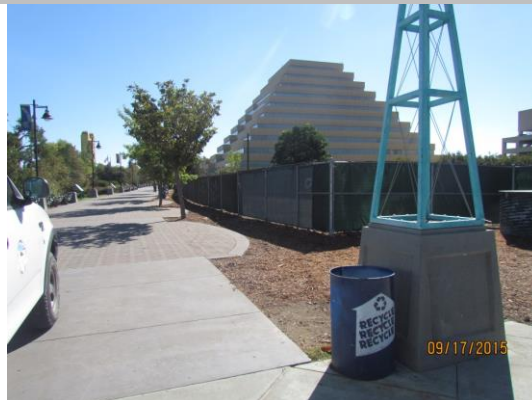
Photo 1 of 1 : SP_2020_MA0004_298_27_20200302_00018.jpg

LM Start	3.24	Rating **	M	Issue No.	27
LM End	3.29	Issue Type +	En	Location *	LS
Category	Earthen Levee			GPS Latitude/Longitude	
				Start	End
Item	Encroachments			38.584168 °	38.583435 °
				-121.508632 °	-121.508785 °
DWR ID	DWR_MA0004_01_f_2015_27				
Comment Code					
FE : Fence					
Inspector Comment					
The fence on the levee shoulder appears to be unauthorized.

View looking downstream at the fence on the crown of the levee . Fall 2015.
