**Flood Control Project Maintenance
Levee Inspections
LMA District Cover Sheet**

**Flood Control Project Maintenance
Levee Inspections
Unit Cover Sheet**

Levee Inspection Report By Mile - Spring 2022

Waterway	Bank	Unit Miles	Inspection Start/End	Inspector
Unit No. 01 Sacramento River	Right	3.47	03/28/2022 03/28/2022	Marvin Marshall

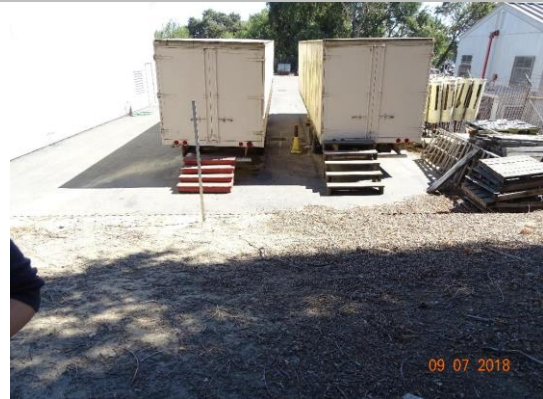
Photo 3 of 3 : UCIP_SP_2022_54255_80006.jpg

LM Start	0.38	Rating **	M	Issue No.	5 (cont)	
LM End	0.38	Issue Type +	En	Location *		
Category	Supplemental			GPS Latitude/Longitude		
				Start	End	
Item	DWR UCIP Field Study			38.598480 °	38.598480 °	
				-121.541376 °	-121.541376 °	
DWR ID	25547

View of landside looking from levee crown

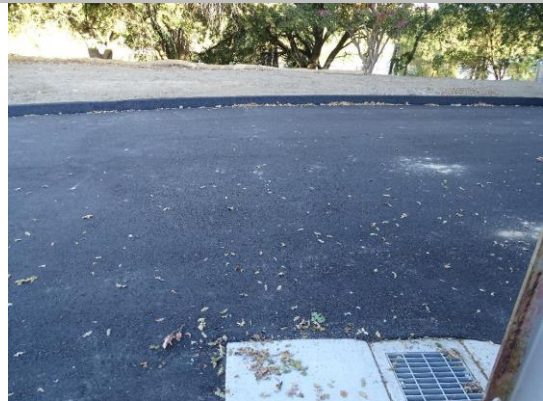
Photo 3 of 3 : UCIP_SP_2022_58977_81539.jpg

LM Start	0.43	Rating **	M	Issue No.	8 (cont)
LM End	0.43	Issue Type +	En	Location *

Drainage box on levee crown

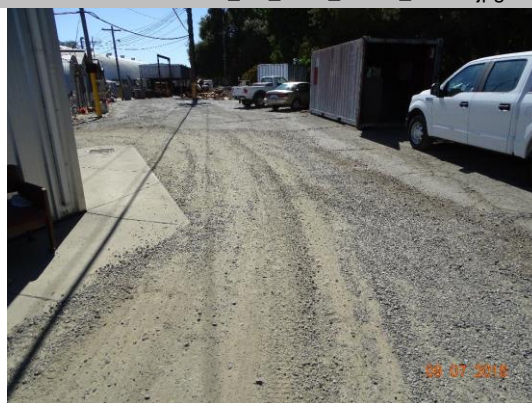
Photo 1 of 3 : UCIP_SP_2022_58714_80008.jpg

FS_ID:58714
 DS_ID:25550
 EP_NO: N/A
 Repair Type: Non-Urgent
 Crossing Status: Not Found
 UCIP Comments: 10/10/2019 Record remains Non-Urgent. Crossing not found. According to FMO staff this pipe was disconnected from Sac Yard storm drainage system and grouted in place. Unable to locate a permit and confirm proper pipe abandonment. No permit has been identified authorizing pipe. (O.Yakimov - DWR UCIP) 09/07/2018
 Crossing not found (O.Yakimov - DWR UCIP)
 FIELD_STRUCT_DESC: 6-inch vitrified clay drainage pipe through the levee, 16.1 feet below levee crown. [Additional Reference(s): Drawing No. 50-04-4179, Sheet 11.2 and 18.1, pdf page 9 and 17 of 19, associated with USACE Sacramento O&M Manual, Unit 116, August 1955, Revised 29 Dec 2016, shows combination of 6-inch vitrified clay pipe and 8-inch CMP referenced as Sta 56+96 (Site Mile 62.25 RT)]
 FS Date: 10/10/2019 9:04:00 AM

Top of levee at crossing

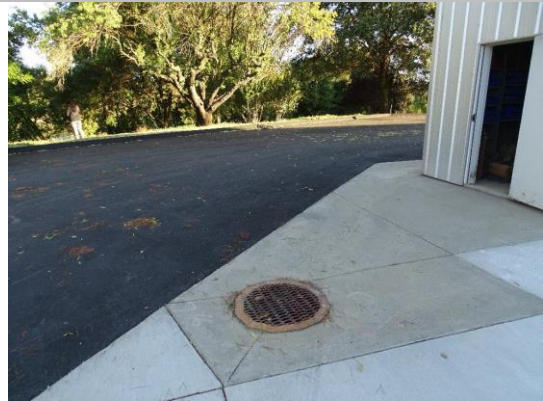
Photo 2 of 3 : UCIP_SP_2022_58714_83347.jpg

LM Start	0.48	Rating **	M	Issue No.	16 (cont)
LM End	0.48	Issue Type +	En	Location *	
Category	Supplemental		GPS Latitude/Longitude		
			Start	End	
Item	DWR UCIP Field Study		38.599396 °	38.599396 °	
			-121.540026 °	-121.540026 °	
DWR ID	25550

View of crown at crossing

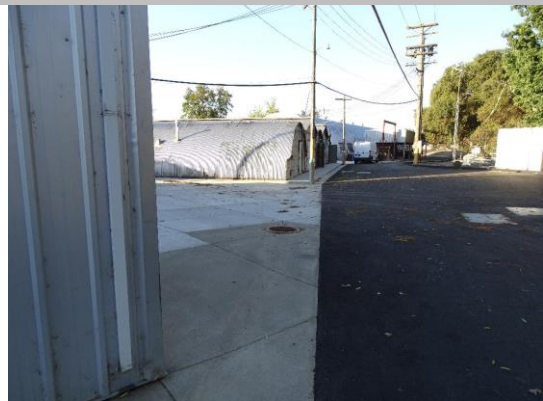
Photo 3 of 3 : UCIP_SP_2022_58714_83348.jpg

LM Start	0.48	Rating **	M	Issue No.	16 (cont)
LM End	0.48	Issue Type +	En	Location *

View of crown at crossing

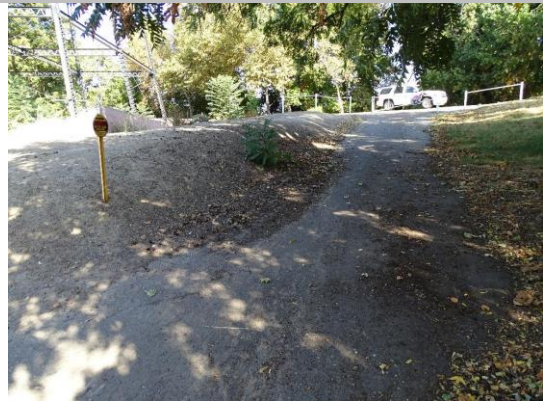
Photo 3 of 3 : UCIP_SP_2022_58716_81568.jpg

FS_ID:58716
 DS_ID:19406
 EP_NO: N/A
 Repair Type: Non-Urgent
 Crossing Status: Found
 UCIP Comments: 10/10/2019 Record remains Non-Urgent. No permit for this crossing was found. (O.Yakimov - DWR UCIP) 09/12/2012 Found during field survey. Not listed in the desk study. (P. Amatya - DWR UCIP)
 FIELD_STRUCT_DESC: 1 of 2: 3-inch wrapped galvanized iron (GI) water pipe through the levee, at an unknown depth. Pipe daylights in a metal cage box. Valve box for the pipe is also found.
 FS Date: 10/10/2019 11:45:00 AM

LM Start	2.78	Rating **	M	Issue No.	28 (cont)
LM End	2.78	Issue Type +	En	Location *

View of landside at the crossing

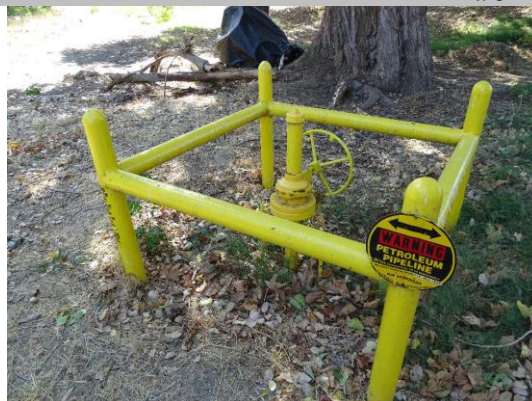
Photo 2 of 3 : UCIP_SP_2022_55310_81564.jpg

LM Start	2.78	Rating **	M	Issue No.	30 (cont)
LM End	2.78	Issue Type +	En	Location *	
Category	Supplemental		GPS Latitude/Longitude		
			Start	End	
Item	DWR UCIP Field Study		38.590100 °	38.590100 °	
			-121.509693 °	-121.509693 °	
DWR ID	265

Petroleum line marker on WS

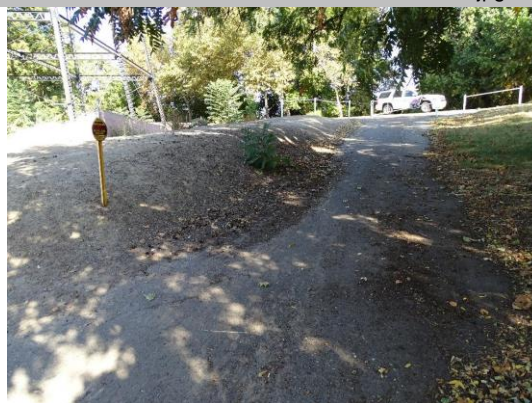
Photo 3 of 3 : UCIP_SP_2022_55310_81565.jpg

LM Start	2.78	Rating **	M	Issue No.	30 (cont)
LM End	2.78	Issue Type +	En	Location *

Petroleum line marker and ramp on LS

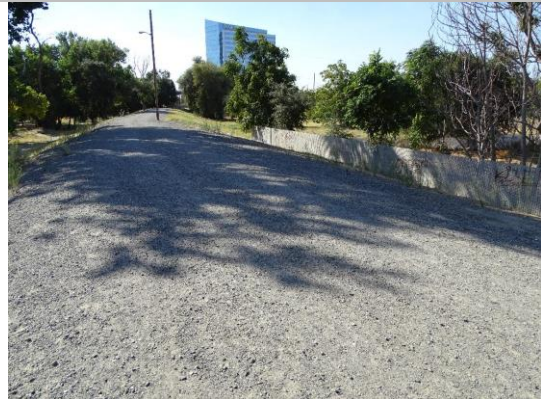
Photo 1 of 3 : UCIP_SP_2022_59773_81572.jpg

LM Start	2.93	Rating **	M	Issue No.	32 (cont)
LM End	2.93	Issue Type +	En	Location *

View of levee crown at crossing

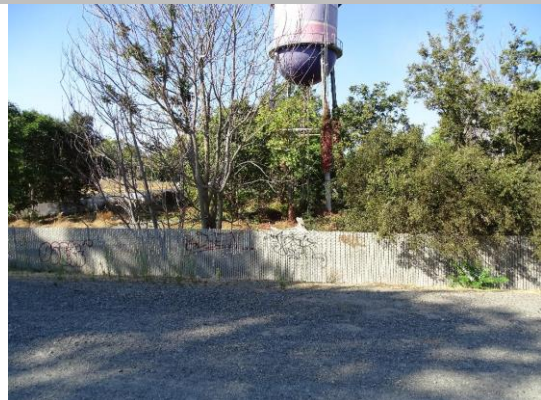
Photo 2 of 3 : UCIP_SP_2022_59773_81574.jpg

Land side view- inside water tower area

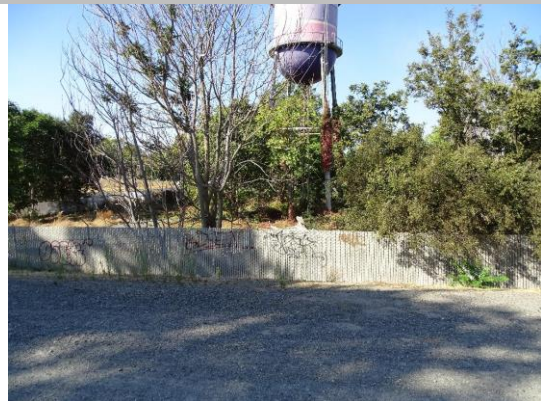
Photo 1 of 3 : UCIP_SP_2022_59775_81578.jpg

Land side view: water tower area

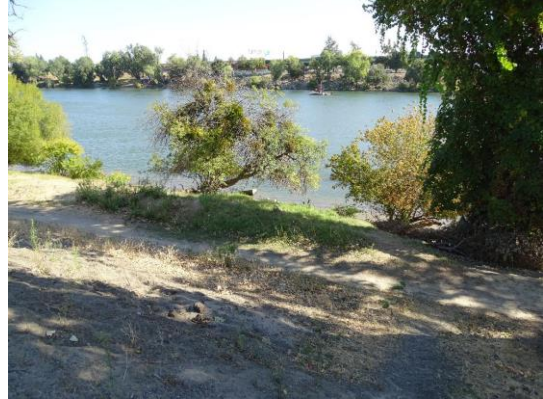
Photo 2 of 3 : UCIP_SP_2022_59775_81579.jpg

LM Start	2.93	Rating **	M	Issue No.	33 (cont)
LM End	2.93	Issue Type +	En	Location *	
Category	Supplemental			GPS Latitude/Longitude	
				Start	End
Item	DWR UCIP Field Study			38.588688 °	38.588688 °
				-121.507910 °	-121.507910 °
DWR ID	18885

Overview of waterside at pipe crossing

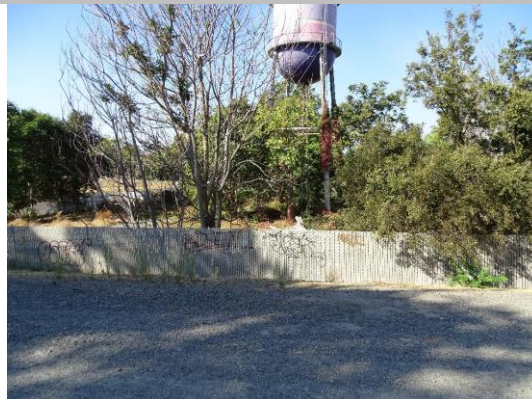
Photo 1 of 3 : UCIP_SP_2022_59774_81576.jpg

Comment Code					
Inspector Comment					
FS_ID:59774 DS_ID:18883 EP_NO: N/A Repair Type: Non-Urgent Crossing Status: Found UCIP Comments: 10/10/2019 Record remains Non-Urgent. Crossing appears abandoned. Geophysical results did not confirm presence of pipe through levee. Record will remain in UCIP's inspection records until future Levee Improvement Project can confirm no crossing was found through the levee. No permit has been identified authorizing pipe. (O.Yakimov - DWR UCIP) 09/12/2012 Abandoned 7-inch pipe found. Needs to be abandoned properly. (P. Amatya - DWR UCIP) FIELD_STRUCT_DESC: 3 of 4: 7-inch pipe of an unknown material or purpose through the levee, 18.6 feet below the crown. Unable to locate. Pipe exposed and extends 10 feet from the bank and 5 feet above current water surface. Needs to be removed or grouted. [Additional Reference(s): DWR Levee Log, 2005 (HLM 2.88). USACE Sacramento O&M Manual, Unit 116, August 1955, Revised 29 Dec 2016, (RM 59.65), listed as one 3-inch, one 10-inch steel, and two 7-inch pipes; no USACE As-Built Drawing found for these pipes]. FS Date: 10/10/2019 1:49:00 PM

Land side view: water tower area

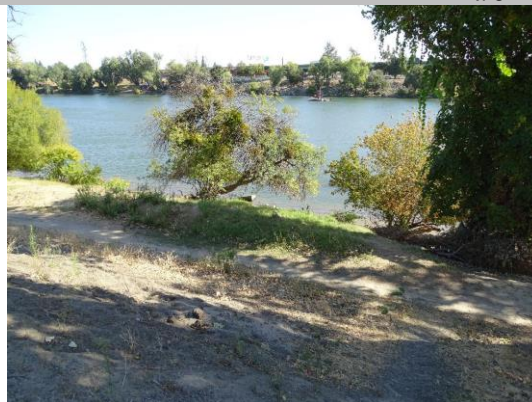
Photo 2 of 3 : UCIP_SP_2022_59774_81577.jpg

LM Start	2.93	Rating **	M	Issue No.	34 (cont)
LM End	2.93	Issue Type +	En	Location *

Overview of waterside at pipe crossing

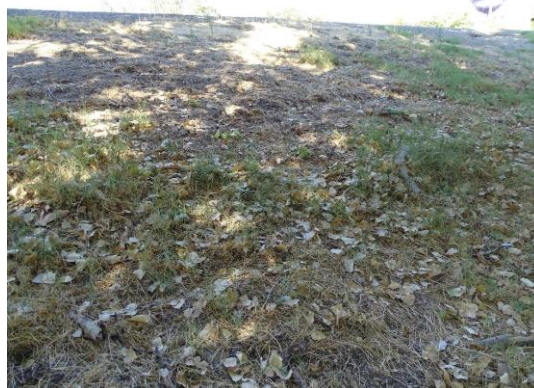
Photo 3 of 3 : UCIP_SP_2022_55317_81583.jpg

LM Start	2.99	Rating **	M	Issue No.	35 (cont)
LM End	2.99	Issue Type +	En	Location *

View of WS slope at possible crossing

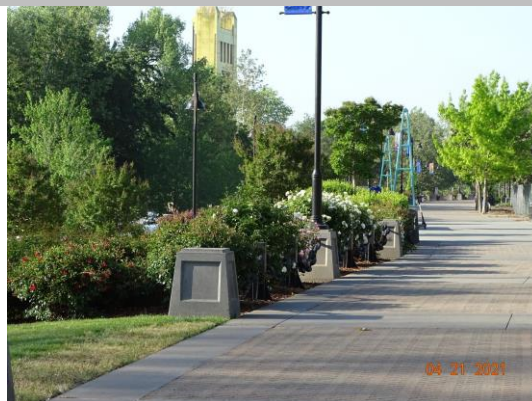
Photo 1 of 1 : SP_2022_MA0004_298_12_20220307_00003.jpg

LM Start	3.08	Rating **	A/W	Issue No.	12
LM End	3.45	Issue Type +	En	Location *	WS
Category	Earthen Levee			GPS Latitude/Longitude	
				Start	End
Item	Vegetation			38.586434 °	38.581349 °
				-121.508090 °	-121.509547 °
DWR ID	DWR_MA0004_01_s_2012_12				
Comment Code					
V6 : Landscaping					
Inspector Comment					
West Sacramento's River Walk runs from the Tower Bridge to the I Street bridge.

View of the landscaping on River Walk. Spring 2021.

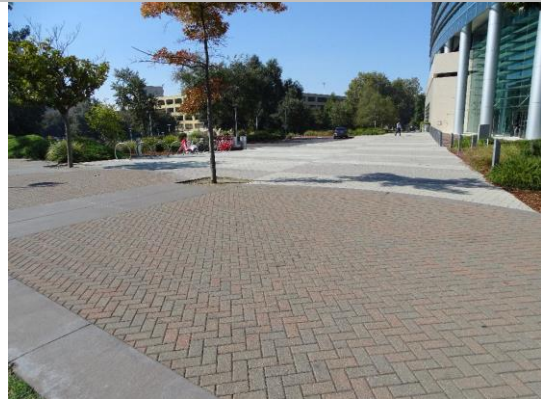
Photo 1 of 1 : UCIP_SP_2022_55346_81587.jpg

LM Start	3.20	Rating **	M	Issue No.	36
LM End	3.20	Issue Type +	En	Location *	
Category	Supplemental			GPS Latitude/Longitude	
				Start	End
Item	DWR UCIP Field Study			38.584860 °	38.584860 °
				-121.508500 °	-121.508500 °
DWR ID	268				
Comment Code					
Inspector Comment					
FS_ID:55346 DS_ID:268 EP_NO: 17058 Repair Type: Non-Urgent Crossing Status: Not Found UCIP Comments: 10/10/2019 Record updated from No Action Needed to Non-Urgent, unable to determine status of crossing. Crossing not found. (O.Yakimov - DWR UCIP) FIELD_STRUCT_DESC: Three 2-inch and two 1.5-inch fiber optics conduits of an unknown material across and bored under the Sacramento River and its west levee. Note in permit indicates this was not installed. FS Date: 10/10/2019 1:36:42 PM

Paved levee crown at possible crossing

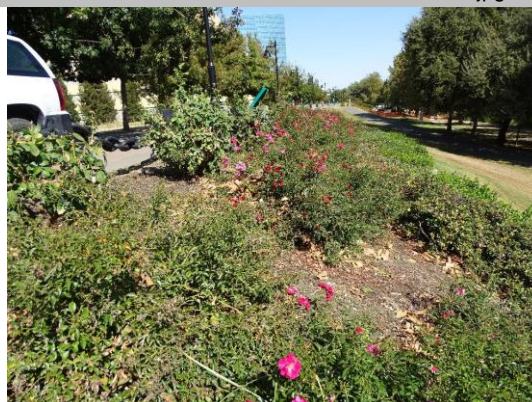
Photo 2 of 2 : UCIP_SP_2022_55349_81592.jpg

LM Start	3.42	Rating **	M	Issue No.	37 (cont)
LM End	3.42	Issue Type +	En	Location *

View of WS slope at potential crossing
